# OPEL Corsa

## Corsa 1.4 Turbo (ecoFLEX) Start/Stop

VIN NO W0V0XEP68J4261812  
Registration Number 68J4261812

### Inspection Report Summary

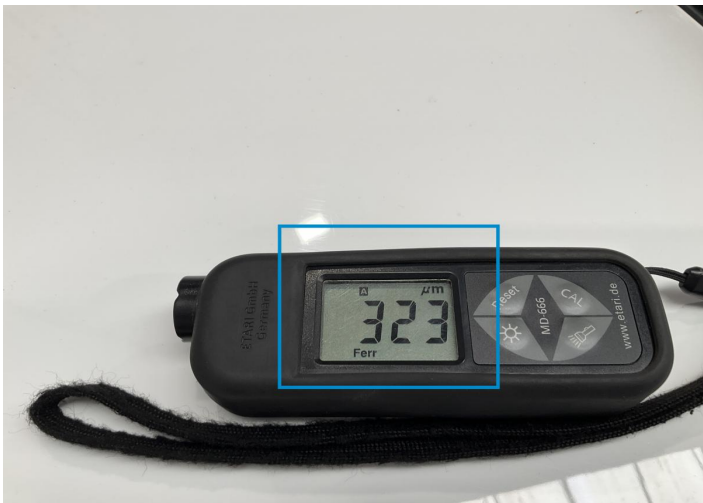
| Component | Damage | Comments |
|---|---|---|
| 1 Other | Anomalyon Element | |

1.  
Anomalyon Element -

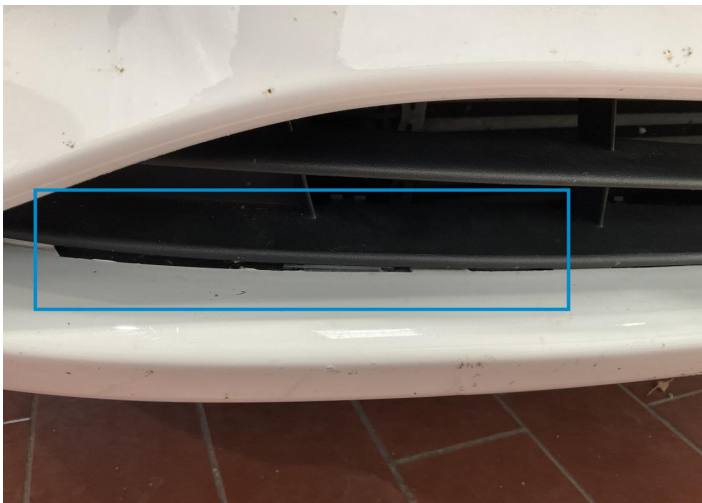
| Component | Damage | Comments |
|---|---|---|
| 2 Blade/spoiler / Front | Bodywork / Breakage | |

2. Blade/spoiler / Front  
Bodywork / Breakage -

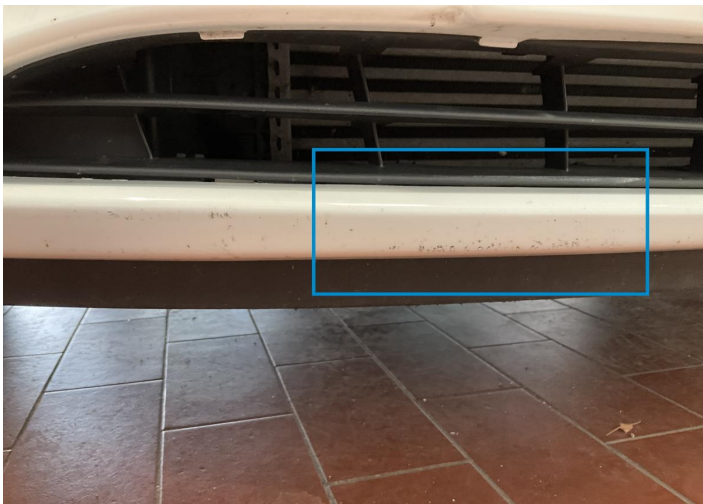
| Component | Damage | Comments |
|---|---|---|
| 3 Bumper / Front | Paint / Scratch / Scuff | |

3. Bumper / Front  
Paint / Scratch / Scuff -

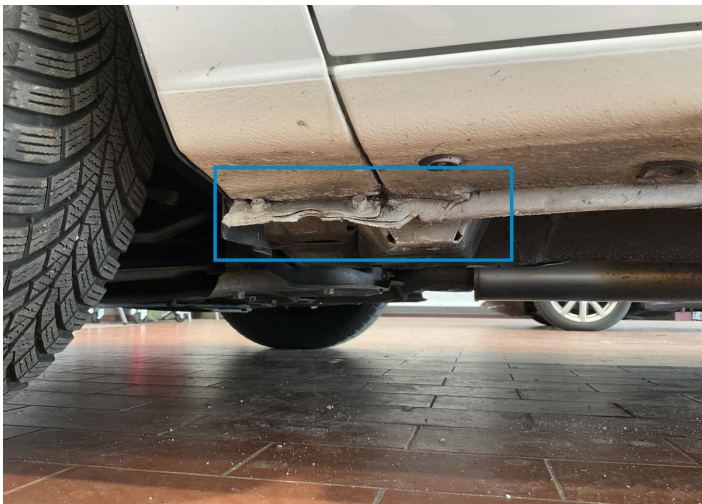
| Component | Damage | Comments |
|---|---|---|
| 4 Rocker Panel / Center Left | Bodywork / Dent / Dent | |

4. Rocker Panel / Center Left  
Bodywork / Dent / Dent -

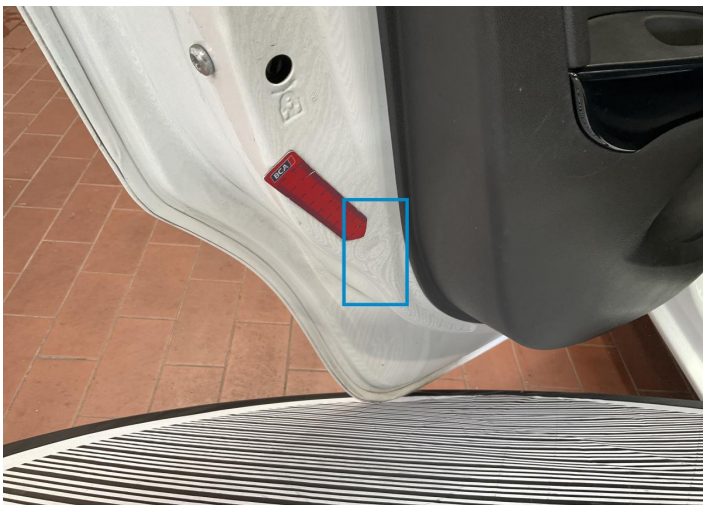
| Component | Damage | Comments |
|---|---|---|
| 5 Door / Back Left | Bodywork / Dent / Dent | |

5. Door / Back Left  
Bodywork / Dent / Dent -

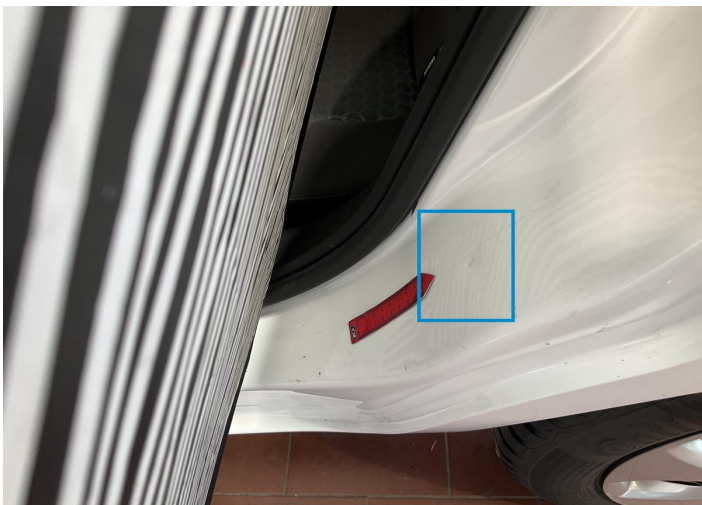
| Component | Damage | Comments |
|---|---|---|
| 6 Door Edge / Back Left | Bodywork / Dent / Dent | |

6. Door Edge / Back Left  
Bodywork / Dent / Dent -

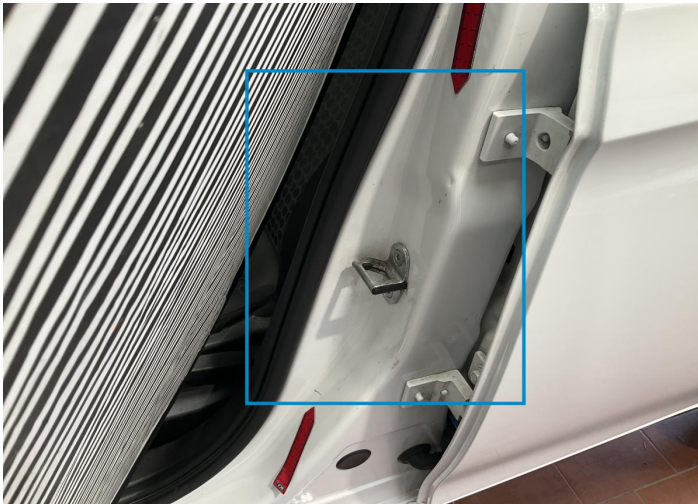
| Component | Damage | Comments |
|---|---|---|
| 7 Pillar / Front Left | Bodywork / Dent / Dent | |

7. Pillar / Front Left  
Bodywork / Dent / Dent -

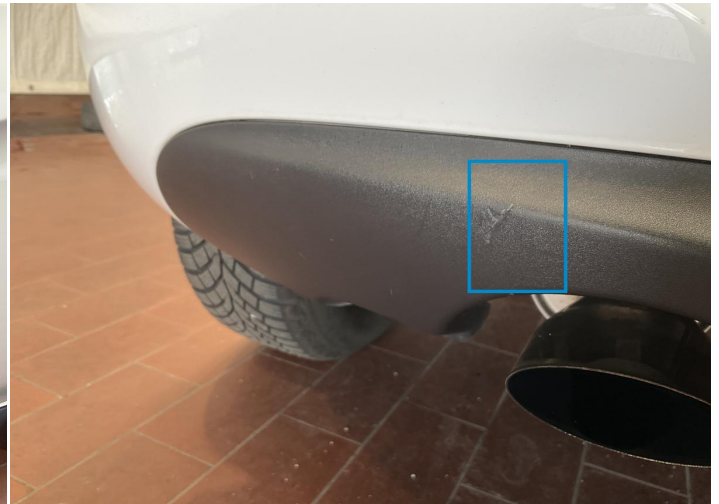
| Component | Damage | Comments |
|---|---|---|
| 8 Bumper / Back | Paint / Scratch / Line | |

8. Bumper / Back  
Paint / Scratch / Line -
