Expertise

Protocol number: 41319362
Order No. / Reference: 24922831
Inspection date: 29 Aug 2025

Manufacturer: Opel	Model: Crossland 1.5 Diesel Elegance
VIN: W0V7H9EN8N4193682

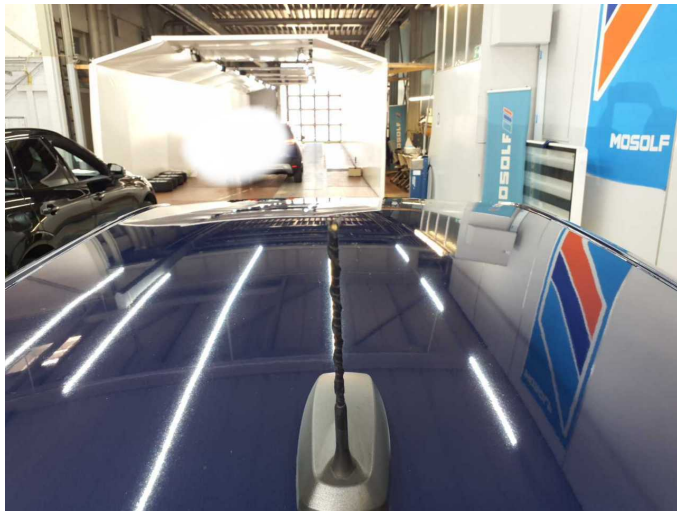
Damage 1: Roof: Stub aerial - Damaged - Replace

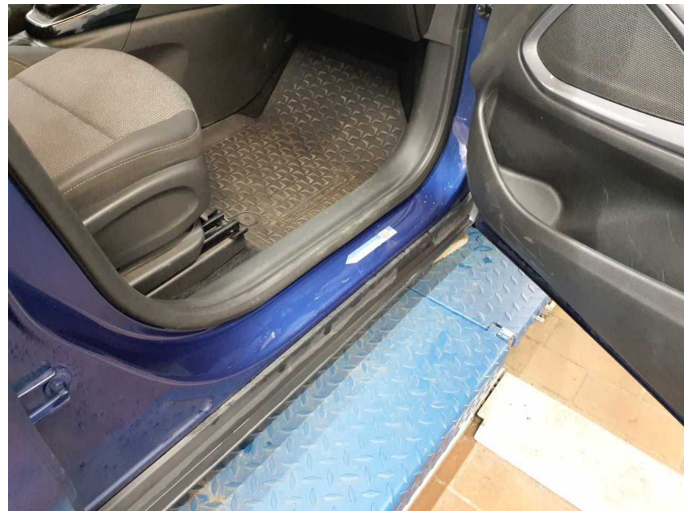
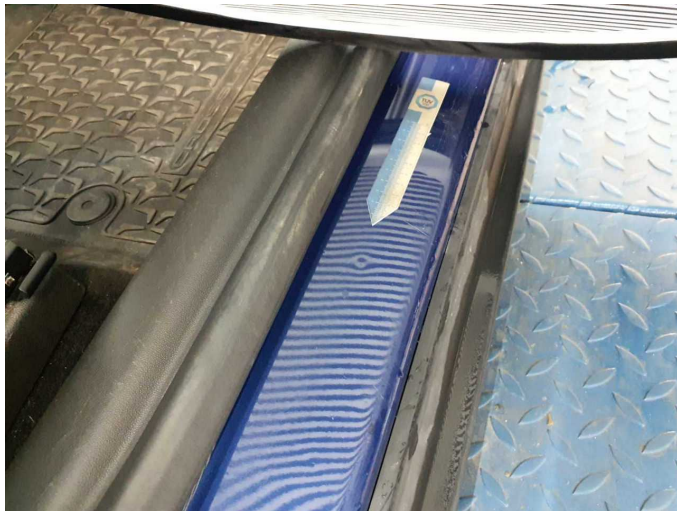
Damage 2: Sill - right side: Sill - dent(s) - Smart repair

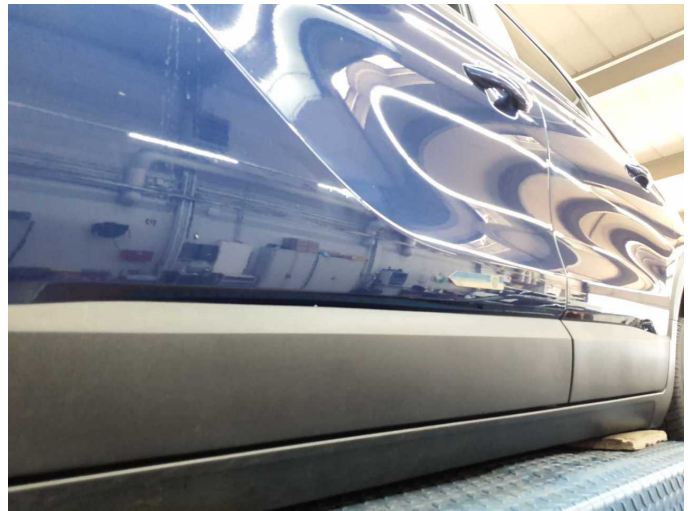
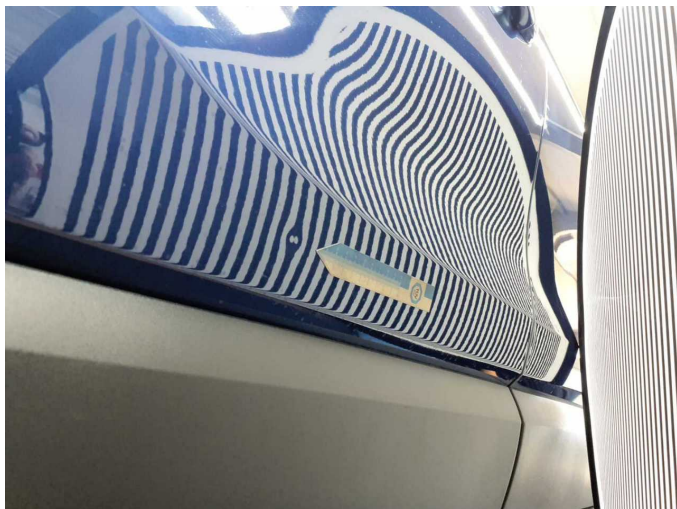
Damage 3: Door - front left side: Door - dent(s) - Smart repair

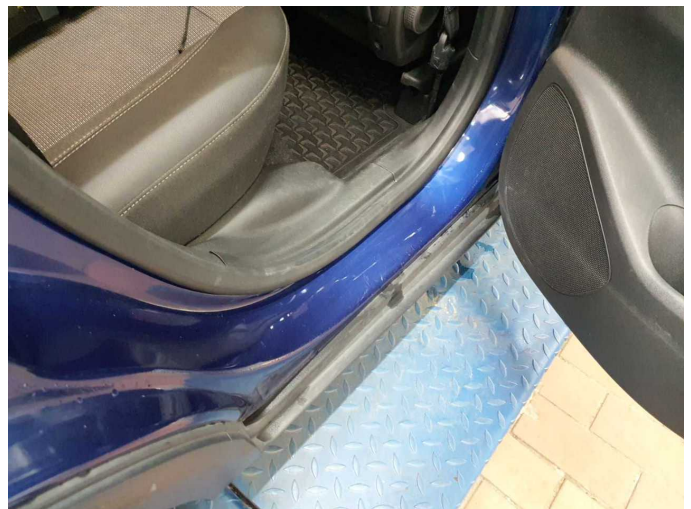
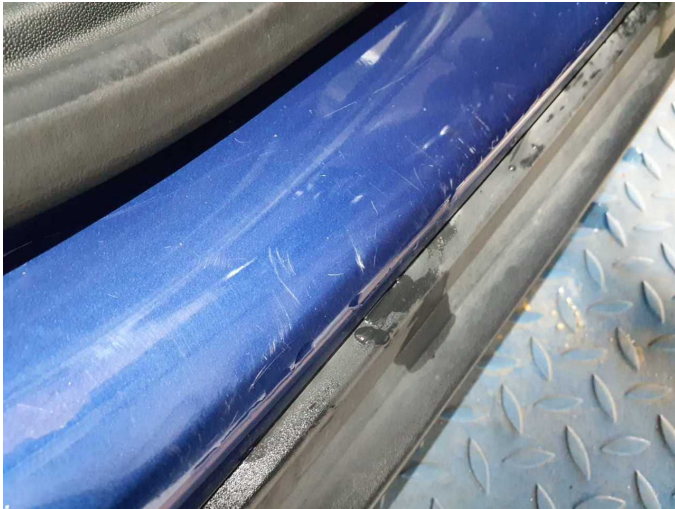
Damage 4: Side panel - rear right side: Sill - Scratched - Smart repair

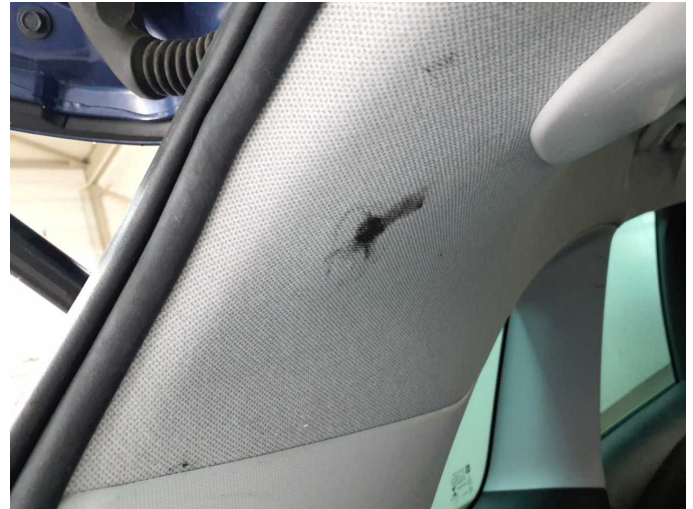
Damage 5: Trim / covers: Roof lining - Soiled - Clean

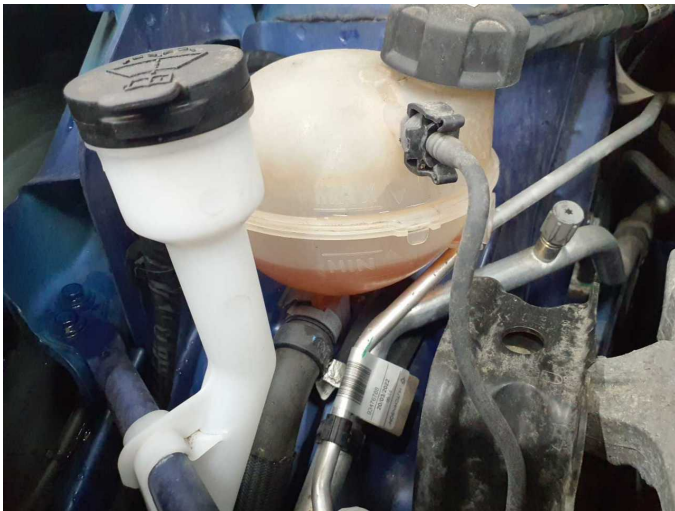
Damage 6: Engine cooling: Coolant - Missing - Perform diagnosis

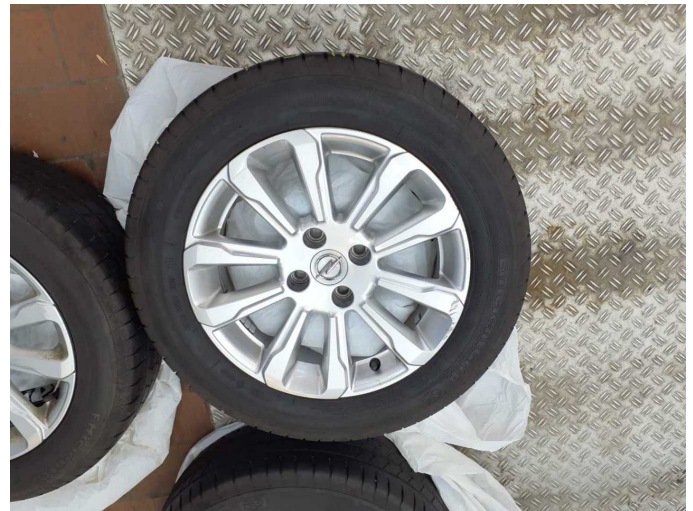
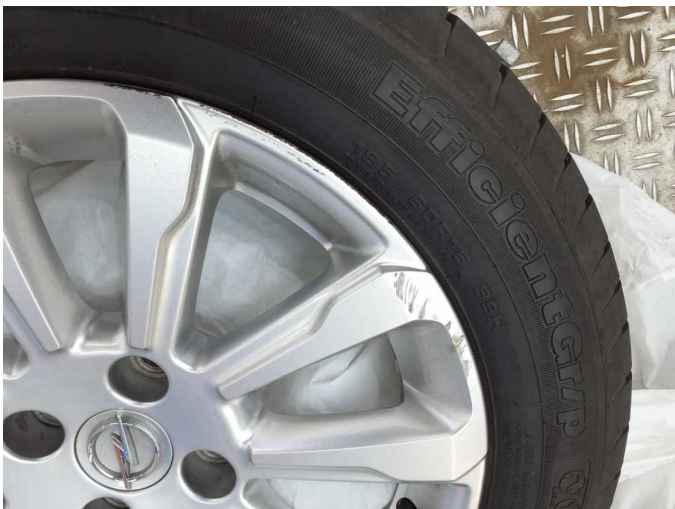
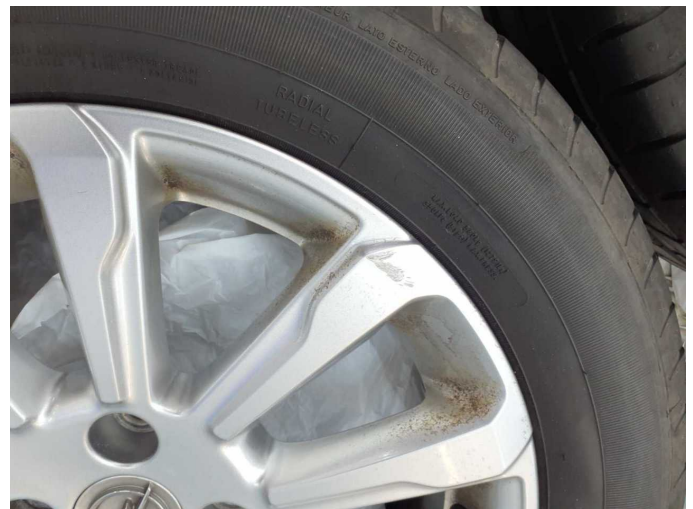
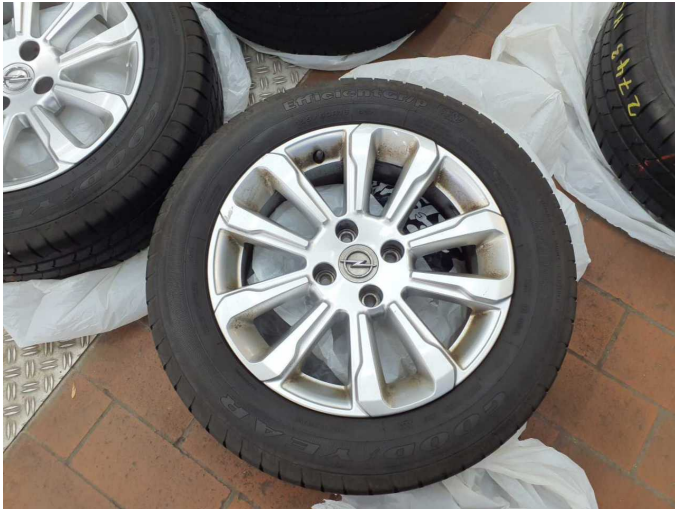
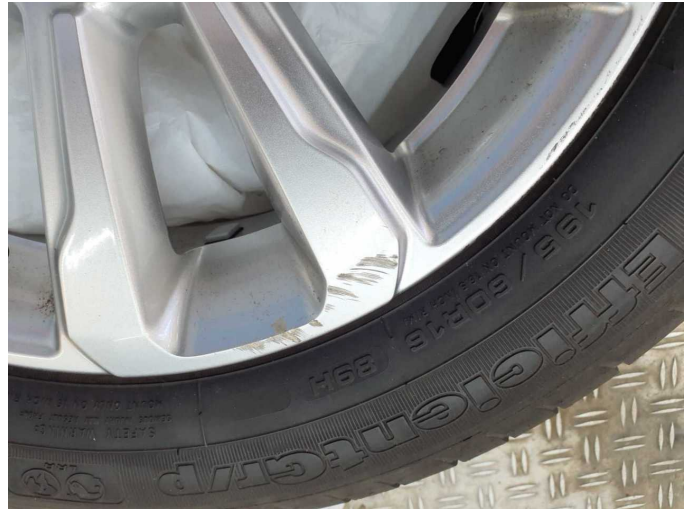
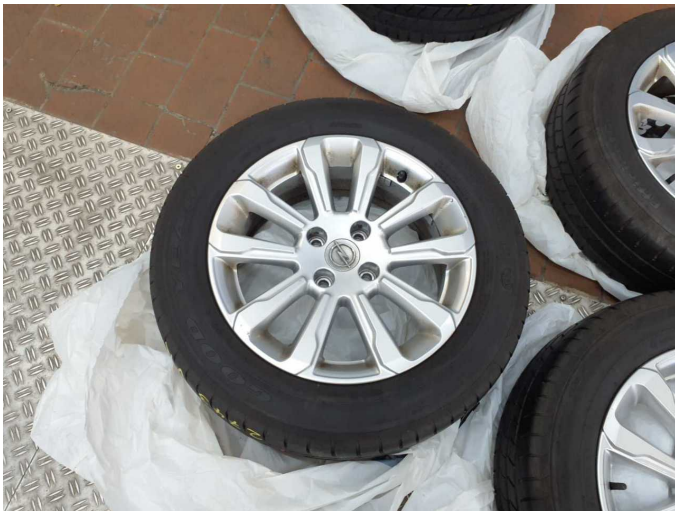
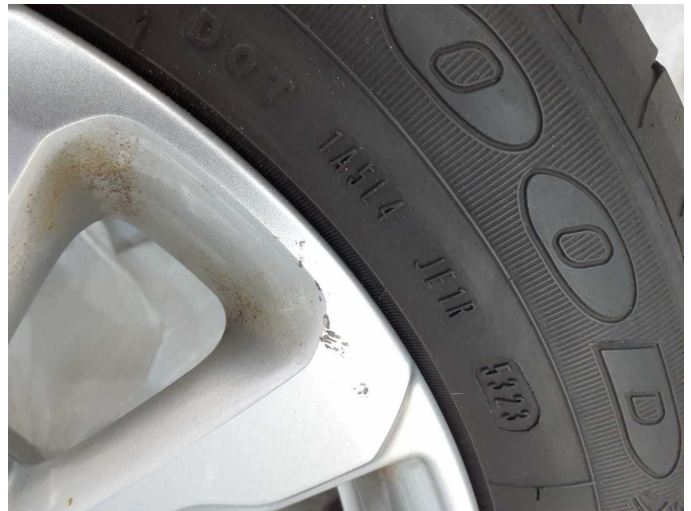
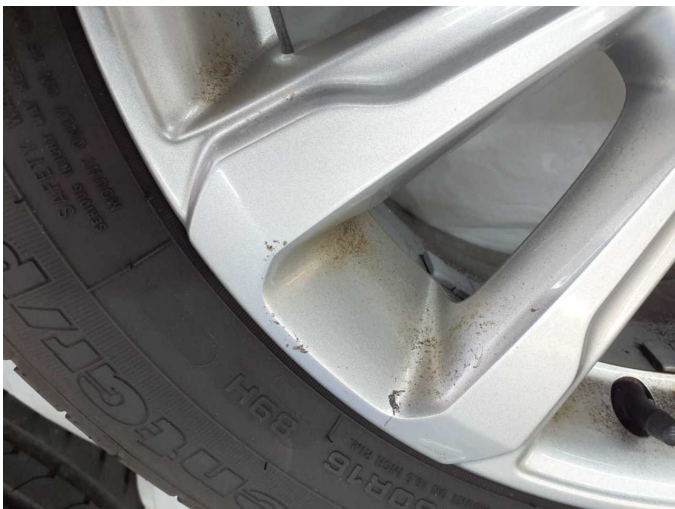
Damage 7: 2nd wheel set: 3 alloy rims - Scratched - Loss in value

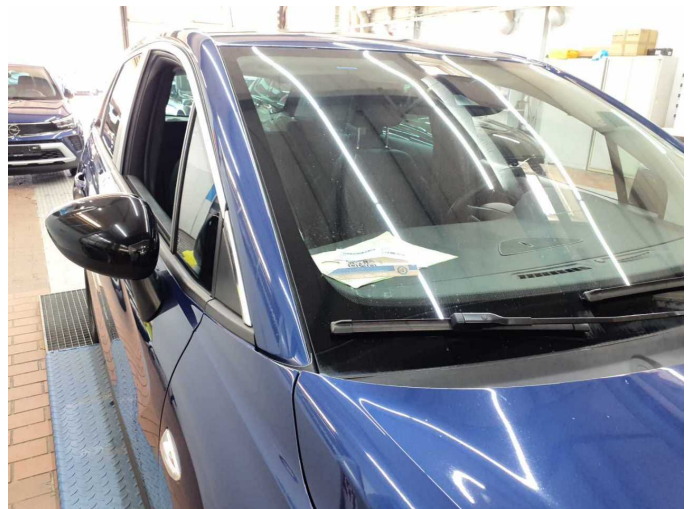
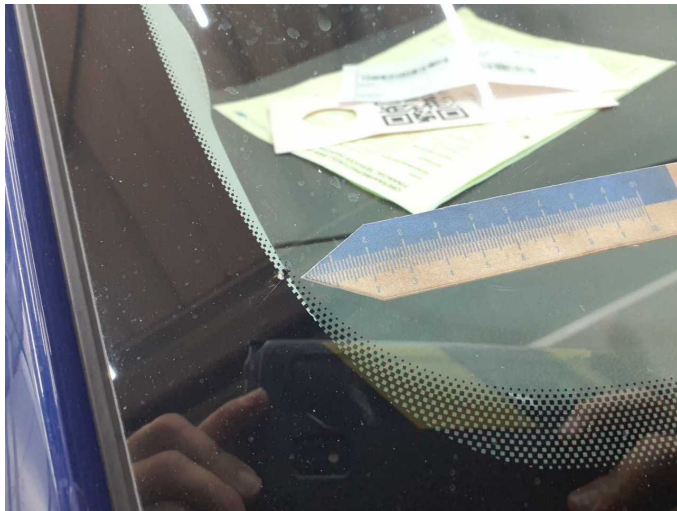
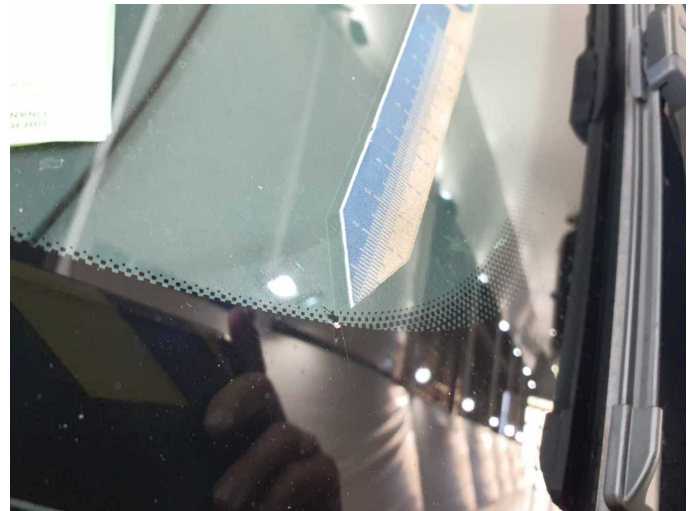
Damage 8: Vehicle glazing: Windscreen - Stone chips - Replace

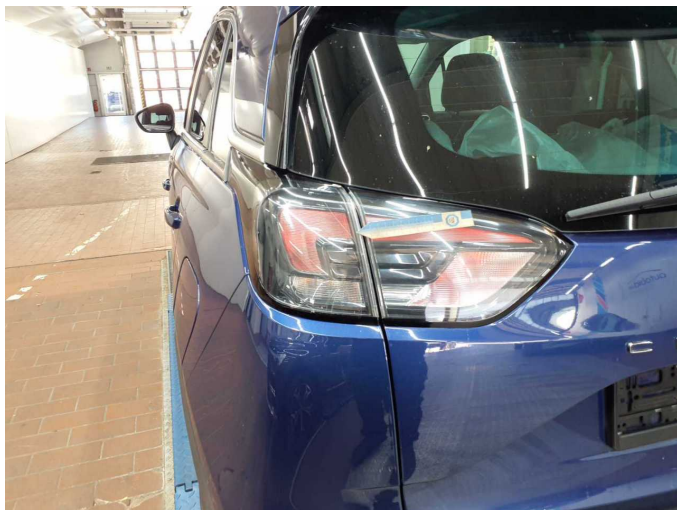
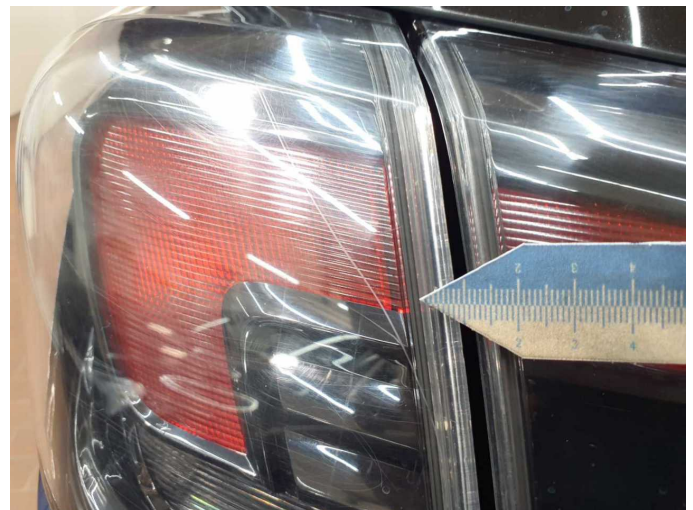
Wear and tear 4: Tail light: Tail lamp - left side - Scratch(es) - No deduction

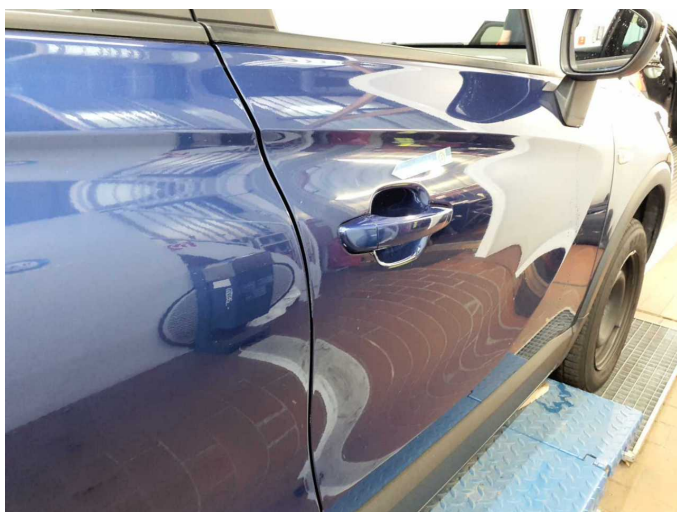
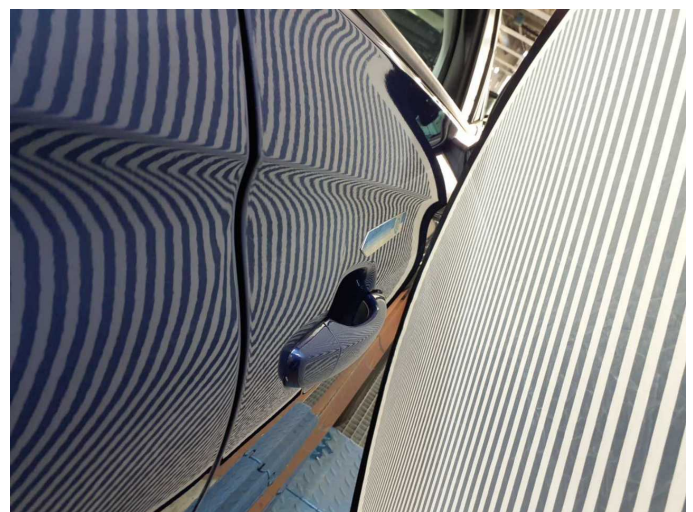
Wear and tear 5: Door - front right side: Door - dent(s) - No deduction
