Expertise

Protocol number: 41310559  
Order No. / Reference: 25000424  
Inspection date: 1 Sept 2025

Manufacturer: Opel

Model: Crossland 1.5 Diesel Elegance

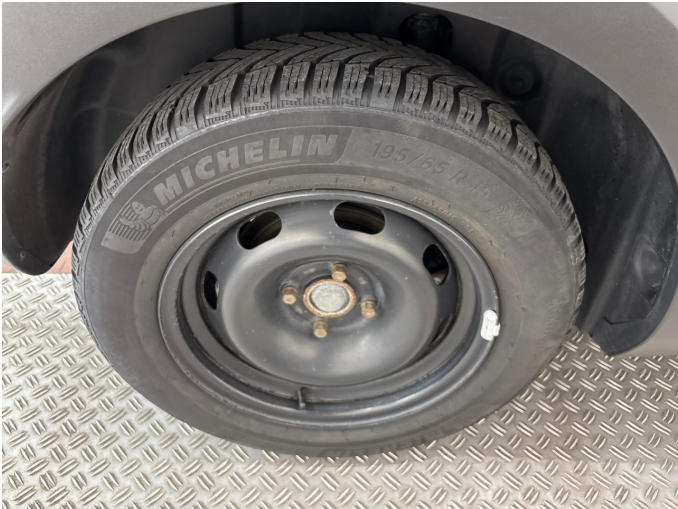
Figure 12: Mounted tyres

#	Tyre size	Type of tyre	Manufacturer	Tread depth
1)	195/65 R15 91T	Winter tyres on Steel	Michelin	4mm / 4mm
2)	195/65 R15 91T	Winter tyres on Steel	Michelin	6mm / 6mm

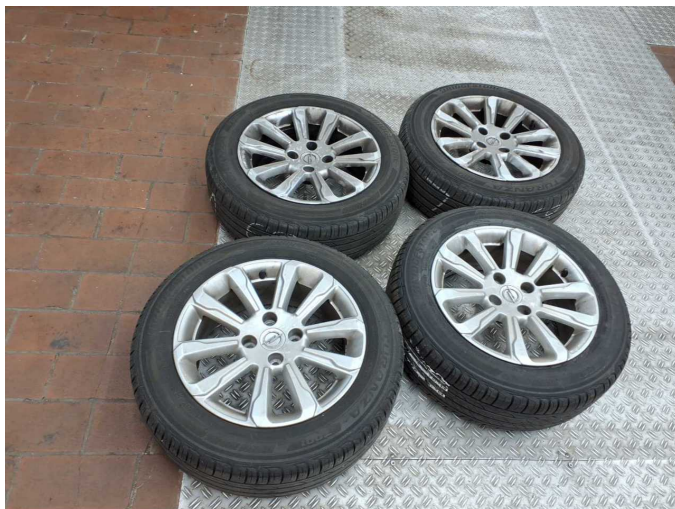
Figure 17: Additional tyres

#	Tyre size	Type of tyre	Manufacturer	Tread depth
1)	195/60 R16 89H	Summer tyres on Light alloy	Bridgestone	5mm / 5mm
2)	195/60 R16 89H	Summer tyres on Light alloy	Bridgestone	6mm / 6mm

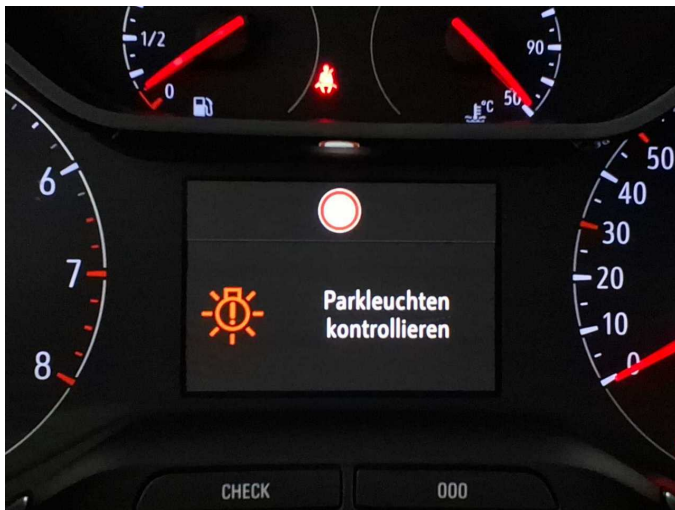
**Damage 2:** Electronic systems: Electronic systems (Parkleuchten) - Specify findings - Perform diagnosis

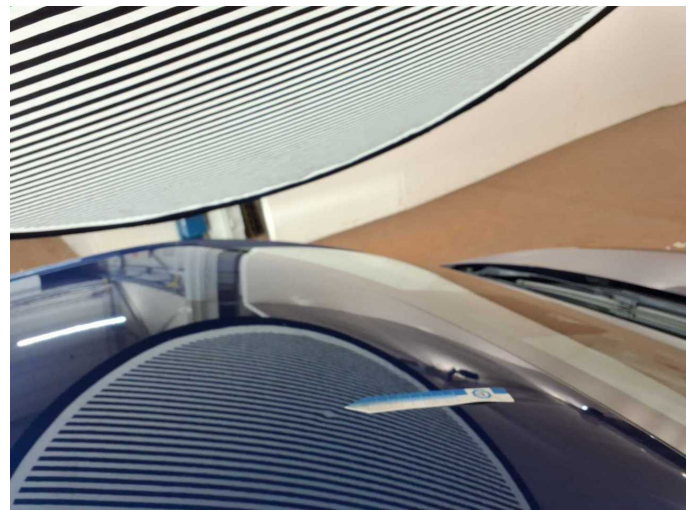
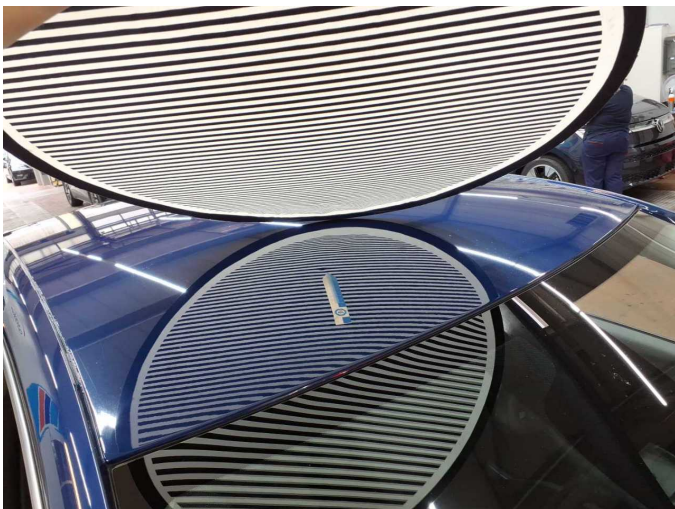
**Damage 3:** Roof: Roof - dent(s) - Smart repair

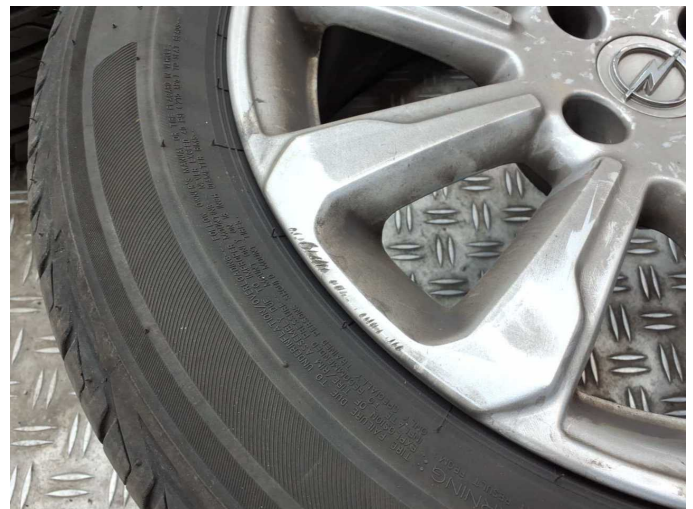
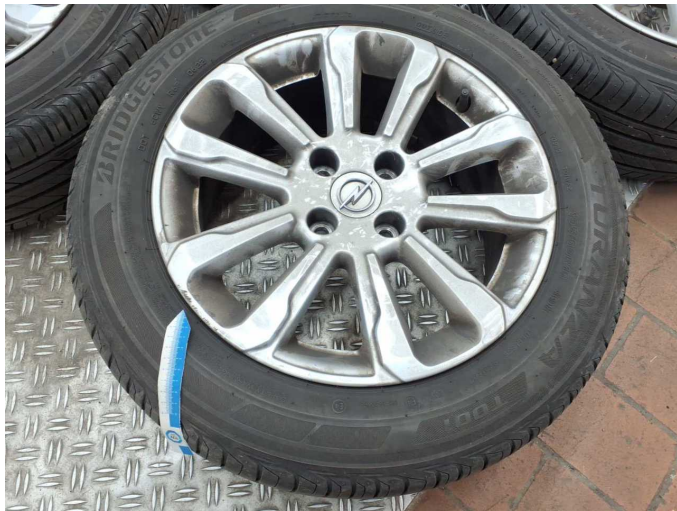
**Damage 4:** 2nd wheel set: 1 alloy rim - Scratched - Loss in value

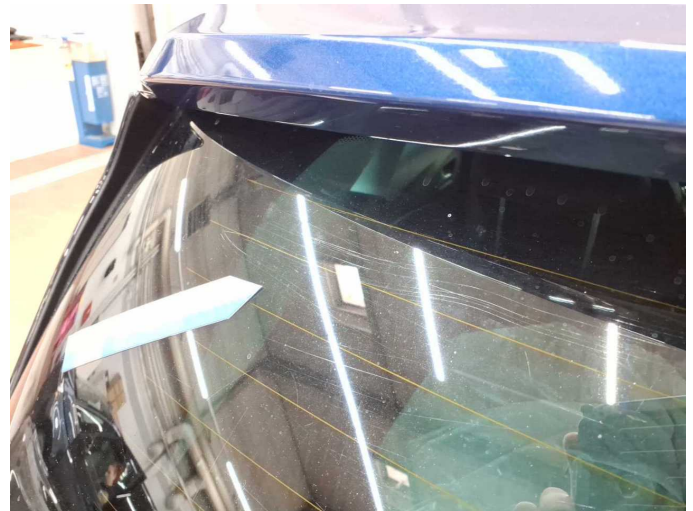
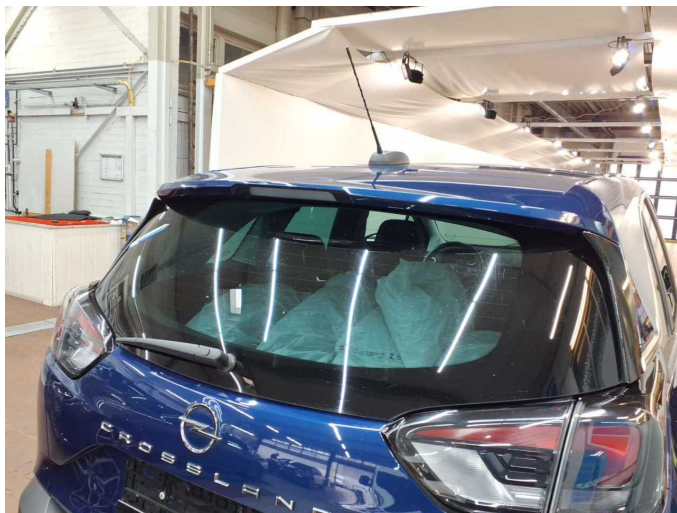
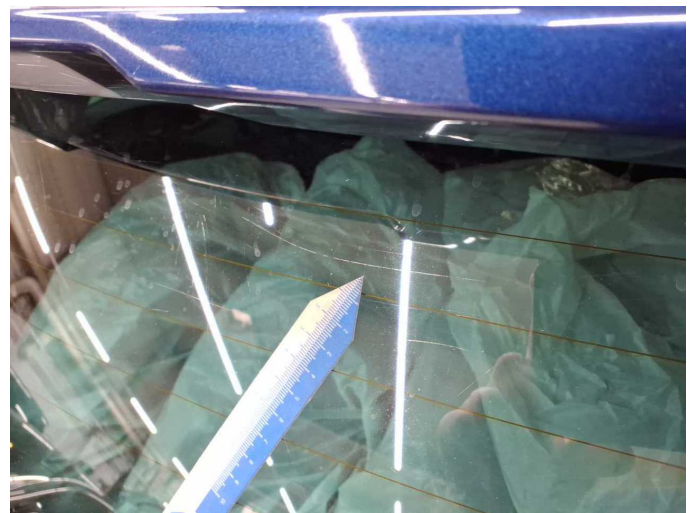
**Damage 5:** Vehicle glazing: Rear window - Scratch(es) - Replace

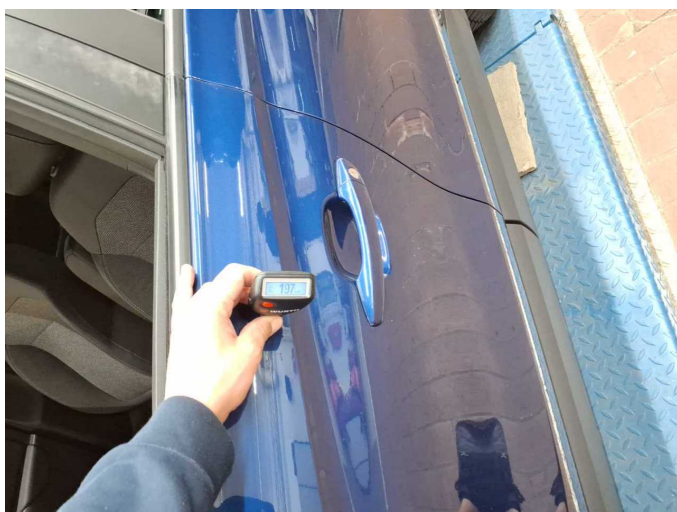
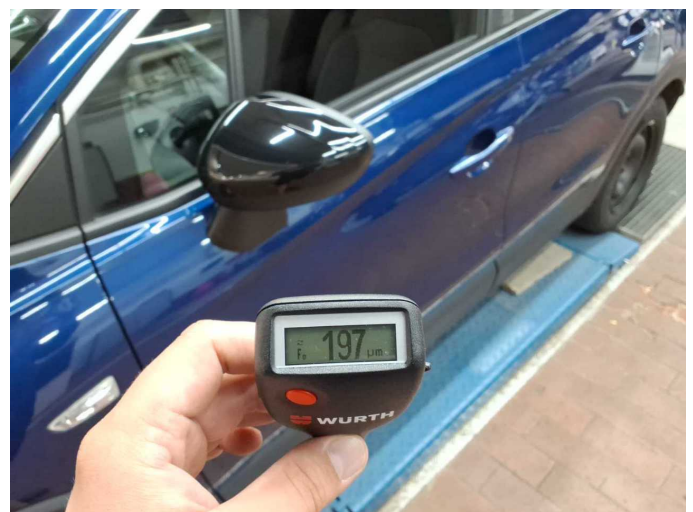
- 1 Door - front left side, Professionally carried out, Invoice of repair done Non-existent

Door - front left side 197 µm

**Repainting 1:** Door - front left side
