Expertise

Protocol number: 41479586
Order No. / Reference: 25171988
Inspection date: 11 Sept 2025

Manufacturer: Opel	Model: Crossland 1.5 Diesel Elegance
VIN: W0V7H9ENXP4013105

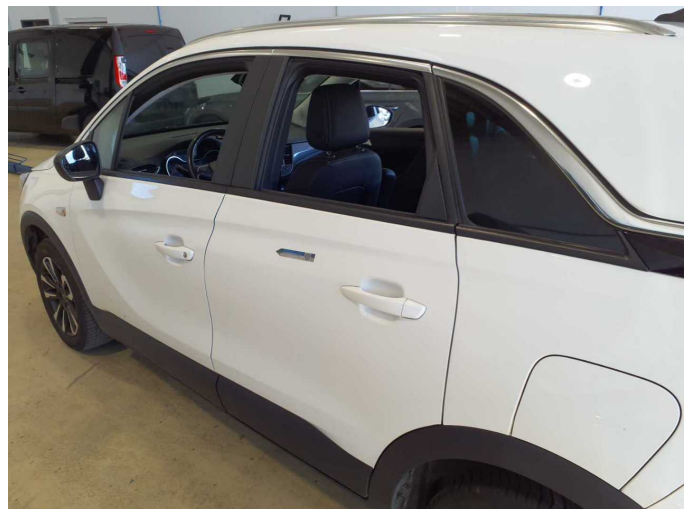
Damage 1: Door - rear left side: Door - Scratch(es) - Smart repair

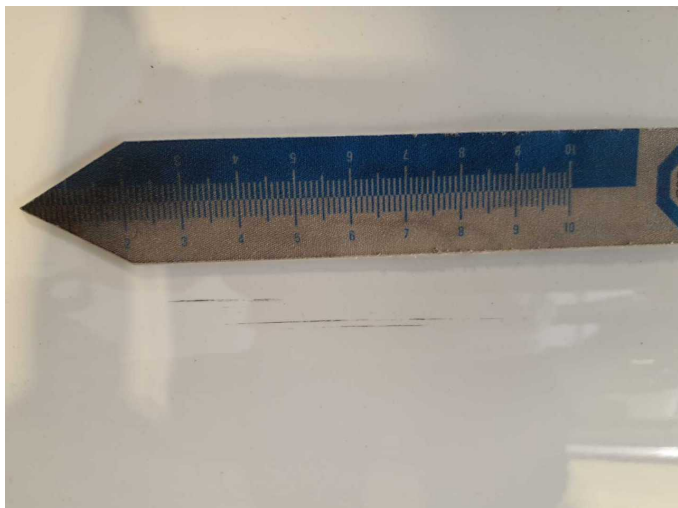
Damage 1: Door - rear left side: Door - Scratch(es) - Smart repair

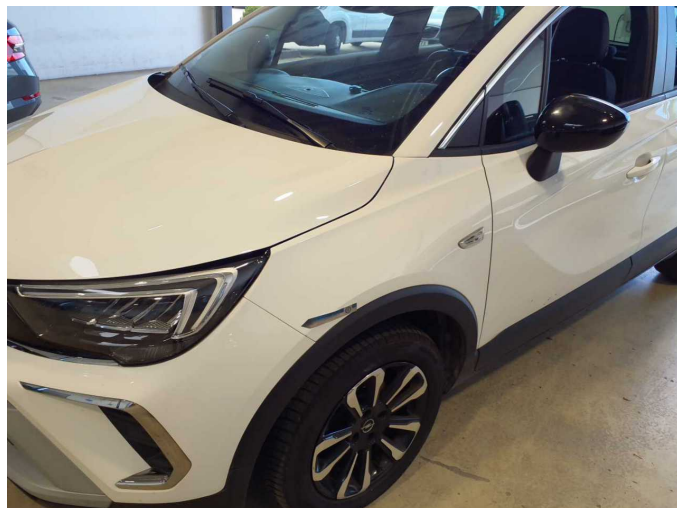
Damage 2: Mudguard - left side: Mudguard - left side - Dent / paintcoat damage - Smart repair

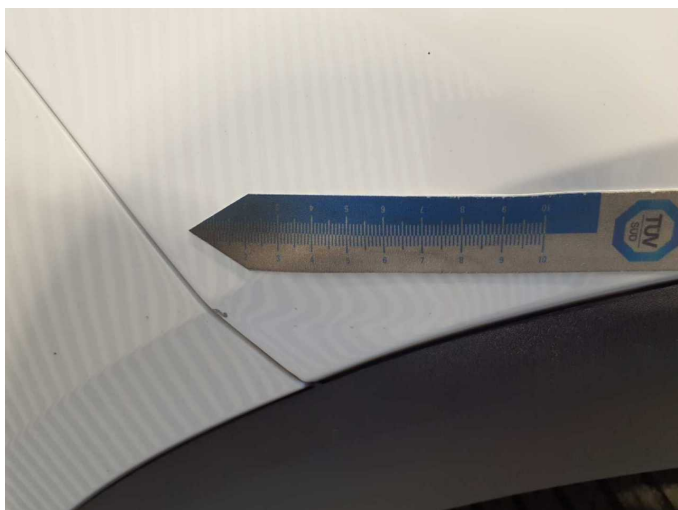
Damage 2: Mudguard - left side: Mudguard - left side - Dent / paintcoat damage - Smart repair

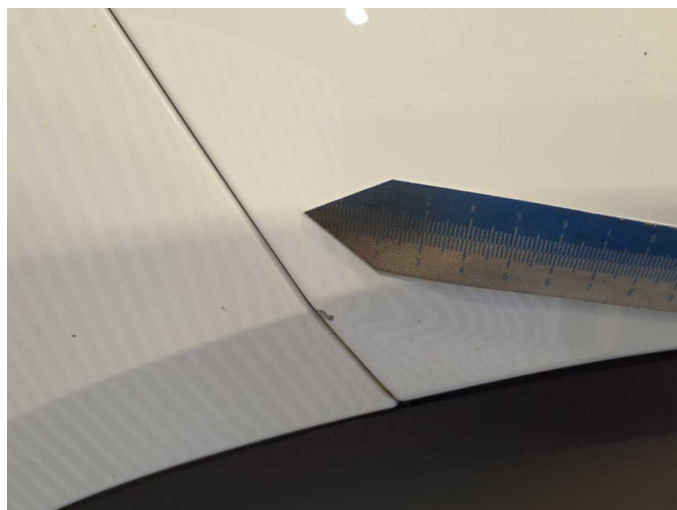
Damage 2: Mudguard - left side: Mudguard - left side - Dent / paintcoat damage - Smart repair

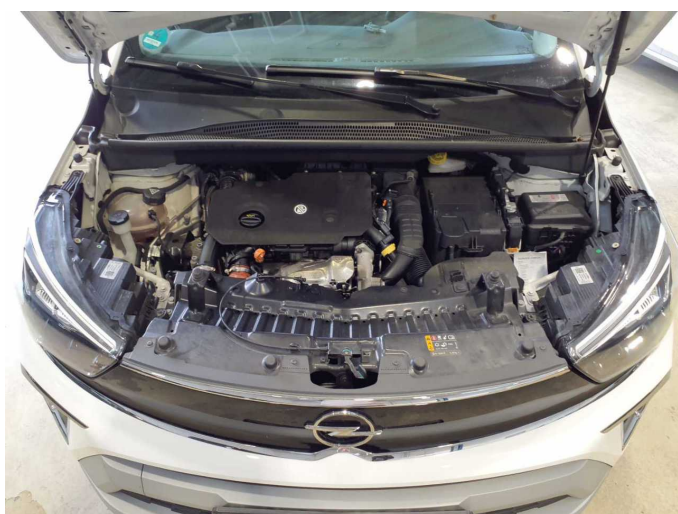
Damage 3: Engine: Engine (Motorraum ölflecht) - Leaking - Perform diagnosis

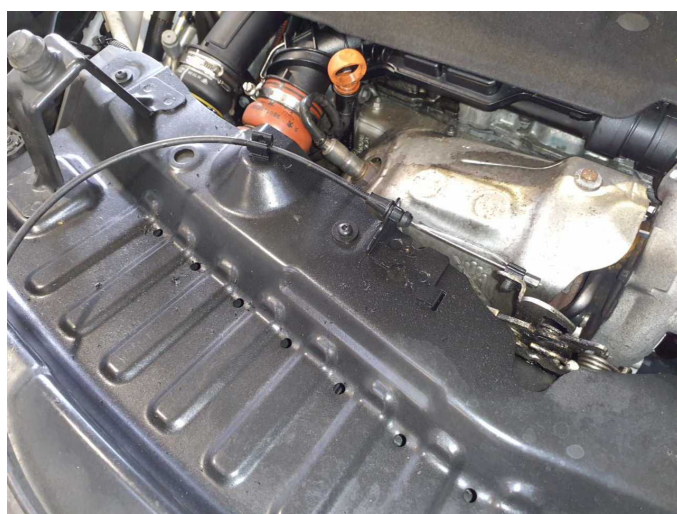
Damage 3: Engine: Engine (Motorraum ölflecht) - Leaking - Perform diagnosis

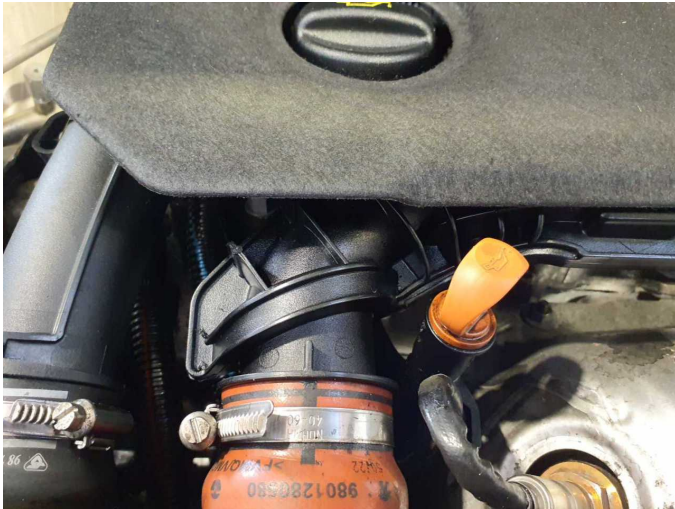
Damage 3: Engine: Engine (Motorraum ölfeucht) - Leaking - Perform diagnosis

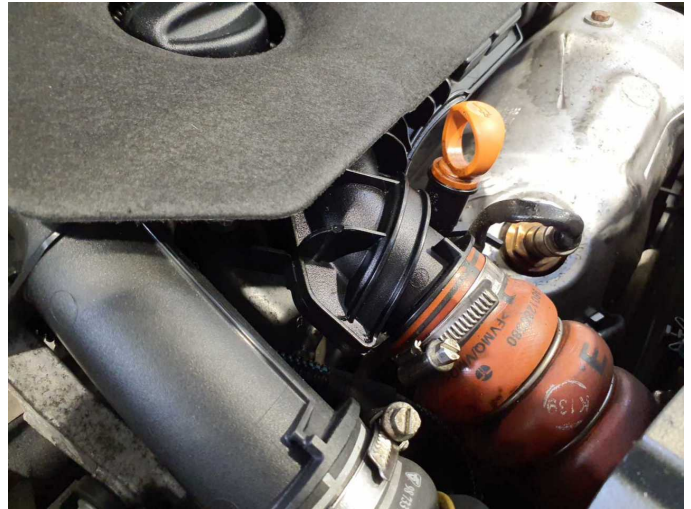
Damage 3: Engine: Engine (Motorraum ölfeucht) - Leaking - Perform diagnosis

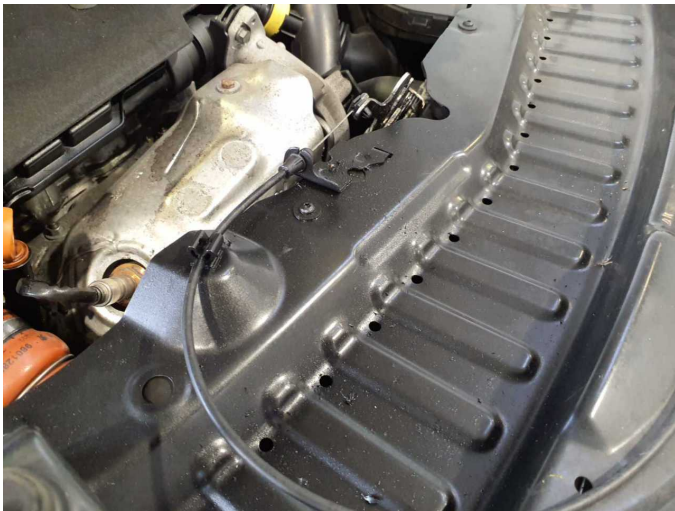
Damage 3: Engine: Engine (Motorraum ölfeucht) - Leaking - Perform diagnosis

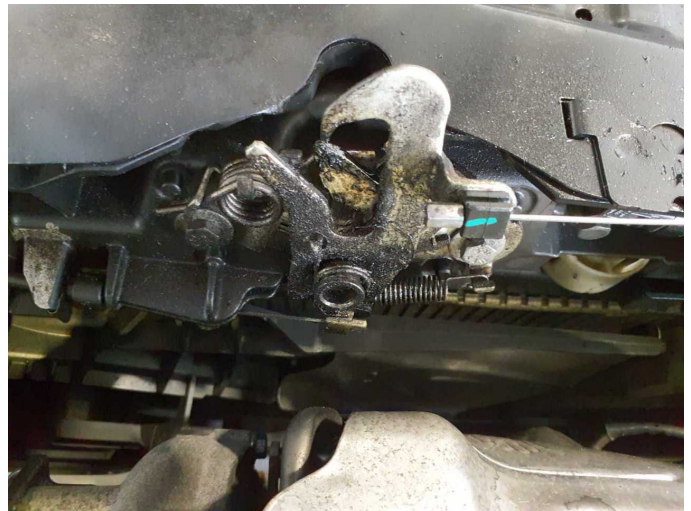
Damage 3: Engine: Engine (Motorraum ölfeucht) - Leaking - Perform diagnosis

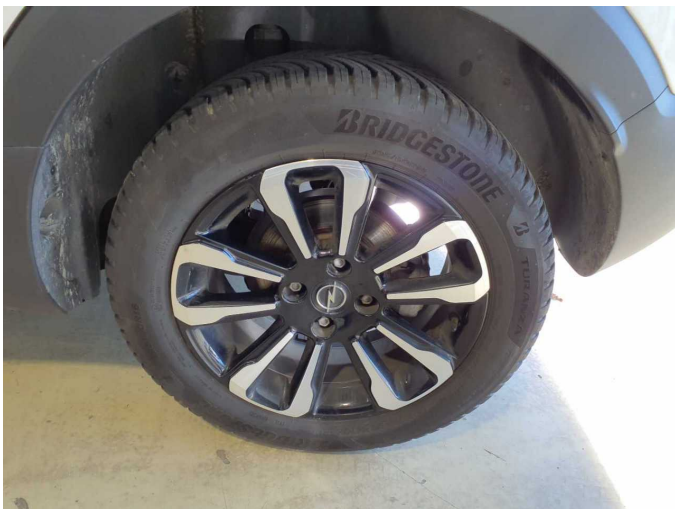
Damage 4: Wheel / tyres: Alloy rim - rear left side - Scratch(es) - Loss in value

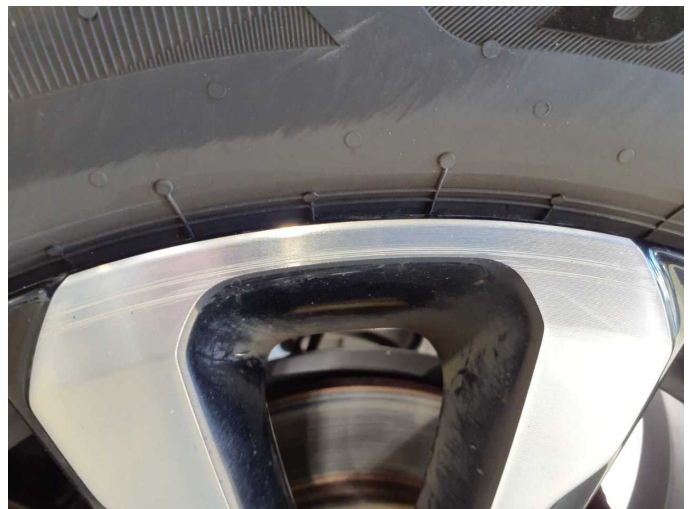
Damage 4: Wheel / tyres: Alloy rim - rear left side - Scratch(es) - Loss in value

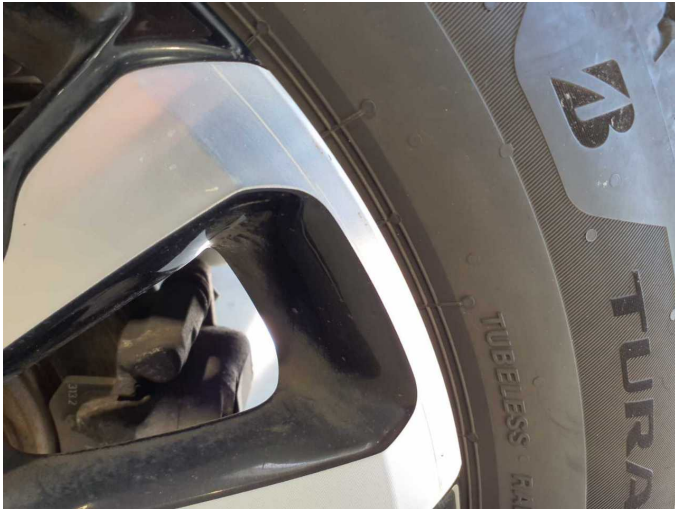
Damage 4: Wheel / tyres: Alloy rim - rear left side - Scratch(es) - Loss in value

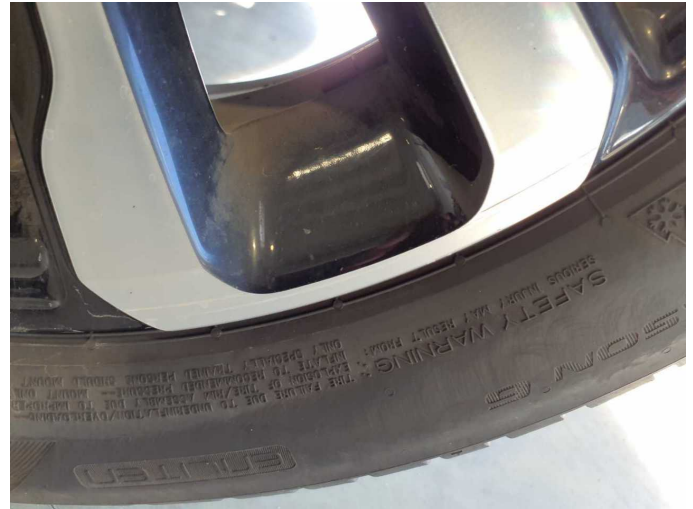
Damage 4: Wheel / tyres: Alloy rim - rear left side - Scratch(es) - Loss in value

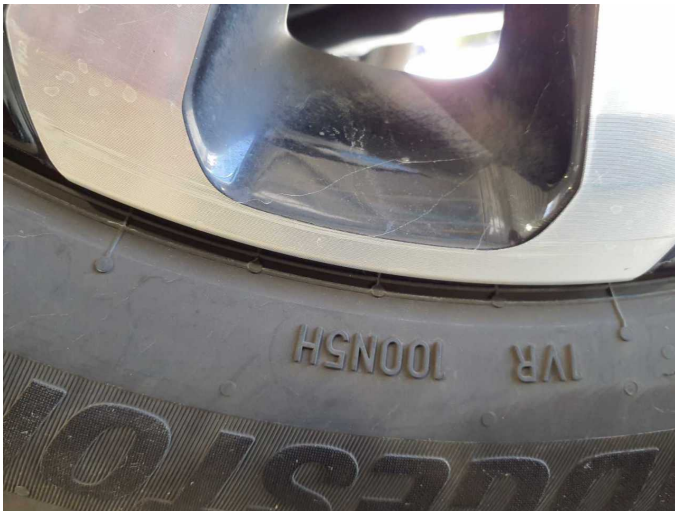
Damage 4: Wheel / tyres: Alloy rim - rear left side - Scratch(es) - Loss in value

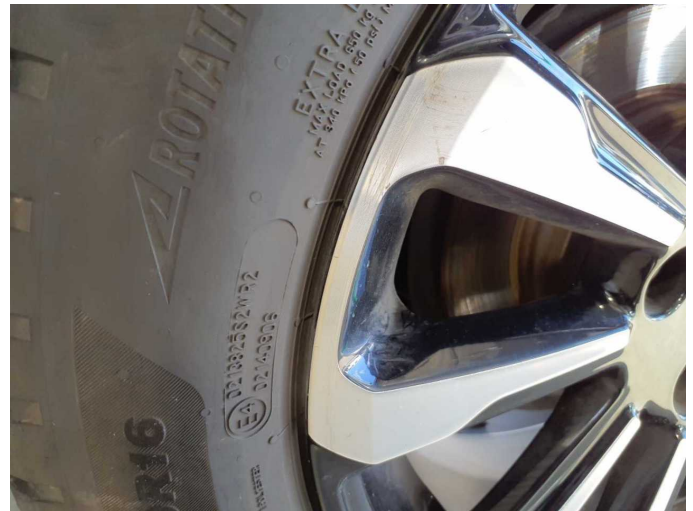
Damage 4: Wheel / tyres: Alloy rim - rear left side - Scratch(es) - Loss in value

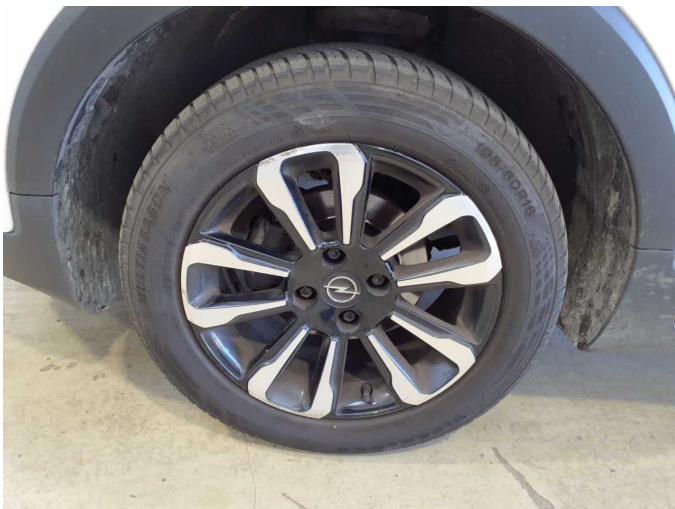
Damage 5: Wheel / tyres: Alloy rim - front left side - Scratch(es) - Loss in value

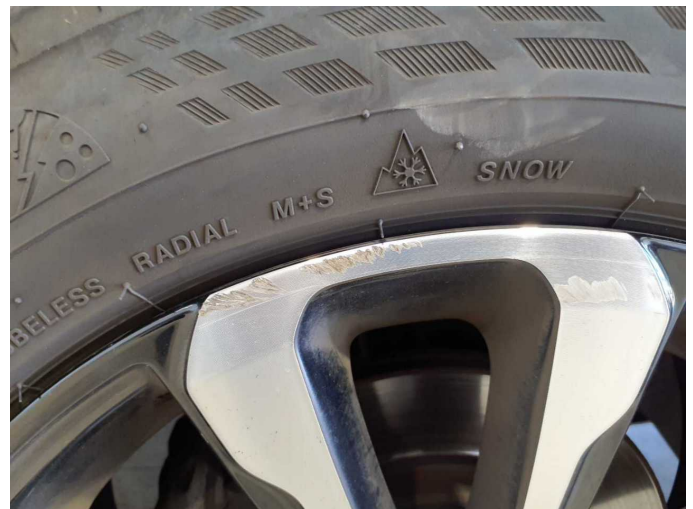
Damage 5: Wheel / tyres: Alloy rim - front left side - Scratch(es) - Loss in value

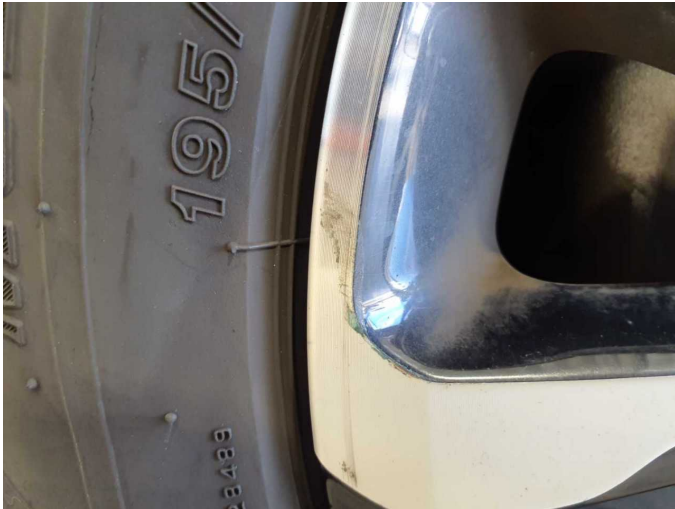
Damage 5: Wheel / tyres: Alloy rim - front left side - Scratch(es) - Loss in value

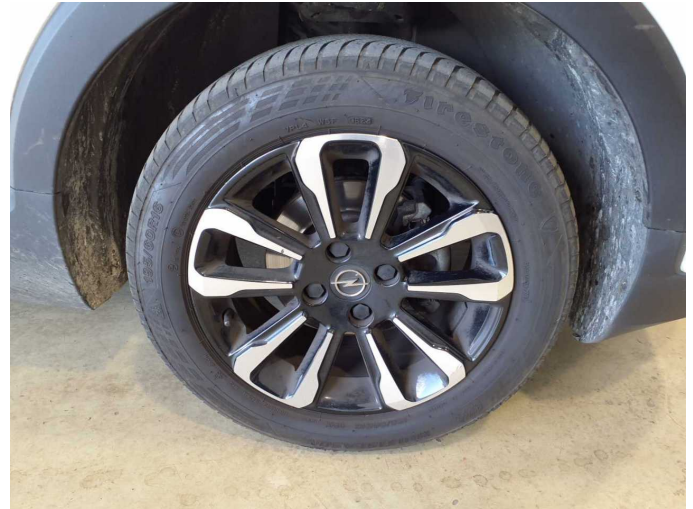
Damage 6: Wheel / tyres: Alloy rim - front right side - Scratch(es) - Loss in value

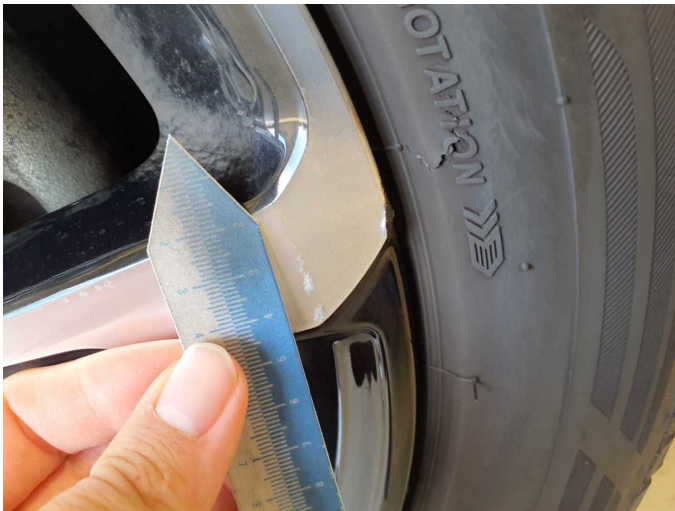
Damage 6: Wheel / tyres: Alloy rim - front right side - Scratch(es) - Loss in value

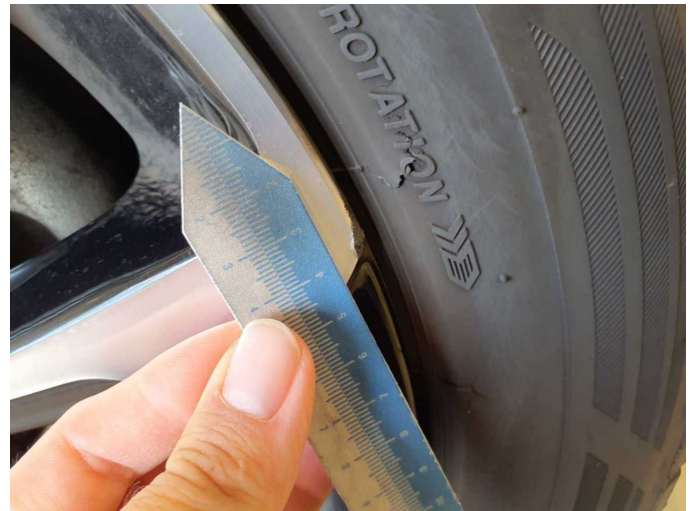
Damage 6: Wheel / tyres: Alloy rim - front right side - Scratch(es) - Loss in value

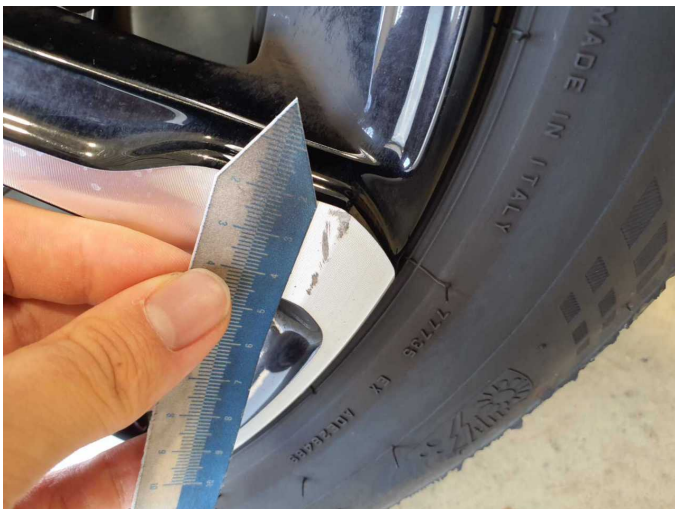
Damage 6: Wheel / tyres: Alloy rim - front right side - Scratch(es) - Loss in value

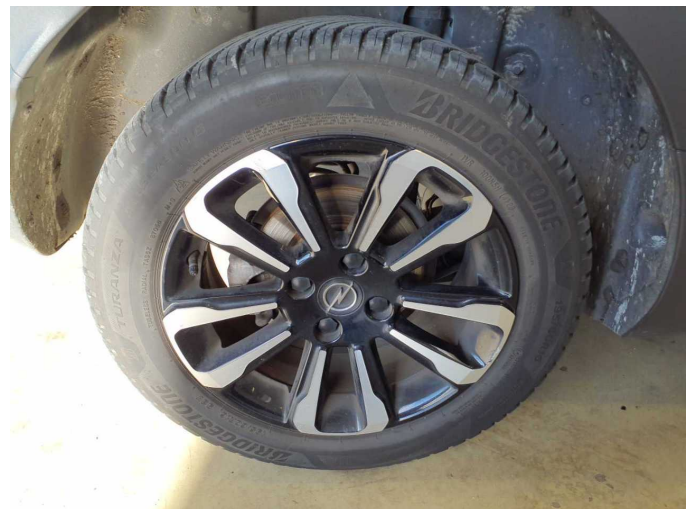
Damage 7: Wheel / tyres: Alloy rim - rear right side - Scratch(es) - Loss in value

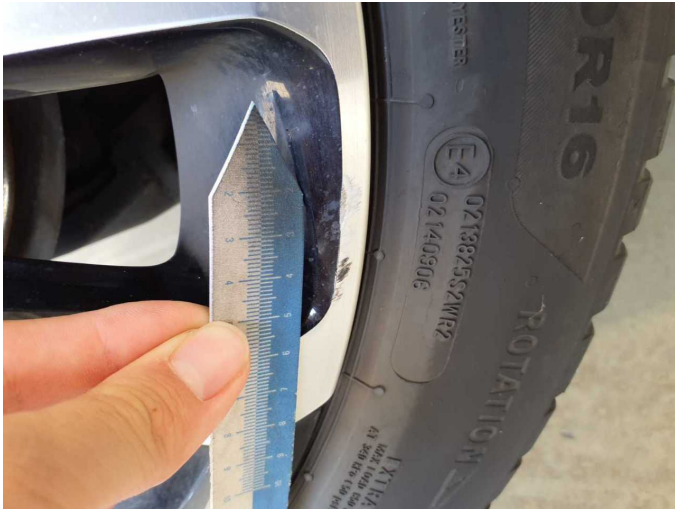
Damage 7: Wheel / tyres: Alloy rim - rear right side - Scratch(es) - Loss in value

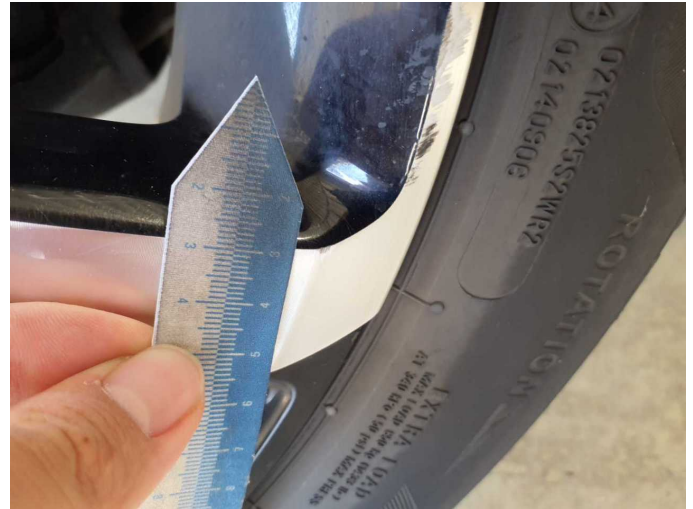
Damage 7: Wheel / tyres: Alloy rim - rear right side - Scratch(es) - Loss in value

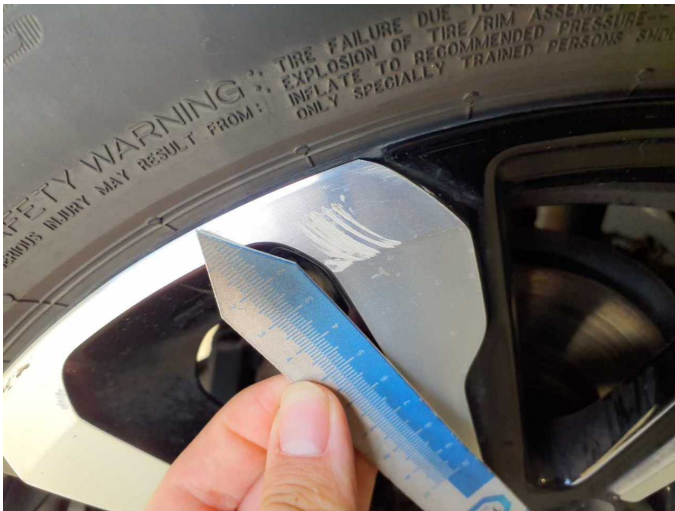
Damage 7: Wheel / tyres: Alloy rim - rear right side - Scratch(es) - Loss in value

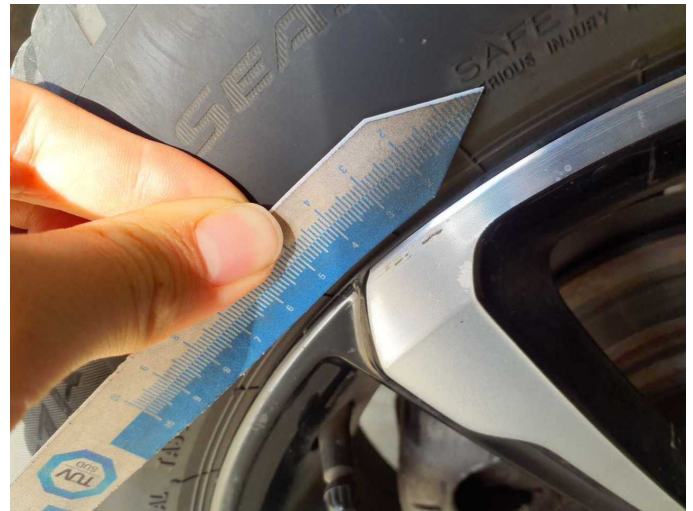
Damage 7: Wheel / tyres: Alloy rim - rear right side - Scratch(es) - Loss in value

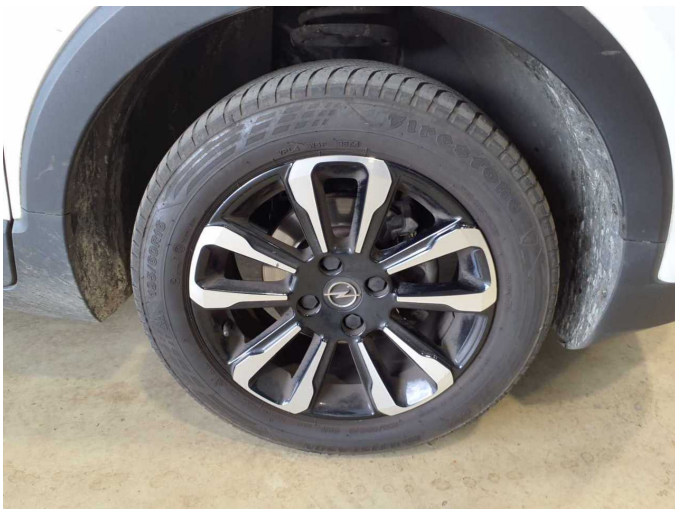
#	Tyre size	Type of tyre	Manufacturer	Tread depth
1)	195/60 R16 89H	All-season tyres on Light alloy	Firestone	2mm / 2mm
2)	195/60 R16 93V	All-season tyres on Light alloy	Bridgestone	6mm / 6mm

Damage 8: Wheel / tyres: Tyre - front - Does not meet the leasing specifications - Replace

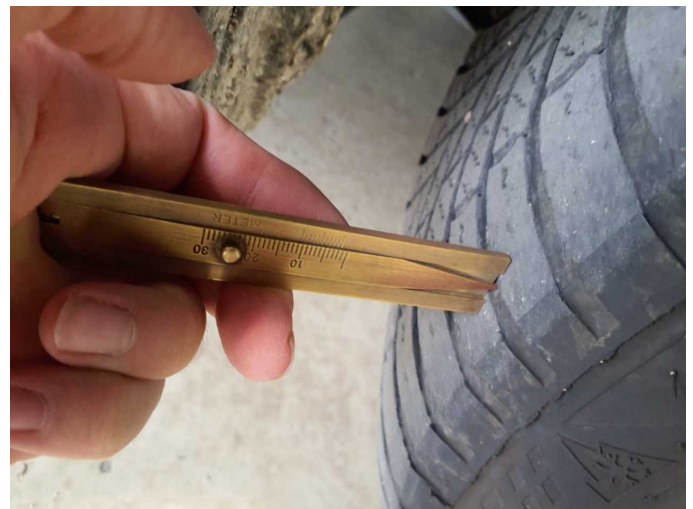
Damage 8: Wheel / tyres: Tyre - front - Does not meet the leasing specifications - Replace

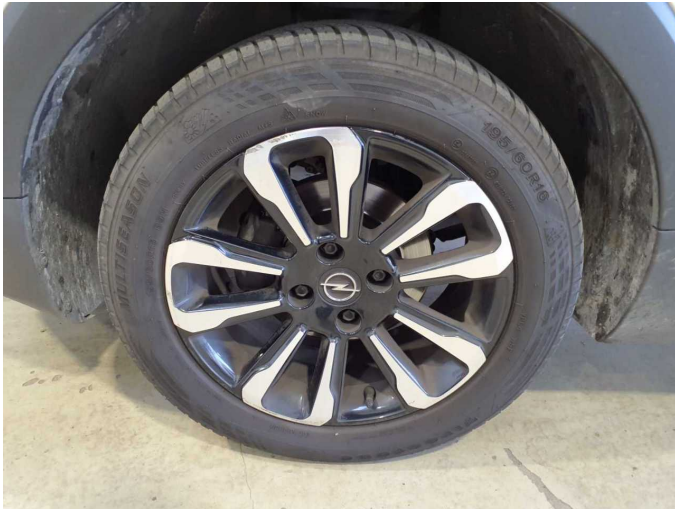
Damage 8: Wheel / tyres: Tyre - front - Does not meet the leasing specifications - Replace

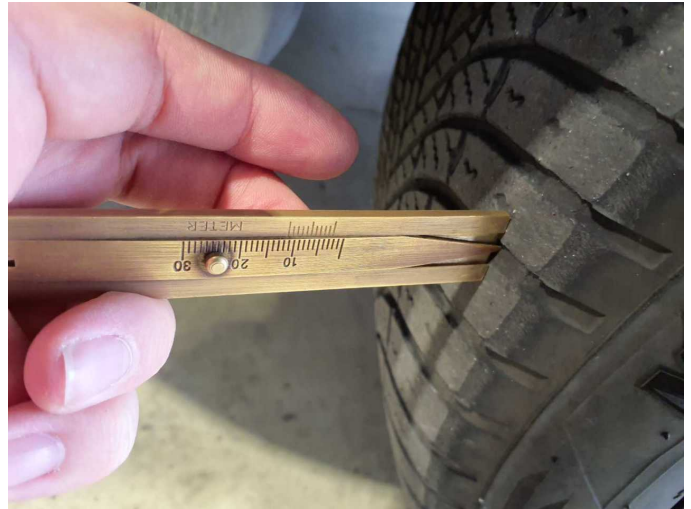
Damage 8: Wheel / tyres: Tyre - front - Does not meet the leasing specifications - Replace

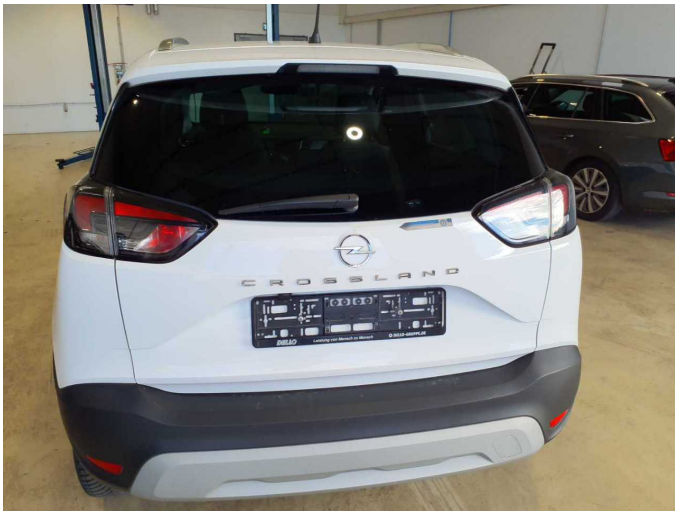
Wear and tear 2: Boot lid / rear door: Boot lid - dent(s) - No deduction

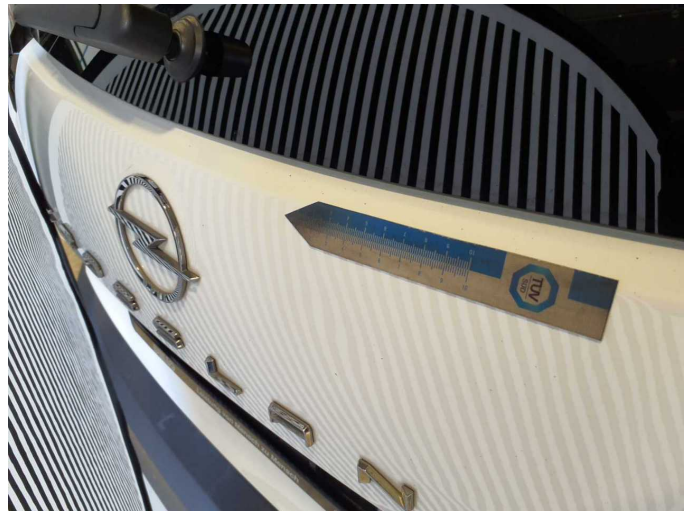
Wear and tear 2: Boot lid / rear door: Boot lid - dent(s) - No deduction

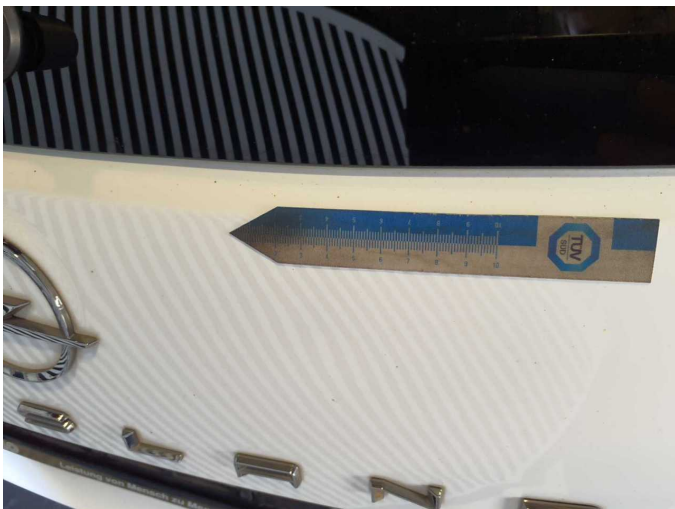
Wear and tear 2: Boot lid / rear door: Boot lid - dent(s) - No deduction

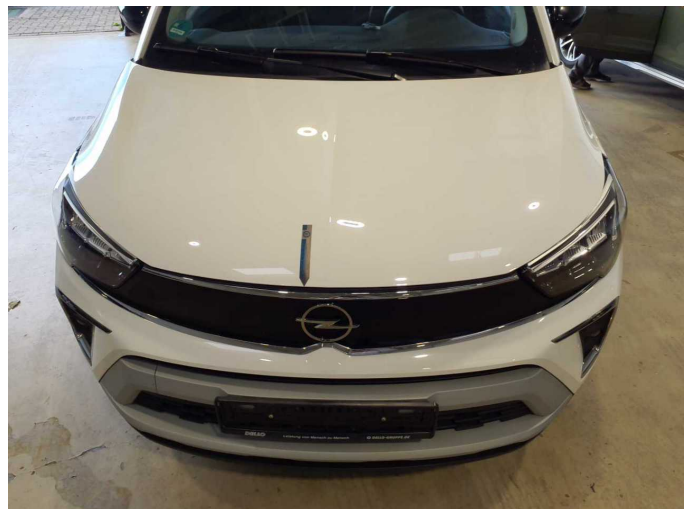
Wear and tear 3: Bonnet: Bonnet - dent(s) - No deduction

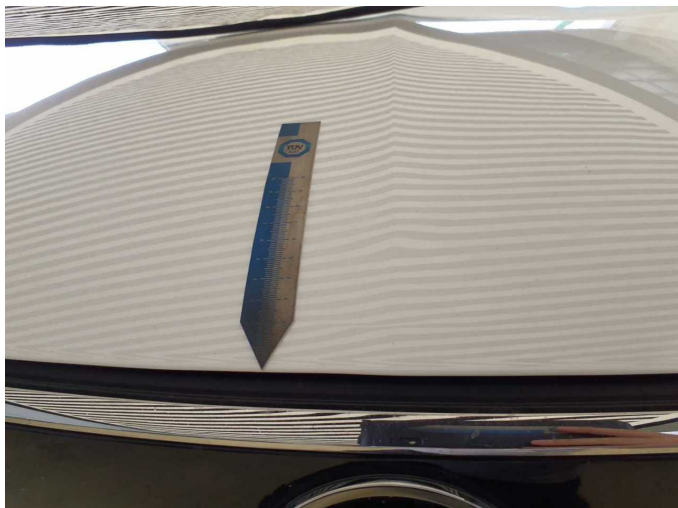
Wear and tear 3: Bonnet: Bonnet - dent(s) - No deduction

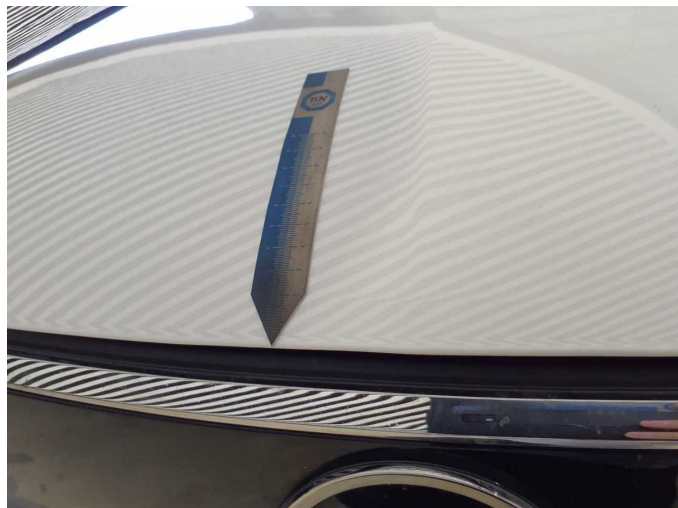
Wear and tear 3: Bonnet: Bonnet - dent(s) - No deduction

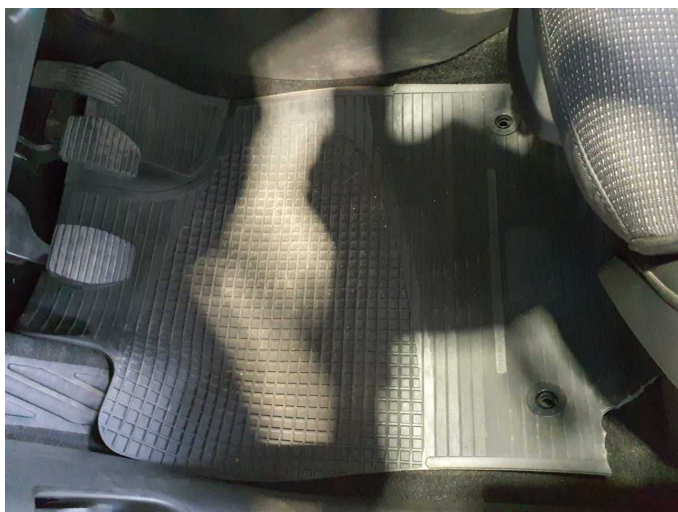
Wear and tear 4: Trim / covers: Floor mats (VL) - Damaged - No deduction

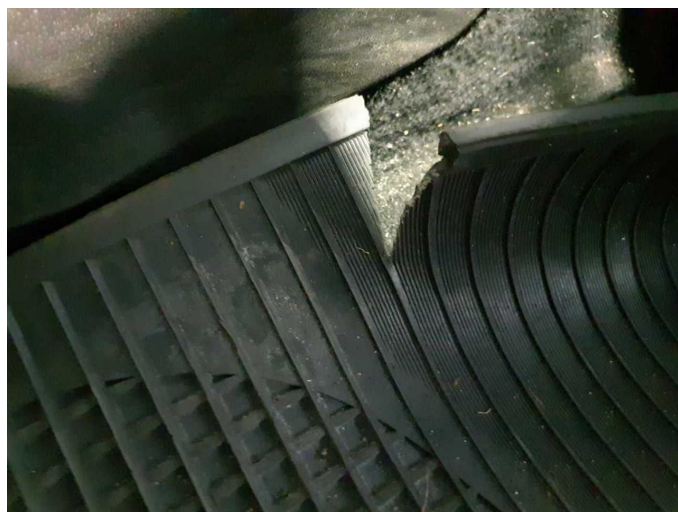
Wear and tear 4: Trim / covers: Floor mats (VL) - Damaged - No deduction
