OPEL Astra

Astra 1.6 D Start/Stop Sports Tourer

VIN NO W0VBD8EF0K8014838
Registration Number F0K8014838

Customer	BCA Online	Report Number	P20250910132029
Inspection Date / Place	2025-09-10 / BCA Heidenheim	Cosmetic Grade	4

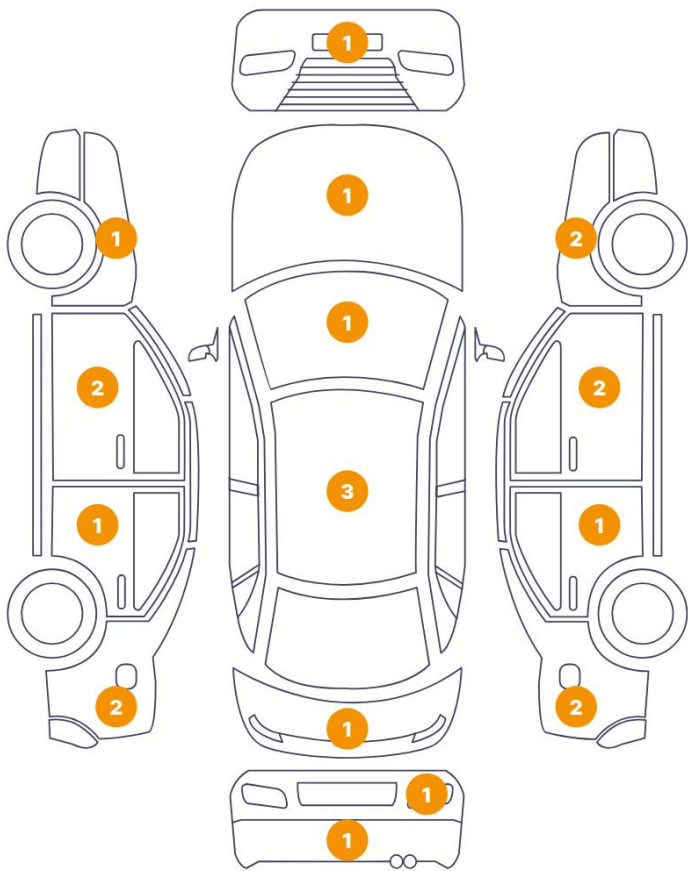
22 Schäden

Component		Damage	Comments
1	Fender / Front Left	Paint / Poor Previous Repair	
2	Side Panel / Back Right	Paint / Poor Previous Repair	
3	Bumper / Front	Paint / Scratch / Scuff	
4	Door / Back Right	Paint / Scratch / Scuff	
5	Door / Front Right	Paint / Scratch / Scuff	
6	Mirror Shell / Front Right	Paint / Scratch / Scuff	
7	Fender / Front Right	Bodywork / Dent / Dent	
8	Side Panel / Back Right	Paint / Poor Previous Repair	
9	Back Light / Right	Glass Break	
10	Tailgate	Paint / Scratch / Scuff	
11	Bumper / Back	Paint / Scratch / Scuff	
12	Door / Front Left	Paint / Scratch / Scuff

13	Side Panel / Back Left	Paint / Scratch / Scuff
14	Side Panel / Back Left	Bodywork / Dent / Dent
15	Door / Front Left	Bodywork / Dent / Dent
16	Hood	Bodywork / Dent / Hail Area
17	Fender / Front Right	Bodywork / Dent / Hail Area
18	Roof	Bodywork / Dent / Hail Area
19	Windshield / Front	Glass Break / Impact
20	Roof	Bodywork / Dent / Hail Area
21	Roof	Bodywork / Dent / Hail Area
22	Door / Back Left	Paint / Scratch / Scuff
23	Panel Filling / Front Left	Interior / Scratched
24	Tailgate Upholstery / Back	Interior / Scratched
25	Roof Upholstery	Interior / Ripped

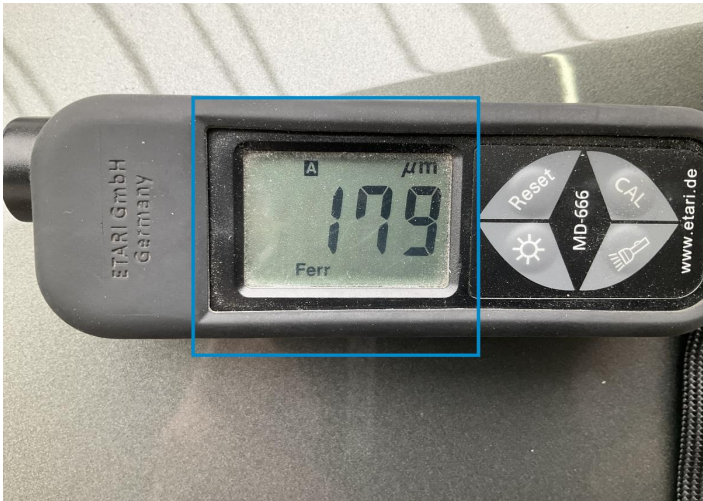
1. Fender / Front Left
Paint / Poor Previous Repair -

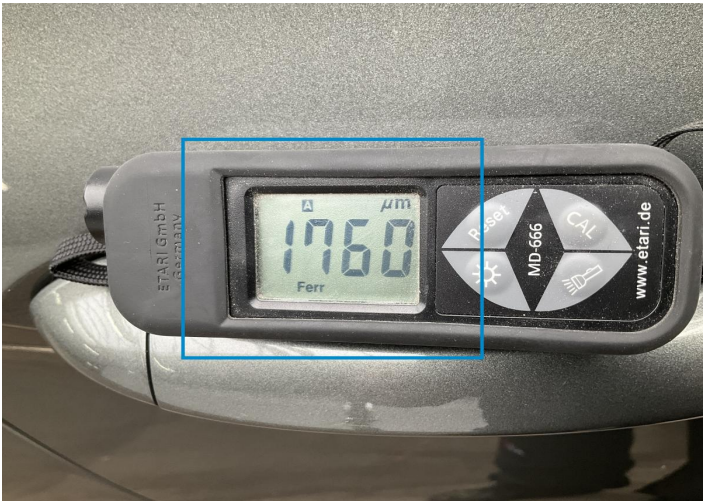
2. Side Panel / Back Right
Paint / Poor Previous Repair -

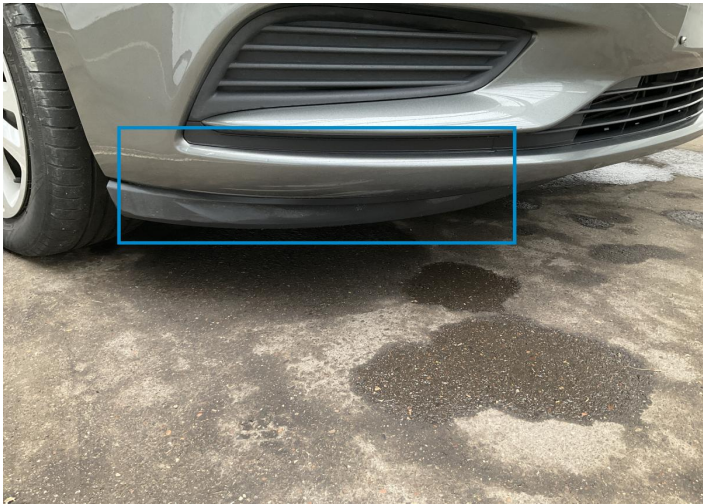
3. Bumper / Front
Paint / Scratch / Scuff -

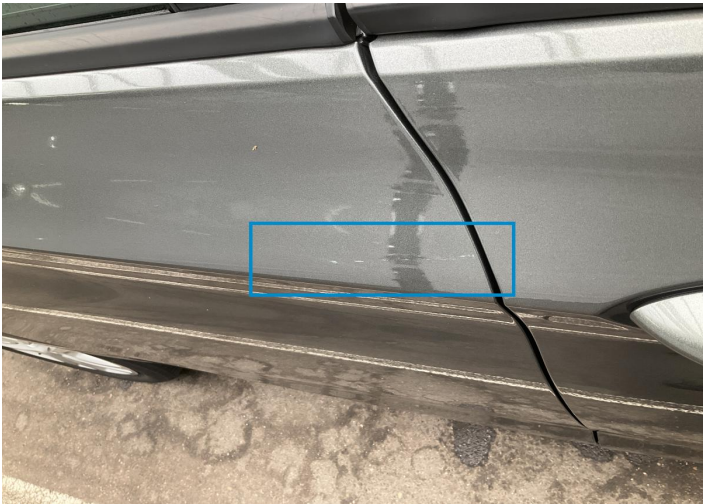
4. Door / Back Right
Paint / Scratch / Scuff -

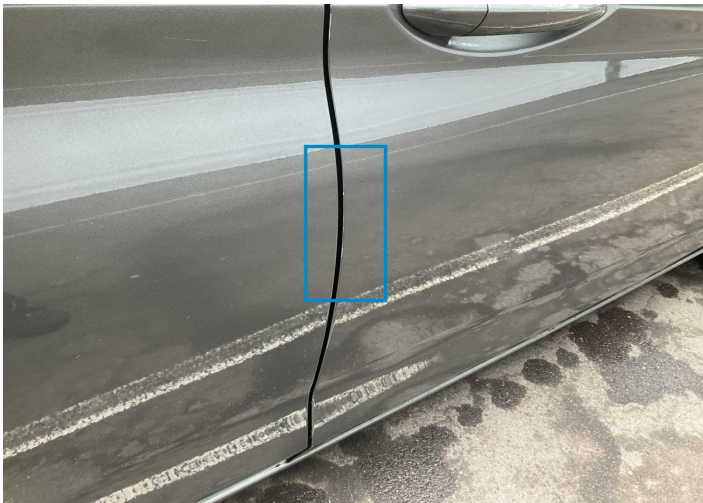
5. Door / Front Right
Paint / Scratch / Scuff -

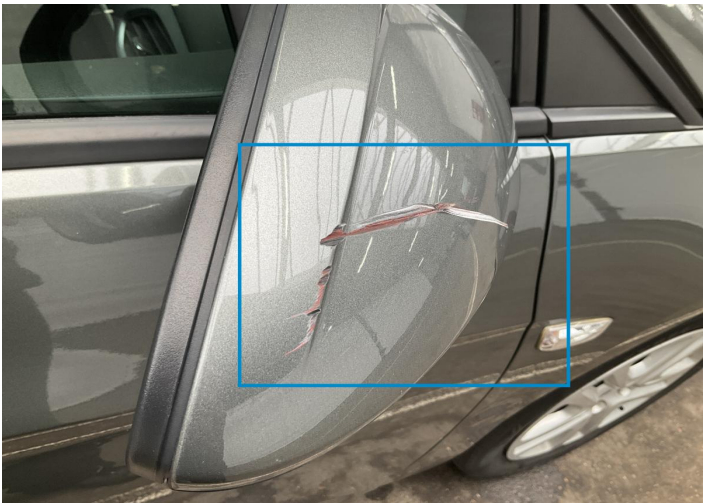
6. Mirror Shell / Front Right
Paint / Scratch / Scuff -

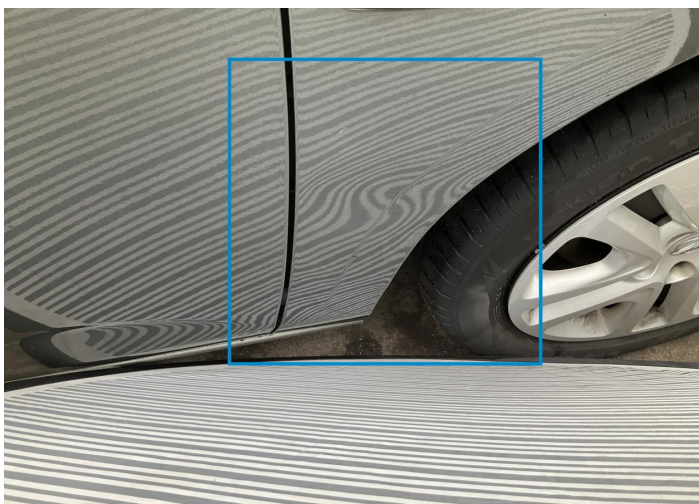
7. Fender / Front Right
Bodywork / Dent / Dent -

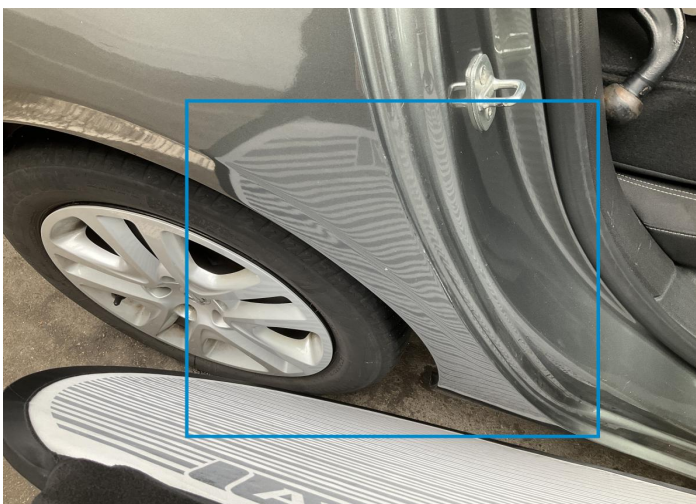
8. Side Panel / Back Right
Paint / Poor Previous Repair -

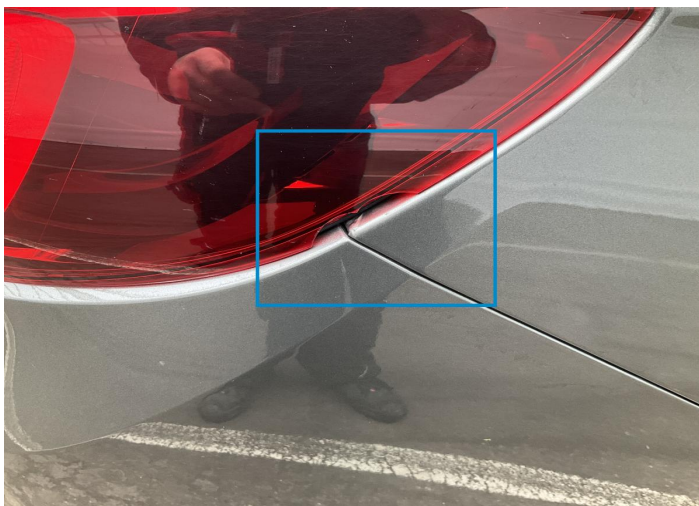
9. Back Light / Right
Glass Break -

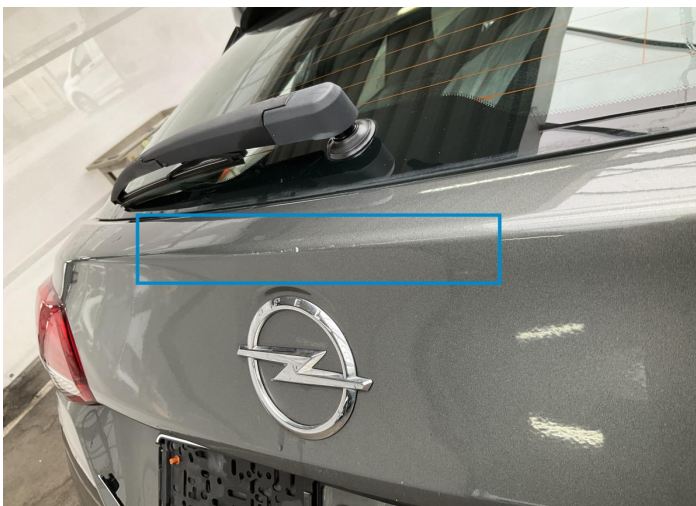
10. Tailgate
Paint / Scratch / Scuff -

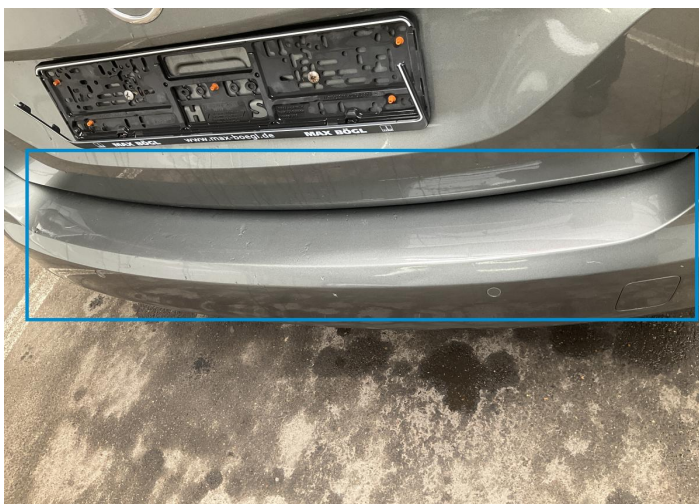
11. Bumper / Back
Paint / Scratch / Scuff -

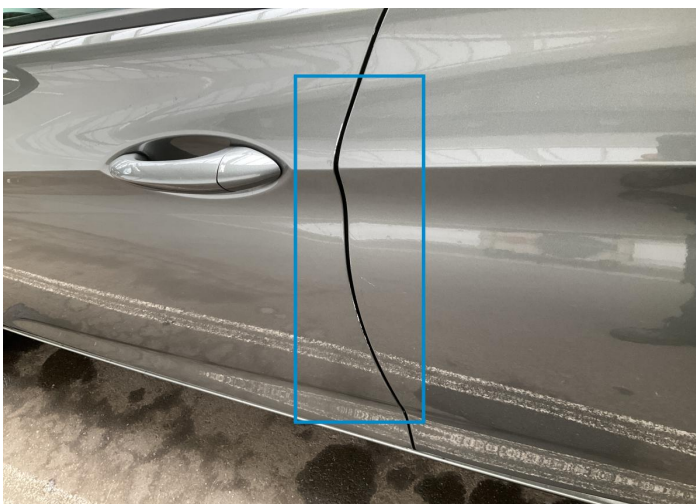
12. Door / Front Left
Paint / Scratch / Scuff -

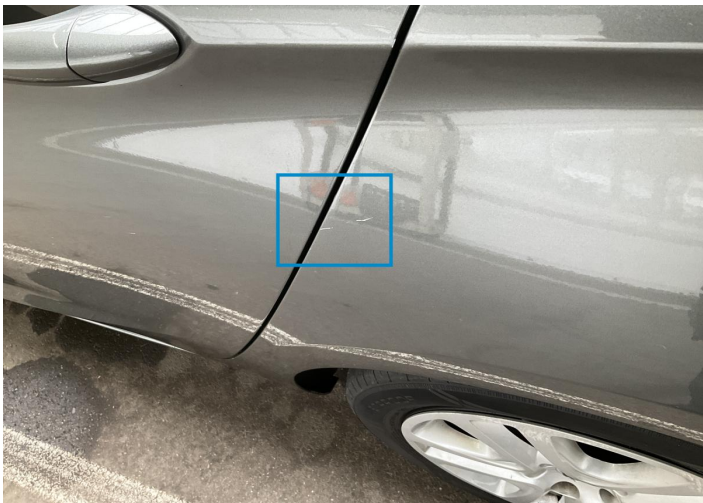
13. Side Panel / Back Left
Paint / Scratch / Scuff -

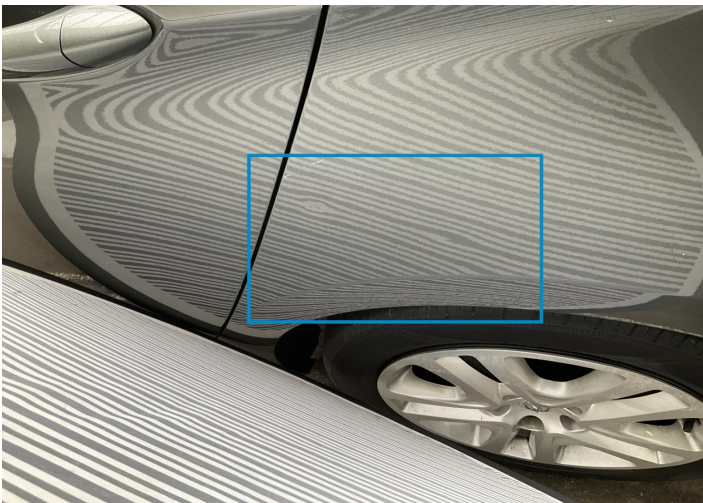
14. Side Panel / Back Left
Bodywork / Dent / Dent -

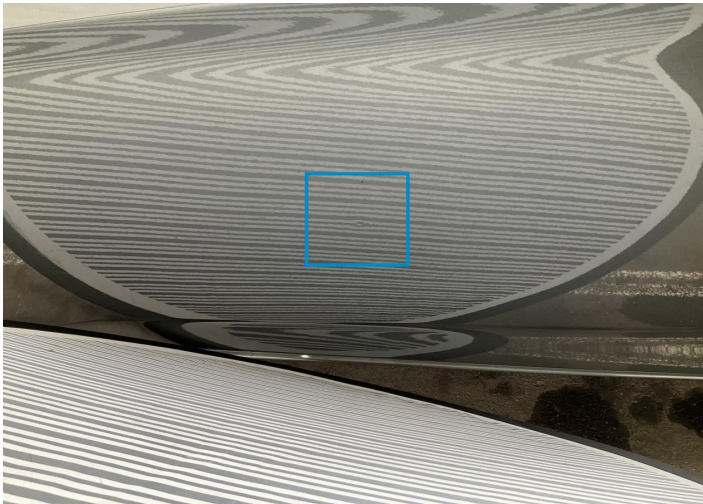
15. Door / Front Left
Bodywork / Dent / Dent -

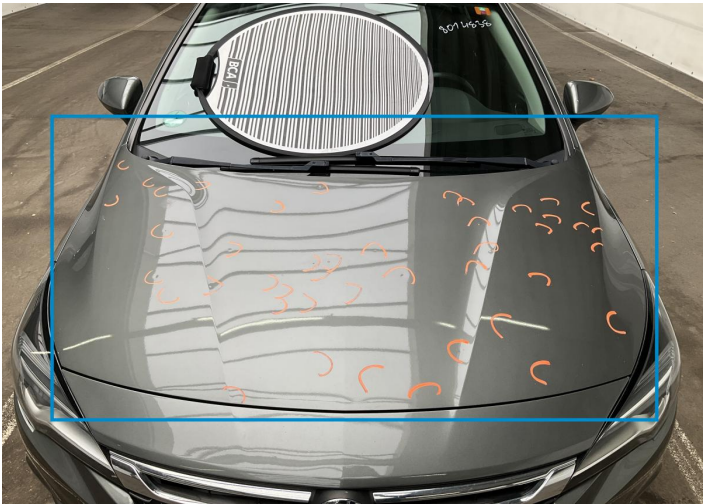
16. Hood
Bodywork / Dent / Hail Area -

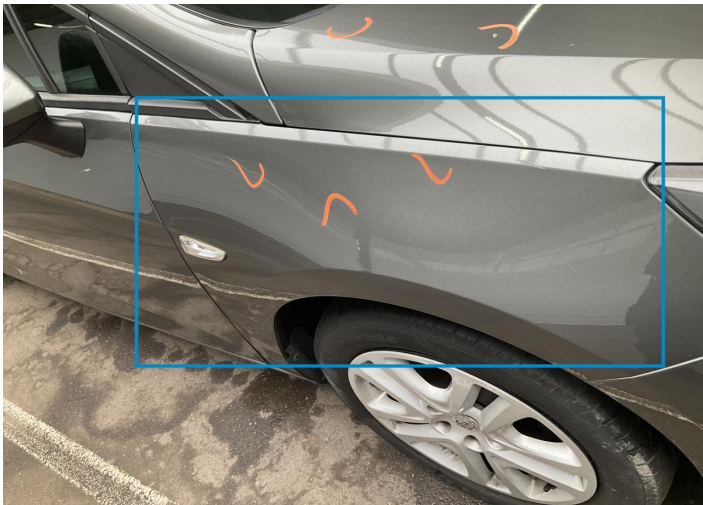
17. Fender / Front Right
Bodywork / Dent / Hail Area -

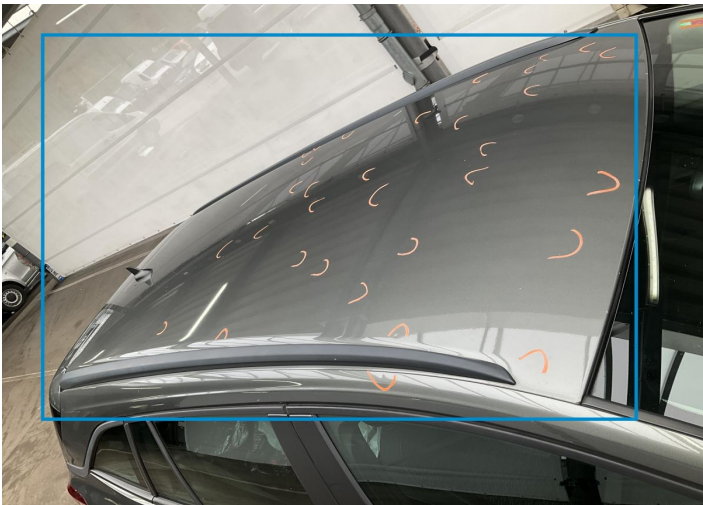
18. Roof
Bodywork / Dent / Hail Area -

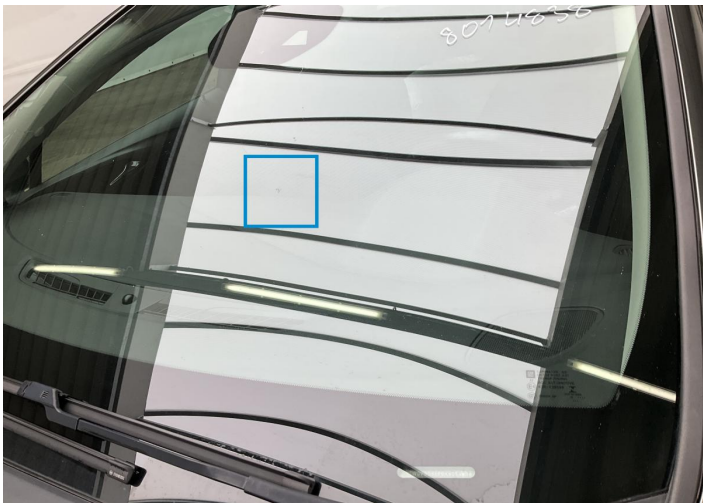
19. Windshield / Front
Glass Break / Impact -

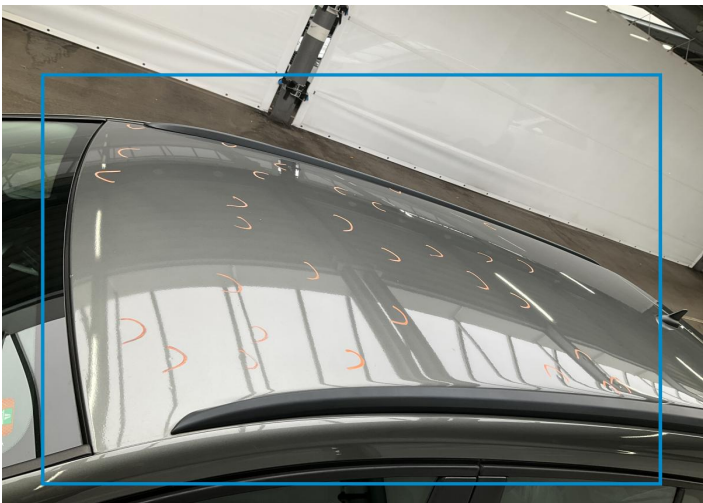
20. Roof
Bodywork / Dent / Hail Area -

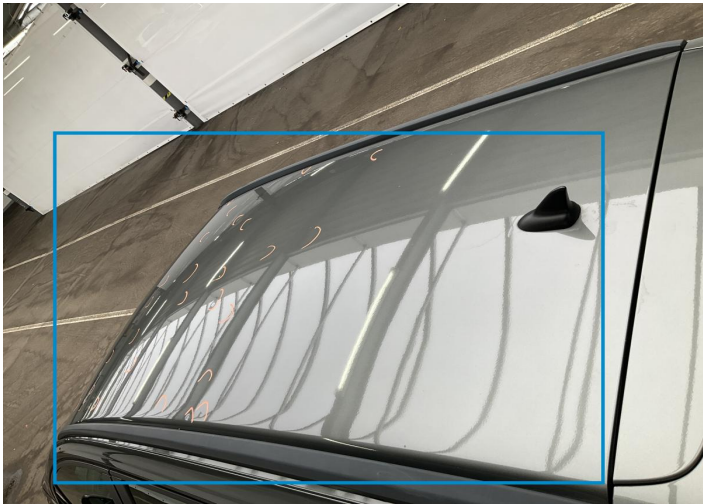
21. Roof
Bodywork / Dent / Hail Area -

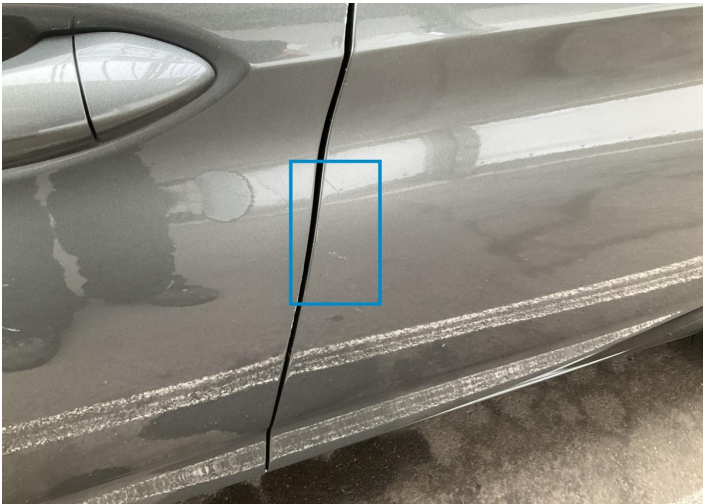
22. Door / Back Left
Paint / Scratch / Scuff -

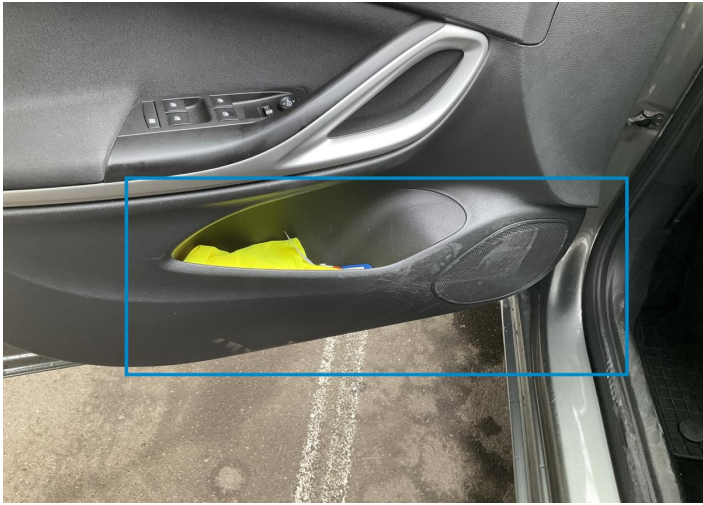
23. Panel Filling / Front Left
Interior / Scratched -

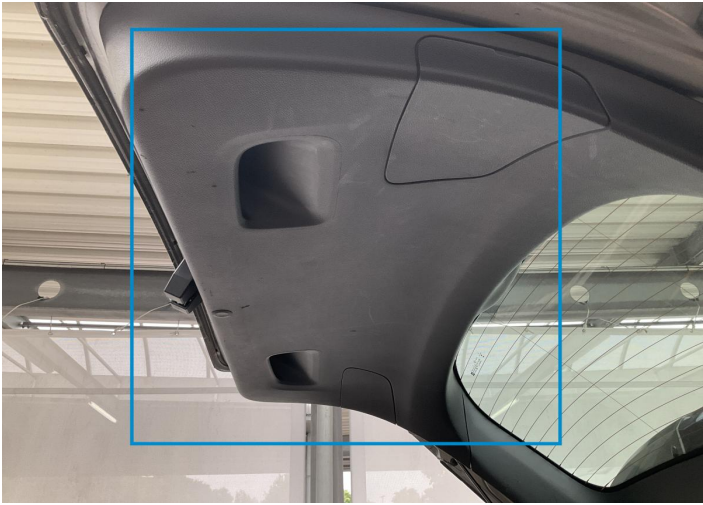
24. Tailgate Upholstery / Back
Interior / Scratched -

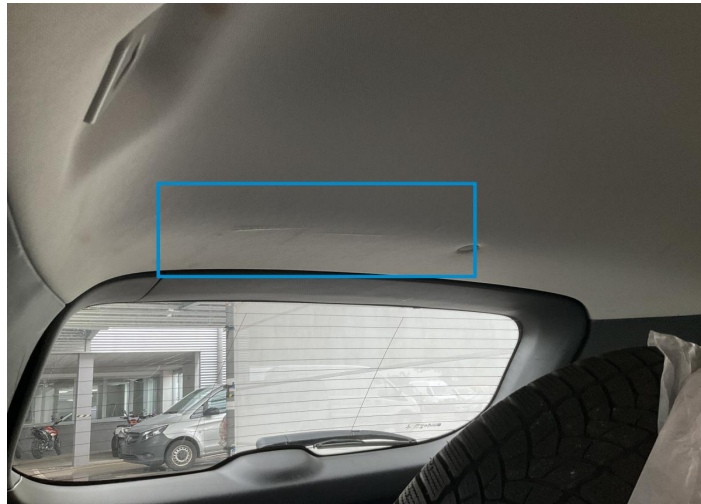
25. Roof Upholstery
Interior / Ripped -
