Expertise

Protocol number: 41603224
Order No. / Reference: 24995582
Inspection date: 15 Sept 2025

Manufacturer: Opel	Model: Astra 1.2 Turbo Start/Stop Sports Tourer Business Edition
VIN: W0VBD8ES4N8043051

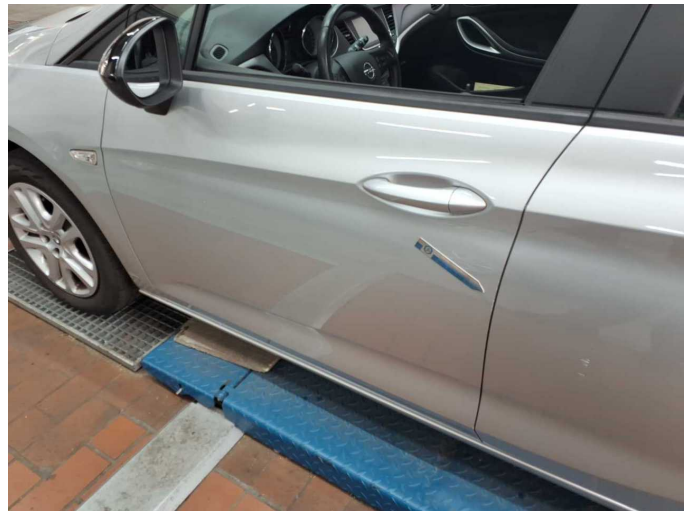
Damage 1: Door - front left side: Door - Scratched - Smart repair

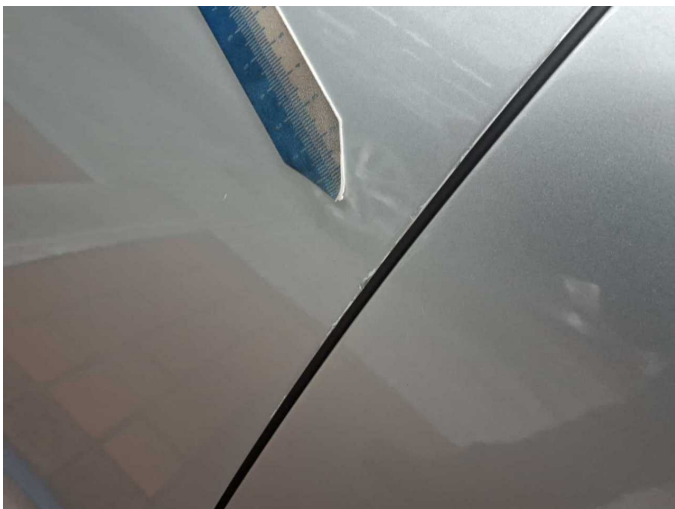
Damage 1: Door - front left side: Door - Scratched - Smart repair

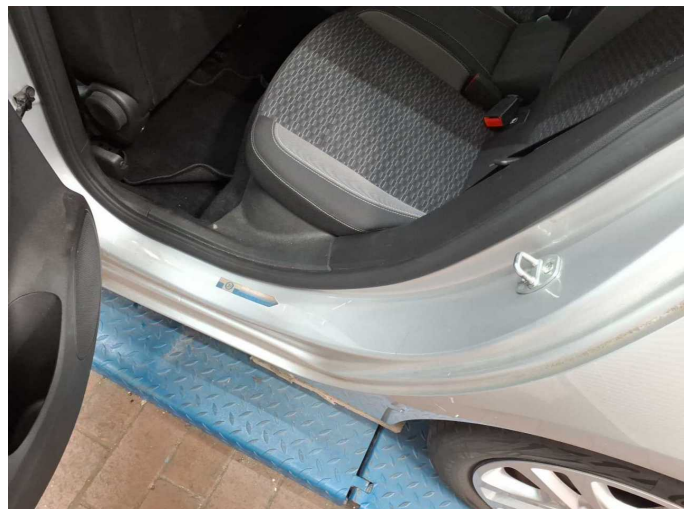
Damage 2: Side panel - rear left side: Sill - Dent / paintcoat damage - Repair and paint

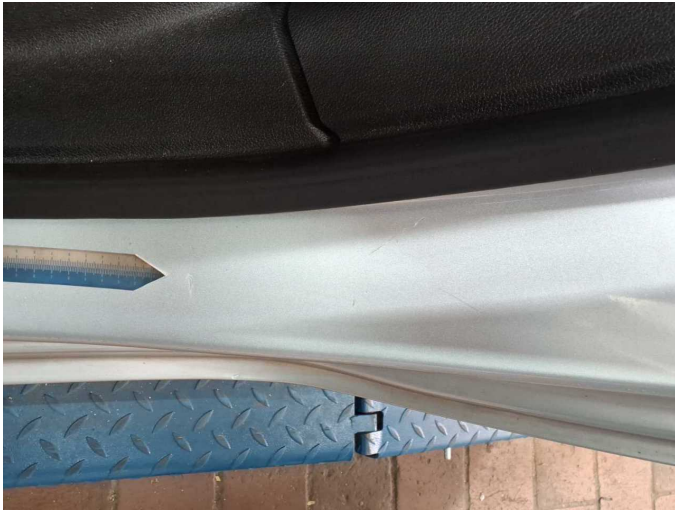
Damage 2: Side panel - rear left side: Sill - Dent / paintcoat damage - Repair and paint

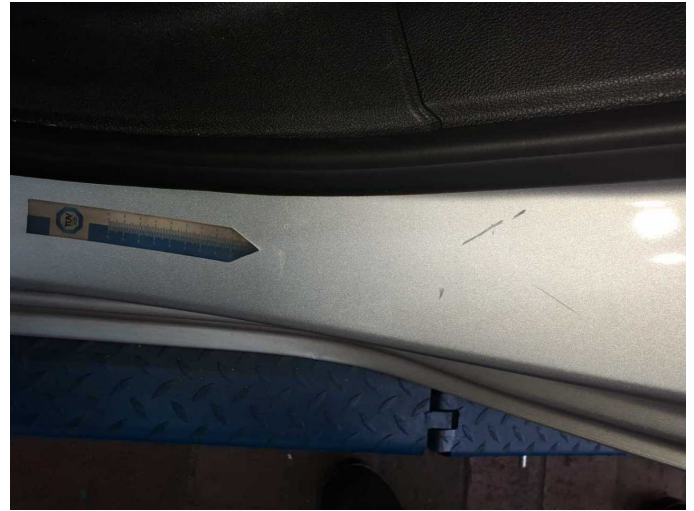
Damage 2: Side panel - rear left side: Sill - Dent / paintcoat damage - Repair and paint

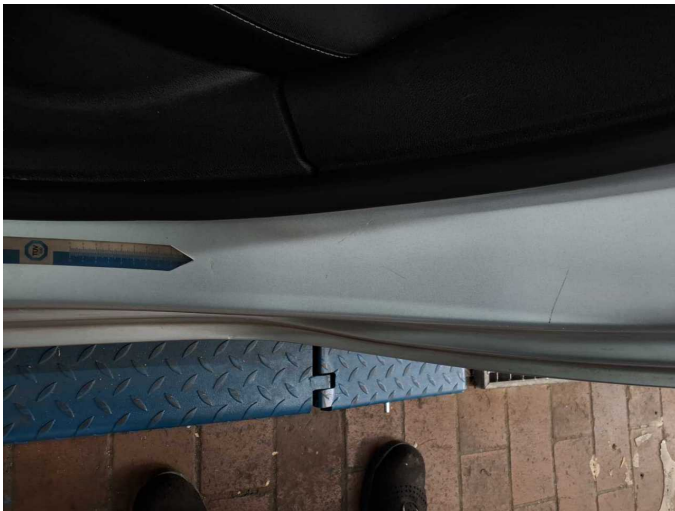
Damage 2: Side panel - rear left side: Sill - Dent / paintcoat damage - Repair and paint

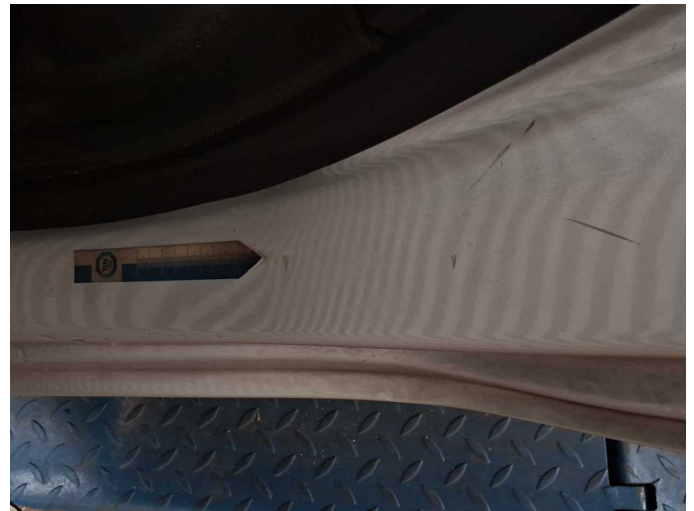
Damage 2: Side panel - rear left side: Sill - Dent / paintcoat damage - Repair and paint

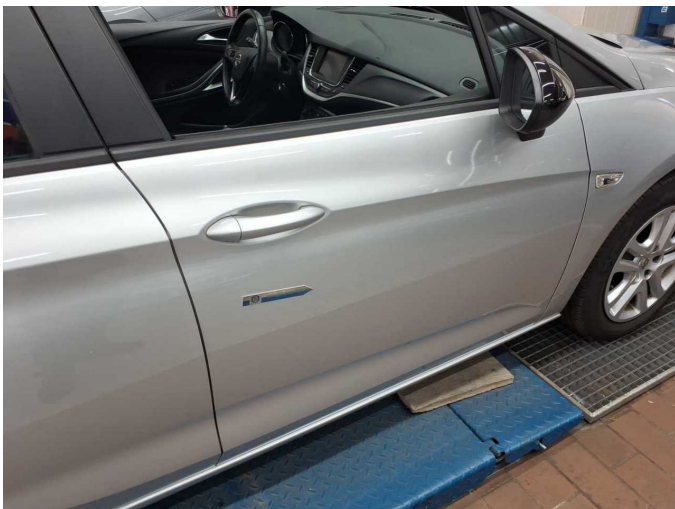
Damage 3: Door - front right side: Door (+ Verätzung) - Scratch(es) - Paint

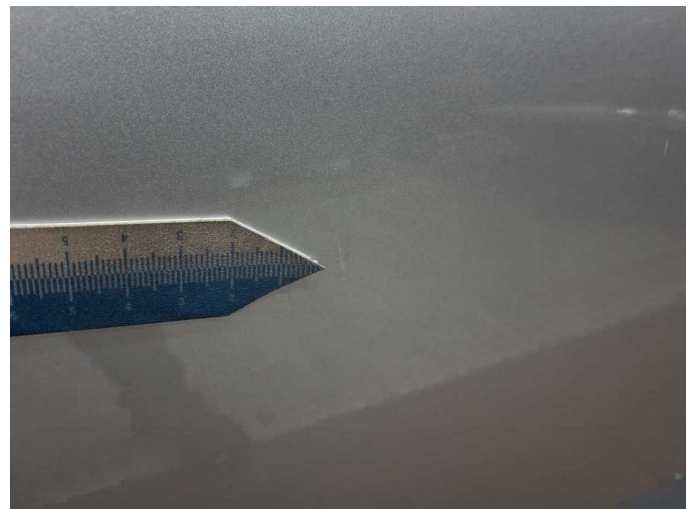
Damage 3: Door - front right side: Door (+ Verätzung) - Scratch(es) - Paint

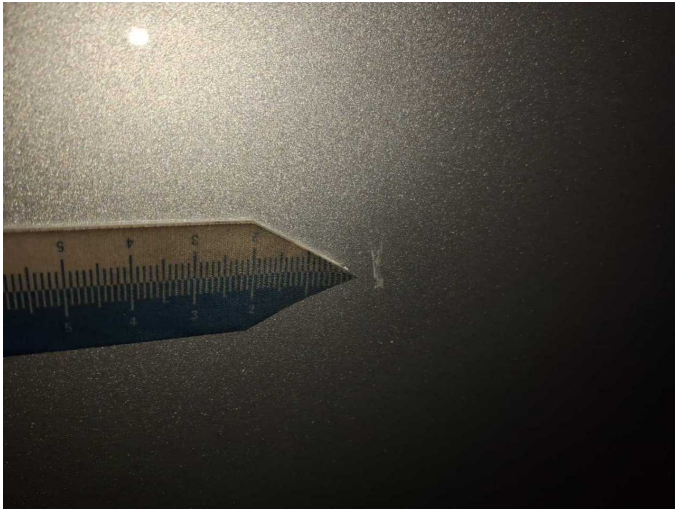
Damage 3: Door - front right side: Door (+ Verätzung) - Scratch(es) - Paint

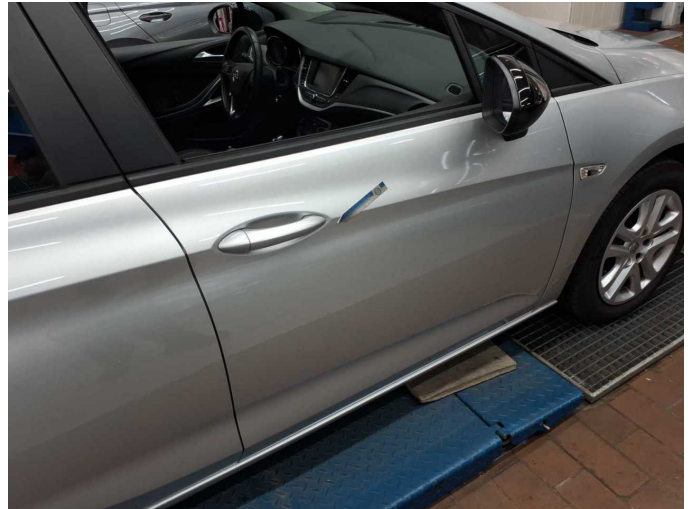
Damage 3: Door - front right side: Door (+ Verätzung) - Scratch(es) - Paint

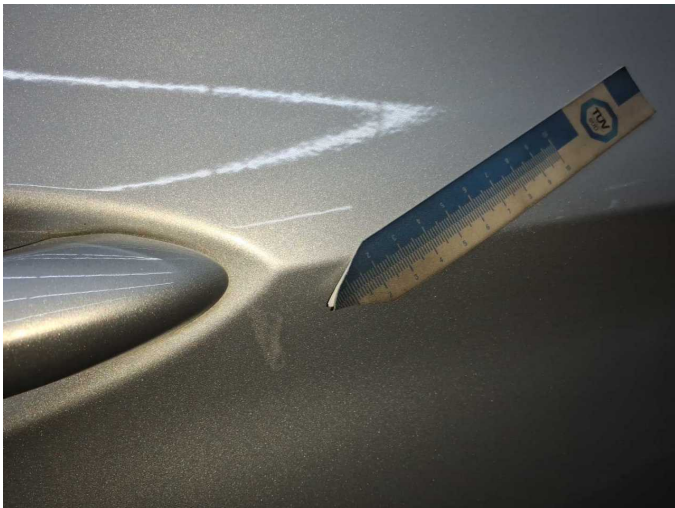
Damage 3: Door - front right side: Door (+ Verätzung) - Scratch(es) - Paint

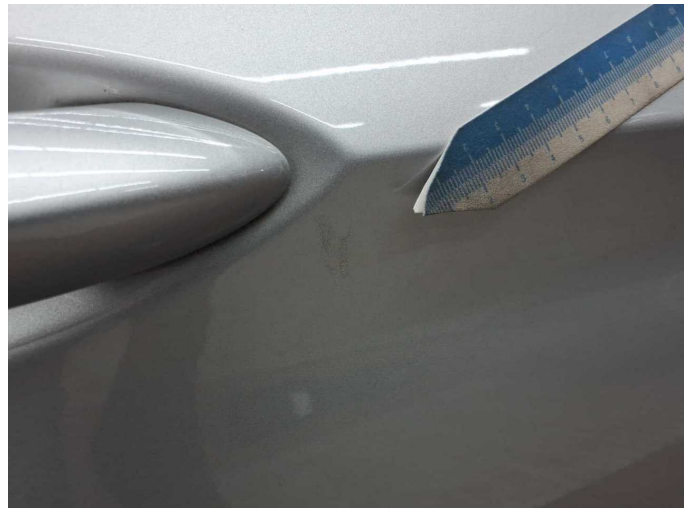
Damage 3: Door - front right side: Door (+ Verätzung) - Scratch(es) - Paint

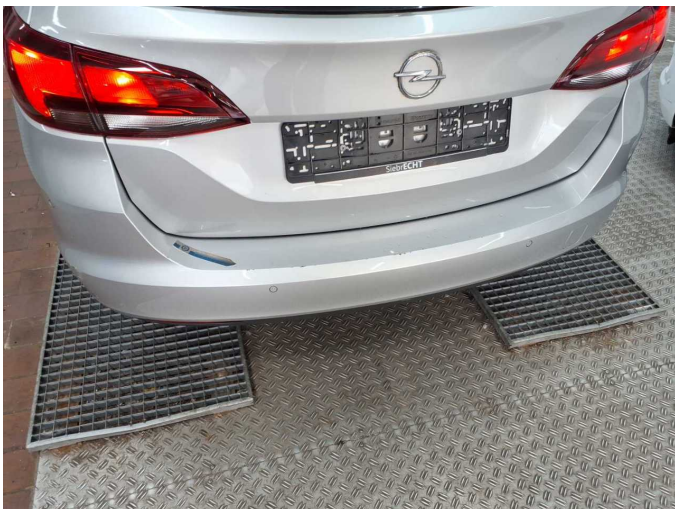
Damage 4: Rear bumper: Rear bumper - Scratched - Paint

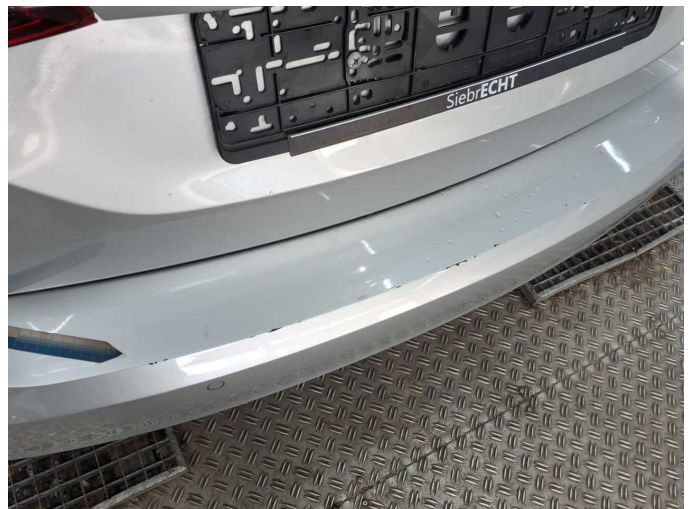
Damage 4: Rear bumper: Rear bumper - Scratched - Paint

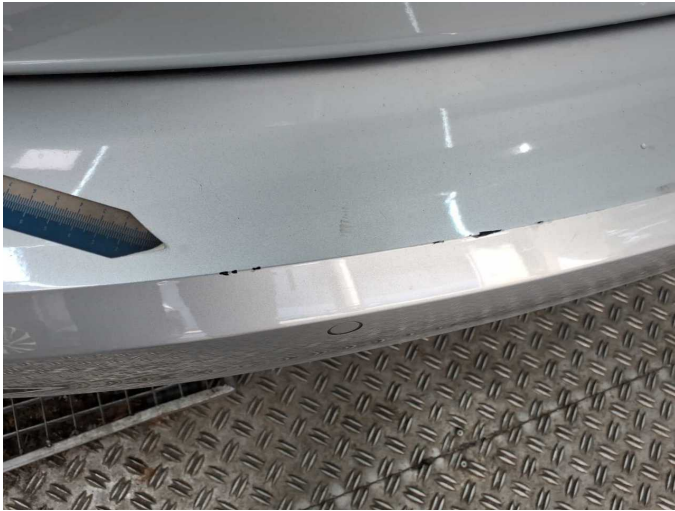
Damage 4: Rear bumper: Rear bumper - Scratched - Paint

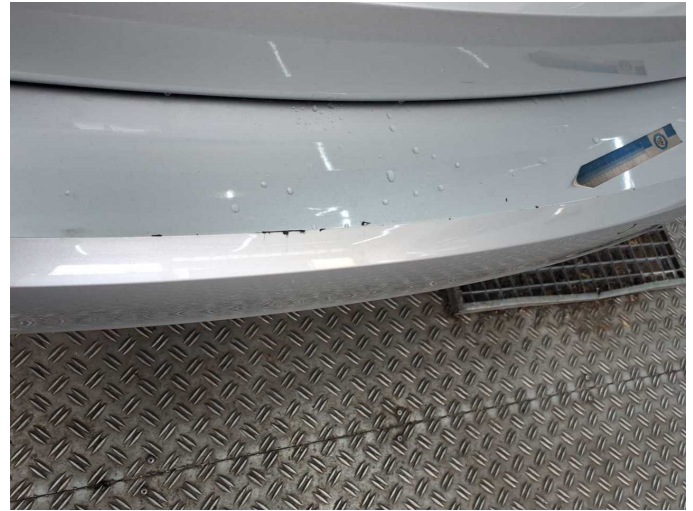
Damage 4: Rear bumper: Rear bumper - Scratched - Paint

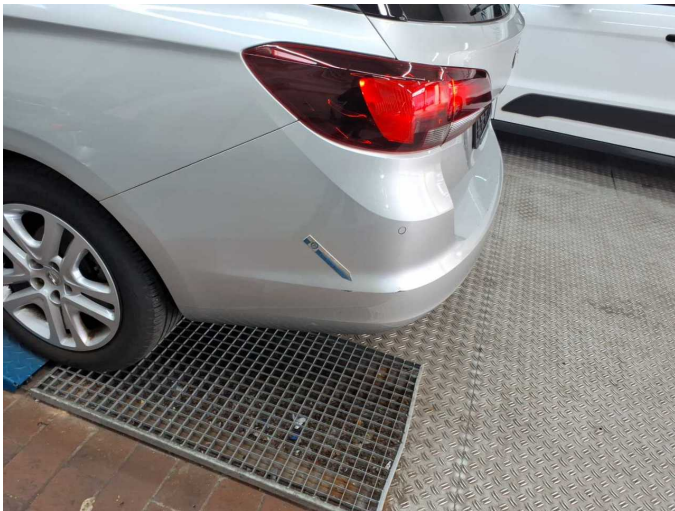
Damage 4: Rear bumper: Rear bumper - Scratched - Paint

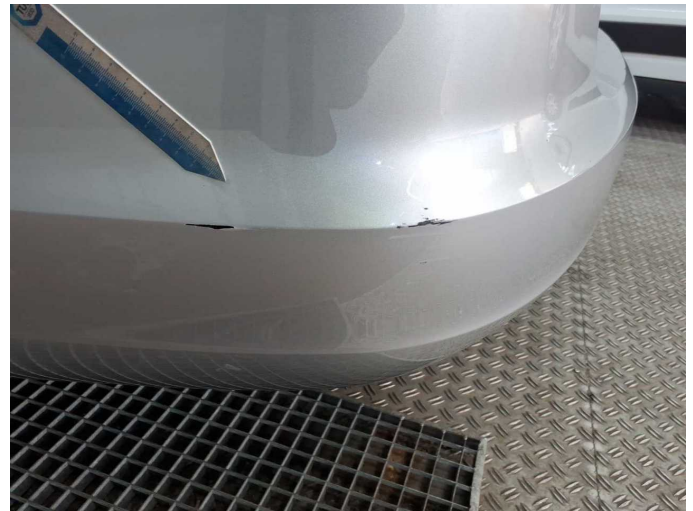
Damage 4: Rear bumper: Rear bumper - Scratched - Paint

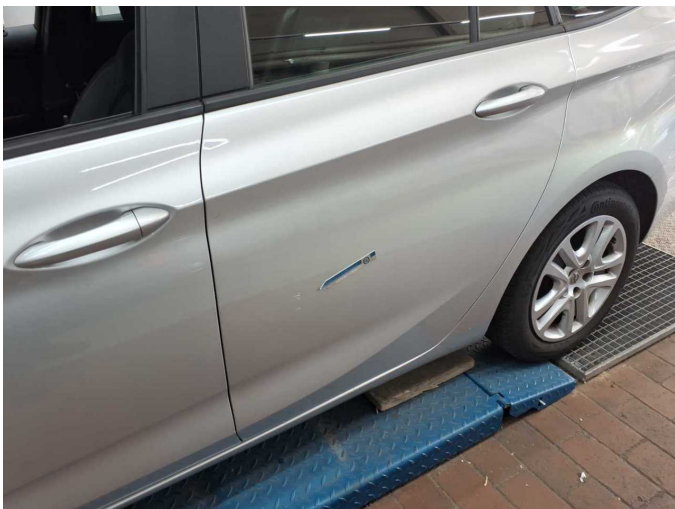
Damage 5: Door - rear left side: Door - Dent / paintcoat damage - Repair and paint

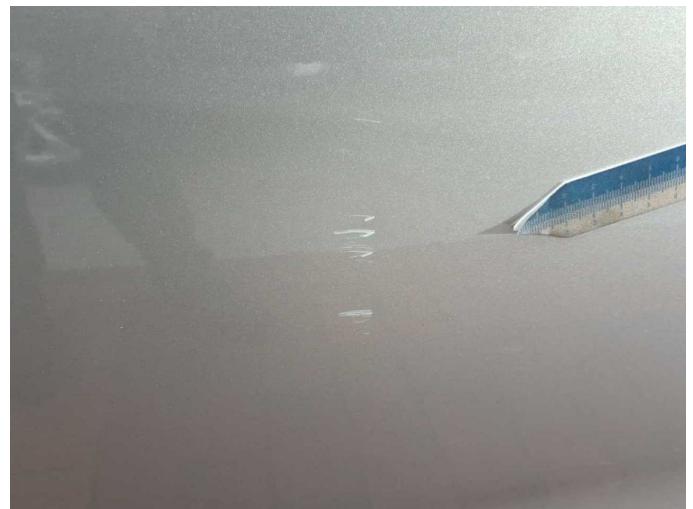
Damage 5: Door - rear left side: Door - Dent / paintcoat damage - Repair and paint

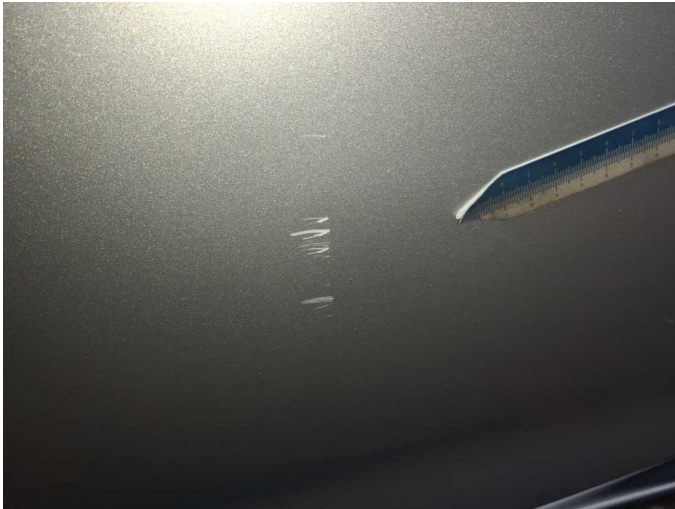
Damage 5: Door - rear left side: Door - Dent / paintcoat damage - Repair and paint

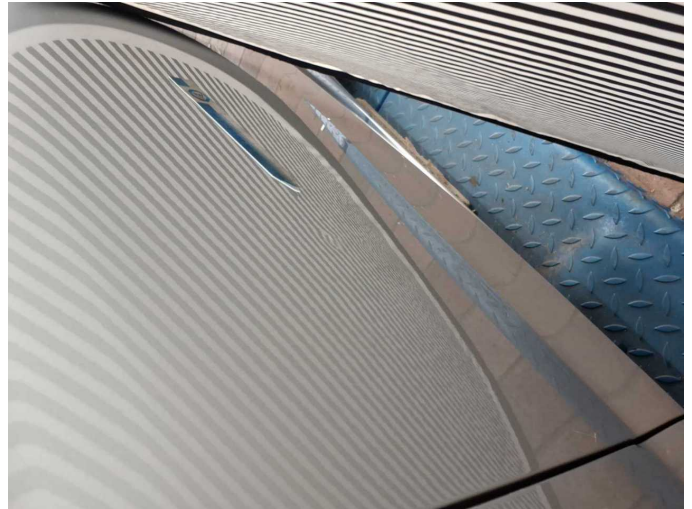
Damage 5: Door - rear left side: Door - Dent / paintcoat damage - Repair and paint

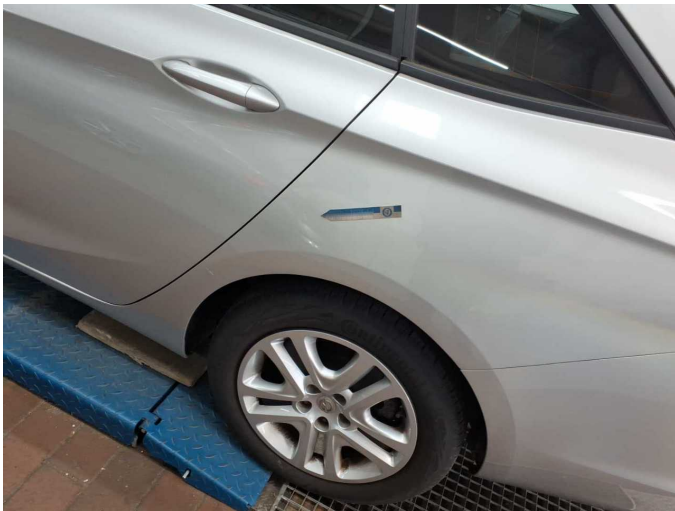
Damage 6: Side panel - rear left side: Side panel - Scratch(es) - Paint

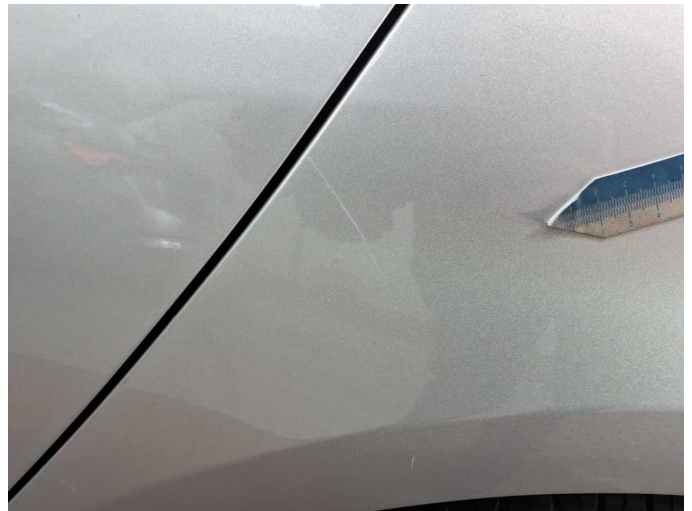
Damage 6: Side panel - rear left side: Side panel - Scratch(es) - Paint

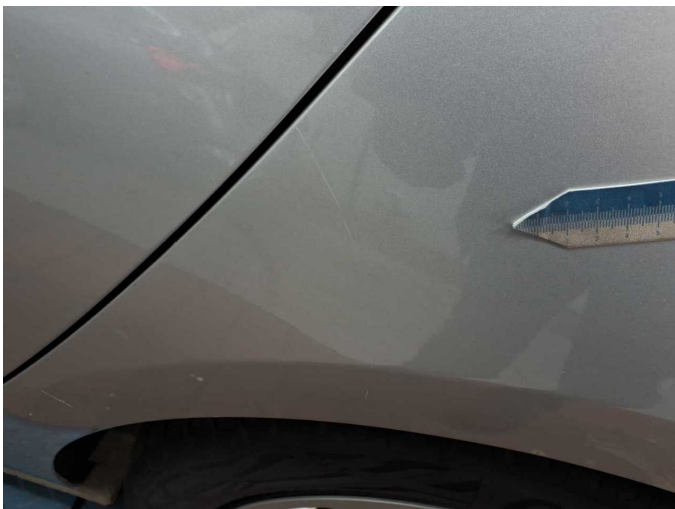
Damage 6: Side panel - rear left side: Side panel - Scratch(es) - Paint

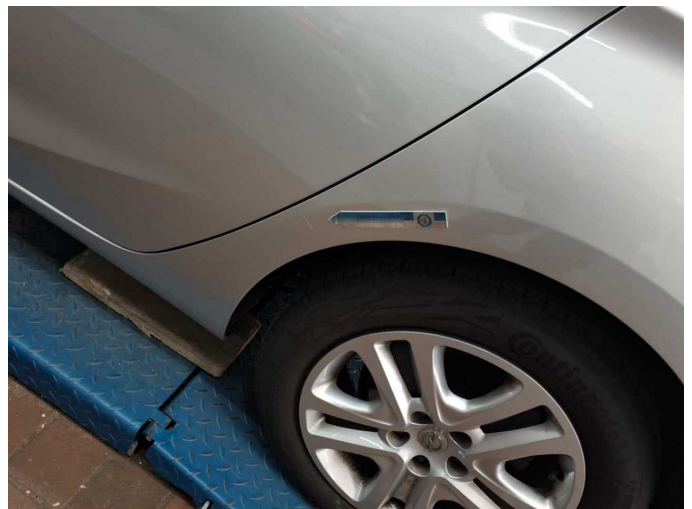
Damage 6: Side panel - rear left side: Side panel - Scratch(es) - Paint

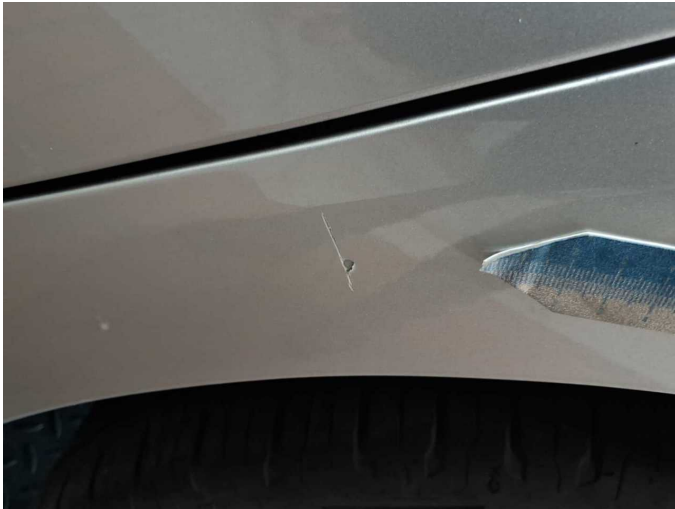
Damage 6: Side panel - rear left side: Side panel - Scratch(es) - Paint

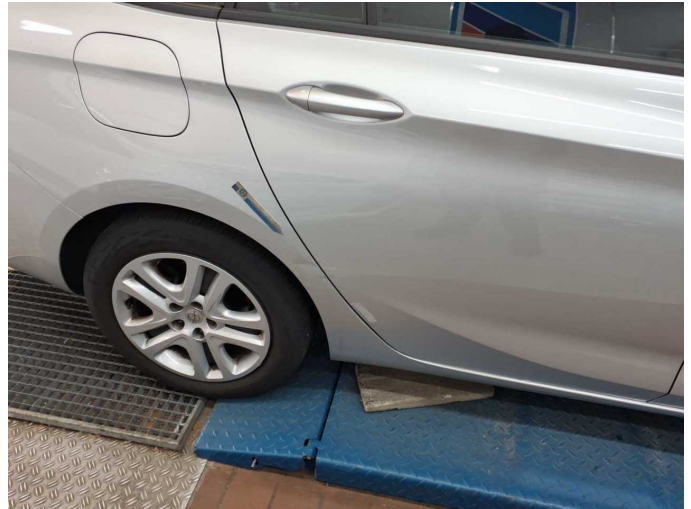
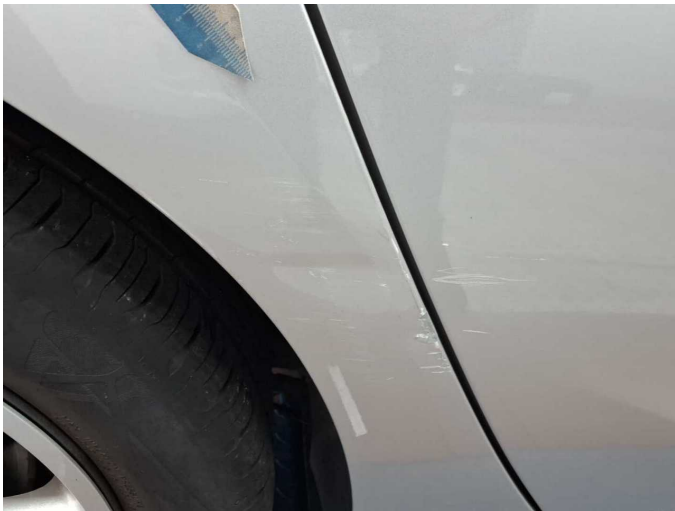
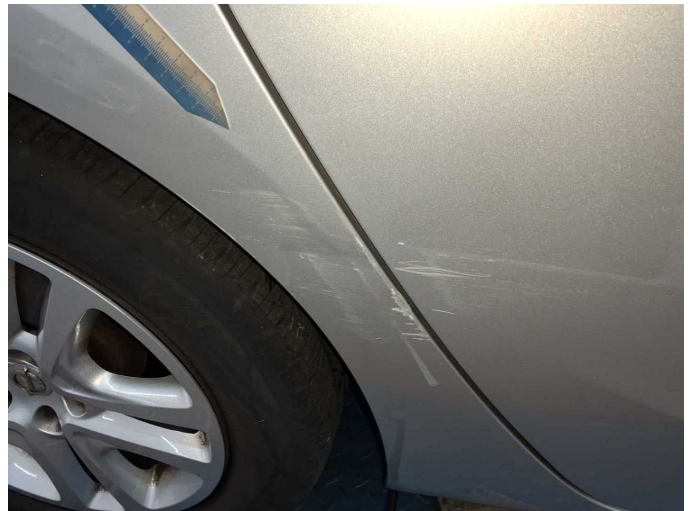
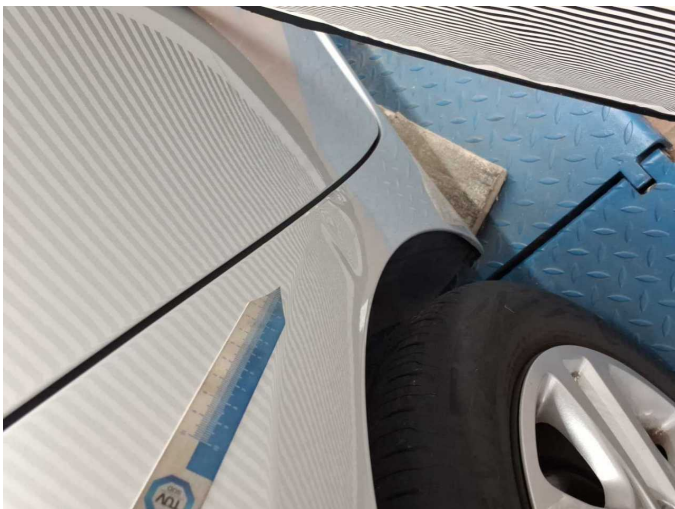
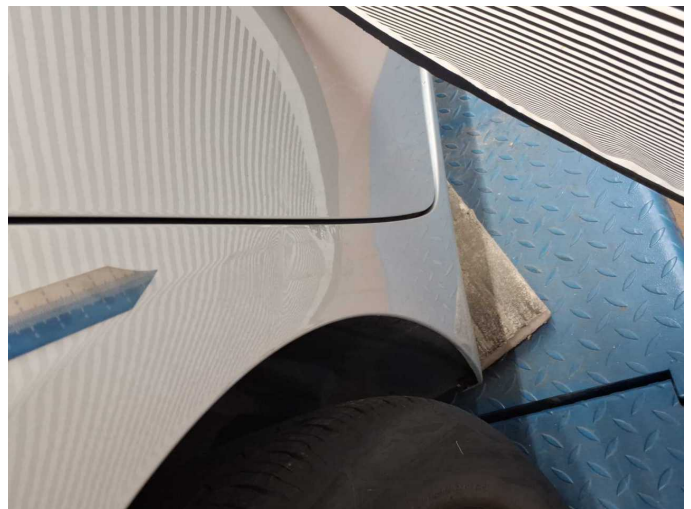
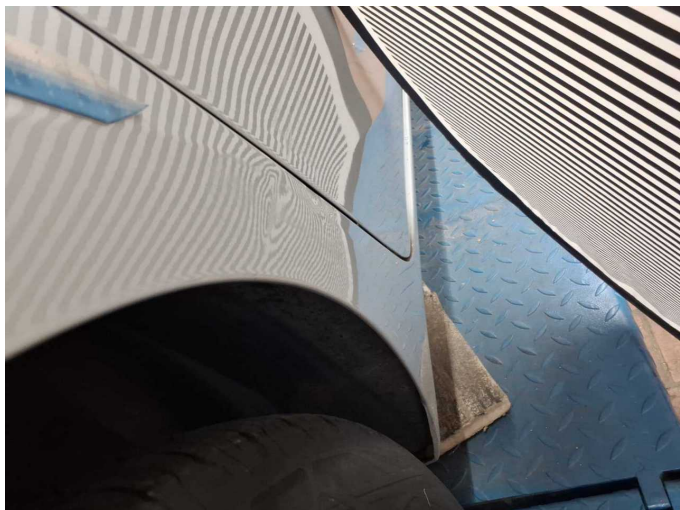
Accident 1: Side right

1 Side right
