Expertise

Protocol number: 41518349
Order No. / Reference: 25228164
Inspection date: 15 Sept 2025

Manufacturer: Opel

Model: Astra 1.5 D Start/Stop Sports Tourer Edition

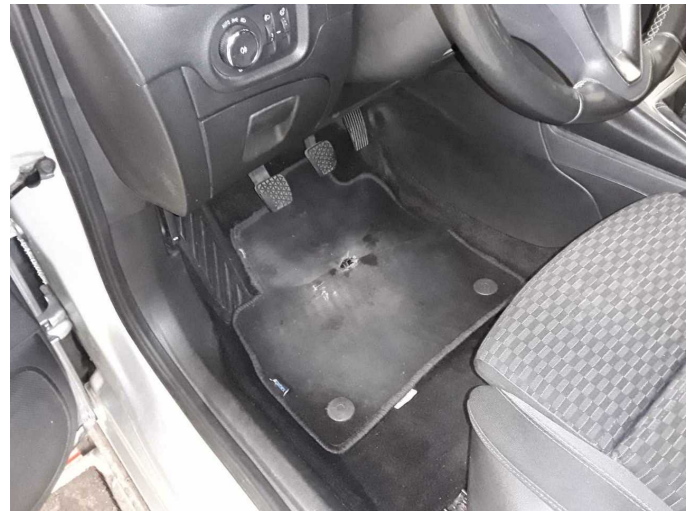
Damage 1: Trim / covers: Floor mats - Broken / torn - No deduction

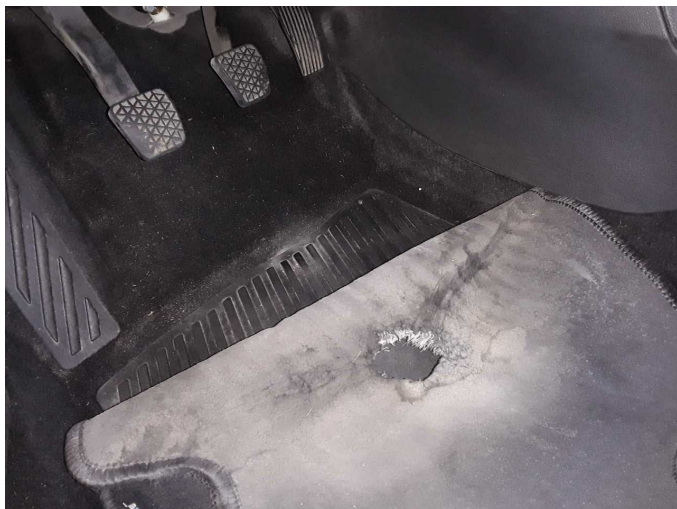
Damage 1: Trim / covers: Floor mats - Broken / torn - No deduction

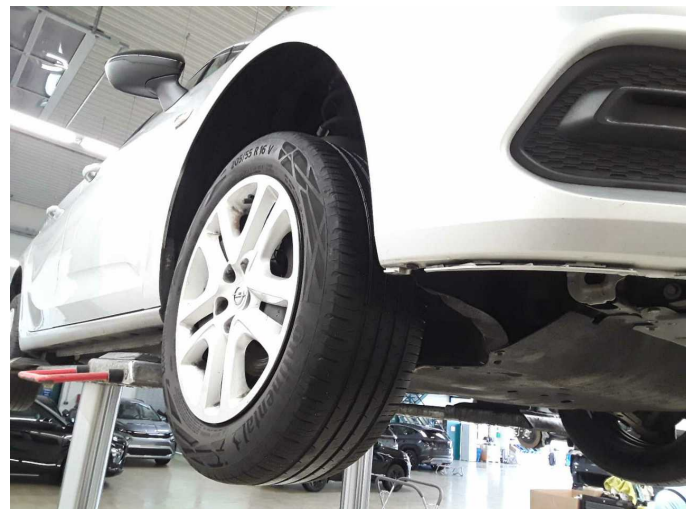
Damage 2: Mudguard - right side: Inner mudguard - Broken / torn - Replace

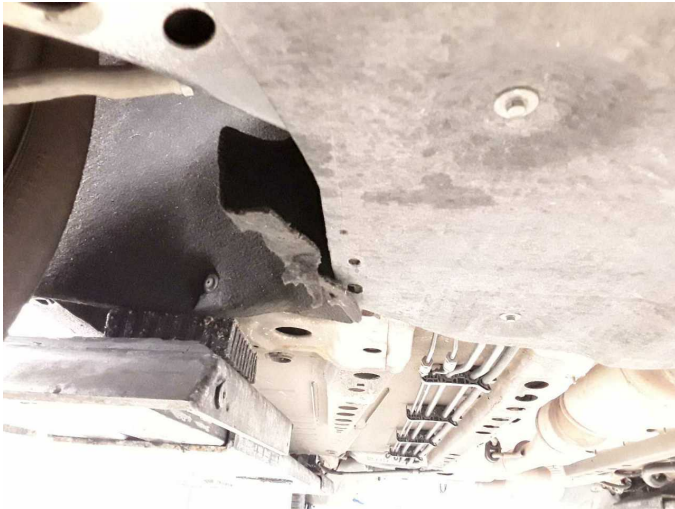
Damage 2: Mudguard - right side: Inner mudguard - Broken / torn - Replace

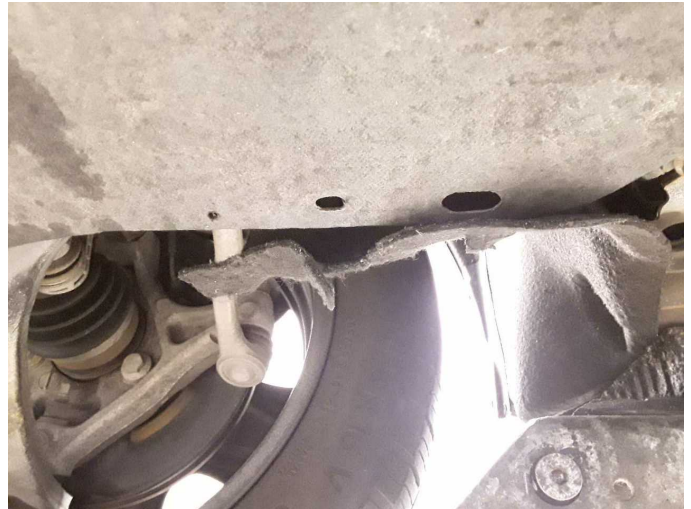
Damage 2: Mudguard - right side: Inner mudguard - Broken / torn - Replace

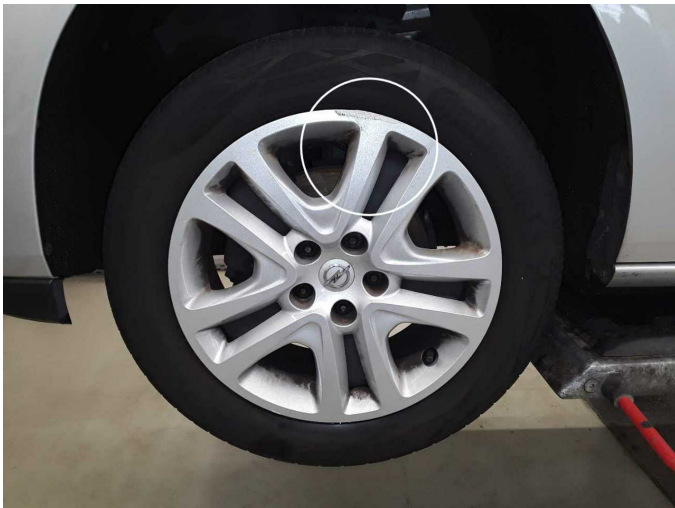
Damage 3: Wheel / tyres: Wheel cover set - complete (4x) - Scratched - Replace

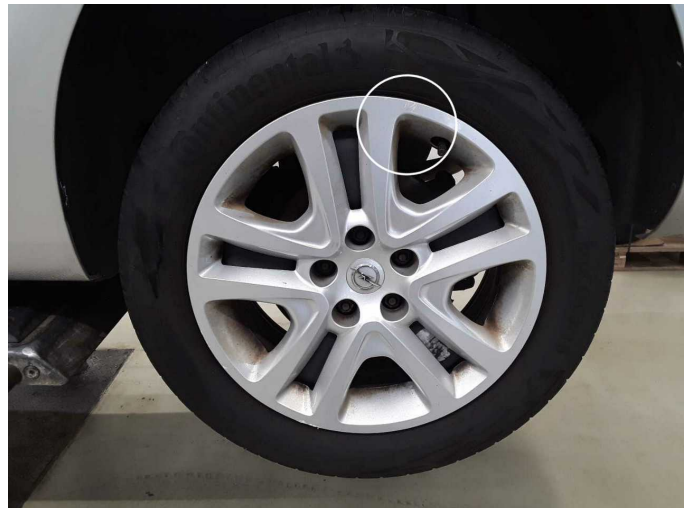
Damage 3: Wheel / tyres: Wheel cover set - complete (4x) - Scratched - Replace

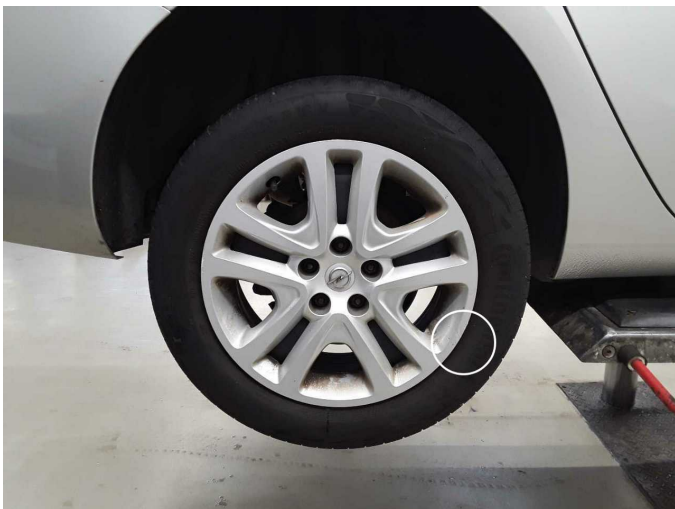
Damage 3: Wheel / tyres: Wheel cover set - complete (4x) - Scratched - Replace

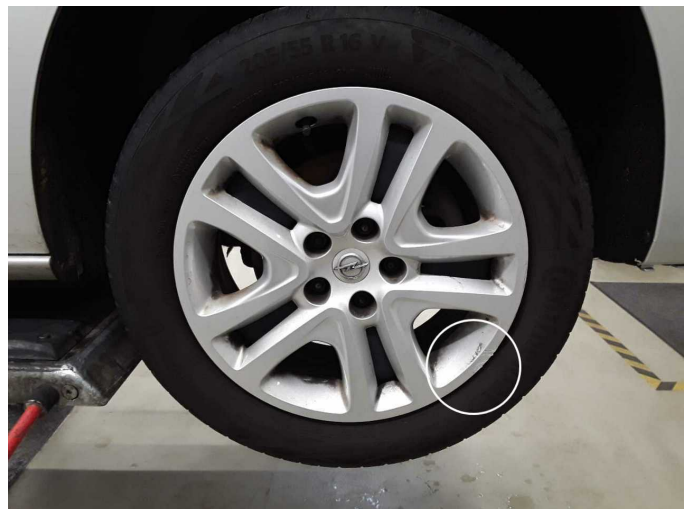
Damage 3: Wheel / tyres: Wheel cover set - complete (4x) - Scratched - Replace

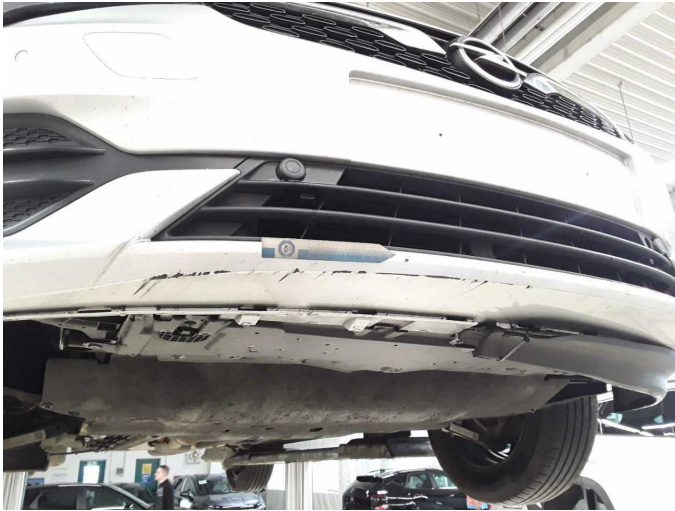
Damage 4: Front bumper: Front bumper - Scratched - Smart repair

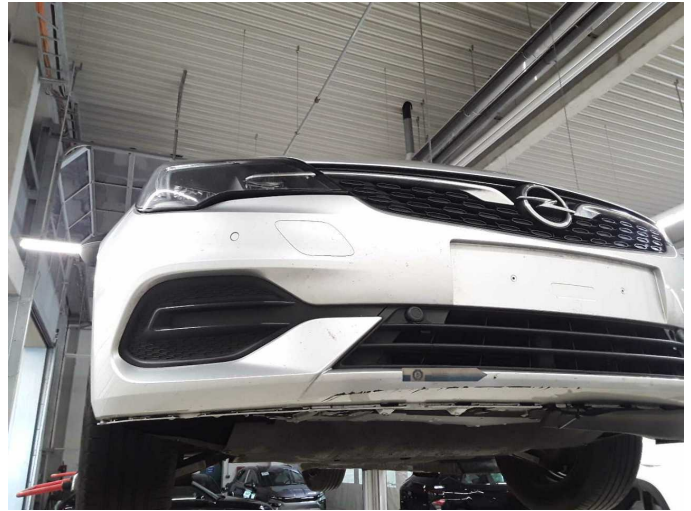
Damage 4: Front bumper: Front bumper - Scratched - Smart repair

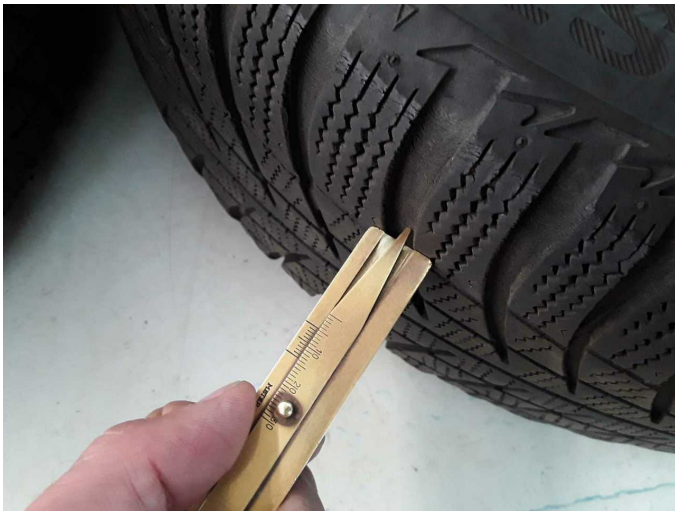
Damage 5: 2nd wheel set: 2 tyres - Does not meet the leasing specifications - Replace

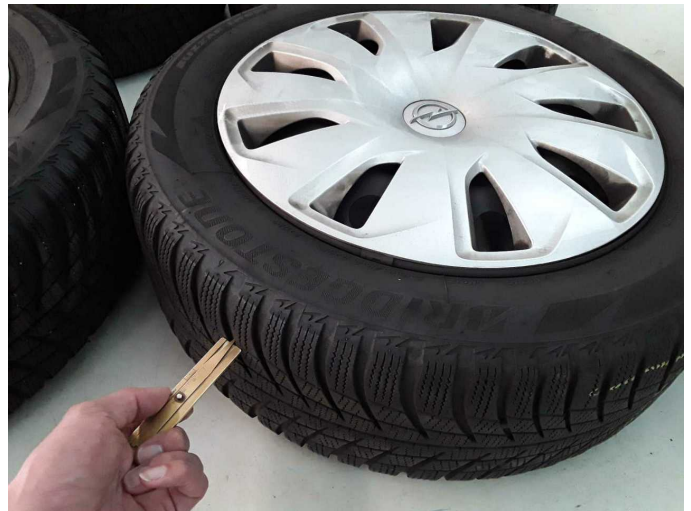
Damage 5: 2nd wheel set: 2 tyres - Does not meet the leasing specifications - Replace

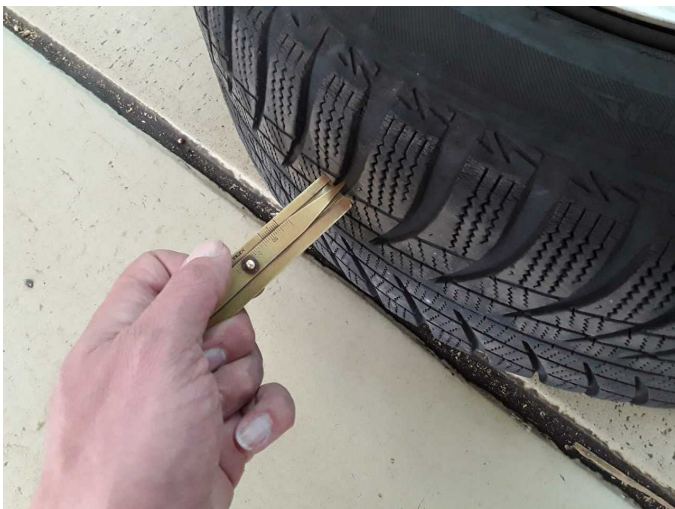
Damage 5: 2nd wheel set: 2 tyres - Does not meet the leasing specifications - Replace

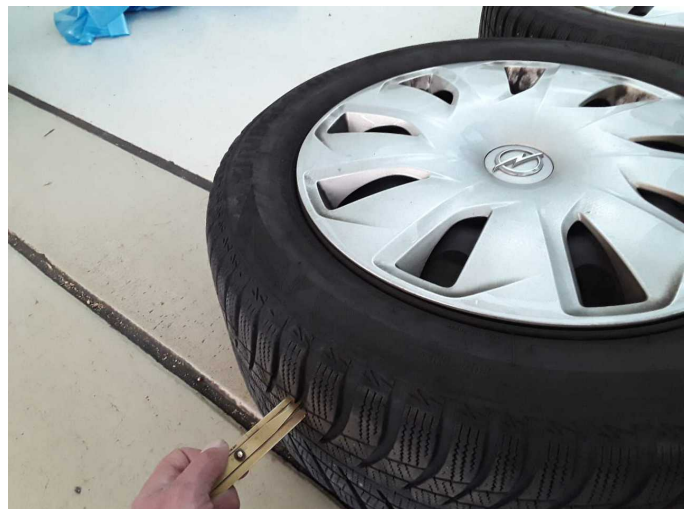
Damage 5: 2nd wheel set: 2 tyres - Does not meet the leasing specifications - Replace

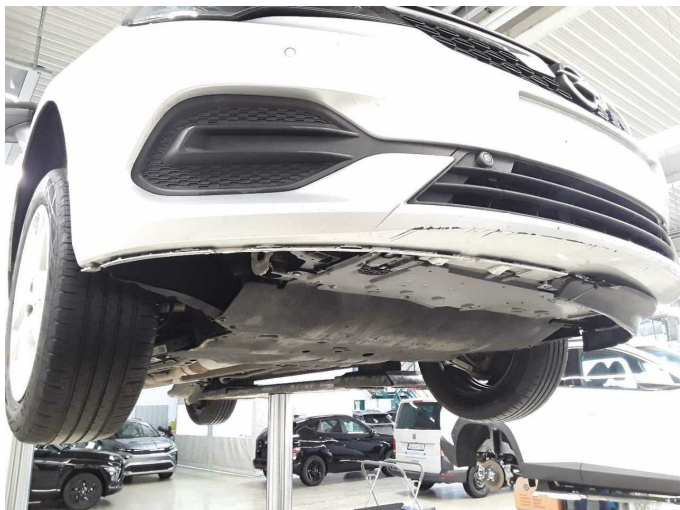
Damage 6: Front bumper: Spoiler (Gumminlippe rechts und links fehlt !) - Broken / torn - Replace

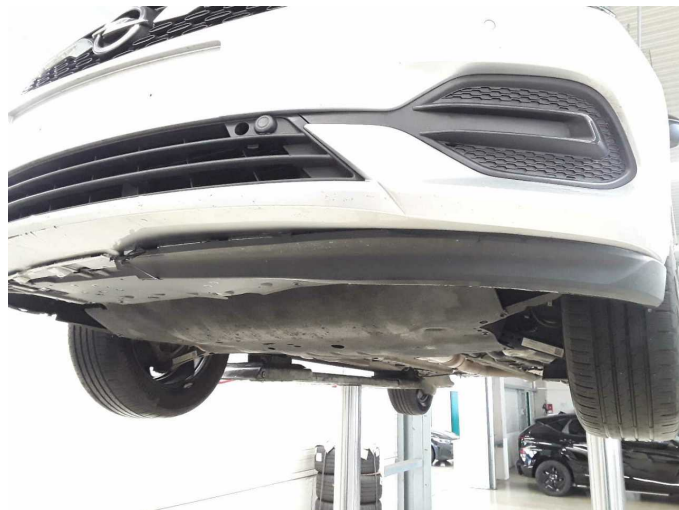
Damage 6: Front bumper: Spoiler (Gumminlippe rechts und links fehlt !) - Broken / torn - Replace

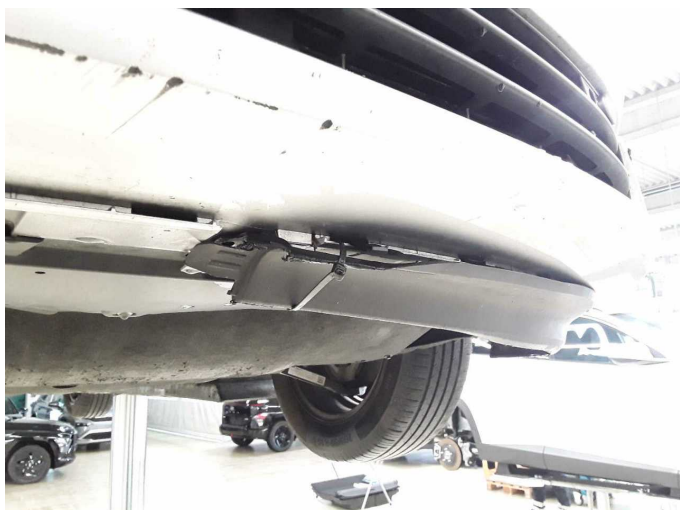
Damage 6: Front bumper: Spoiler (Gumminlippe rechts und links fehlt !) - Broken / torn - Replace
