Expertise

Protocol number: 41861043  
Order number / reference: 25287105  
Inspection date: 2 Oct 2025

| Manufacturer: Opel | Model: Astra 1.5 D Start/Stop Sports Tourer Edition |

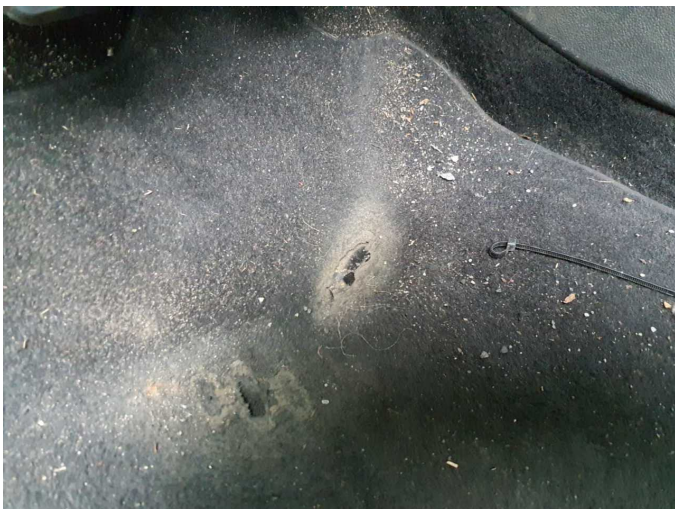
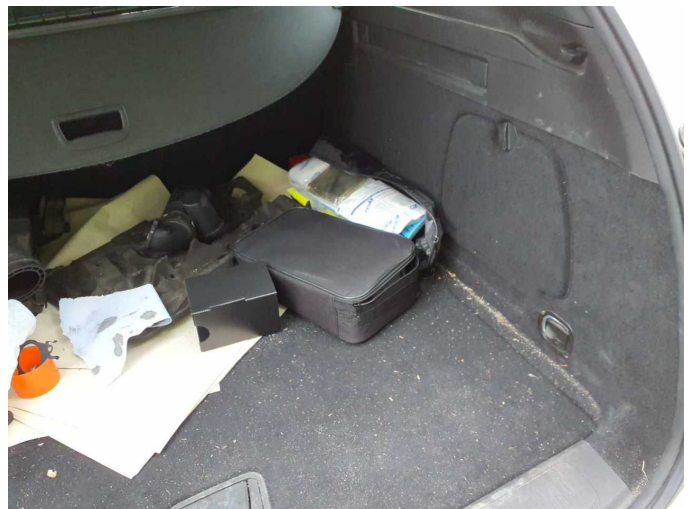
| No. | Component group | Description |
|---|---|---|
| 1 | Trim / covers | Floor mats - Holes - Replace |

**Damage 1:** Trim / covers: Floor mats - Holes - Replace

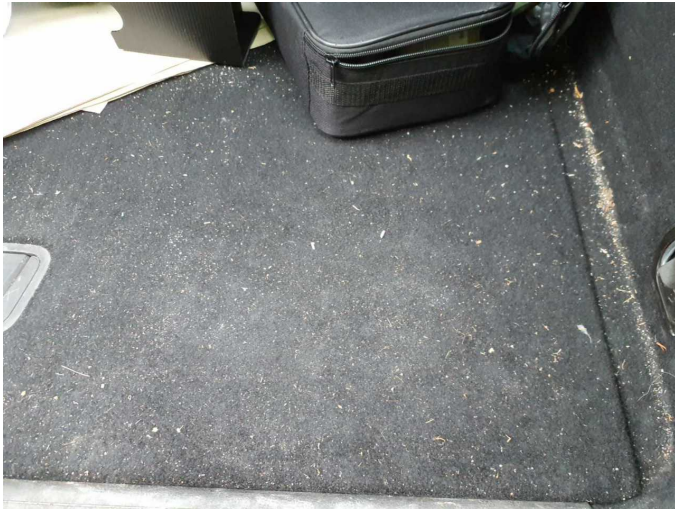
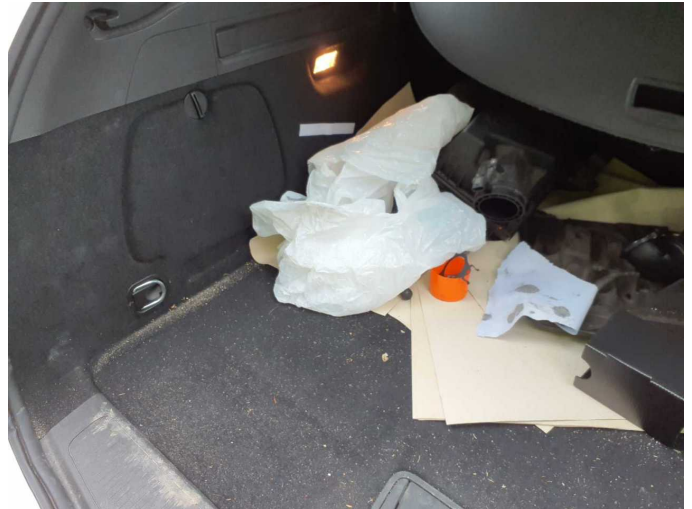
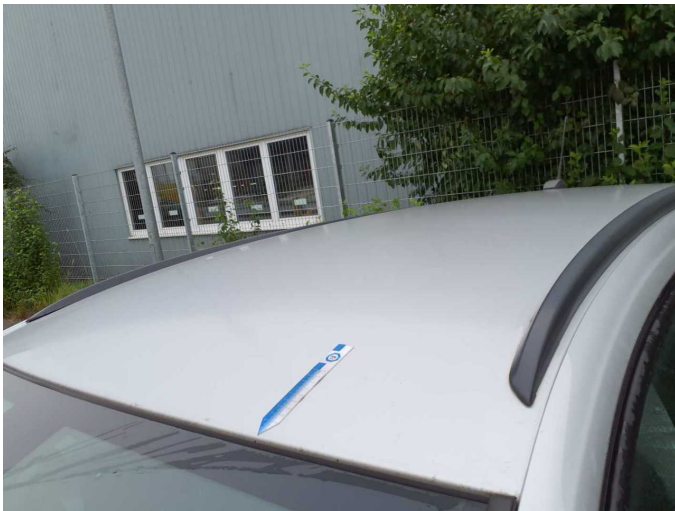
| No. | Component group | Description |
|---|---|---|
| 2 | Interior | Interior - Soiled - Clean |

**Damage 2:** Interior: Interior - Soiled - Clean

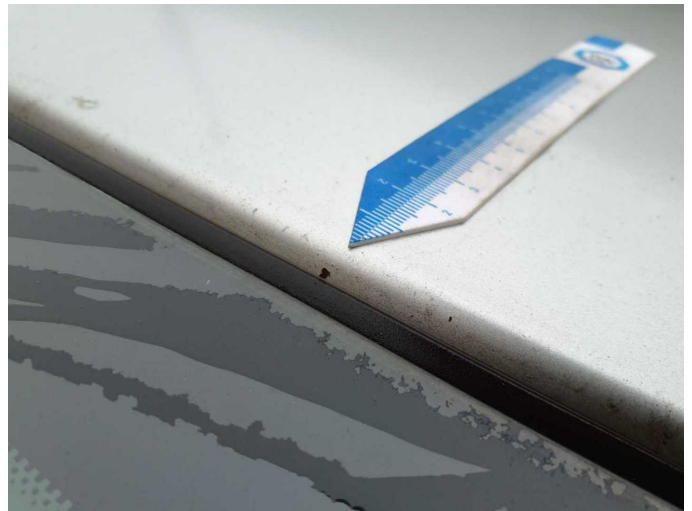
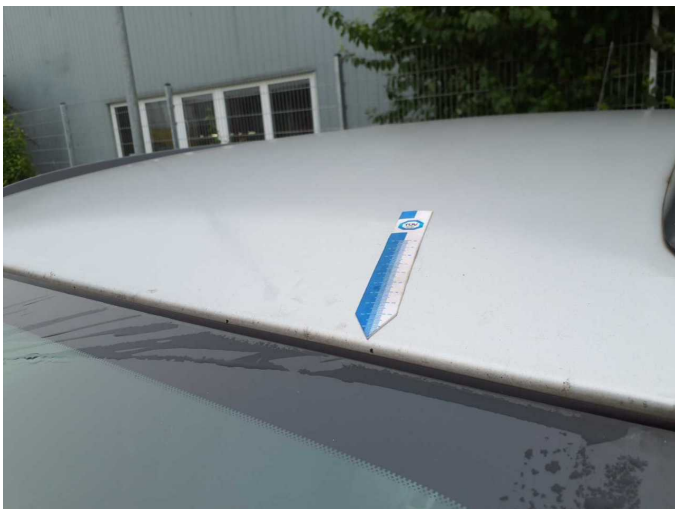
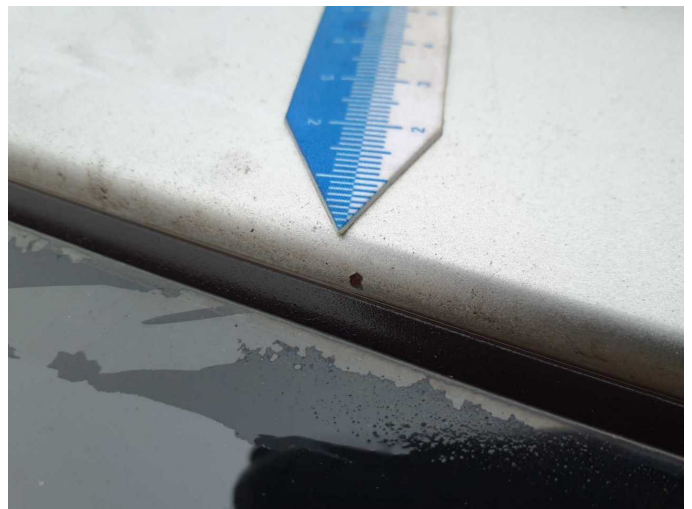
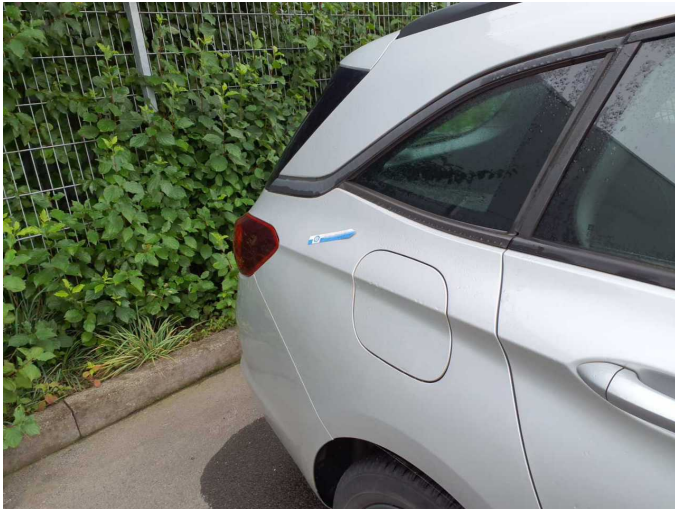
| No. | Component group | Description |
|---|---|---|
| 3 | Roof | Roof (Korrosion) - Stone chips - Smart repair |

**Damage 3:** Roof: Roof (Korrosion) - Stone chips - Smart repair

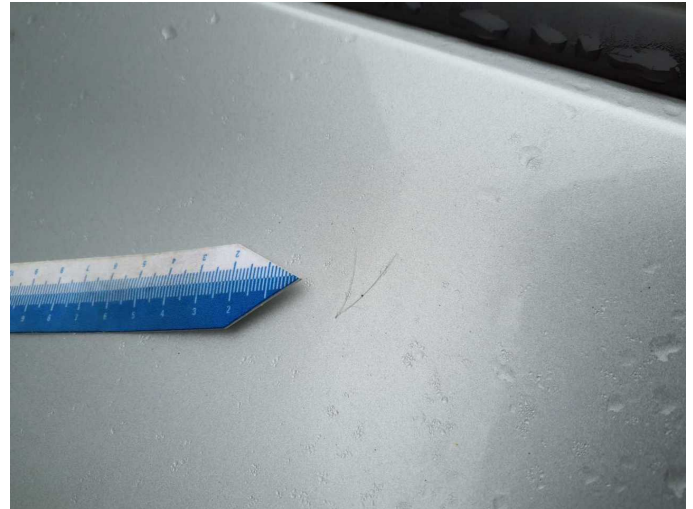
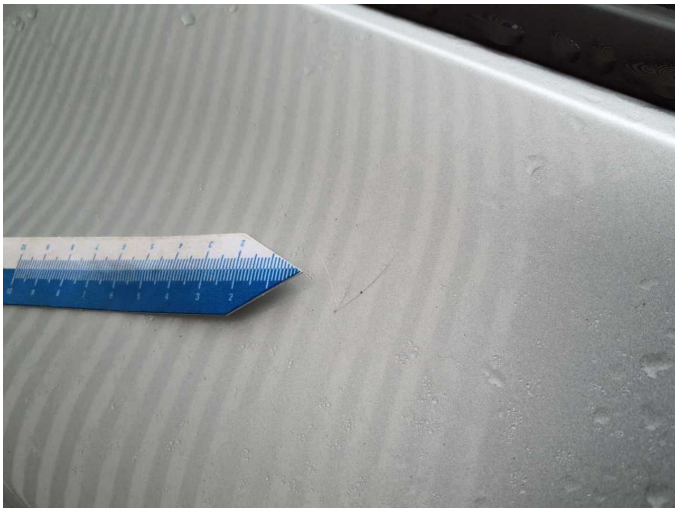
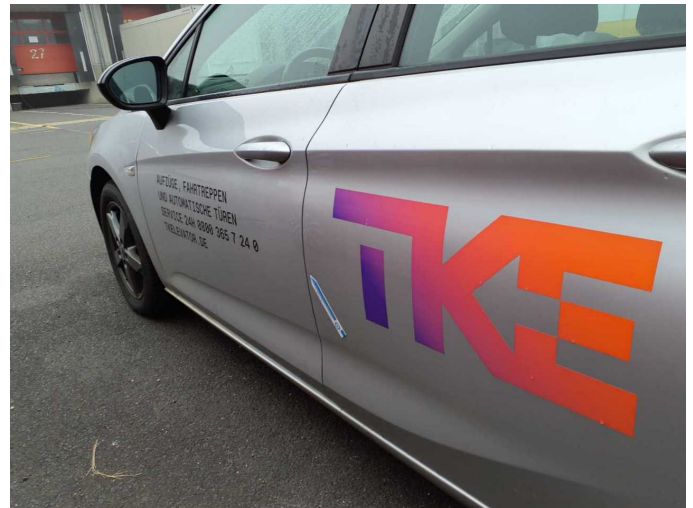
| No. | Component group | Description |
|---|---|---|
| 4 | Side panel - rear right side | Side panel - Scratched - Smart repair |

**Damage 4:** Side panel - rear right side: Side panel - Scratched - Smart repair

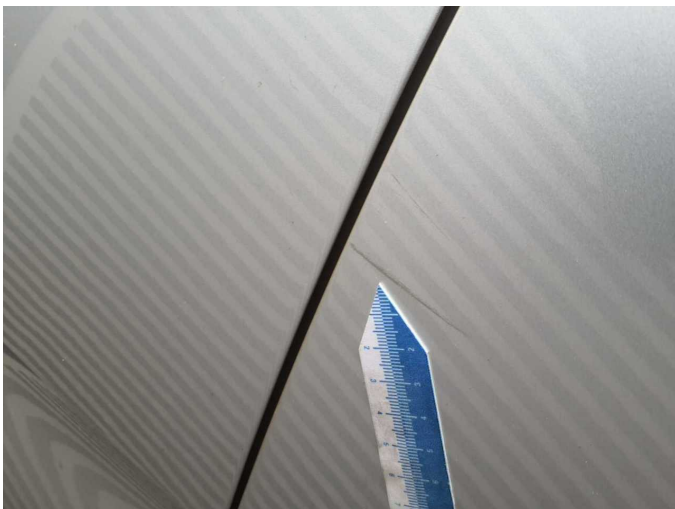
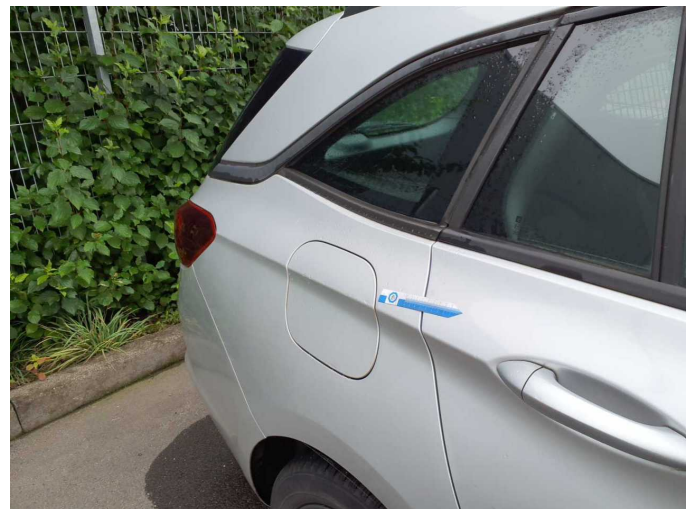
| No. | Component group | Description |
|---|---|---|
| 5 | Door - rear left side | Door - Scratched - Smart repair |

**Damage 5:** Door - rear left side: Door - Scratched - Smart repair

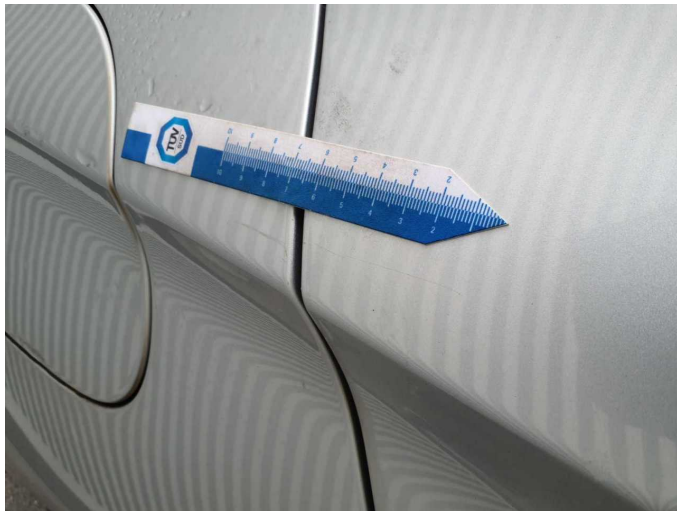
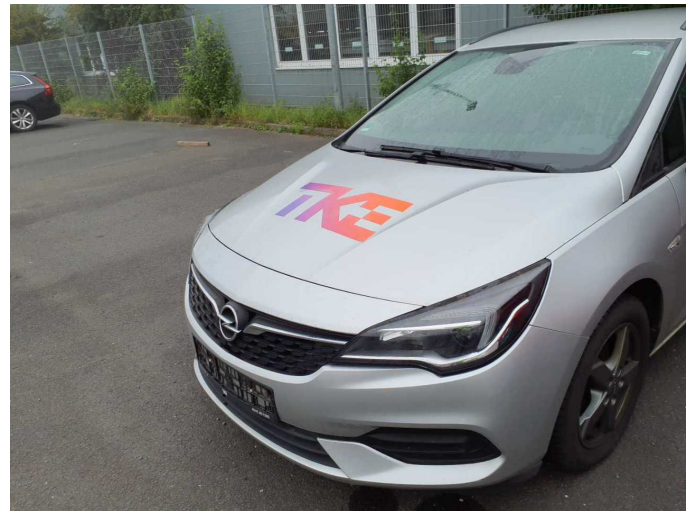
| No. | Component group | Description |
|---|---|---|
| 6 | Door - rear right side | Door - Scratched - Smart repair |

**Damage 6:** Door - rear right side: Door - Scratched - Smart repair

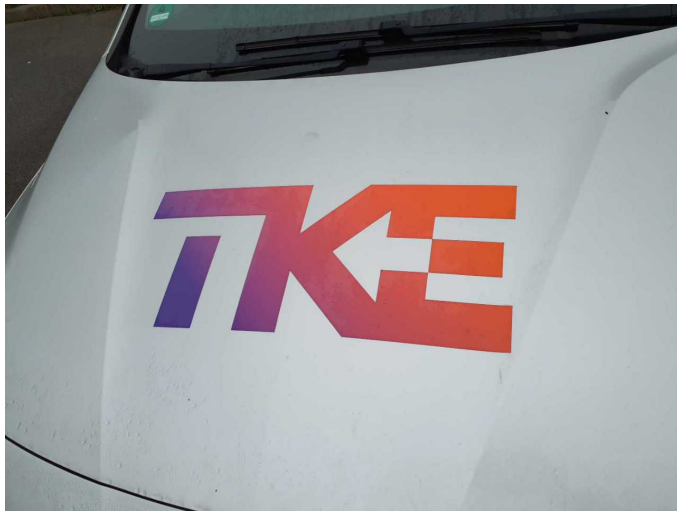
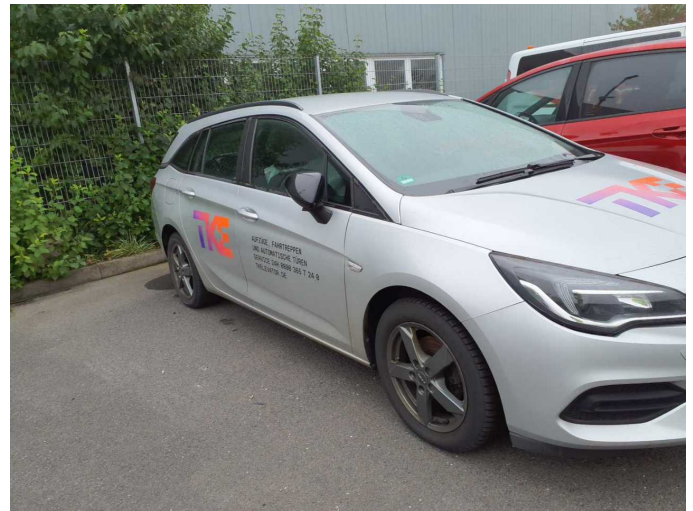
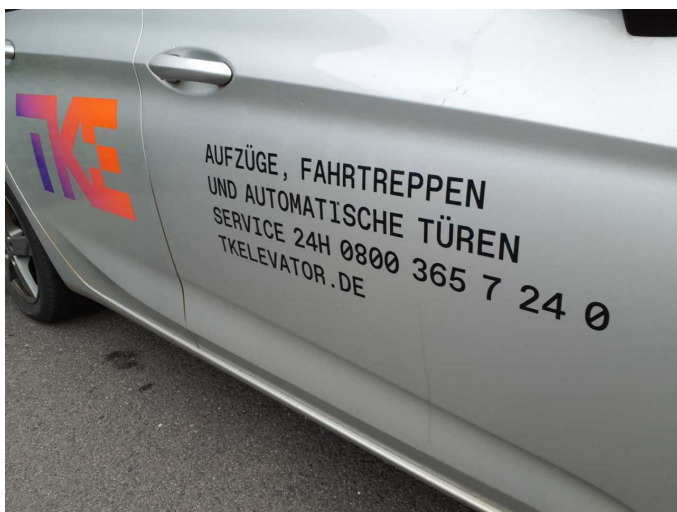
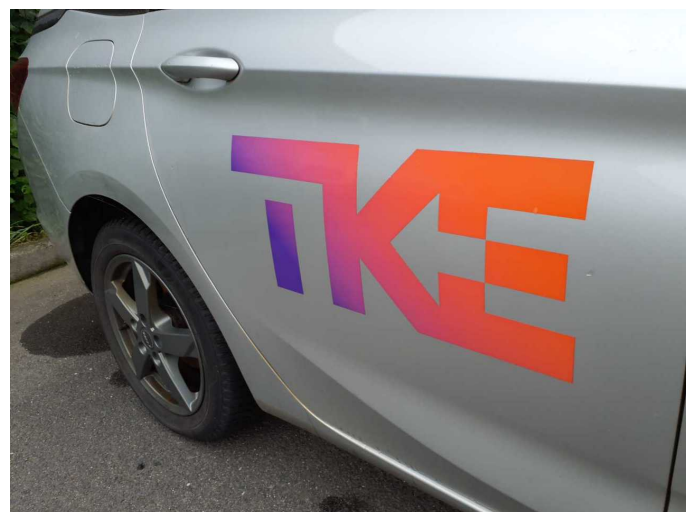
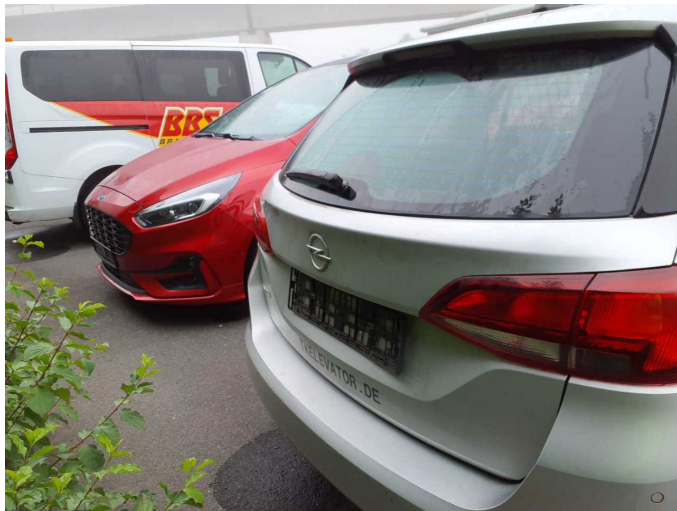
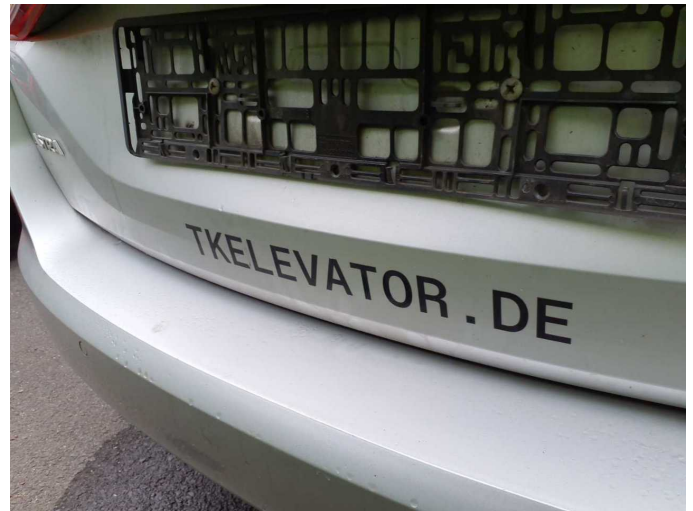
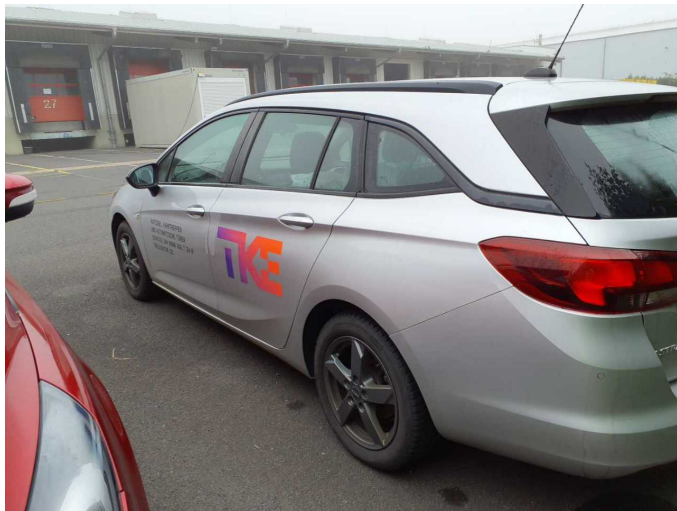
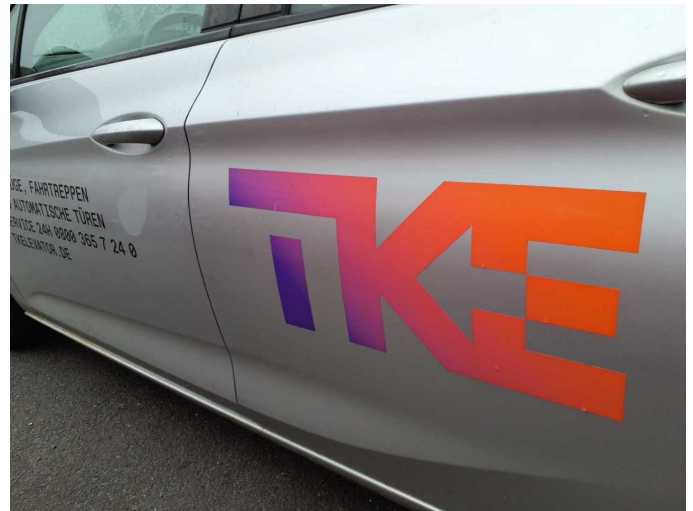
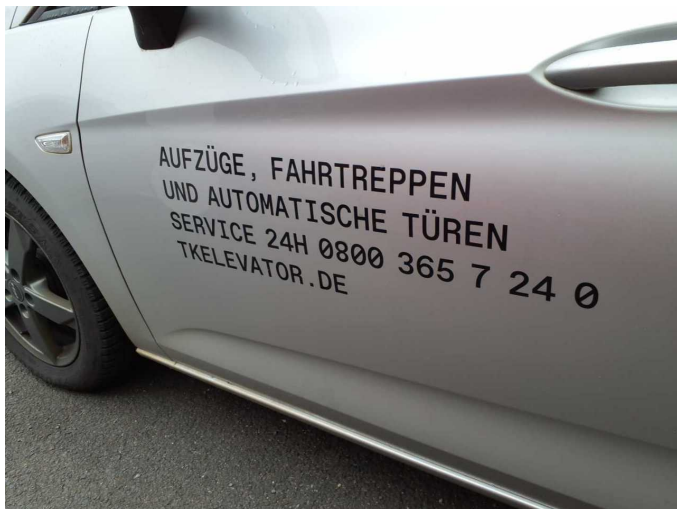
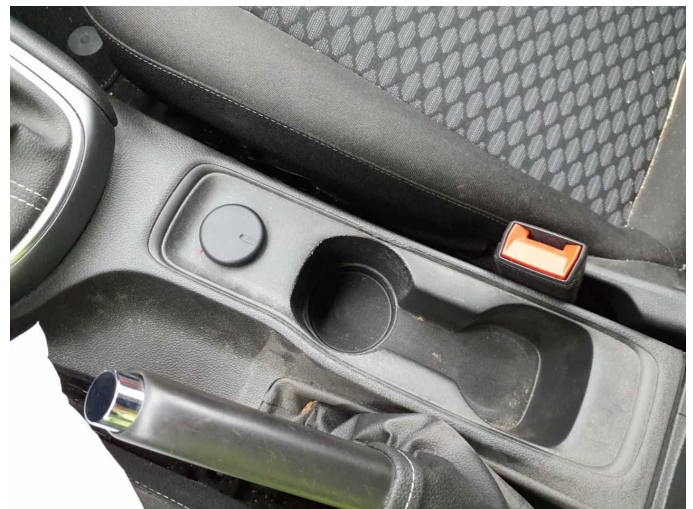
| No. | Component group | Description |
|---|---|---|
| 7 | Body | Body - Glued / labelled - De-glue / neutralise |

**Damage 7:** Body: Body - Glued / labelled - De-glue / neutralise

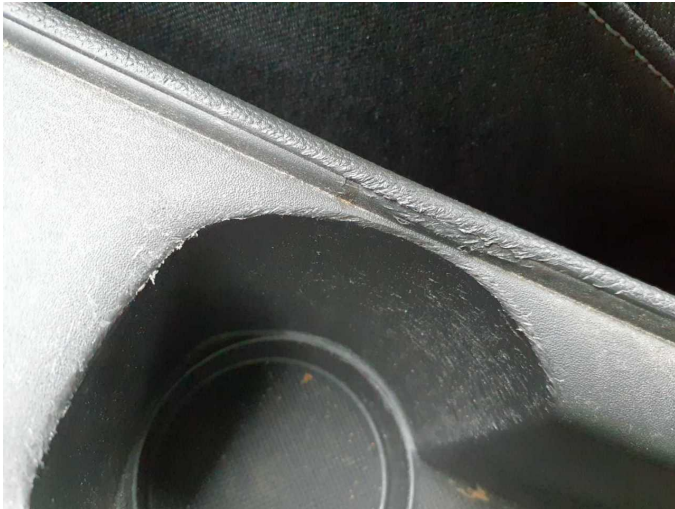
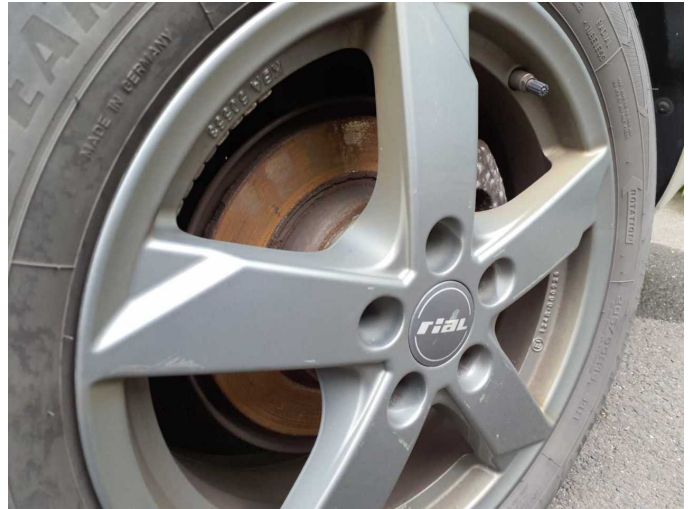
| No. | Component group | Description |
|---|---|---|
| 8 | Instrument panel | Centre console - front - Scratched - Replace |

**Damage 8:** Instrument panel: Centre console - front - Scratched - Replace

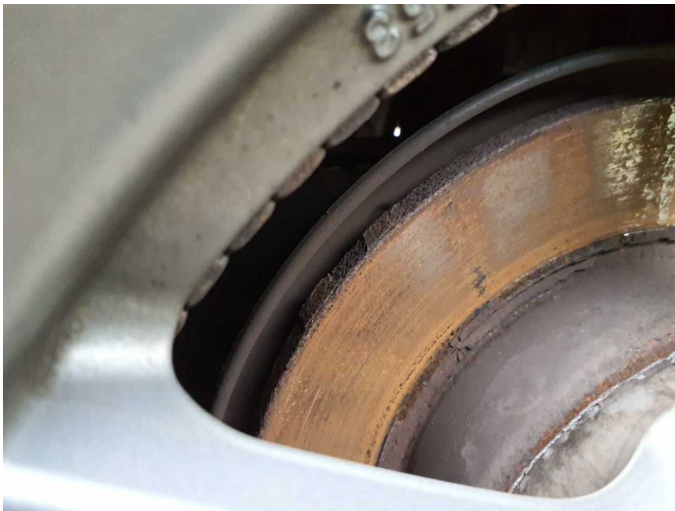
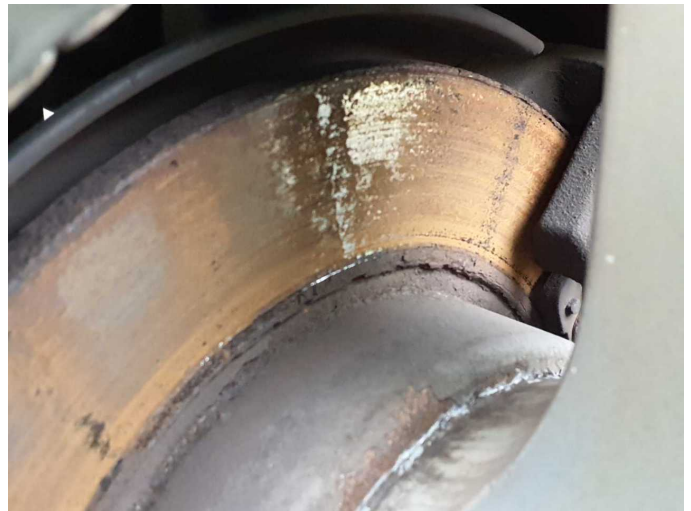
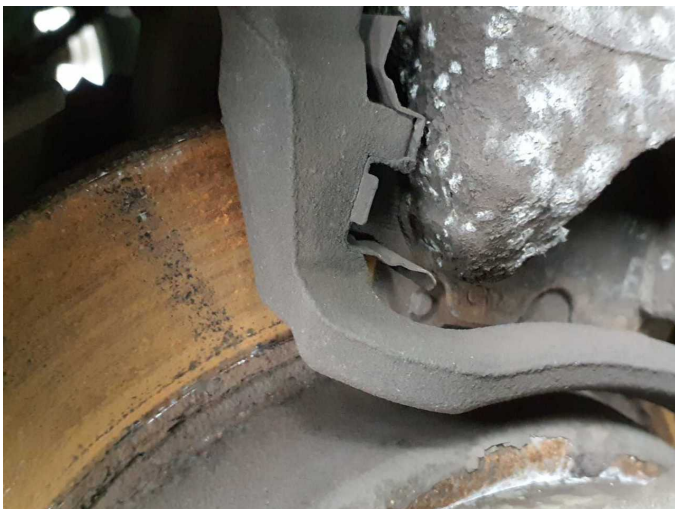
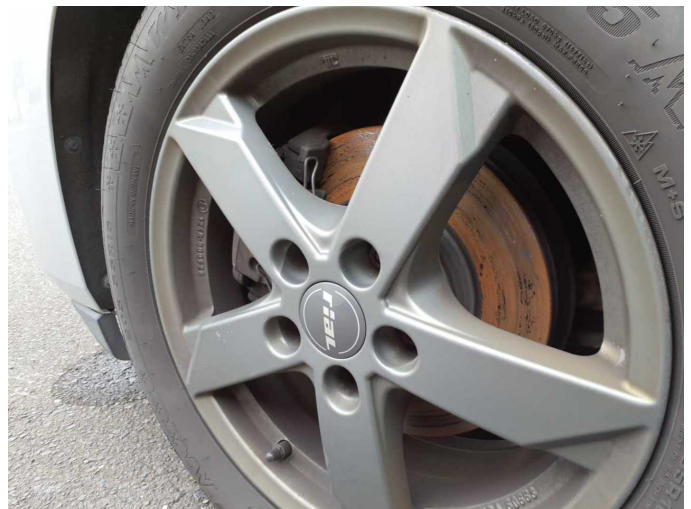
| No. | Component group | Description |
|---|---|---|
| 9 | Braking system | Brake discs and pads - rear (Tragbild mangelhaft) - Corrosion - Replace |

**Damage 9:** Braking system: Brake discs and pads - rear (Tragbild mangelhaft) - Corrosion - Replace

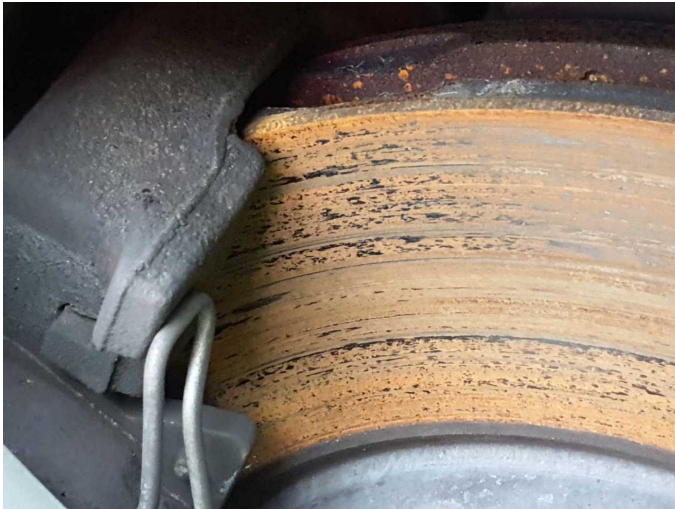
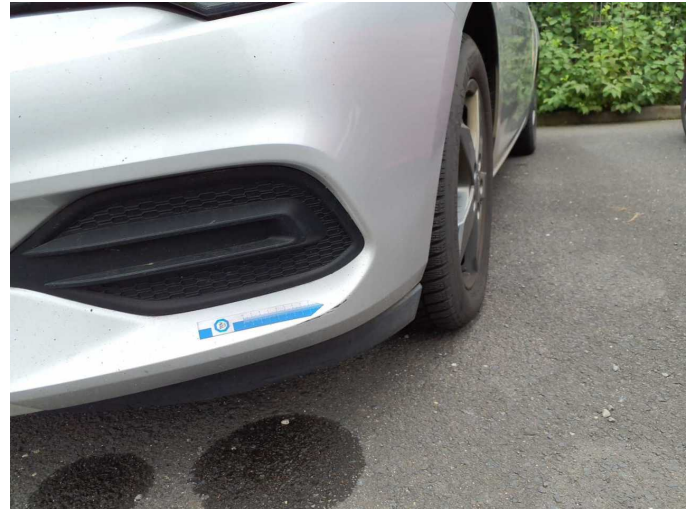
| No. | Component group | Description |
|---|---|---|
| 10 | Braking system | Brake discs and brake pads - front (Tragbild mangelhaft) - Corrosion - Replace |

**Damage 10:** Braking system: Brake discs and brake pads - front (Tragbild mangelhaft) - Corrosion - Replace

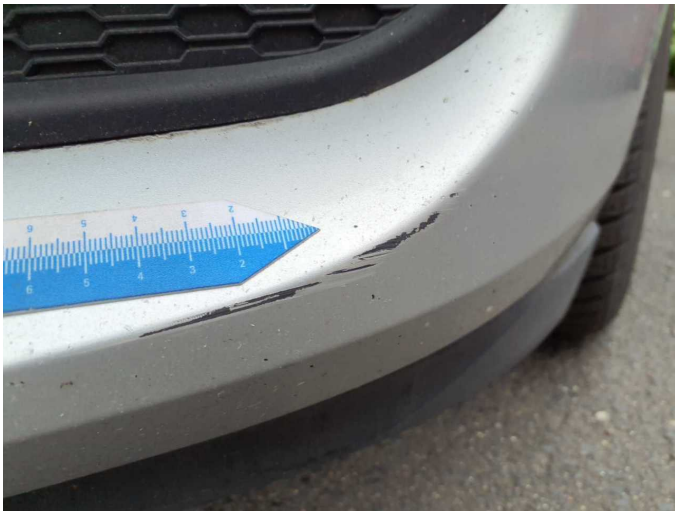
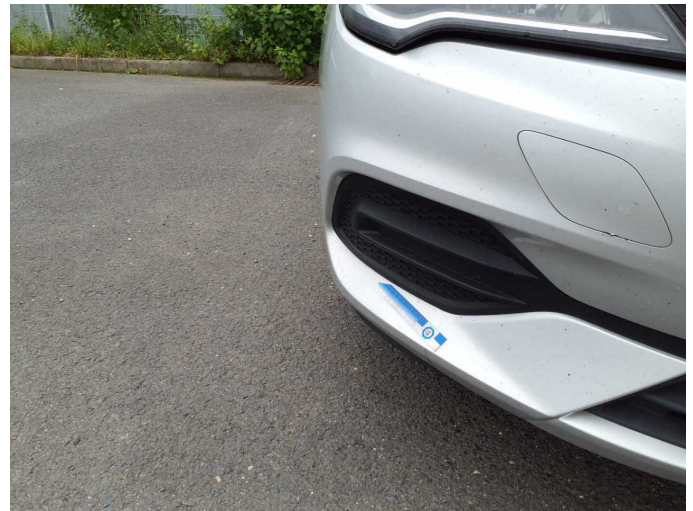
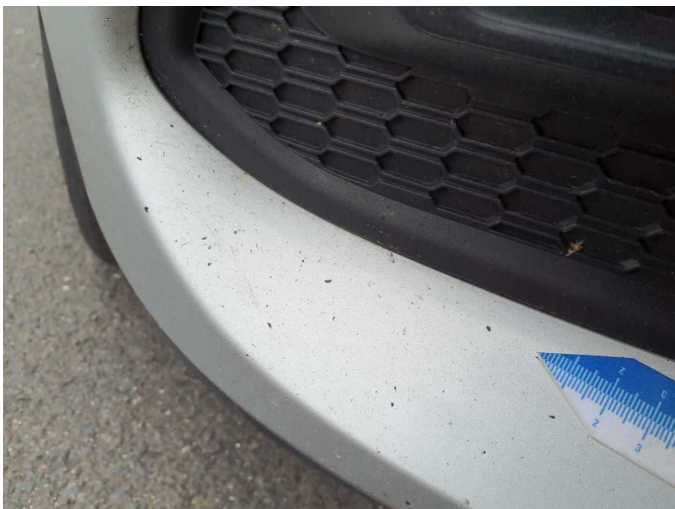
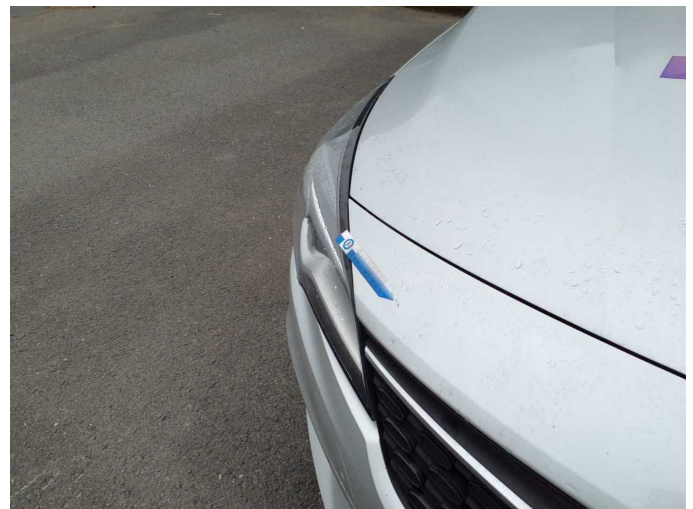
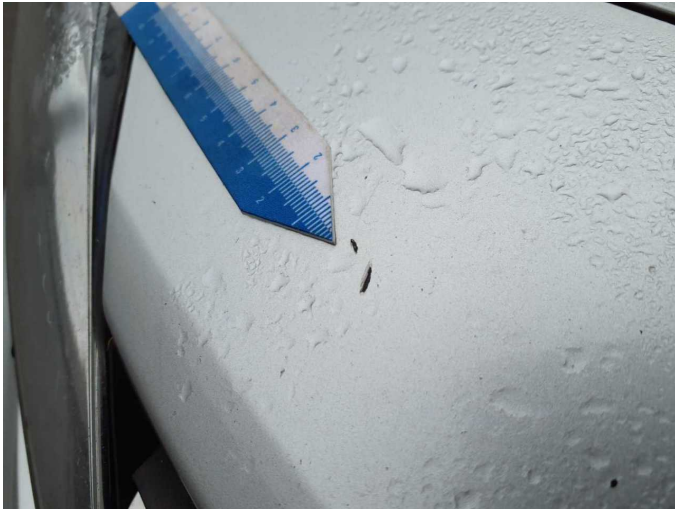
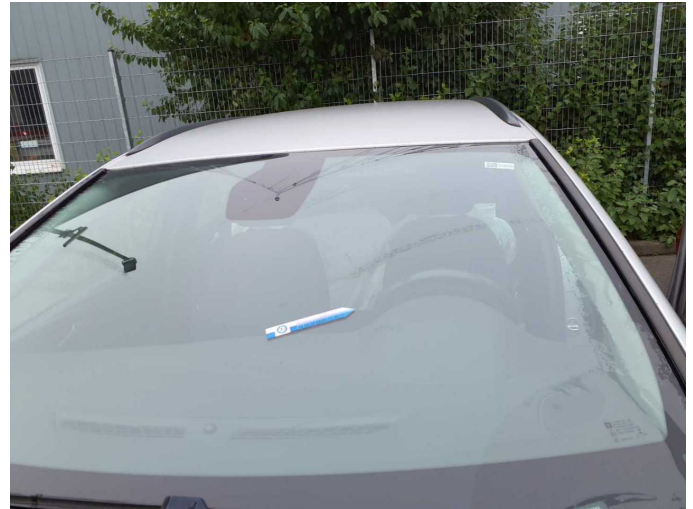
| No. | Component group | Description |
|---|---|---|
| 11 | Front bumper | Front bumper (Steinschlag) - Scratched - Repair and paint |

**Damage 11:** Front bumper: Front bumper (Steinschlag) - Scratched - Repair and paint

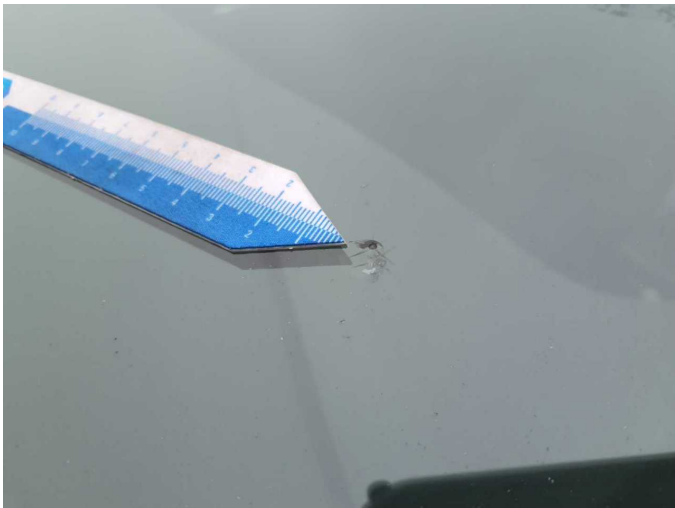
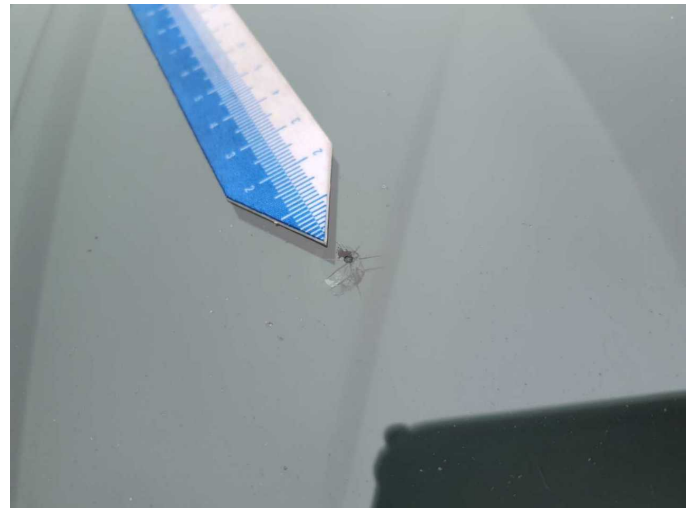
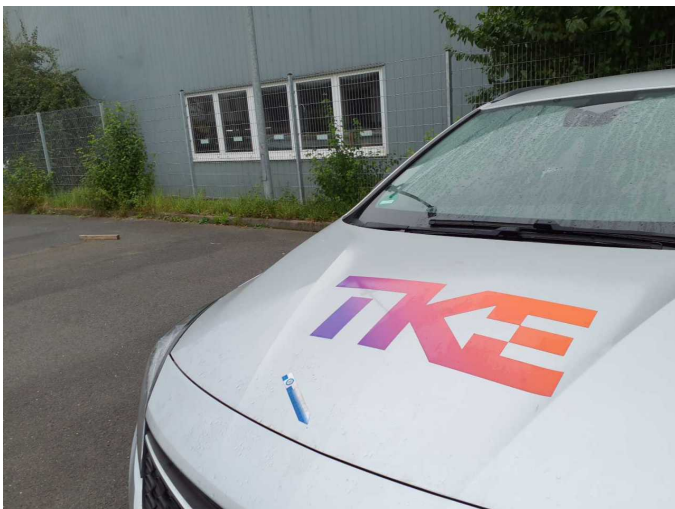
| No. | Component group | Description |
|---|---|---|
| 12 | Vehicle glazing | Windscreen (Rissbildung) - Stone chips - Replace |

**Damage 12:** Vehicle glazing: Windscreen (Rissbildung) - Stone chips - Replace

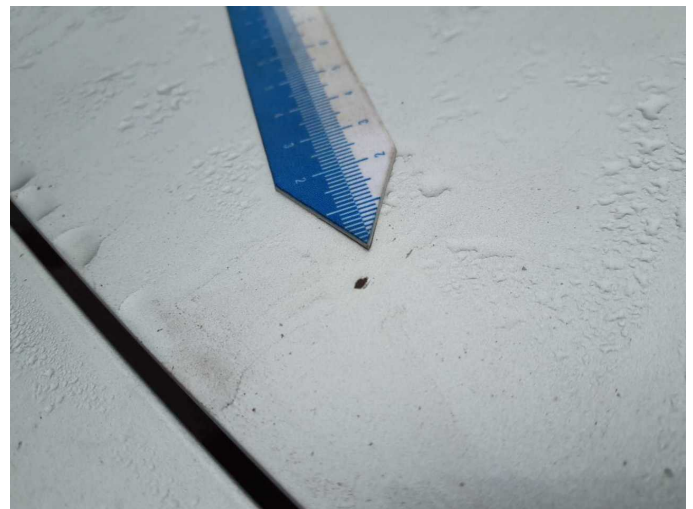
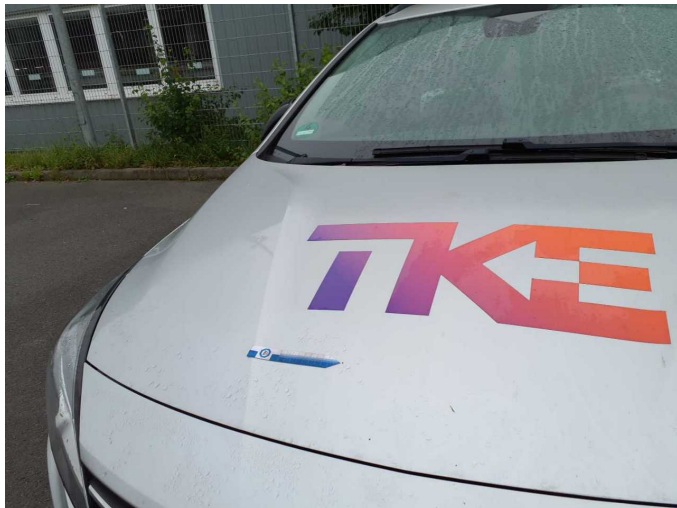
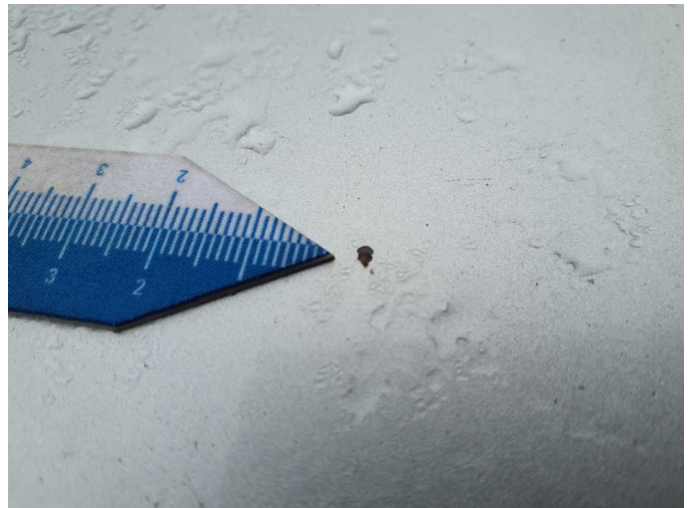
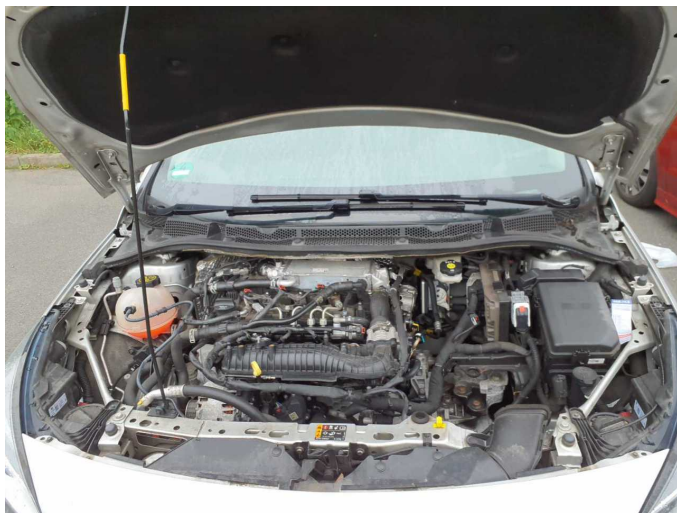
| No. | Component group | Description |
|---|---|---|
| 13 | Bonnet | Bonnet (Korrosion) - Stone chips - Repair and paint |

**Damage 13:** Bonnet: Bonnet (Korrosion) - Stone chips - Repair and paint

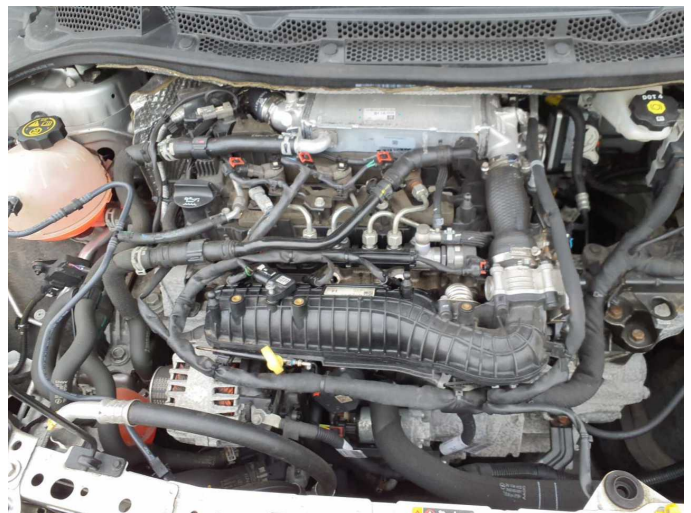
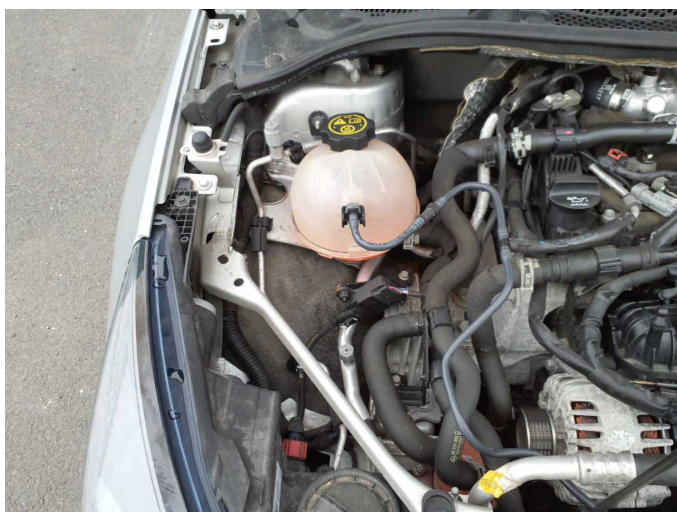
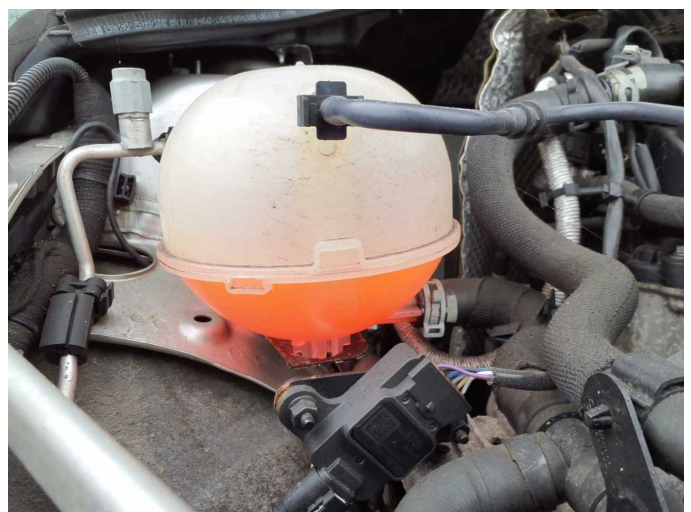
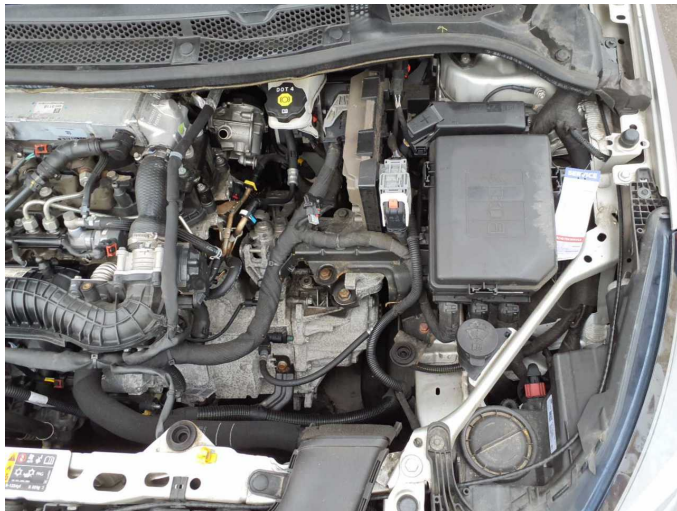
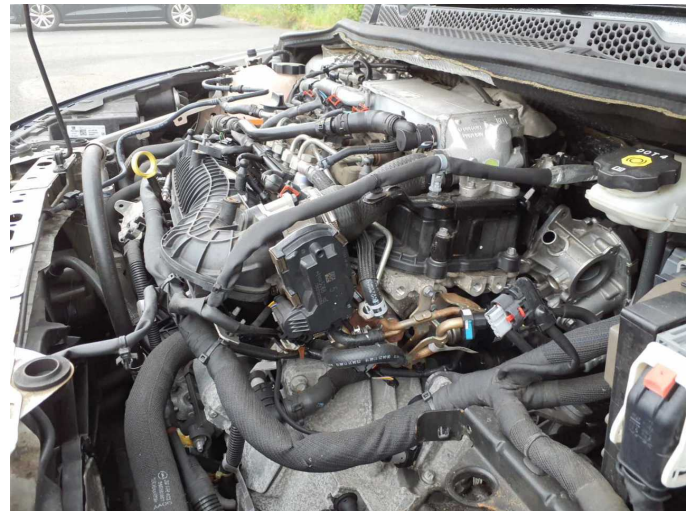
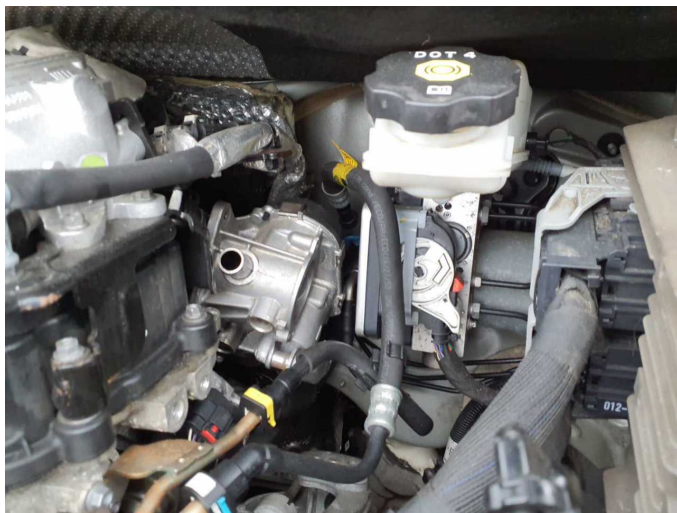
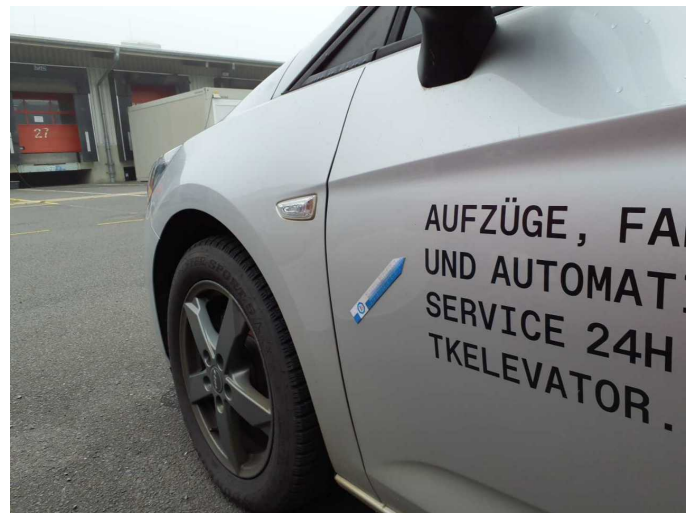
| Engine function test | An engine test run could not be performed.<br>This is due to the following reason:<br>Motorschaden |

| No. | Component group | Description |
|---|---|---|
| 14 | Engine | Engine - Non-operational - Replace |

**Damage 14:** Engine: Engine - Non-operational - Replace

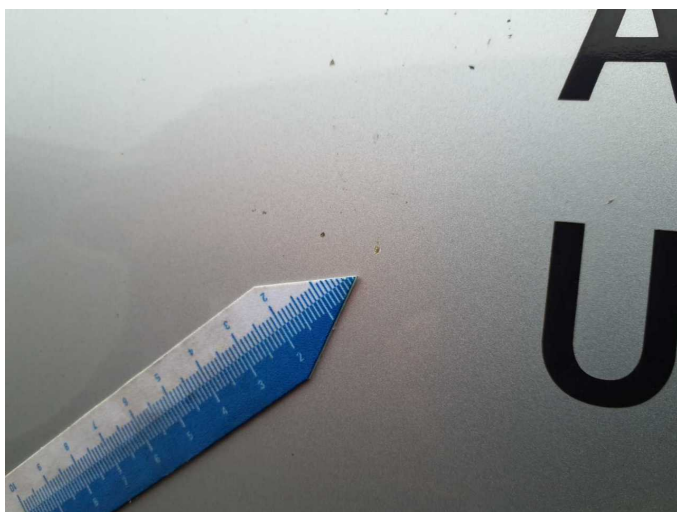
| No. | Component group | Description |
|---|---|---|
| 9 | Door - front left side | Door (Kratzer) - Stone chips - No deduction |

**Wear and tear 9:** Door - front left side: Door (Kratzer) - Stone chips - No deduction
