Expertise

Protocol number: 41775944
Order number / reference: 25259230
Inspection date: 1 Oct 2025

Manufacturer: Opel

Model: Astra 1.5 D Start/Stop Sports Tourer Automatik Business Edition

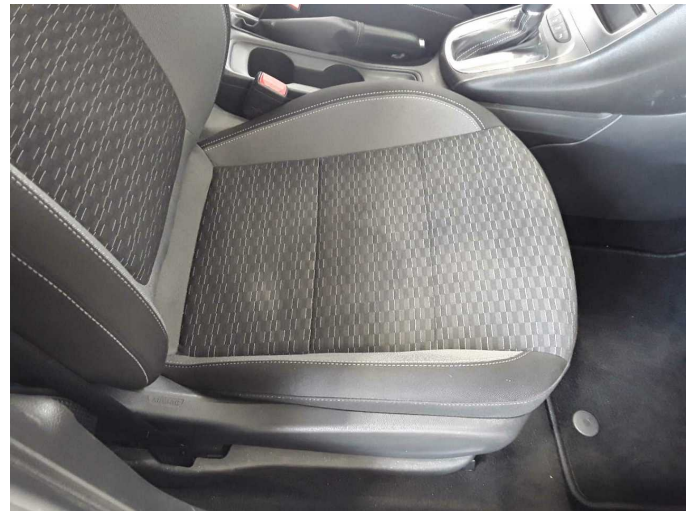
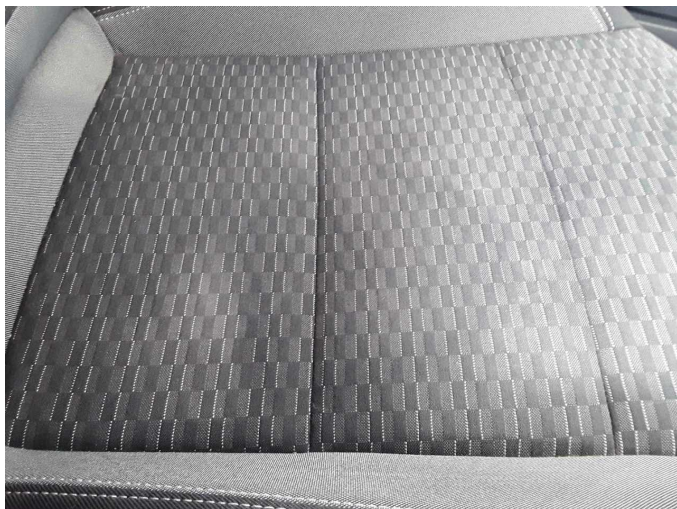
No.	Component group	Description
1	Seat - front	Seat cover - right side - Soiled - Clean
2	Door - front right side	Door - Dent / paintcoat damage - Smart repair
3	Wheel / tyres	Alloy rim - rear right side - Scratch(es) - Loss in value
4	Bonnet	Bonnet - Deformed - Repair and paint

Damage 1: Seat - front: Seat cover - right side - Soiled - Clean

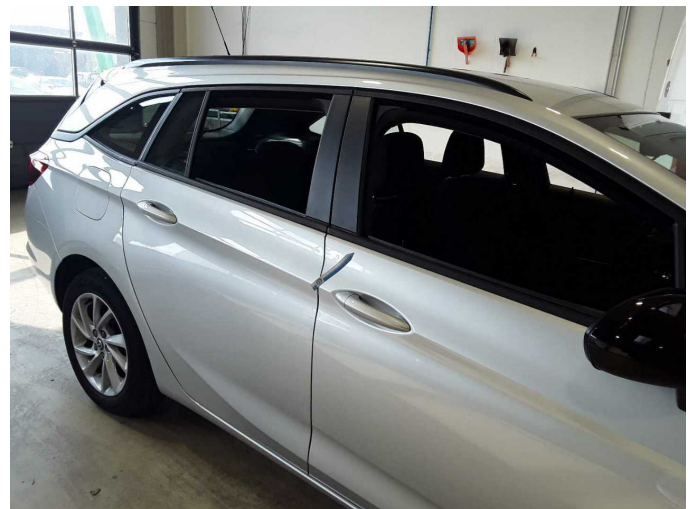
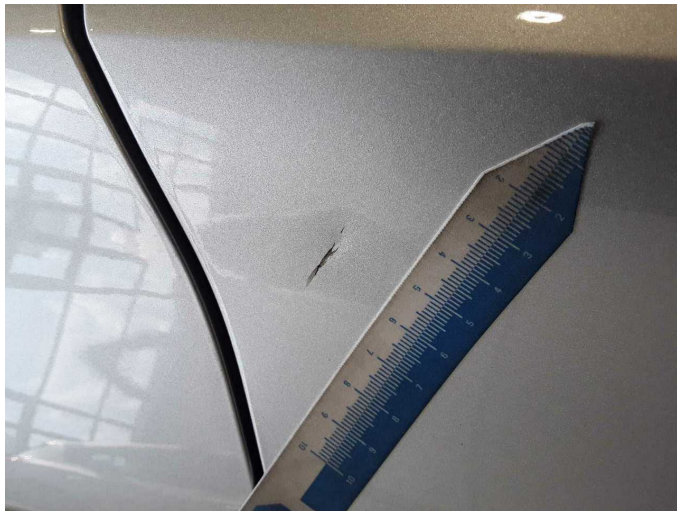
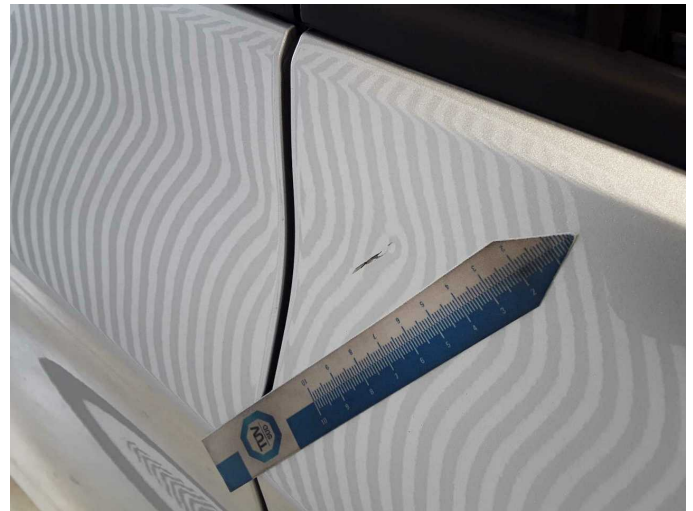
Damage 2: Door - front right side: Door - Dent / paintcoat damage - Smart repair

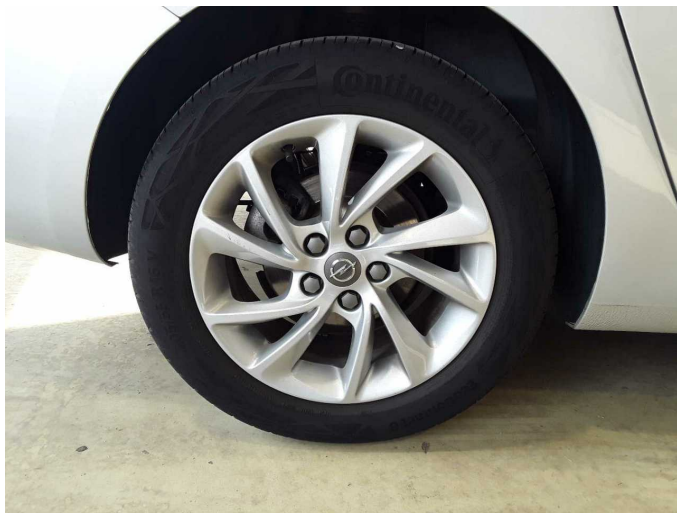
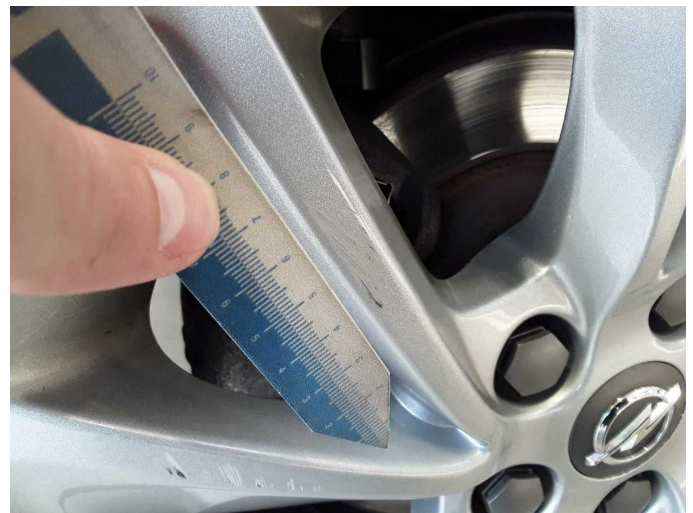
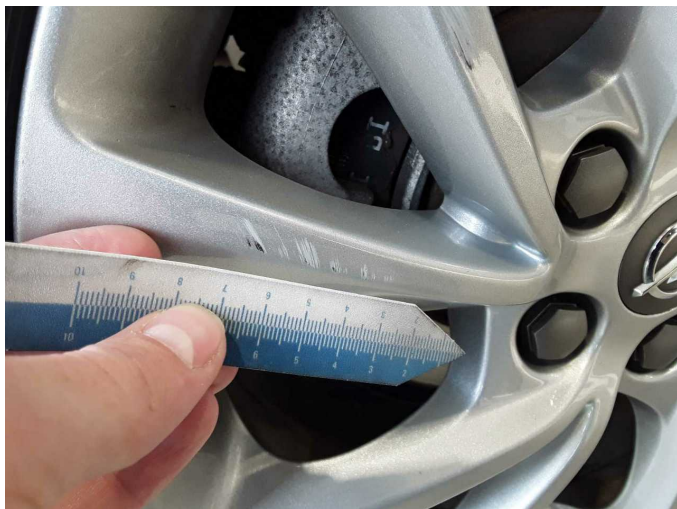
Damage 3: Wheel / tyres: Alloy rim - rear right side - Scratch(es) - Loss in value

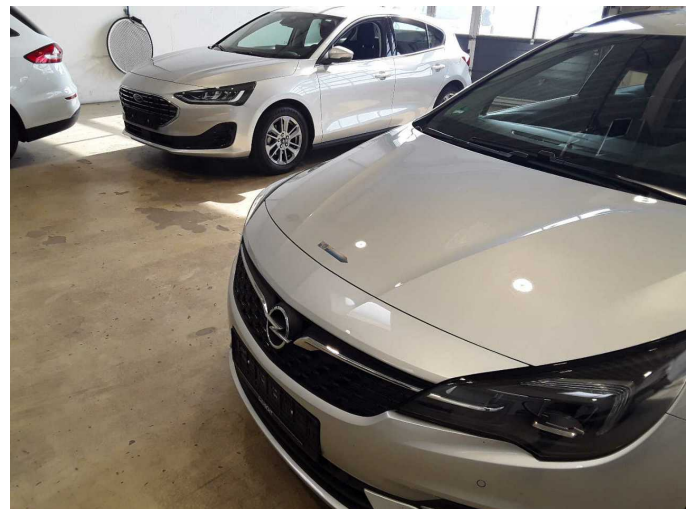
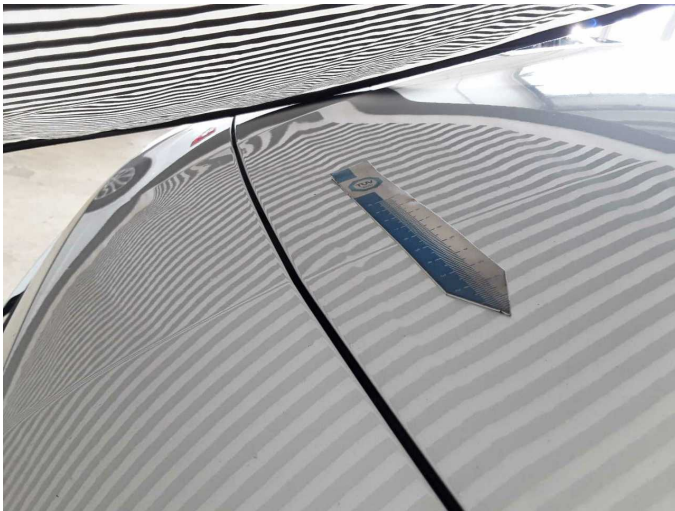
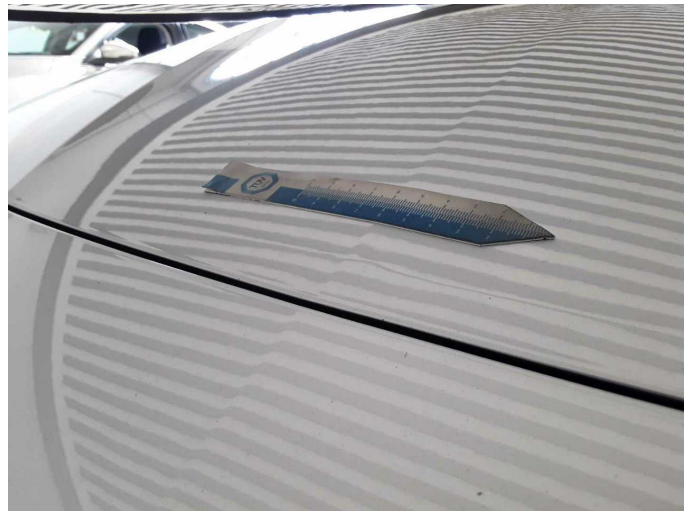
Damage 4: Bonnet: Bonnet - Deformed - Repair and paint

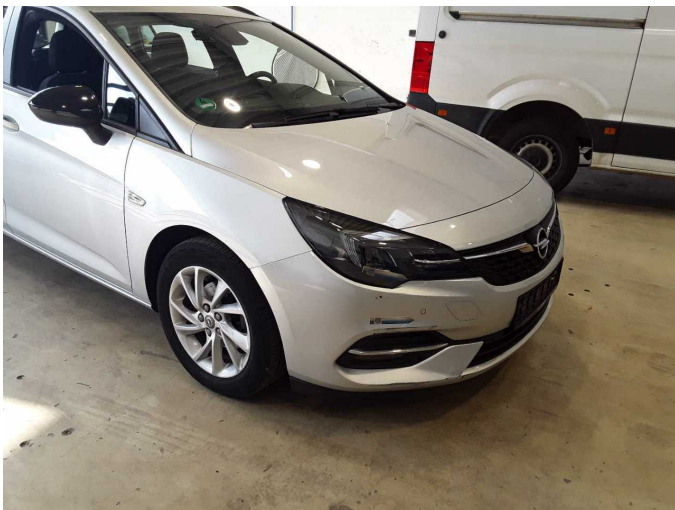
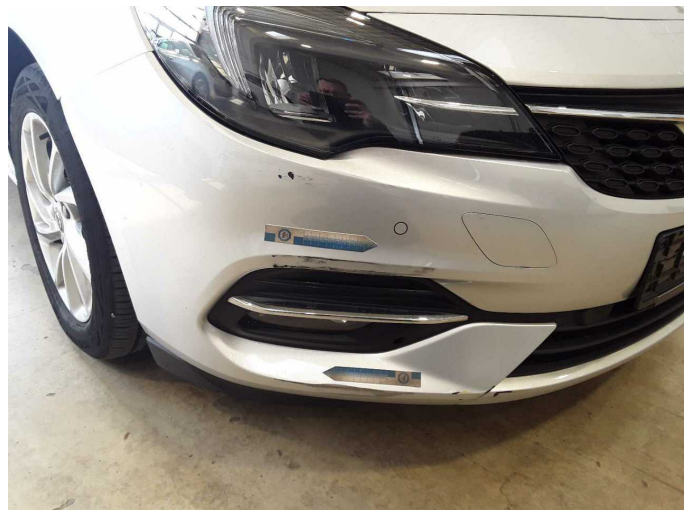
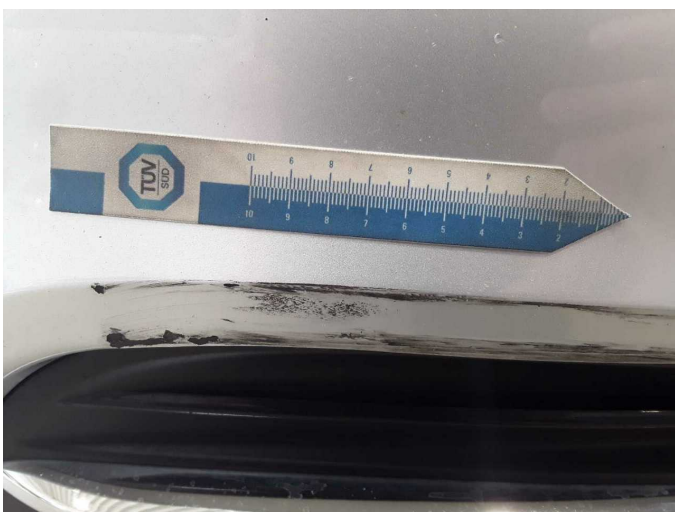
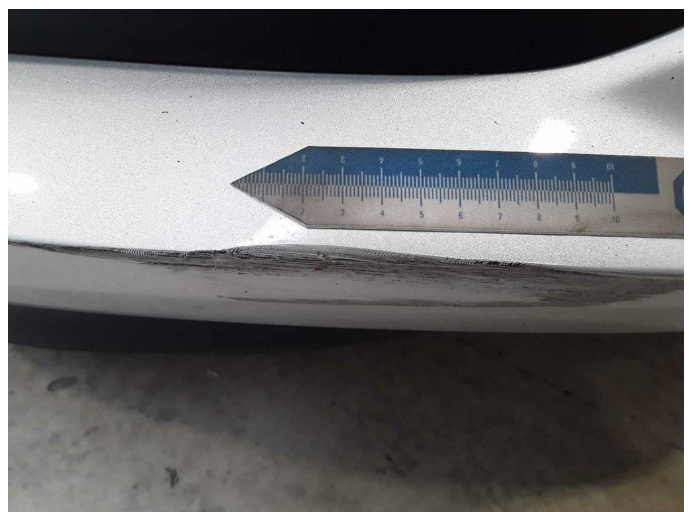
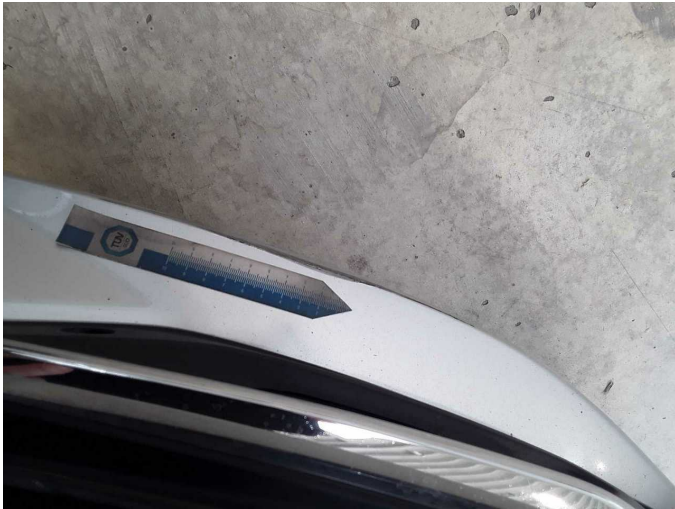
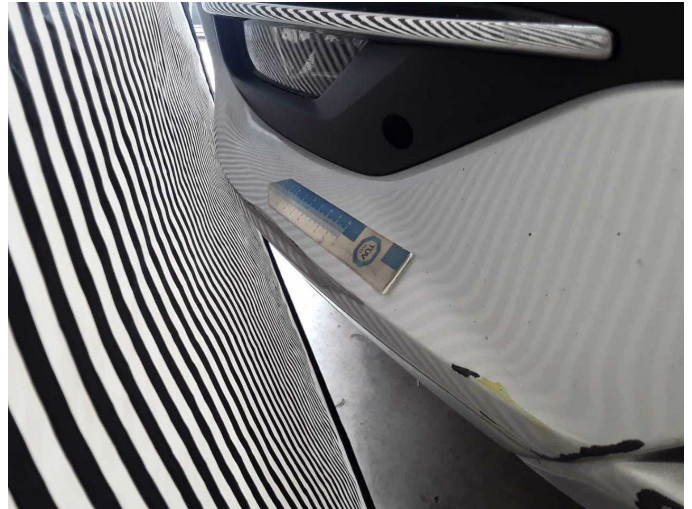
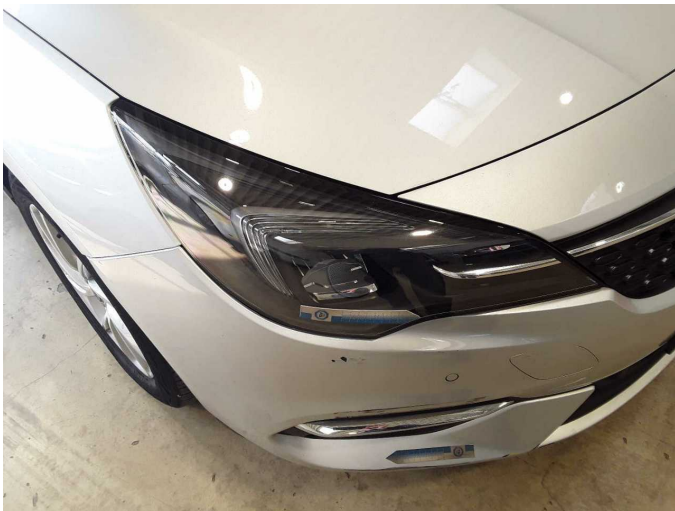
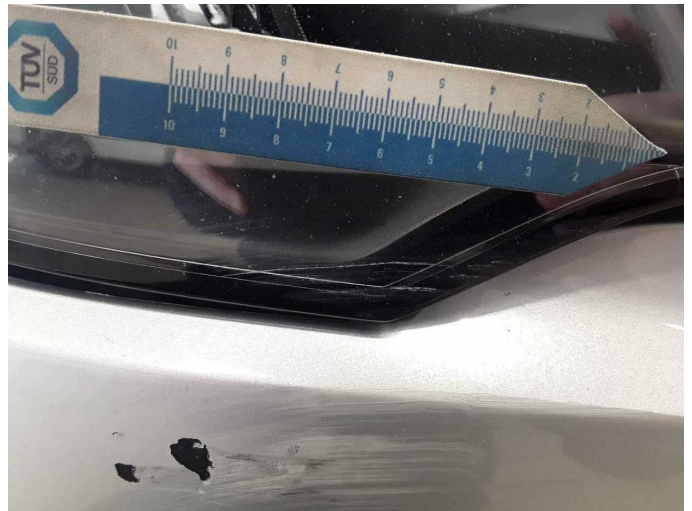
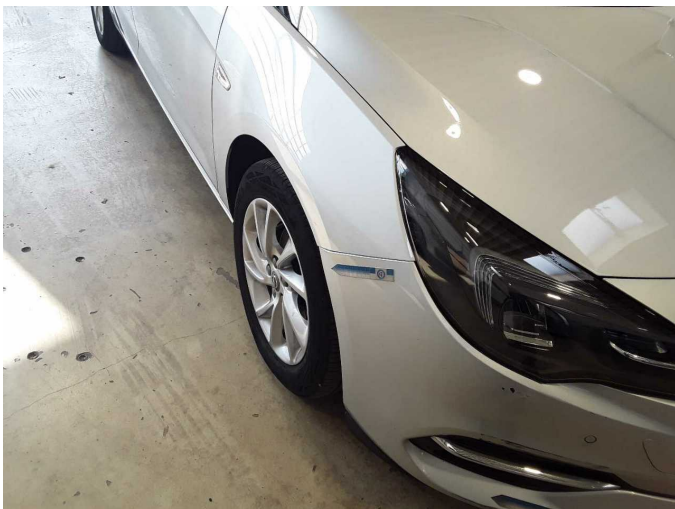
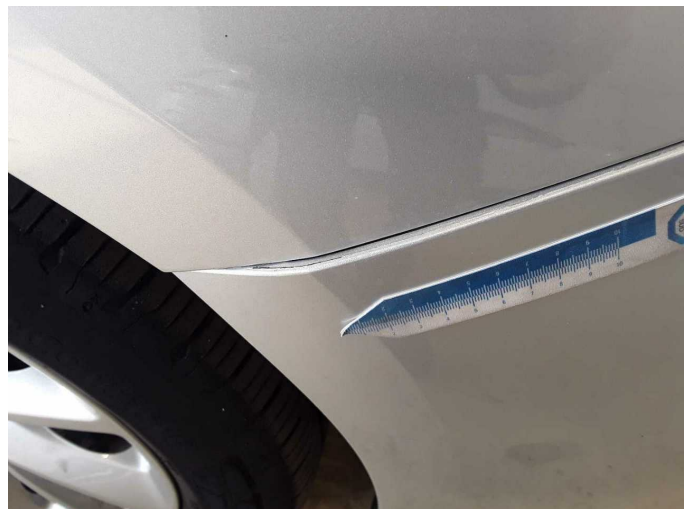
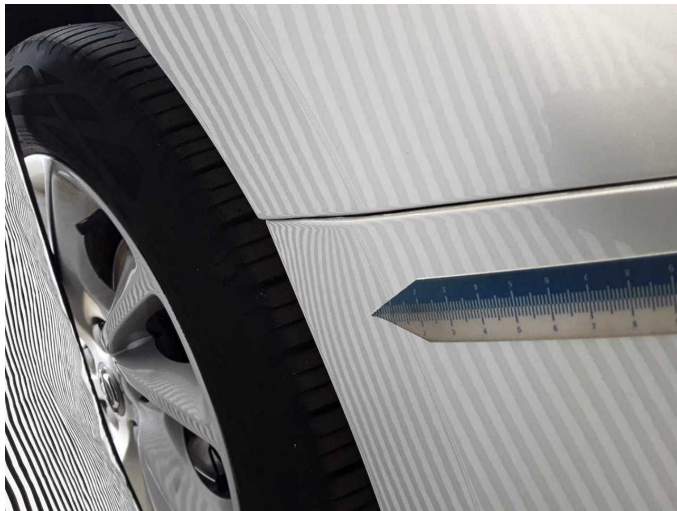
Accident 1: Front

1 Front

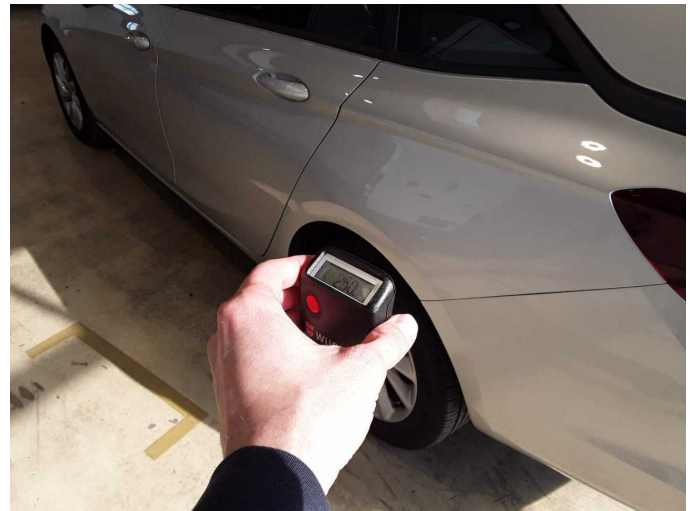
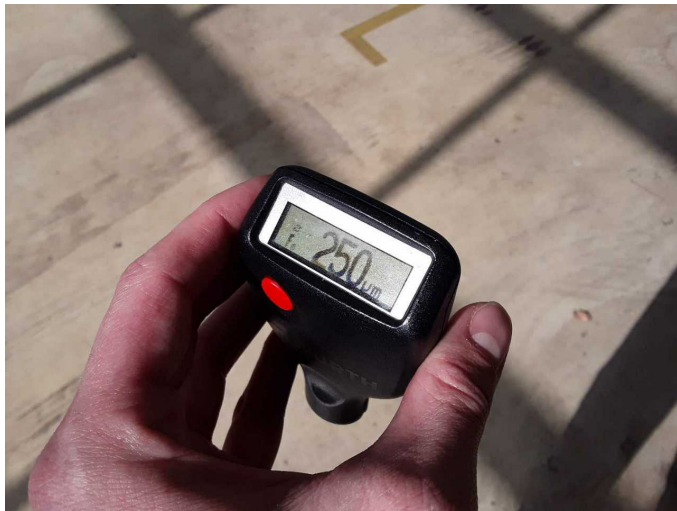
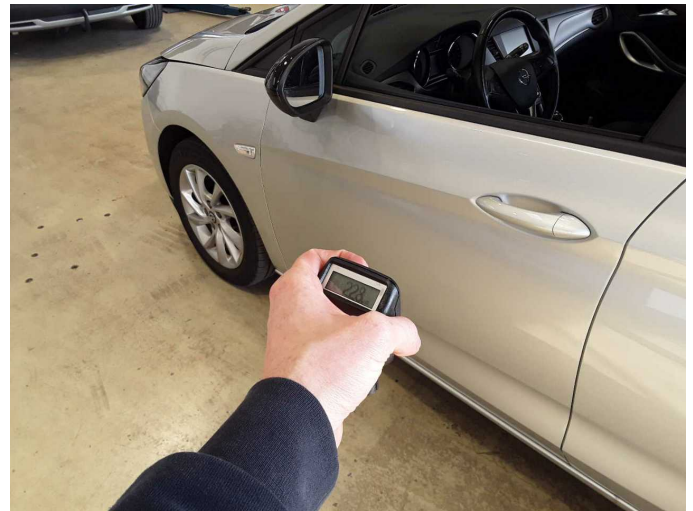
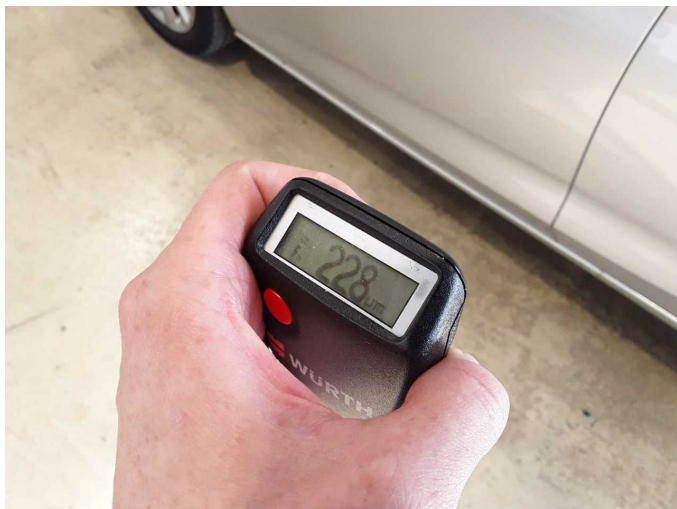
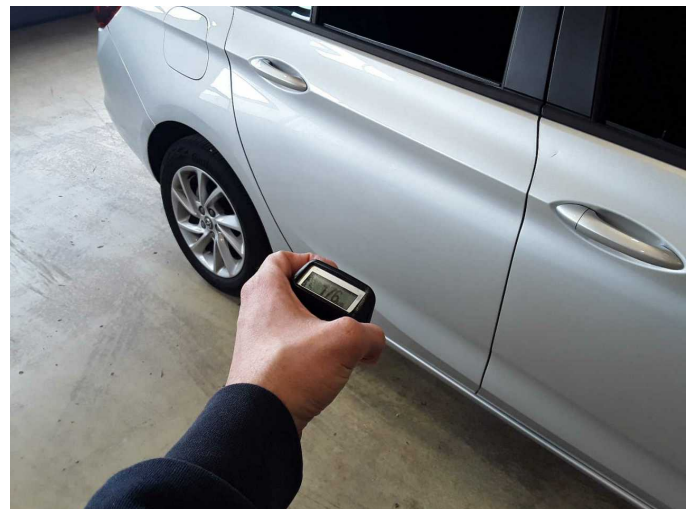
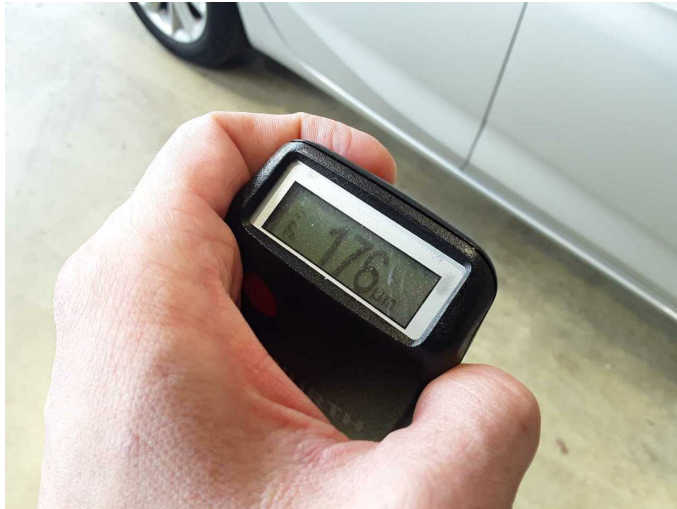
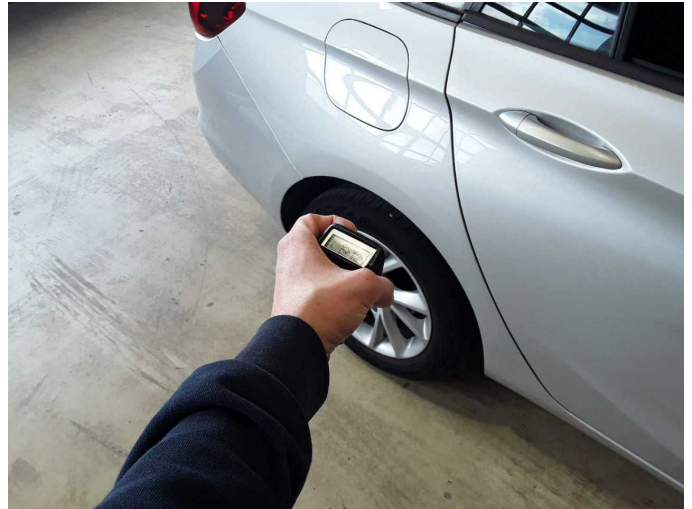
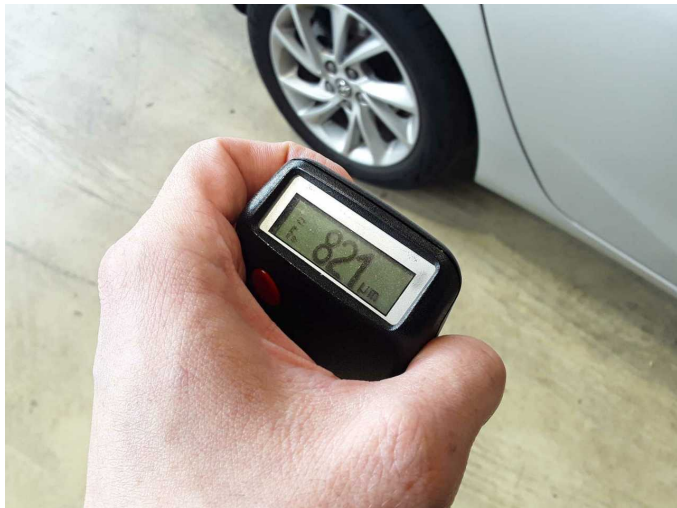
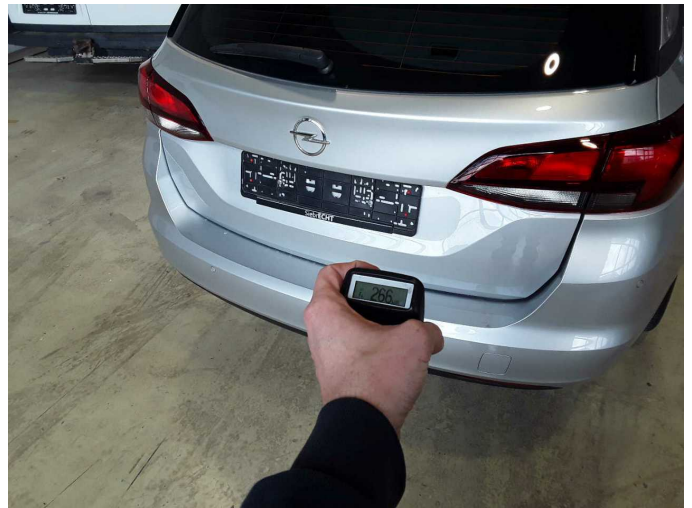
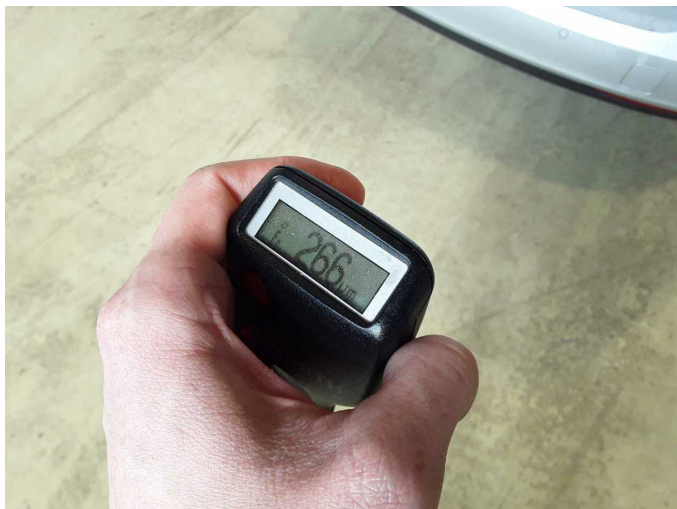
1 Boot lid / rear door, Side panel - rear left side, Side panel - rear right side, Door - rear right side, Door - front left side, Professionally carried out, Invoice of repair done Non-existent

Boot lid / rear door	266 µm	Side panel - rear left side	250 µm
Side panel - rear right side	821 µm	Door - rear right side	176 µm
Door - front left side	228 µm

Repainting 1: Boot lid / rear door, Side panel - rear left side, Side panel - rear right side, Door - rear right side, Door - front left side
