# **Expertise**

Protocol number: 41518507 Order No. / Reference: 25209552 Inspection date: 15 Sept 2025

Manufacturer: Opel

Model: Astra 1.5 D Start/Stop Sports Tourer Automatik Business Edition

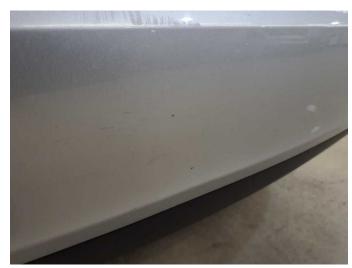
Damage 2: Rear bumper: Rear bumper - Scratch(es) - Paint

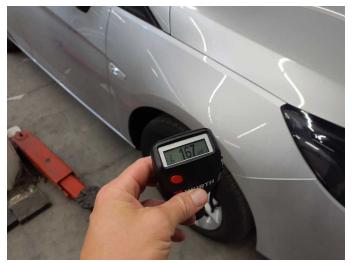
Mudguard - right side	167 µm	Side panel - rear right side	195 µm
Door - rear left side	223 µm	Door - front left side	181 µm

Repainting 1: Mudguard - right side, Side panel - rear right side, Door - rear left side, Door - front left side

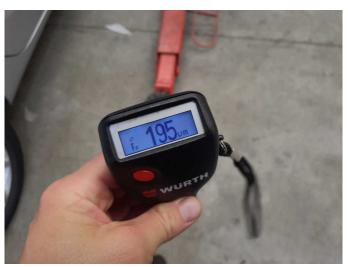
**Repainting 1:** Mudguard - right side, Side panel - rear right side, Door - rear left side, Door - front left side

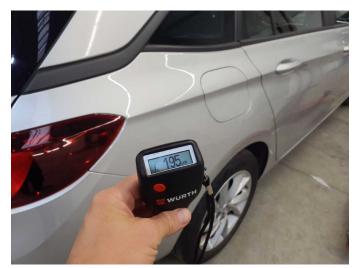
Repainting 1: Mudguard - right side, Side panel - rear right side, Door - rear left side, Door - front left side

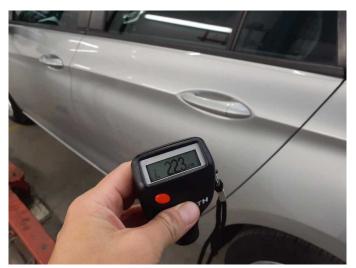
Repainting 1: Mudguard - right side, Side panel - rear right side, Door - rear left side, Door - front left side

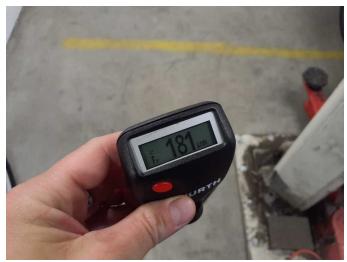
Repainting 1: Mudguard - right side, Side panel - rear right side, Door - rear left side, Door - front left side

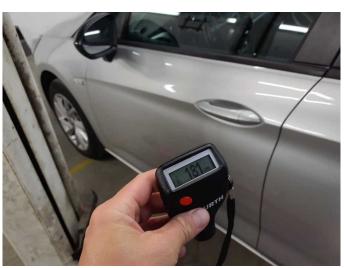
Repainting 1: Mudguard - right side, Side panel - rear right side, Door - rear left side, Door - front left side

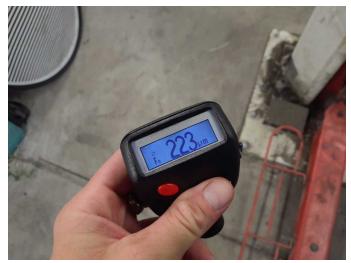
Repainting 1: Mudguard - right side, Side panel - rear right side, Door - rear left side, Door - front left side
