Expertise

Protocol number: 41453869
Order No. / Reference: 25148088-1
Inspection date: 5 Sept 2025

Manufacturer: Opel	Model: Astra 1.5 D Start/Stop Sports Tourer Automatik Business Edition
VIN: W0VBD8EV6N8042610

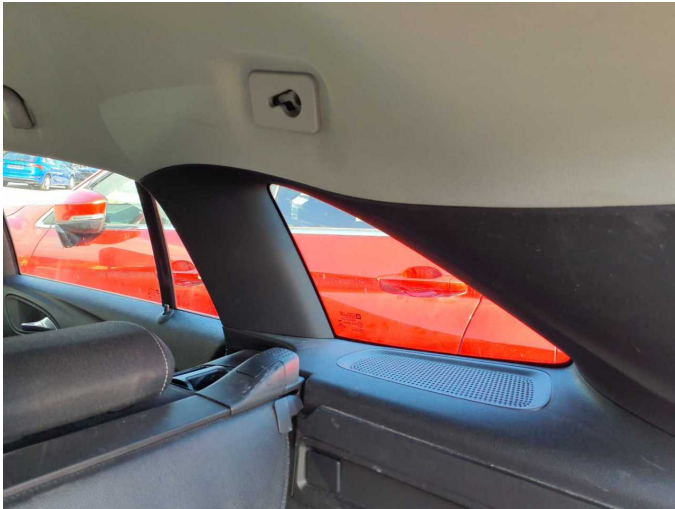
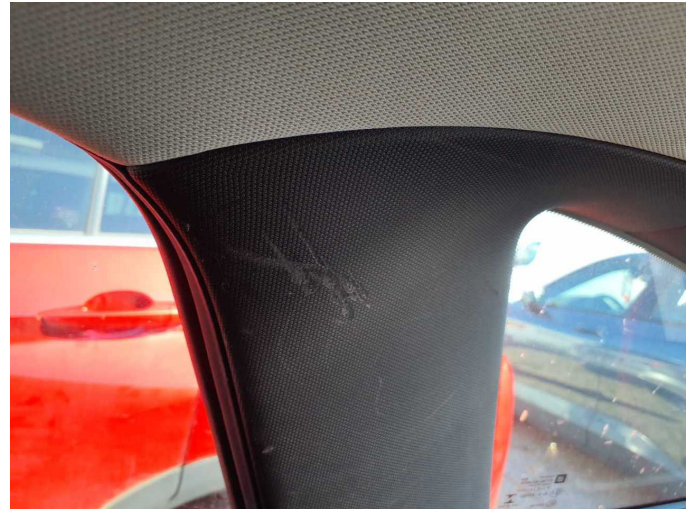
Damage 2: Trim / covers: C-pillar - trim - interior, right side - Scratch(es) - Loss in value

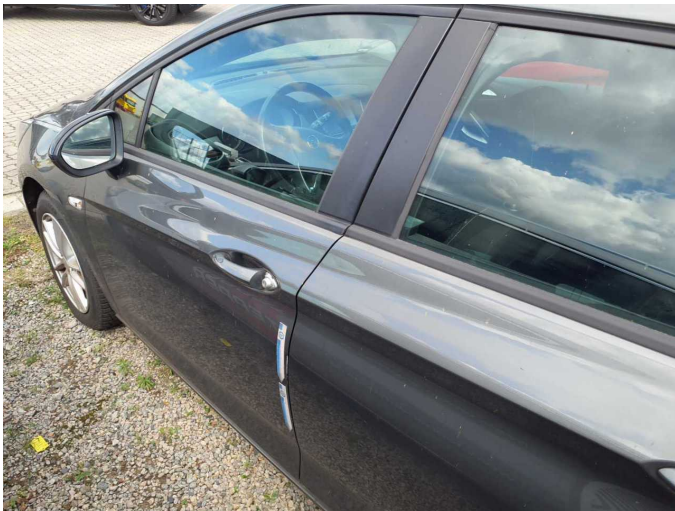
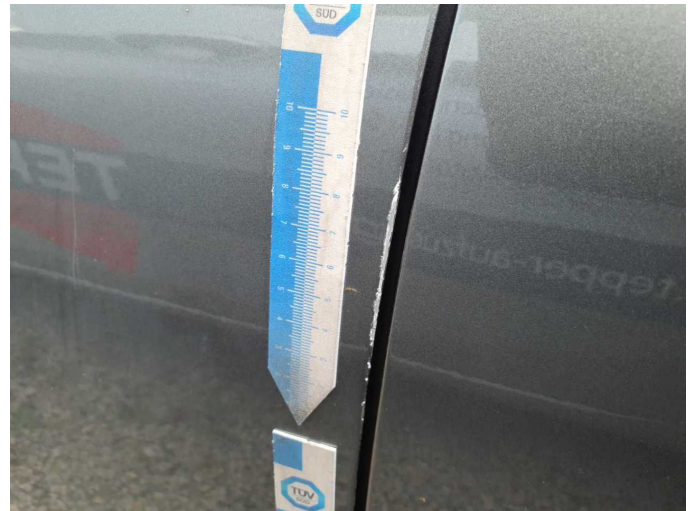
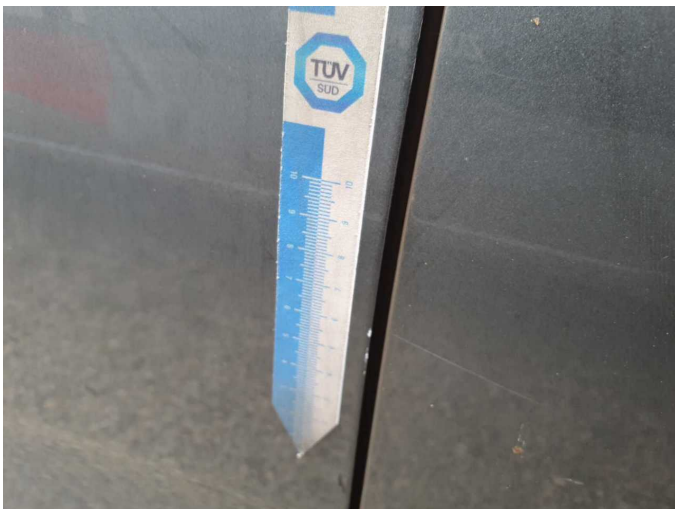
Damage 3: Door - front left side: Door edge - Scratch(es) - Smart repair

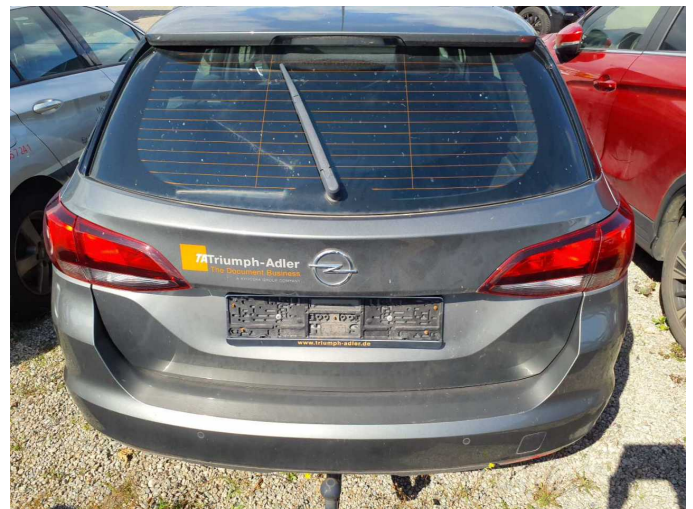
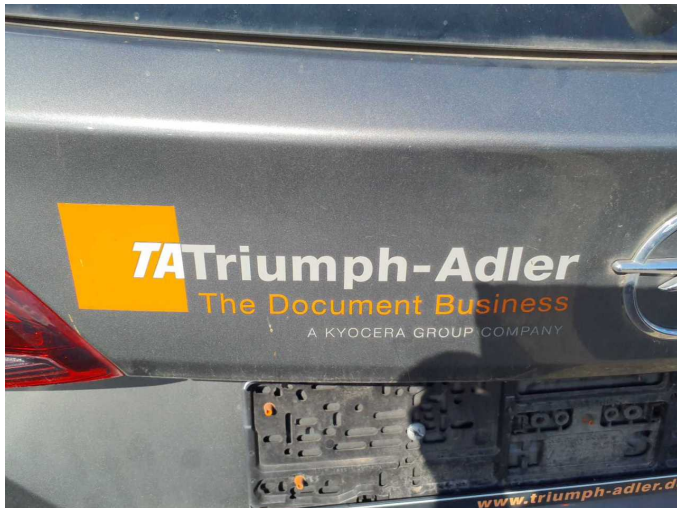
Damage 4: Boot lid / rear door: Boot lid - Glued / labelled - De-glue / neutralise

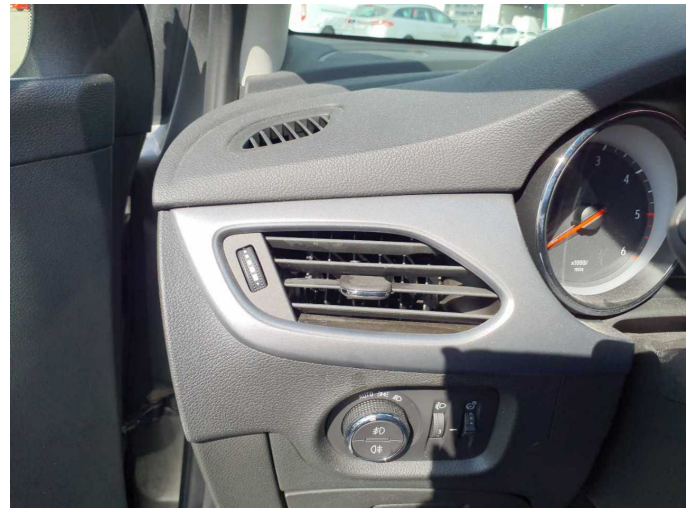
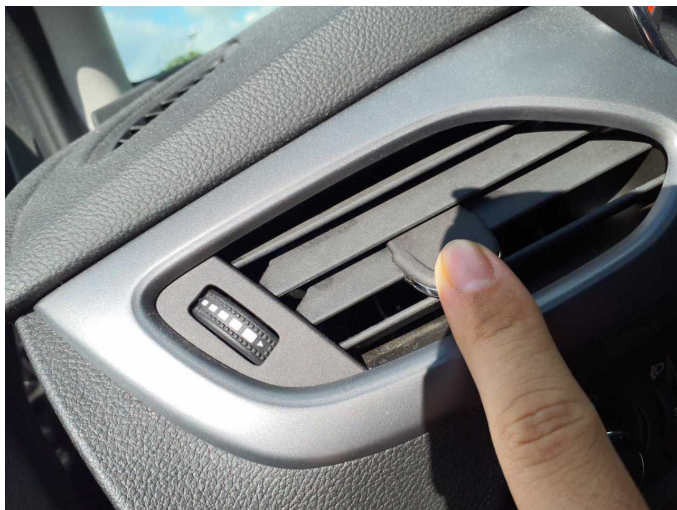
Damage 5: Instrument panel: Air nozzle - right side - Damaged - Replace

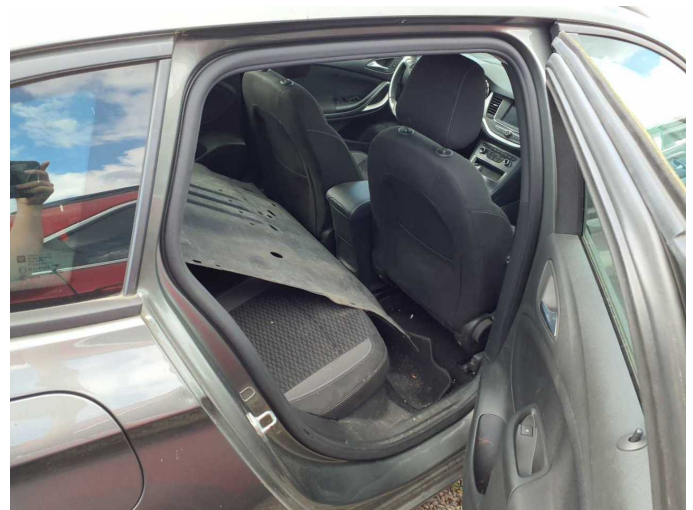
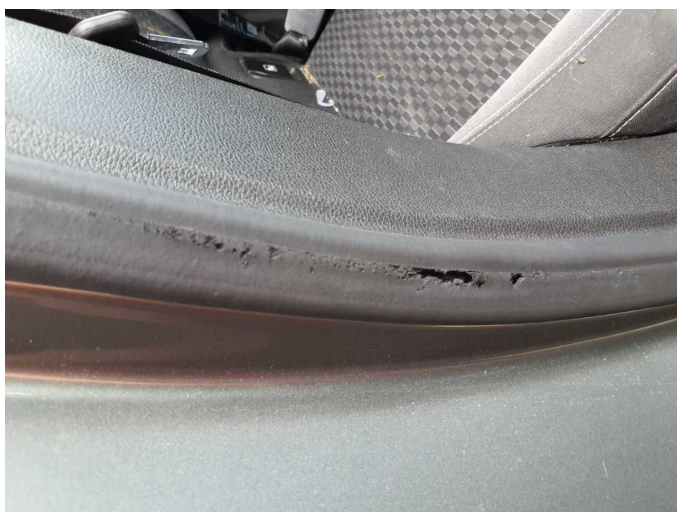
Damage 6: Door - rear right side: Door seal - Damaged - Replace

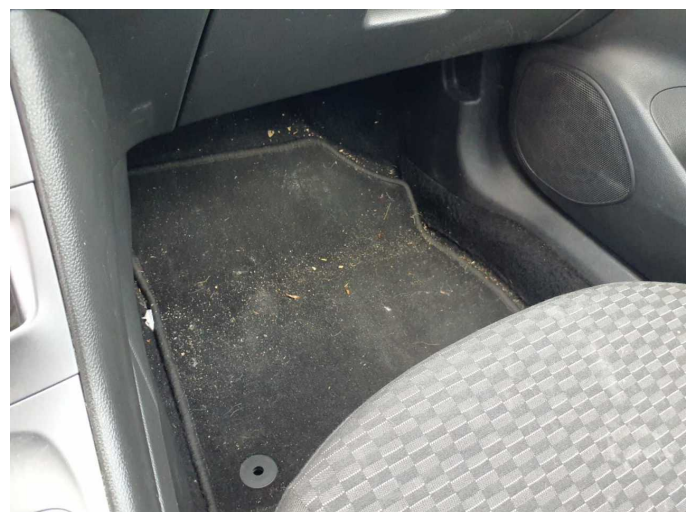
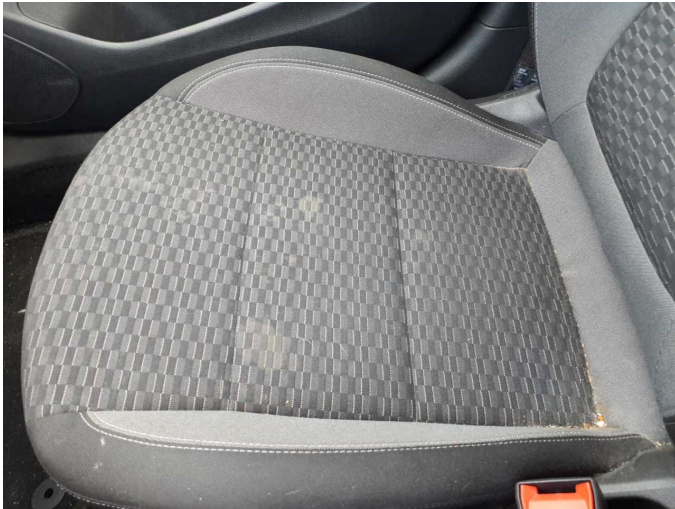
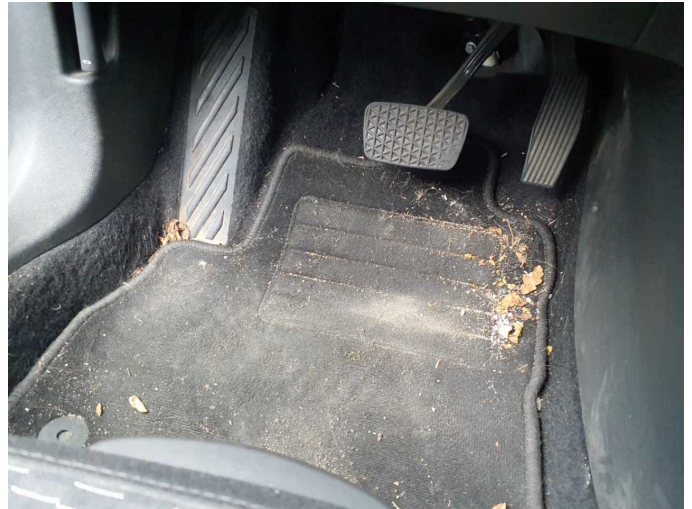
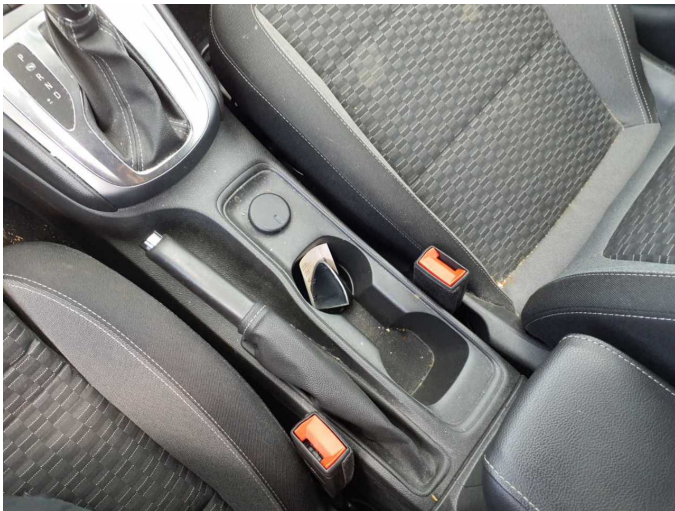
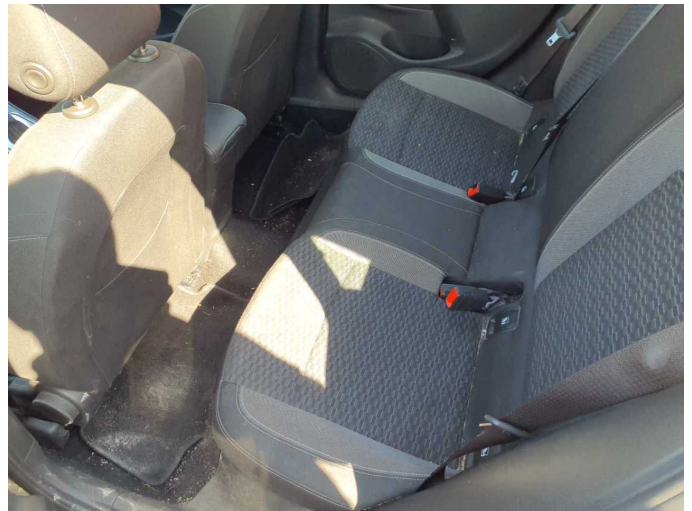
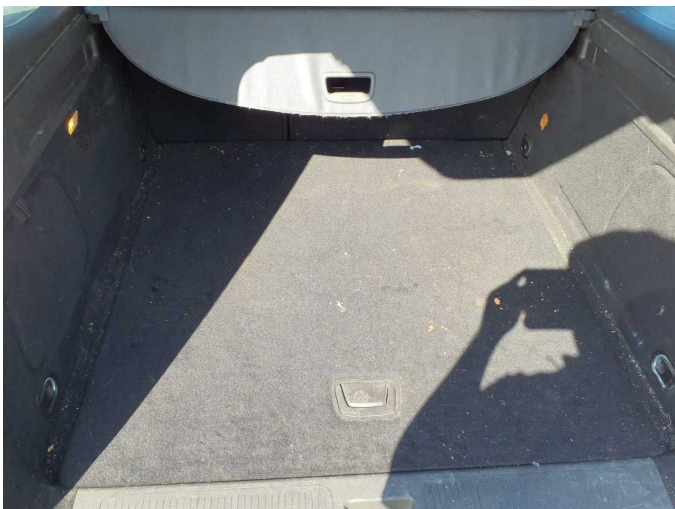
Damage 7: Interior: Interior - Soiled - Clean

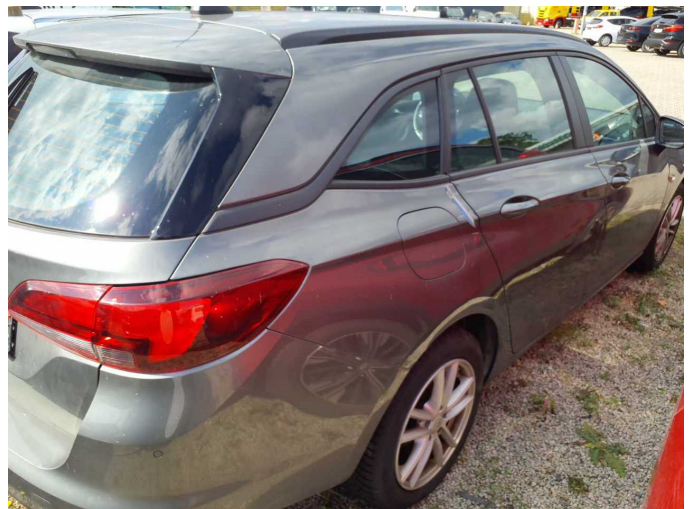
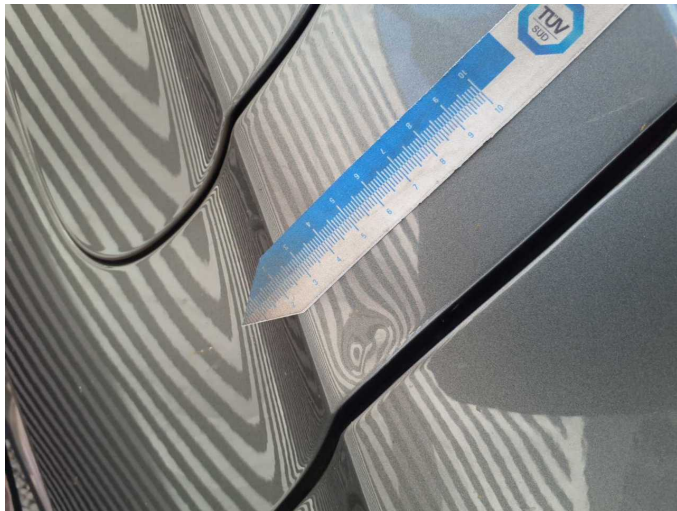
Damage 8: Side panel - rear right side: Side panel - dent(s) - Smart repair

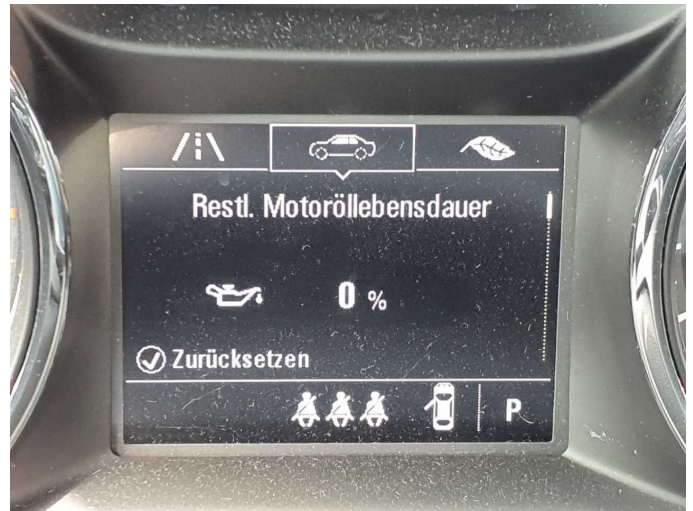
Damage 9: Misc.: Inspection / maintenance - Due - Perform

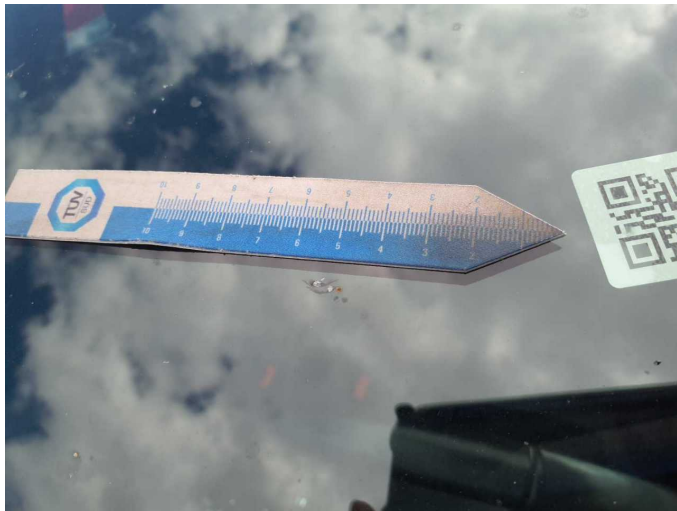
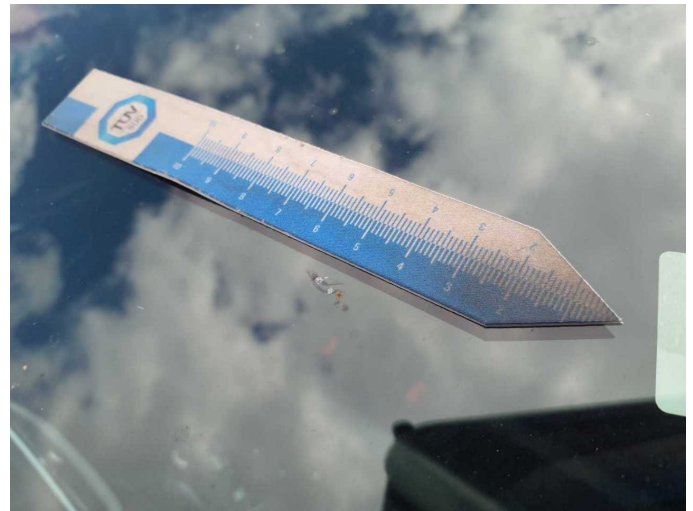
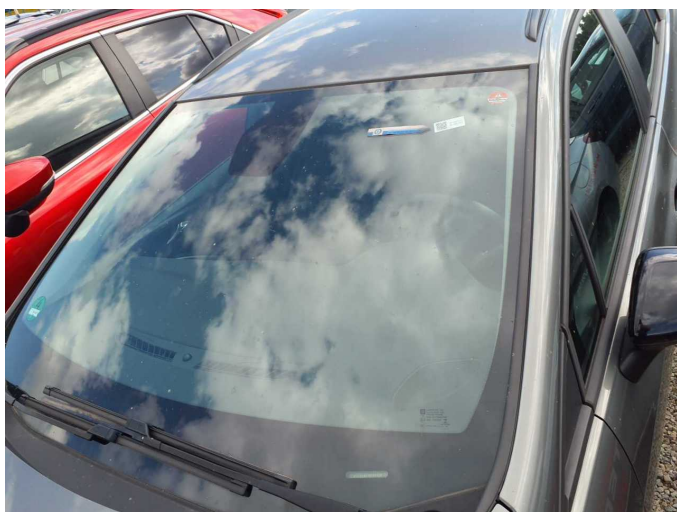
Damage 10: Vehicle glazing: Windscreen - Damaged - Replace

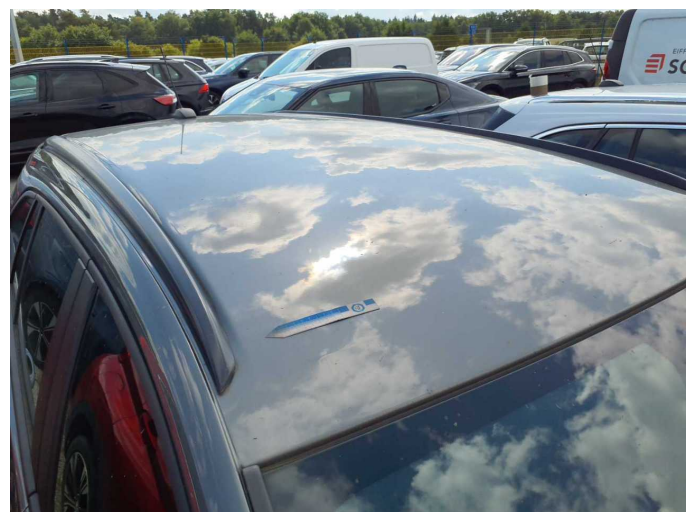
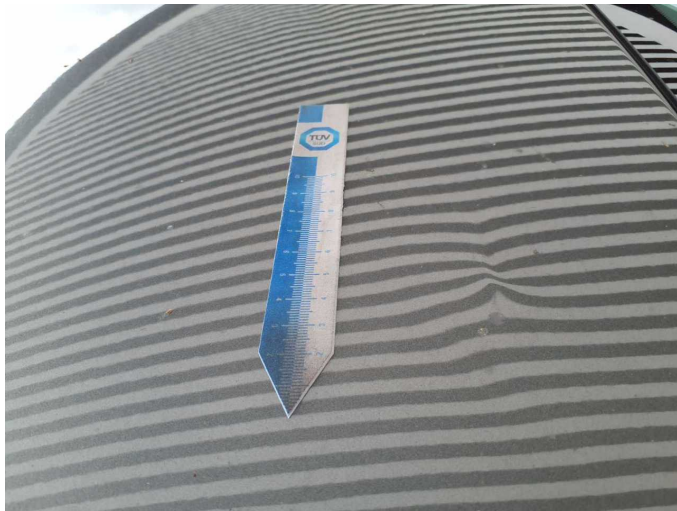
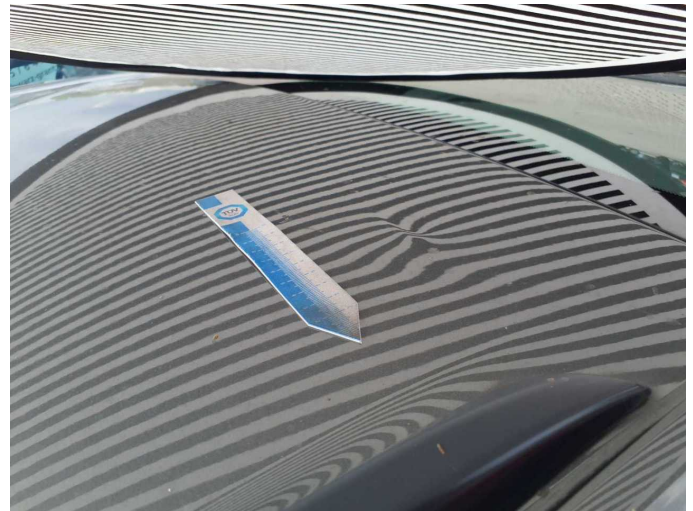
Damage 11: Roof: Roof - Deformed - Repair and paint

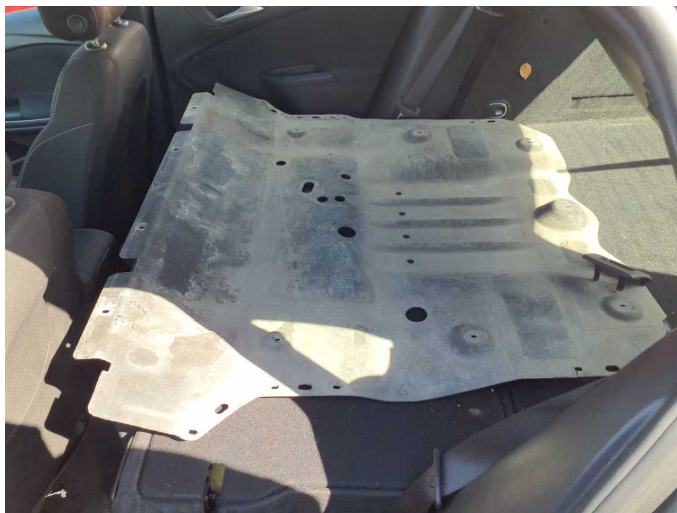
- Aufgrund des Motorschaden kann das Fahrzeug nicht Gewaschen werden, Motorlauf und Elektronische Verbraucher können nicht geprüft werden, es können Folgekosten entstehen.
- Unterbodenbesichtigung nicht möglich, es können Folgekosten entstehen
- Die beigefügte Reparaturkostenkalkulation wurde nach bestem Wissen und Gewissen unter eingeschränkten Besichtigungsbedingung im demontagefreien Zustand erstellt. Es können aufgrund verdeckter Beschädigung erhebliche Mehrkosten und somit Abweichung der für den Unfall ausgewiesenen Reparaturkosten nicht ausgeschlossen werden
- Bremsscheiben zeigen Rost, sollte dies beim Freibremssen sich nicht entfernen lassen, können Mehrkosten entstehen.
- Minderwerte höher als HEK

Damage 12: Engine: Engine - Damaged - repair according to calculation

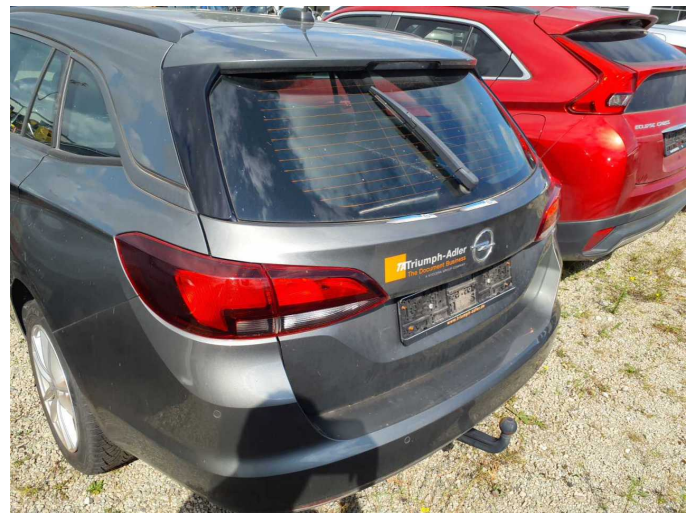
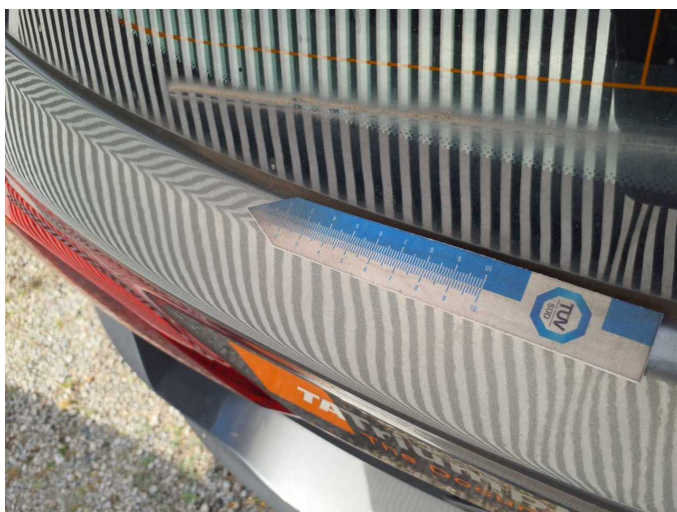
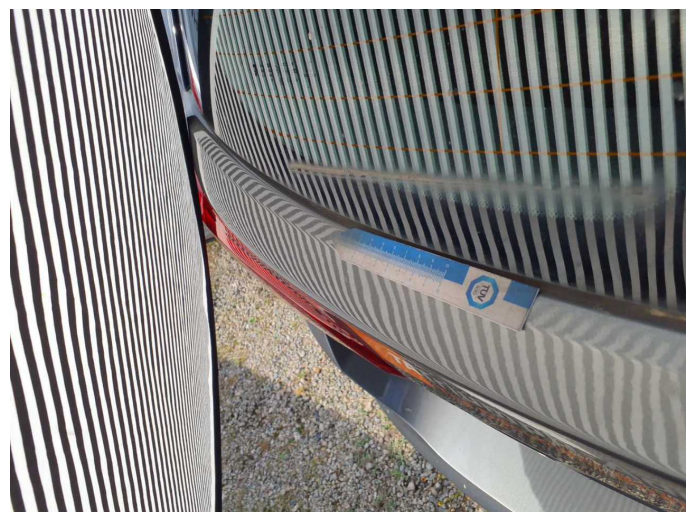
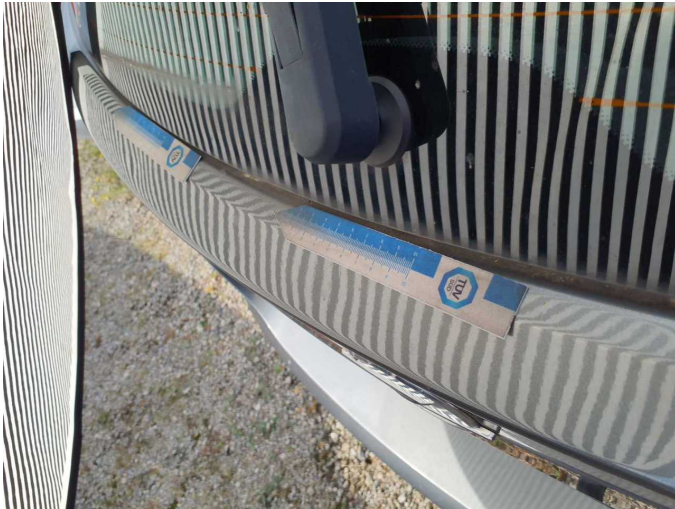
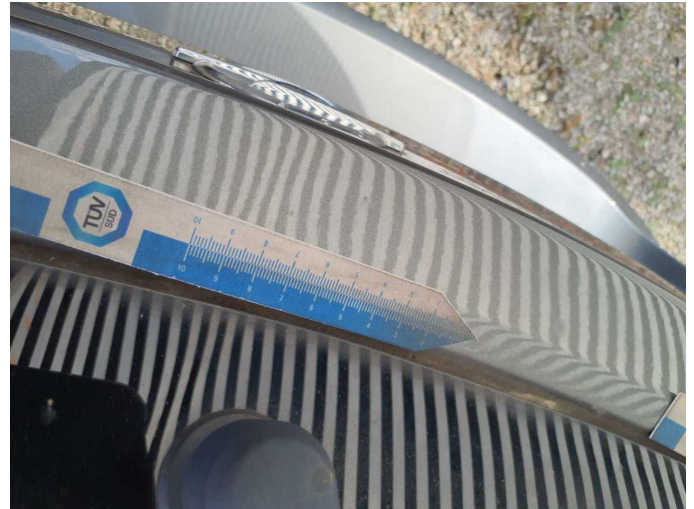
Wear and tear 4: Boot lid / rear door: Boot lid - dent(s) - No deduction

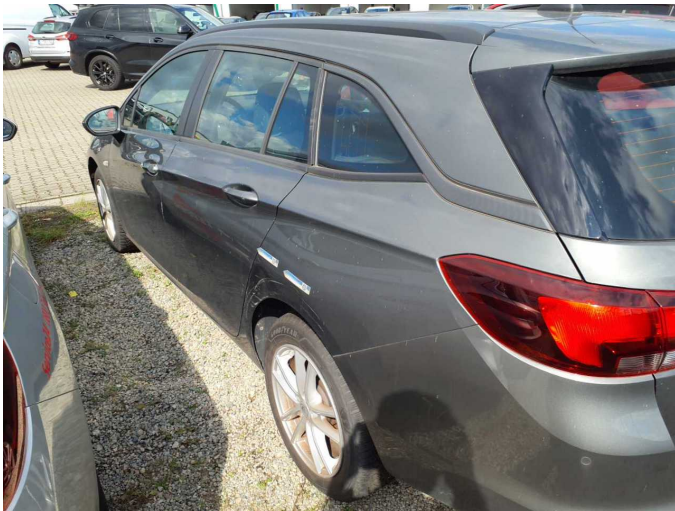
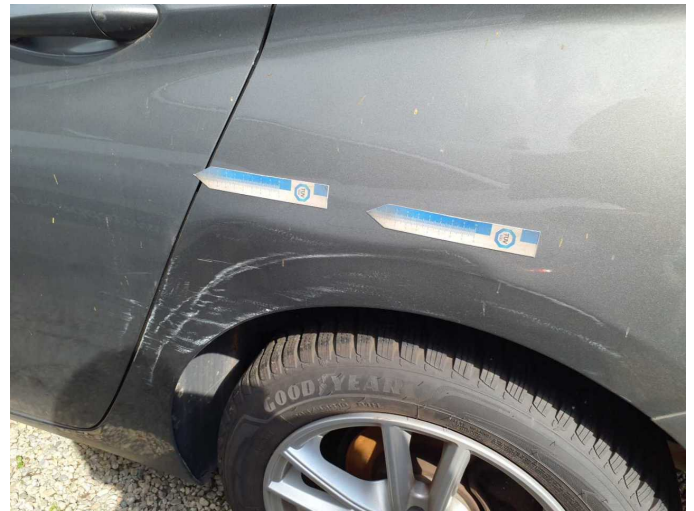
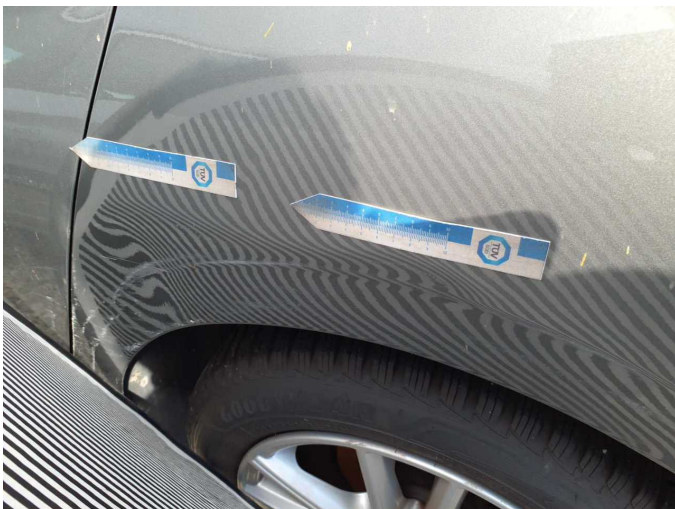
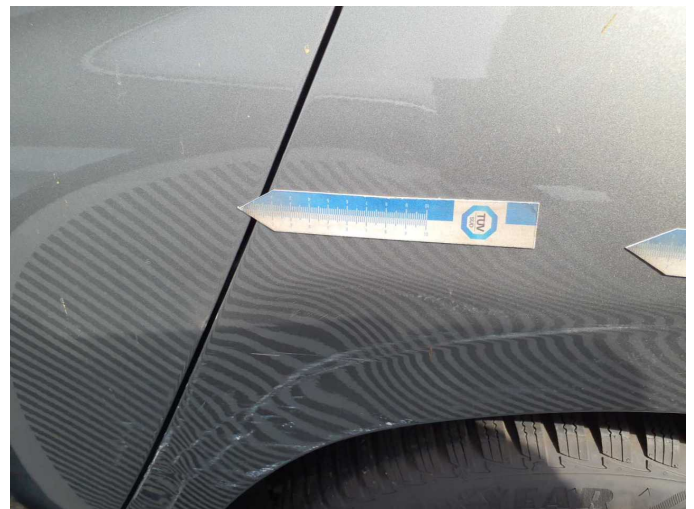
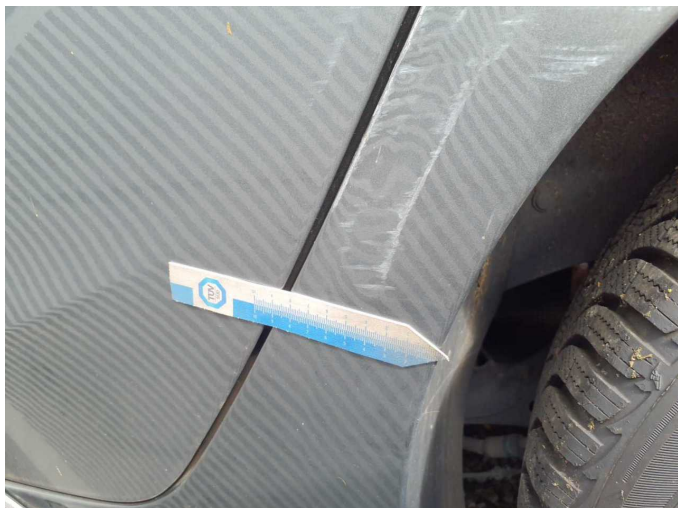
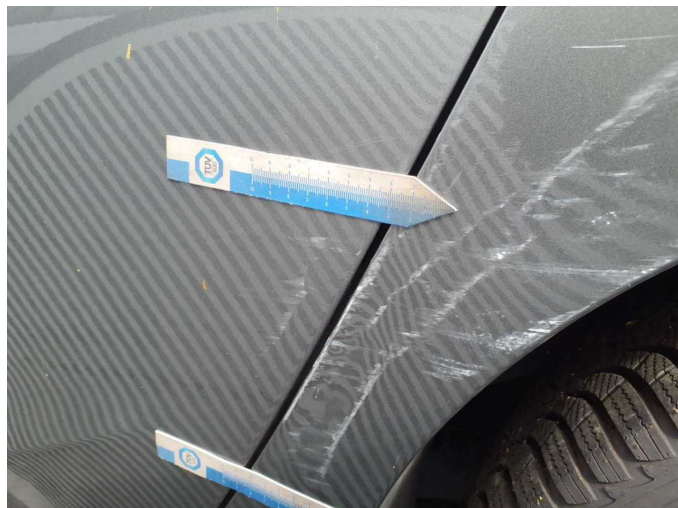
No.	Previous damage	Extent of damage (Net)
1	Side - left, Provided by user / customer, from 15 Jan 2024	1.017,98 €
2	Front, Side - left, Provided by user / customer, from 3 Jun 2023	1.643,63 €

Accident 1: Side - left

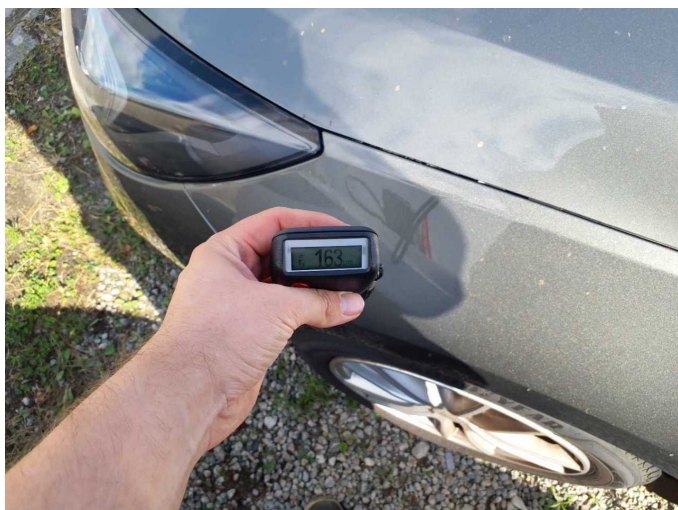
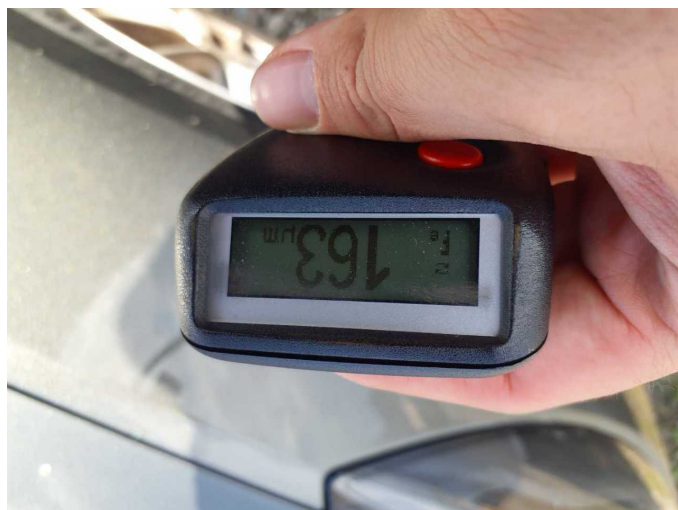
- Mudguard - left side, Professionally carried out, Invoice of repair done Non-existent

Mudguard - left side 163 µm

Repainting 1: Mudguard - left side
