Expertise

Protocol number: 41325976
Order No. / Reference: 25182750
Inspection date: 29 Aug 2025

Manufacturer: Opel	Model: Astra 1.5 D Start/Stop Sports Tourer Automatik Business Edition
VIN: W0VBD8EV7N8042423

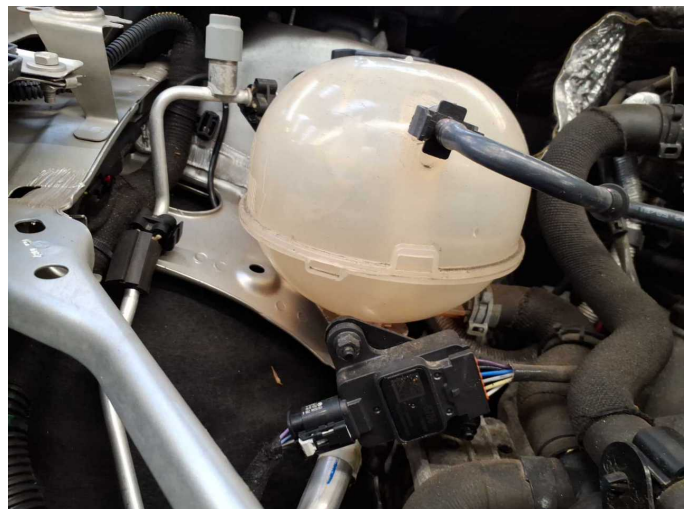
Damage 1: Engine cooling: Coolant (Ausgleichbehälter leer) - Specify findings - Perform diagnosis

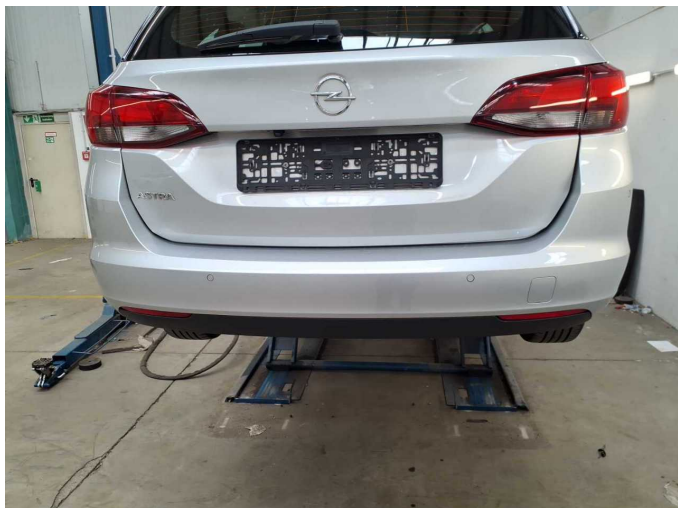
Damage 2: Rear bumper: Rear bumper - Scratch(es) - Cover / polish

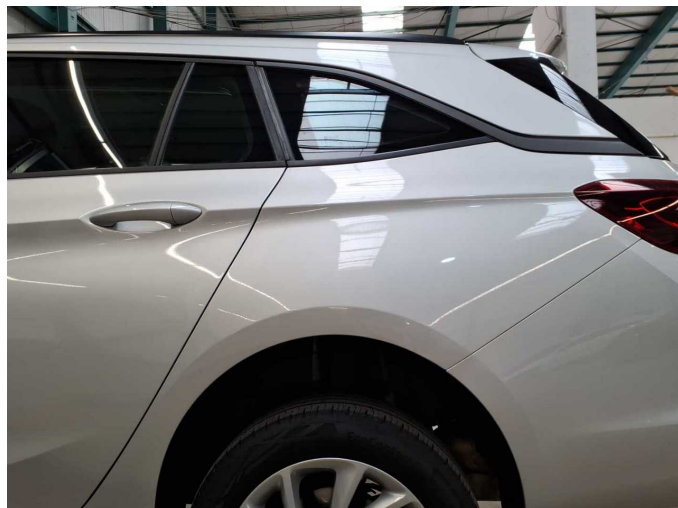
Damage 3: Side panel - rear left side: Side panel - Scratch(es) - Smart repair

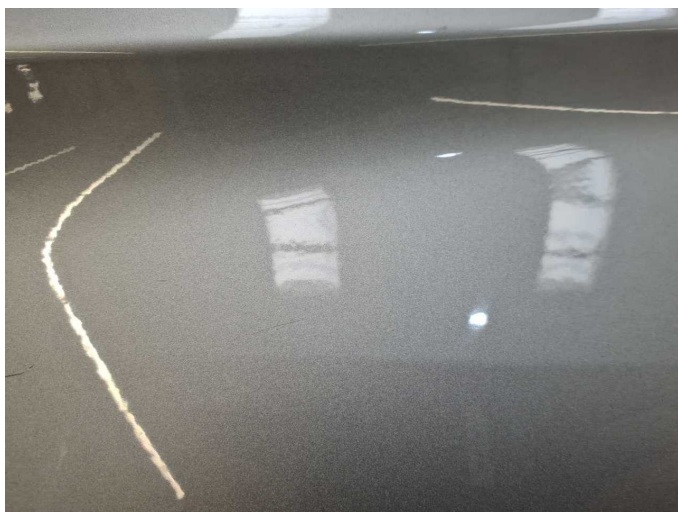
Damage 3: Side panel - rear left side: Side panel - Scratch(es) - Smart repair

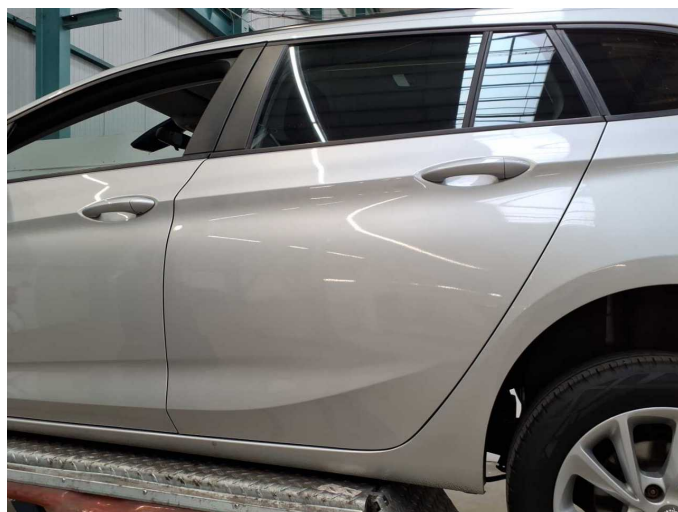
Damage 4: Door - rear left side: Door - dent(s) - Smooth repair work

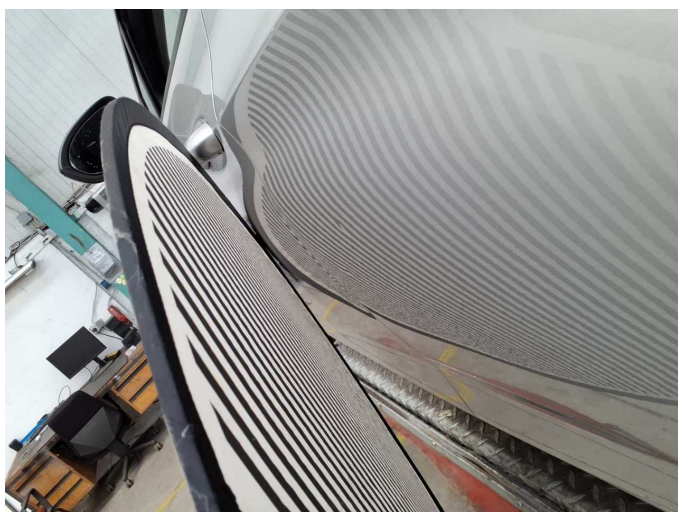
Damage 4: Door - rear left side: Door - dent(s) - Smooth repair work
