Expertise

Protocol number: 41662648  
Order No. / Reference: 25098174  
Inspection date: 18 Sept 2025

| Manufacturer: Opel | Model: Astra 1.5 D Start/Stop Sports Tourer Automatik Business Edition |
| VIN: W0VBD8EV8N8036999 | |

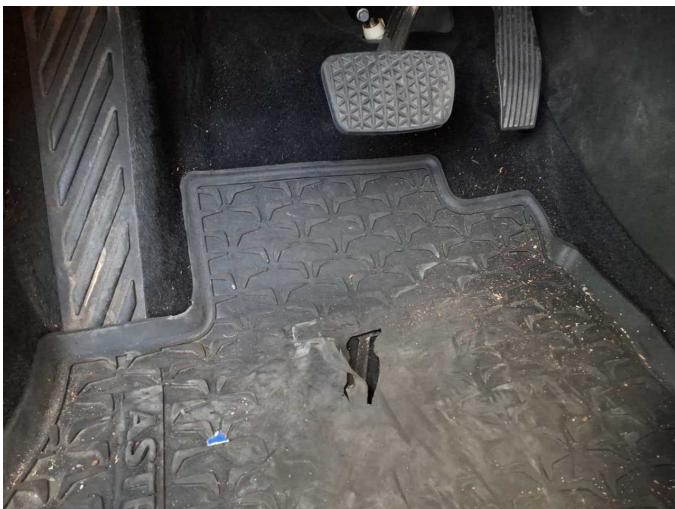
| No. | Component group | Description |
|---|---|---|
| 1 | Trim / covers | Floor mats (VI) - Damaged - Replace |

Damage 1: Trim / covers: Floor mats (VI) - Damaged - Replace

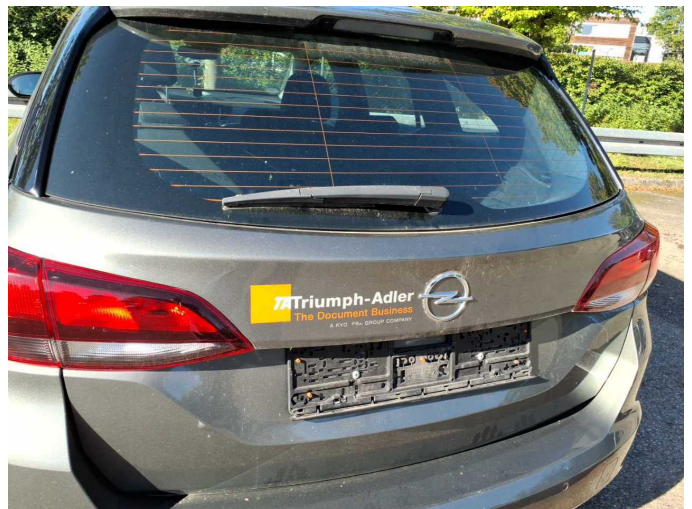
| No. | Component group | Description |
|---|---|---|
| 2 | Body | Body - Glued / labelled - De-glue / neutralise |

Damage 2: Body: Body - Glued / labelled - De-glue / neutralise

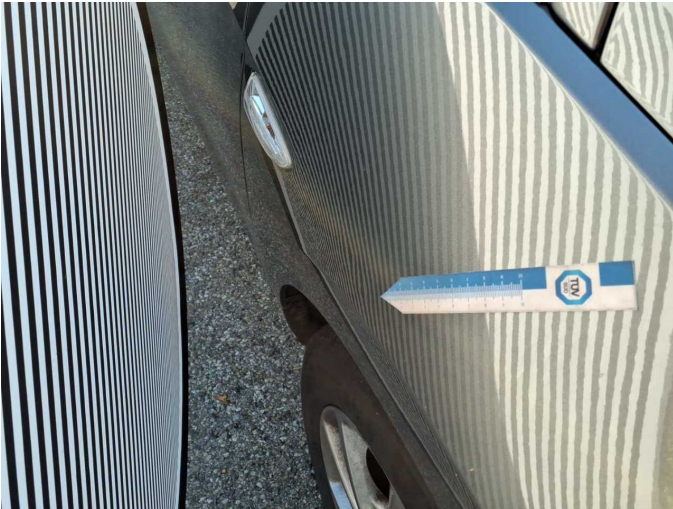
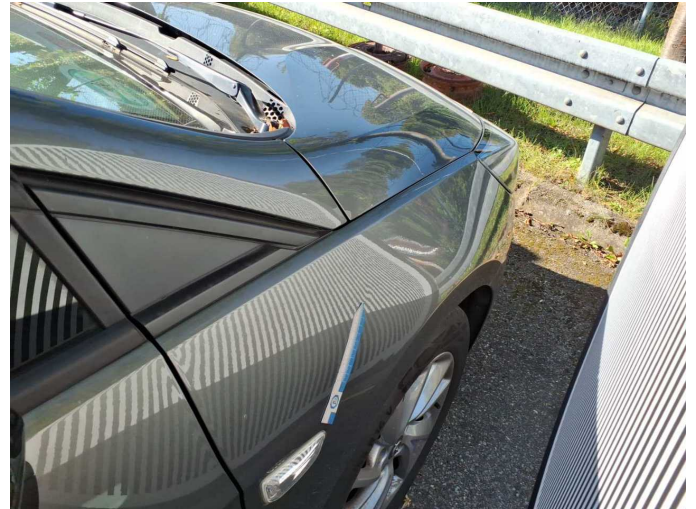
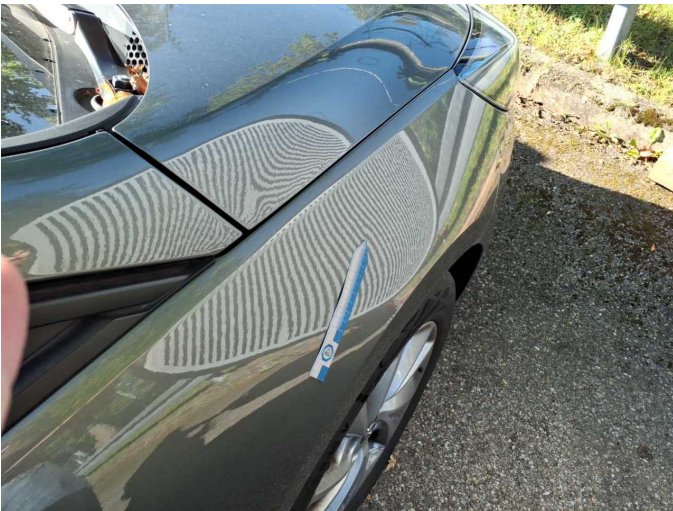
| No. | Component group | Description |
|---|---|---|
| 3 | Mudguard - right side | Mudguard - right side - dent(s) - Smart repair |

**Damage 3:** Mudguard - right side: Mudguard - right side - dent(s) - Smart repair

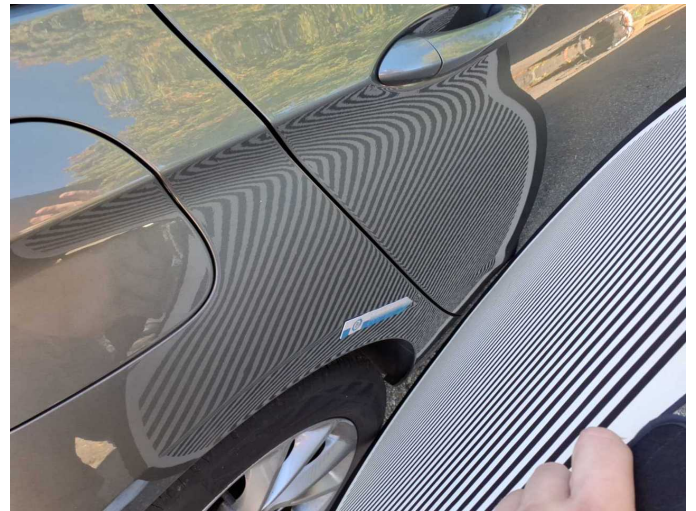
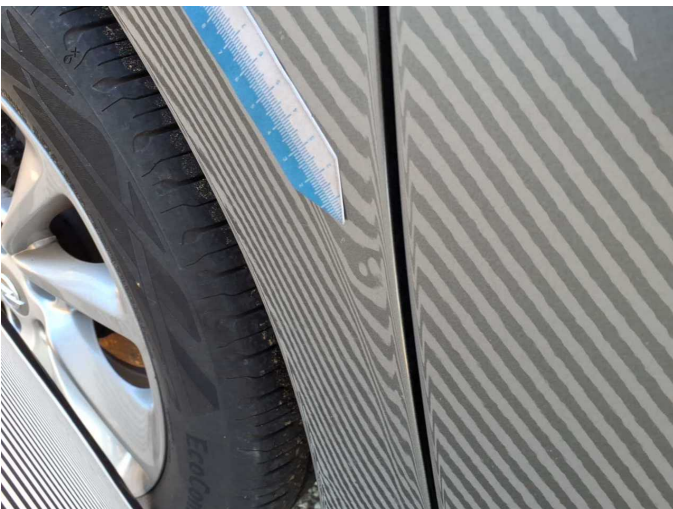
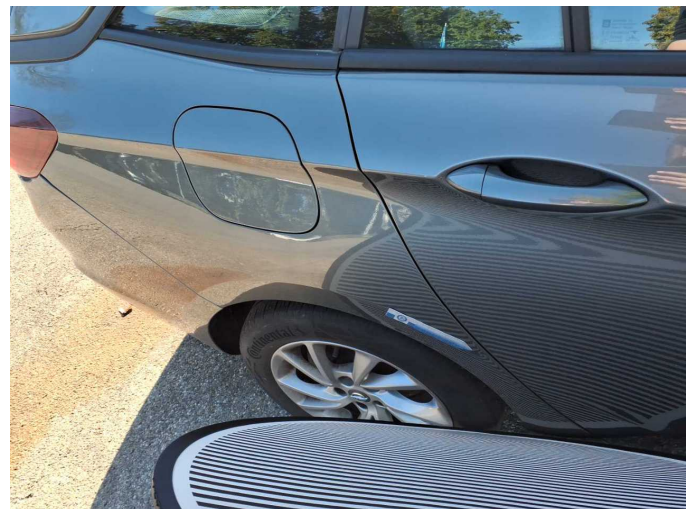
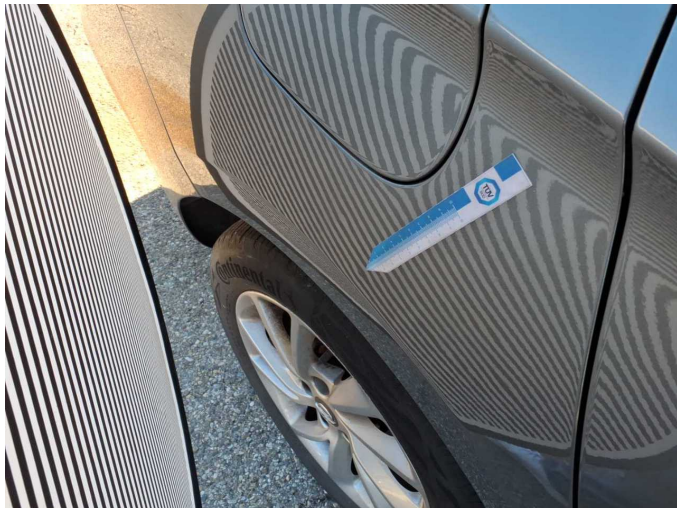
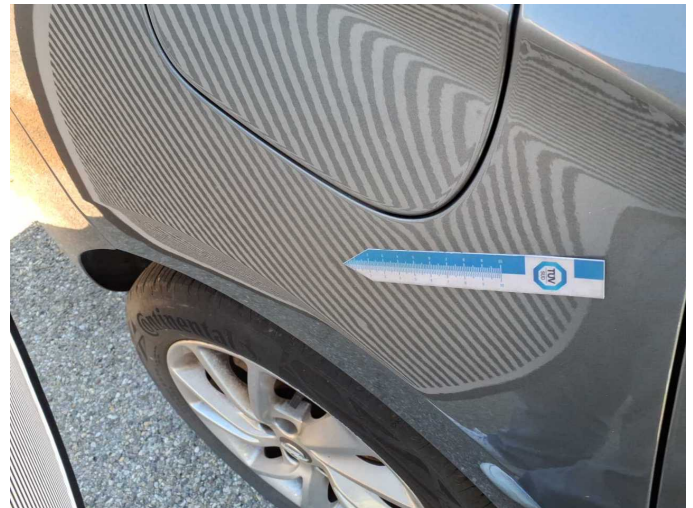
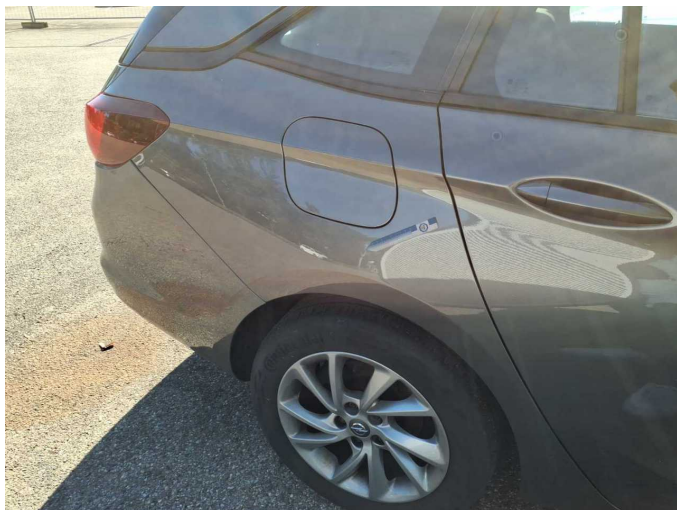
| No. | Component group | Description |
|---|---|---|
| 4 | Side panel - rear right side | Side panel - dent(s) - Smart repair |

**Damage 4:** Side panel - rear right side: Side panel - dent(s) - Smart repair

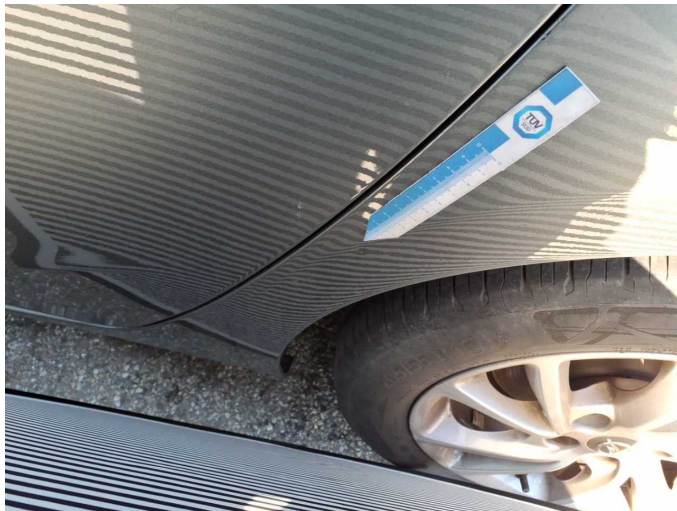
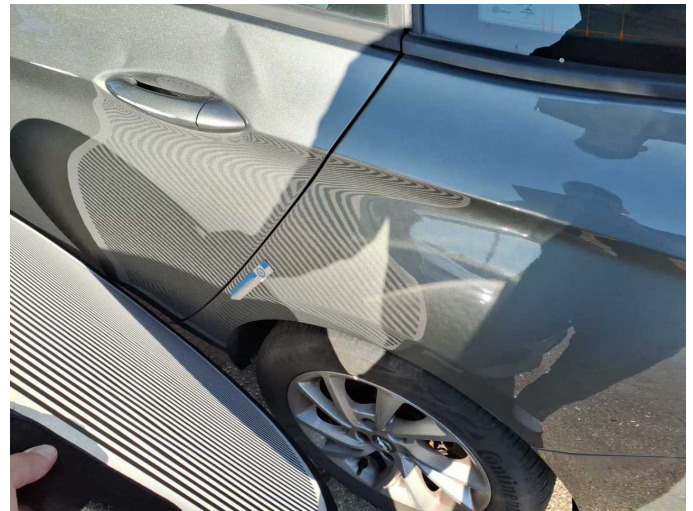
| No. | Component group | Description |
|---|---|---|
| 3 | Side panel - rear left side | Side panel - dent(s) - No deduction |

**Wear and tear 3:** Side panel - rear left side: Side panel - dent(s) - No deduction

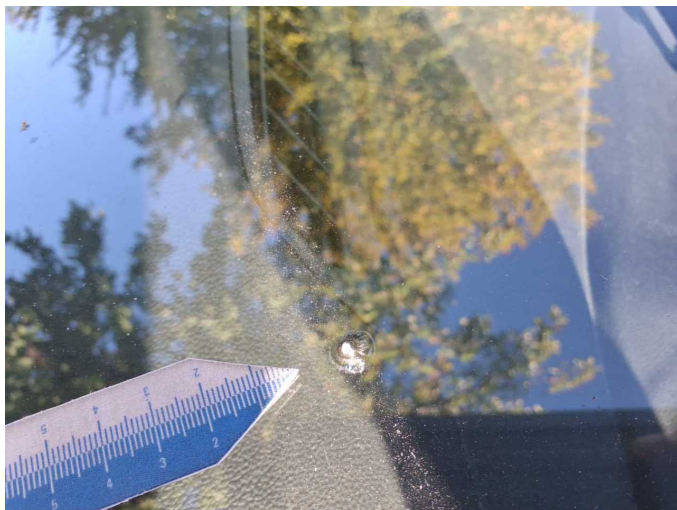
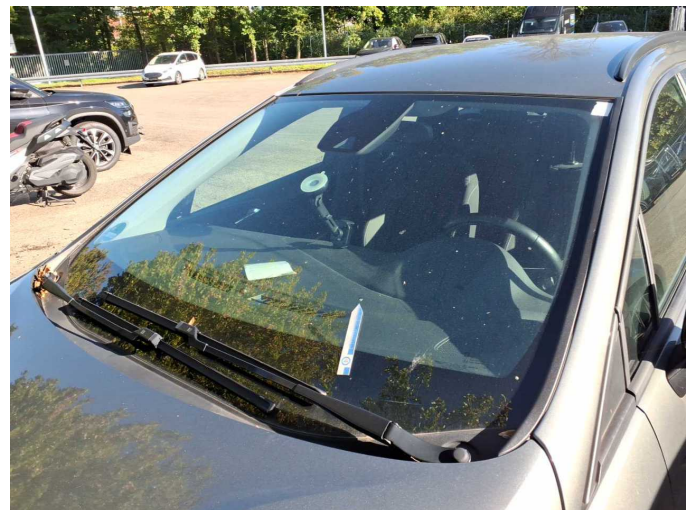
| No. | Component group | Description |
|---|---|---|
| 4 | Vehicle glazing | Windscreen - Stone chips - Replace |

**Wear and tear 4:** Vehicle glazing: Windscreen - Stone chips - Replace

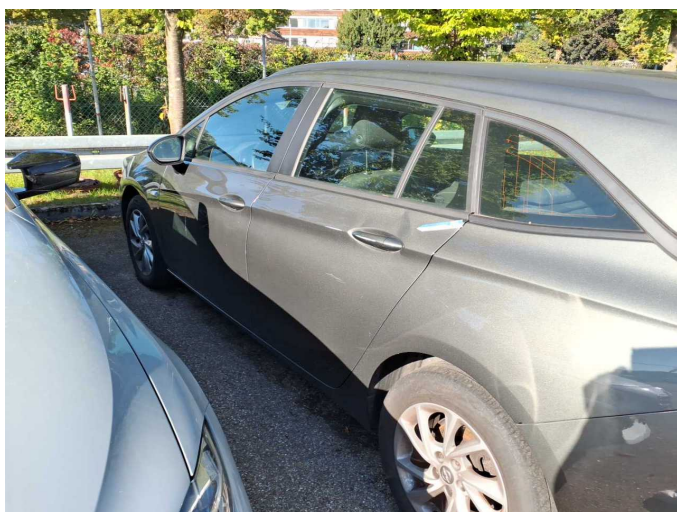
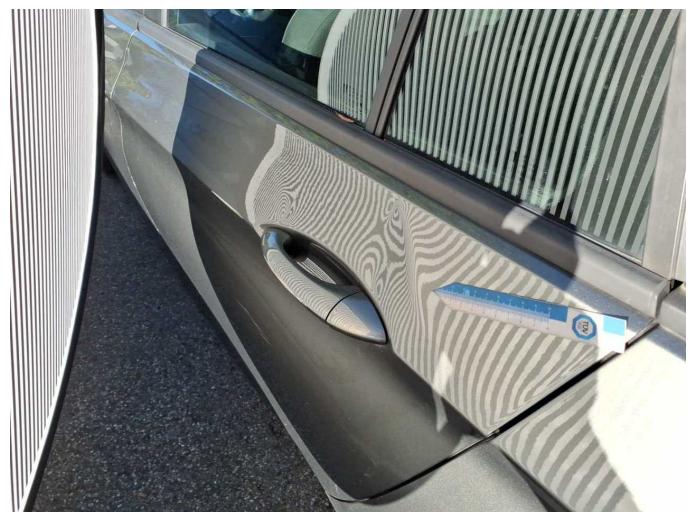
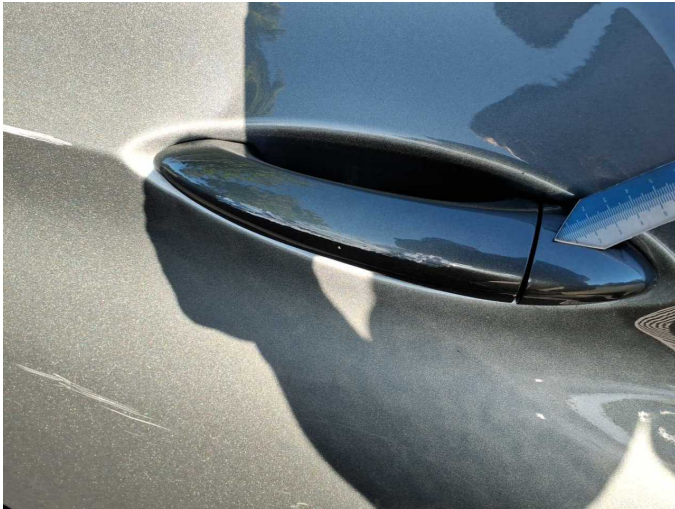
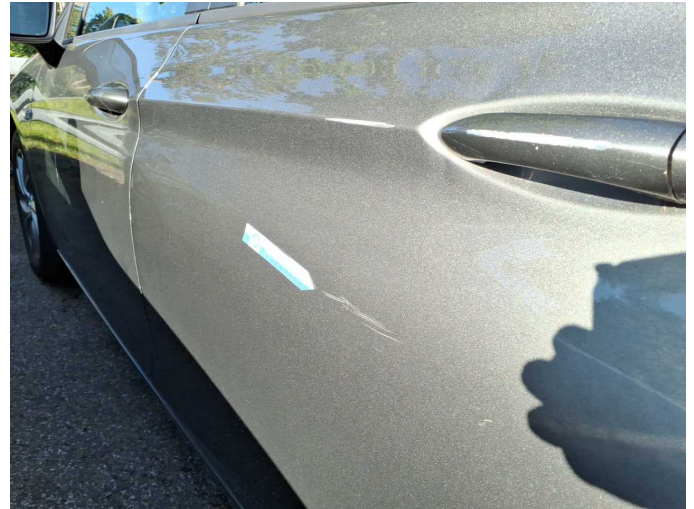
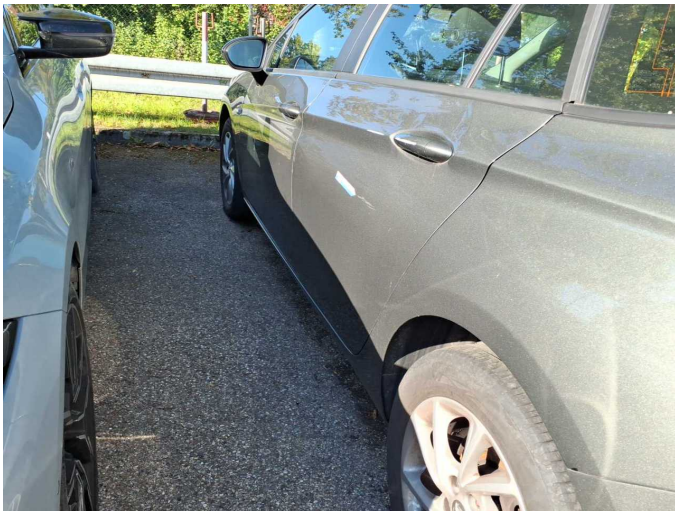
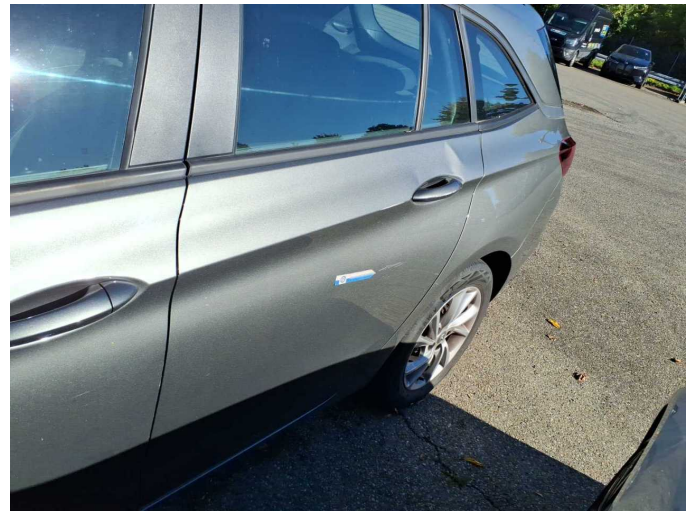
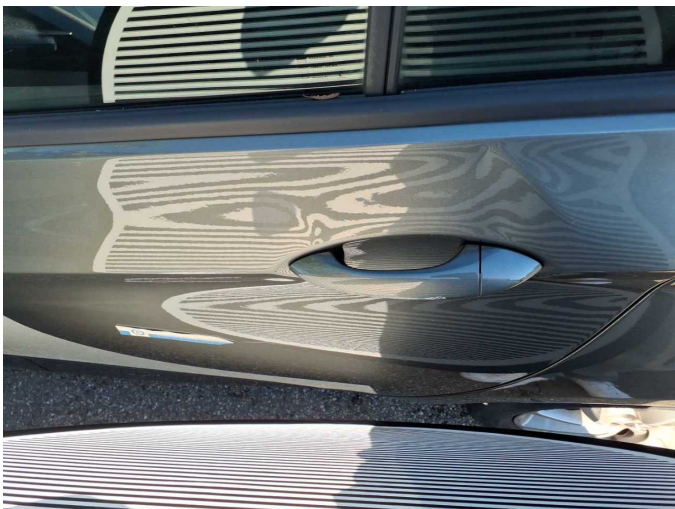
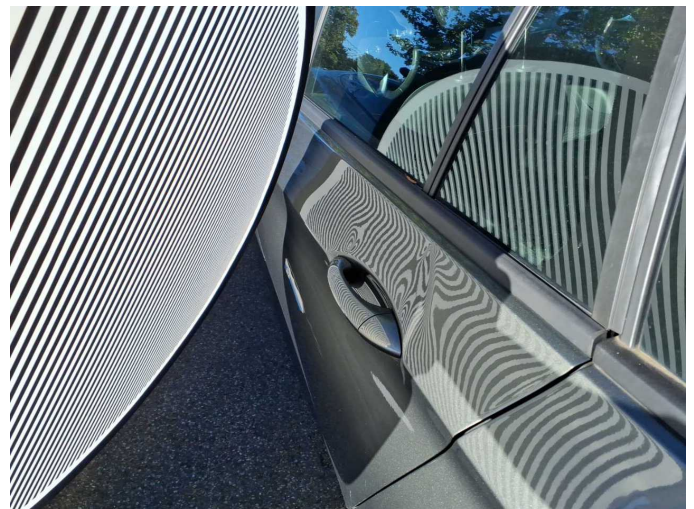
**Accident 1:** Side - left

| No. | Accident |
|---|---|
| 1 | Side - left |

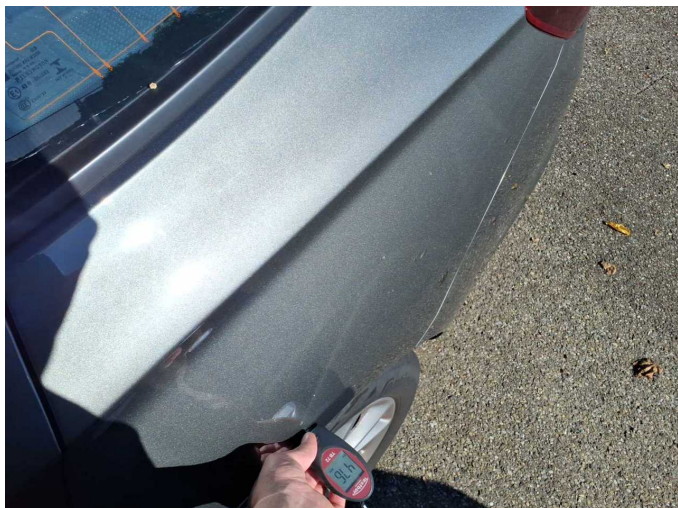
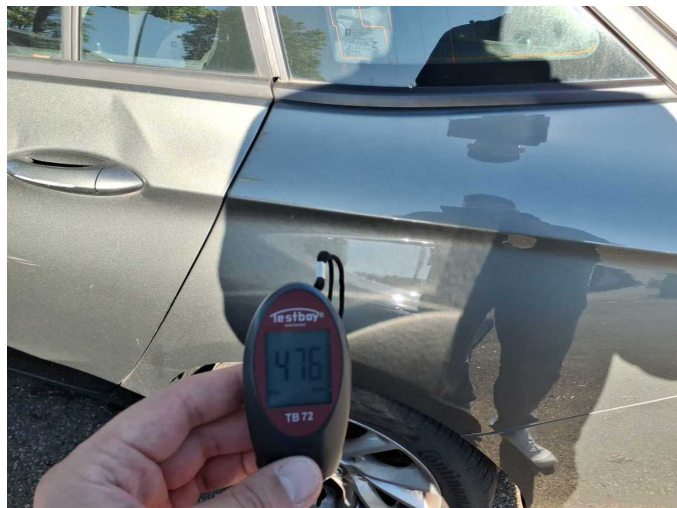
| No. | Repainting |
|---|---|
| 1 | Side panel - rear left side, Professionally carried out, Invoice of repair done Non-existent |

Side panel - rear left side

476 µm |

**Repainting 1:** Side panel - rear left side
