Expertise

Protocol number: 41665924
Order No. / Reference: 25215176
Inspection date: 24 Sept 2025

Model: Astra 1.5 D Start/Stop Sports Tourer Business Edition

VIN: W0VBD8EV8N8042303

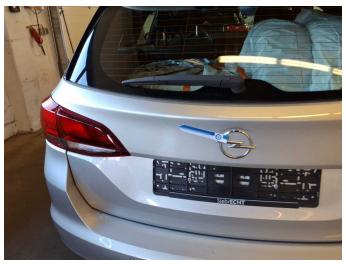
Damage 2: Rear bumper: Rear bumper - Scratch(es) - Smart repair

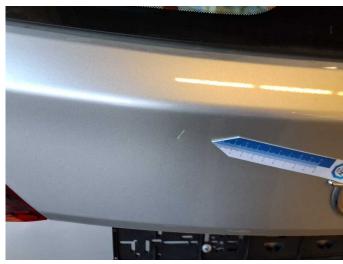
Damage 3: Boot lid / rear door: Boot lid - Scratch(es) - Smart repair
