Expertise

Protocol number: 41500800  
Order No. / Reference: 25129875  
Inspection date: 12 Sept 2025

Manufacturer: Opel	Model: Astra 1.5 D Start/Stop Sports Tourer Automatik Business Edition
VIN: W0VBD8EV9N8043041

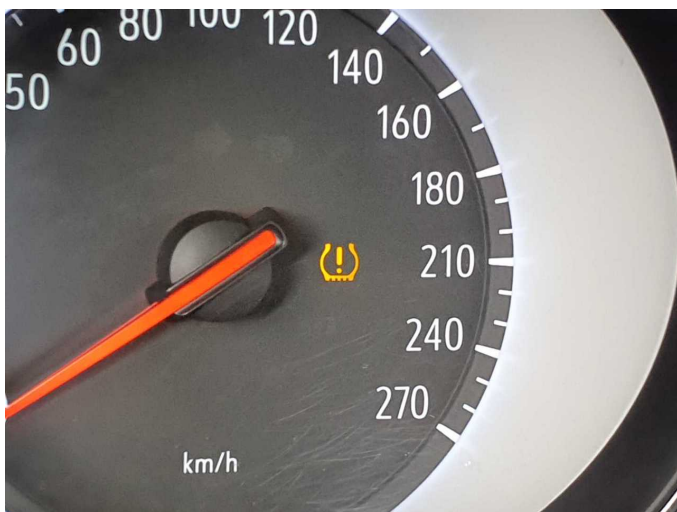
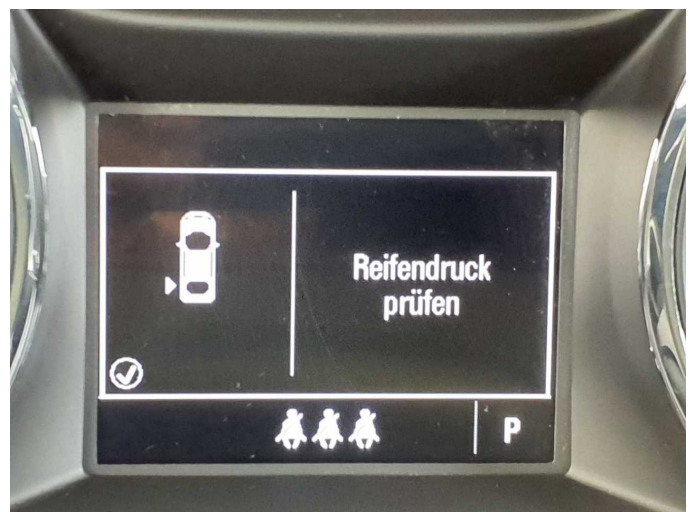
No.	Component group	Description
1	Instrument panel	Indicator light (Reifendruck) - on - Perform diagnosis
2	Bonnet	Bonnet - dent(s) - Smart repair
3	Engine	Engine (Ruckelt) - Functional / admissibility - Perform diagnosis

Damage 1: Instrument panel: Indicator light (Reifendruck) - on - Perform diagnosis

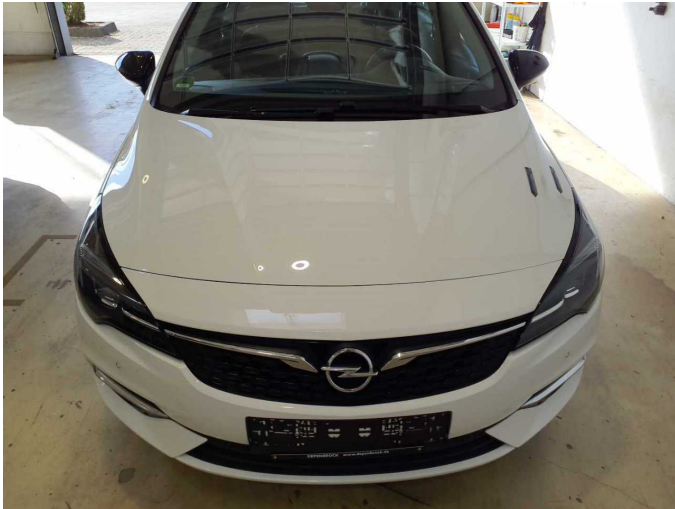
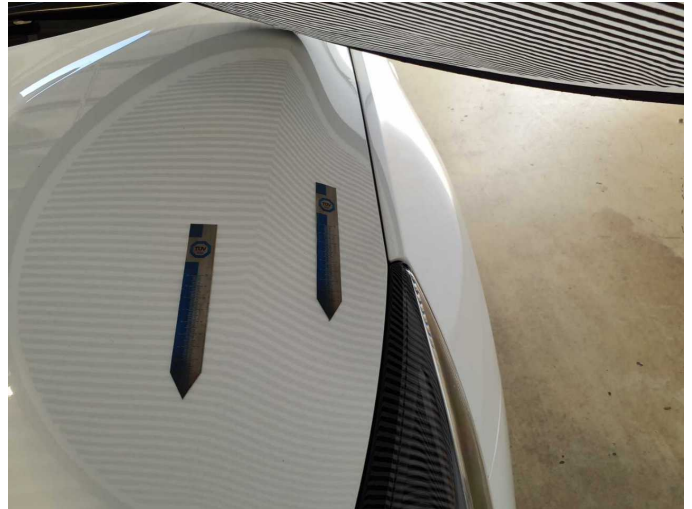
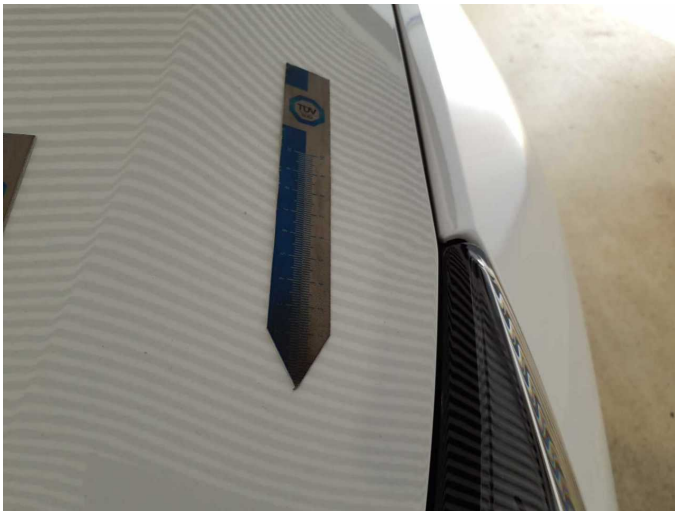
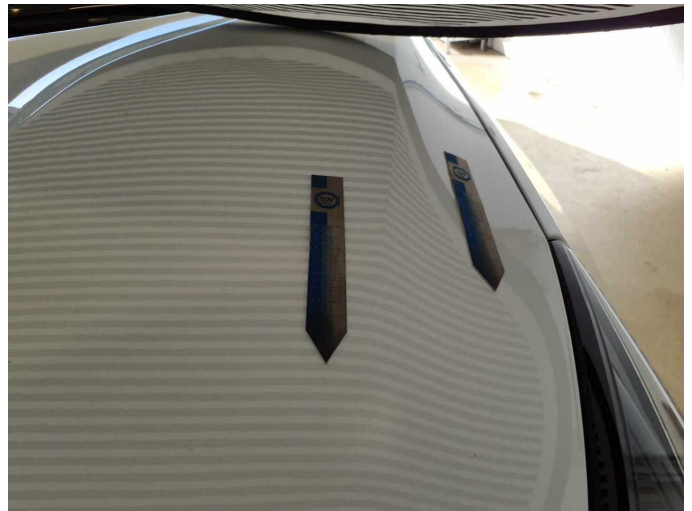
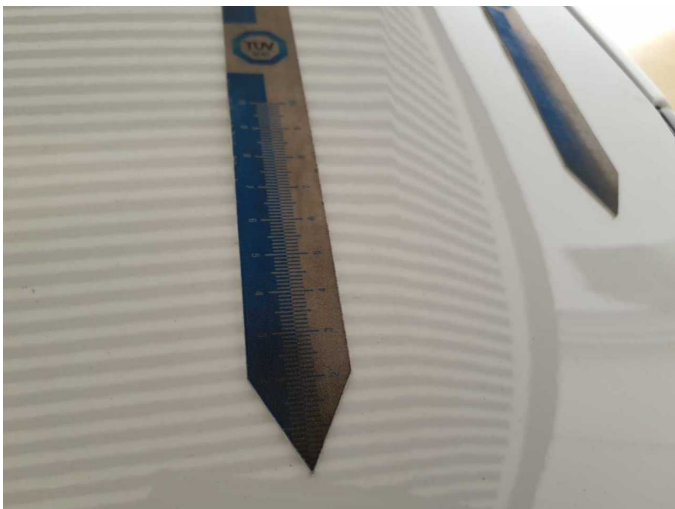
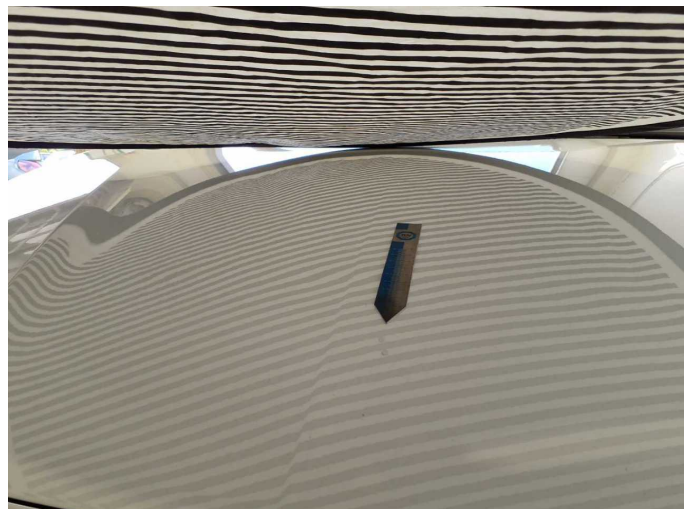
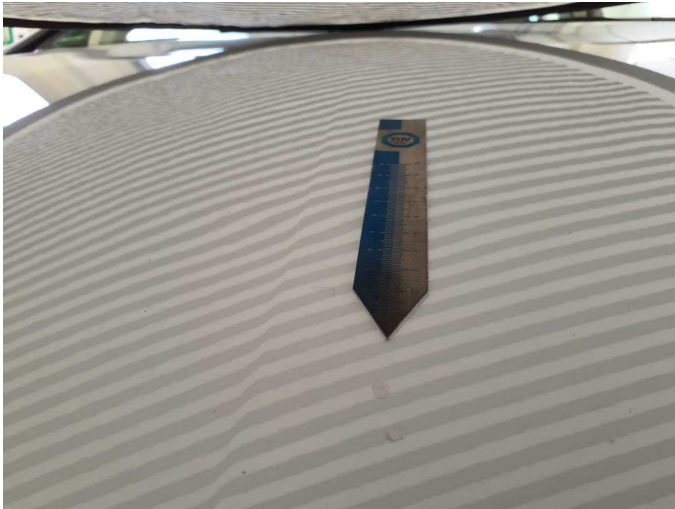
**Damage 2:** Bonnet: Bonnet - dent(s) - Smart repair

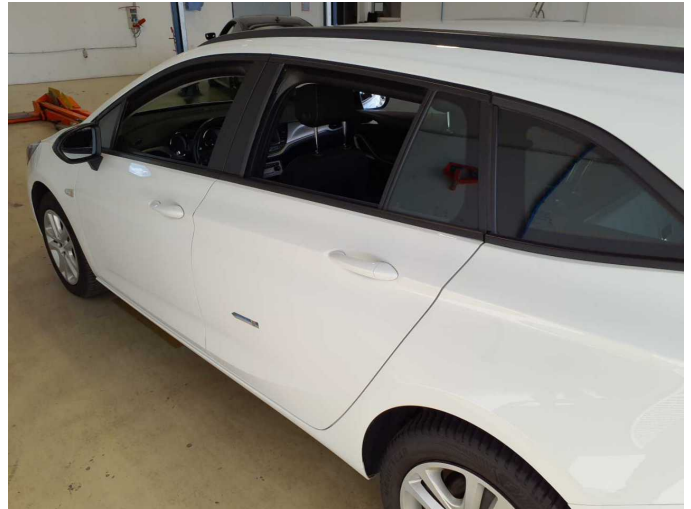
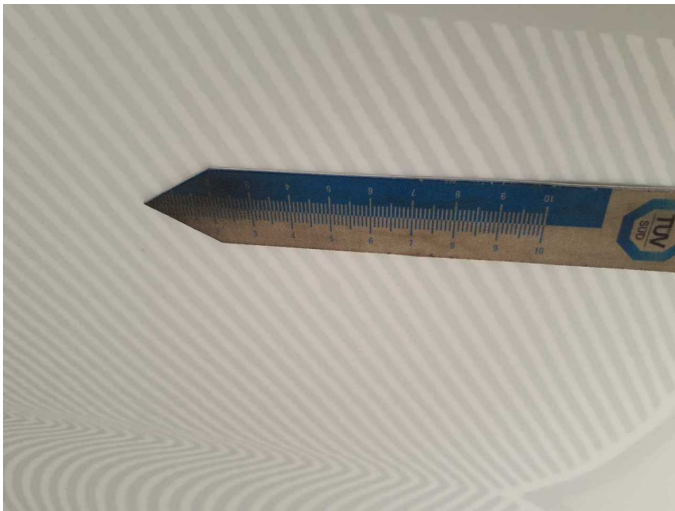
**Wear and tear 8:** Door - rear left side: Door - dent(s) - No deduction

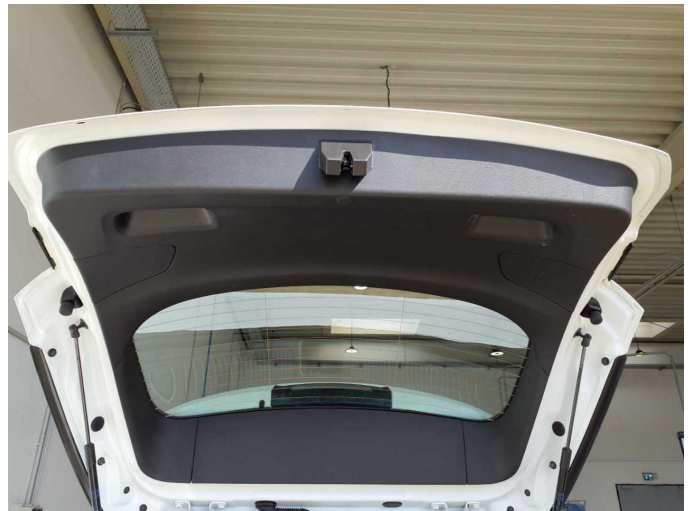
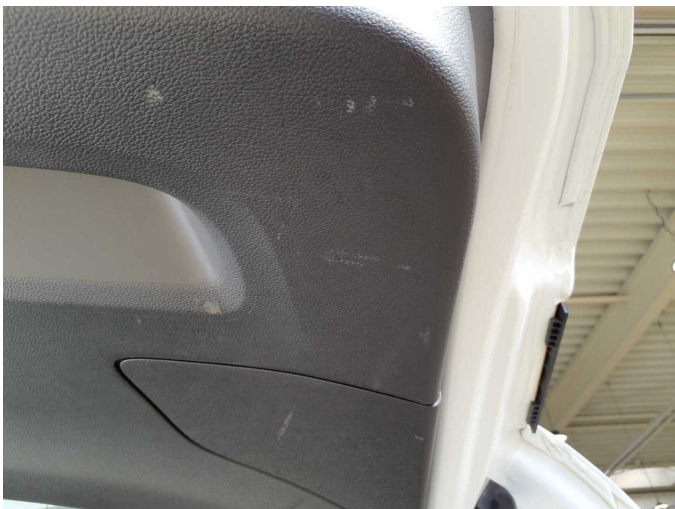
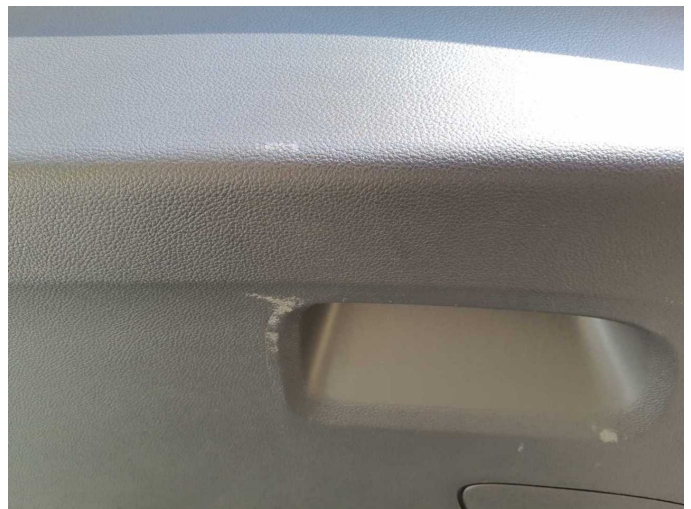
**Wear and tear 9:** Trim / covers: Boot lid - interior trim - Scratch(es) - No deduction
