OPEL Astra Astra 1.5 D Start/Stop Sports Tourer

VIN NO W0VBE8EU2L8039107 Registration Number U2L8039107

Inspection Report Summary

| Customer | BCA Online | Report Number | P20250924155838 |

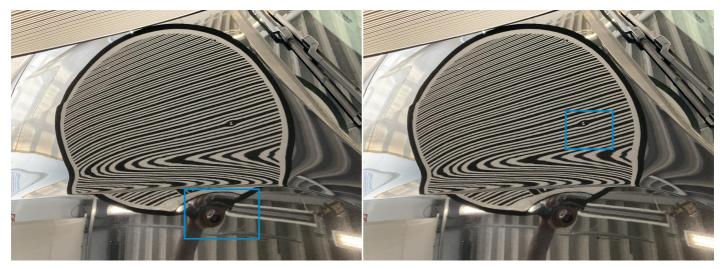
1. Hood Bodywork / Dent / Dent -

2. Hood Bodywork / Dent / Dent -

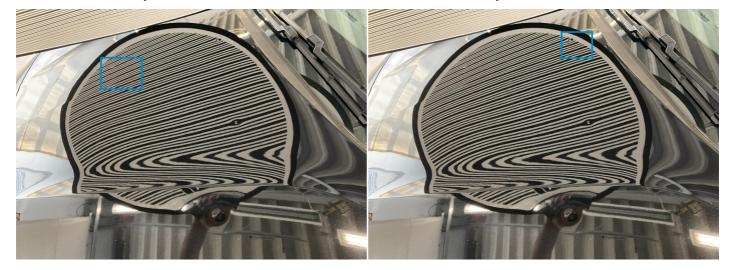
3. Hood Bodywork / Dent / Dent -

4. Hood Bodywork / Dent / Dent -

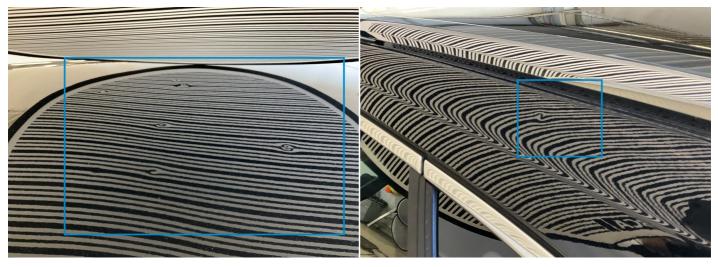
5. Roof Bodywork / Dent / Dent -

6. B Pillar / Center Left Bodywork / Dent / Dent -

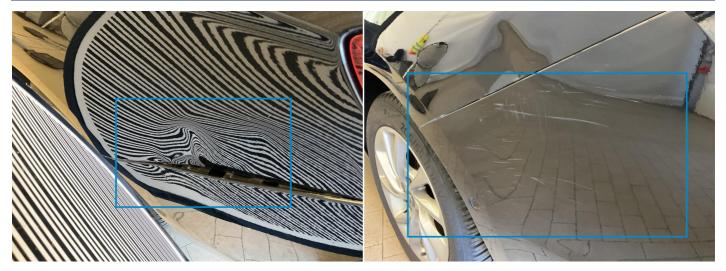
7. Fender / Back Left Bodywork / Dent / Dent -

8. Corner Bumper / Back Left Paint / Scratch / Scuff -

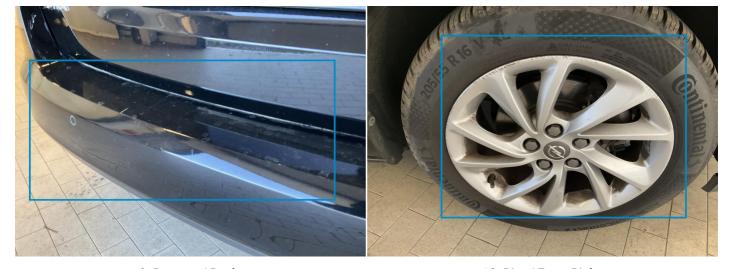
9. Bumper / Back Paint / Scratch / Scuff -

10. Rim / Front Right Out of Bodywork / Scratch -

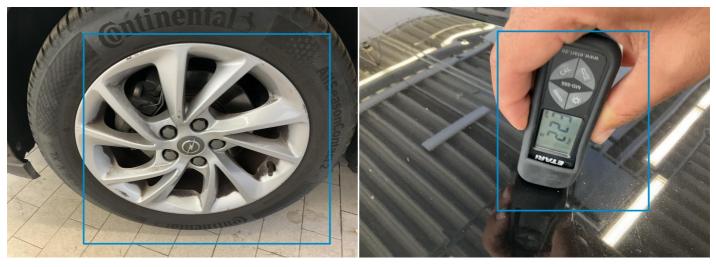
11. Rim / Front Left Out of Bodywork / Scratch -

12. Hood Paint / Poor Previous Repair -

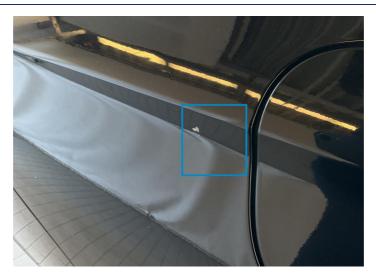
13. Fender / Back Right Paint / Scratch / Scuff -
