## status report

#### Opel Combo Life E Innovation

| Vehicle identification number | <b>W0VECYHZRKJ772710</b> | mileage read: | <b>135155 km</b> |

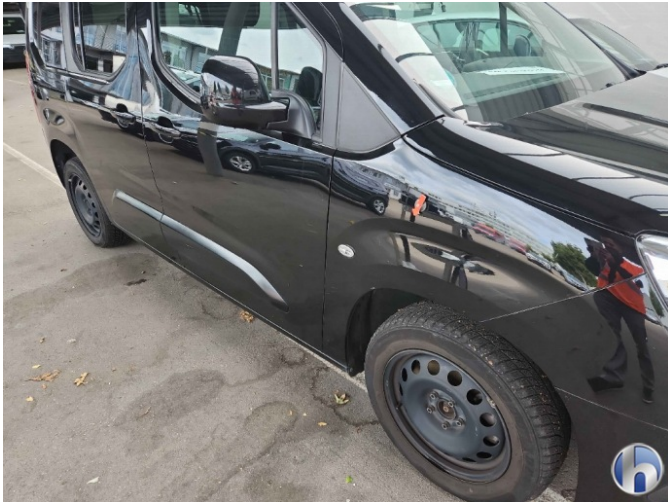
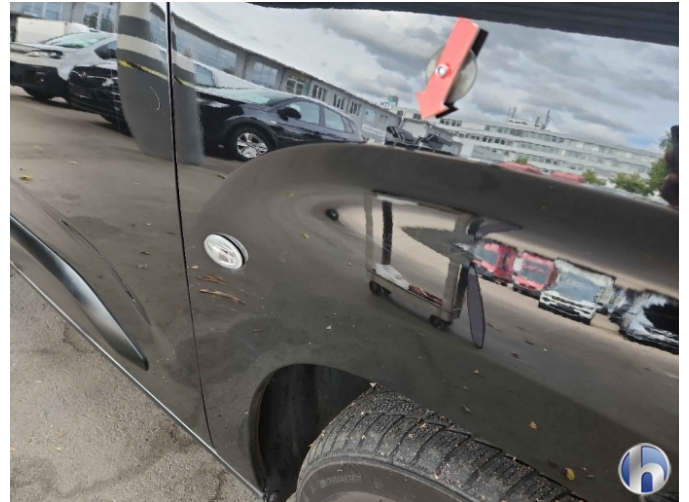
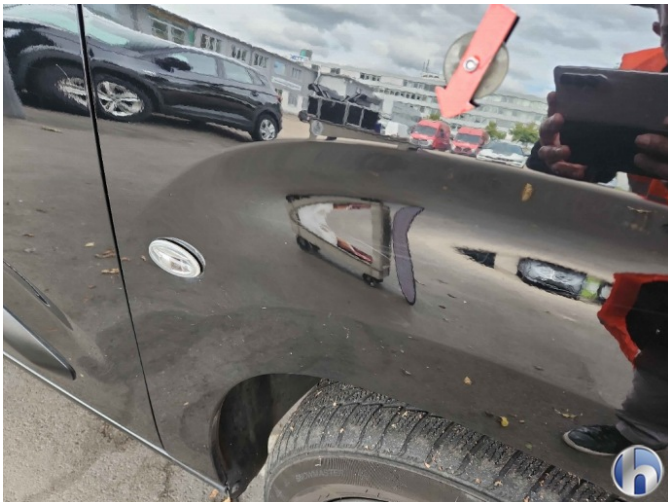
| component | Damage | Rep kind |
|---|---|---|
| 3. Front fender - right | Damaged | Paint |

3. Front fender - right

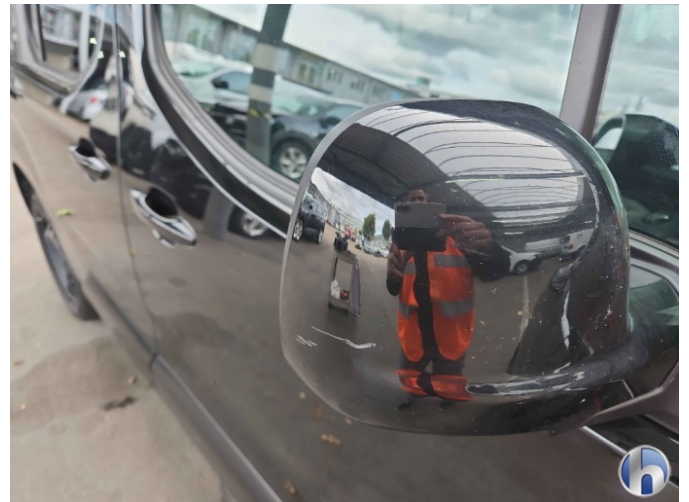
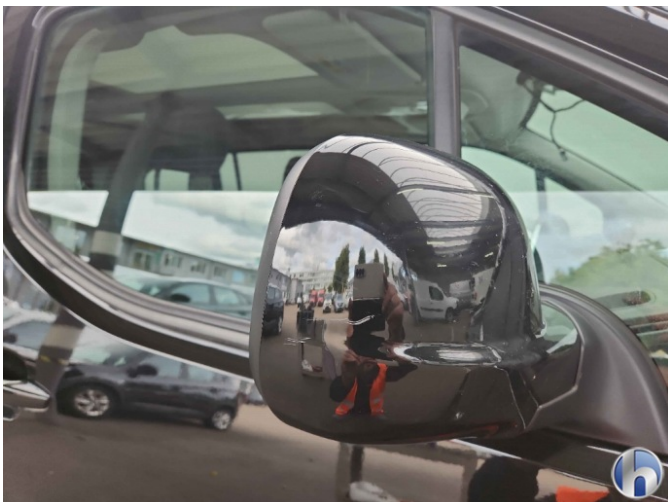
| component | Damage | Rep kind |
|---|---|---|
| 4. Outside mirror - left | Damaged | Paint |

4. Outside mirror - left

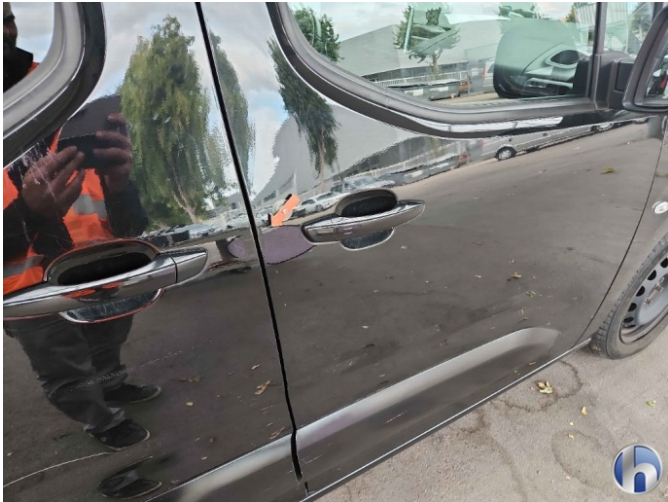
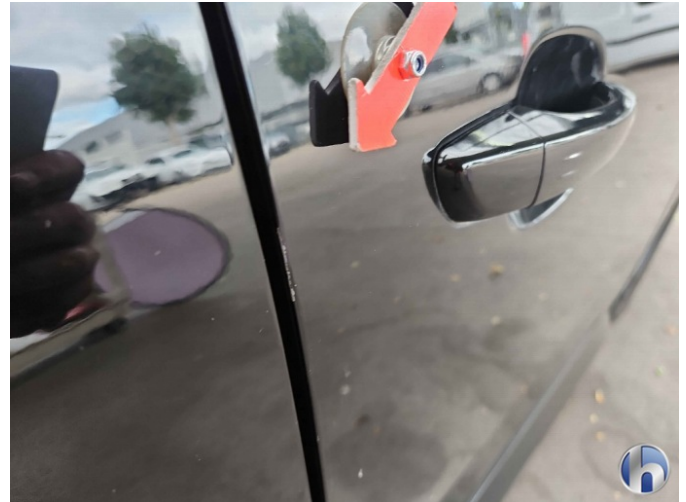
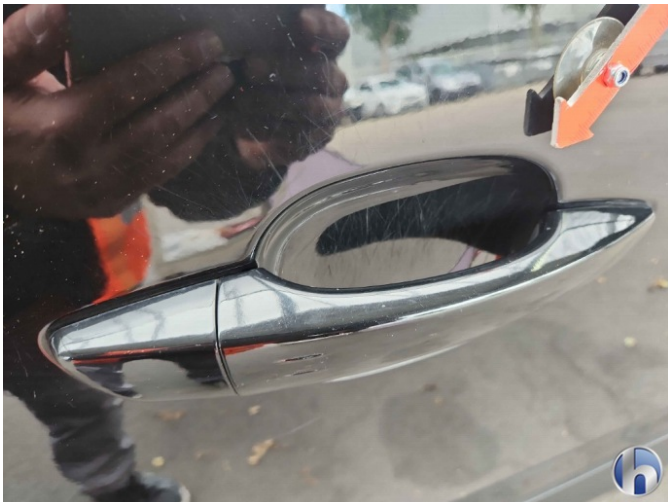
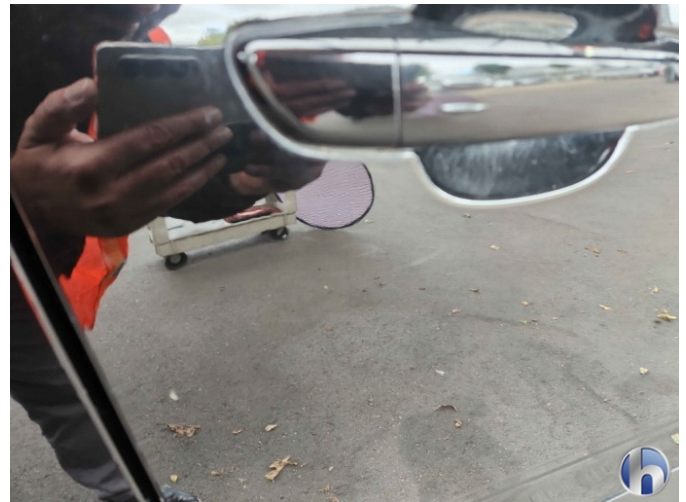
| component | Damage | Rep kind |
|---|---|---|
| 6. Front door - right | Damaged | Paint |

6. Front door - right

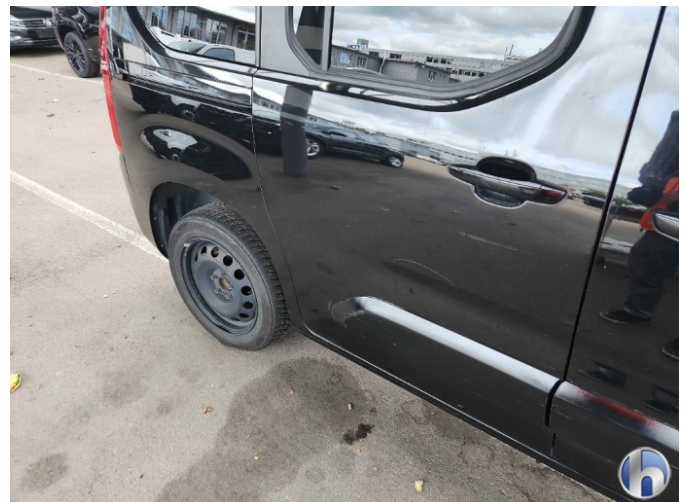
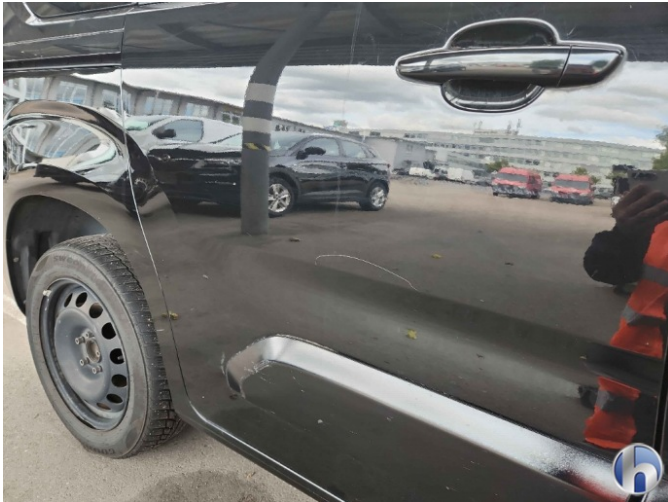
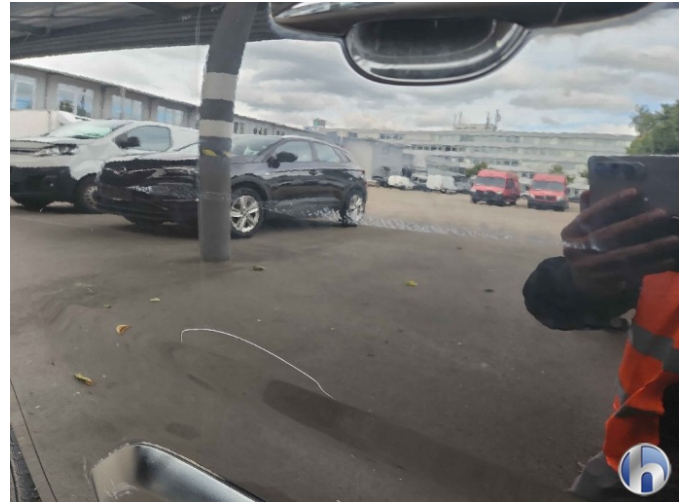
| component | Damage | Rep kind |
|---|---|---|
| 8. Sliding door - right | Damaged | Paint |

8. Sliding door - right

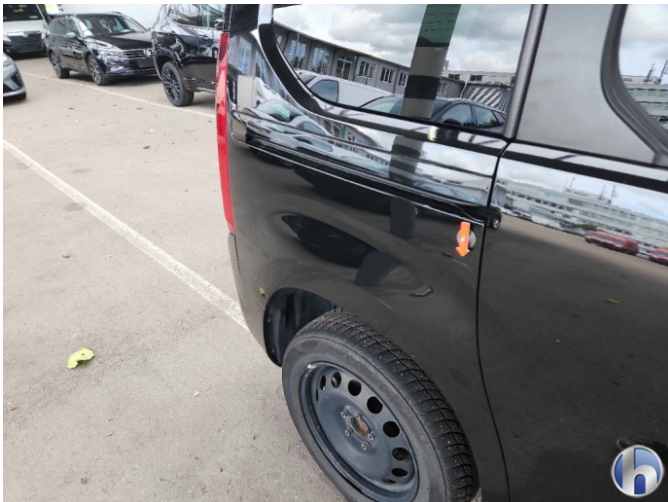
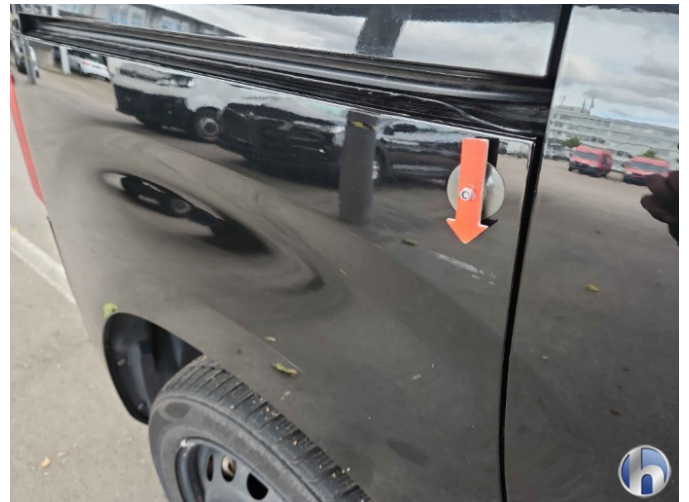
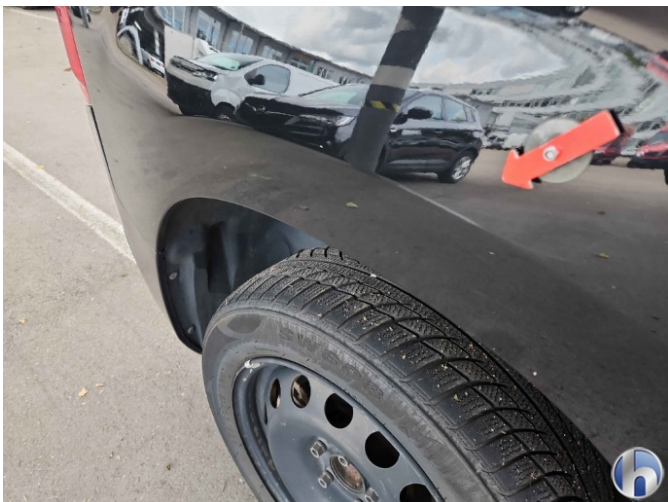
| component | Damage | Rep kind |
|---|---|---|
| 9. Sidewall - Rear - right | Damaged | Paint |

9. Sidewall - Rear - right

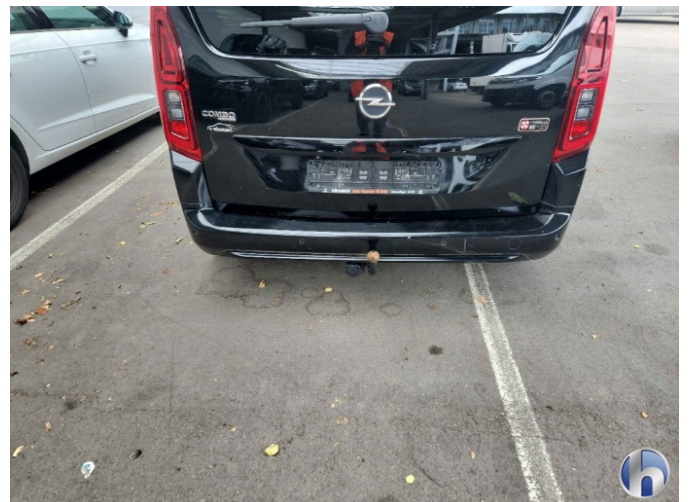
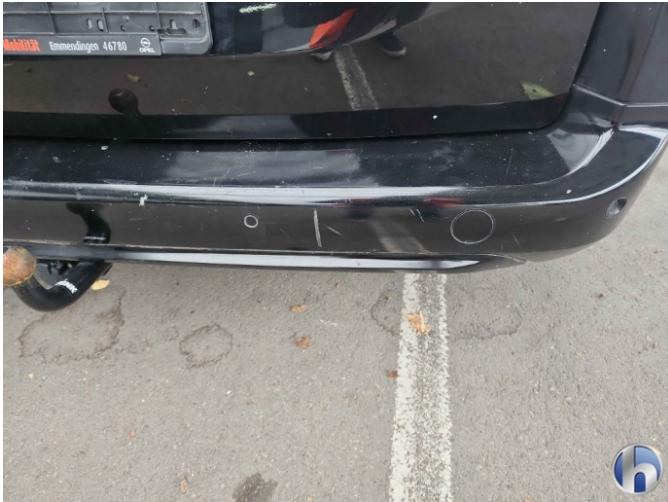
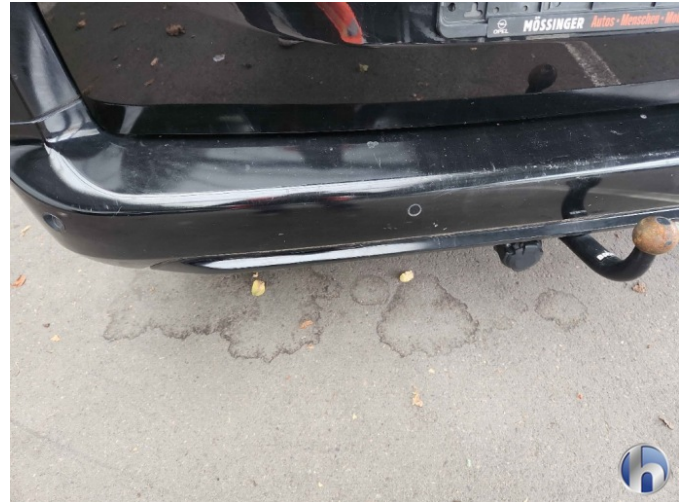
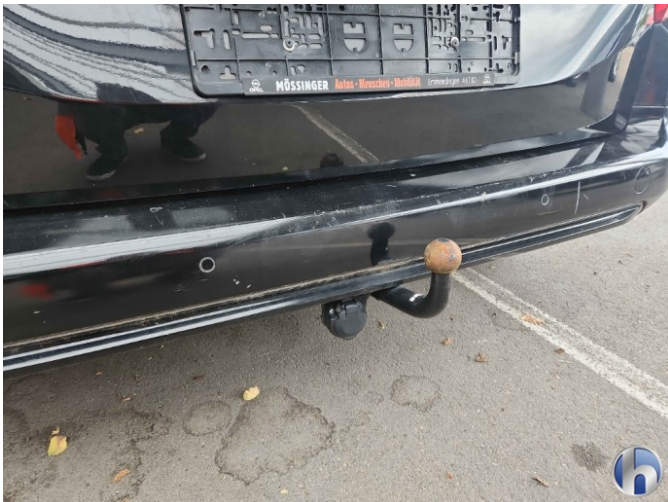
| component | Damage | Rep kind |
|---|---|---|
| 10. Rear bumper | Damaged | Replace |

10. Rear bumper

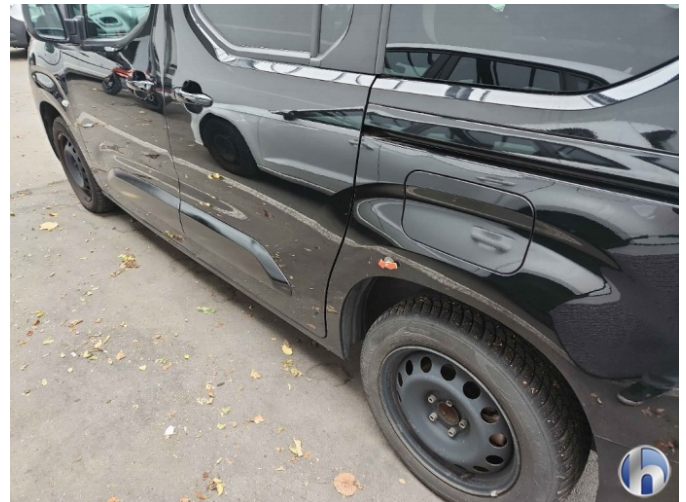
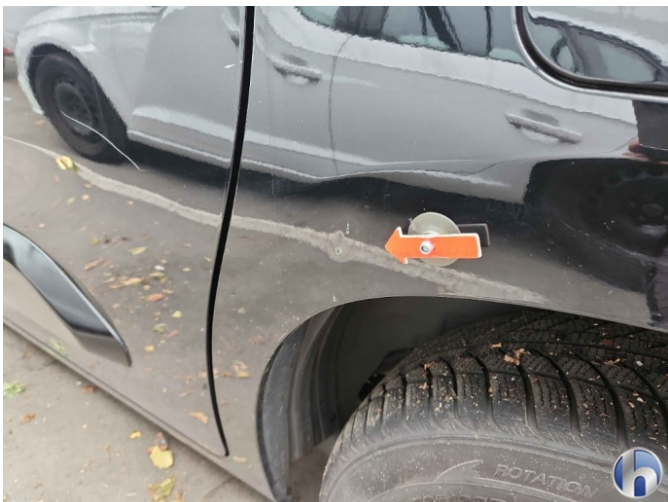
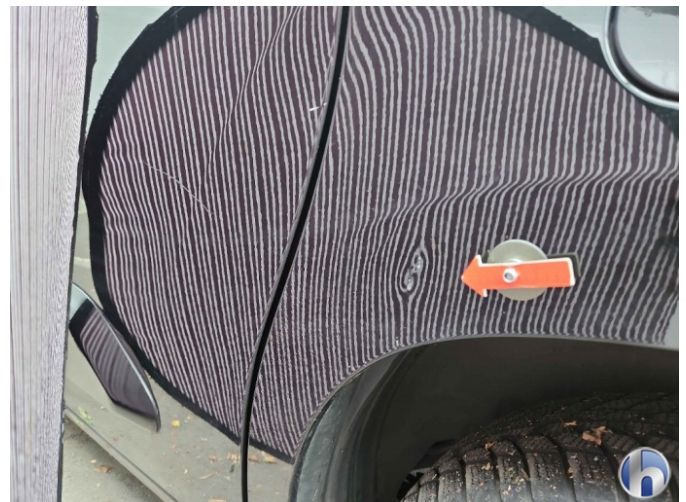
| component | Damage | Rep kind |
|---|---|---|
| 11. Sidewall - Rear - Left | Damaged | Refurbish and paint |

11. Sidewall - Rear - Left

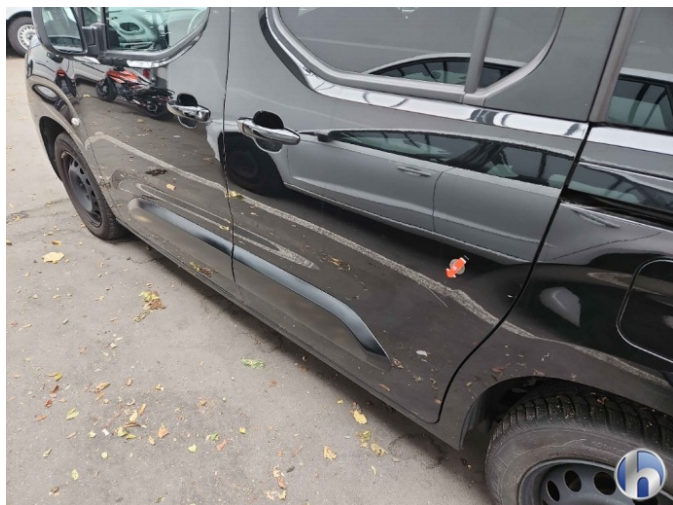
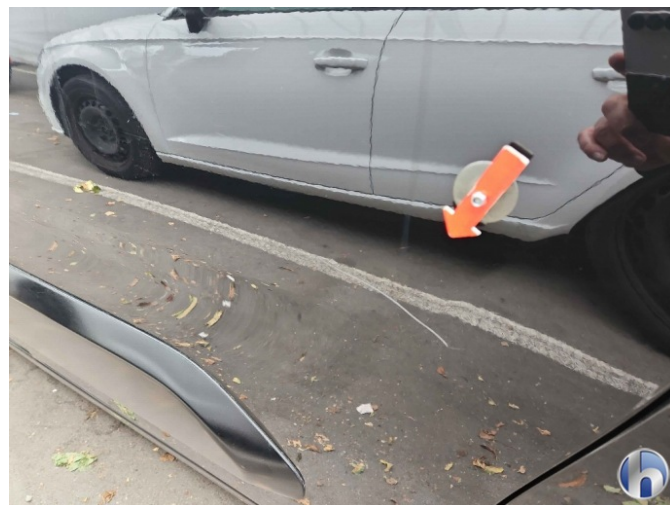
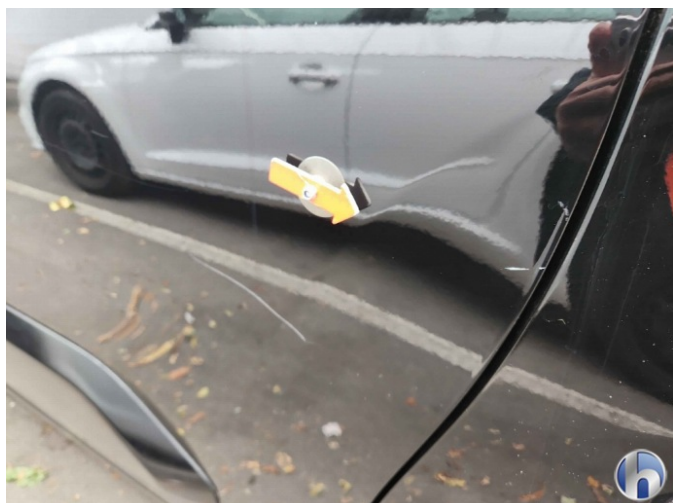
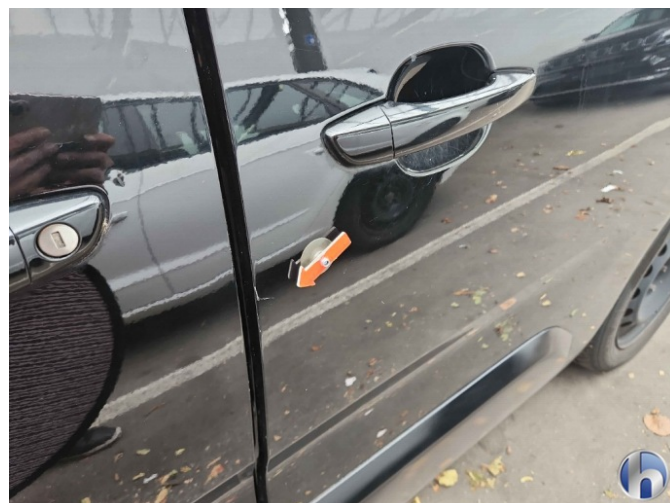
| component | Damage | Rep kind |
|---|---|---|
| 12. Sliding door - left | Damaged | Paint |

12. Sliding door - left

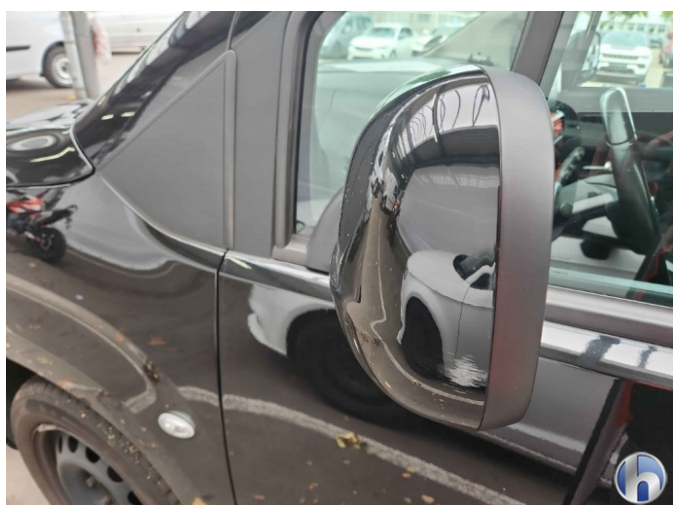
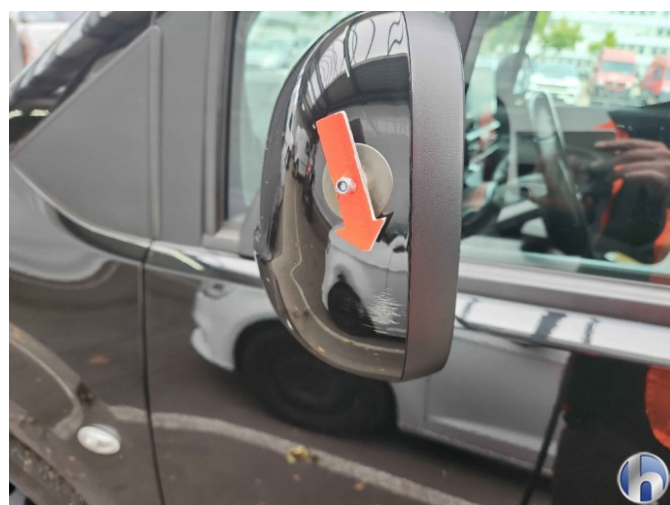
| component | Damage | Rep kind |
|---|---|---|
| 13. Outside mirror - left | Damaged | Paint |

13. Outside mirror - left

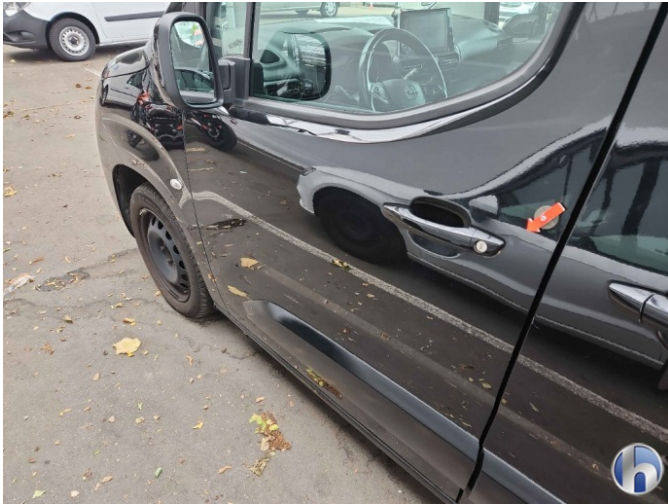
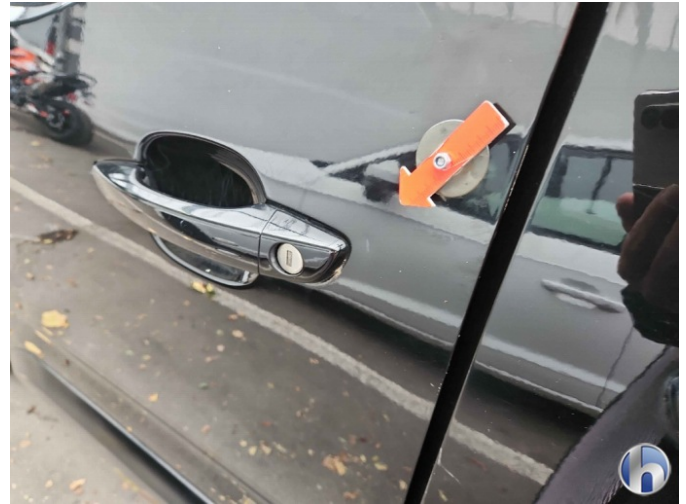
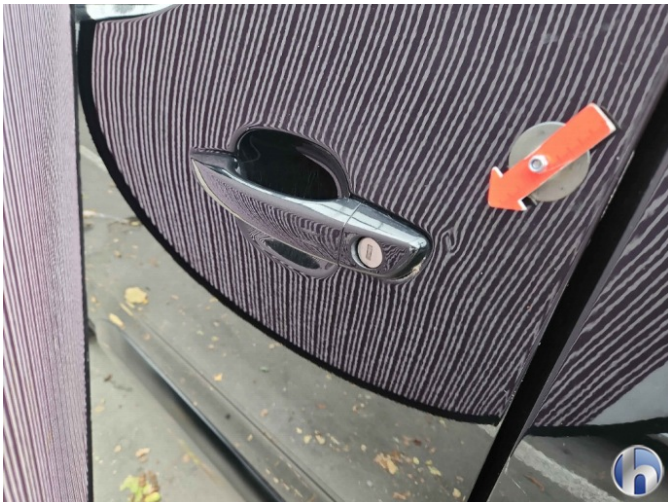
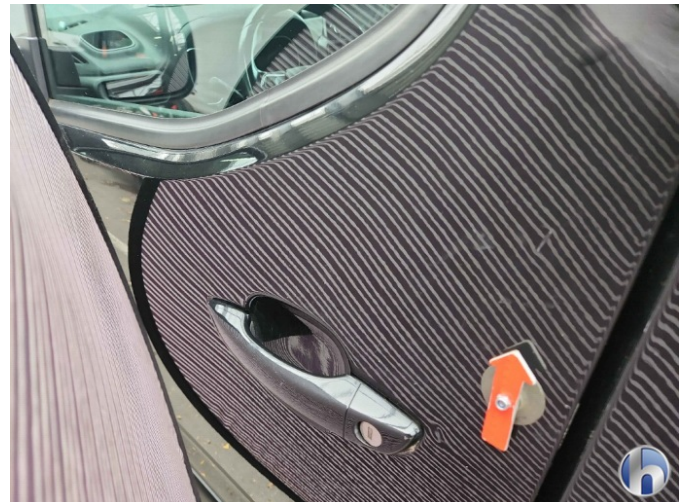
| component | Damage | Rep kind |
|---|---|---|
| 14. Front door - left | Damaged | Refurbish and paint |

14. Front door - left

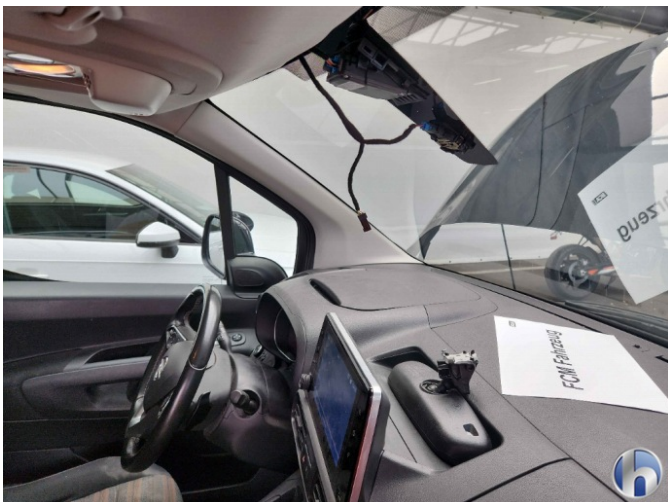
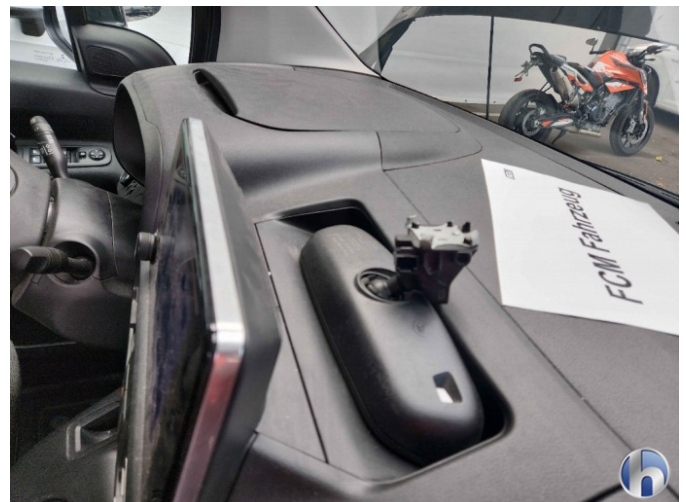
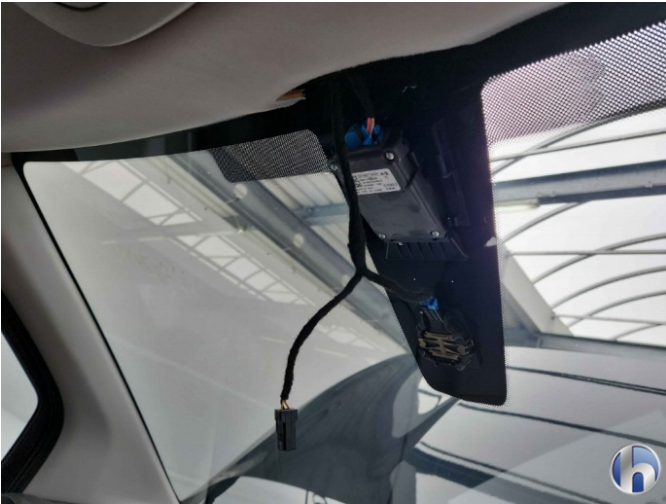
| component | Damage | Rep kind |
|---|---|---|
| 15. | Damaged | Replace |

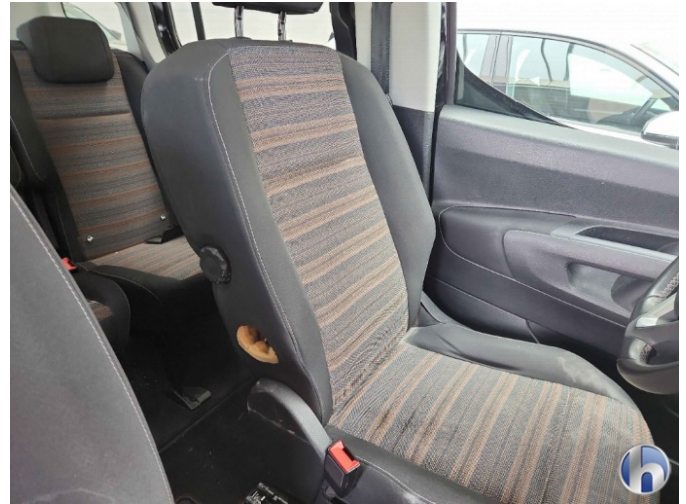
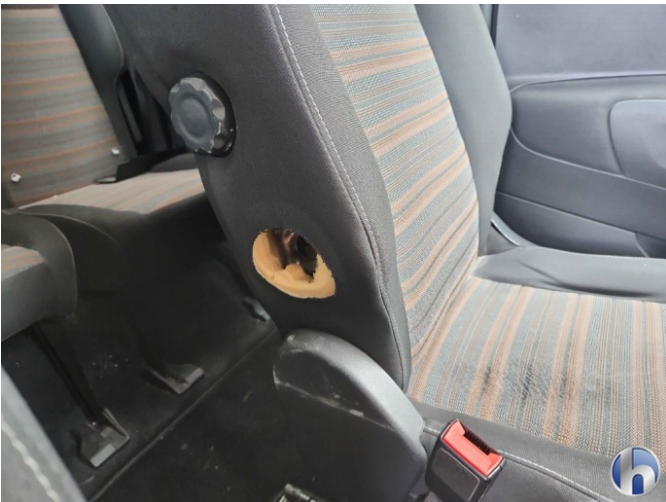
| component | Damage | Rep kind |
|---|---|---|
| 16. | Damaged | Replace |

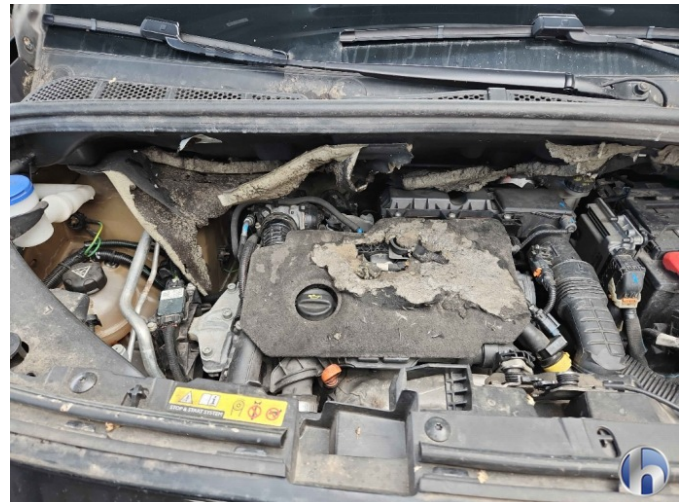
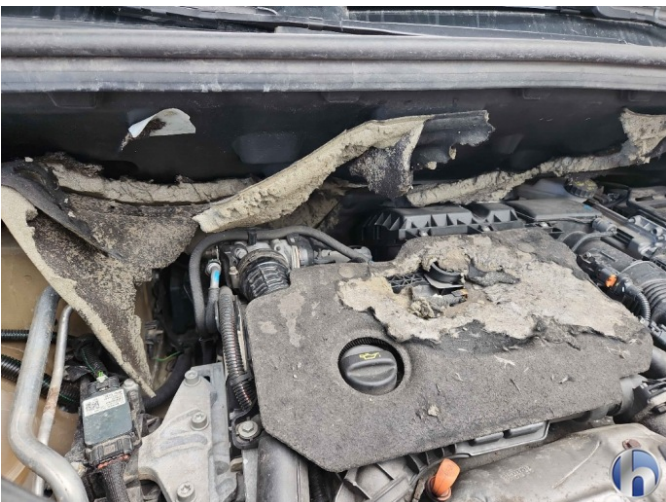
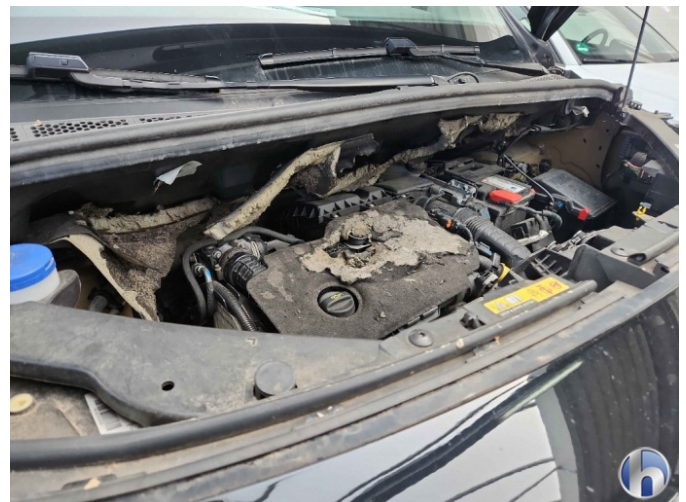
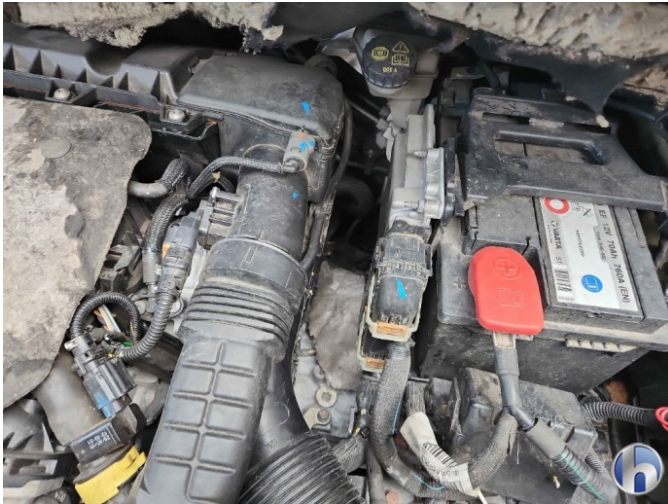
| component | Damage | Rep kind |
|---|---|---|
| 17. motor insulation | Damaged | Replace |

17. motor insulation
