Expertise

Protocol number: 41551146
Order No. / Reference: 25243533
Inspection date: 16 Sept 2025

Manufacturer: Opel	Model: Combo Cargo 1.5 D S&S Selection
VIN: W0VEFYHWCMJ753240

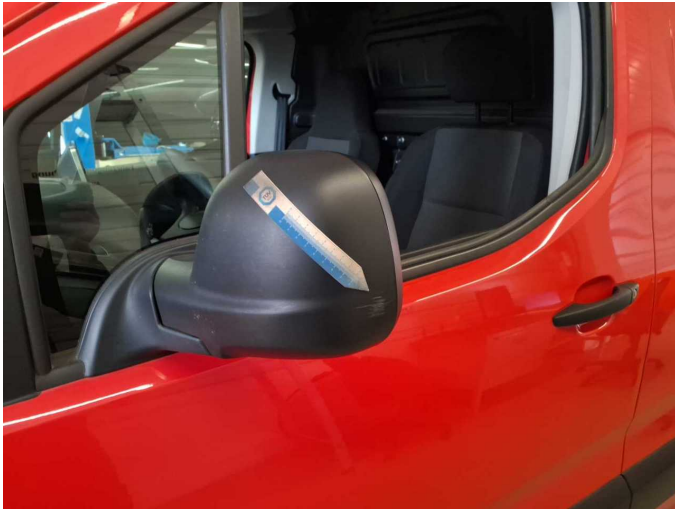
No.	Component group	Description
1	Wing mirror - left side	Cap - Scratch(es) - No deduction
2	Misc.	Misc. (BOTT Regaleinbauten) - Missing - No deduction

Damage 1: Wing mirror - left side: Cap - Scratch(es) - No deduction

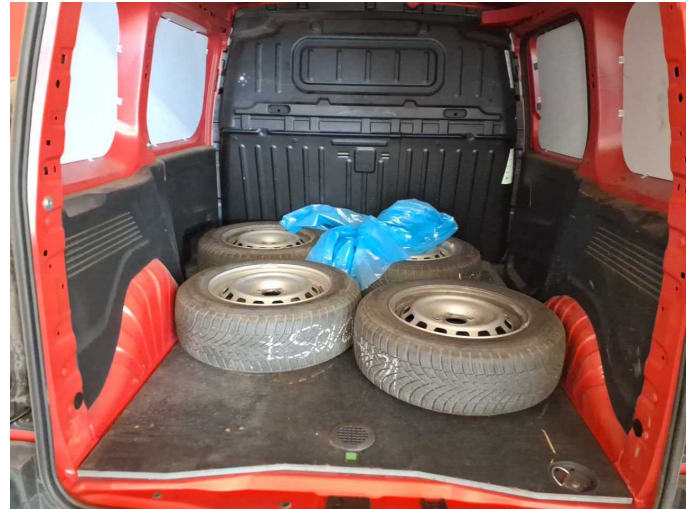
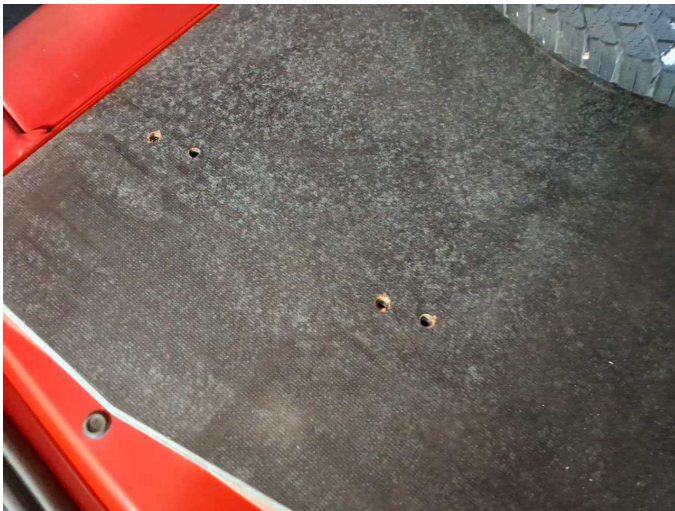
Damage 2: Misc.: Misc. (BOTT Regaleinbauten) - Missing - No deduction

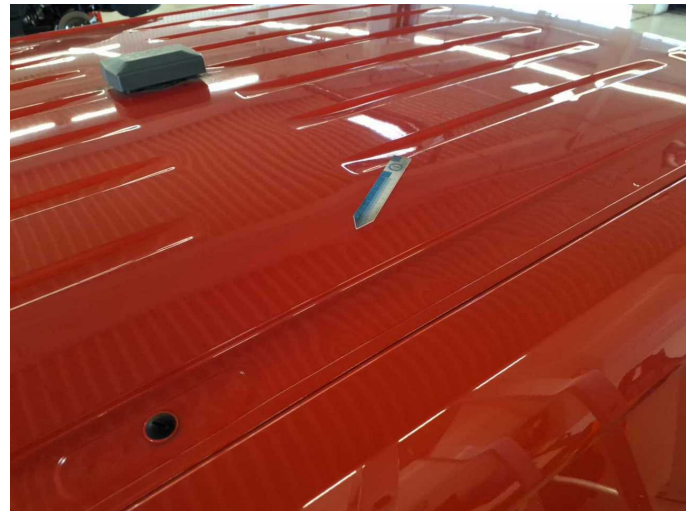
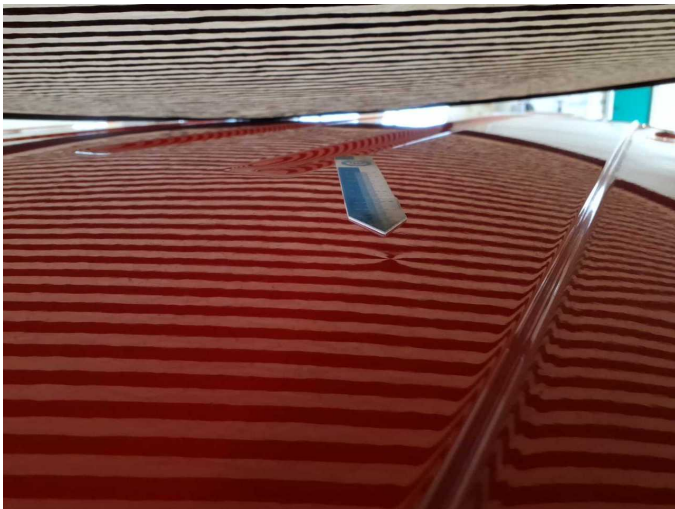
No.	Component group	Description
3	Roof	Roof - dent(s) - Smart repair
4	Side panel - rear right side	Side panel - dent(s) - Smart repair
5	Sliding door, right	Sliding door - dent(s) - Smart repair
6	Boot lid / rear door	Rear door - left side - Scratch(es) - Smart repair
7	Misc.	Main inspection - Due - Perform
8	Side panel - rear left side	Side panel - dent(s) - Smart repair
9	Body	Partition wall (Oberteil) - Differs from the original configuration - Loss in value
10	Trim / covers	Cargo area - lining - right side (+links) - Scratched - Loss in value
11	Misc.	Inspection / maintenance - Due - Perform
12	Sill - left side	Sill - Deformed - Repair and paint
13	Door - front left side	Door - Deformed - Repair and paint

Damage 3: Roof: Roof - dent(s) - Smart repair

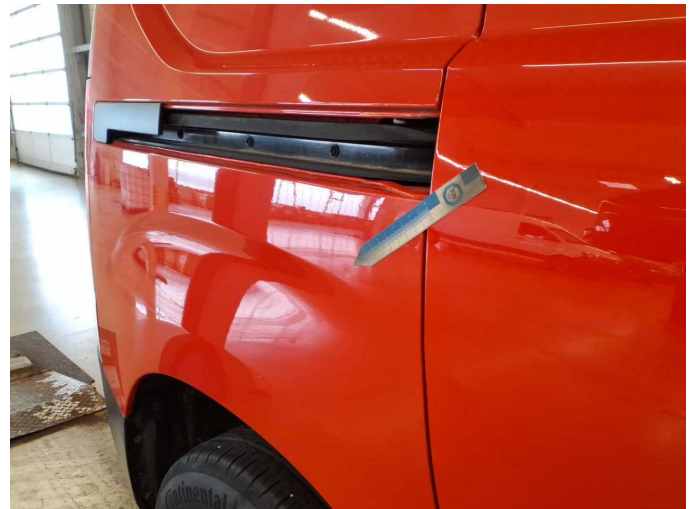
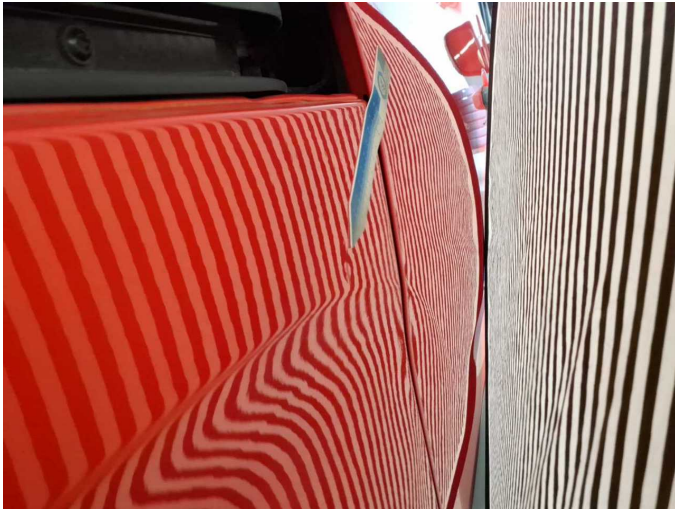
Damage 4: Side panel - rear right side: Side panel - dent(s) - Smart repair

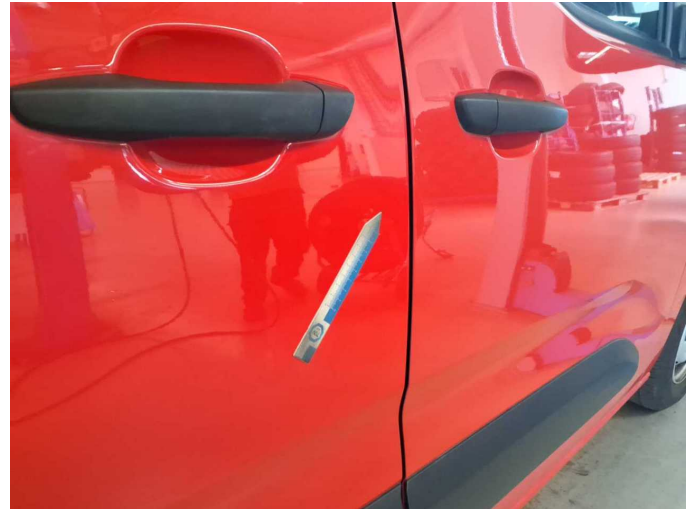
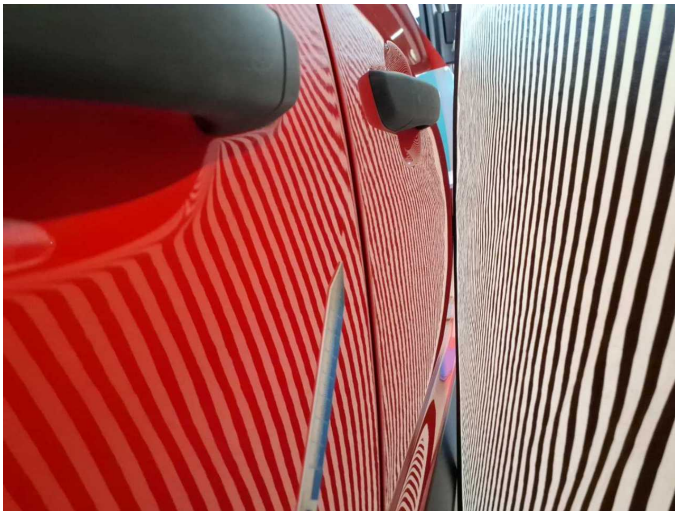
Damage 5: Sliding door, right: Sliding door - dent(s) - Smart repair

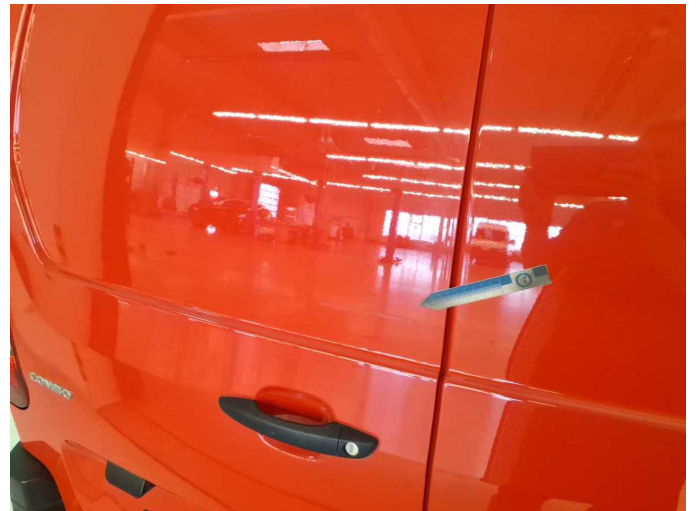
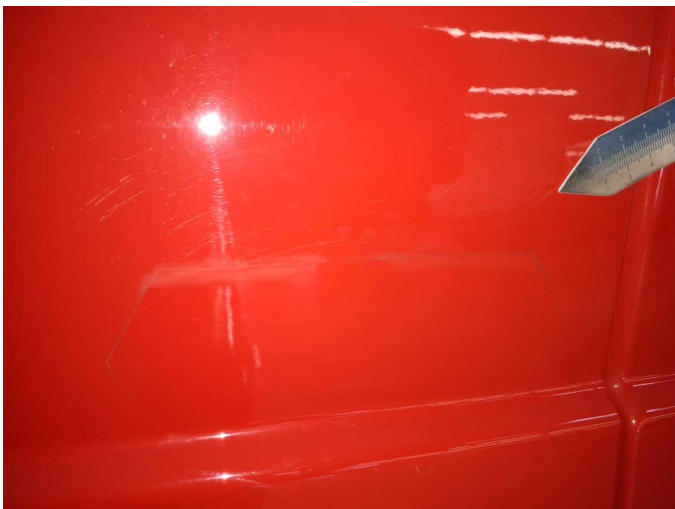
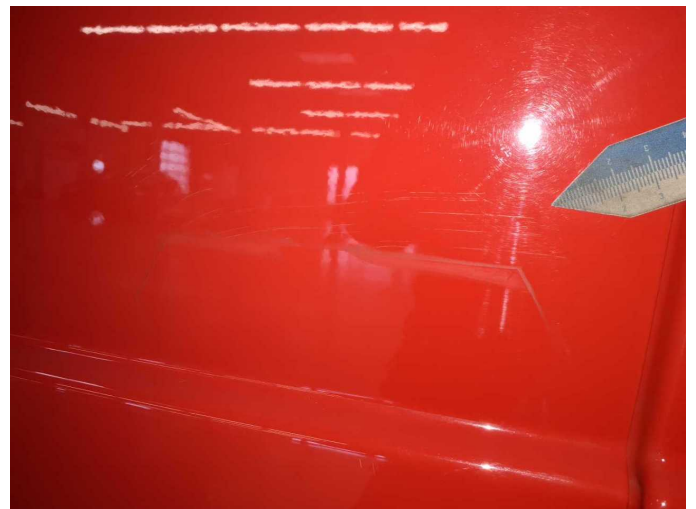
Damage 6: Boot lid / rear door: Rear door - left side - Scratch(es) - Smart repair

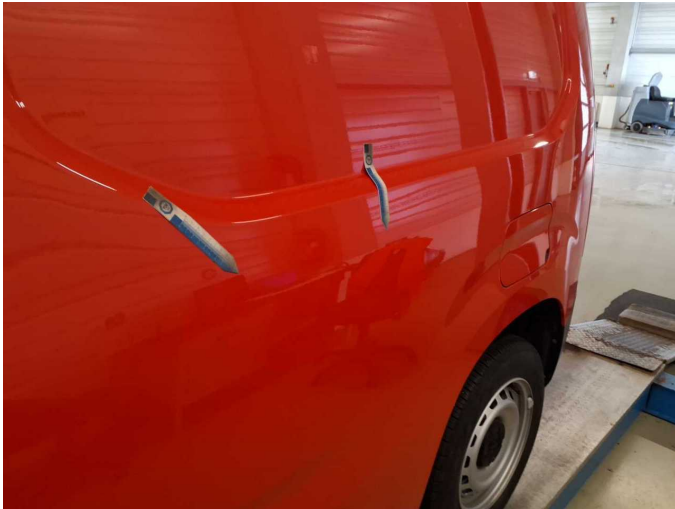
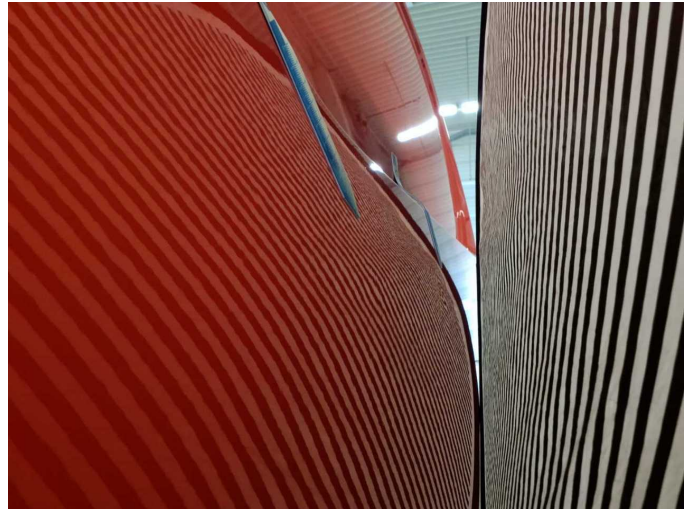
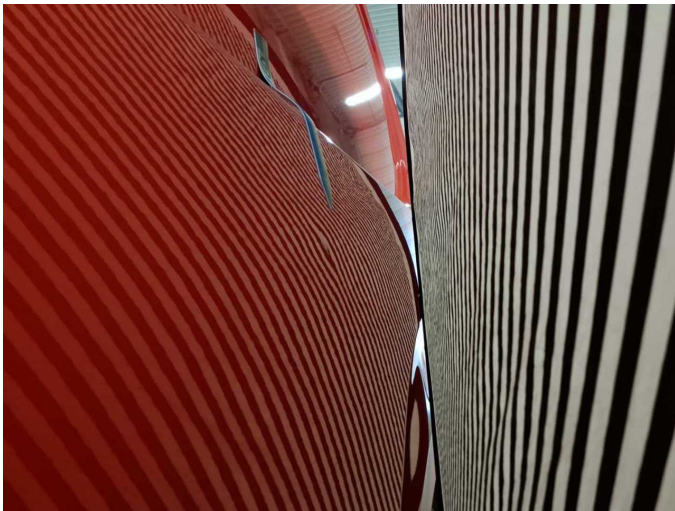
Damage 8: Side panel - rear left side: Side panel - dent(s) - Smart repair

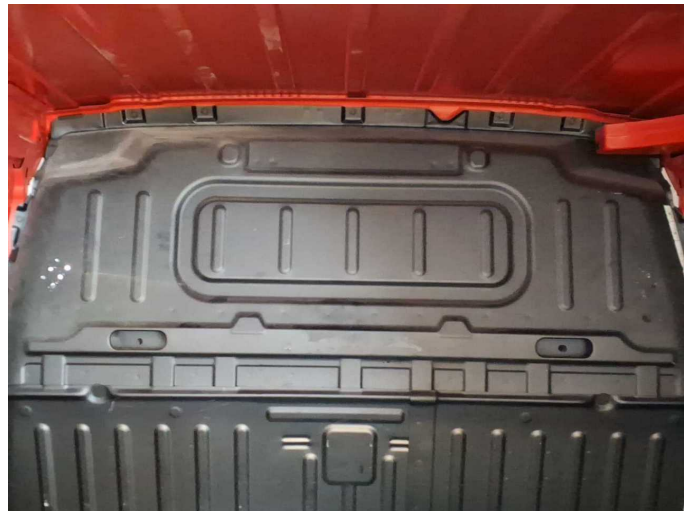
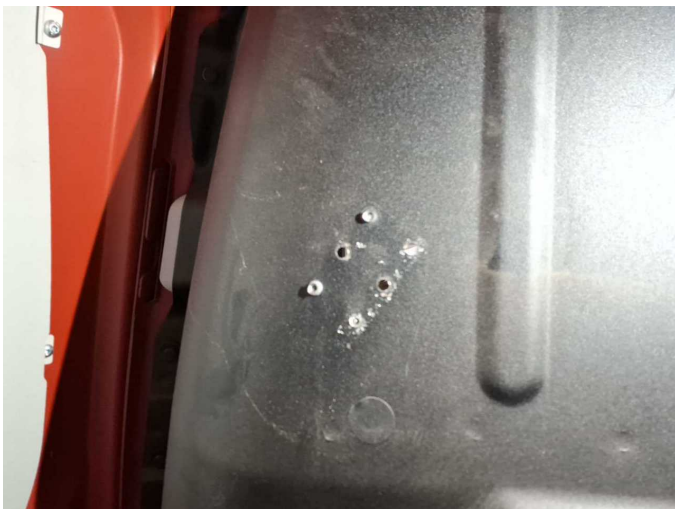
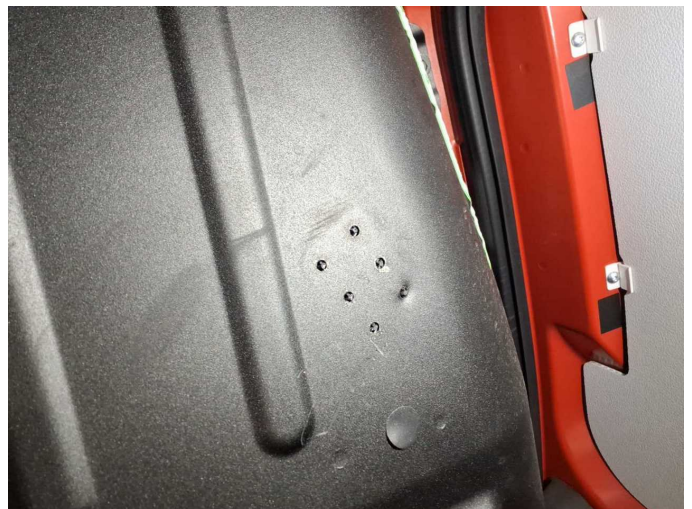
Damage 9: Body: Partition wall (Oberteil) - Differs from the original configuration - Loss in value

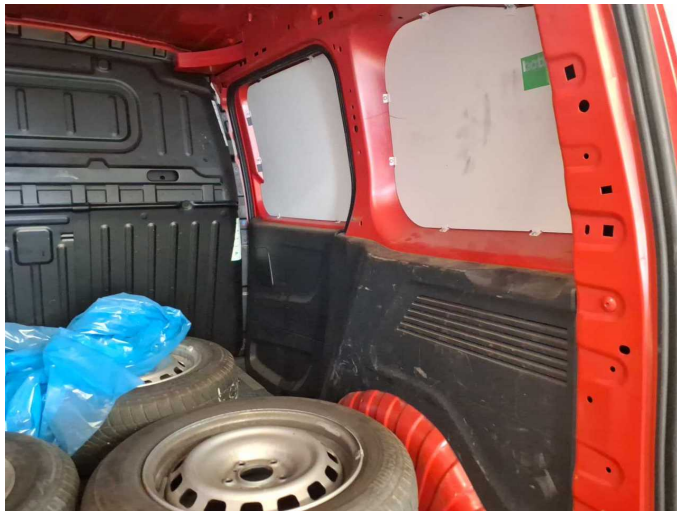
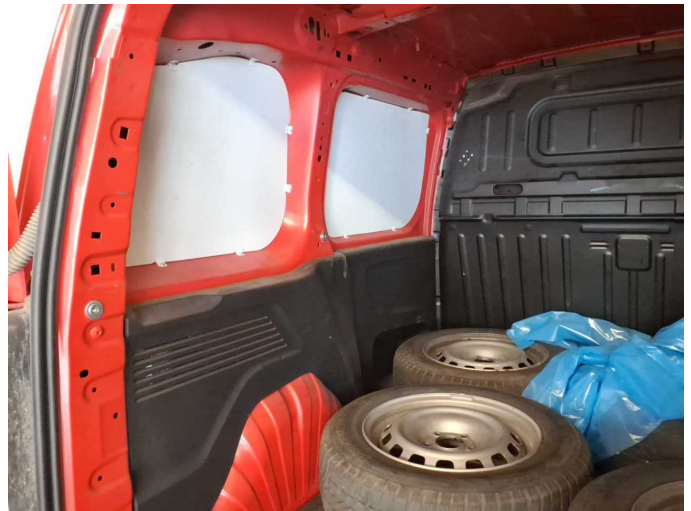
Damage 10: Trim / covers: Cargo area - lining - right side (+links) - Scratched - Loss in value

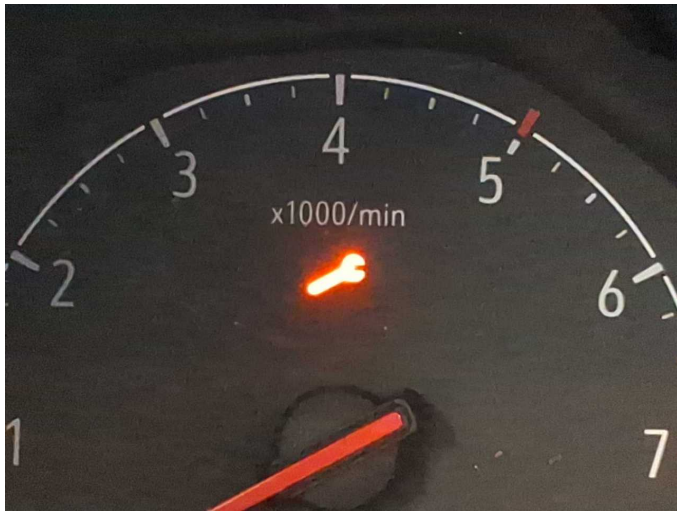
Damage 11: Misc.: Inspection / maintenance - Due - Perform

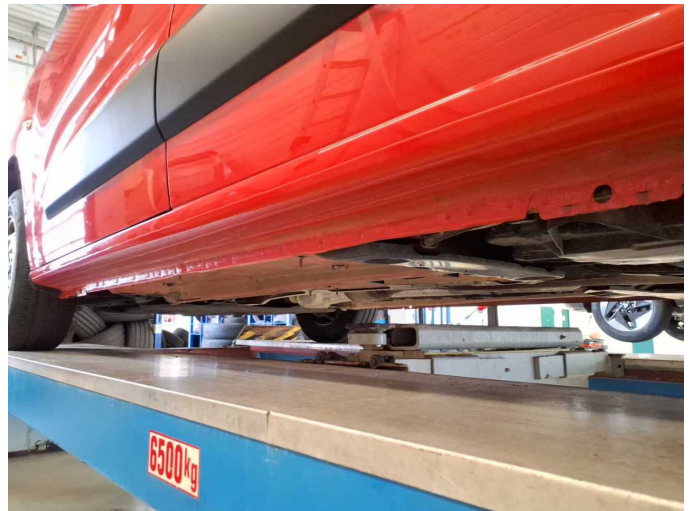
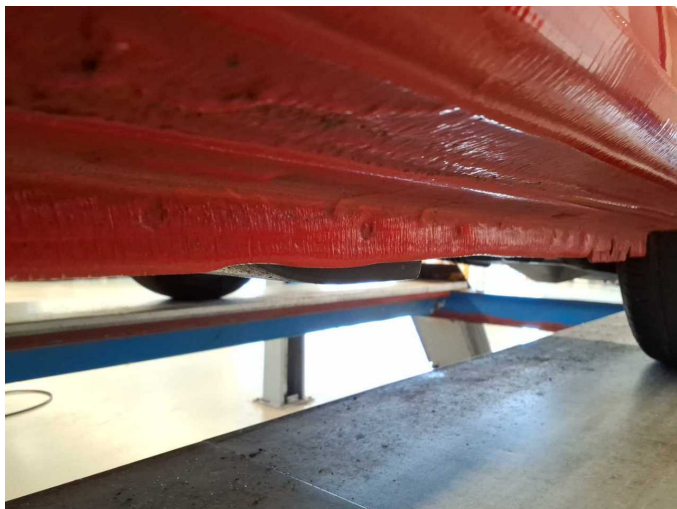
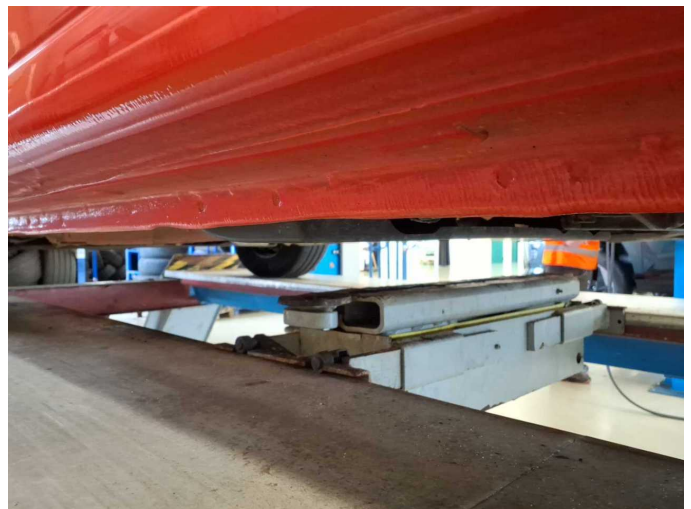
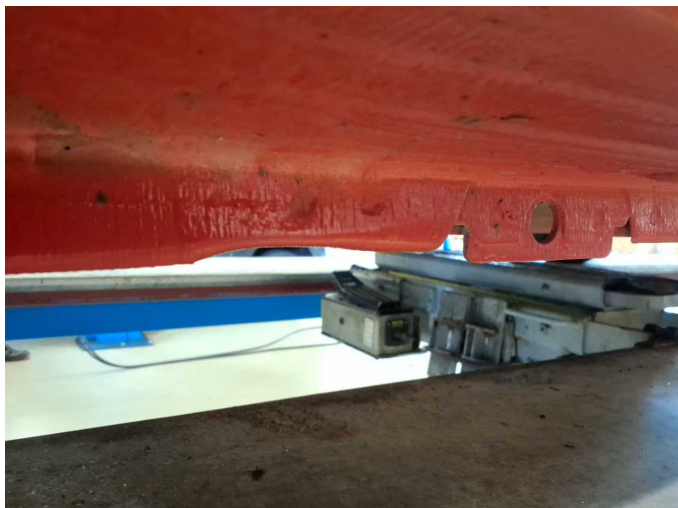
Damage 12: Sill - left side: Sill - Deformed - Repair and paint

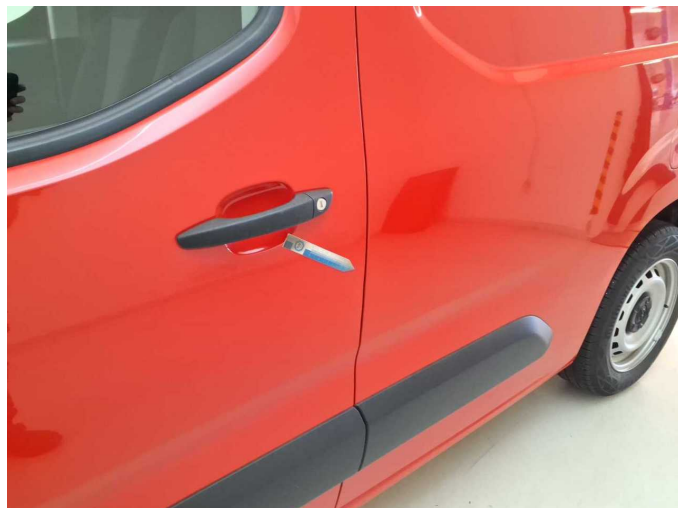
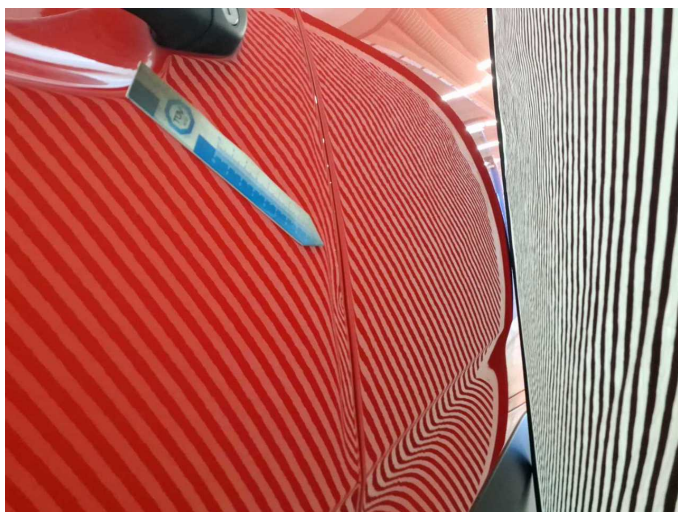
Damage 13: Door - front left side: Door - Deformed - Repair and paint

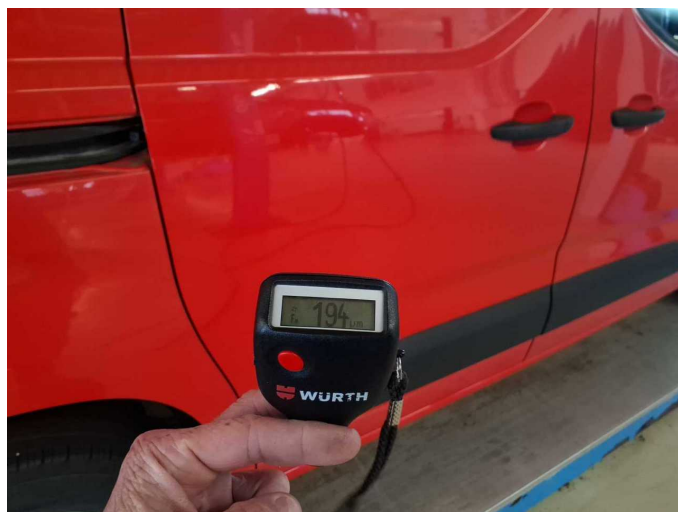
- Door - rear right side, Professionally carried out

Door - rear right side: 194 µm
