Expertise

Protocol number: 41262937
Order No. / Reference: 25085143
Inspection date: 26 Aug 2025

Manufacturer: Opel

Model: Combo Cargo XL 1.5 D EHZ Edition

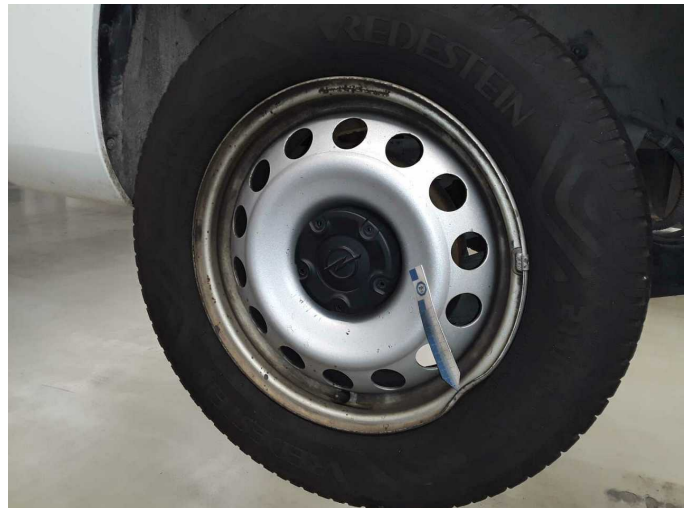
Damage 1: Wheel / tyres: Wheel rim - rear right side - Deformed - Replace

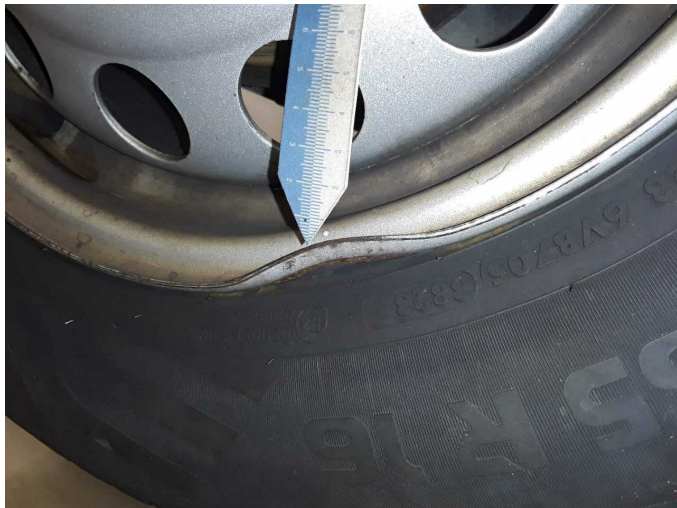
Damage 1: Wheel / tyres: Wheel rim - rear right side - Deformed - Replace

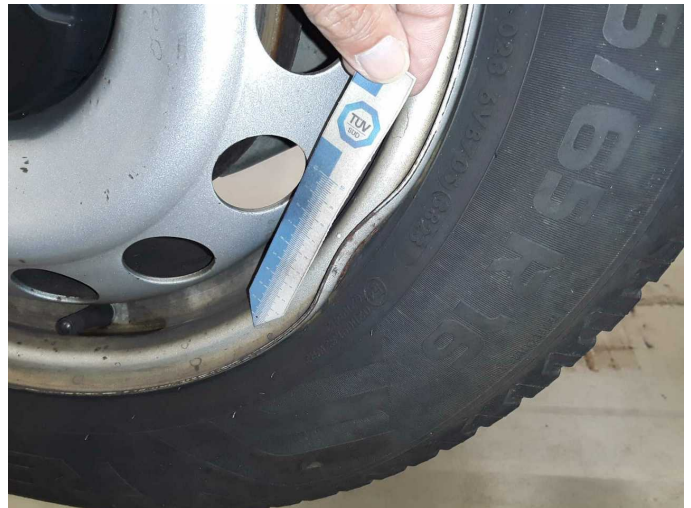
Damage 1: Wheel / tyres: Wheel rim - rear right side - Deformed - Replace

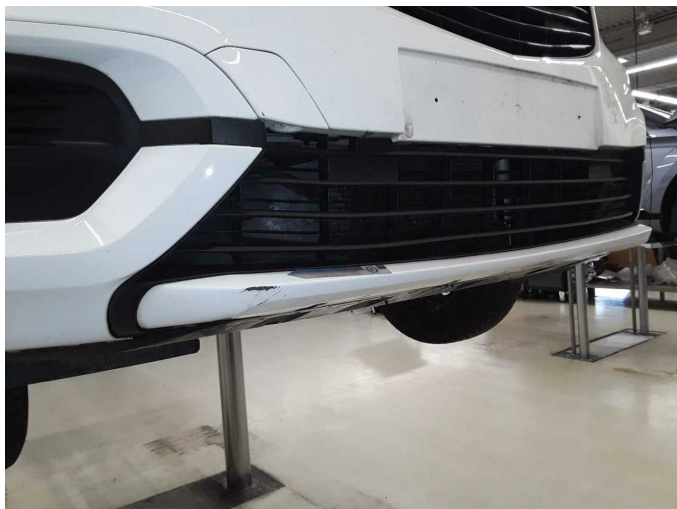
Damage 2: Front bumper: Spoiler (Weiss) - Scratched - Smart repair

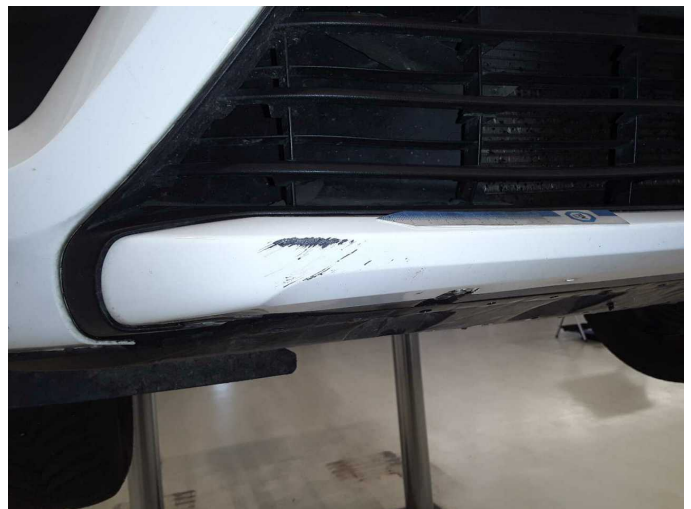
Damage 2: Front bumper: Spoiler (Weiss) - Scratched - Smart repair

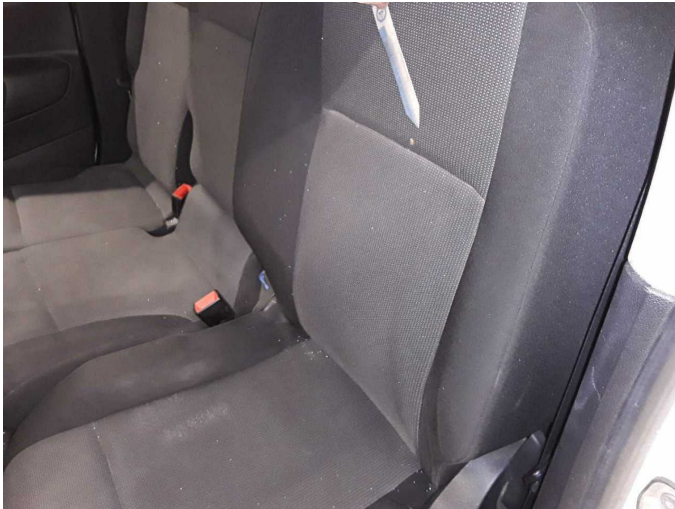
Damage 3: Seat - front: Backrest cover - left side - Burn hole (cigarettes)
- Smart repair

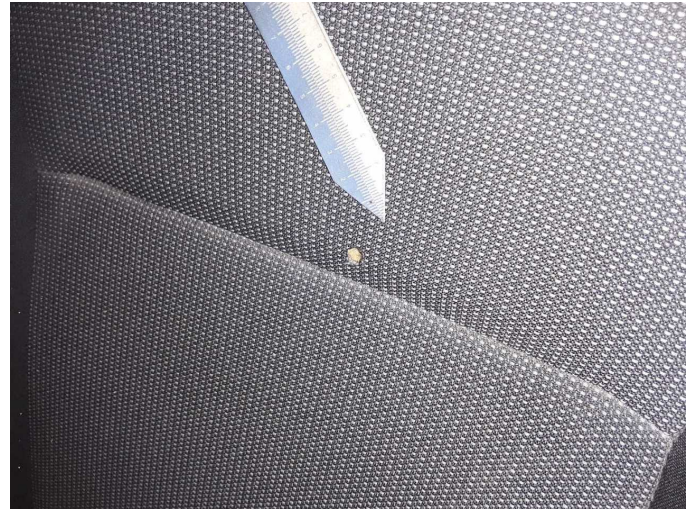
Damage 3: Seat - front: Backrest cover - left side - Burn hole (cigarettes)
- Smart repair

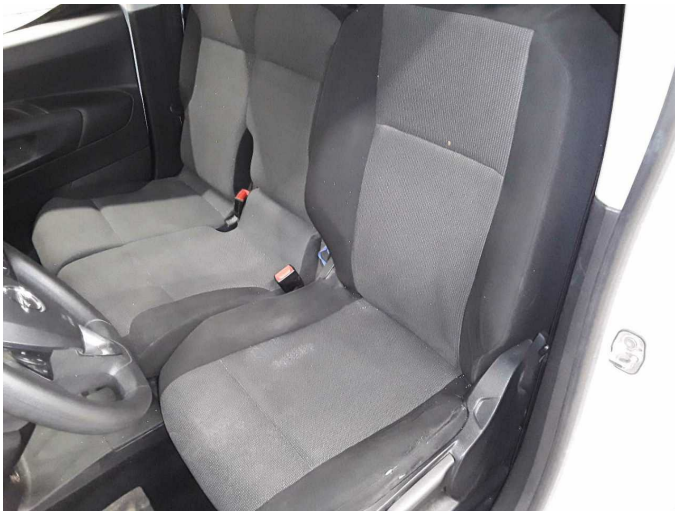
Damage 3: Seat - front: Backrest cover - left side - Burn hole (cigarettes)
- Smart repair

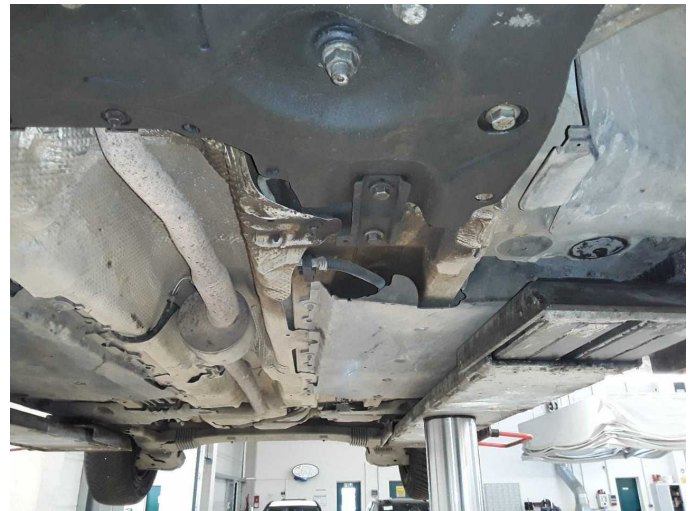
Damage 4: Body: Underbody panelling (Links mitte) - Broken / torn -
Replace

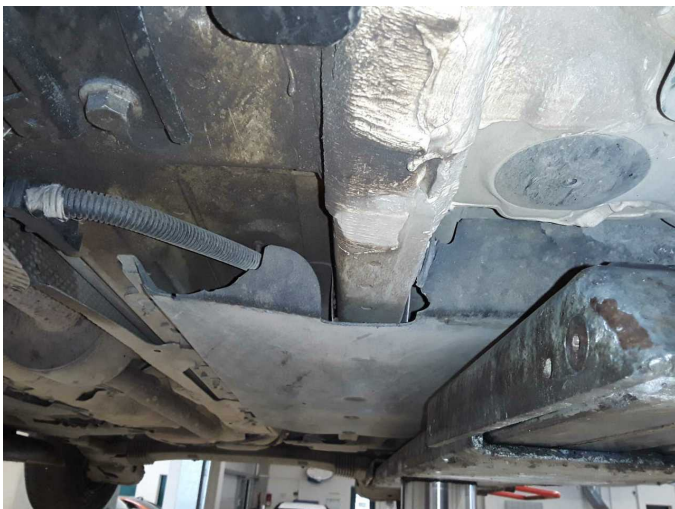
Damage 4: Body: Underbody panelling (Links mitte) - Broken / torn -
Replace

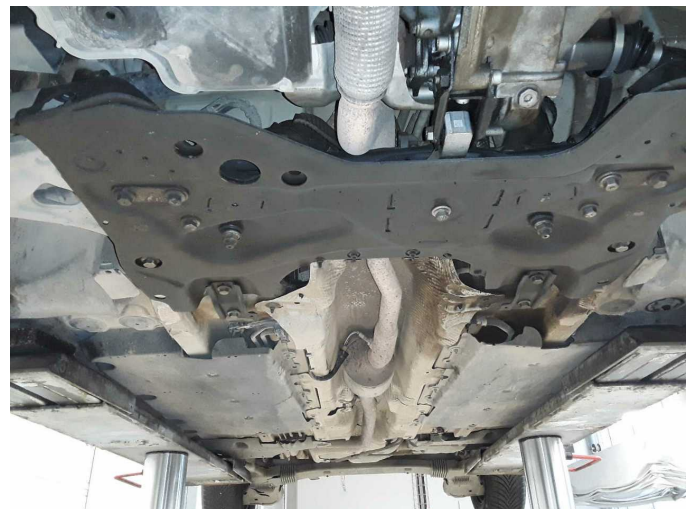
Damage 4: Body: Underbody panelling (Links mitte) - Broken / torn -
Replace

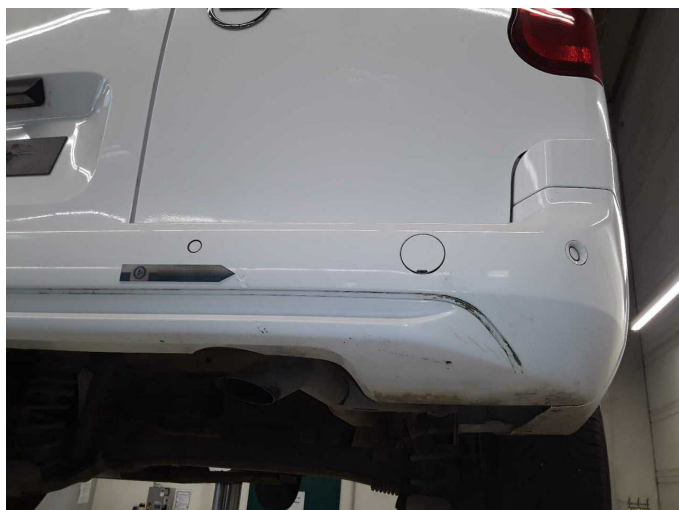
Damage 5: Rear bumper: Rear bumper - Scratched - Smart repair

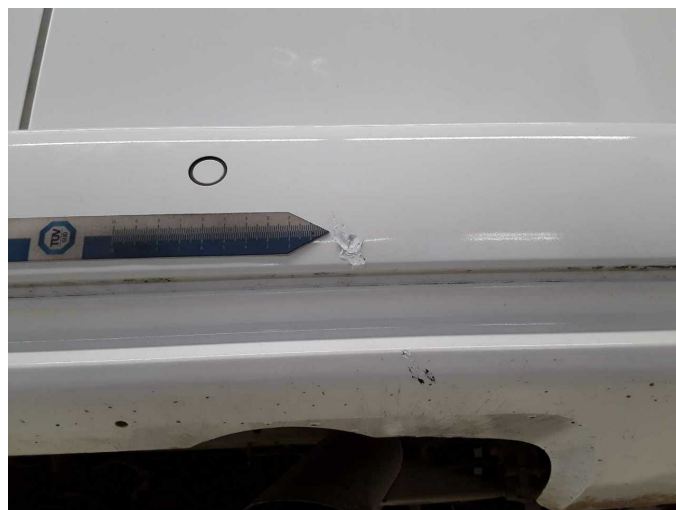
Damage 5: Rear bumper: Rear bumper - Scratched - Smart repair

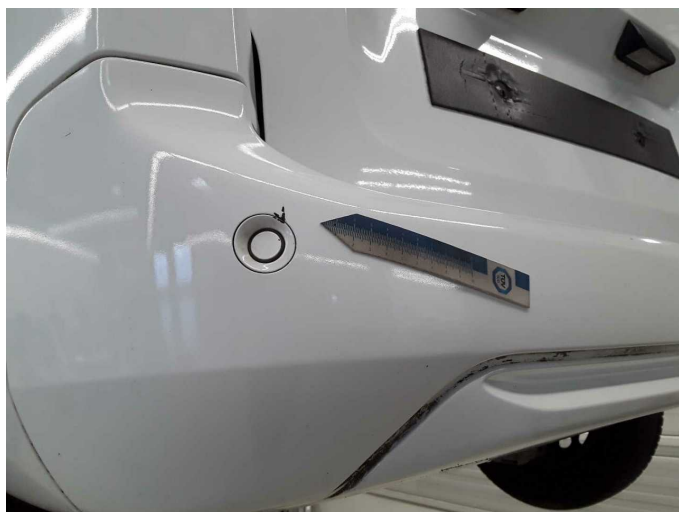
Damage 5: Rear bumper: Rear bumper - Scratched - Smart repair

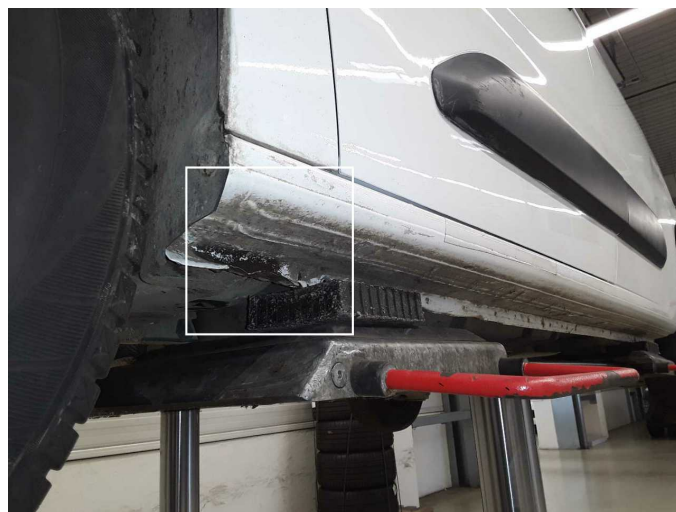
Damage 6: Sill - left side: Sill - Scratched - Smart repair

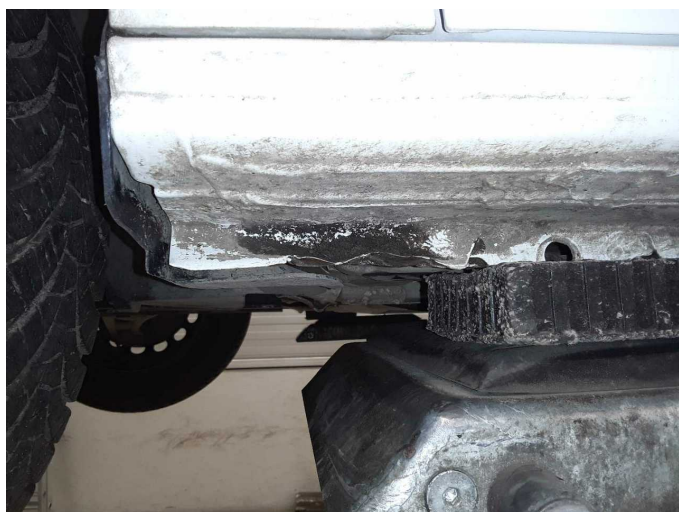
Damage 6: Sill - left side: Sill - Scratched - Smart repair

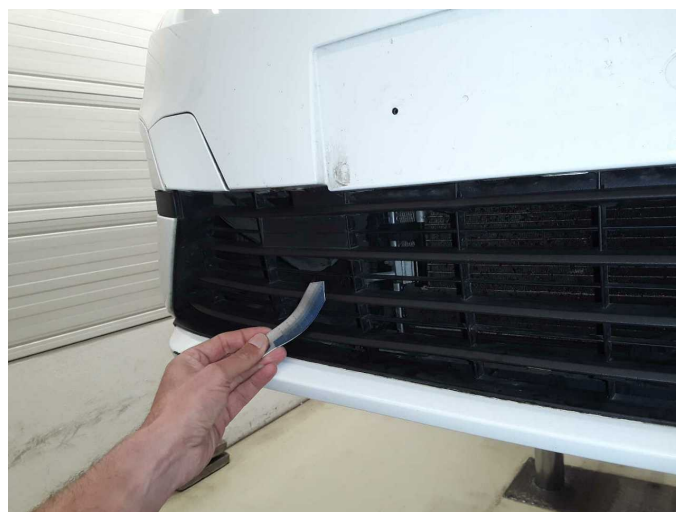
Damage 7: Front bumper: Air-inlet grille - Broken / torn - Replace

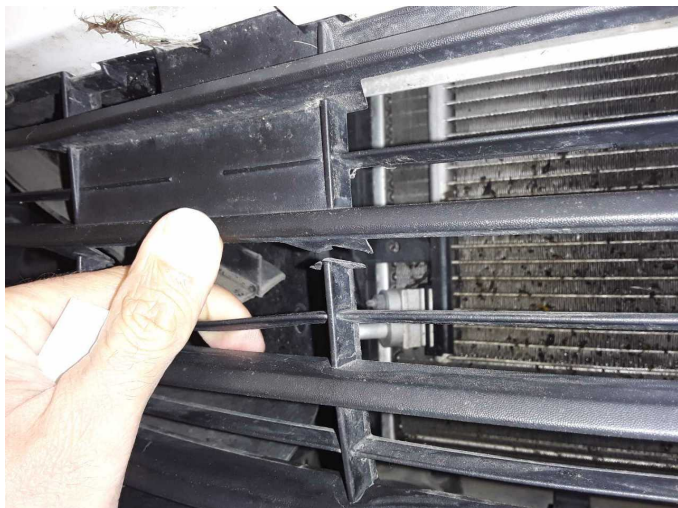
Damage 7: Front bumper: Air-inlet grille - Broken / torn - Replace

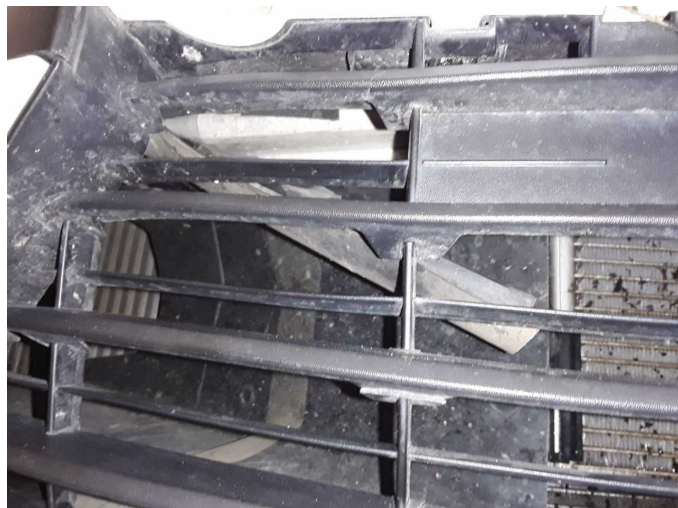
Damage 7: Front bumper: Air-inlet grille - Broken / torn - Replace

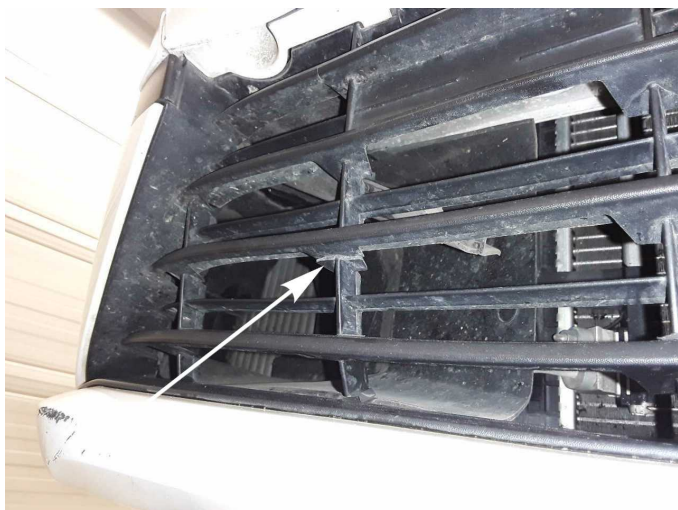
Damage 7: Front bumper: Air-inlet grille - Broken / torn - Replace

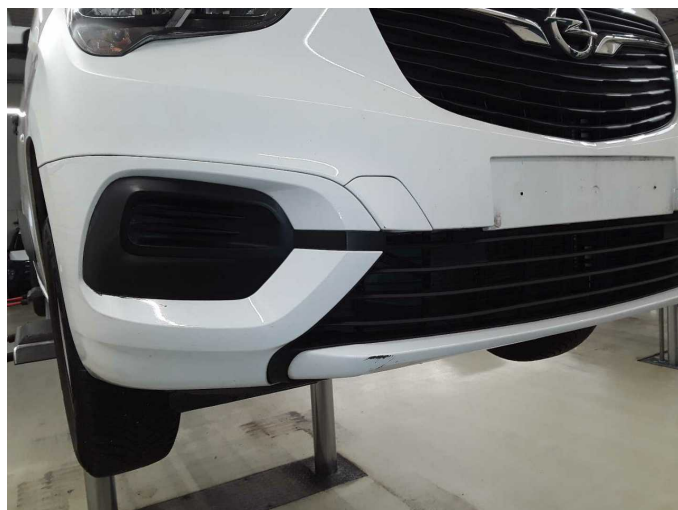
Damage 7: Front bumper: Air-inlet grille - Broken / torn - Replace

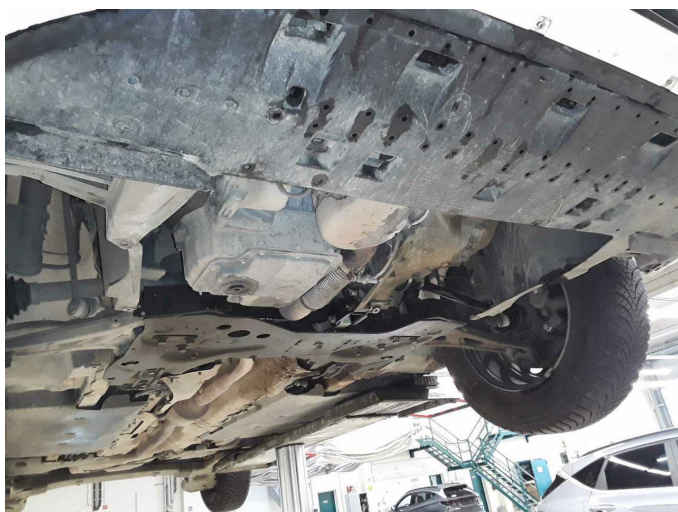
Damage 8: Body: Underbody panelling (Aus Metall) - Missing - Replace

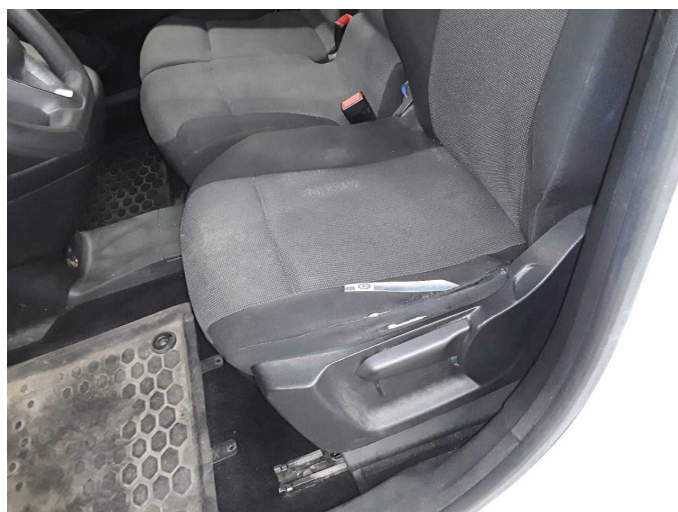
Damage 9: Seat - front: Seat cover - left side (inkl. Poslter) - Broken / torn - Replace

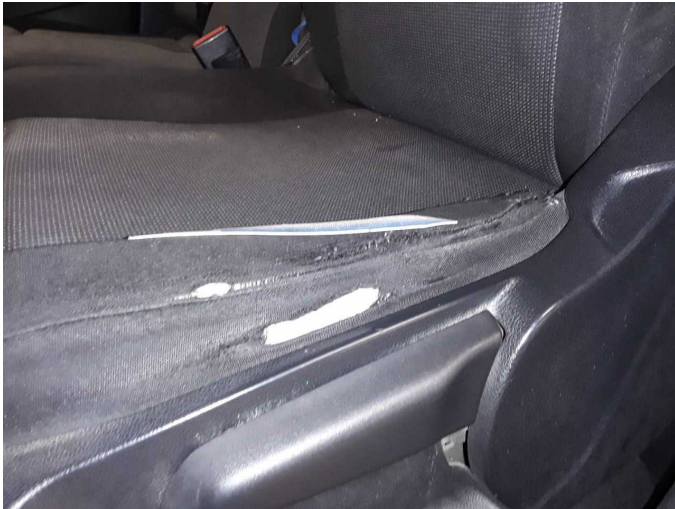
Damage 9: Seat - front: Seat cover - left side (inkl. Poslter) - Broken / torn - Replace

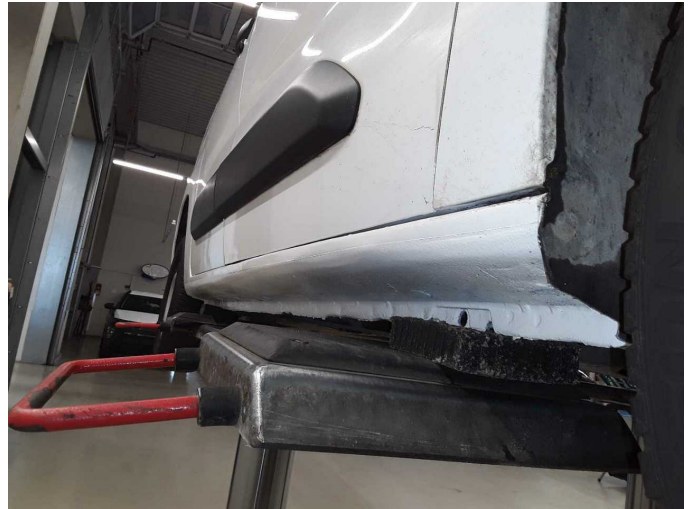
Wear and tear 1: Sill - right side: Sill - dent(s) - No deduction

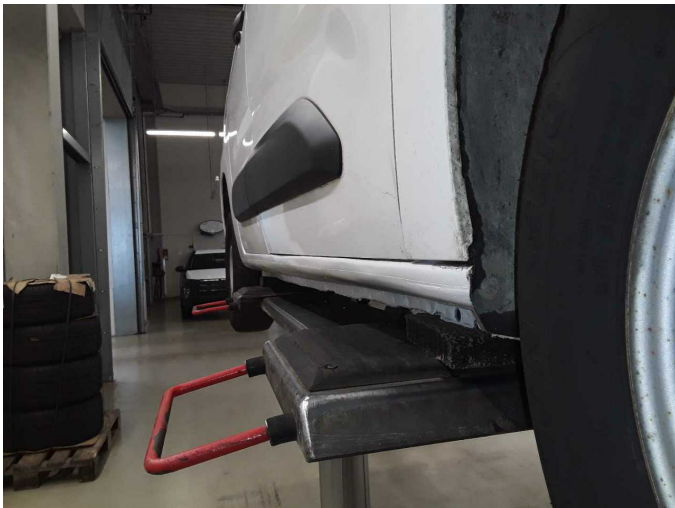
Wear and tear 1: Sill - right side: Sill - dent(s) - No deduction

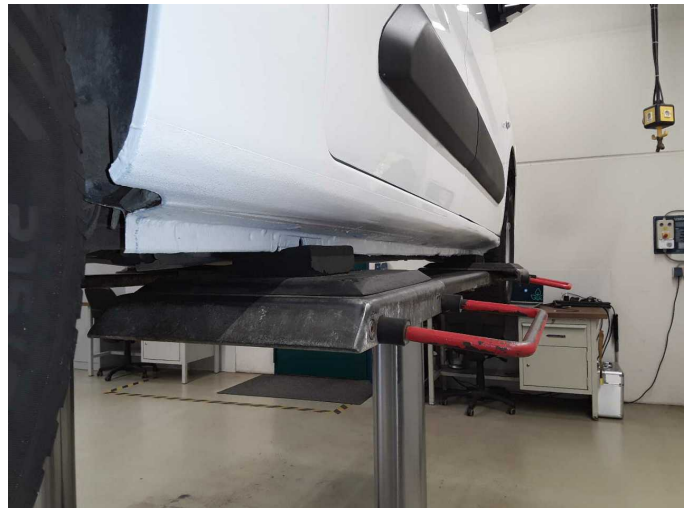
Wear and tear 1: Sill - right side: Sill - dent(s) - No deduction

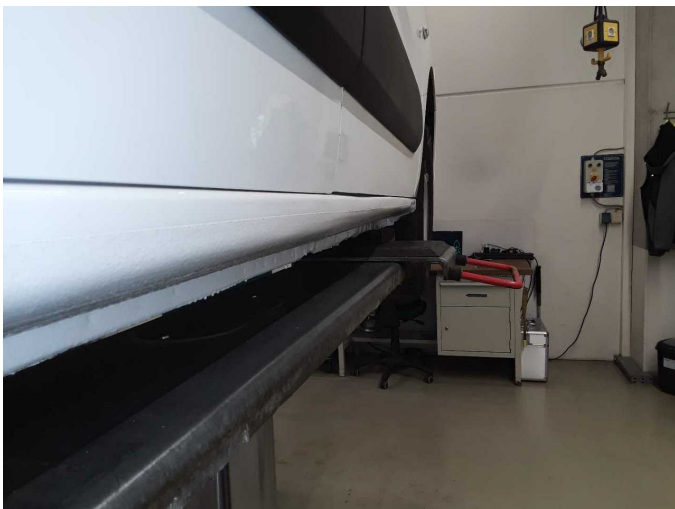
Wear and tear 1: Sill - right side: Sill - dent(s) - No deduction

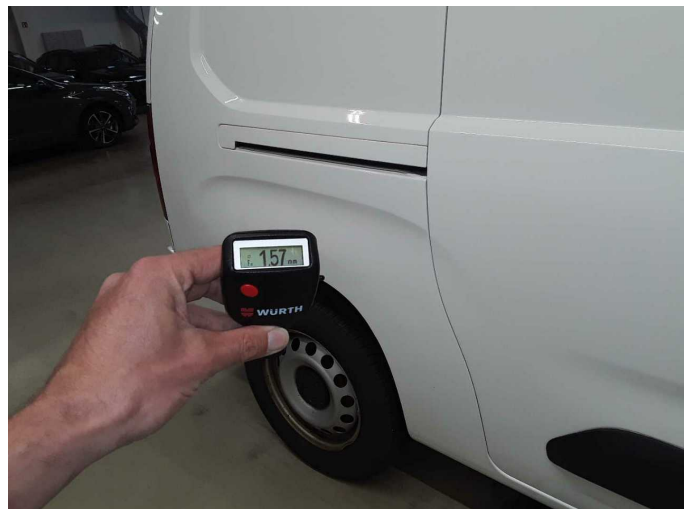
- Side panel - rear right side, Door - rear right side, Door - front left side, Professionally carried out

Side panel - rear right side: 1,570 µm

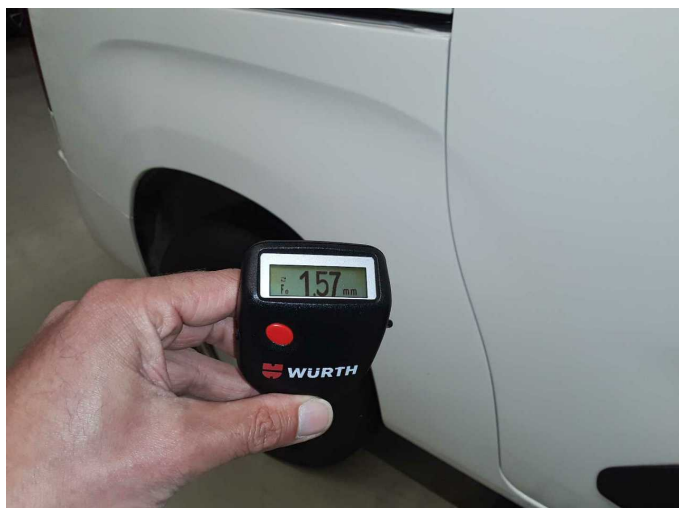
Side panel - rear right side: 1,570 μm

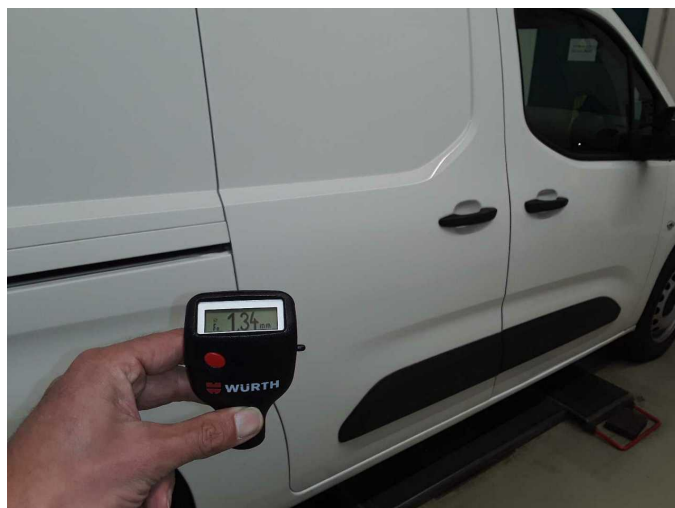
Door - rear right side: 1,340 μm

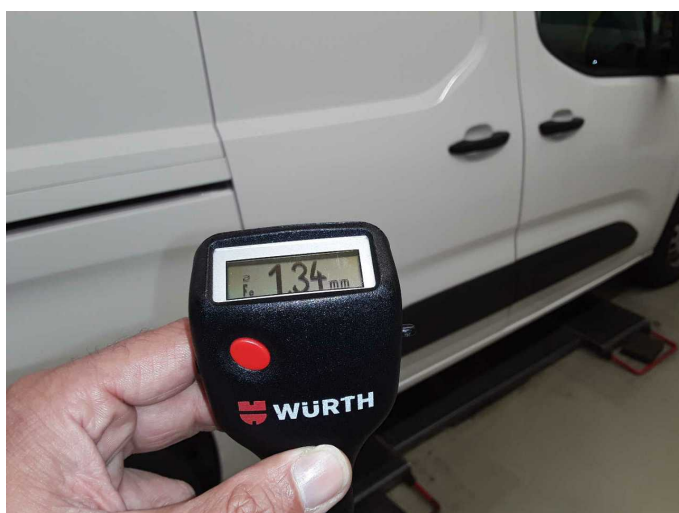
Door - rear right side: 1,340 μm

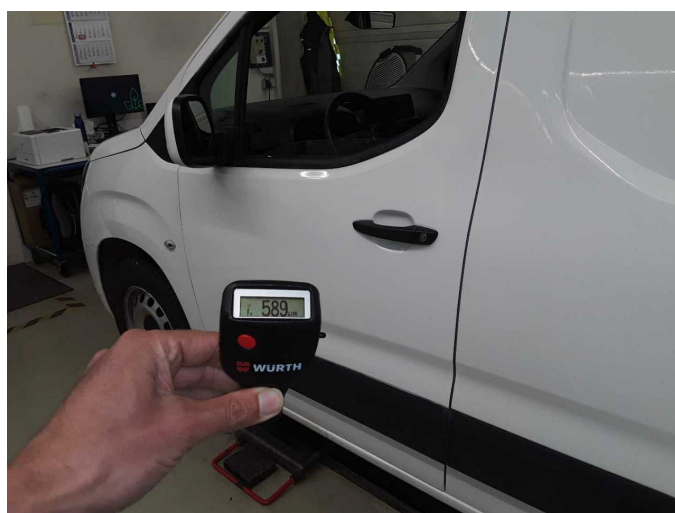
Door - front left side: 589 μm

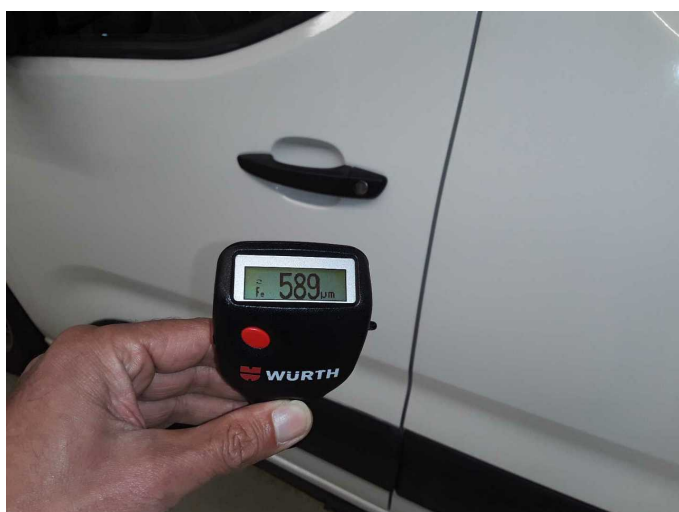
Door - front left side: 589 μm
