Expertise

Protocol number: 41131264  
Order No. / Reference: 25084781  
Inspection date: 14 Aug 2025

Manufacturer: Opel	Model: Combo Cargo 1.5 D Edition
VIN: W0VEFYHYCMJ672494

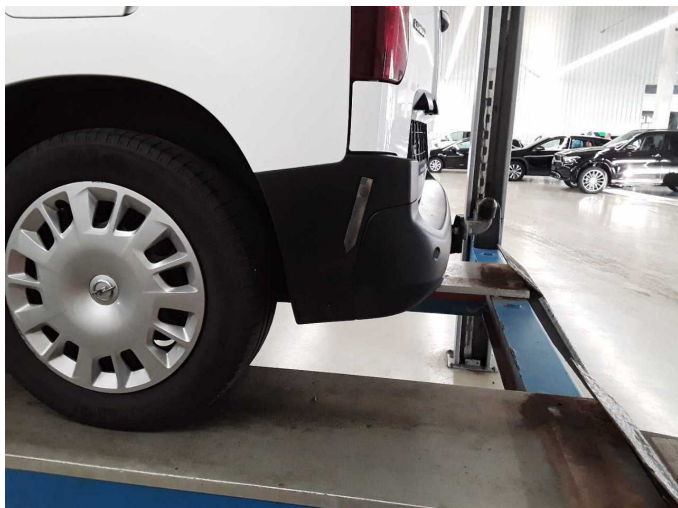
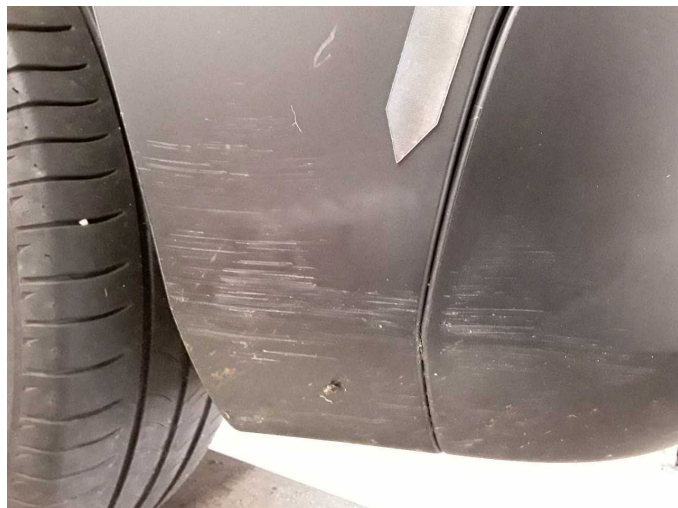
**Damage 1:** Rear bumper: Bumper with Parktronic - Scratched - Loss in value

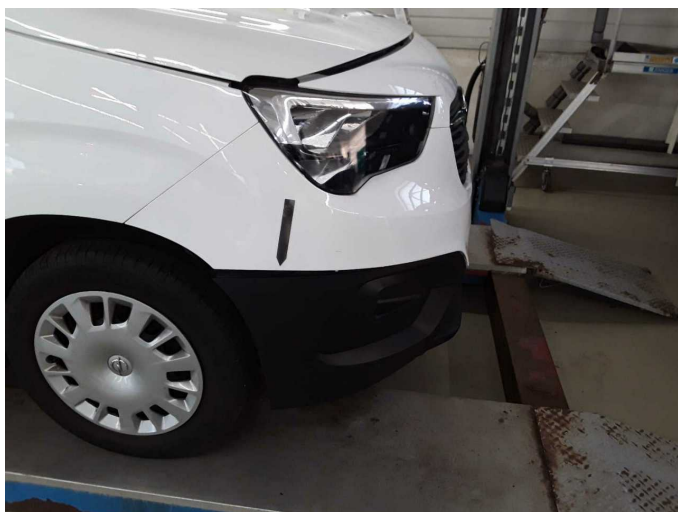
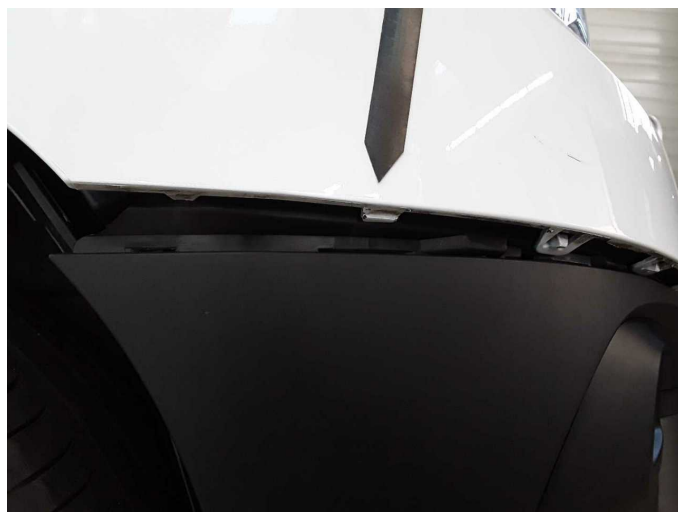
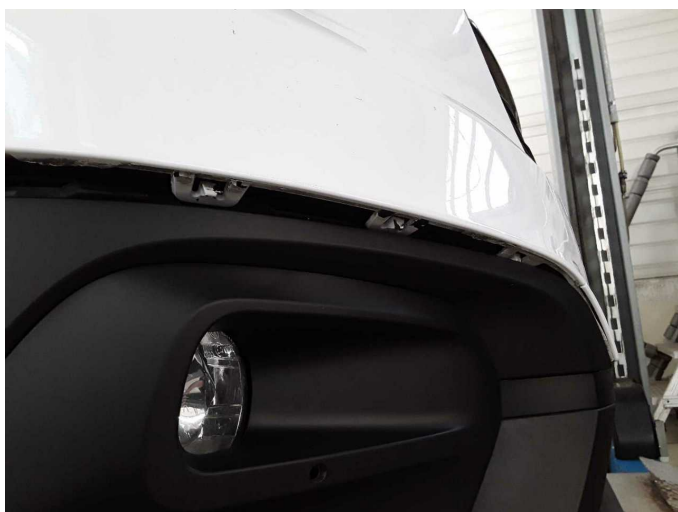
**Damage 2:** Front bumper: Bumper with Parktronic (Unterteil) - Loose - Repair

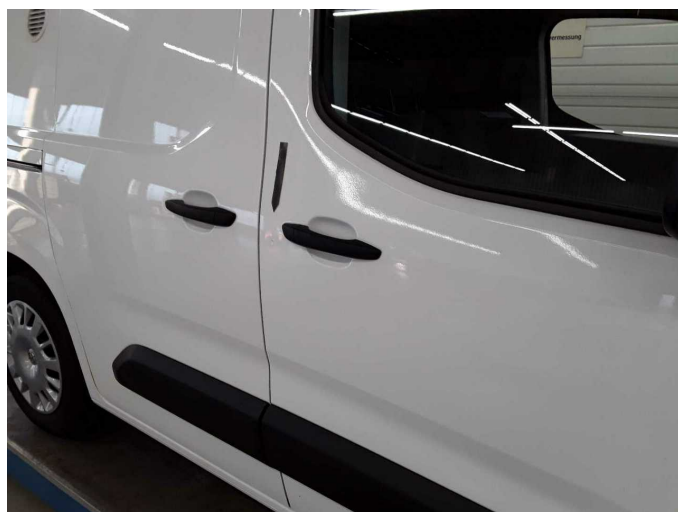
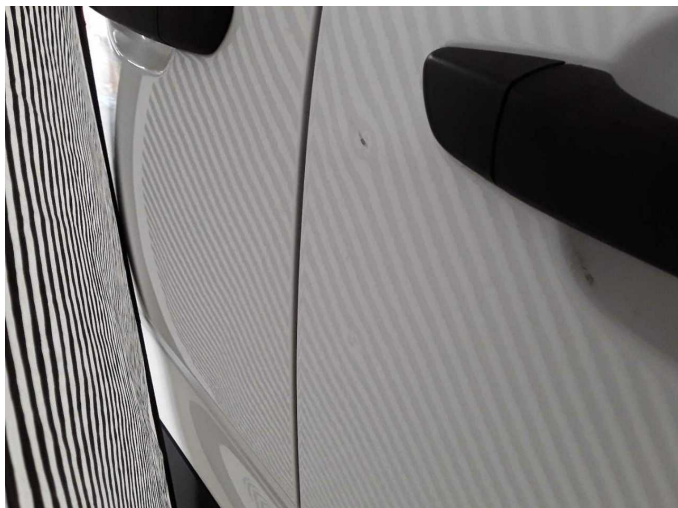
**Damage 3:** Door - front right side: Door - Dent / paintcoat damage - Smart repair

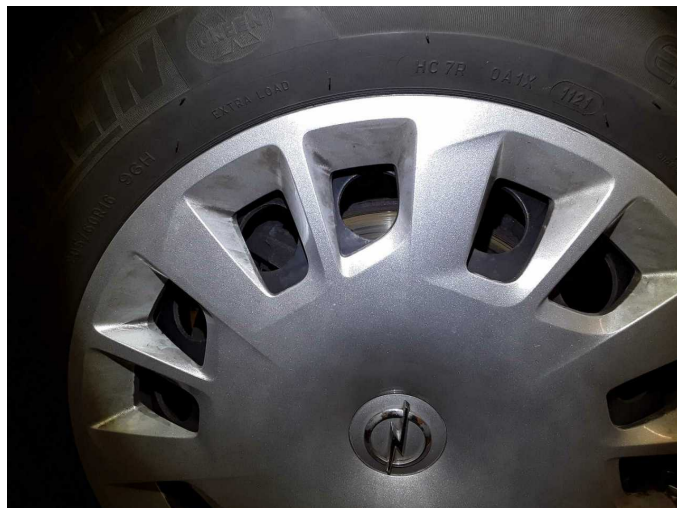
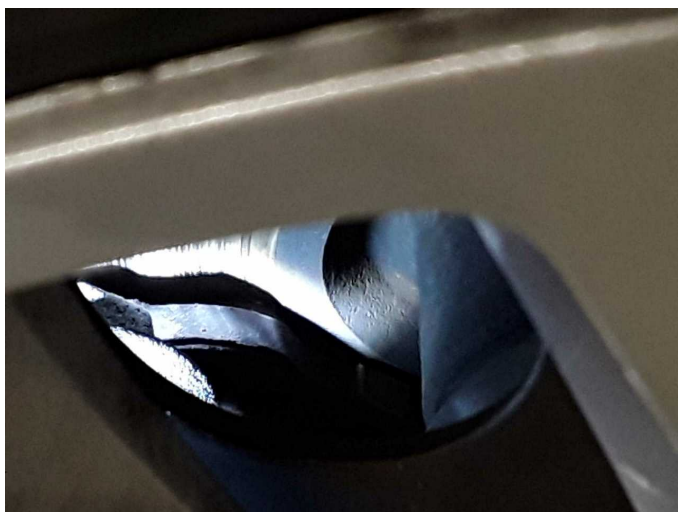
**Damage 4:** Braking system: Brake discs and brake pads - front - Worn - Replace

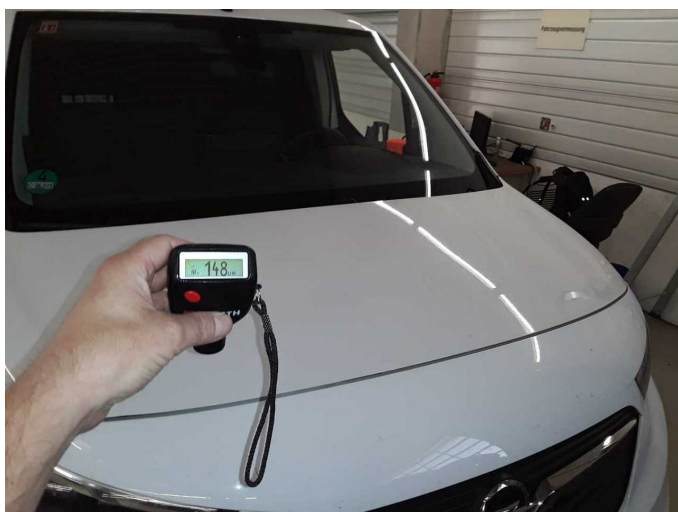
**Bonnet:** 148 µm

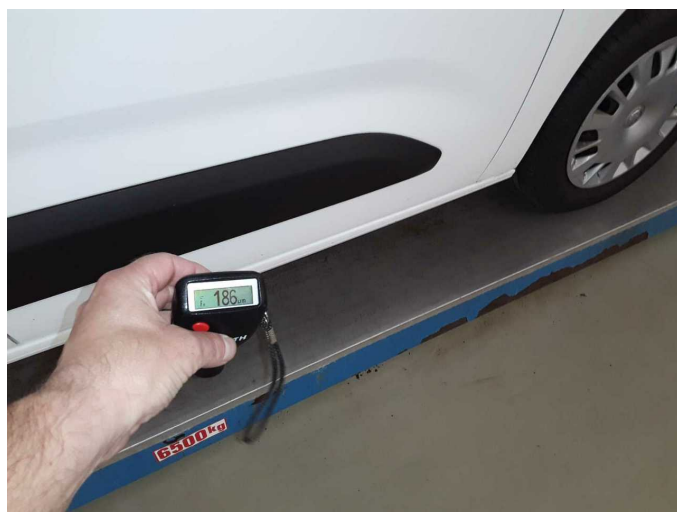
**Sill - right side:** 186 µm

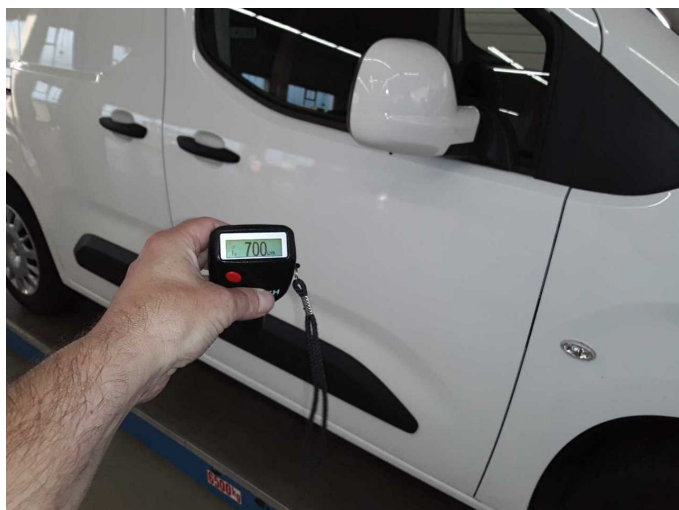
**Door - front right side: 700 µm**
