Expertise

Protocol number: 41602210
Order No. / Reference: 25172488
Inspection date: 15 Sept 2025

Manufacturer: Opel

Model: Combo Cargo XL 1.5 D EHZ Edition

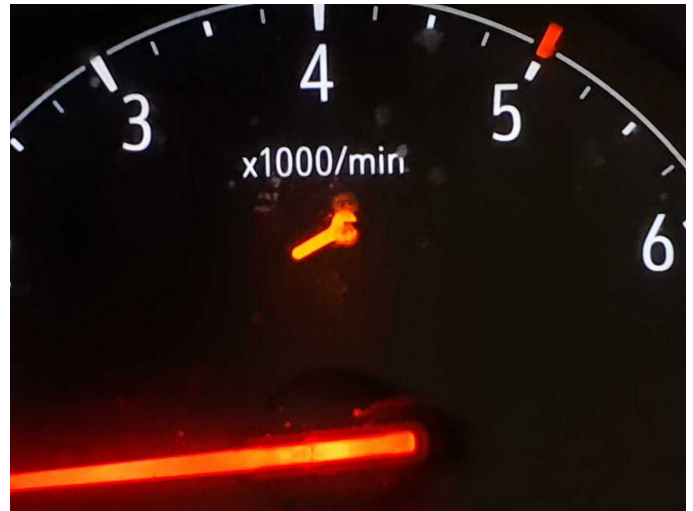
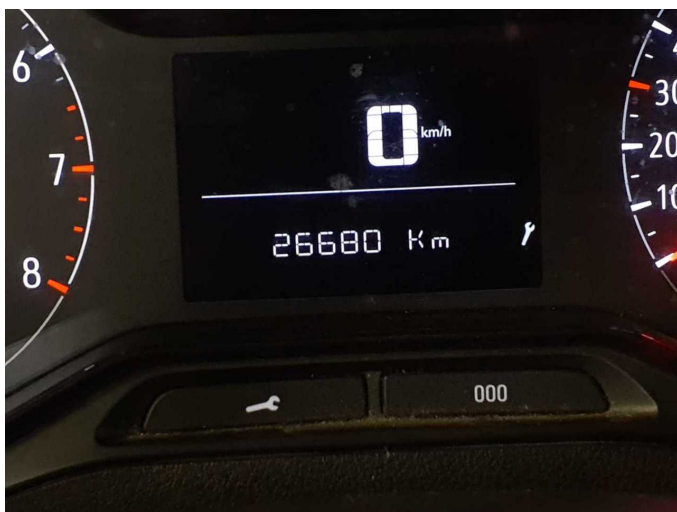
No.	Component group	Description
1	Instrument panel	Indicator light (Servicekontrolle, unplausibel) - on - Perform diagnosis
2	Sill - left side	Sill - Scratched - Smart repair
3	Seat - front	Seat cover - left side - Holes - Replace

Damage 1: Instrument panel: Indicator light (Servicekontrolle, unplausibel) - on - Perform diagnosis

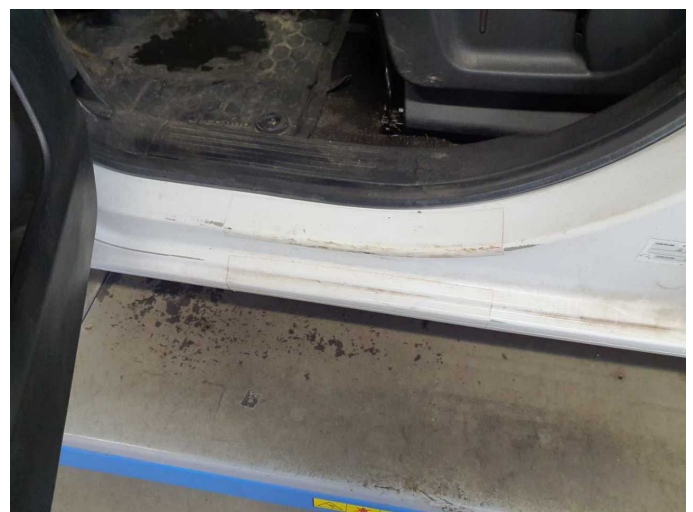
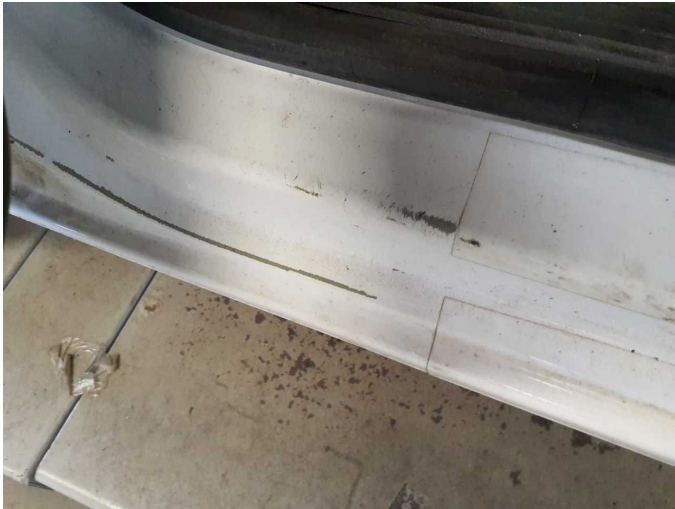
Damage 2: Sill - left side: Sill - Scratched - Smart repair

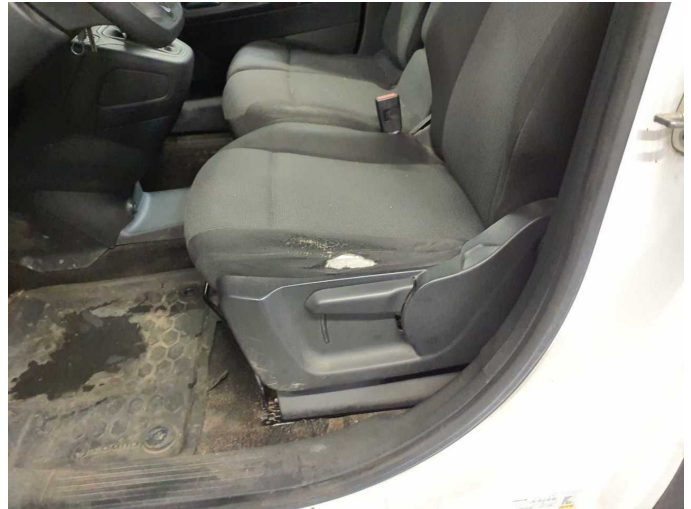
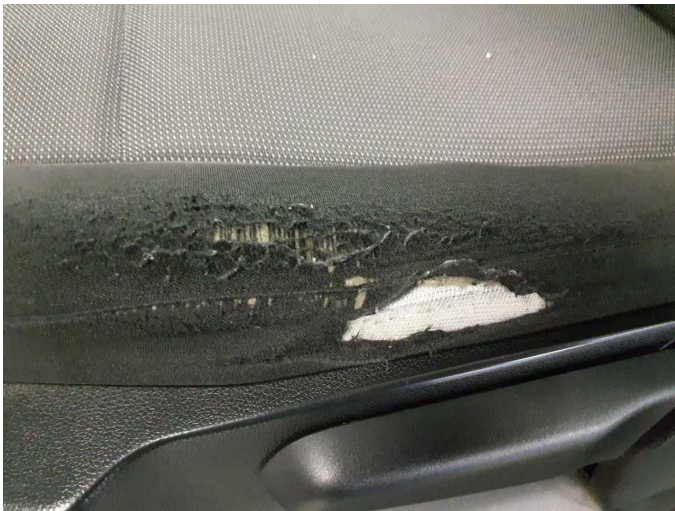
Damage 3: Seat - front: Seat cover - left side - Holes - Replace

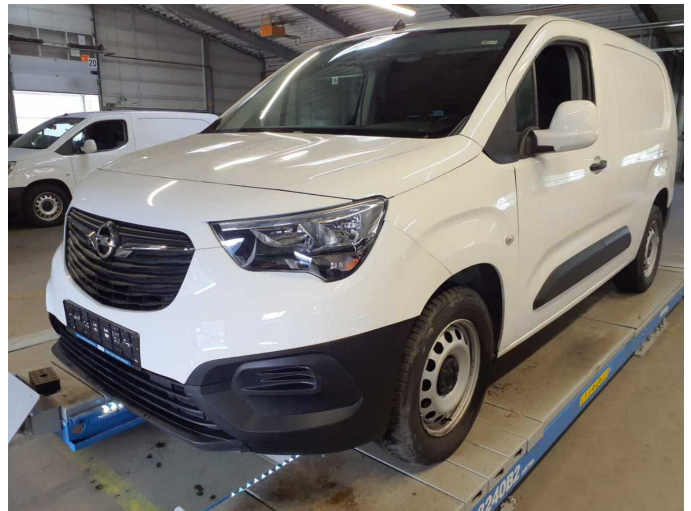
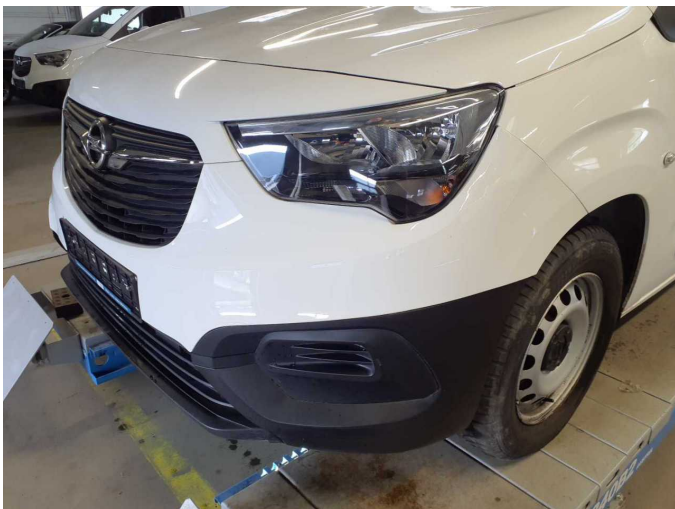
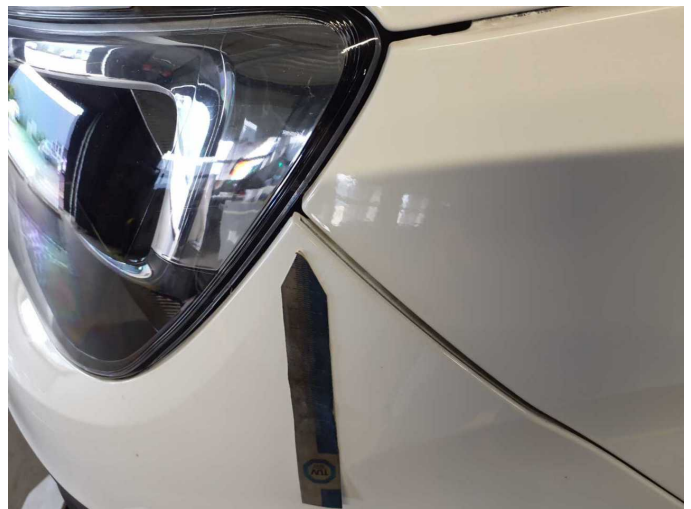
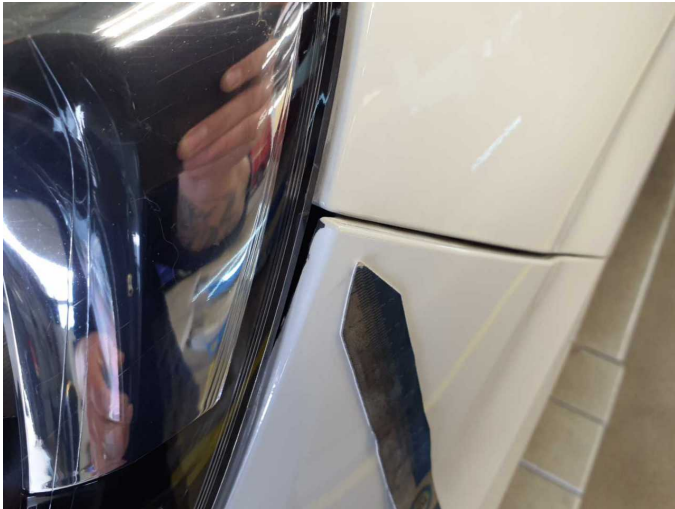
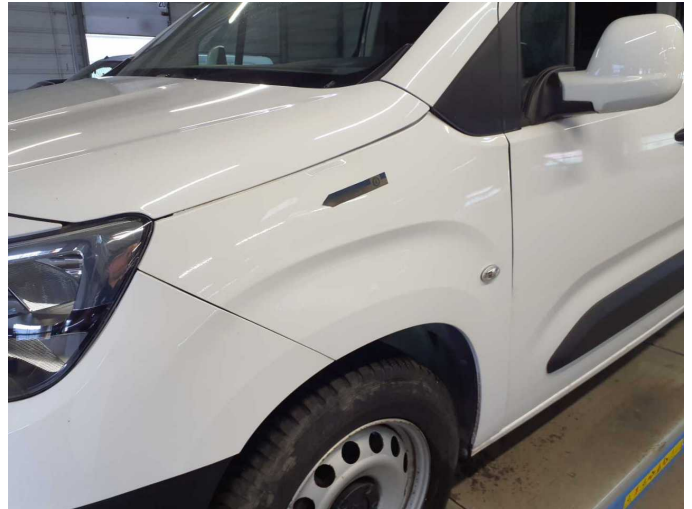
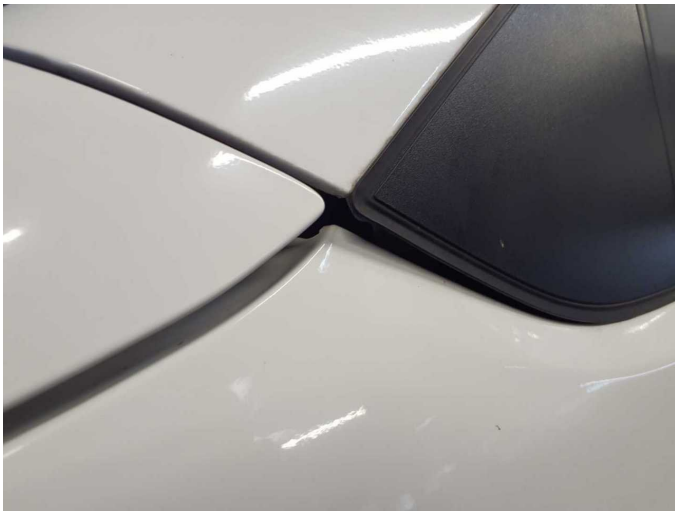
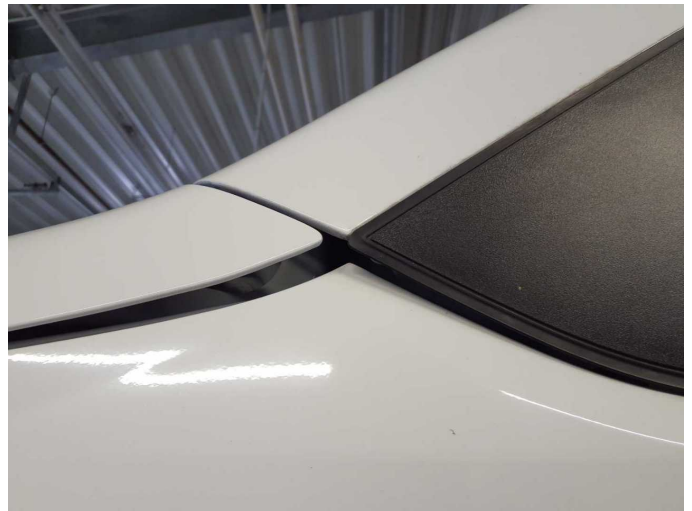
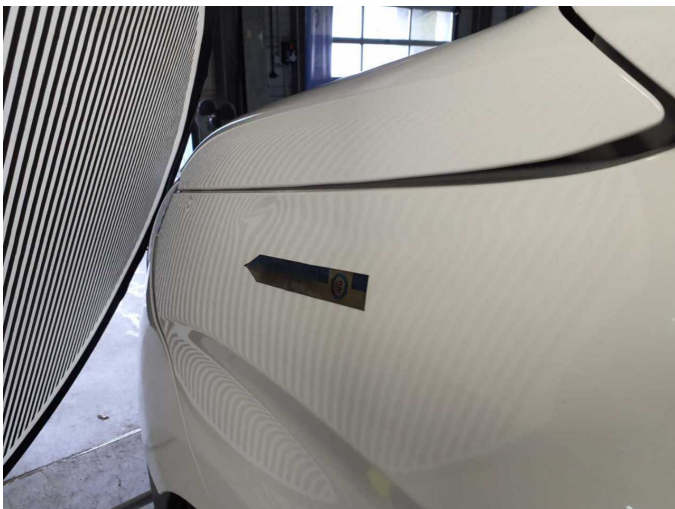
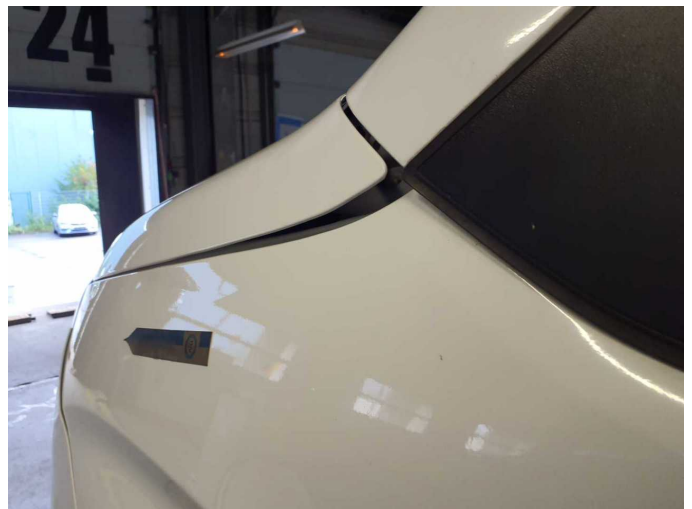
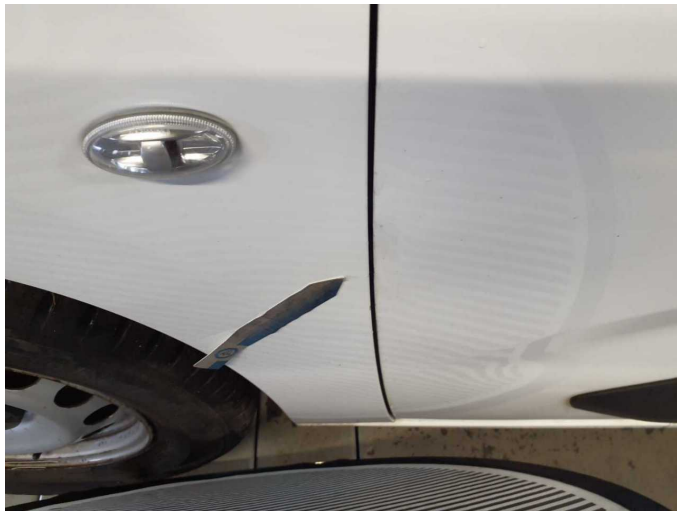
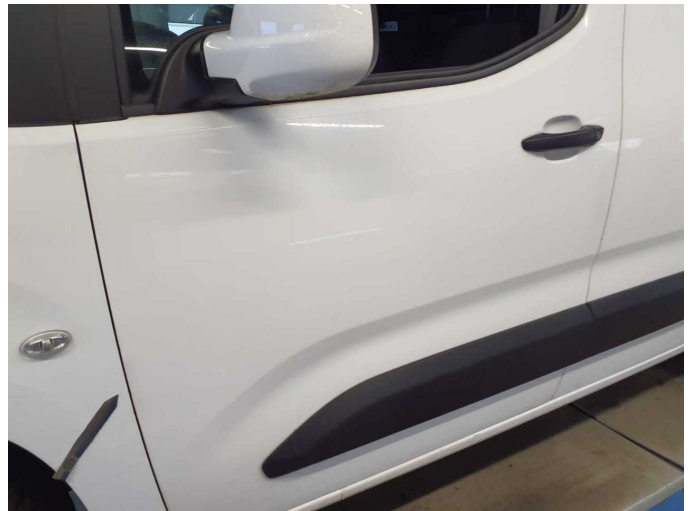
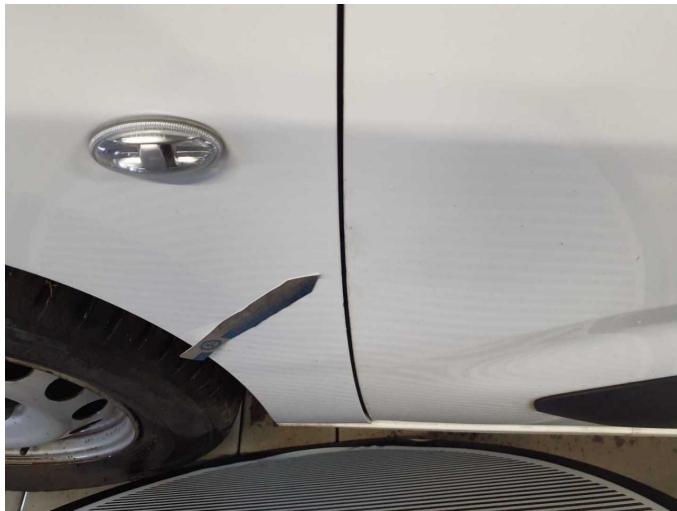
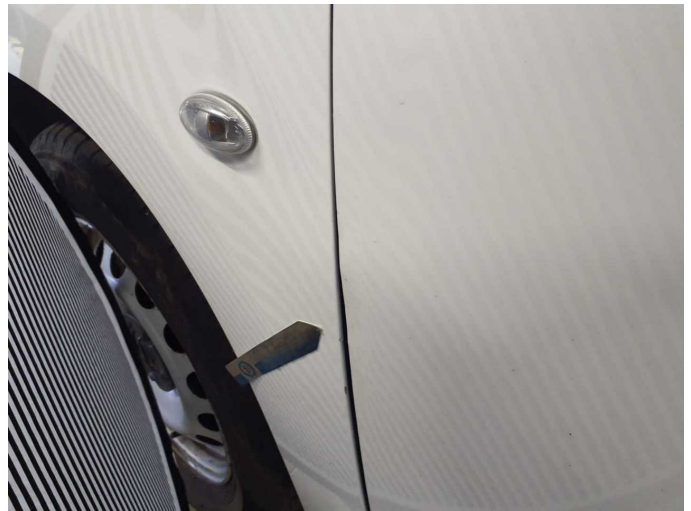
No.	Accident
1	Front, Side - left

Accident 1: Front, Side - left

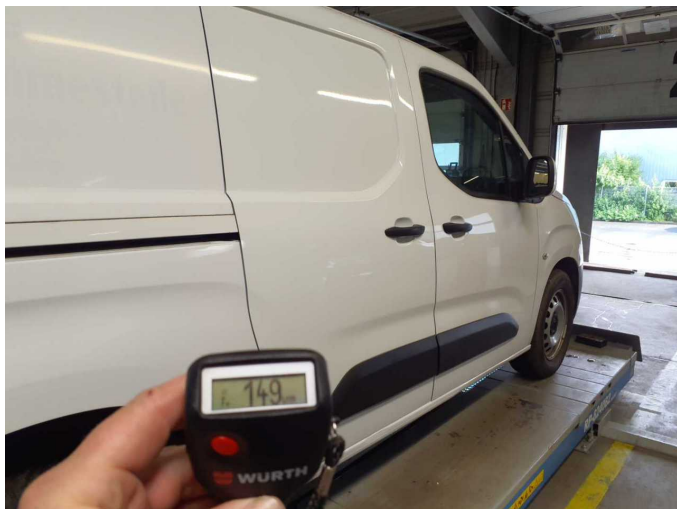
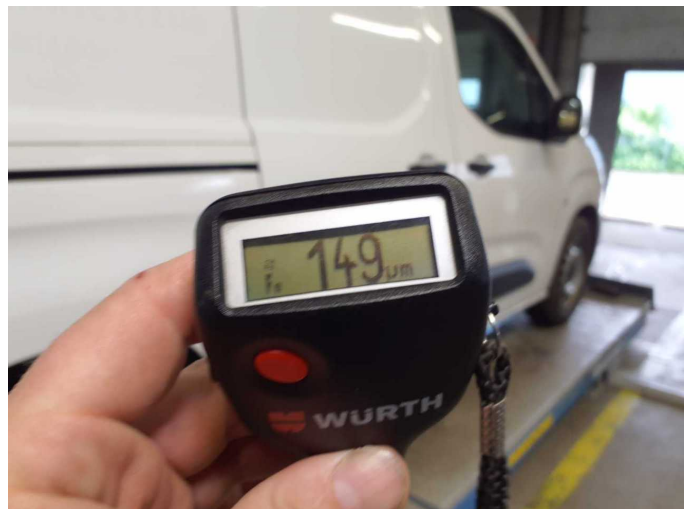
No.	Repainting
1	Door - rear right side, Professionally carried out, Invoice of repair done Non-existent

Door - rear right side	149 µm
------------------------	--------

Repainting 1: Door - rear right side
