Expertise

Protocol number: 41317834
Order No. / Reference: 25085246
Inspection date: 28 Aug 2025

Manufacturer: Opel

Model: Combo Cargo XL 1.5 D EHZ Edition

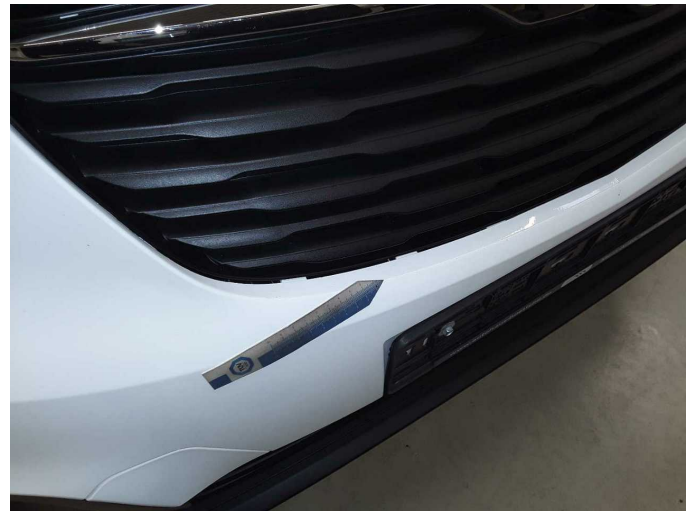
Damage 1: Front bumper: Air-inlet grille - Loose - Diagnosed and repair if necessary

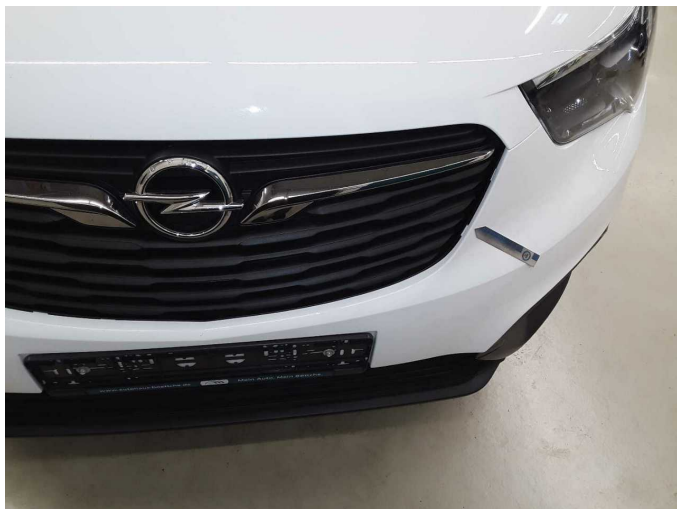
Damage 1: Front bumper: Air-inlet grille - Loose - Diagnosed and repair if necessary

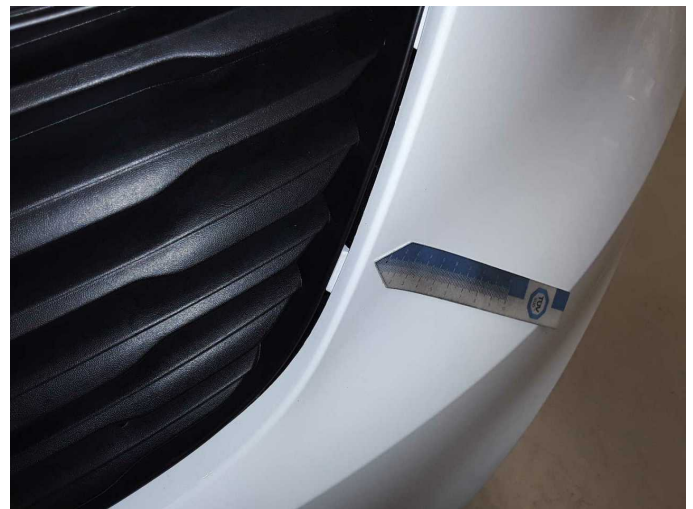
Damage 1: Front bumper: Air-inlet grille - Loose - Diagnosed and repair if necessary

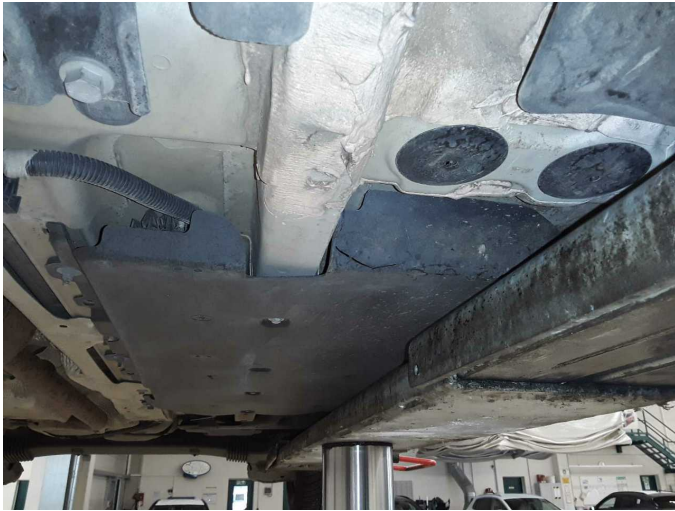
Damage 2: Body: Underbody panelling (Links) - Broken / torn - Replace

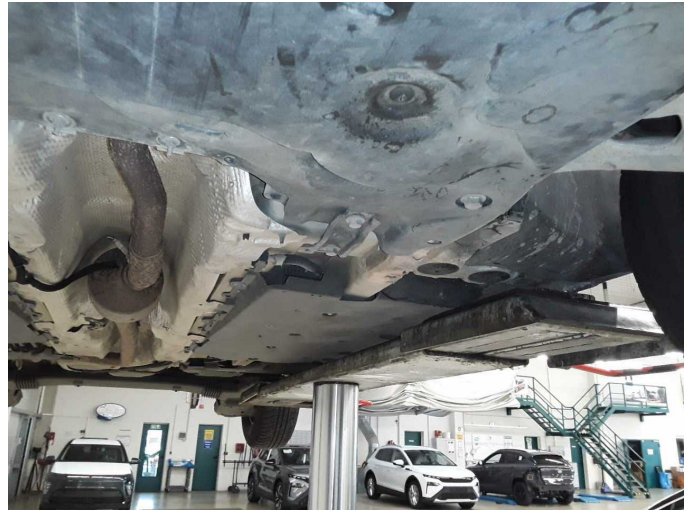
Damage 2: Body: Underbody panelling (Links) - Broken / torn - Replace

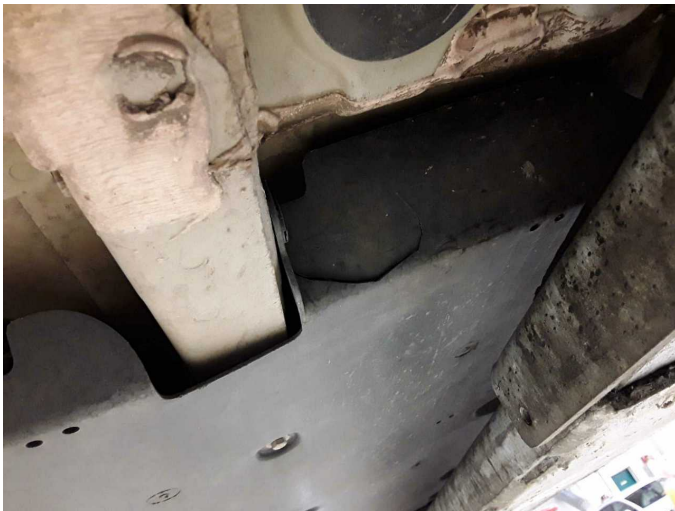
Damage 2: Body: Underbody panelling (Links) - Broken / torn - Replace

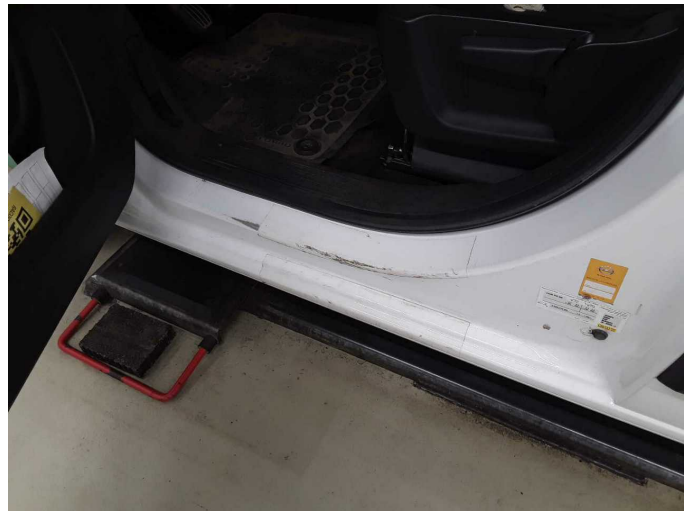
Damage 3: Sill - left side: Sill - Scratched - Smart repair

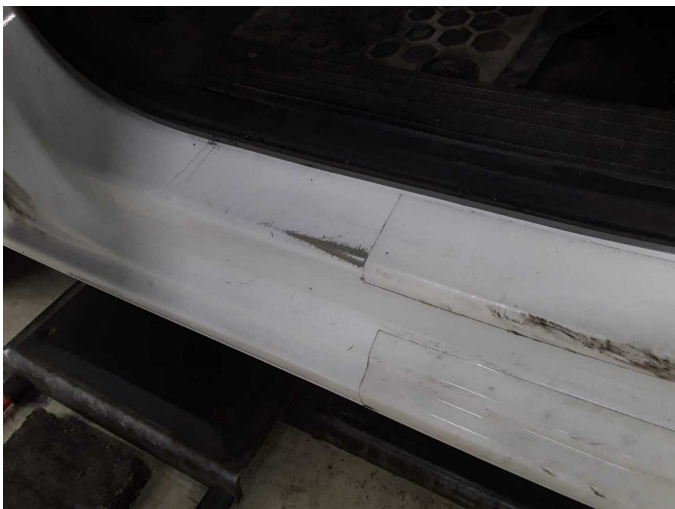
Damage 3: Sill - left side: Sill - Scratched - Smart repair

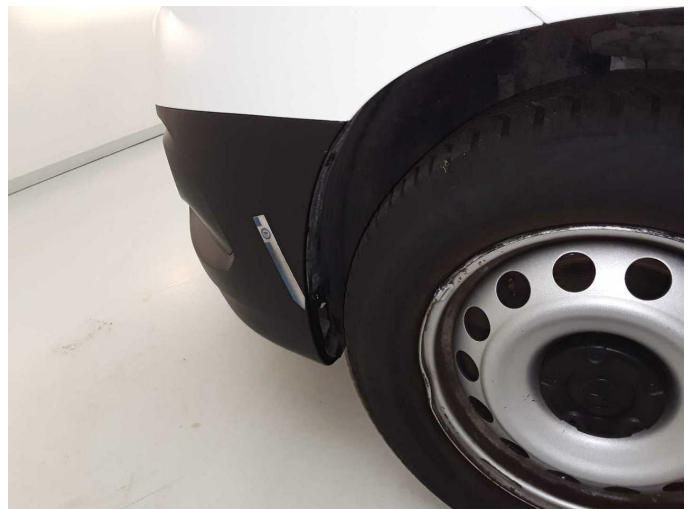
Damage 4: Mudguard - left side: Inner mudguard - Broken / torn - Replace

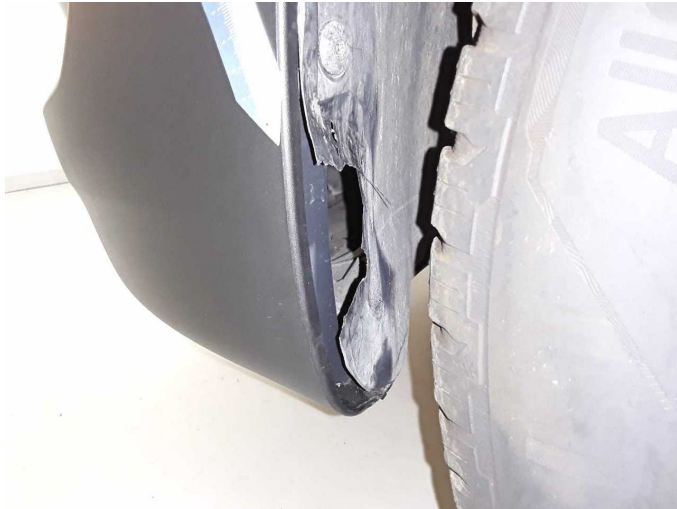
Damage 4: Mudguard - left side: Inner mudguard - Broken / torn - Replace

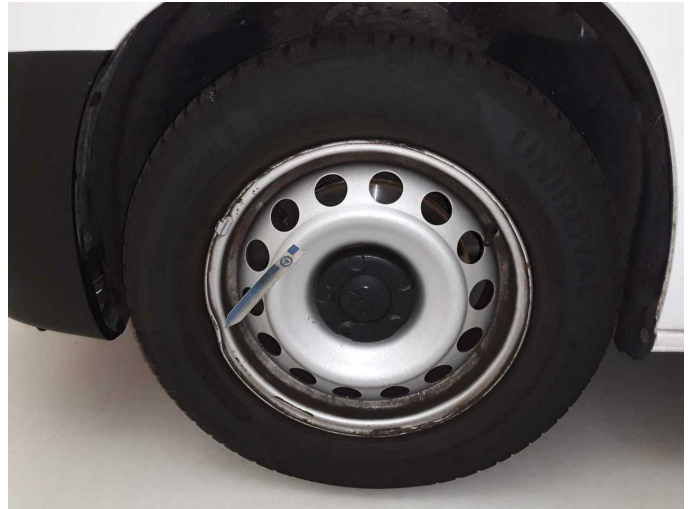
Damage 5: Wheel / tyres: Wheel rim - front left side - Deformed - Replace

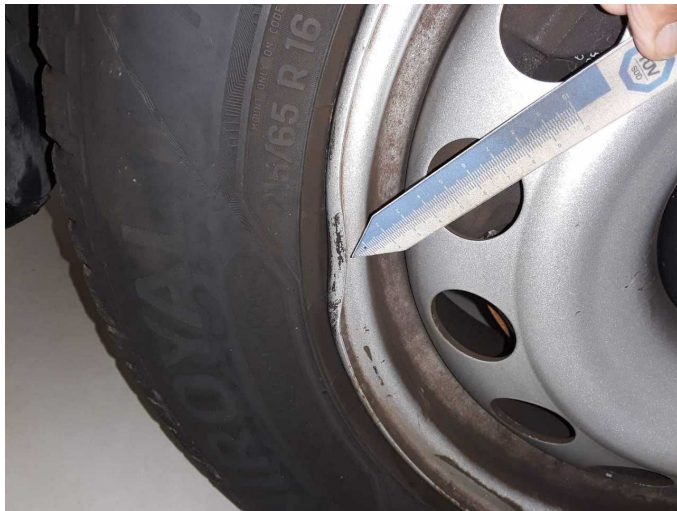
Damage 5: Wheel / tyres: Wheel rim - front left side - Deformed - Replace

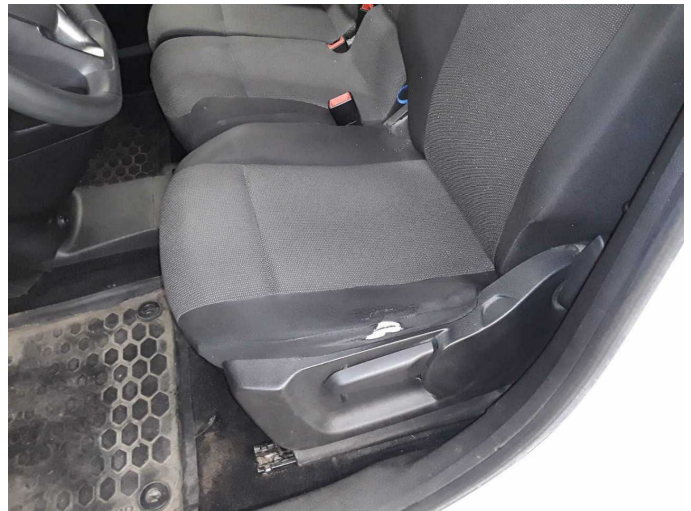
Damage 6: Seat - front: Seat cover - left side - Broken / torn - Replace

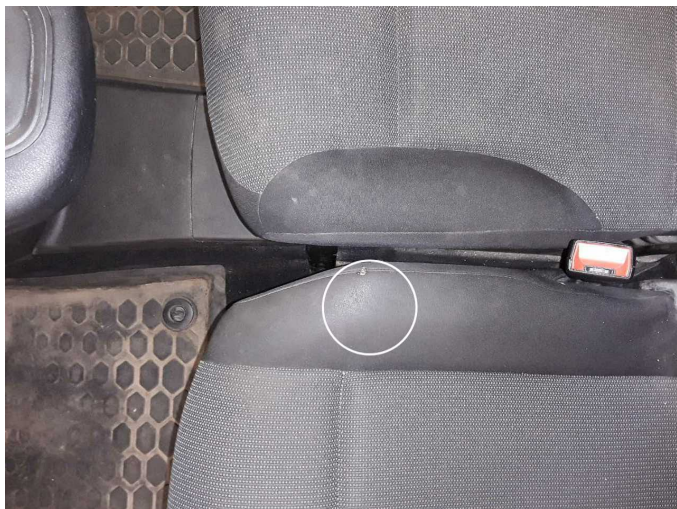
Damage 6: Seat - front: Seat cover - left side - Broken / torn - Replace

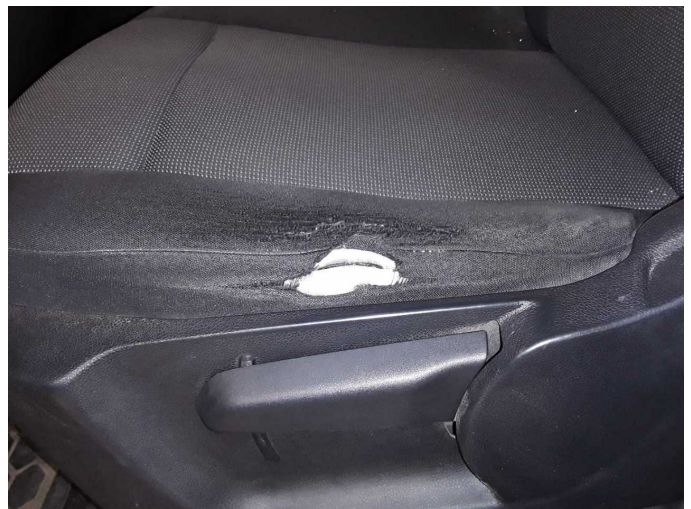
Damage 6: Seat - front: Seat cover - left side - Broken / torn - Replace

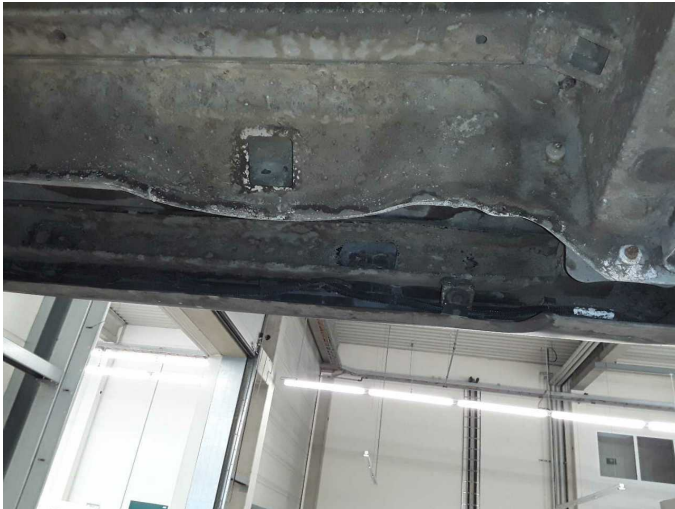
Damage 7: Rear bumper: Support - Deformed - Replace

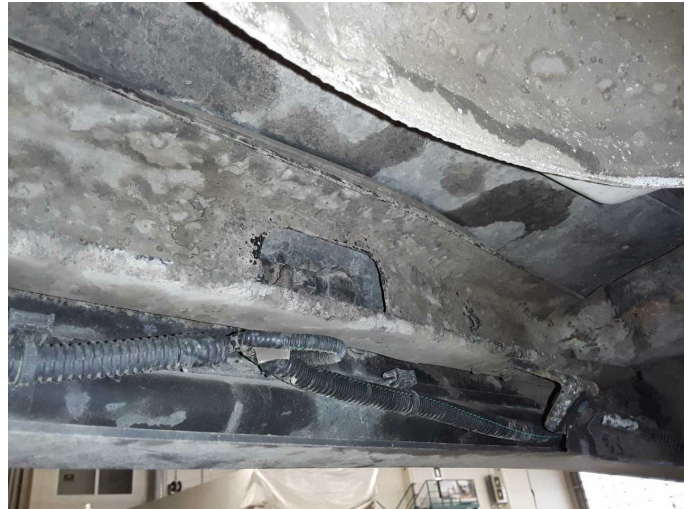
Damage 7: Rear bumper: Support - Deformed - Replace

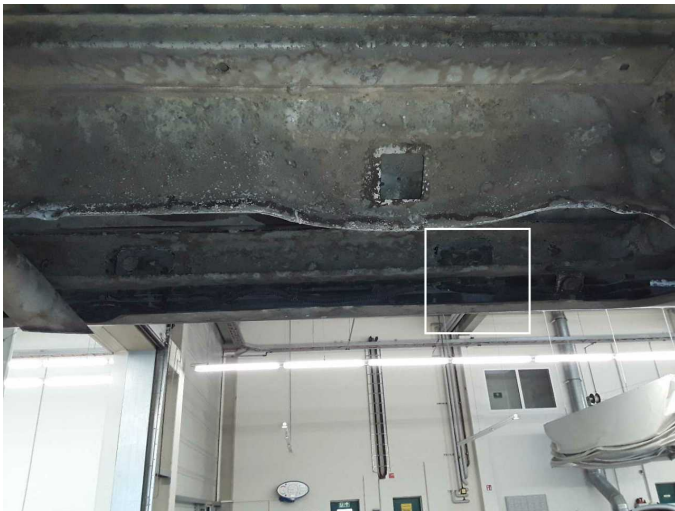
Damage 7: Rear bumper: Support - Deformed - Replace

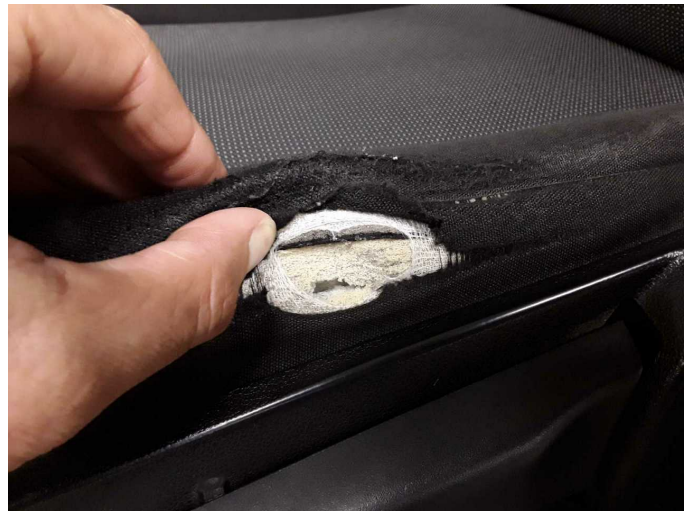
Damage 8: Seat - front: Seat upholstery - left side - Broken / torn - Replace

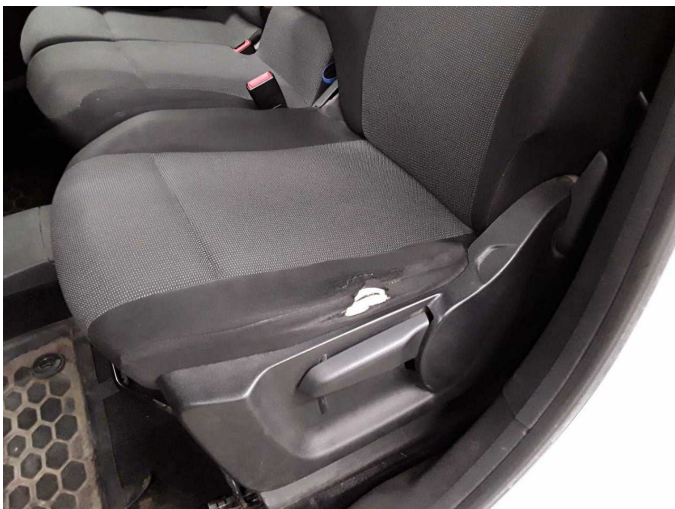
Damage 8: Seat - front: Seat upholstery - left side - Broken / torn - Replace

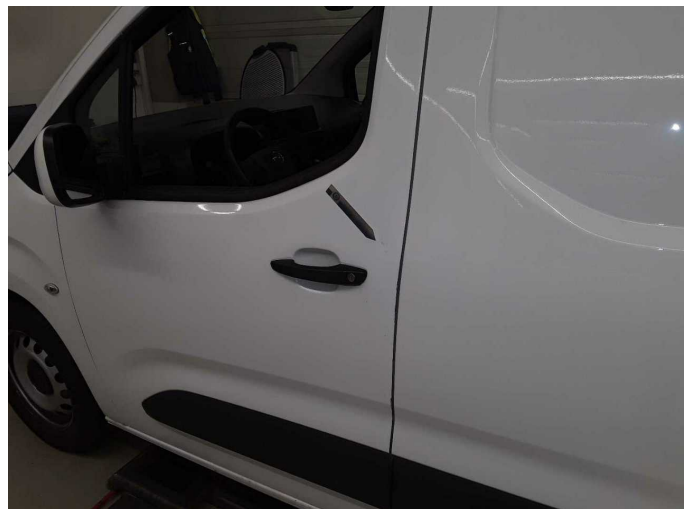
Wear and tear 1: Door - front left side: Door - dent(s) - No deduction

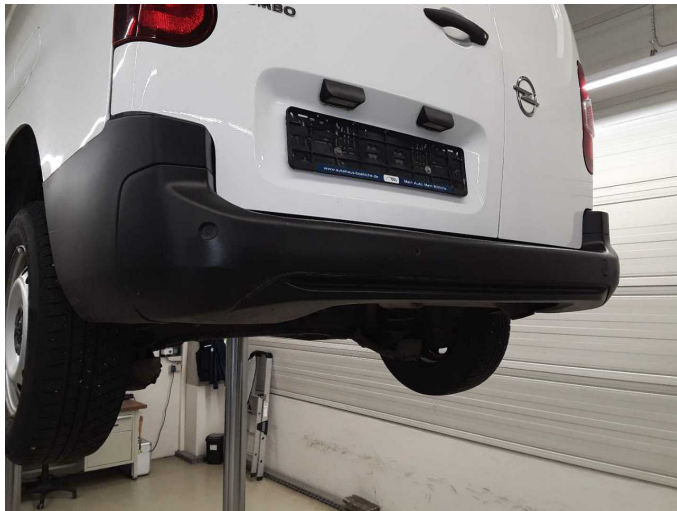
Wear and tear 2: Rear bumper: Rear bumper (unpainted) - Scratch(es) -
No deduction

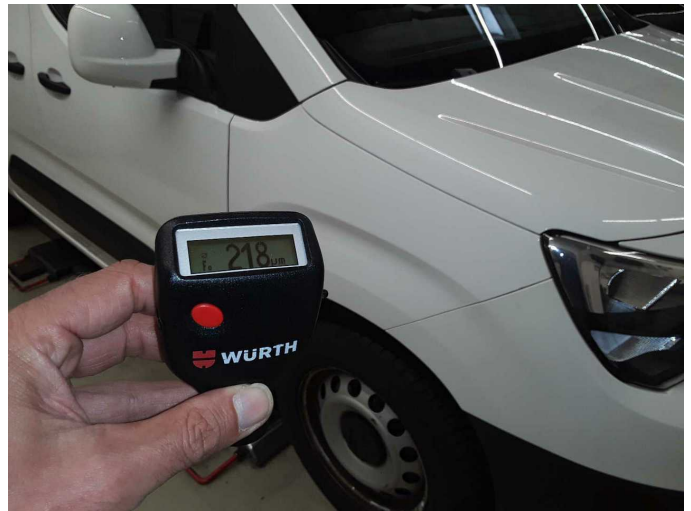
- Mudguard - right side, Side panel - rear right side, Door - front right side, Professionally carried out

Mudguard - right side: 218 µm

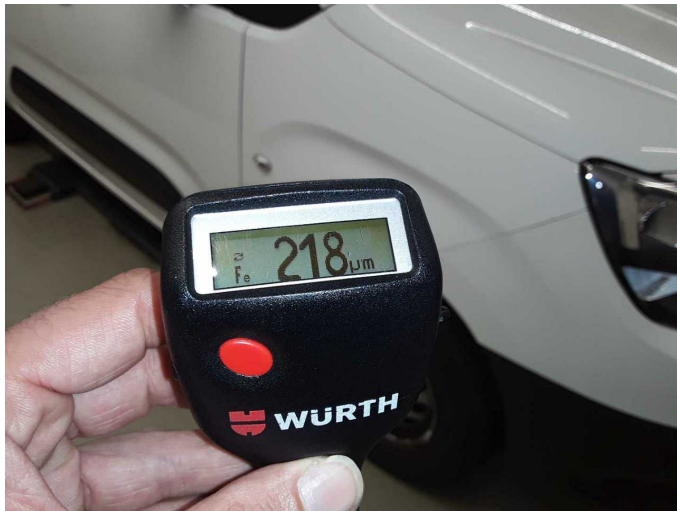
Mudguard - right side: 218 µm

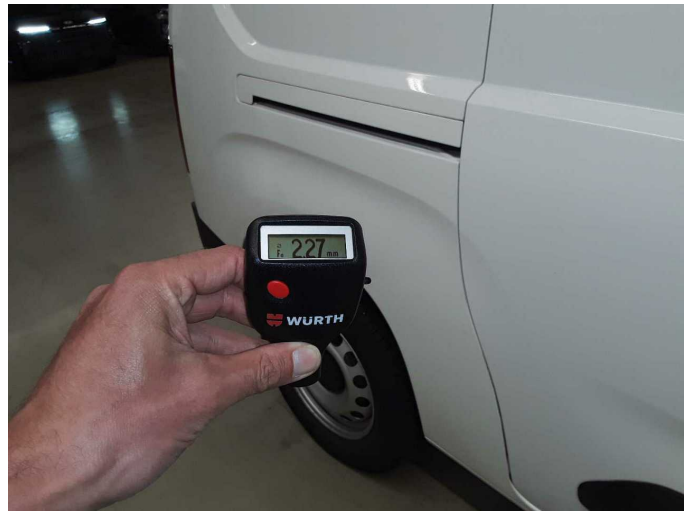
Side panel - rear right side: 2,270 µm

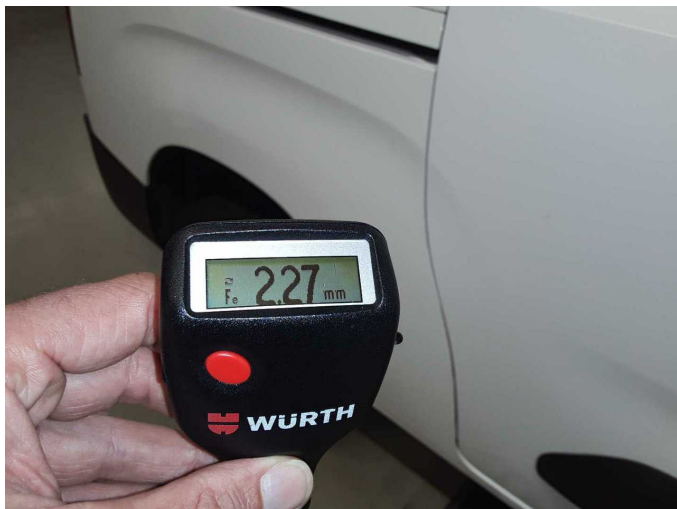
Side panel - rear right side: 2,270 µm

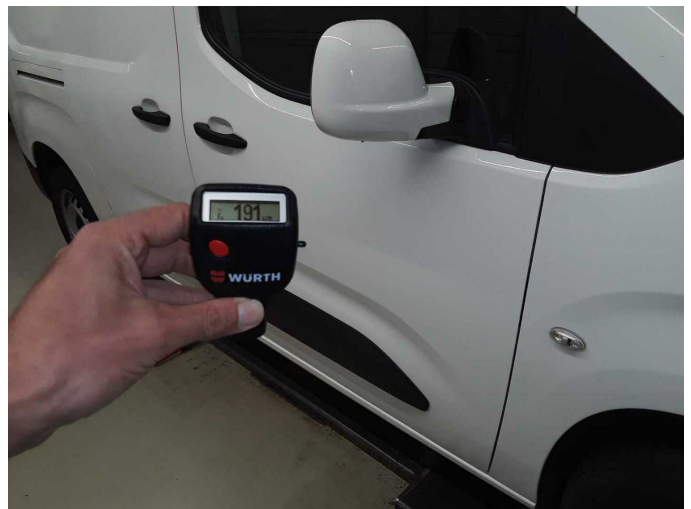
Door - front right side: 191 µm
