Expertise

Protocol number: 41231422  
Order No. / Reference: 25085117  
Inspection date: 25 Aug 2025

Manufacturer: Opel

Model: Combo Cargo XL 1.5 D EHZ Edition

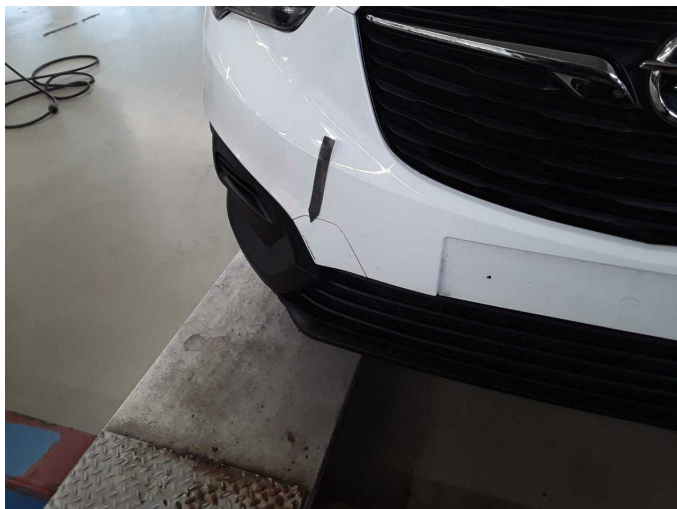
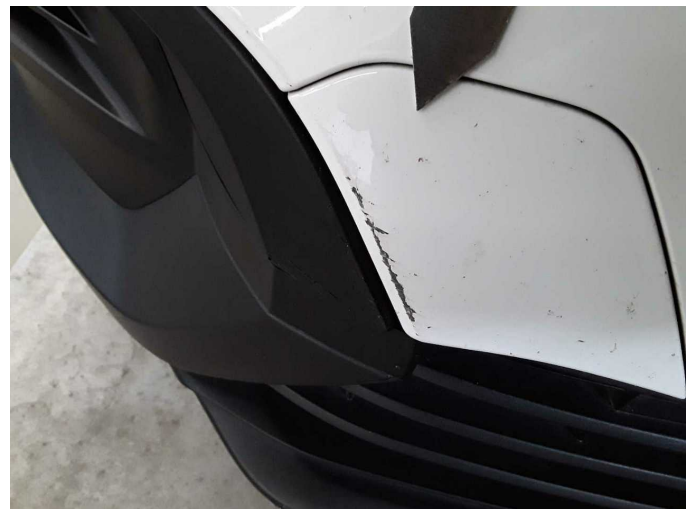
| No. | Component group | Description |
|---|---|---|
| 1 | Trim / covers | Trim / covers (Abschleppöse vorn) - Scratch(es) - Smart repair |

Damage 1: Trim / covers: Trim / covers (Abschleppöse vorn) - Scratch(es) - Smart repair

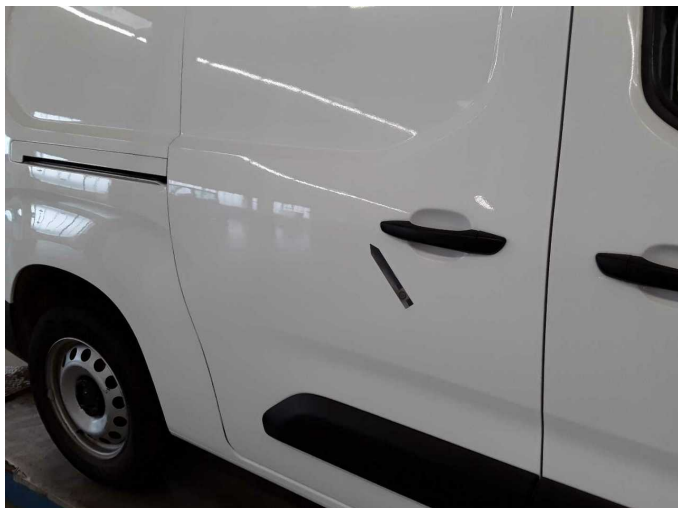
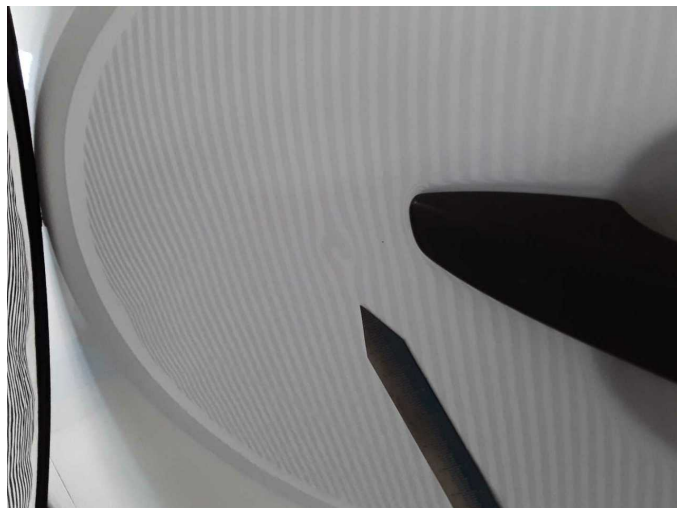
| No. | Component group | Description |
|---|---|---|
| 2 | Sliding door, right | Sliding door - dent(s) - Smart repair |

**Damage 2:** Sliding door, right: Sliding door - dent(s) - Smart repair

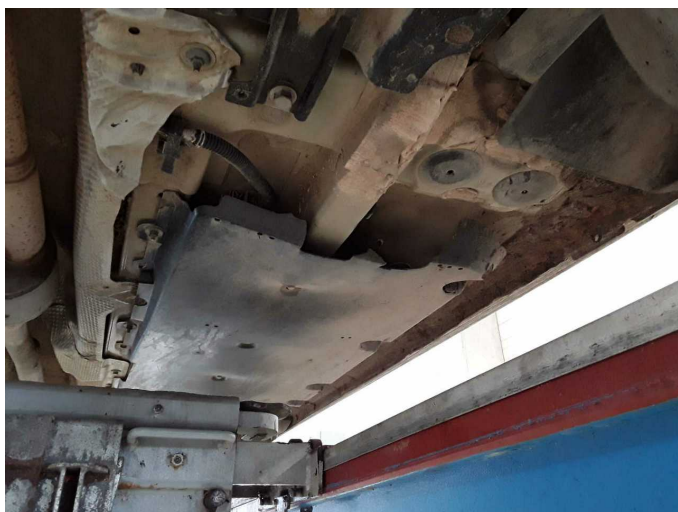
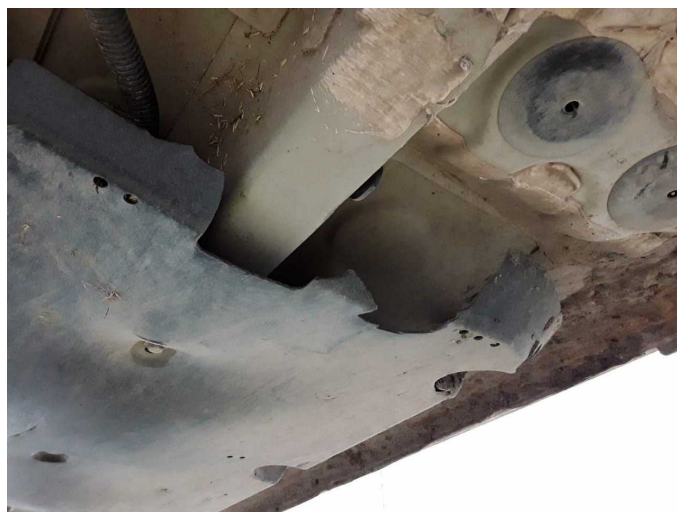
| No. | Component group | Description |
|---|---|---|
| 3 | Body | Underbody panelling (links) - Broken / torn - Replace |

**Damage 3:** Body: Underbody panelling (links) - Broken / torn - Replace

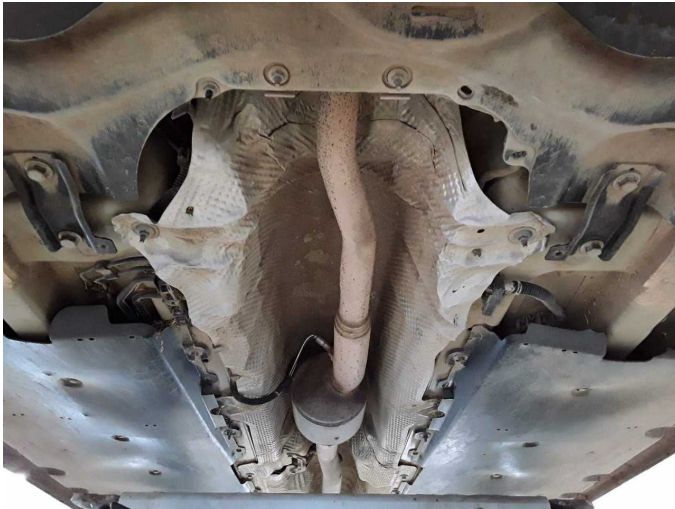
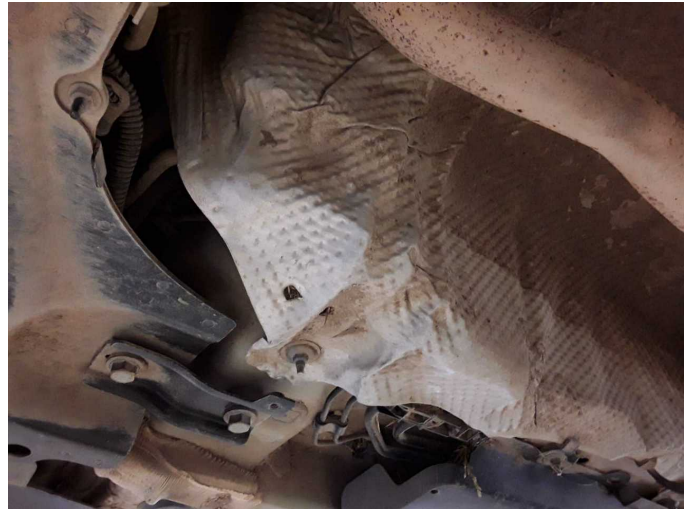
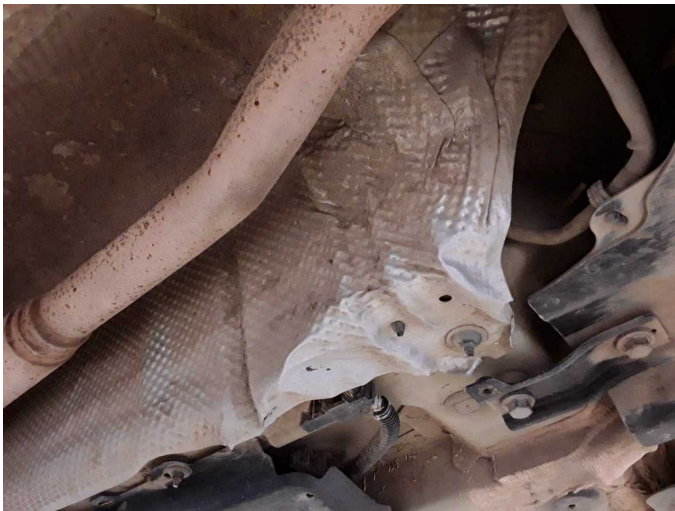
| No. | Component group | Description |
|---|---|---|
| 6 | Exhaust system | Heat shield - Deformed - Replace |

**Damage 6:** Exhaust system: Heat shield - Deformed - Replace

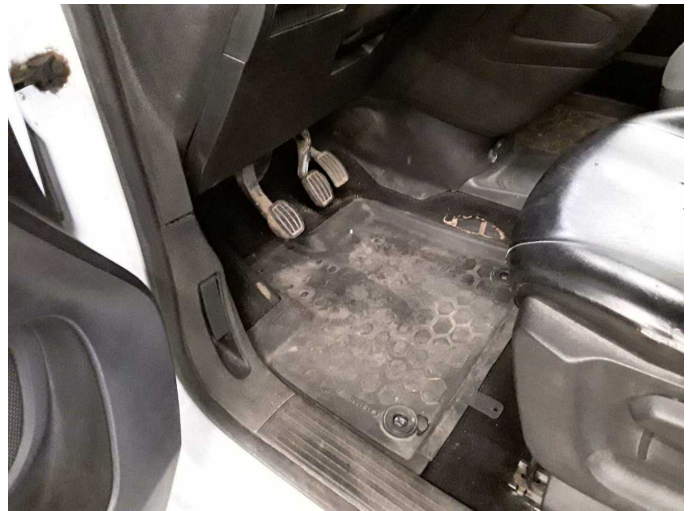
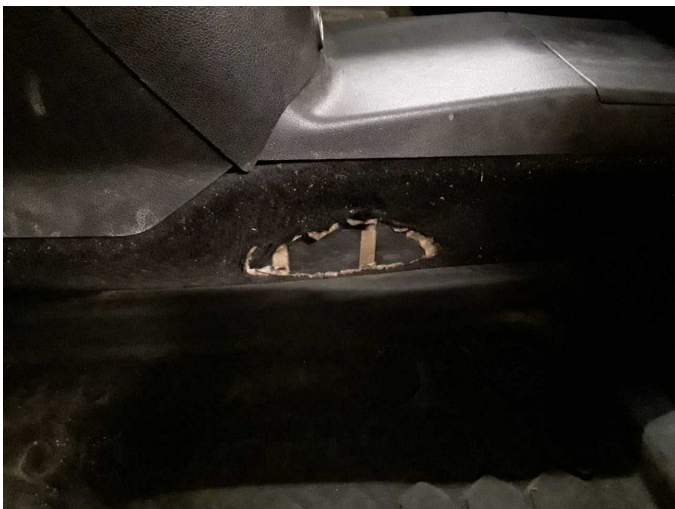
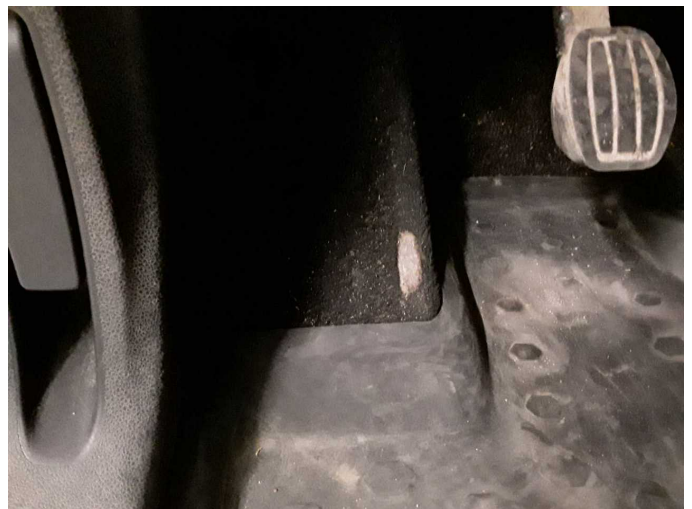
| No. | Component group | Description |
|---|---|---|
| 7 | Trim / covers | Floor covering - front left side - Damaged - Loss in value |

**Damage 7:** Trim / covers: Floor covering - front left side - Damaged - Loss in value

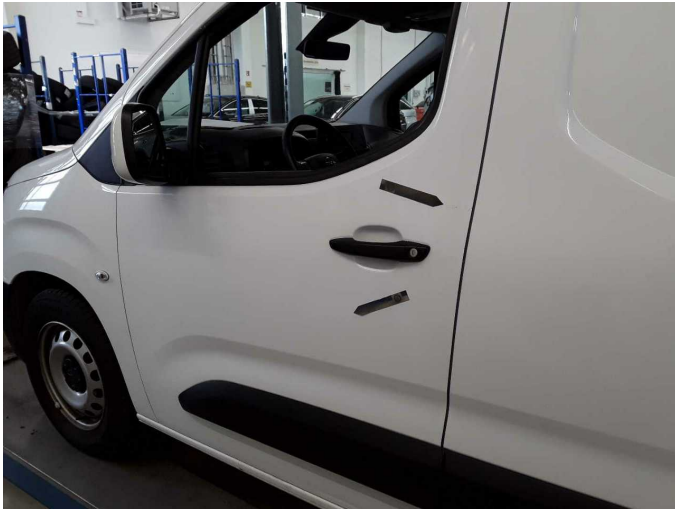
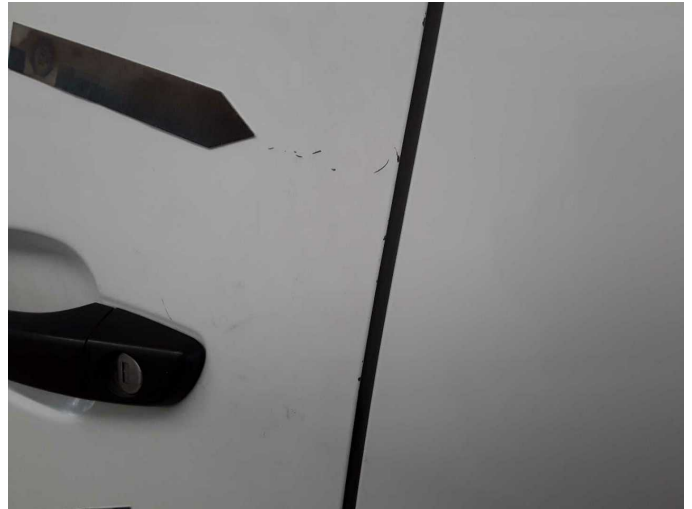
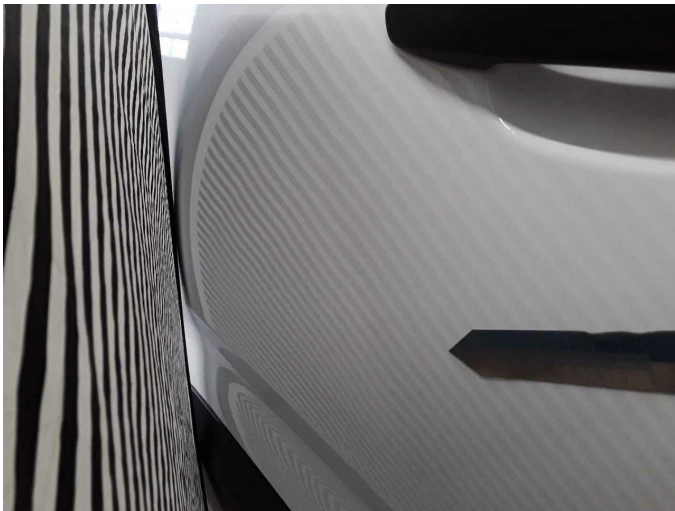
| No. | Component group | Description |
|---|---|---|
| 8 | Door - front left side | Door - Dent / paintcoat damage - Smart repair |

**Damage 8:** Door - front left side: Door - Dent / paintcoat damage - Smart repair

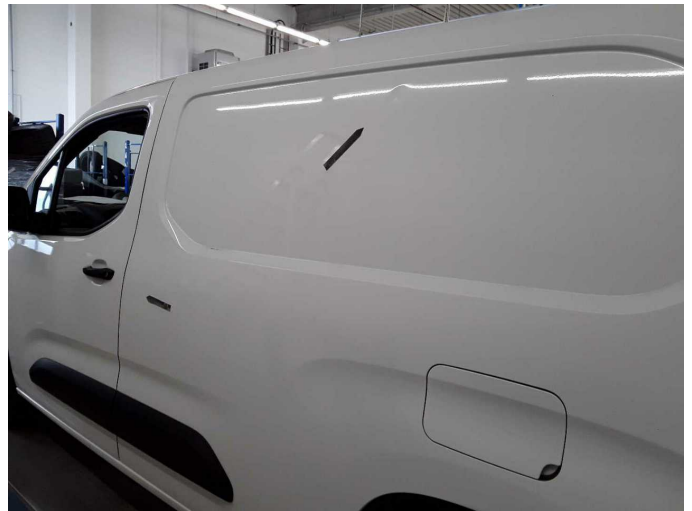
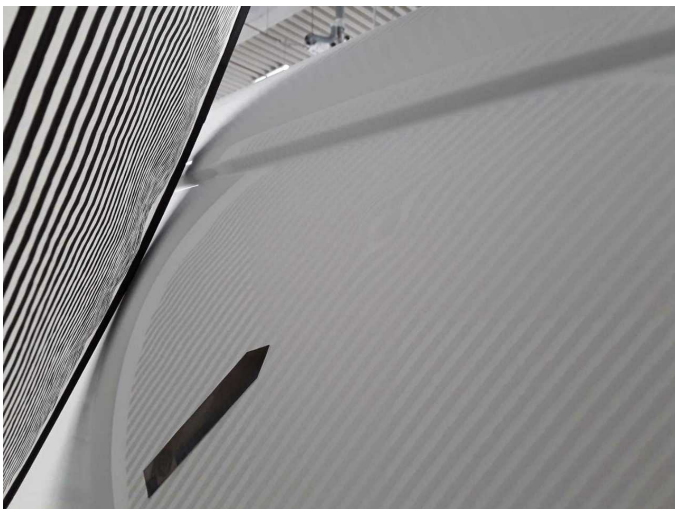
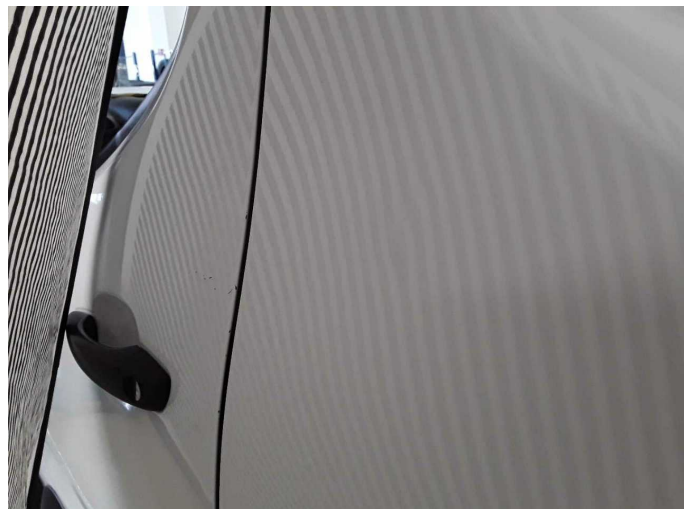
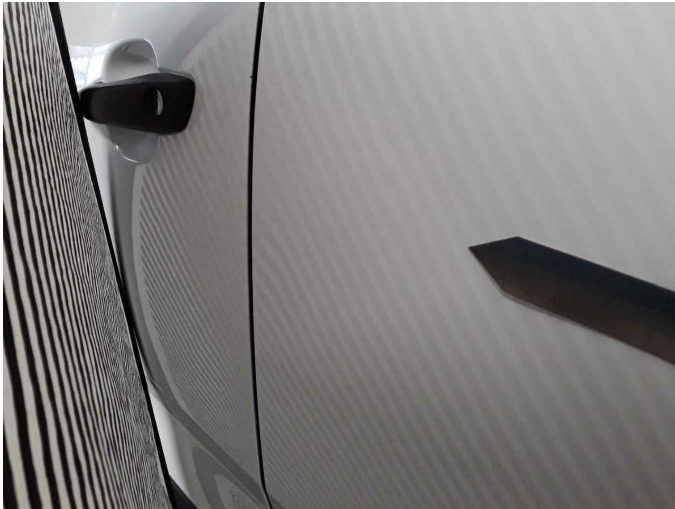
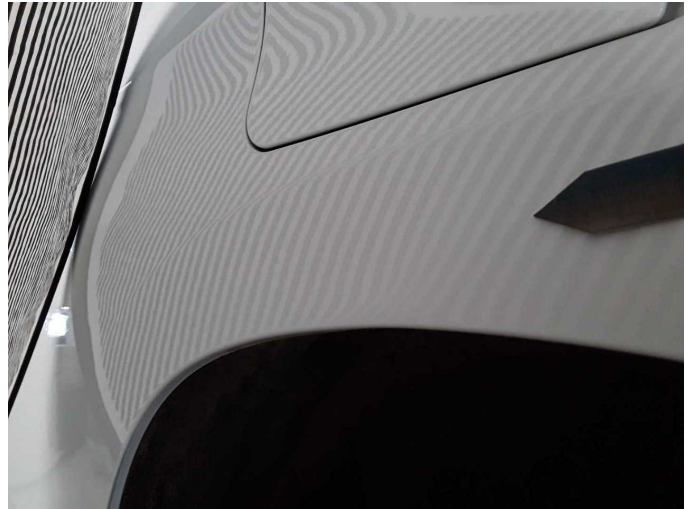
| No. | Component group | Description |
|---|---|---|
| 9 | Side panel - rear left side | Side panel - dent(s) - Smart repair |

**Damage 9:** Side panel - rear left side: Side panel - dent(s) - Smart repair

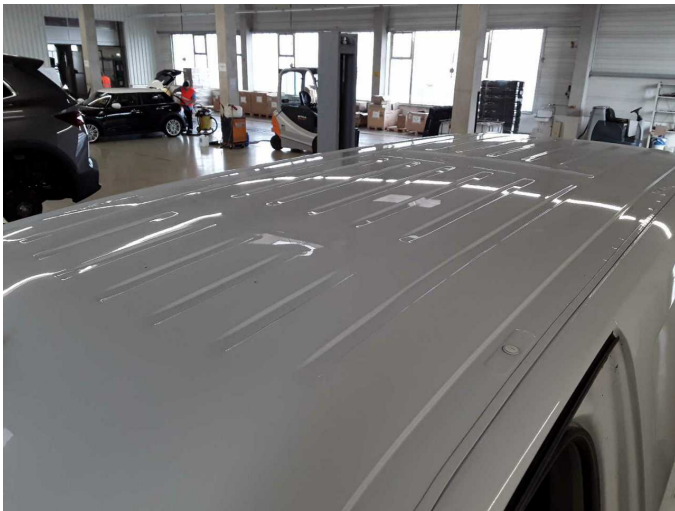
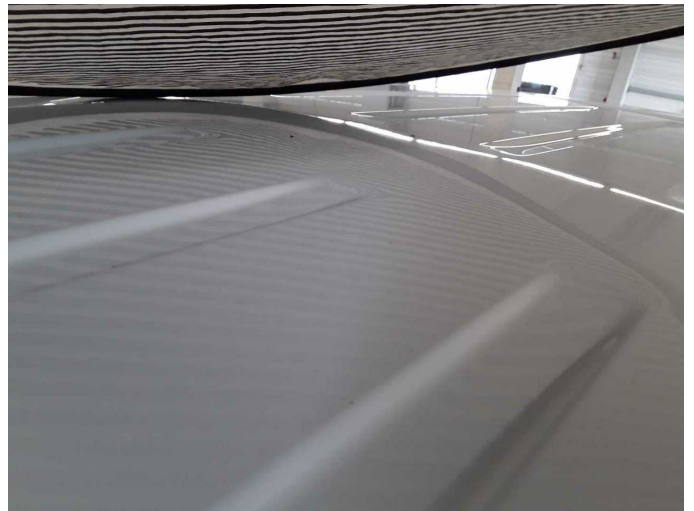
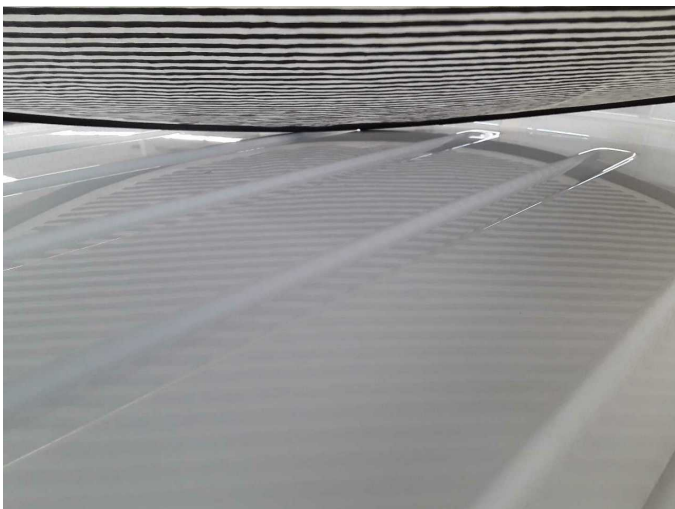
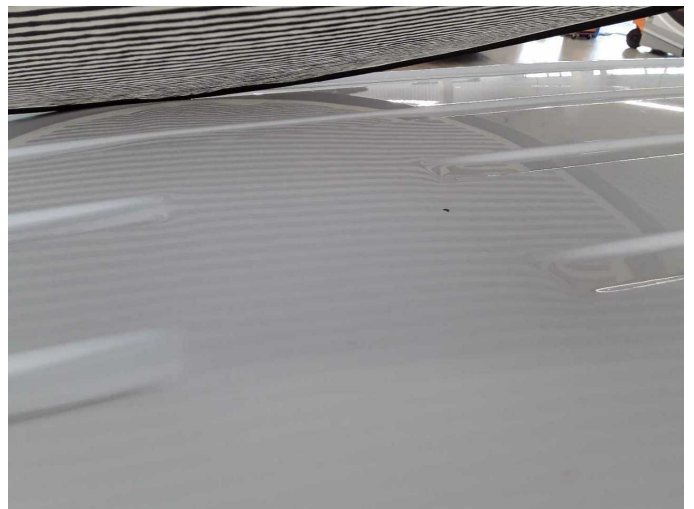
| No. | Component group | Description |
|---|---|---|
| 10 | Roof | Roof - dent(s) - Smart repair |

**Damage 10:** Roof: Roof - dent(s) - Smart repair

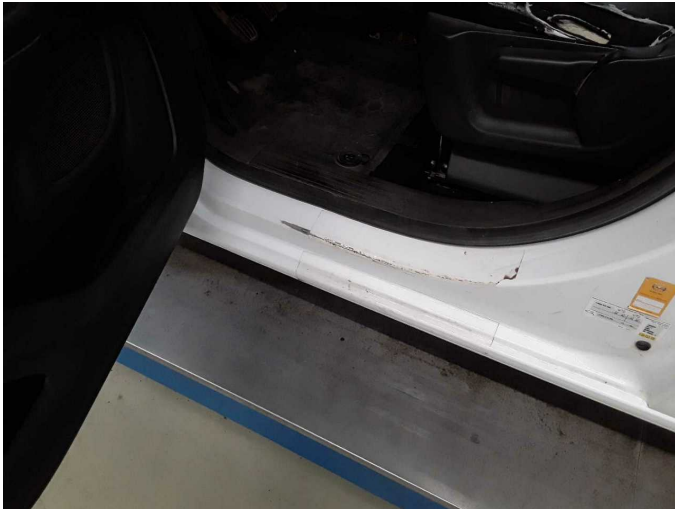
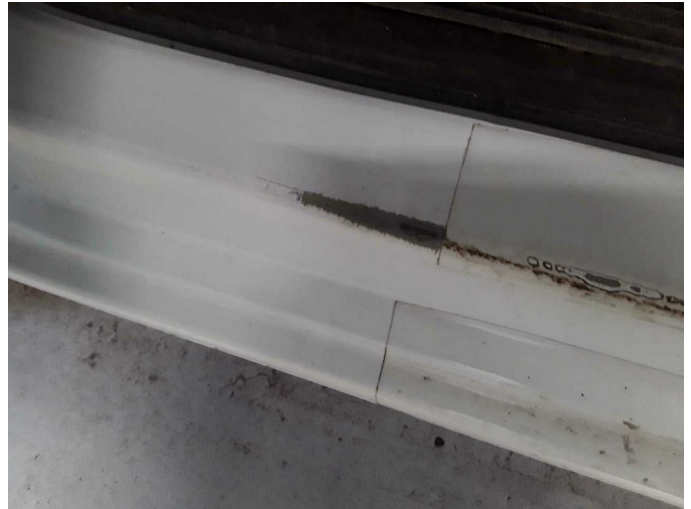
| No. | Component group | Description |
|---|---|---|
| 11 | Sill - left side | Sill - Scratched - Paint |

**Damage 11:** Sill - left side: Sill - Scratched - Paint

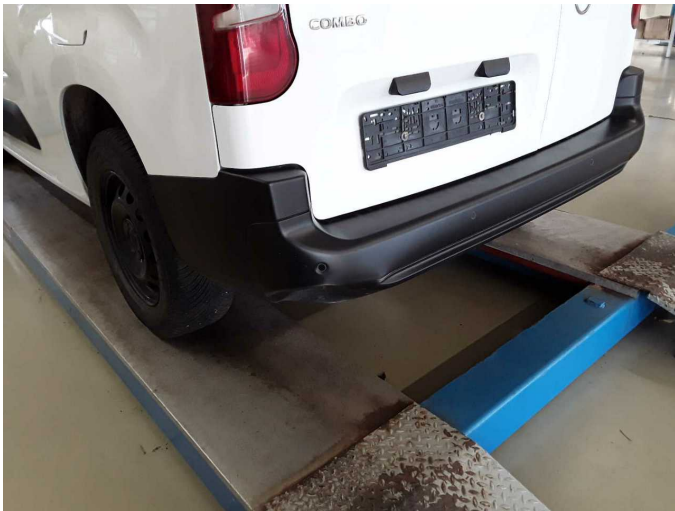
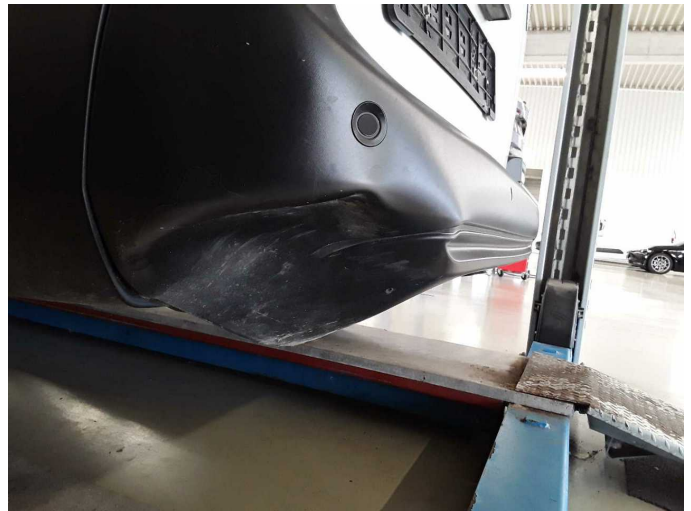
| No. | Component group | Description |
|---|---|---|
| 12 | Rear bumper | Bumper with Parktronic - Deformed - Replace |

**Damage 12:** Rear bumper: Bumper with Parktronic - Deformed - Replace

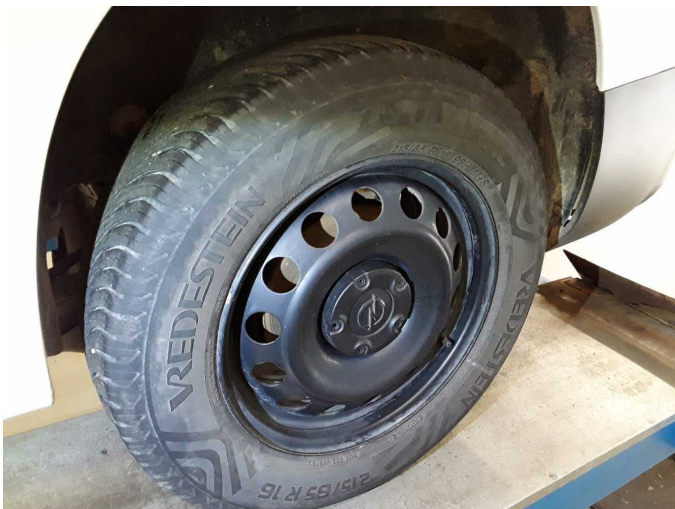
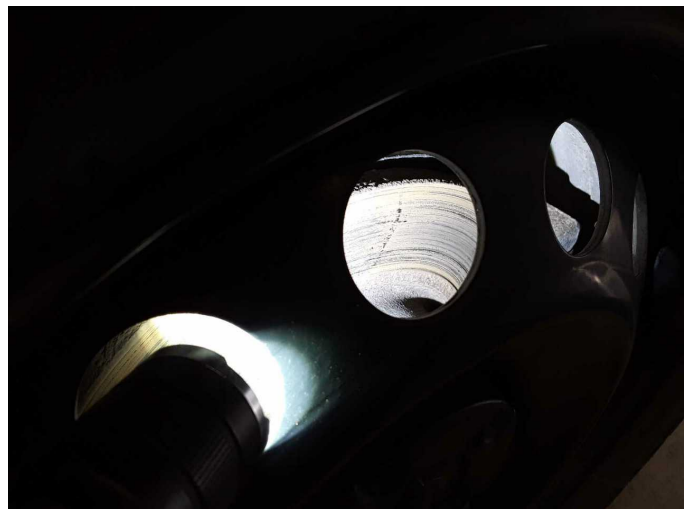
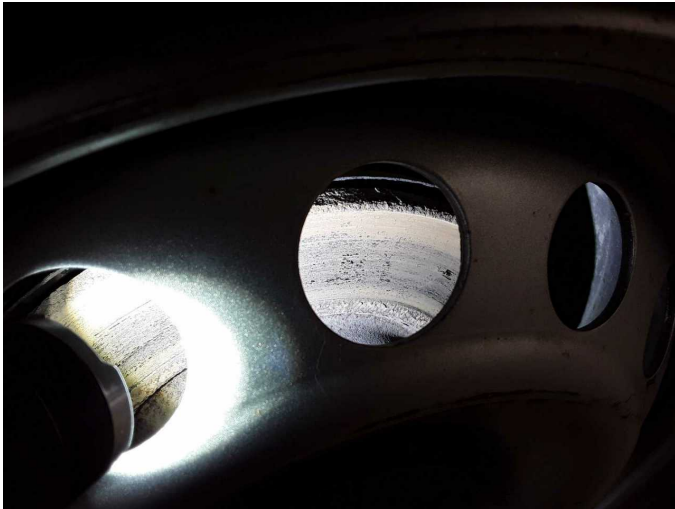
| No. | Component group | Description |
|---|---|---|
| 13 | Braking system | Brake discs and pads - rear (schlechtes Tragbild und Rostrand) - Corrosion - Replace |

**Damage 13:** Braking system: Brake discs and pads - rear (schlechtes Tragbild und Rostrand) - Corrosion - Replace

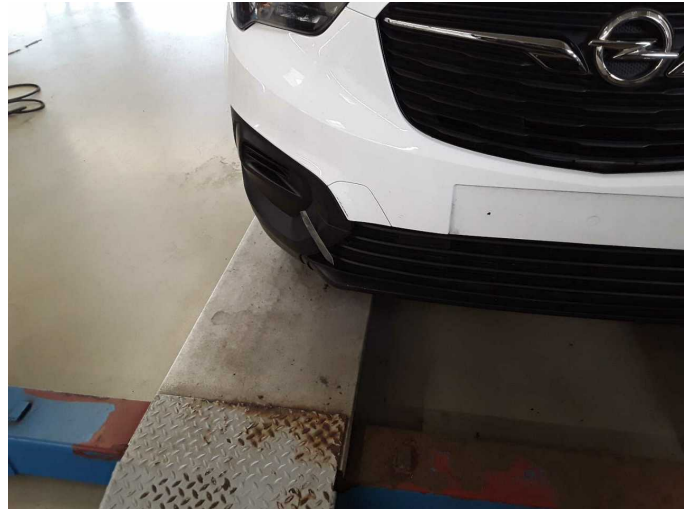
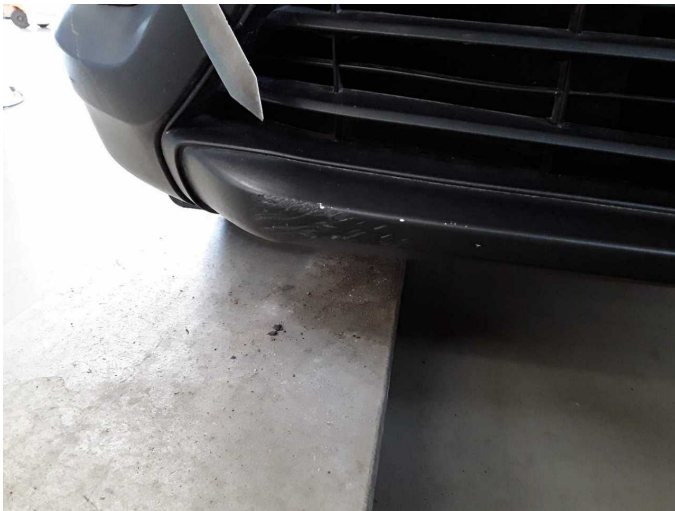
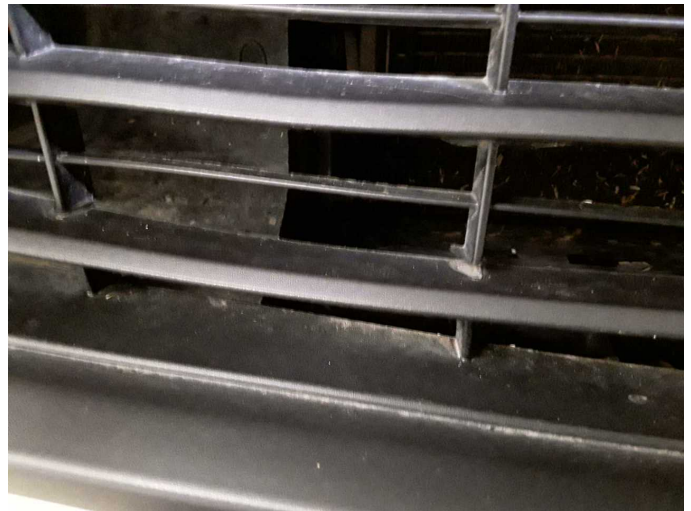
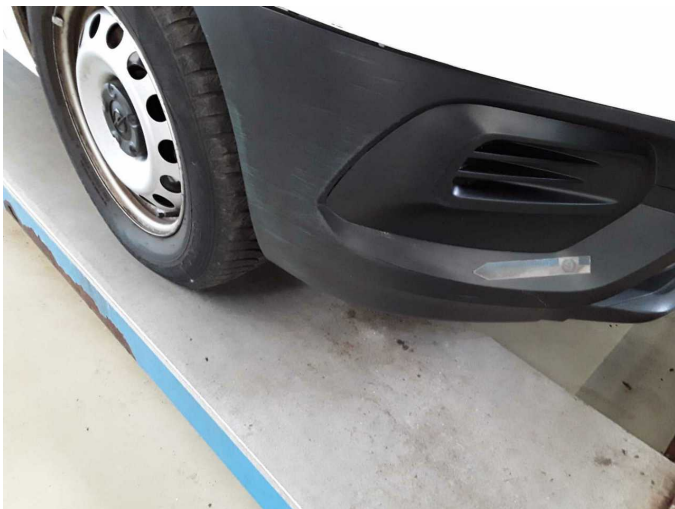
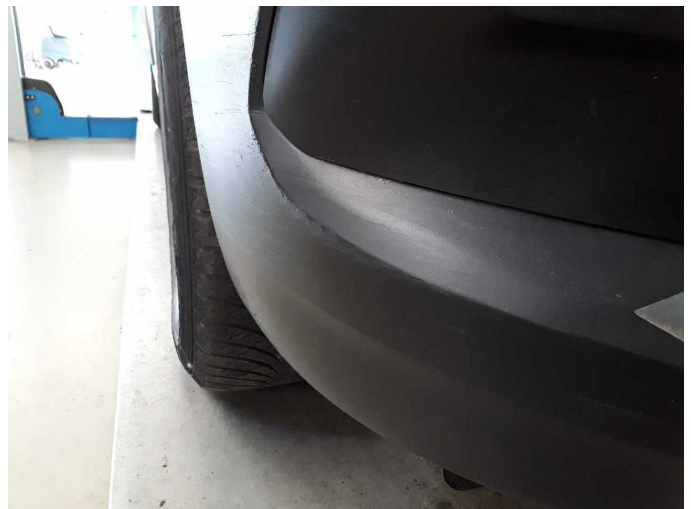
| No. | Component group | Description |
|---|---|---|
| 14 | Front bumper | Front bumper (Unterteil) - Deformed - Replace |

**Damage 14:** Front bumper: Front bumper (Unterteil) - Deformed - Replace

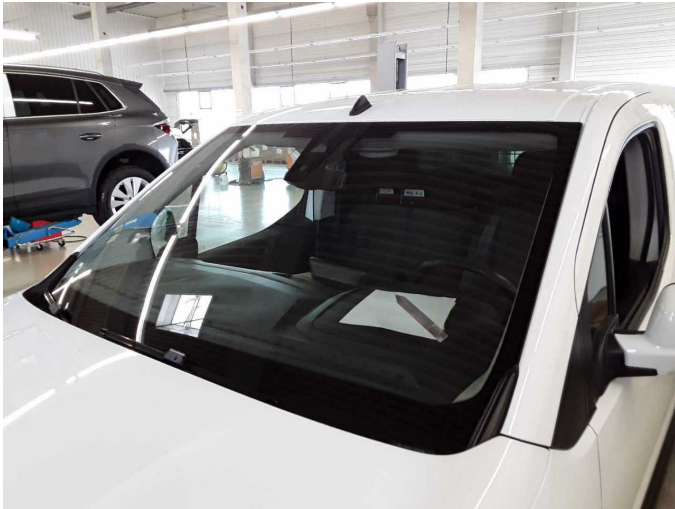
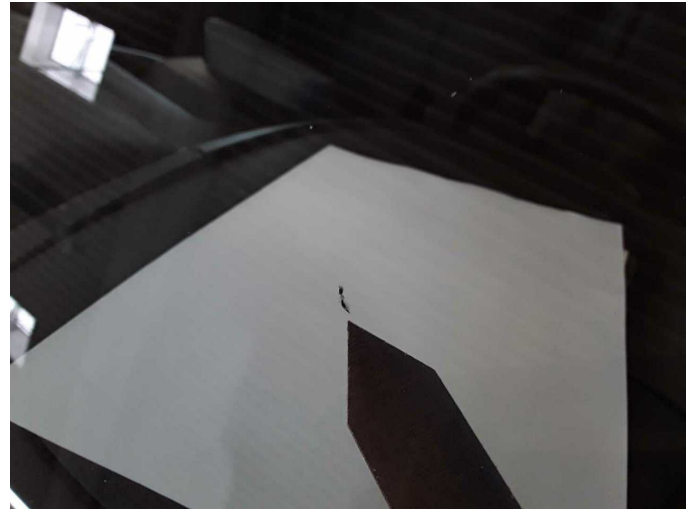
| No. | Component group | Description |
|---|---|---|
| 15 | Vehicle glazing | Windscreen with rain sensor (Rißbildung) - Stone chips - Replace |

**Damage 15:** Vehicle glazing: Windscreen with rain sensor (Rißbildung) - Stone chips - Replace

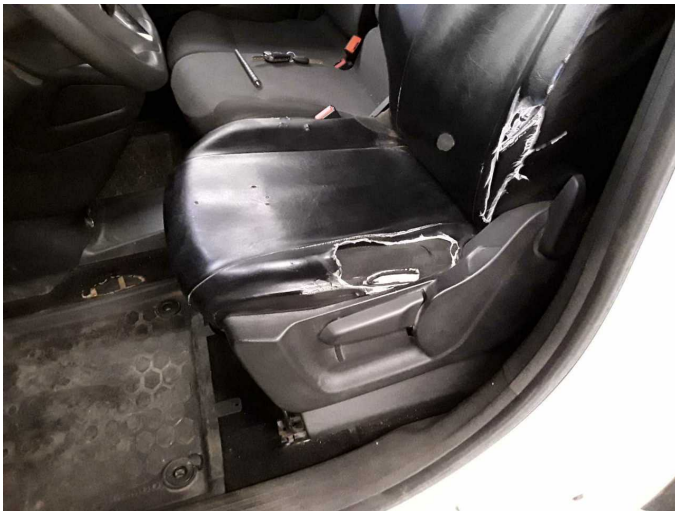
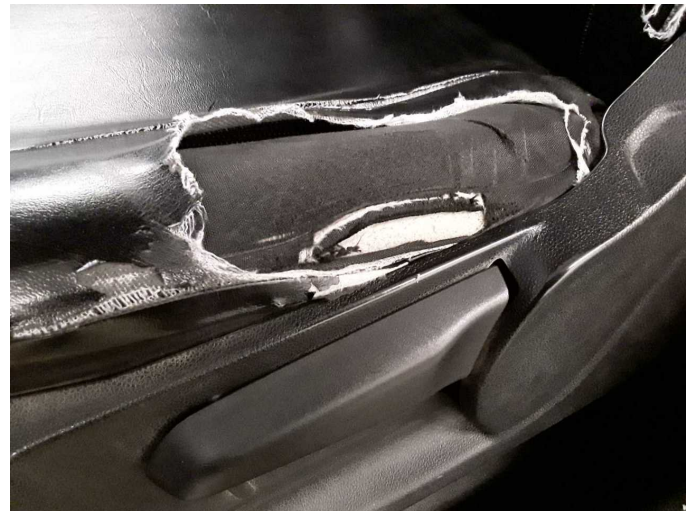
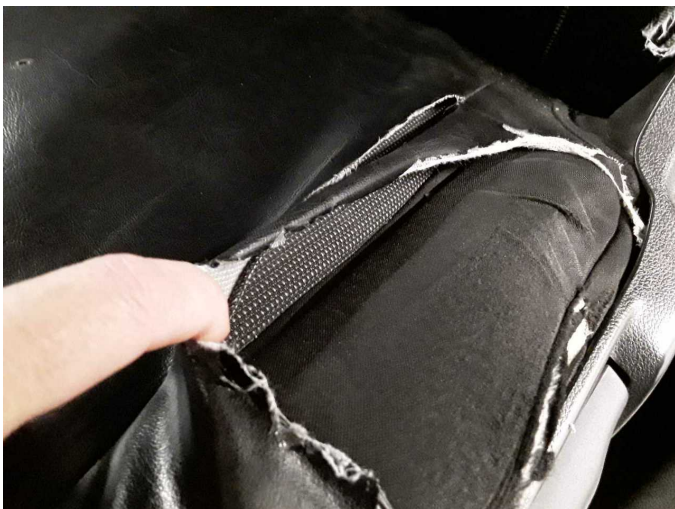
| No. | Component group | Description |
|---|---|---|
| 16 | Seat - front | Seat cover - left side (inkl. Polster) - Broken / torn - Replace |

**Damage 16:** Seat - front: Seat cover - left side (inkl. Polster) - Broken / torn - Replace

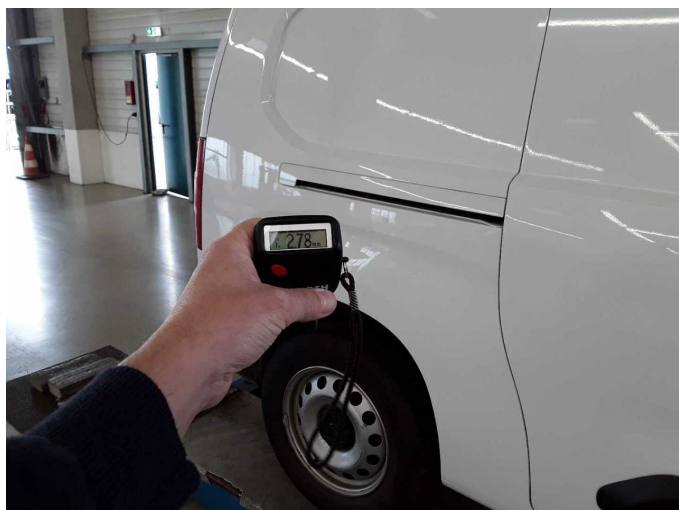
1 Sill - right side, Side panel - rear right side, Door - rear right side, Professionally carried out

| Sill - right side | 192 µm | Side panel - rear right side | 2,780 µm |

**Side panel - rear right side: 2,780 µm**
