Expertise

Protocol number: 41580514  
Order No. / Reference: 25233287  
Inspection date: 16 Sept 2025

Model: Combo Cargo XL 1.5 D EHZ Edition

VIN: W0VEFYHYCMJ854575

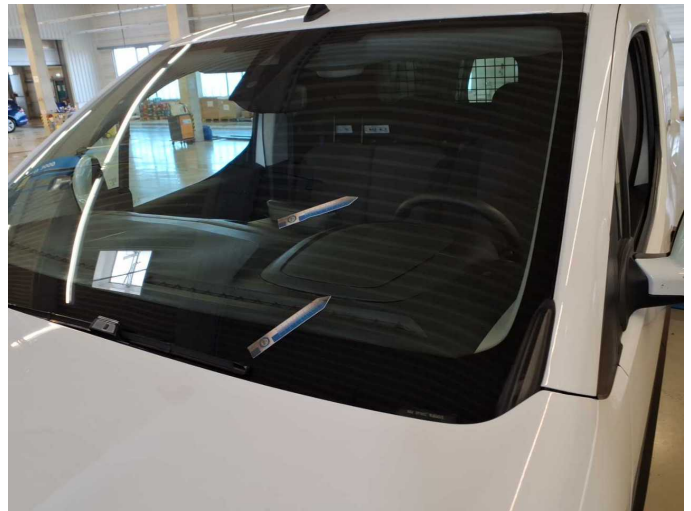
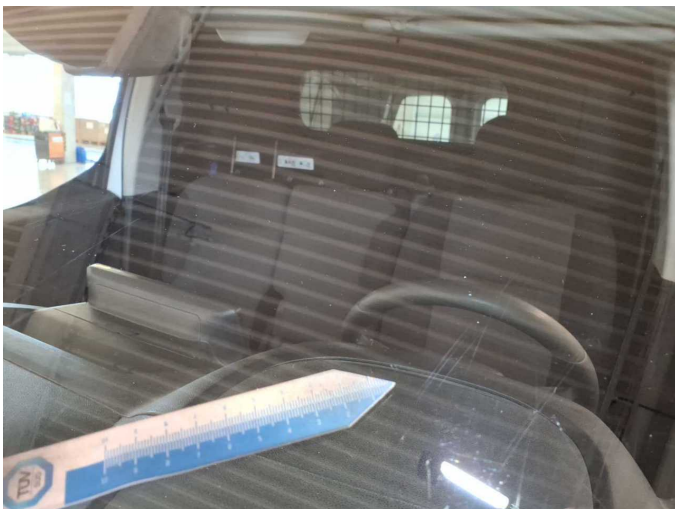
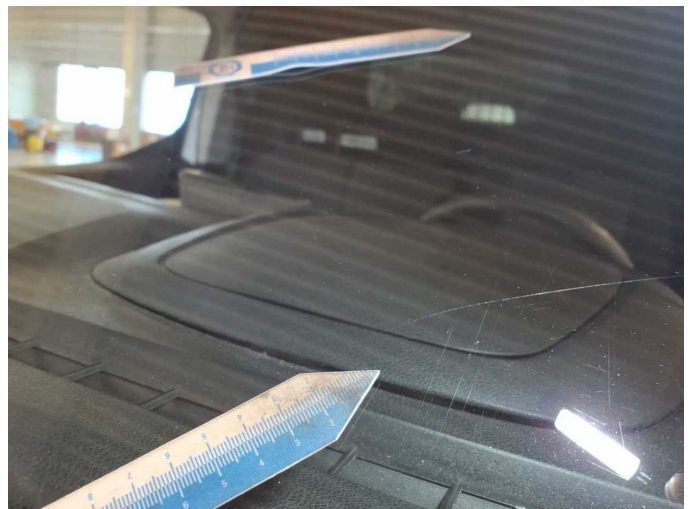
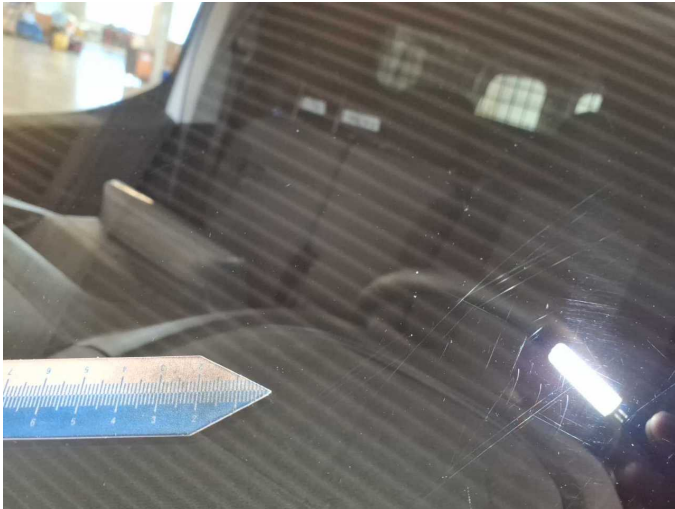
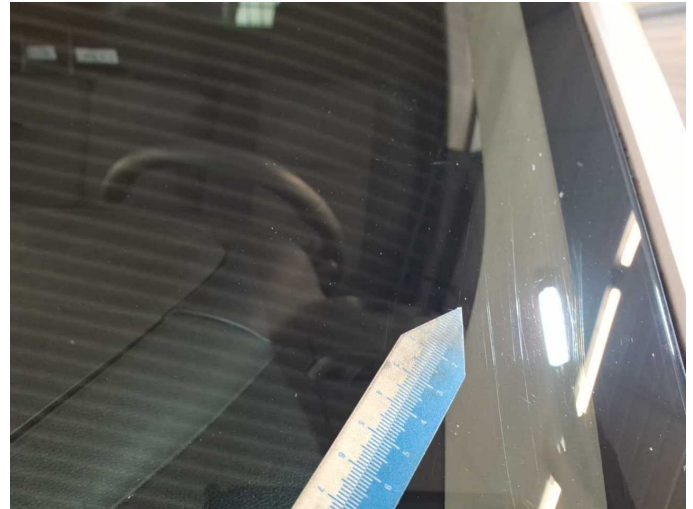
| No. | Component group | Description |
|---|---|---|
| 1 | Vehicle glazing | Windscreen - Scratch(es) - No deduction |

Damage 1: Vehicle glazing: Windscreen - Scratch(es) - No deduction

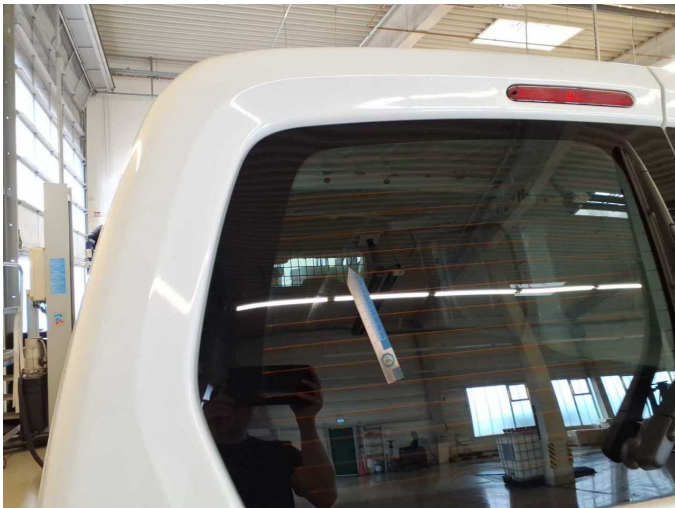
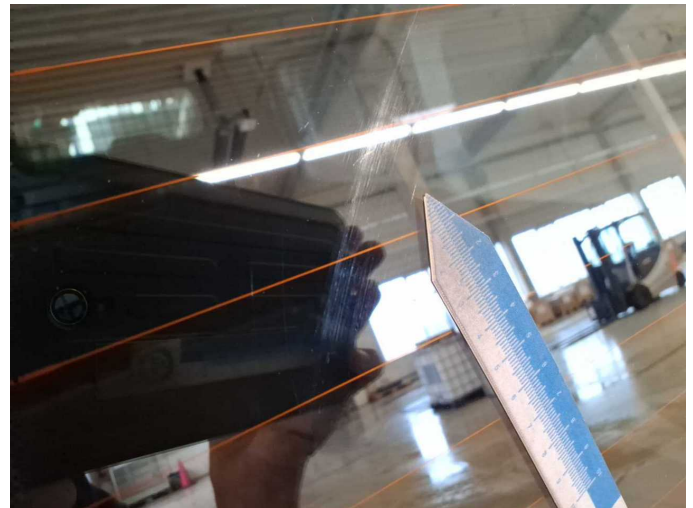
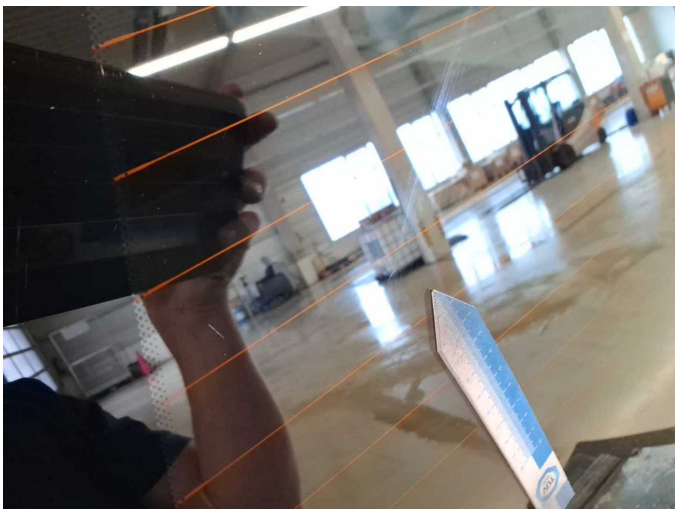
| No. | Component group | Description |
|---|---|---|
| 2 | Vehicle glazing | Rear window heated (links) - Scratch(es) - Loss in value |

**Damage 2:** Vehicle glazing: Rear window heated (links) - Scratch(es) - Loss in value

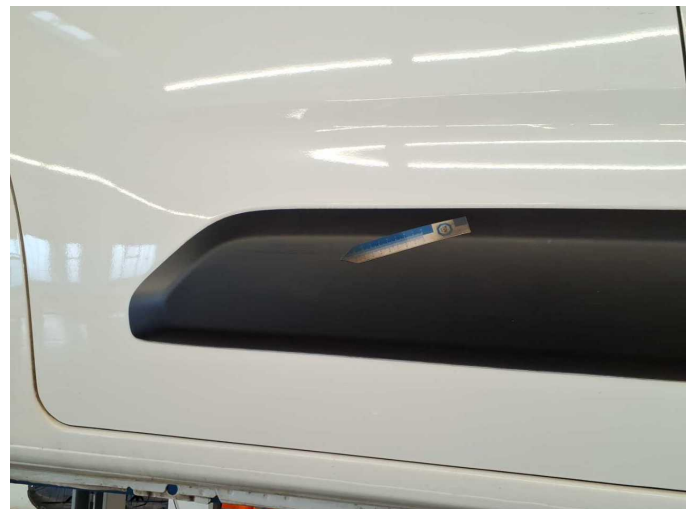
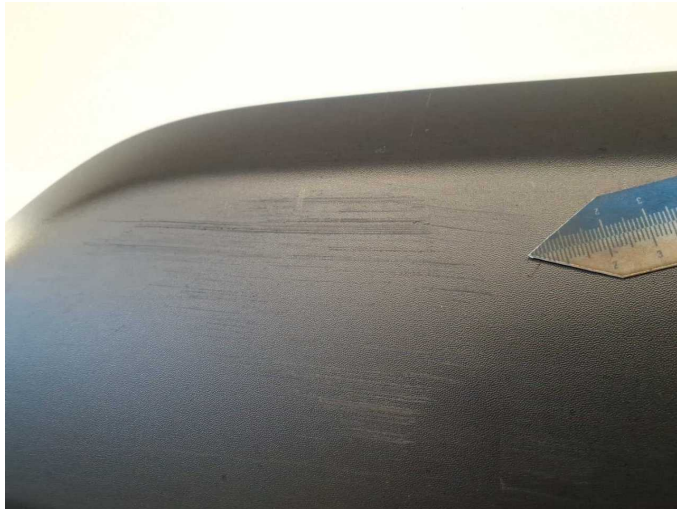
| No. | Component group | Description |
|---|---|---|
| 3 | Sliding door, right | Protection strip - Scratch(es) - Loss in value |

**Damage 3:** Sliding door, right: Protection strip - Scratch(es) - Loss in value

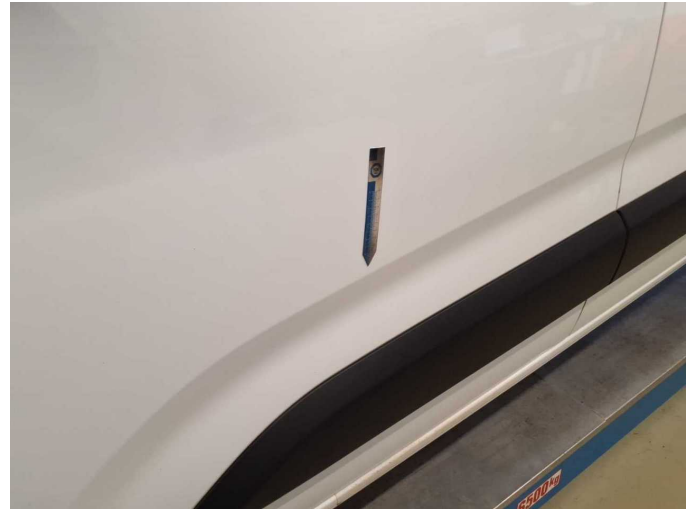
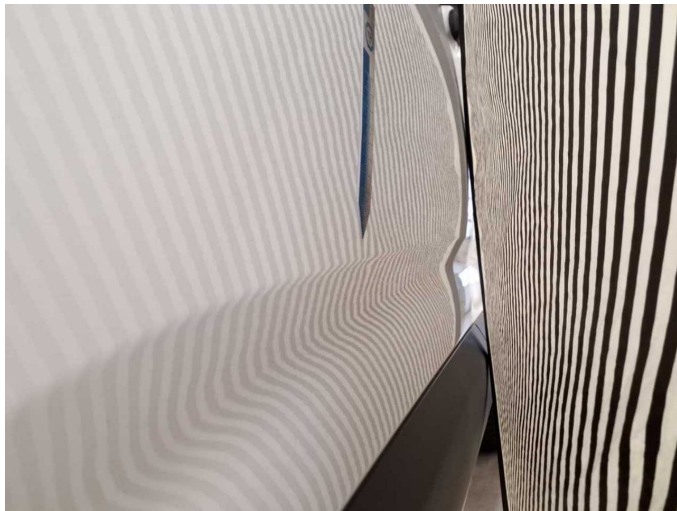
| No. | Component group | Description |
|---|---|---|
| 4 | Door - front left side | Door - dent(s) - Smart repair |

**Damage 4:** Door - front left side: Door - dent(s) - Smart repair

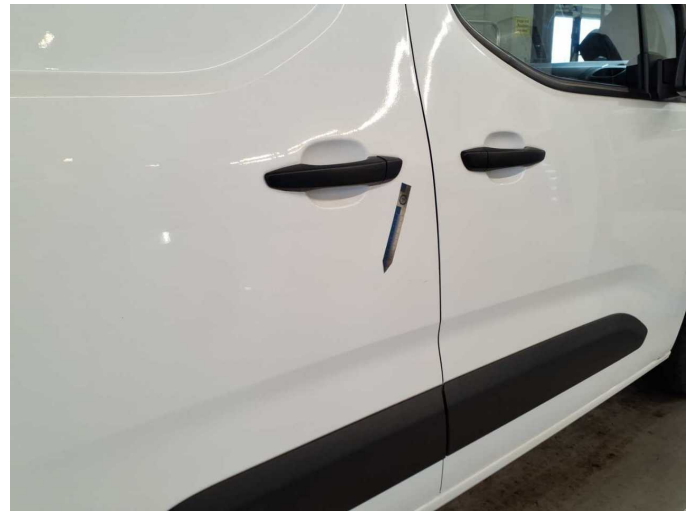
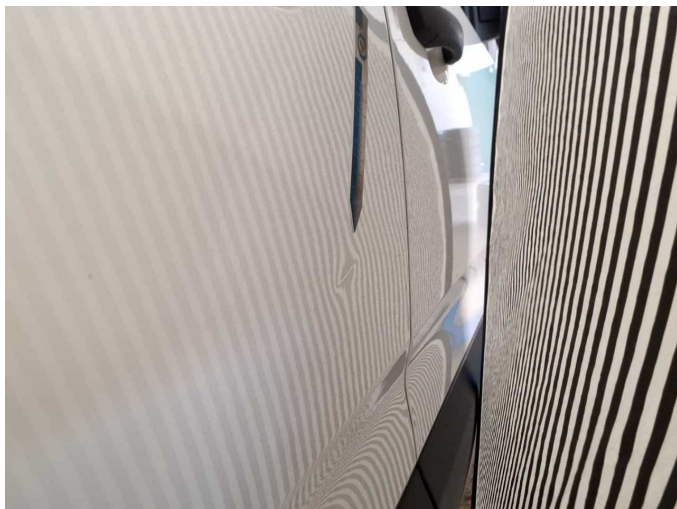
| No. | Component group | Description |
|---|---|---|
| 5 | Sliding door, right | Sliding door - dent(s) - Smart repair |

**Damage 5:** Sliding door, right: Sliding door - dent(s) - Smart repair

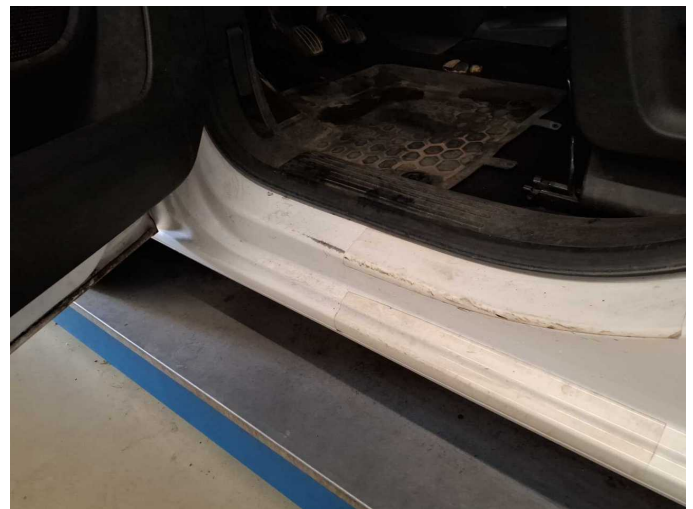
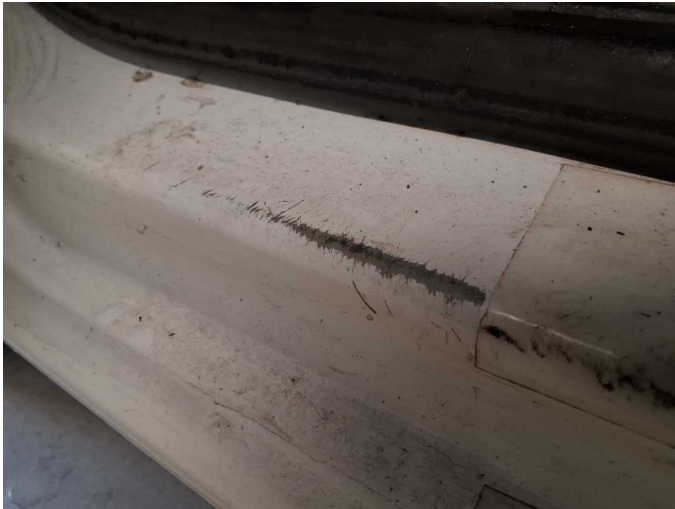
| No. | Component group | Description |
|---|---|---|
| 6 | Sill - left side | Sill - Scratched - Smart repair |

**Damage 6:** Sill - left side: Sill - Scratched - Smart repair

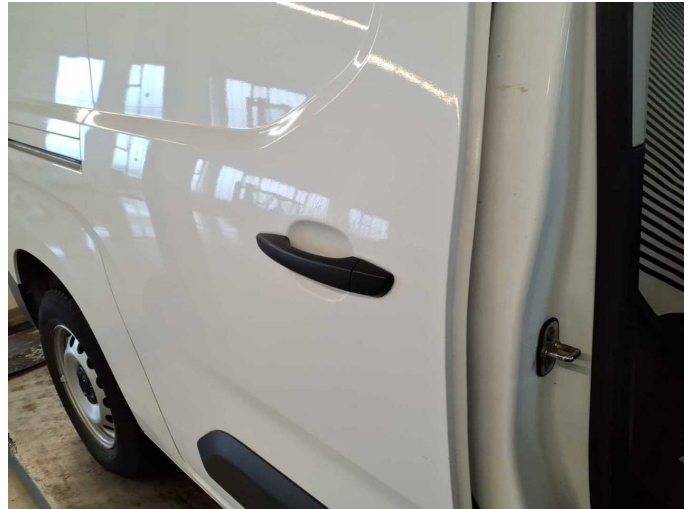
| No. | Component group | Description |
|---|---|---|
| 7 | Sliding door, right | Sliding door (lässt sich nicht öffnen - Mehrkosten können entstehen) - Functional / admissibility - Perform diagnosis |

**Damage 7:** Sliding door, right: Sliding door (lässt sich nicht öffnen - Mehrkosten können entstehen) - Functional / admissibility - Perform diagnosis

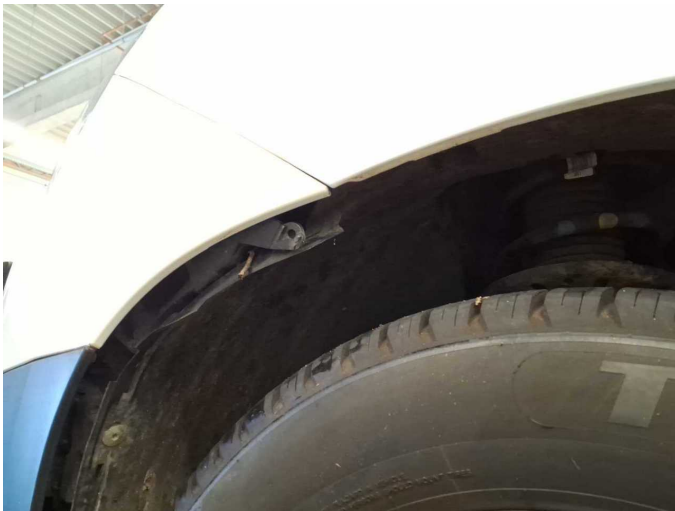
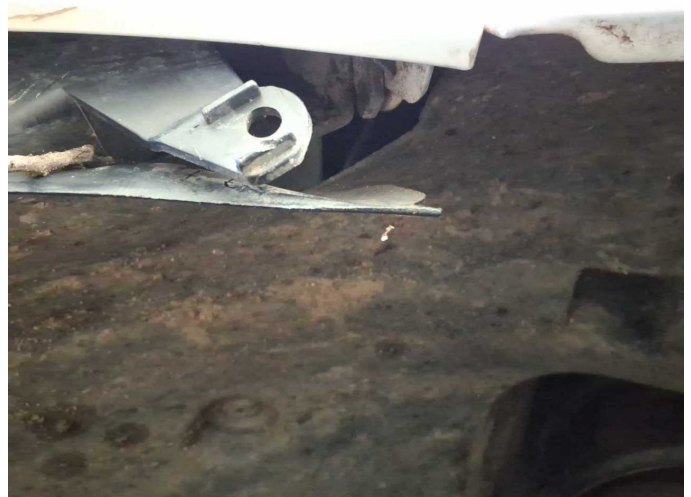
| No. | Component group | Description |
|---|---|---|
| 8 | Mudguard - left side | Inner mudguard - Broken / torn - Replace |

**Damage 8:** Mudguard - left side: Inner mudguard - Broken / torn - Replace

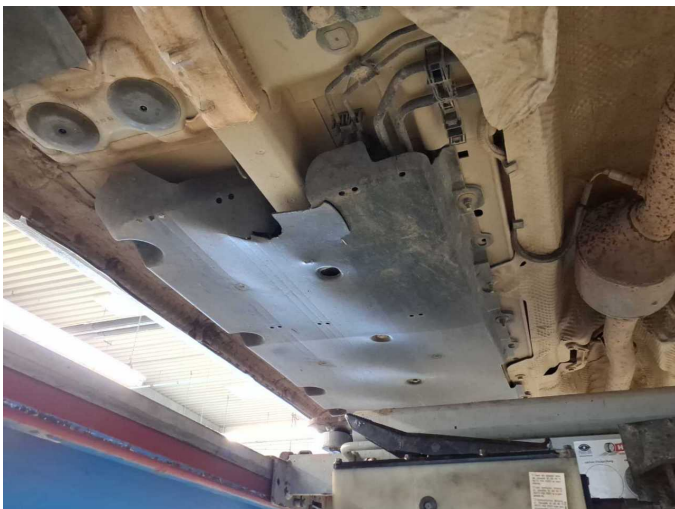
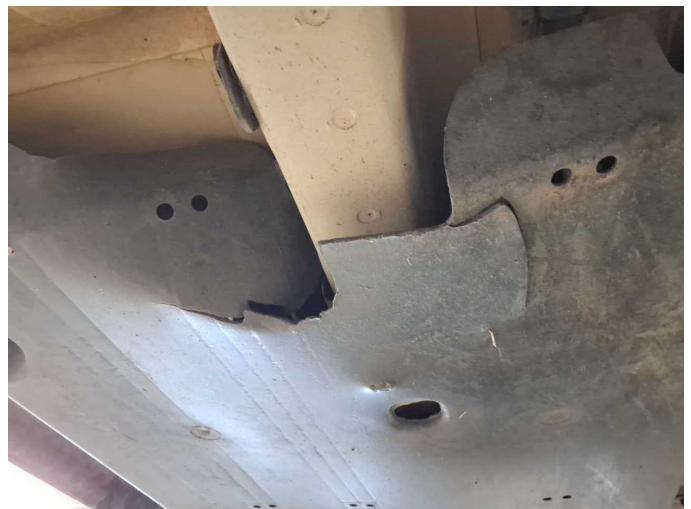
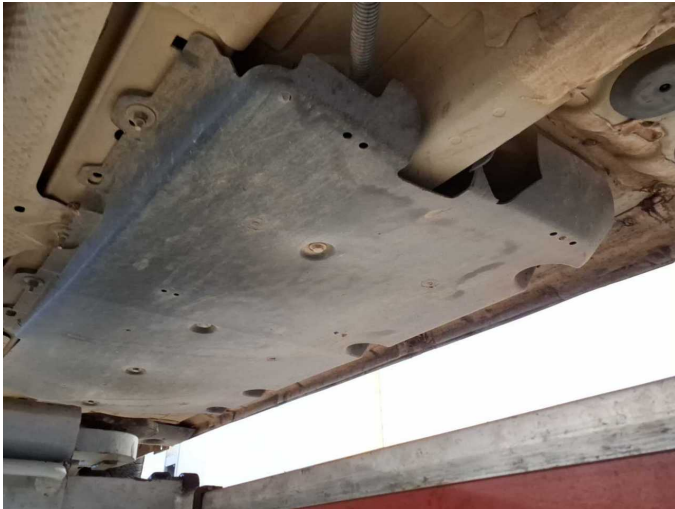
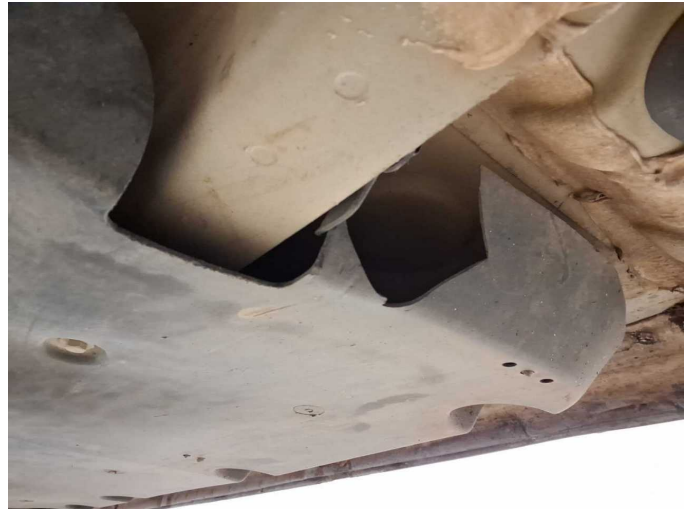
| No. | Component group | Description |
|---|---|---|
| 9 | Body | Underbody panelling (rechts + links) - Broken / torn - Replace |

**Damage 9:** Body: Underbody panelling (rechts + links) - Broken / torn - Replace

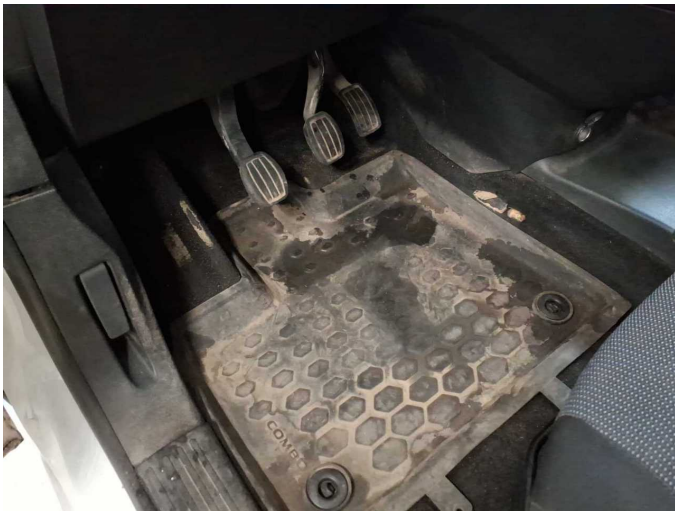
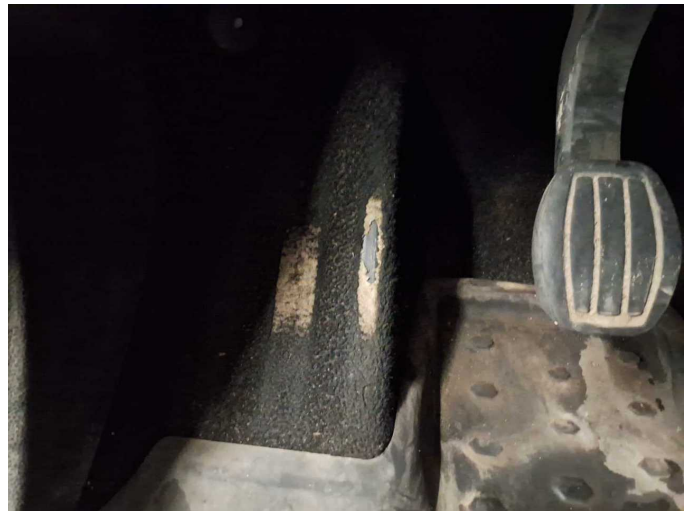
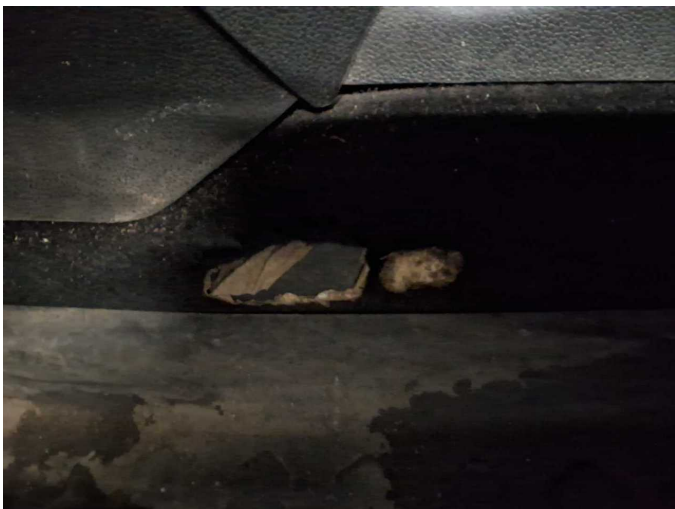
| No. | Component group | Description |
|---|---|---|
| 10 | Trim / covers | Carpet - front left side - Broken / torn - Replace |

**Damage 10:** Trim / covers: Carpet - front left side - Broken / torn - Replace

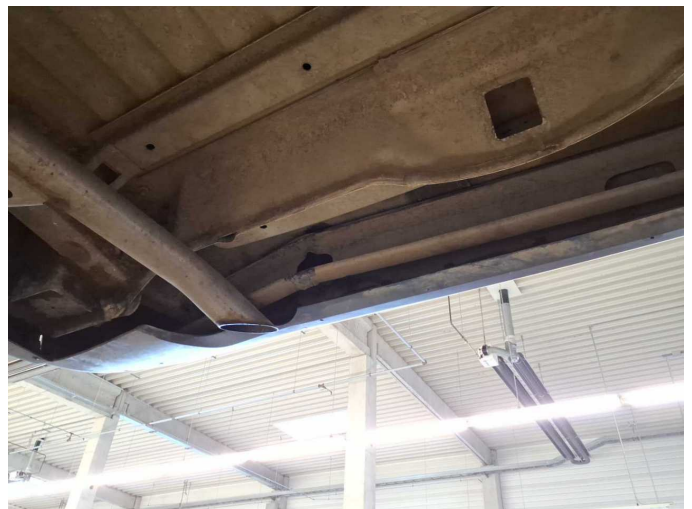
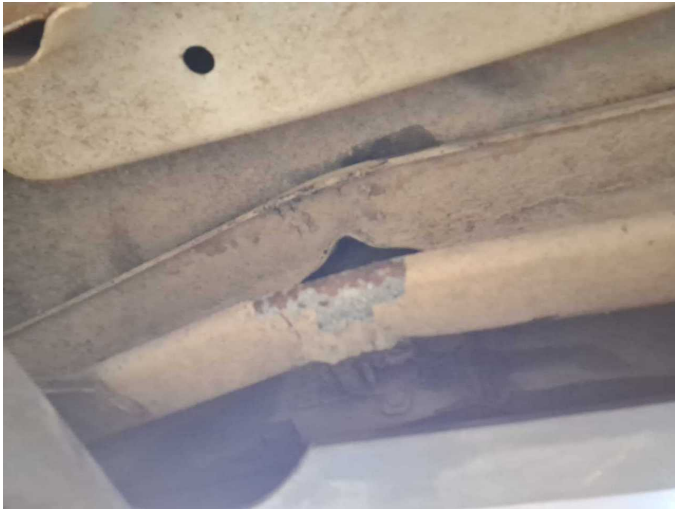
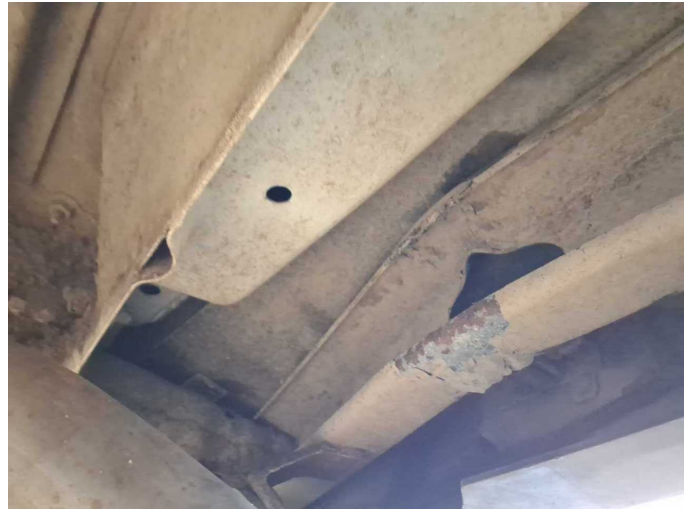
| No. | Component group | Description |
|---|---|---|
| 11 | Rear of vehicle | Crossmember - Deformed - Replace |

**Damage 11:** Rear of vehicle: Crossmember - Deformed - Replace

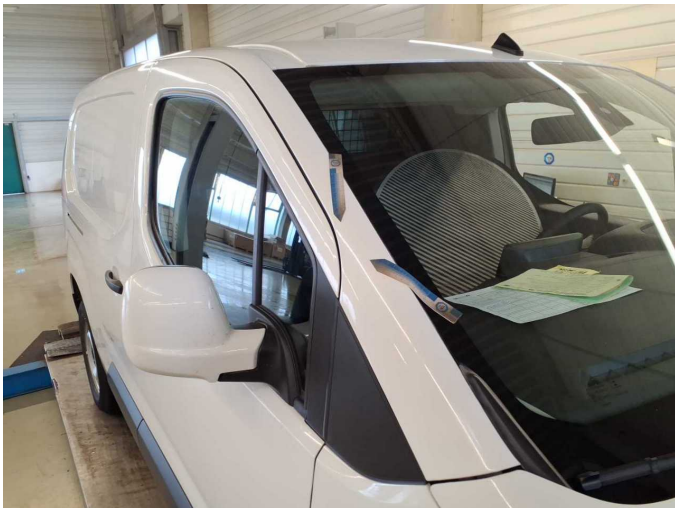
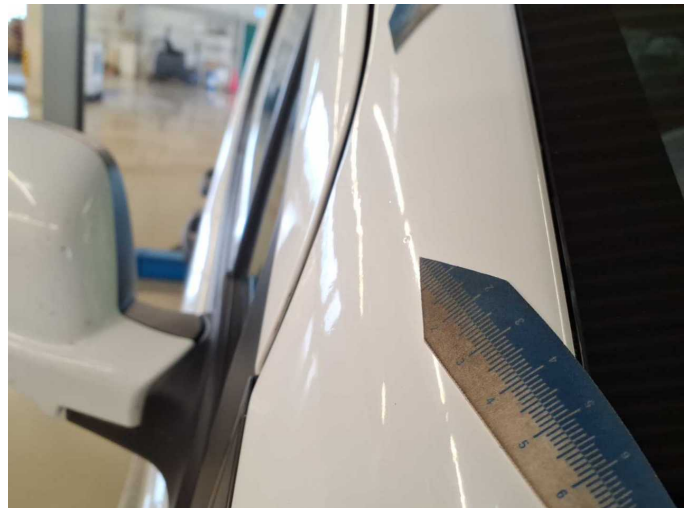
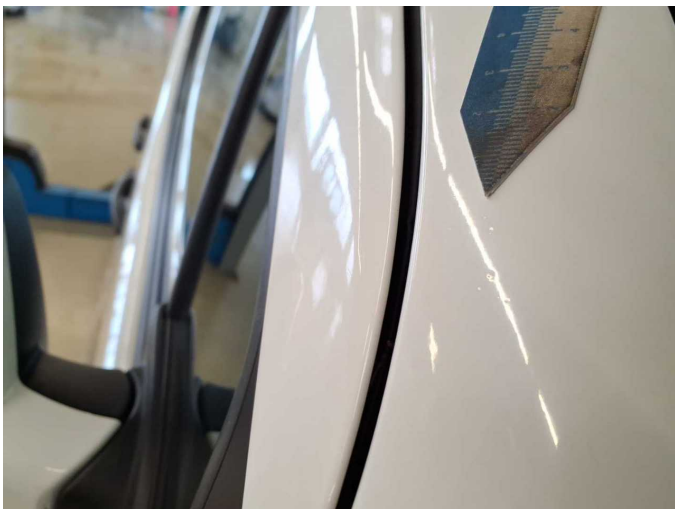
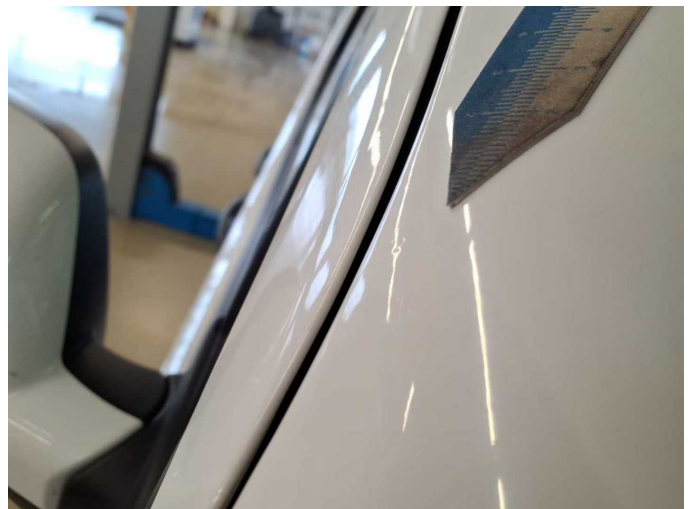
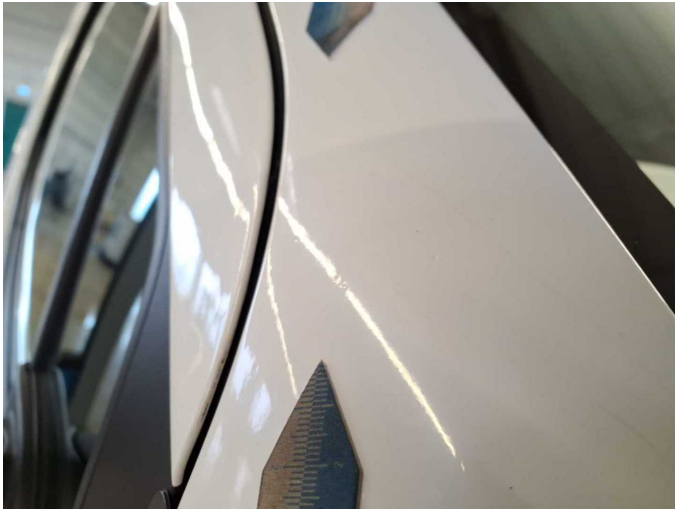
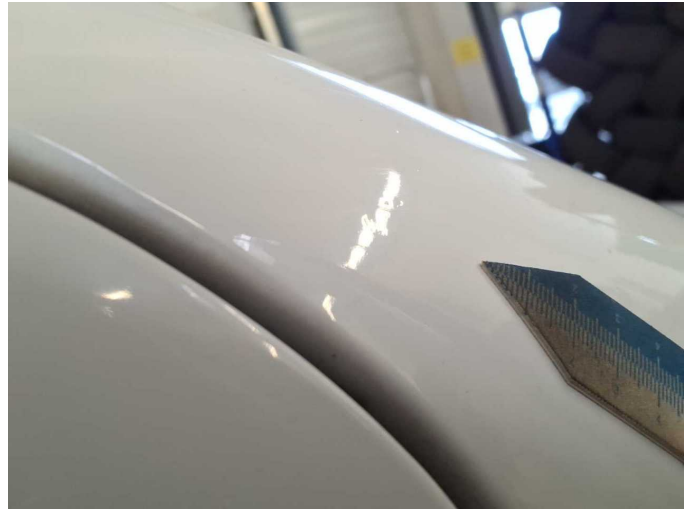
| No. | Component group | Description |
|---|---|---|
| 12 | Roof | Roof rail - right side (A-Säule Lackeinschlüsse) - Unprofessionally repaired - Repair and paint |

- 1 Roof rail - right side, Side panel - rear right side, Door - rear right side, Door - front right side, Unprofessionally carried out

| Roof rail - right side | 1,340<br>µm | Side panel - rear right side | 215 µm |

**Damage 12:** Roof: Roof rail - right side (A-Säule Lackeinschlüsse) - Unprofessionally repaired - Repair and paint

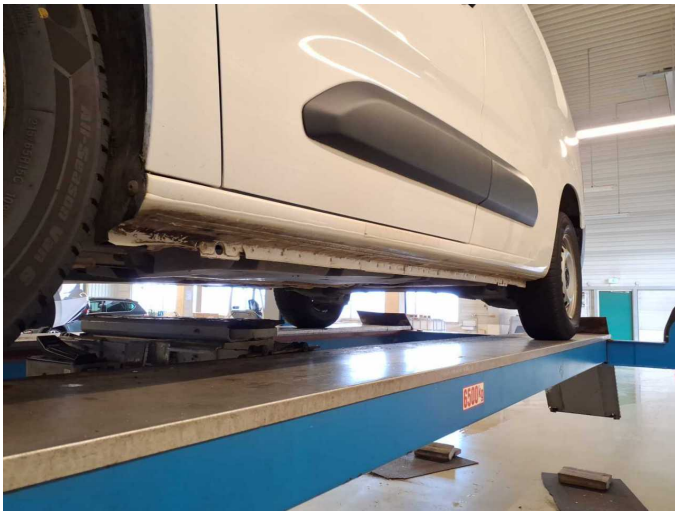
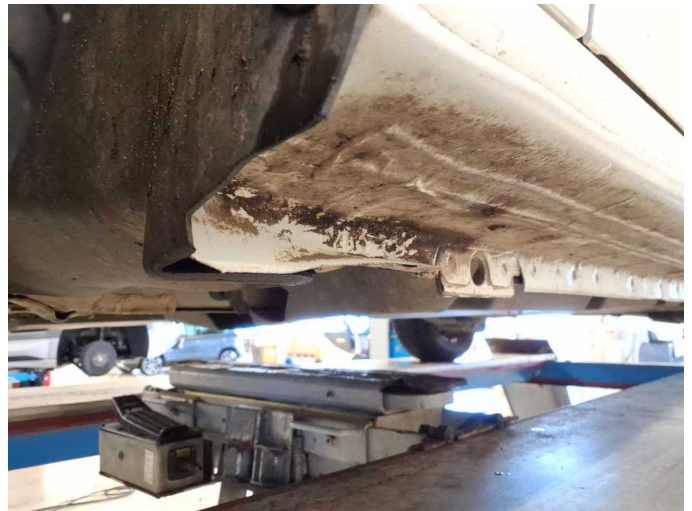
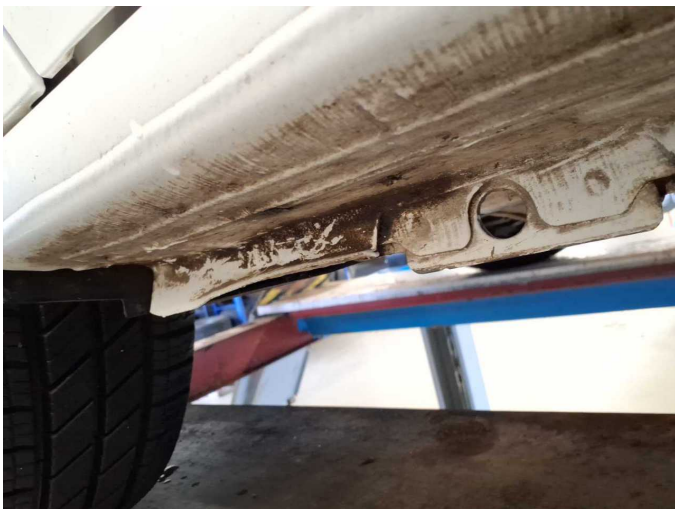
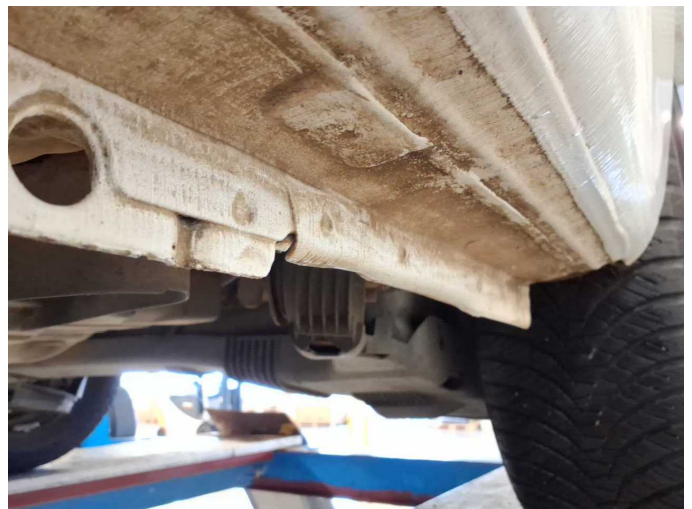
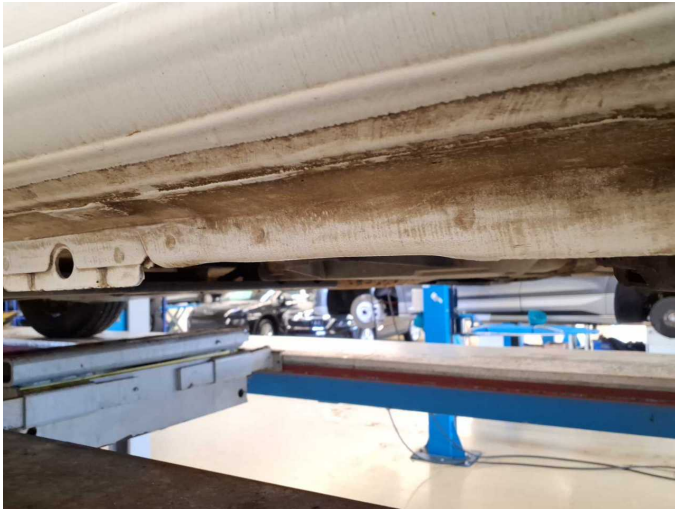
| No. | Component group | Description |
|---|---|---|
| 13 | Sill - left side | Sill - Deformed - Repair and paint |

**Damage 13:** Sill - left side: Sill - Deformed - Repair and paint

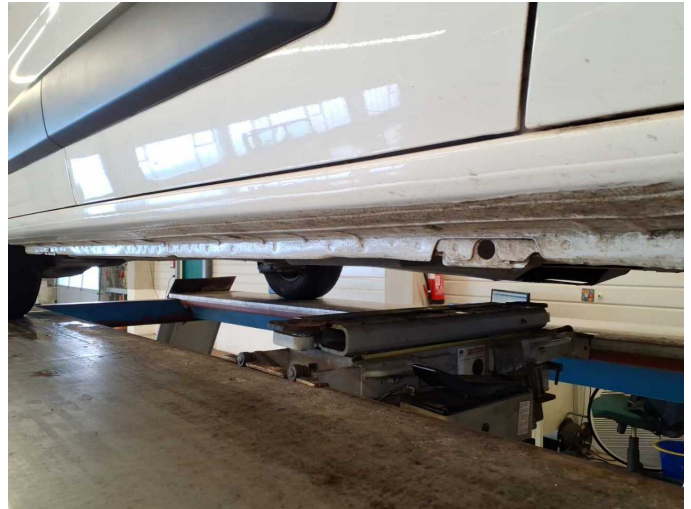
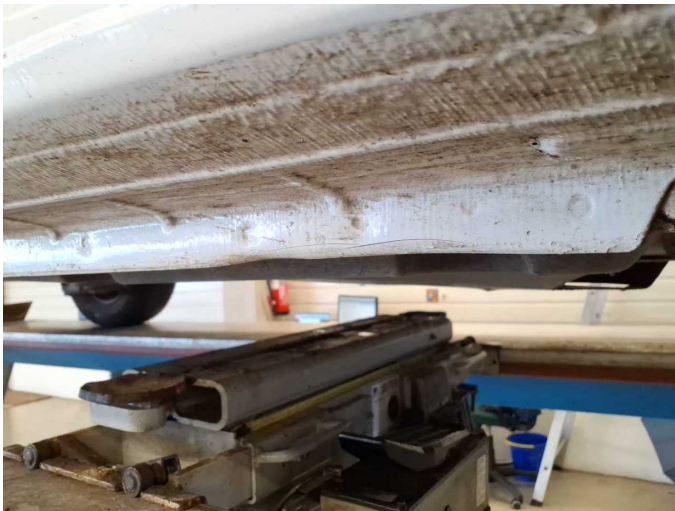
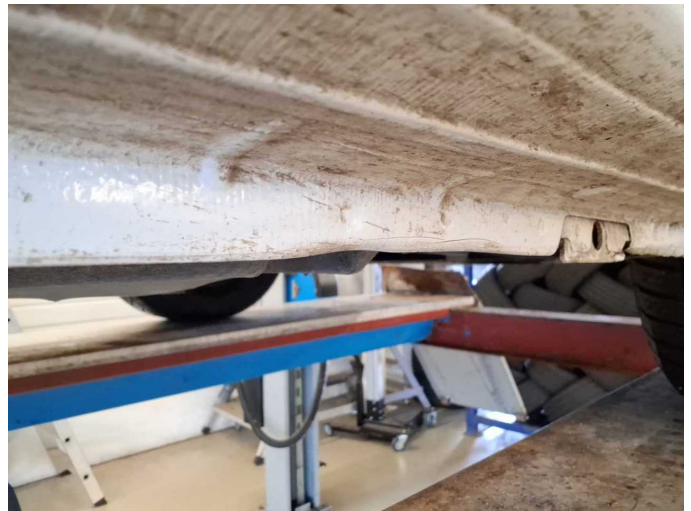
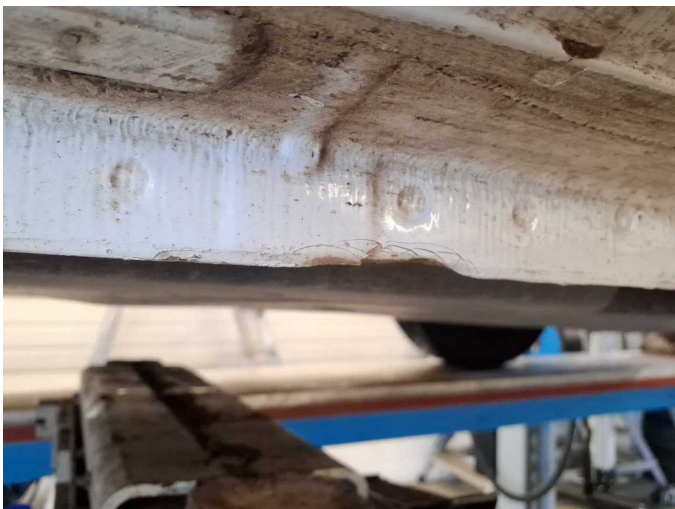
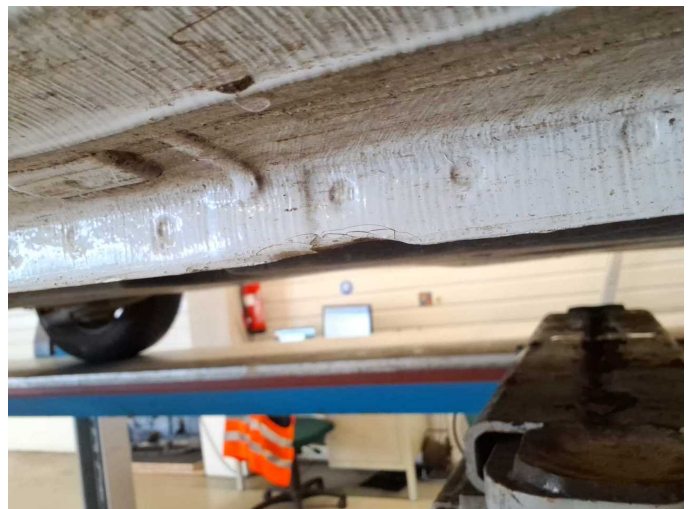
| No. | Component group | Description |
|---|---|---|
| 14 | Sill - right side | Sill - Deformed - Repair and paint |

**Damage 14:** Sill - right side: Sill - Deformed - Repair and paint

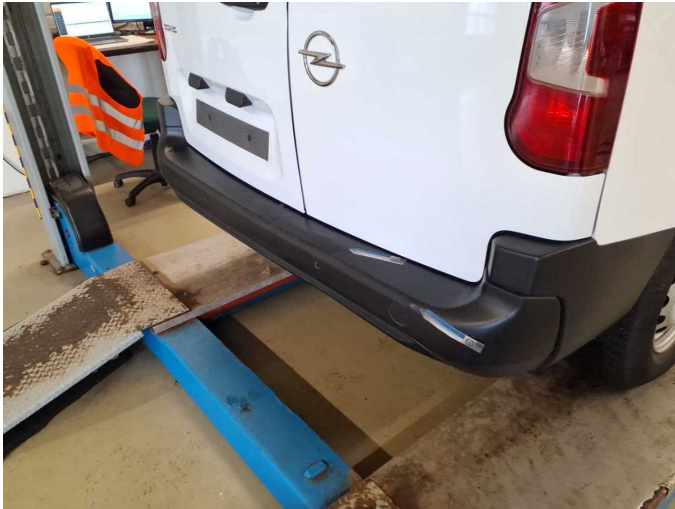
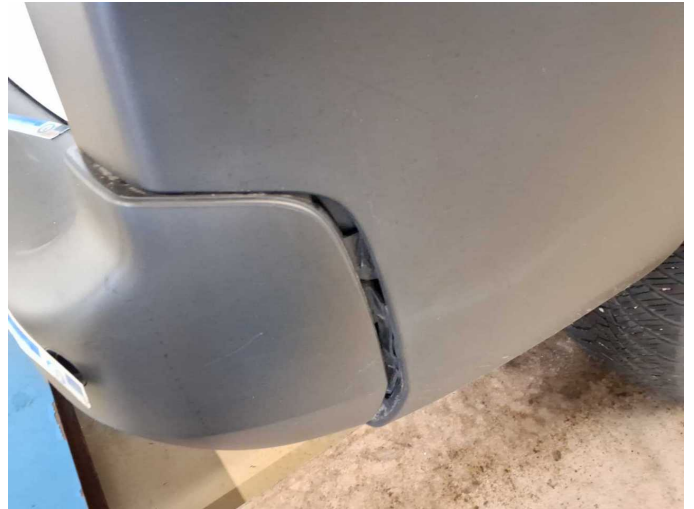
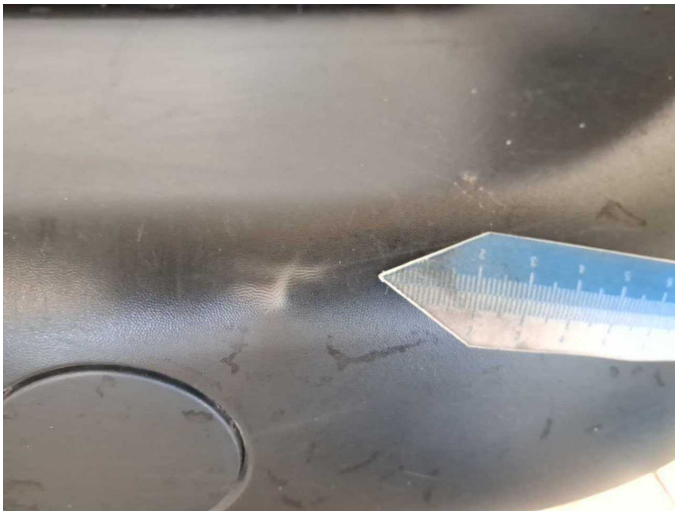
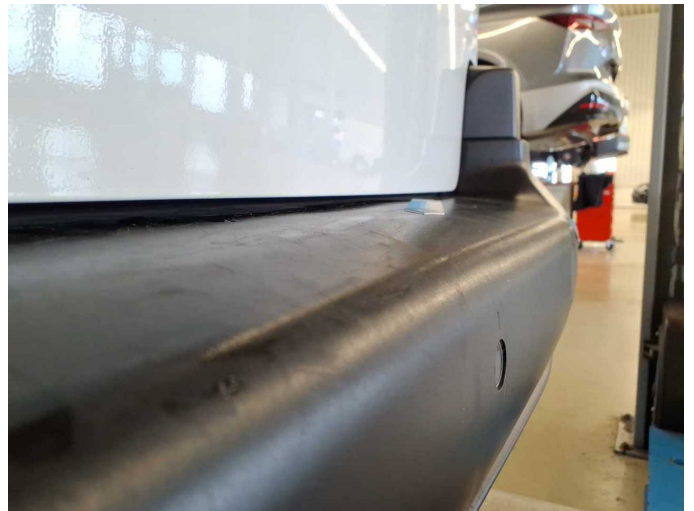
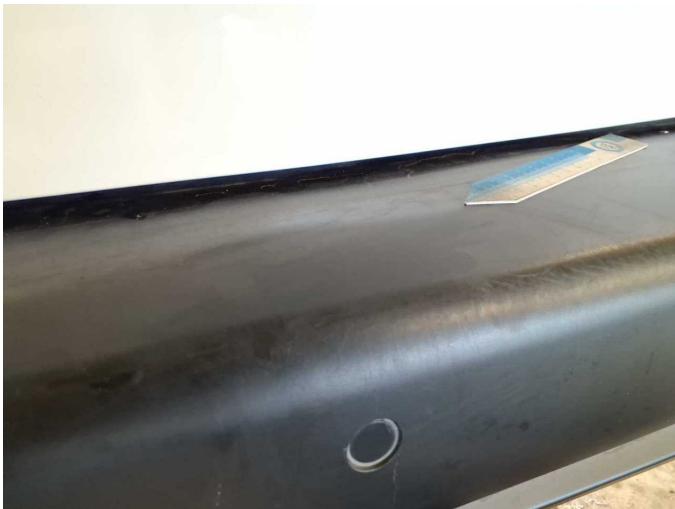
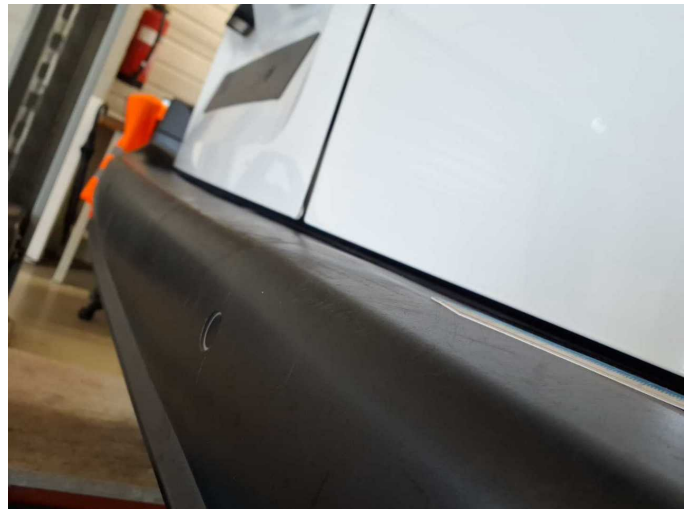
| No. | Component group | Description |
|---|---|---|
| 15 | Rear bumper | Bumper with Parktronic - Deformed - Replace |

**Damage 15:** Rear bumper: Bumper with Parktronic - Deformed - Replace

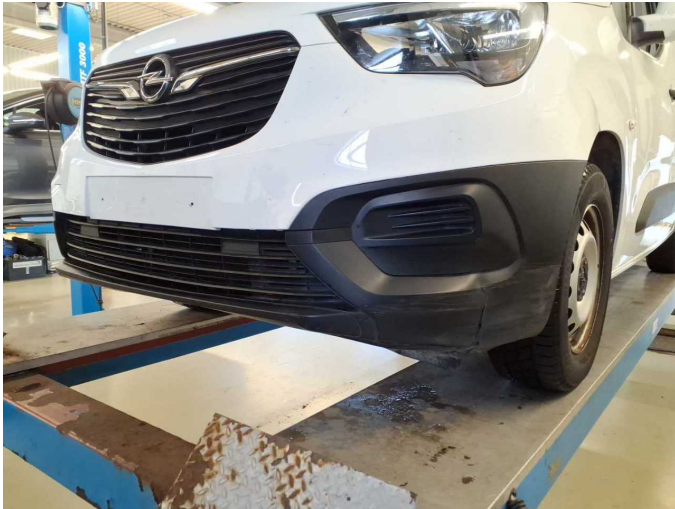
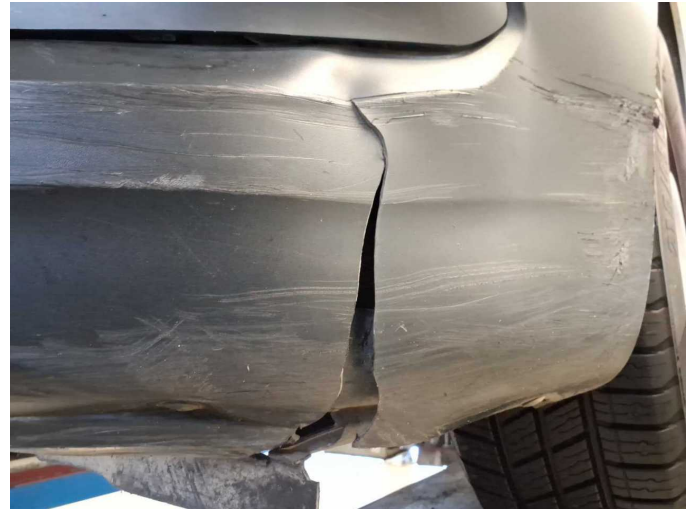
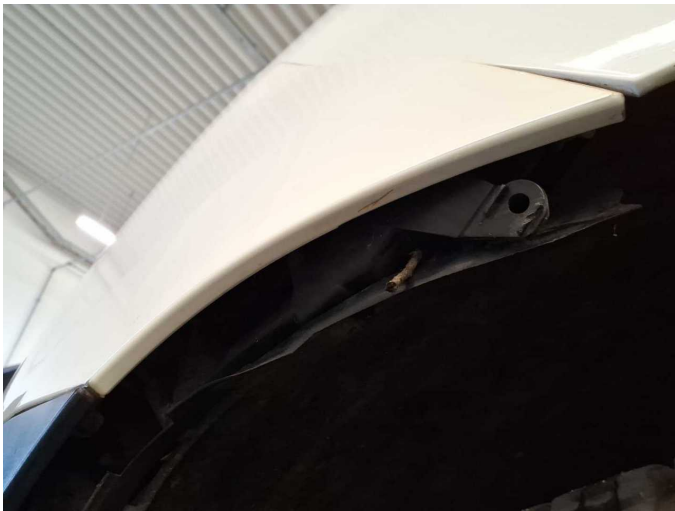
| No. | Component group | Description |
|---|---|---|
| 16 | Front bumper | Front bumper (Unterteil + Verstärkung links) - Broken / torn - Replace |

**Damage 16:** Front bumper: Front bumper (Unterteil + Verstärkung links) - Broken / torn - Replace

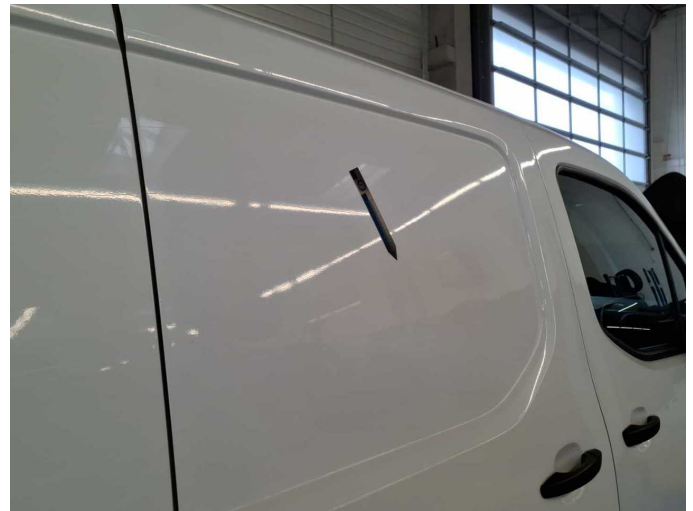
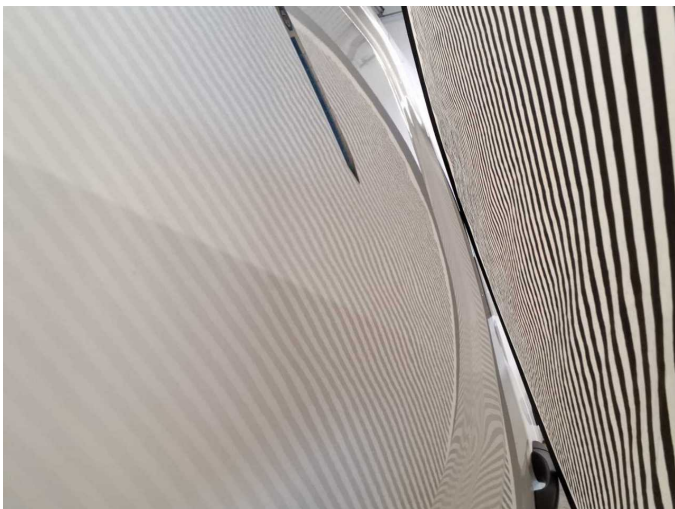
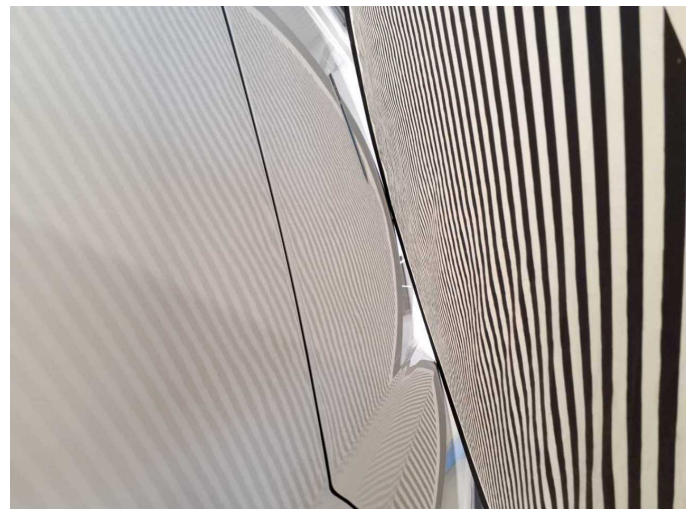
| No. | Component group | Description |
|---|---|---|
| 17 | Sliding door, right | Sliding door (wellig) - Unprofessionally repaired - Repair and paint |

**Damage 17:** Sliding door, right: Sliding door (wellig) - Unprofessionally repaired - Repair and paint

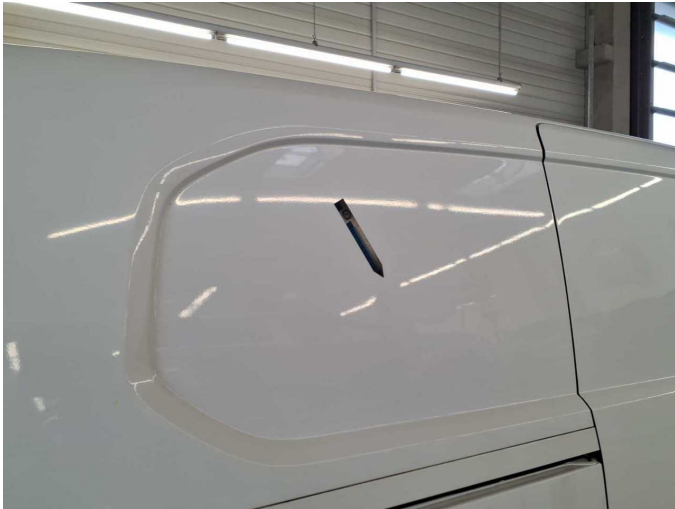
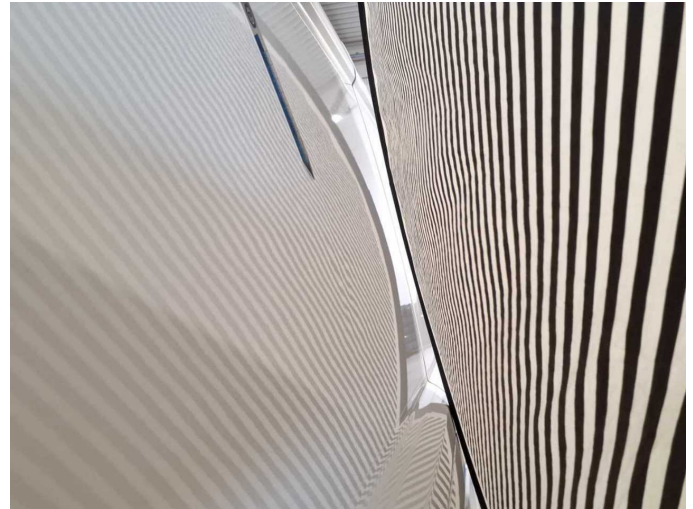
| No. | Component group | Description |
|---|---|---|
| 18 | Side panel - rear right side | Side panel (wellig) - Unprofessionally repaired - Repair and paint |

**Damage 18:** Side panel - rear right side: Side panel (wellig) - Unprofessionally repaired - Repair and paint
