Expertise

Protocol number: 41580514  
Order No. / Reference: 25233287  
Inspection date: 16 Sept 2025

Model: Combo Cargo XL 1.5 D EHZ Edition

VIN: W0VEFYHYCMJ854575

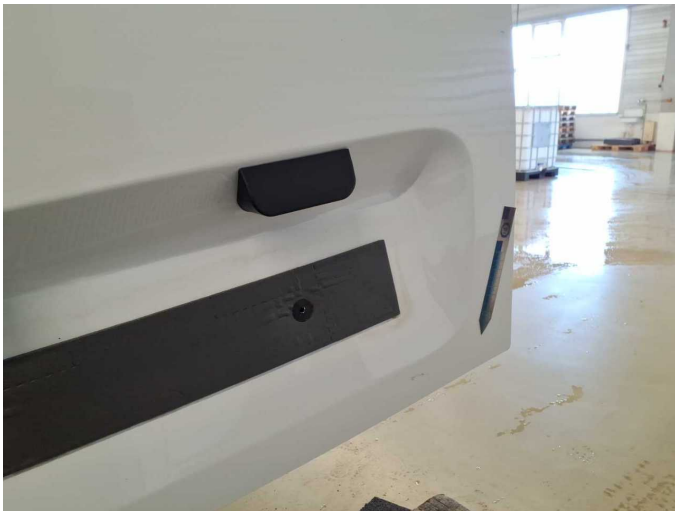
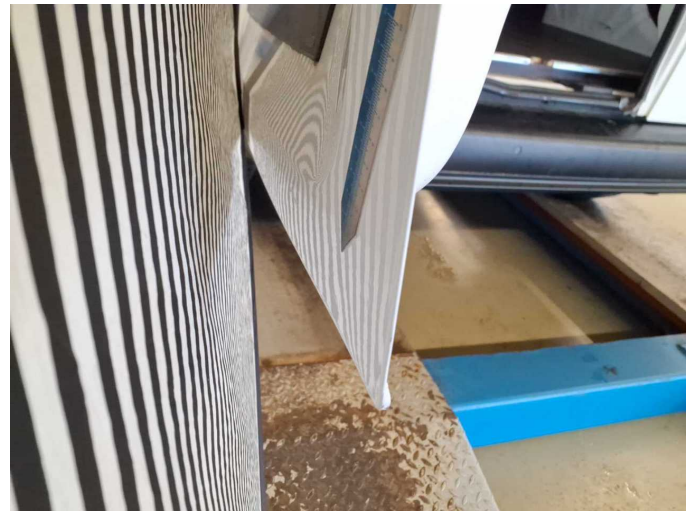
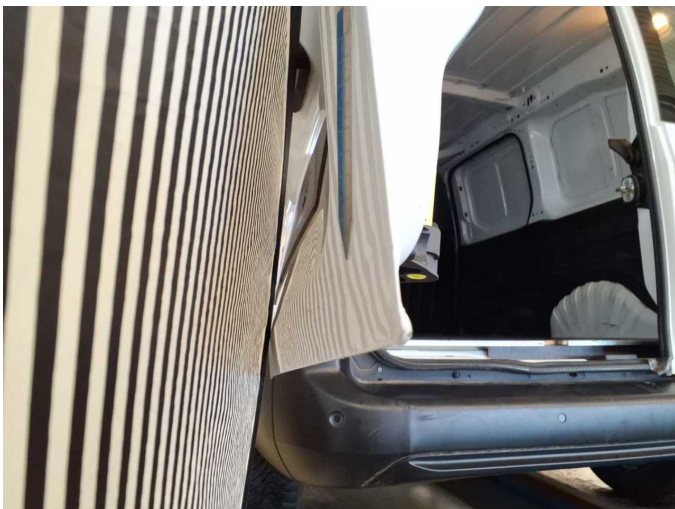
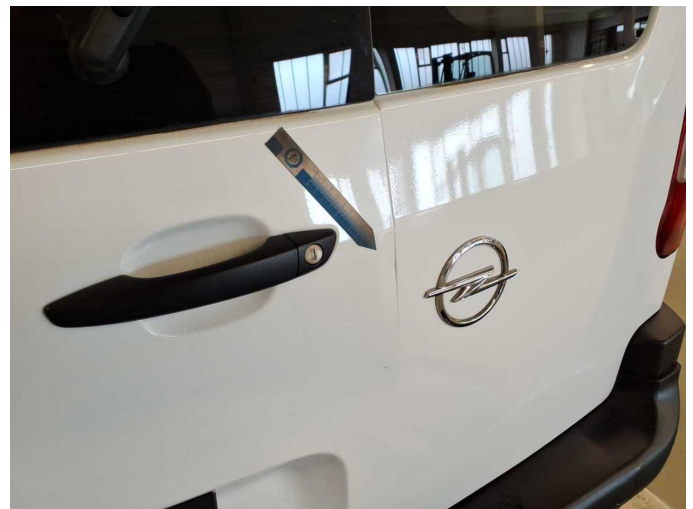
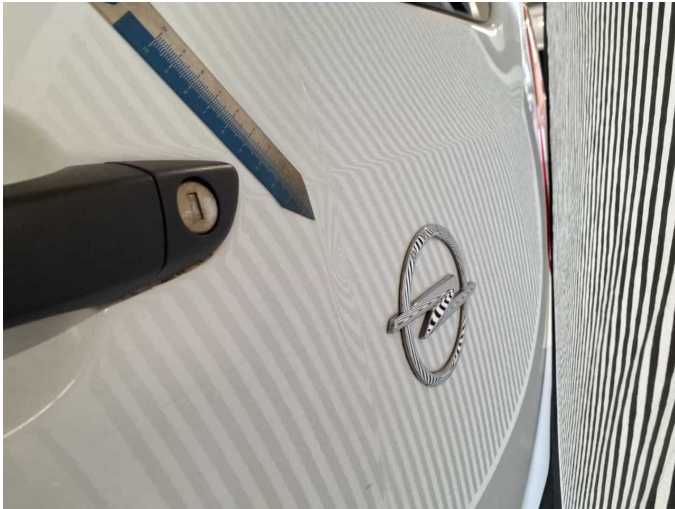
| No. | Component group | Description |
|---|---|---|
| 19 | Boot lid / rear door | Rear door - left side - Deformed - Repair and paint |

**Damage 19:** Boot lid / rear door: Rear door - left side - Deformed - Repair and paint

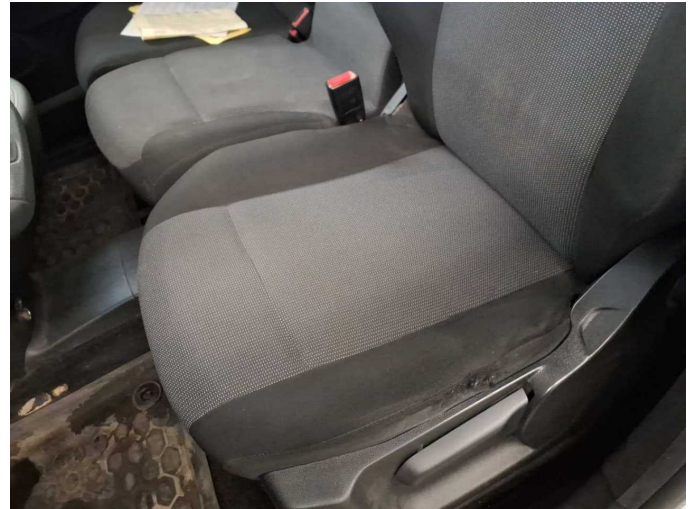
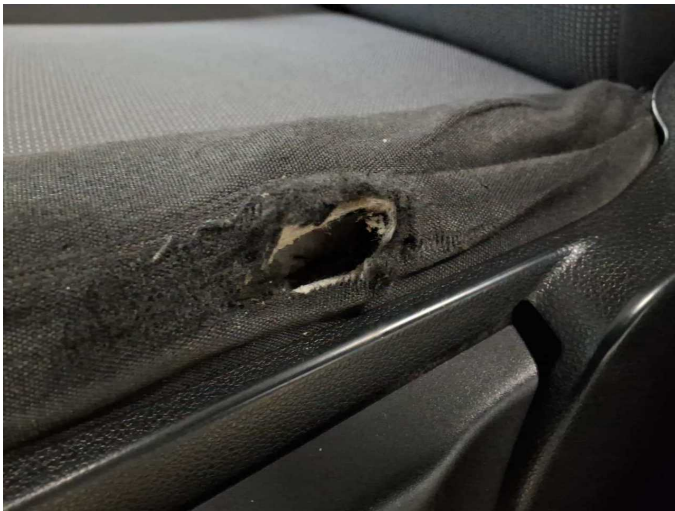
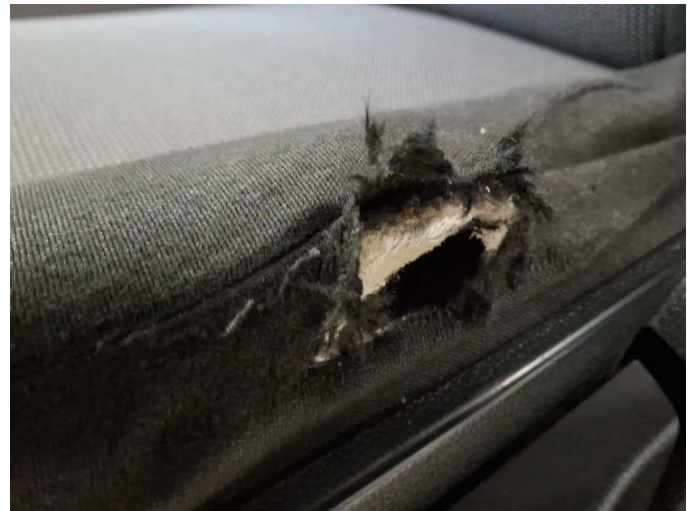
| No. | Component group | Description |
|---|---|---|
| 20 | Seat - front | Seat cover - left side (inkl. Polster) - Broken / torn - Replace |

**Damage 20:** Seat - front: Seat cover - left side (inkl. Polster) - Broken / torn - Replace

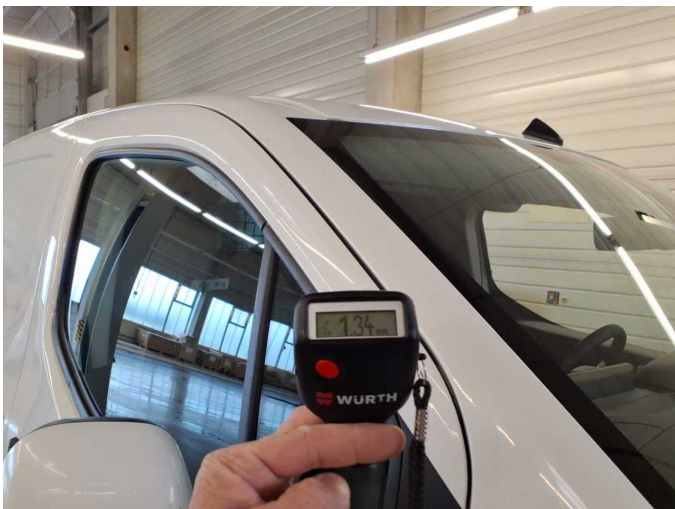
**Roof rail - right side:** 1,340 µm
