Expertise

Protocol number: 41471920  
Order No. / Reference: 25191316  
Inspection date: 11 Sept 2025

Manufacturer: Opel

Model: Combo Cargo XL 1.5 D EHZ Edition

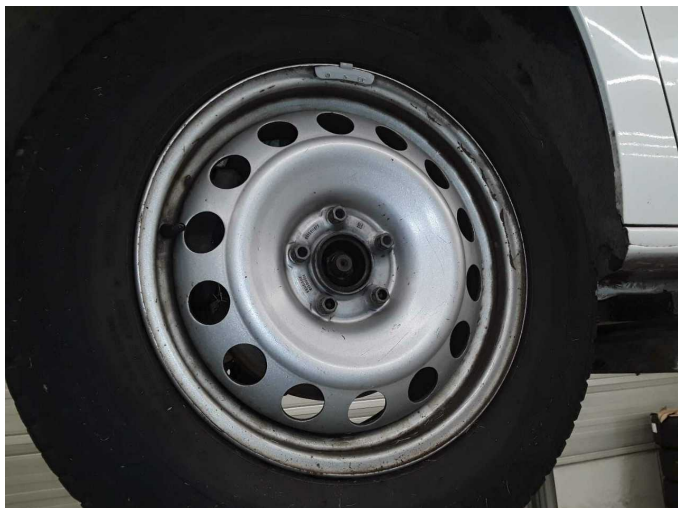
| No. | Component group | Description |
|---|---|---|
| 1 | Wheel / tyres | Wheel cover - front left side - Missing - Replace |

**Damage 1:** Wheel / tyres: Wheel cover - front left side - Missing - Replace

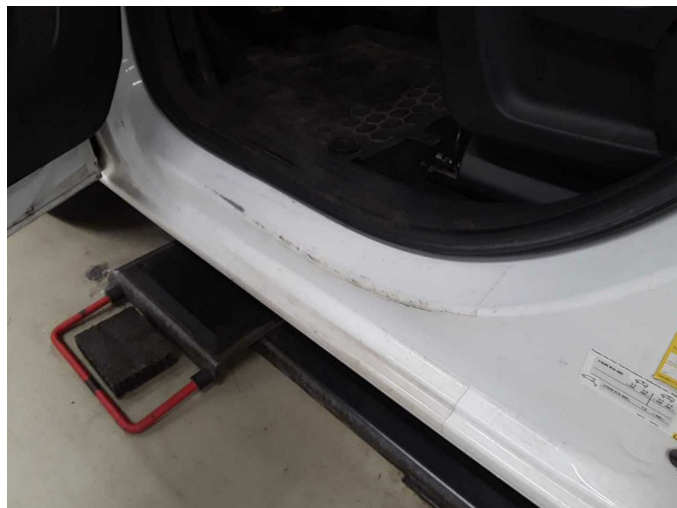
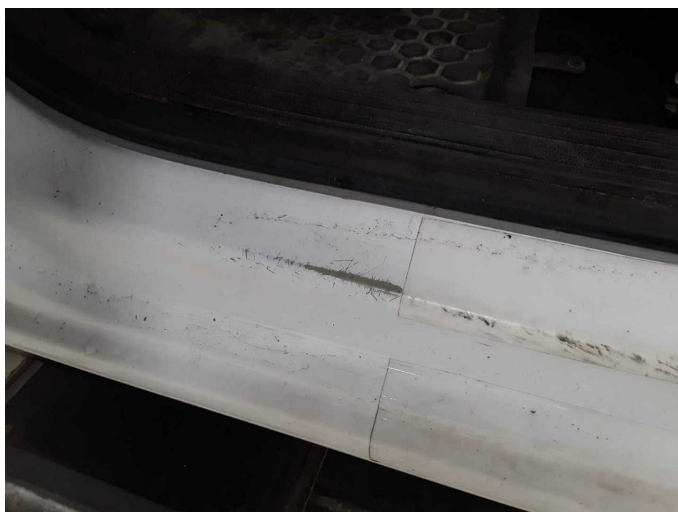
| No. | Component group | Description |
|---|---|---|
| 2 | Sill - left side | Sill - Scratch(es) - Smart repair |

**Damage 2:** Sill - left side: Sill - Scratch(es) - Smart repair

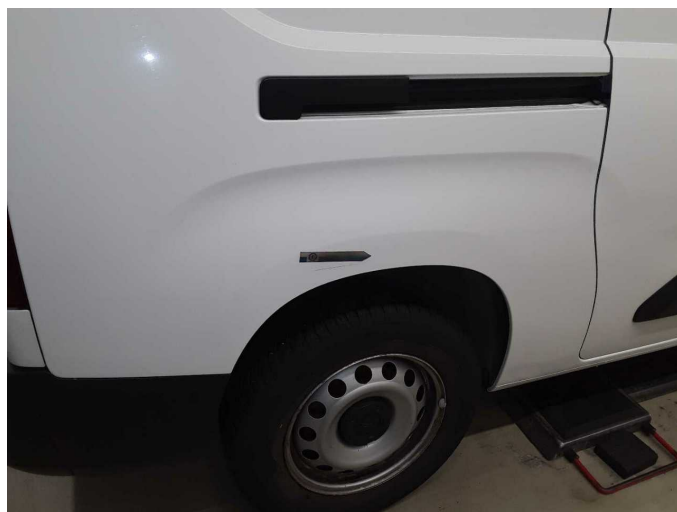
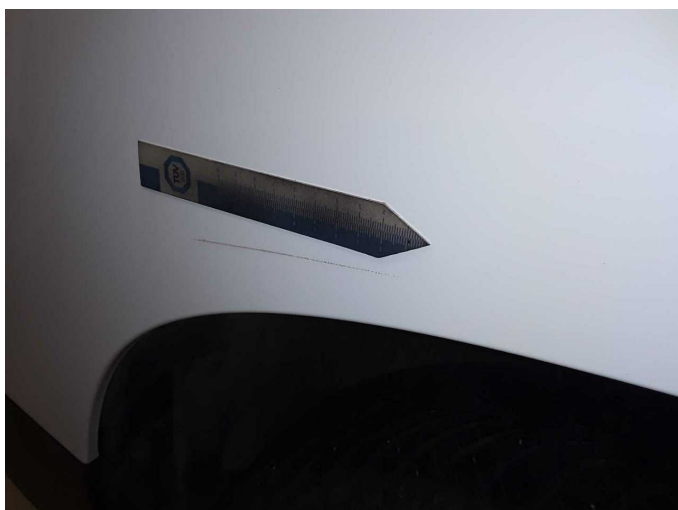
| No. | Component group | Description |
|---|---|---|
| 3 | Side panel - rear right side | Side panel - Scratch(es) - Smart repair |

**Damage 3:** Side panel - rear right side: Side panel - Scratch(es) - Smart repair

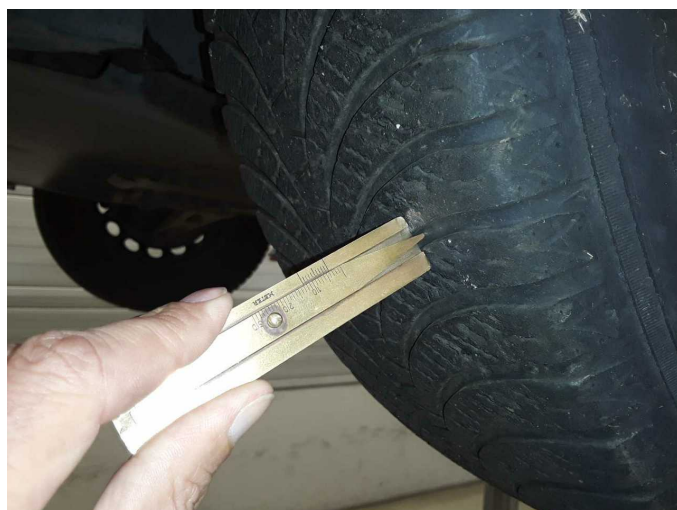
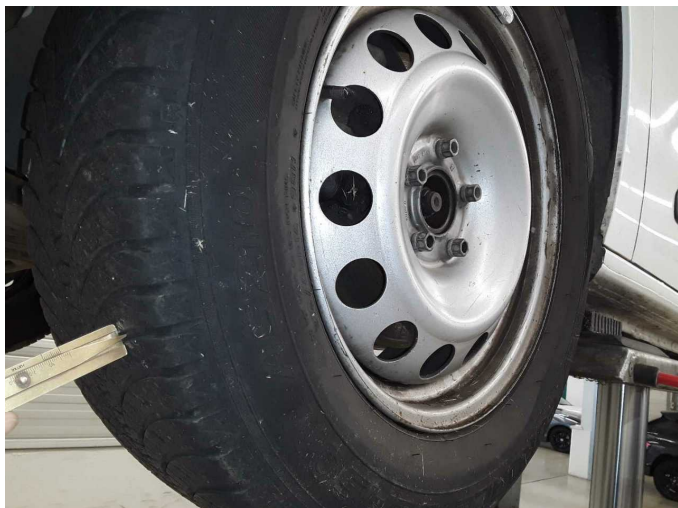
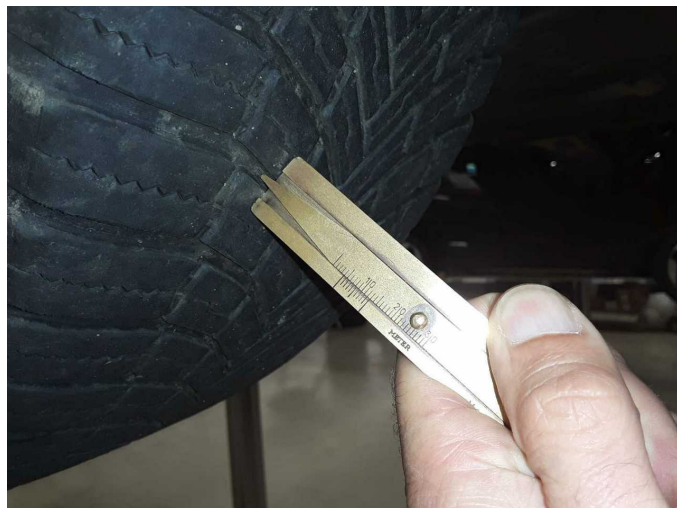
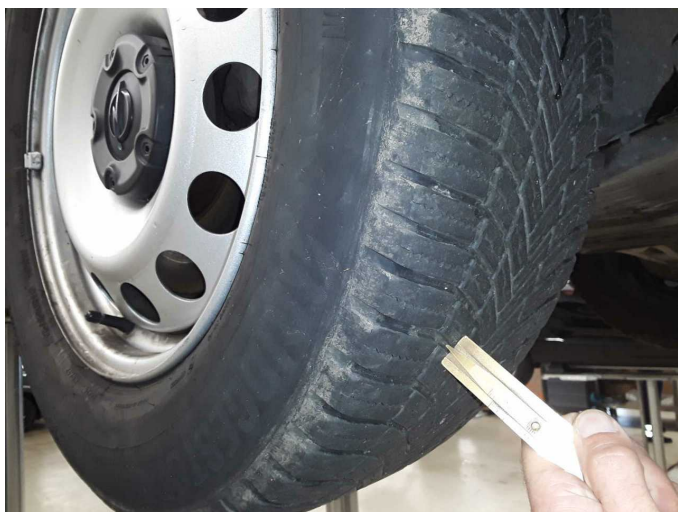
| No. | Component group | Description |
|---|---|---|
| 4 | Wheel / tyres | Tyre - front (unter 4mm) - Worn - Replace |

**Damage 4:** Wheel / tyres: Tyre - front (unter 4mm) - Worn - Replace

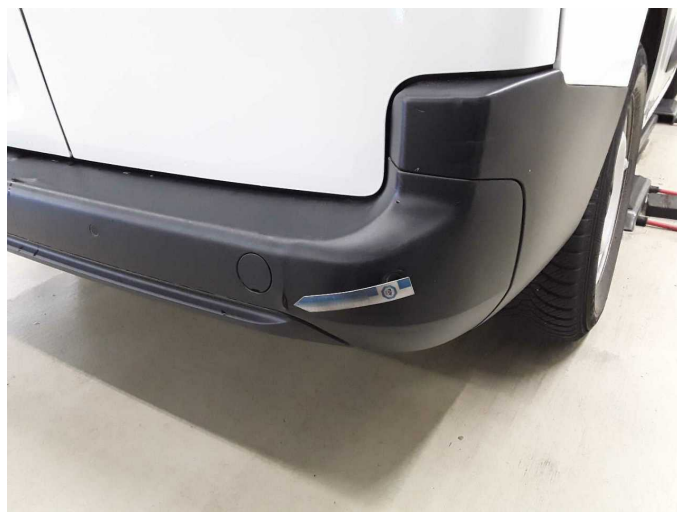
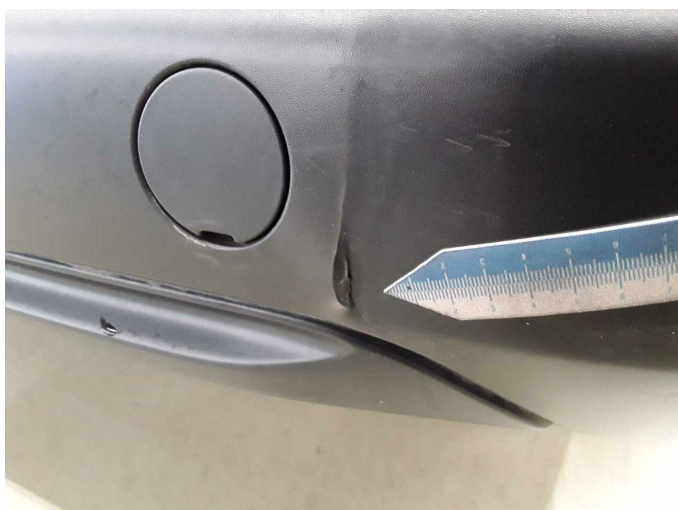
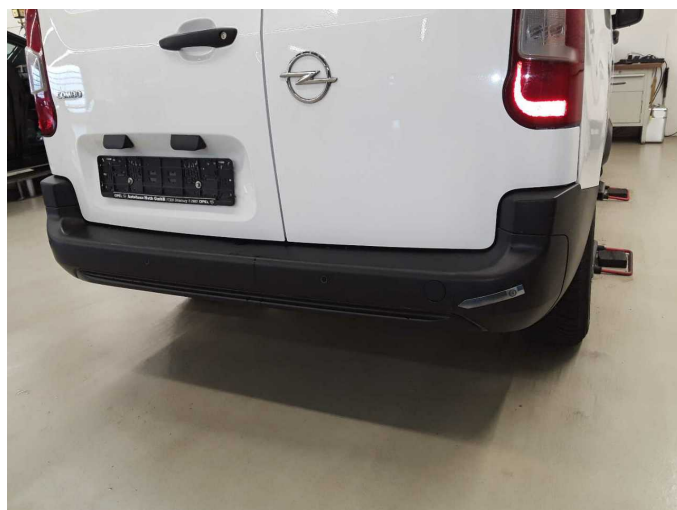
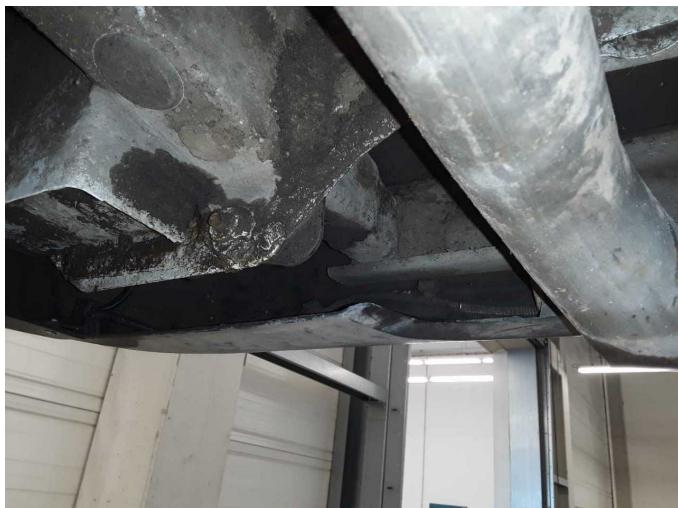
| No. | Component group | Description |
|---|---|---|
| 5 | Rear bumper | Rear bumper (unpainted) - Broken / torn - Replace |

**Damage 5:** Rear bumper: Rear bumper (unpainted) - Broken / torn - Replace

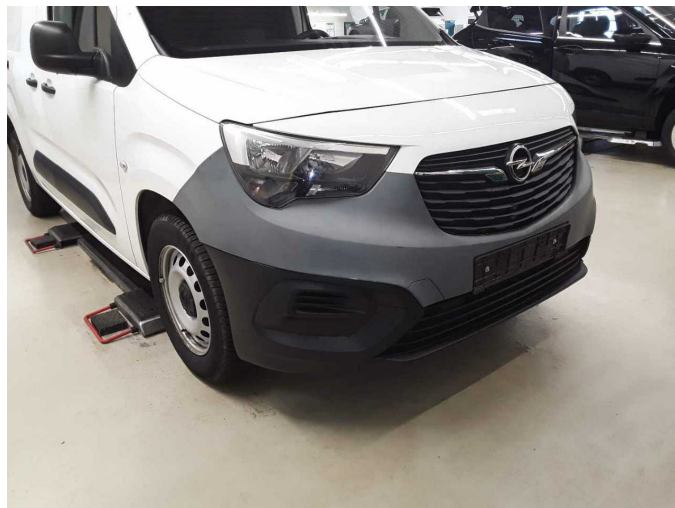
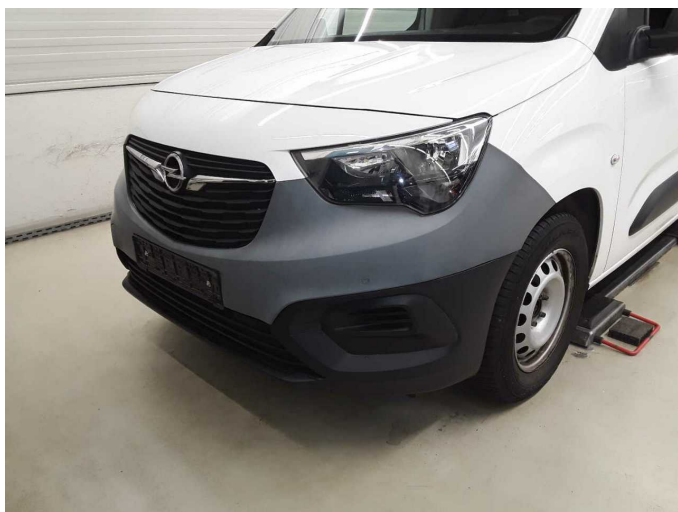
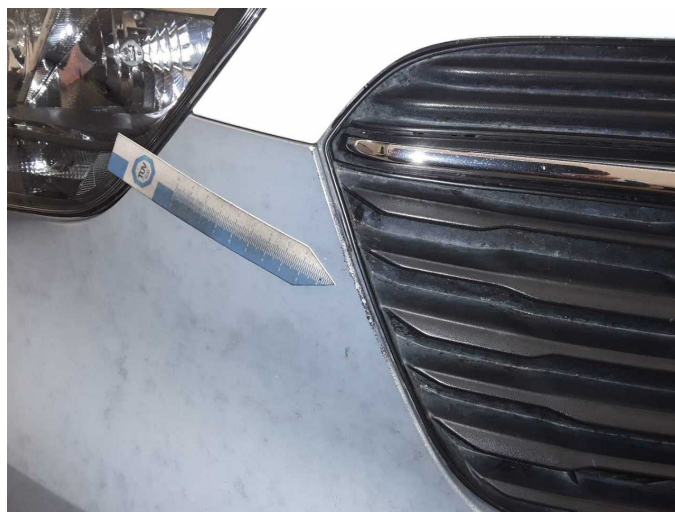
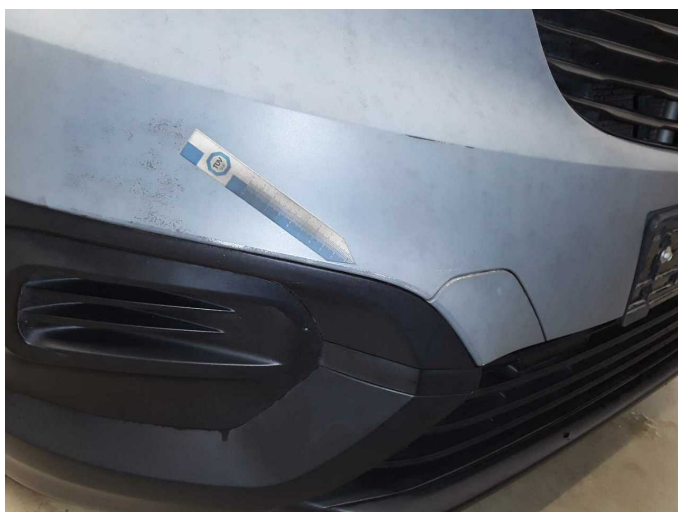
| No. | Component group | Description |
|---|---|---|
| 6 | Front bumper | Front bumper (Oberteil nicht lackiert) - Unprofessionally repaired - Repair and paint |

**Damage 6:** Front bumper: Front bumper (Oberteil nicht lackiert) - Unprofessionally repaired - Repair and paint

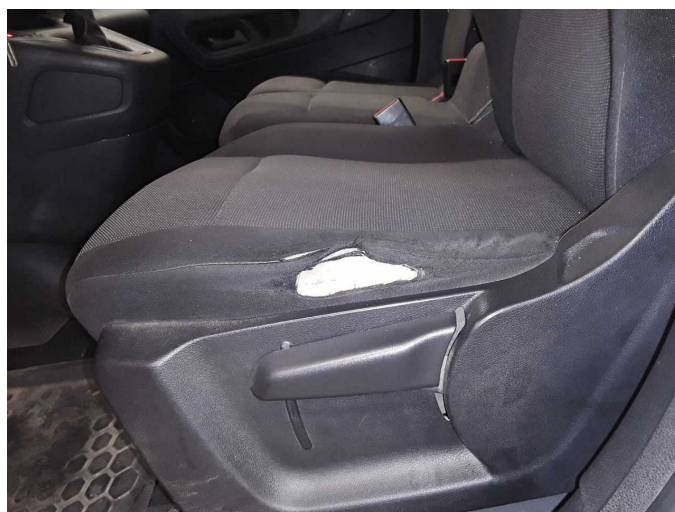
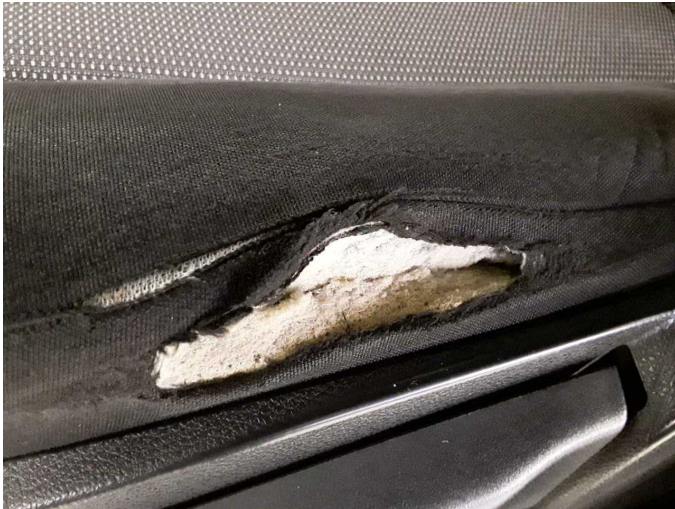
| No. | Component group | Description |
|---|---|---|
| 7 | Seat - front | Seat upholstery - left side (inkl. Bezug) - Broken / torn - Replace |

**Damage 7:** Seat - front: Seat upholstery - left side (inkl. Bezug) - Broken / torn - Replace

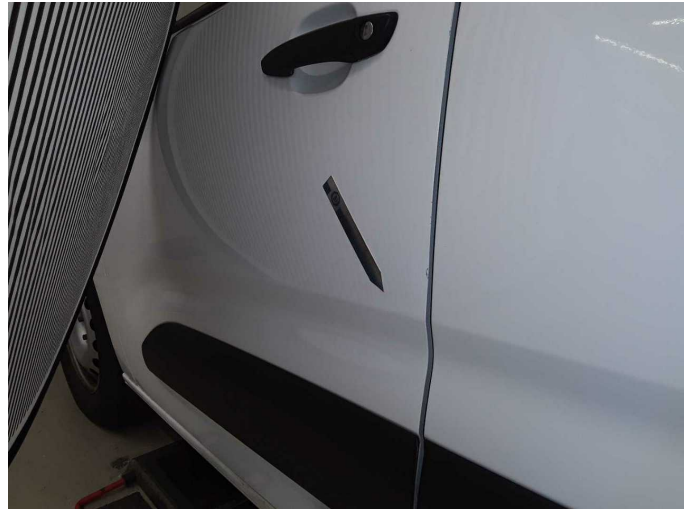
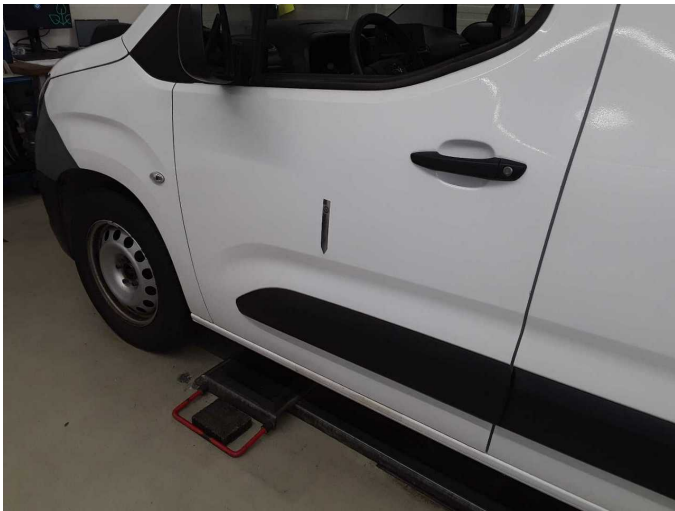
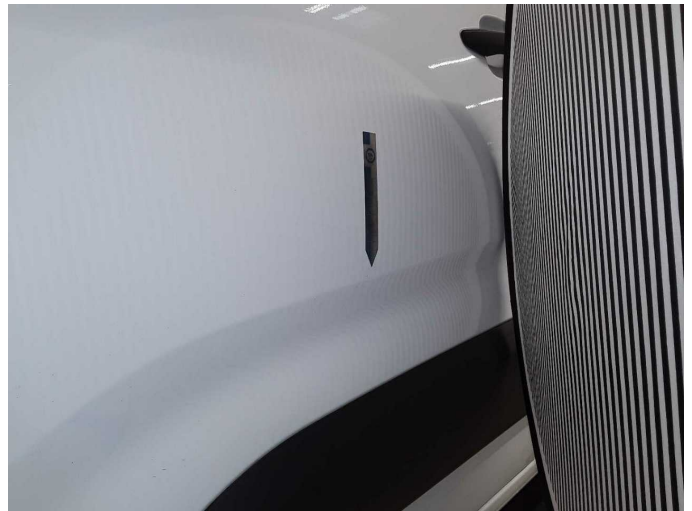
| No. | Component group | Description |
|---|---|---|
| 1 | Door - front left side | Door - dent(s) - No deduction |

**Wear and tear 1:** Door - front left side: Door - dent(s) - No deduction

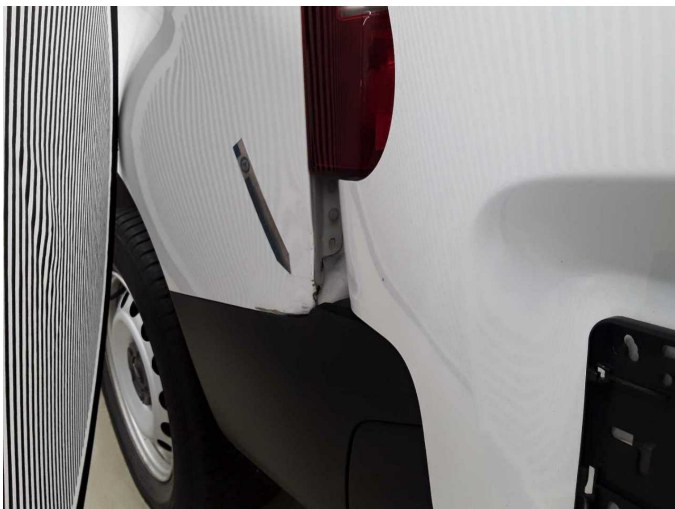
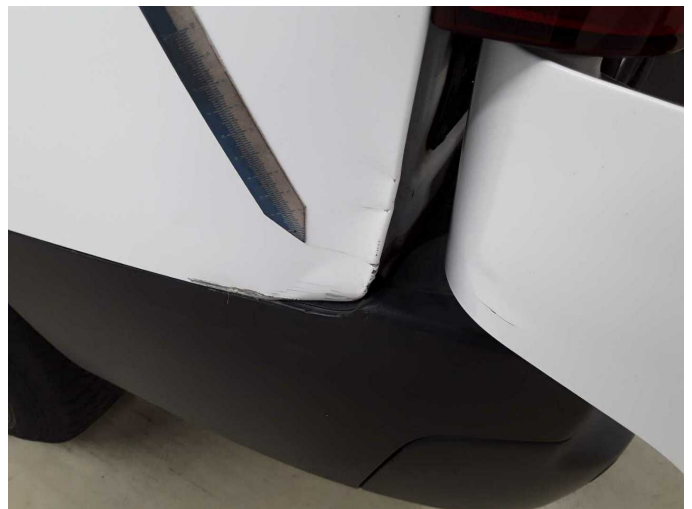
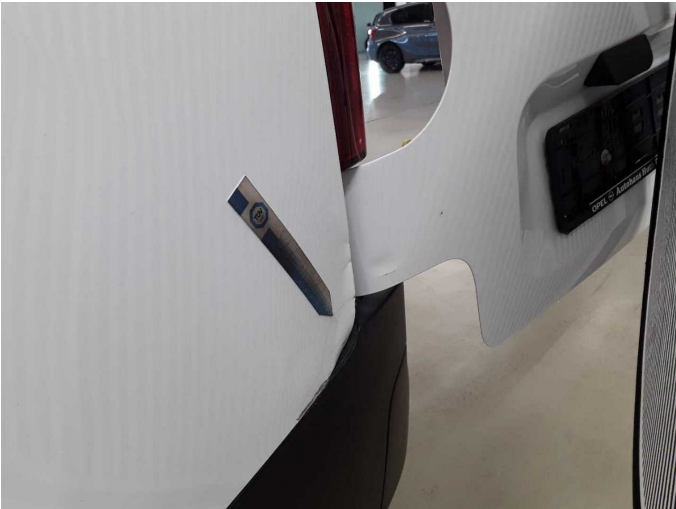
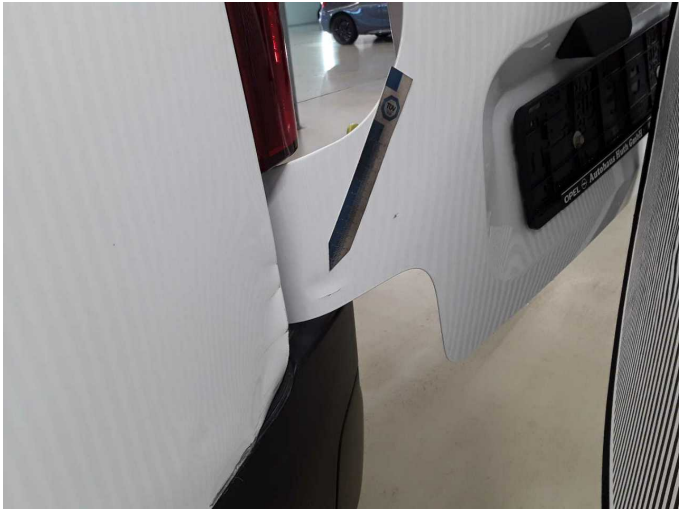
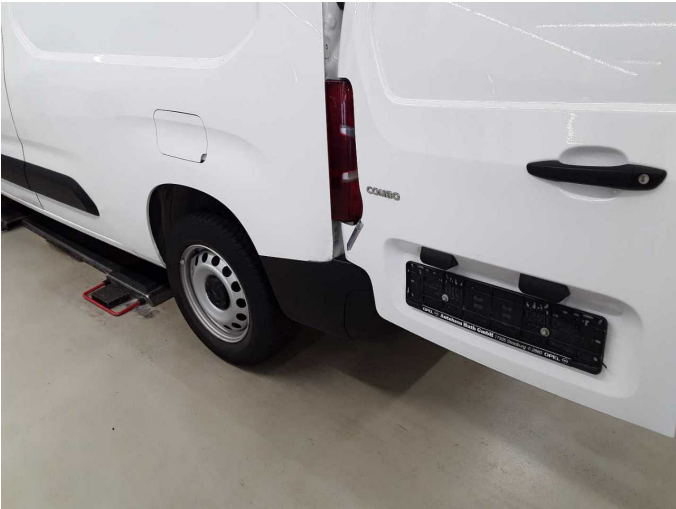
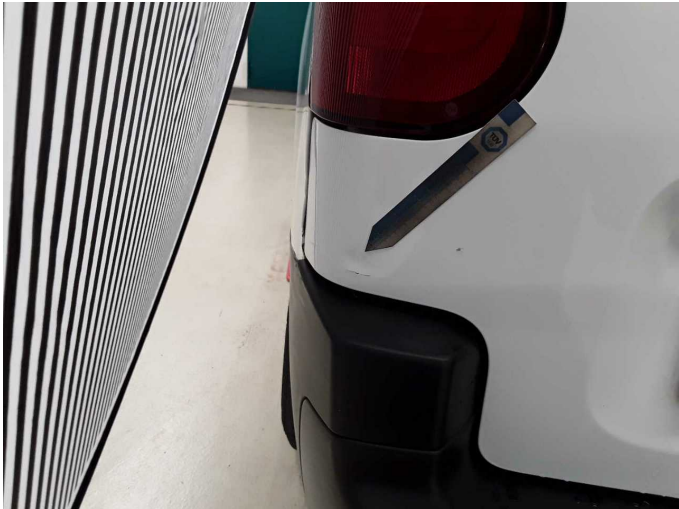
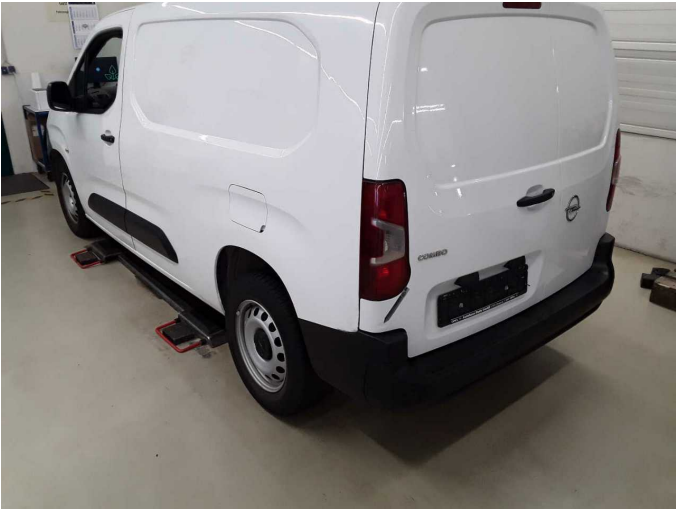
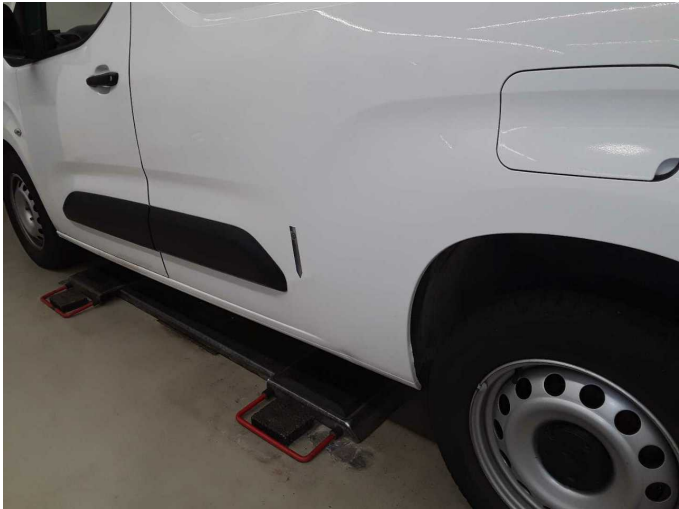
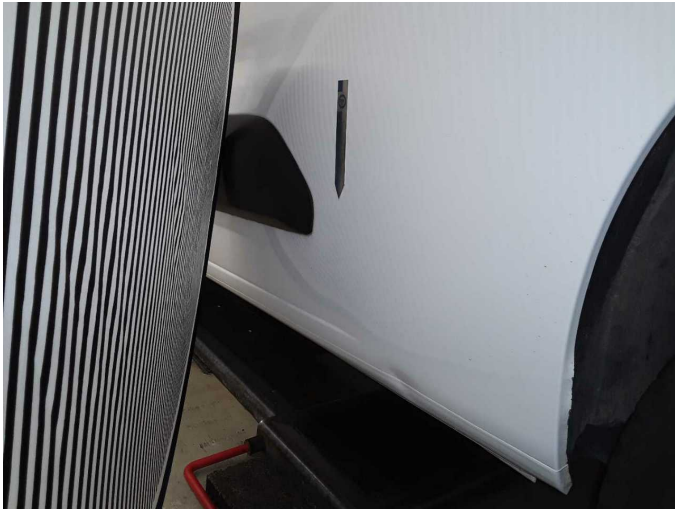
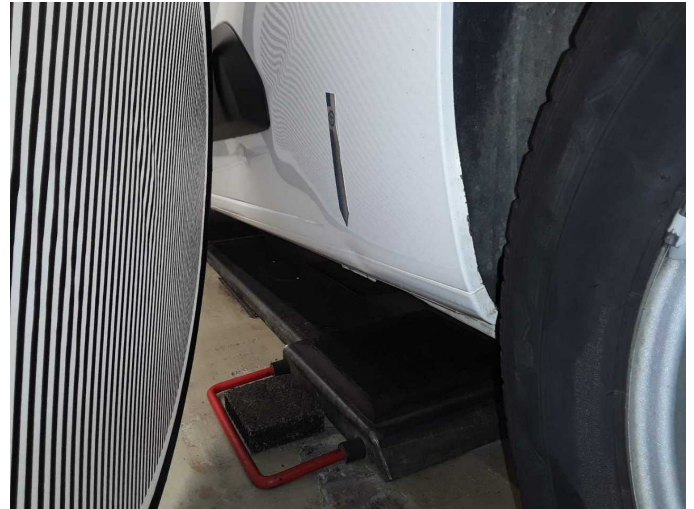
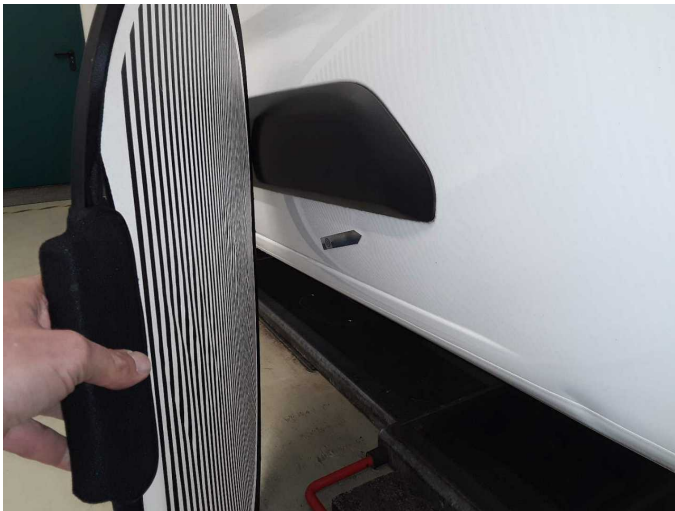
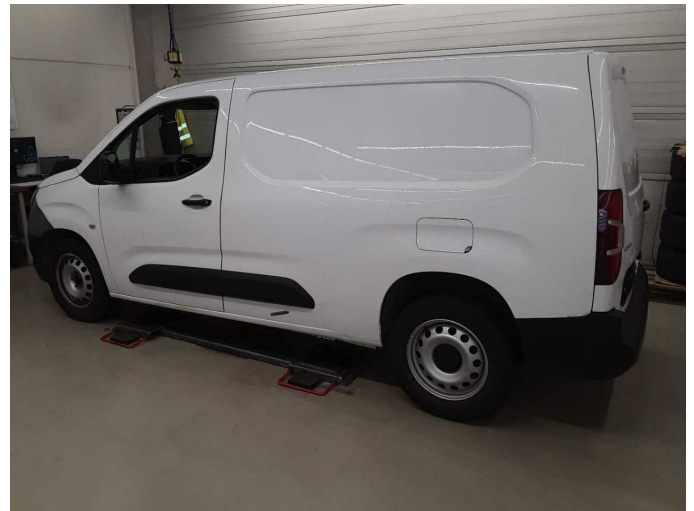
- 1 Rear, Side - left

**Accident 1:** Rear, Side - left

Accident 1: Rear, Side - left

**Accident 1: Rear, Side - left**
