Expertise

Protocol number: 41482760  
Order No. / Reference: 25191376  
Inspection date: 11 Sept 2025

Manufacturer: Opel

Model: Combo Cargo XL 1.5 D EHZ Edition

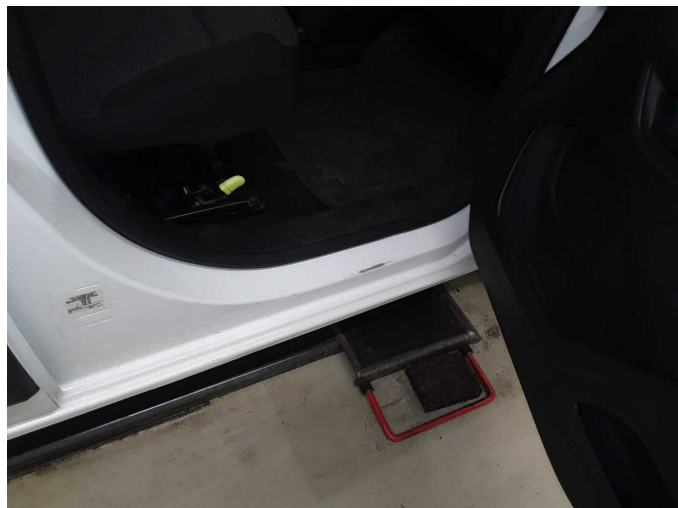
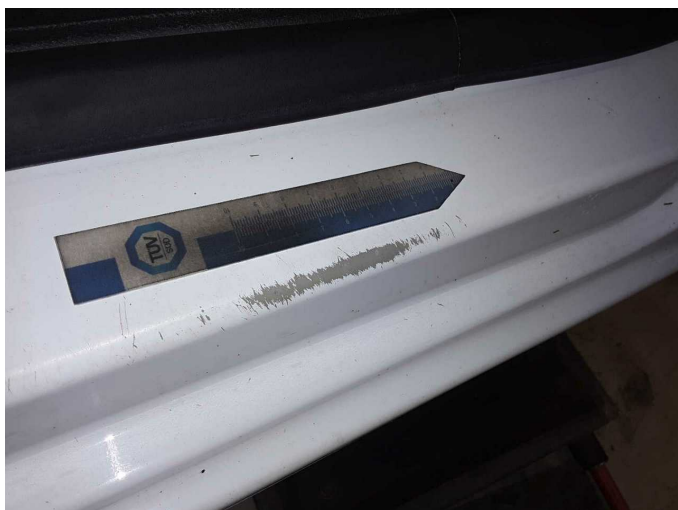
| No. | Component group | Description |
|---|---|---|
| 1 | Sill - right side | Sill - Scratch(es) - Smart repair |

**Damage 1:** Sill - right side: Sill - Scratch(es) - Smart repair

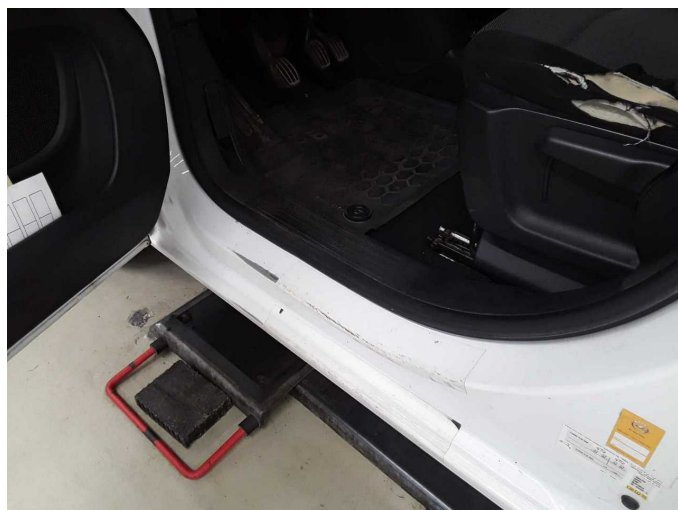
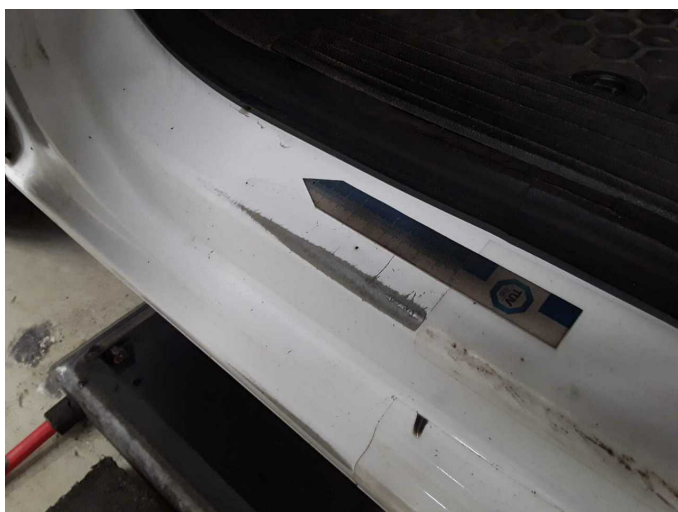
| No. | Component group | Description |
|---|---|---|
| 2 | Sill - left side | Sill - Scratched - Smart repair |

**Damage 2:** Sill - left side: Sill - Scratched - Smart repair

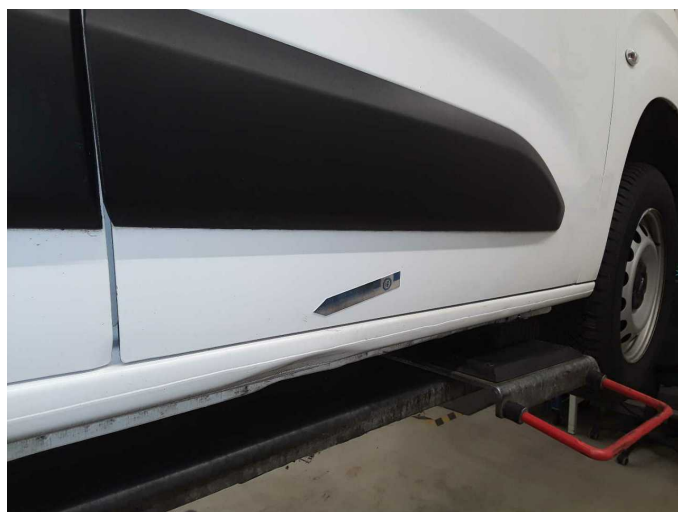
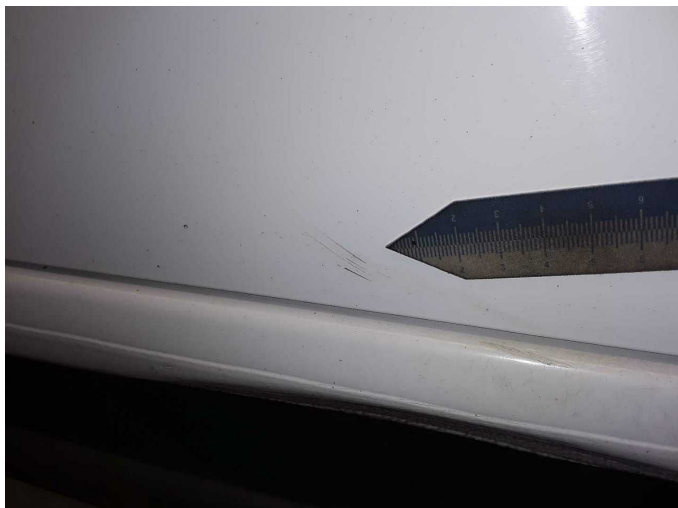
| No. | Component group | Description |
|---|---|---|
| 3 | Door - front right side | Door - Scratch(es) - Smart repair |

**Damage 3:** Door - front right side: Door - Scratch(es) - Smart repair

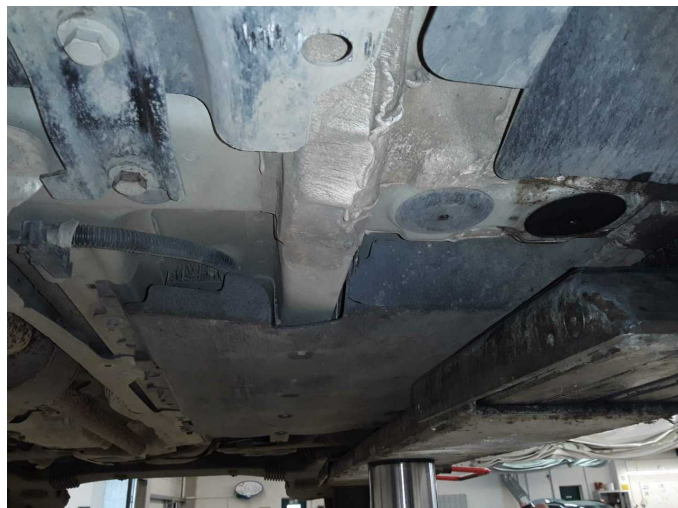
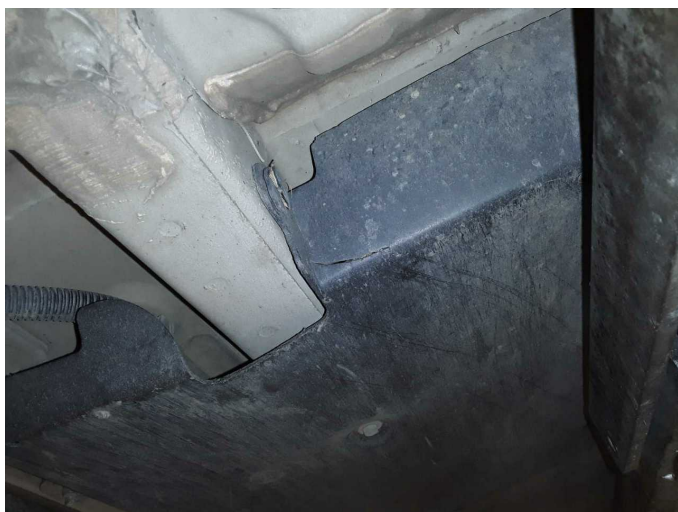
| No. | Component group | Description |
|---|---|---|
| 4 | Body | Underbody panelling (Links) - Broken / torn - Replace |

**Damage 4:** Body: Underbody panelling (Links) - Broken / torn - Replace

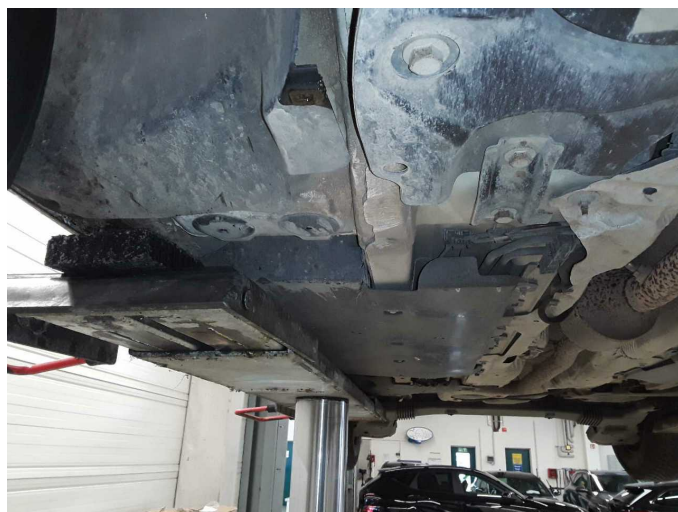
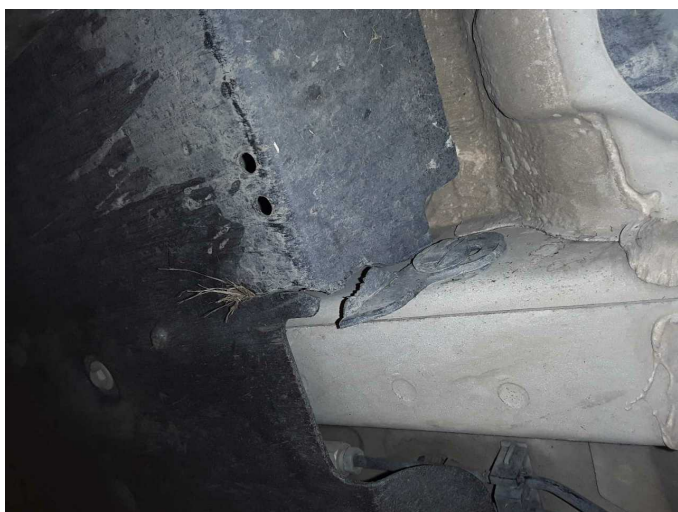
| No. | Component group | Description |
|---|---|---|
| 5 | Body | Underbody panelling (Rechts) - Broken / torn - Replace |

**Damage 5:** Body: Underbody panelling (Rechts) - Broken / torn - Replace

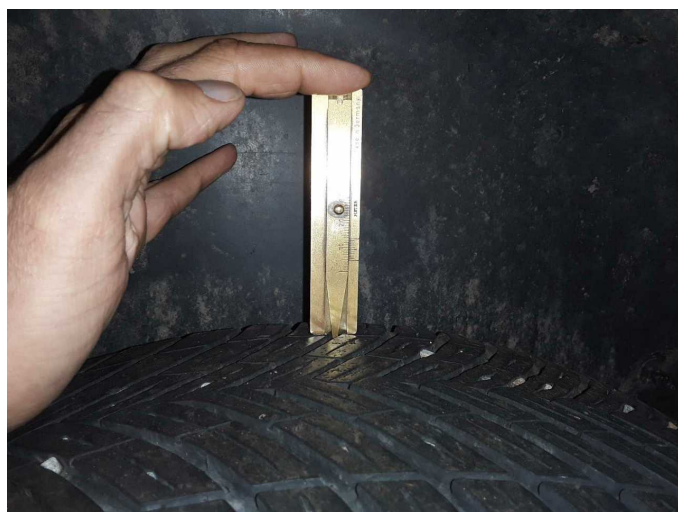
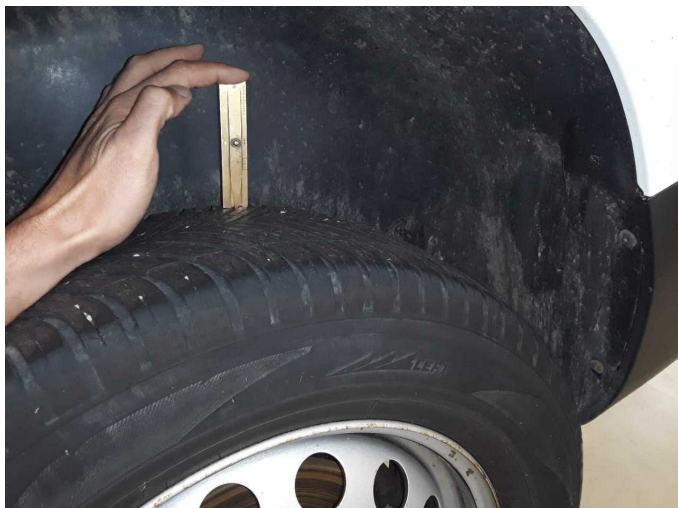
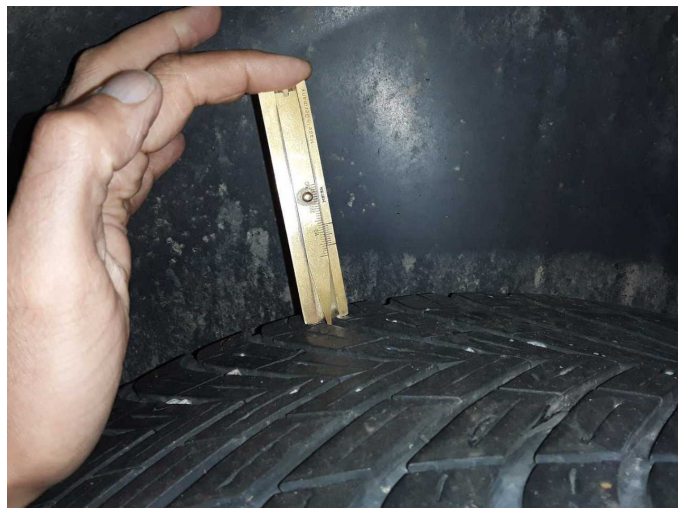
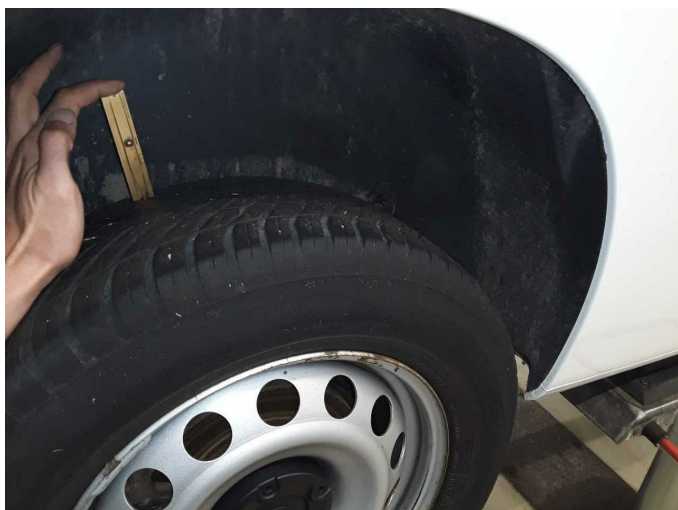
| No. | Component group | Description |
|---|---|---|
| 6 | Wheel / tyres | Tyre - right - Does not meet the leasing specifications - Replace |

**Damage 6:** Wheel / tyres: Tyre - right - Does not meet the leasing specifications - Replace

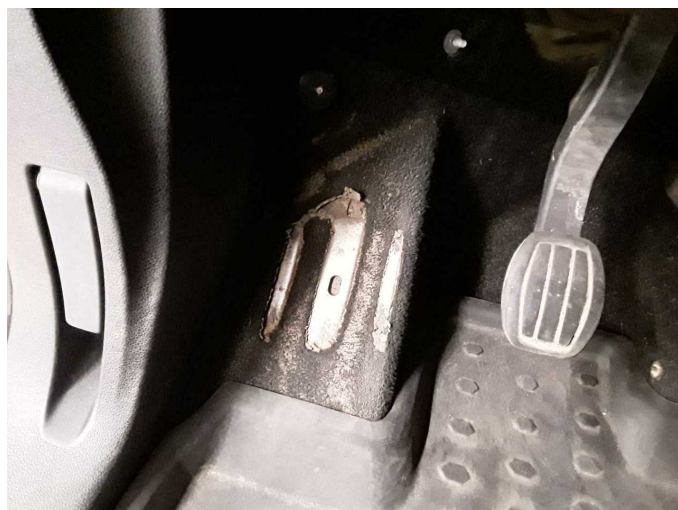
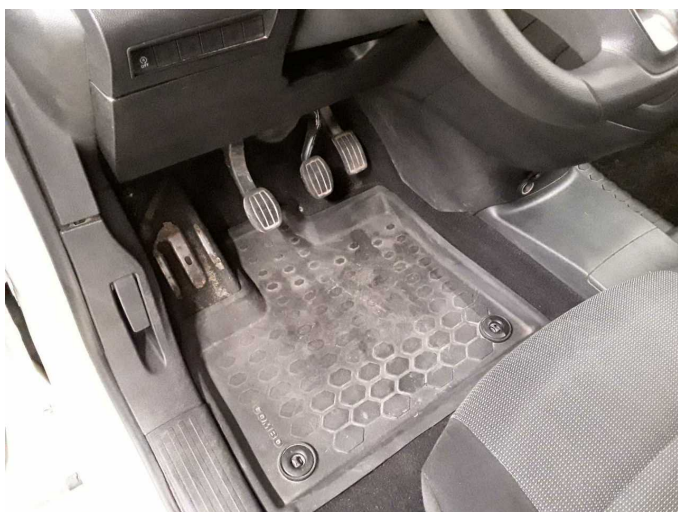
| No. | Component group | Description |
|---|---|---|
| 7 | Trim / covers | Carpet - front left side - Broken / torn - Replace |

**Damage 7:** Trim / covers: Carpet - front left side - Broken / torn - Replace

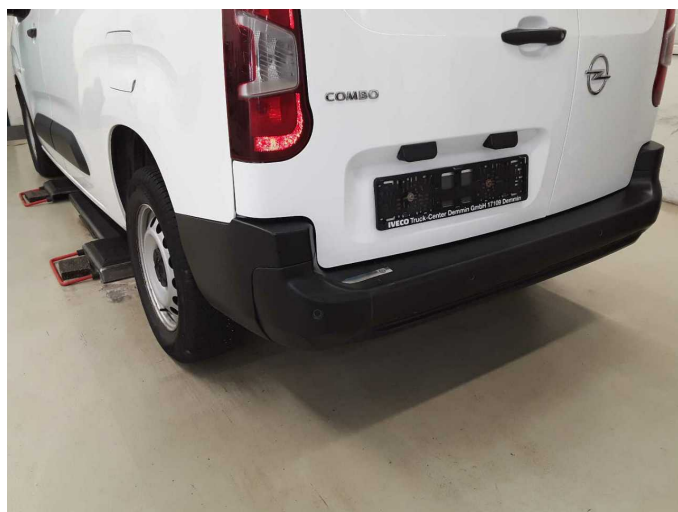
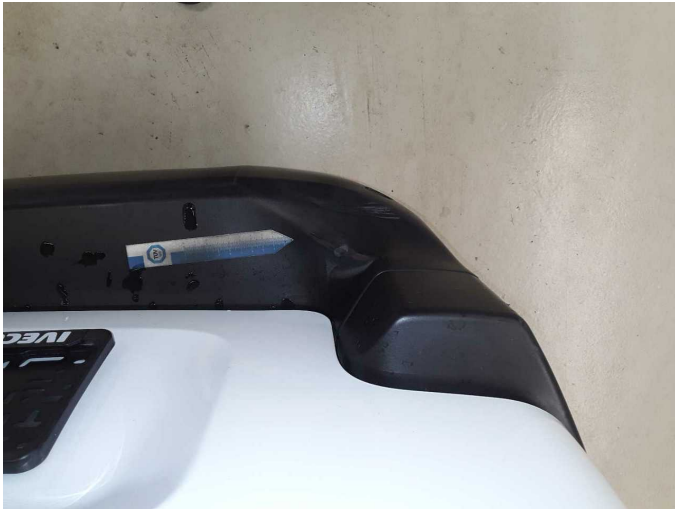
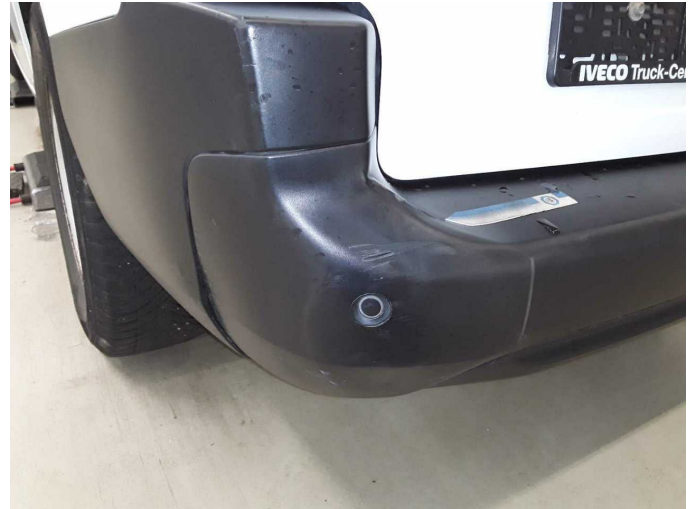
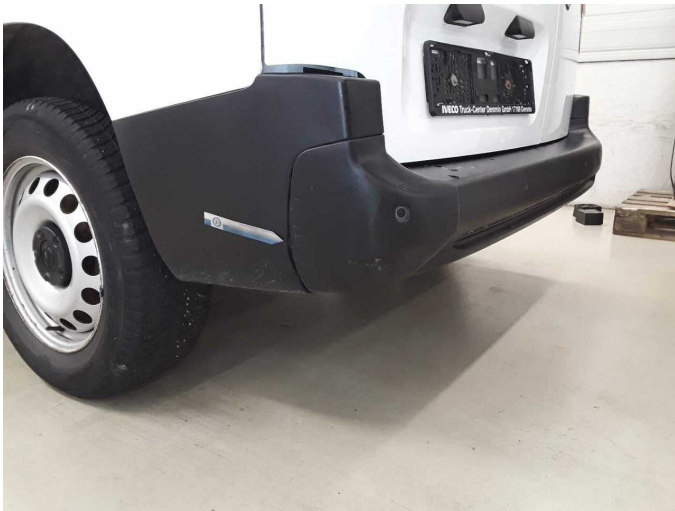
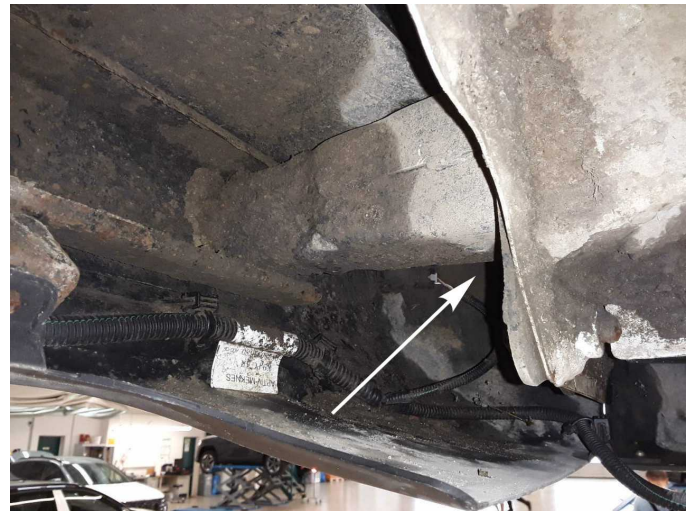
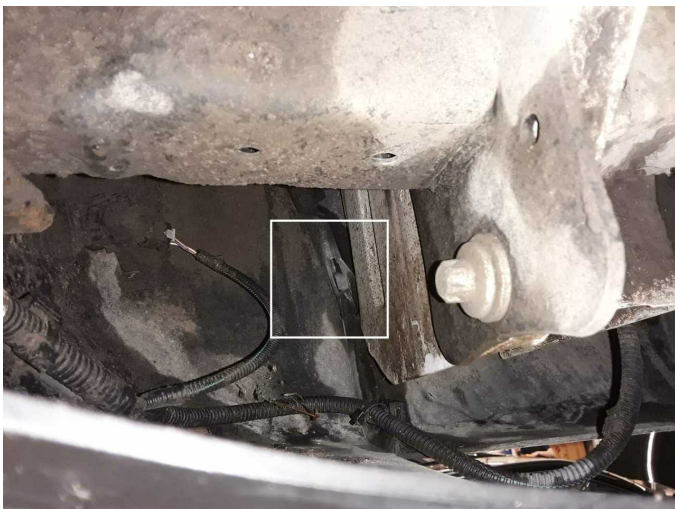
| No. | Component group | Description |
|---|---|---|
| 8 | Rear bumper | Rear bumper (unpainted) (Mehrkosten können entstehen) - Deformed - Replace |

**Damage 8:** Rear bumper: Rear bumper (unpainted) (Mehrkosten können entstehen) - Deformed - Replace

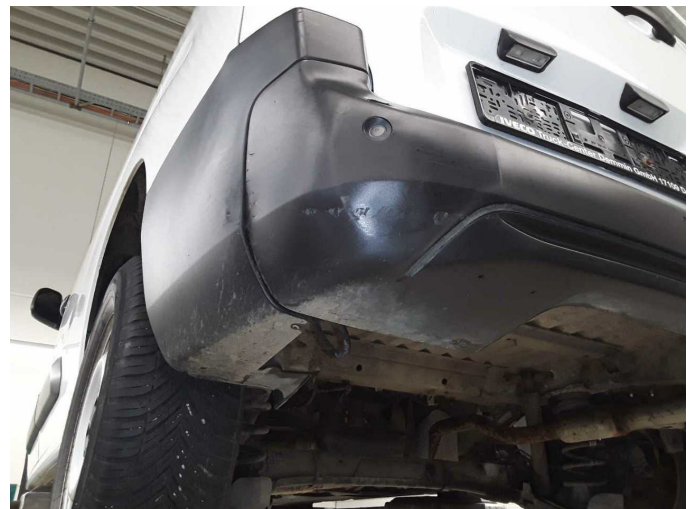
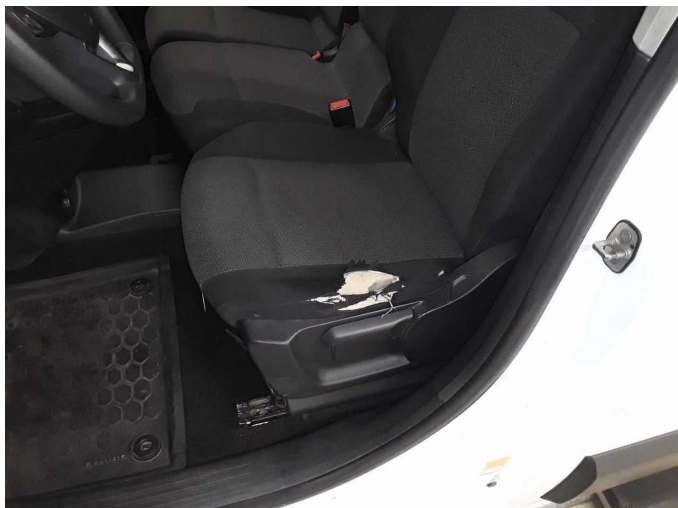
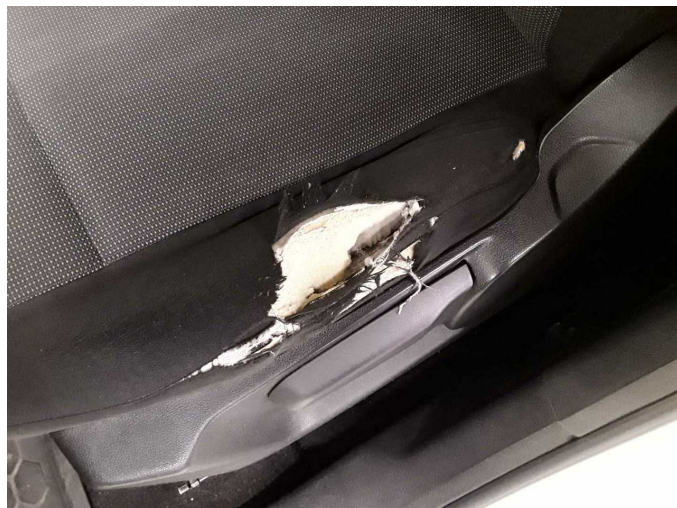
| No. | Component group | Description |
|---|---|---|
| 9 | Seat - front | Seat cover - left side (inkl. Polster) - Broken / torn - Replace |

**Damage 8:** Rear bumper: Rear bumper (unpainted) (Mehrkosten können entstehen) - Deformed - Replace

**Damage 9:** Seat - front: Seat cover - left side (inkl. Polster) - Broken / torn - Replace

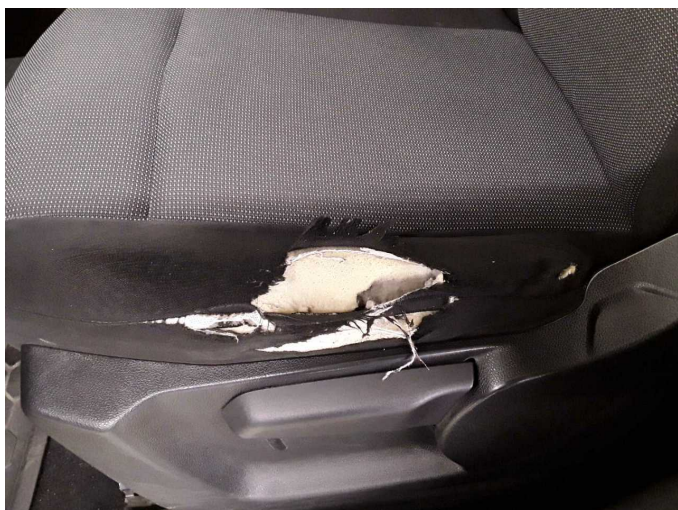
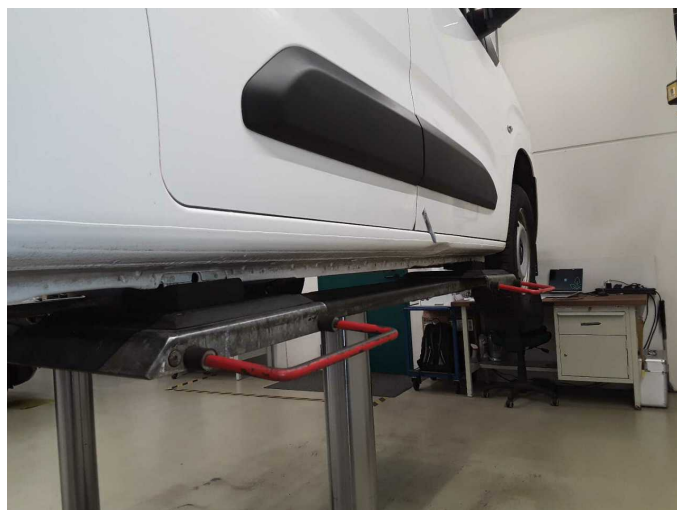
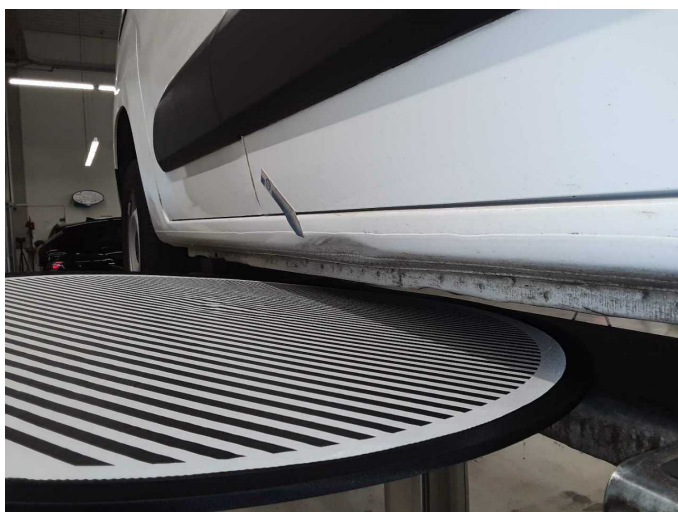
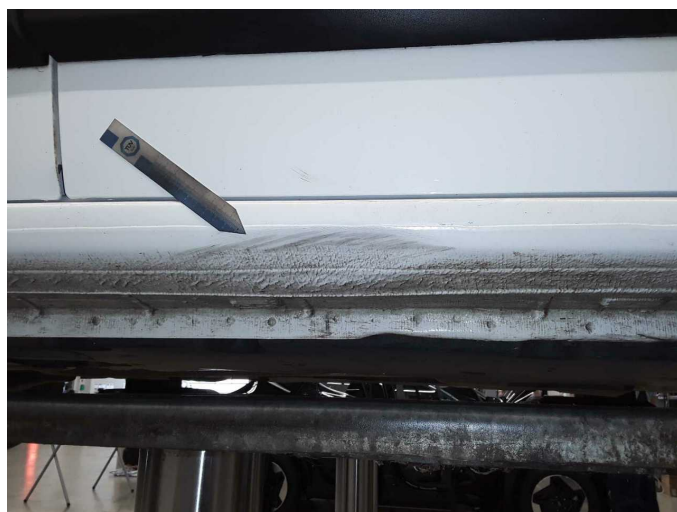
| No. | Component group | Description |
|---|---|---|
| 10 | Sill - right side | Sill (Incl. Delle) - dent(s) - Repair and paint |

**Damage 9:** Seat - front: Seat cover - left side (inkl. Polster) - Broken / torn - Replace

**Damage 10:** Sill - right side: Sill (Incl. Delle) - dent(s) - Repair and paint

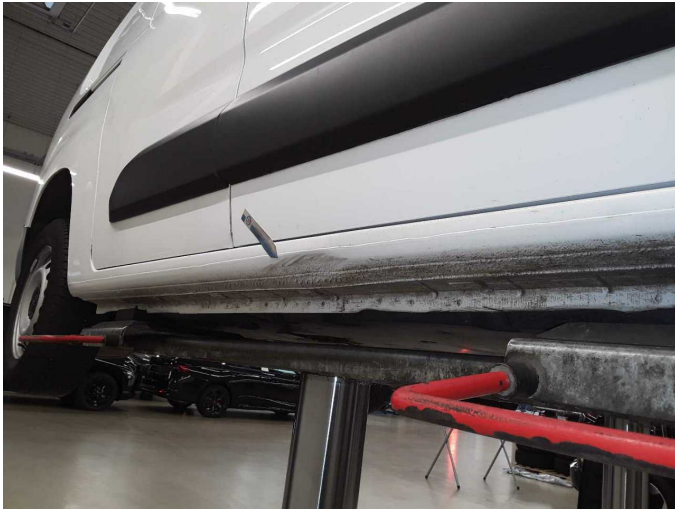
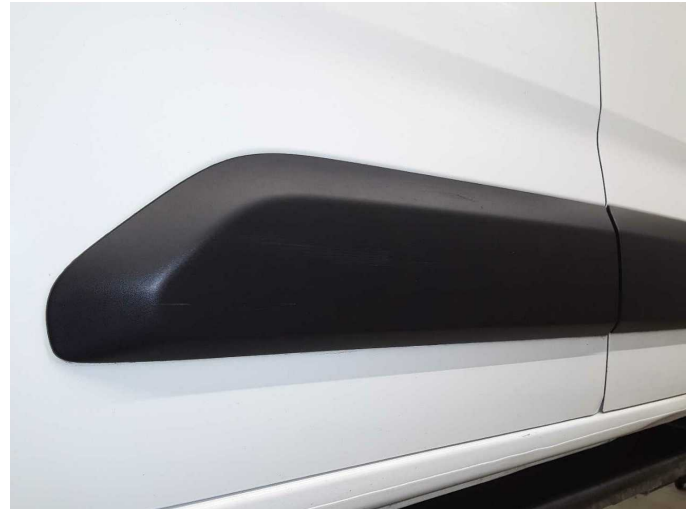
| No. | Component group | Description |
|---|---|---|
| 1 | Body | Body - Scratch(es) - No deduction |

**Damage 10:** Sill - right side: Sill (Incl. Delle) - dent(s) - Repair and paint

**Wear and tear 1:** Body: Body - Scratch(es) - No deduction
