## status report

**customer:** Bank 11, Neuss  
**contract number:** 1075725230-INSO  
**reference:**

#### Opel Mokka X Ultimate Start/Stop 4x4

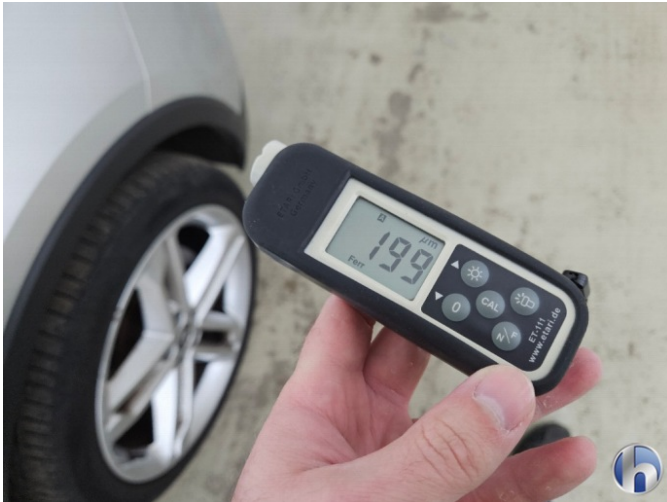
| component | Damage | Rep kind |
|---|---|---|
| 1. Front door - right | Subsequently painted | acceptable |

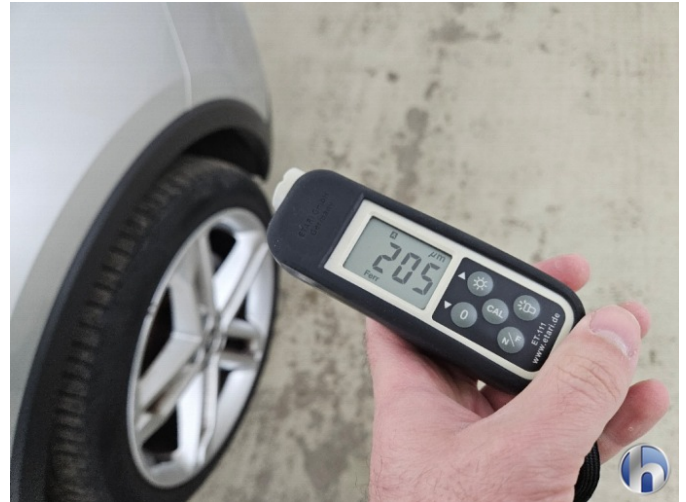
| component | Damage | Rep kind |
|---|---|---|
| 2. Front fender - right | Subsequently painted | acceptable |

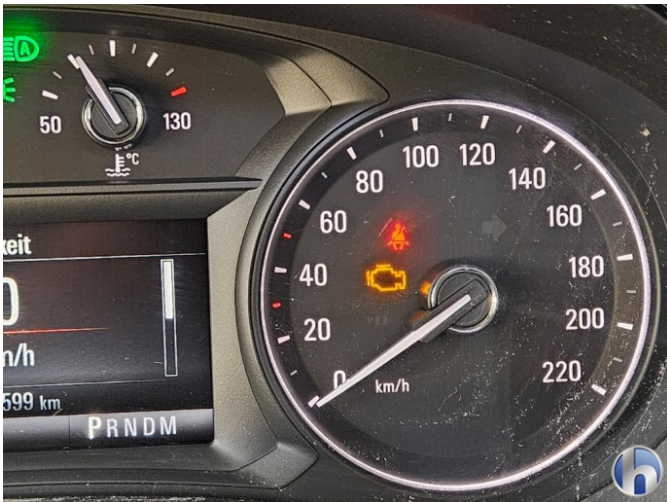
6. motor

| component | Damage | Rep kind |
|---|---|---|
| 5. motor | Error message | Carry out a fault diagnosis |

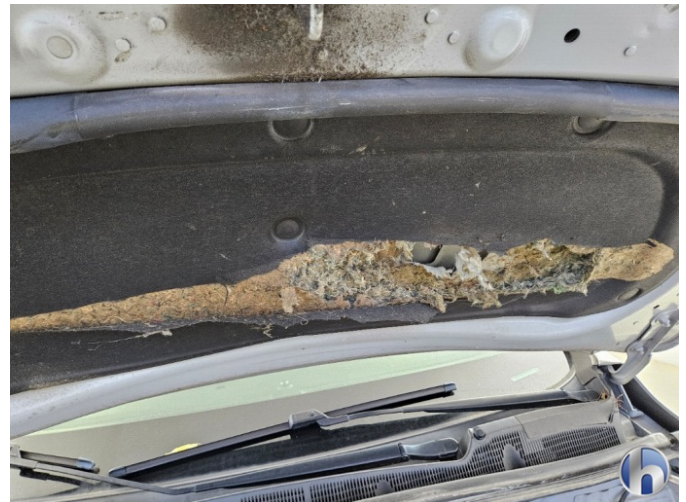
7. motor insulation

| component | Damage | Rep kind |
|---|---|---|
| 6. motor insulation | Damaged | Replace |

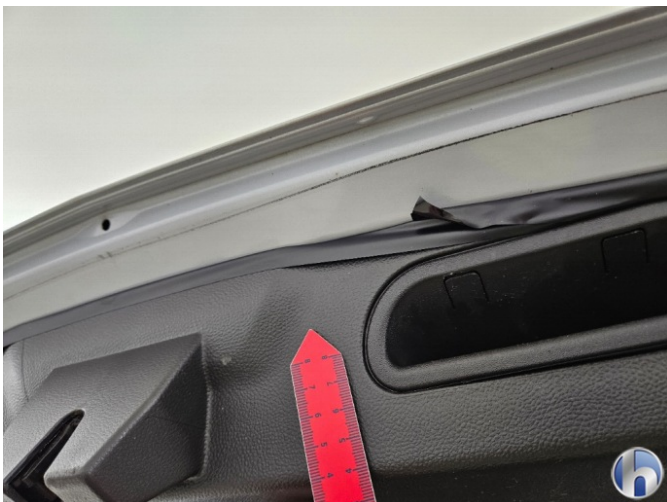
8. tailgate trim

| component | Damage | Rep kind |
|---|---|---|
| 7. tailgate trim | Not okay | Carry out a fault diagnosis |

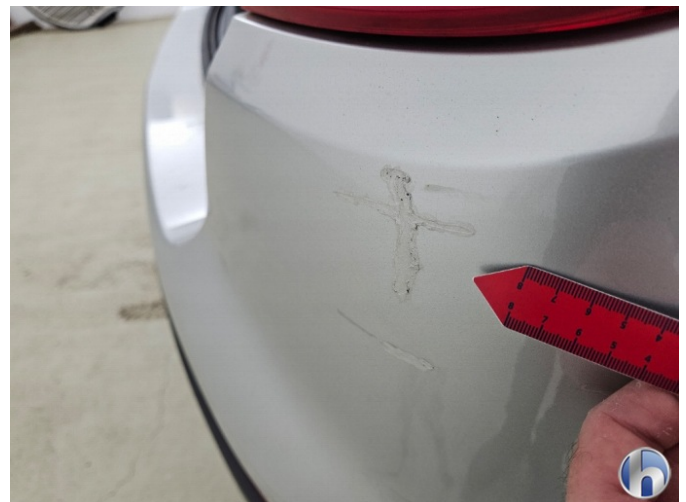
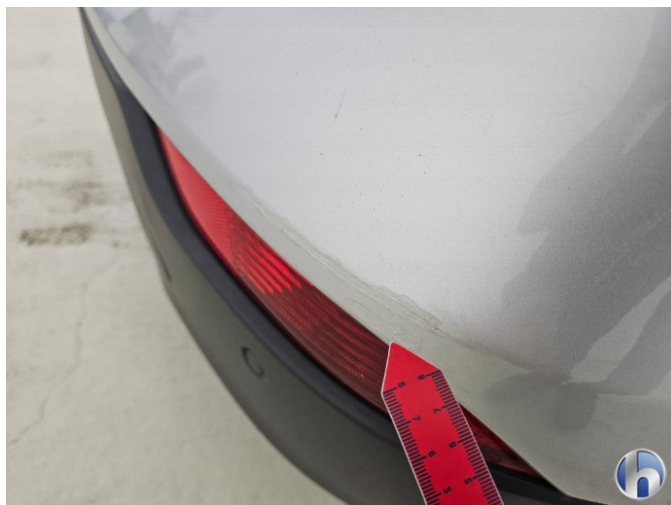
9. Rear bumper

| component | Damage | Rep kind |
|---|---|---|
| 8. Rear bumper | Scratch(es) | Paint |

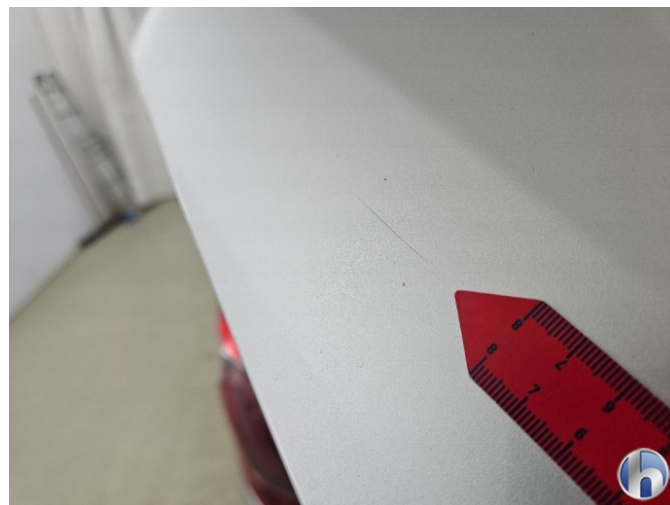
10. tailgate

| component | Damage | Rep kind |
|---|---|---|
| 9. tailgate | Scratch(es) | Paint |

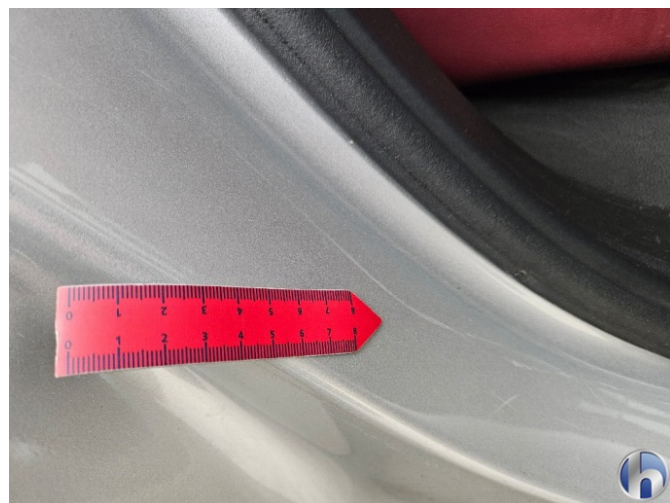
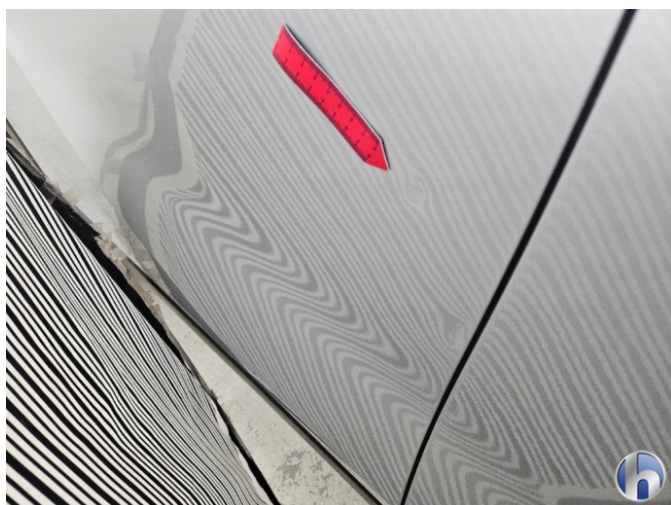
12. Türeinstieg Hinten - Rechts

| component | Damage | Rep kind |
|---|---|---|
| 10. TürEinstieg Hinten - Rechts | Scratch(es) | Paint |

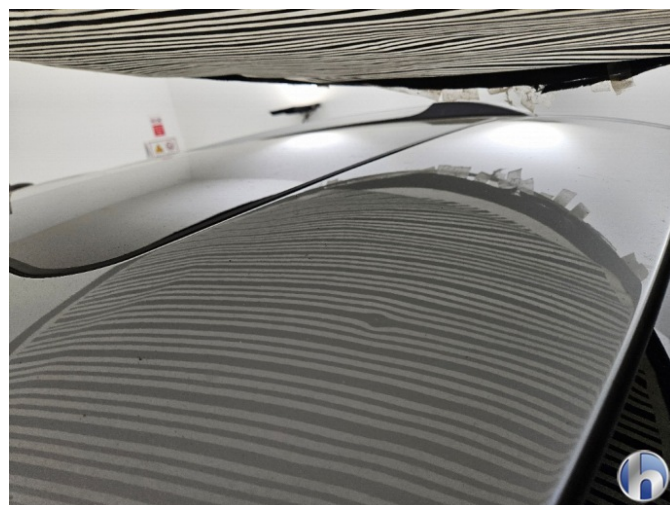
13. roof

| component | Damage | Rep kind |
|---|---|---|
| 11. roof | Delle | Smart repair |

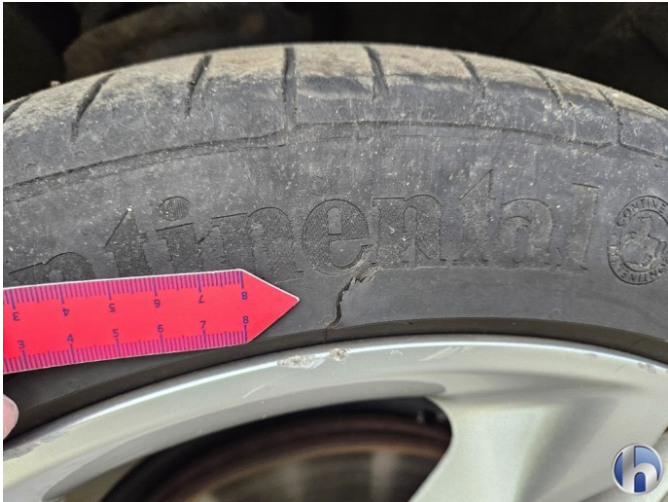
14. tire front - right

| component | Damage | Rep kind |
|---|---|---|
| 12. tire front - right | Damaged | Smart repair |

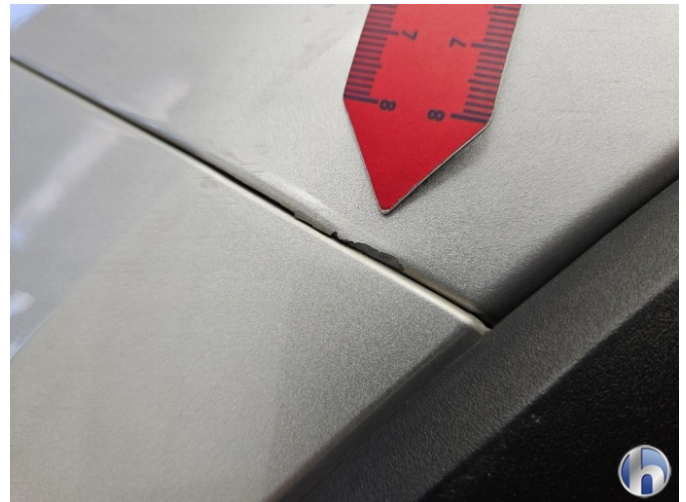
17. Front fender - left

| component | Damage | Rep kind |
|---|---|---|
| 13. Front fender - left | Scratch(es) | Replace |

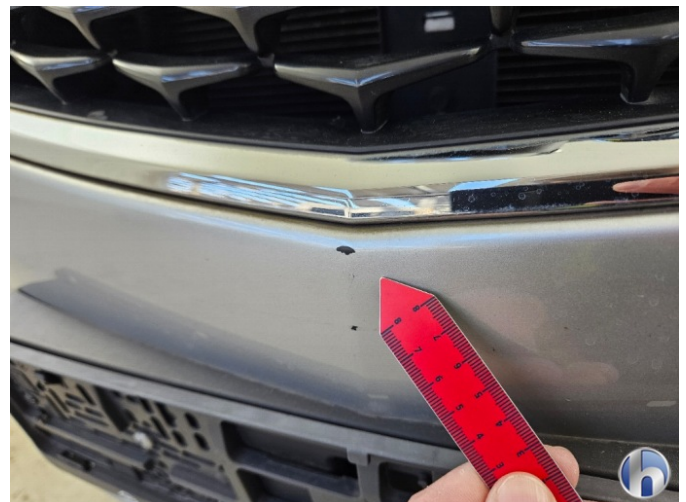
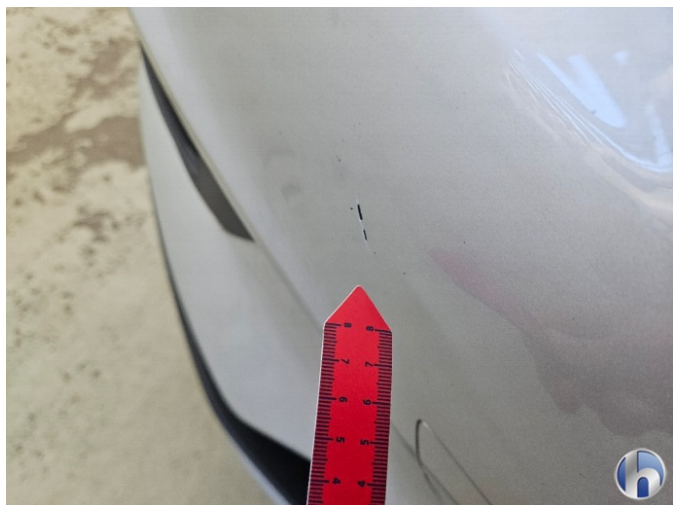
19. Front bumper

| component | Damage | Rep kind |
|---|---|---|
| 14. Front bumper | Scratch(es) | Paint |

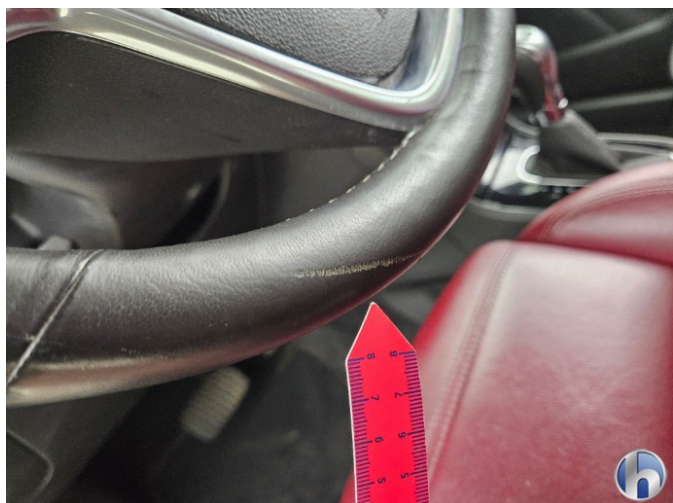
| component | Damage | Rep kind |
|---|---|---|
| 21. Steering wheel (leather) | Damaged | Replace |

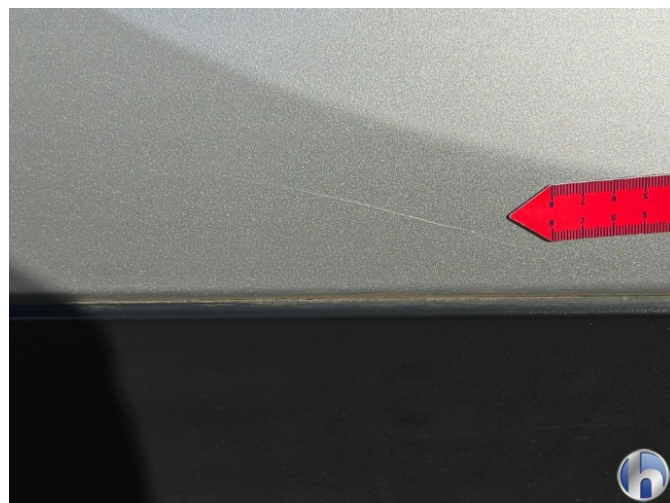
| component | Damage | Rep kind |
|---|---|---|
| 22. Door Rear - right | Scratch(es) | Paint |

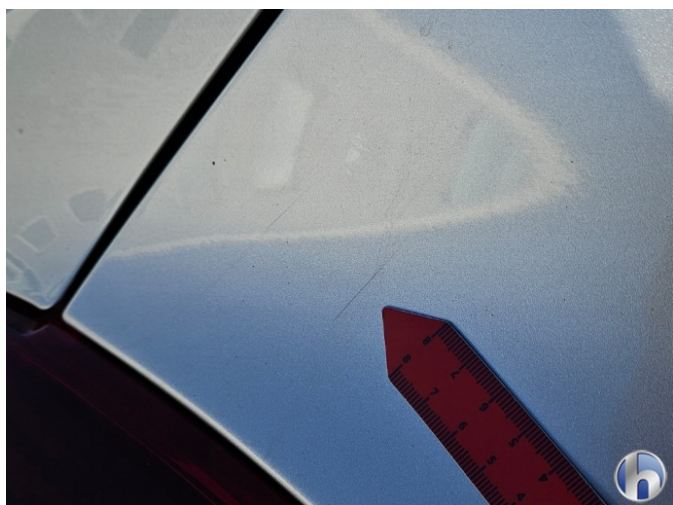
| component | Damage | Rep kind |
|---|---|---|
| 23. Sidewall - Rear - right | Scratch(es) | Paint |
