## status report

#### Opel Movano B Kasten/Kombi HKa L2H2 3,5t

| Vehicle identification number | <b>W0VMR8605MB250217</b> | mileage read: | <b>140371 km</b> |

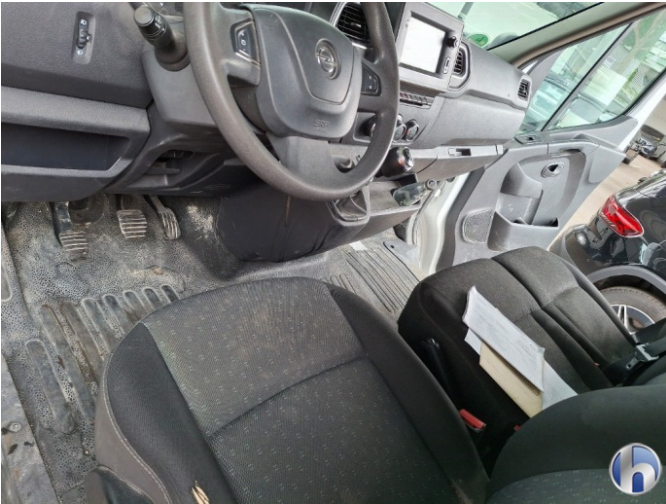
1. Fahrerkabine

| | component | Damage | Rep kind |
|---|---|---|---|
| 1. | Fahrerkabine | Dirty | |

**Dirty**

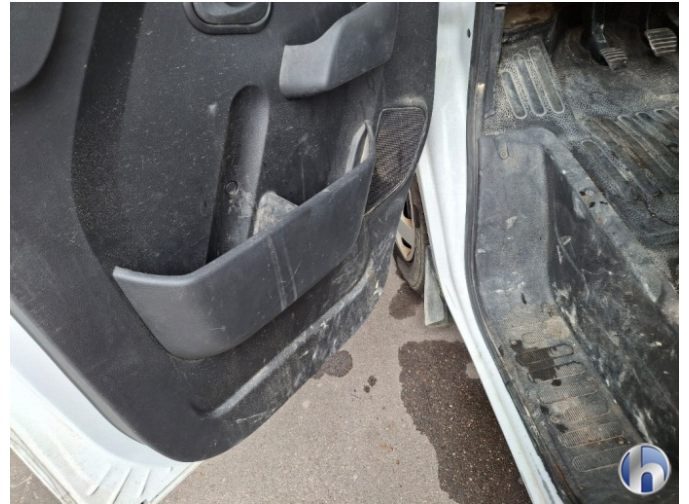
1. Fahrerkabine

**Dirty**

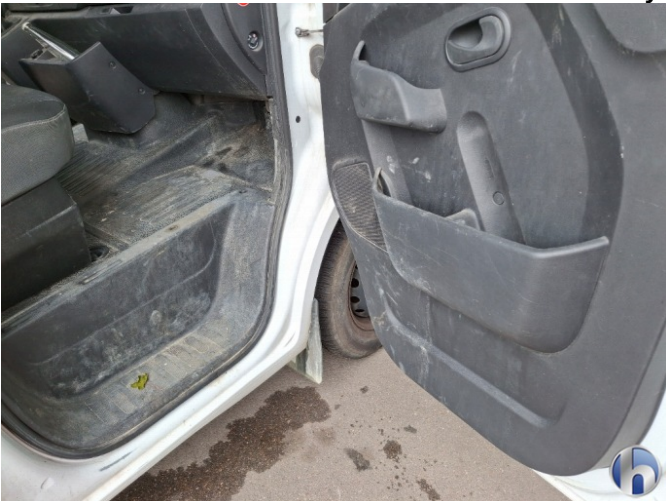
1. Fahrerkabine

**Dirty**

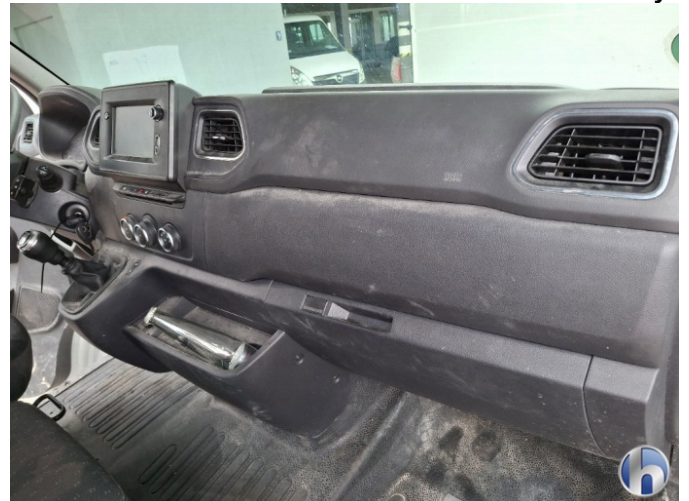
1. Fahrerkabine

**Dirty**

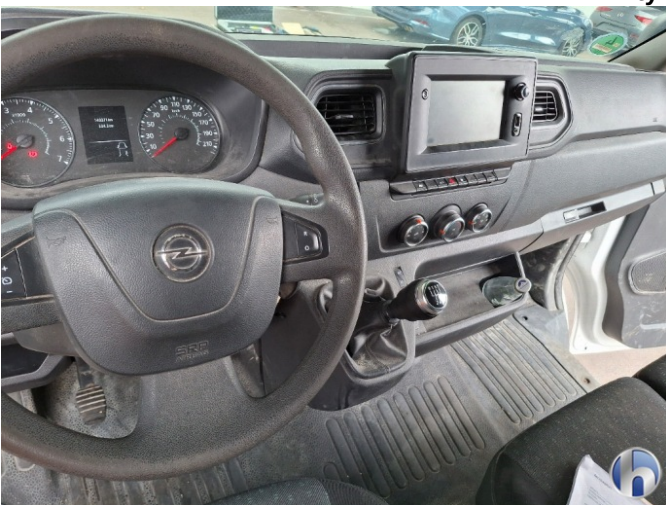
1. Fahrerkabine

**Dirty**

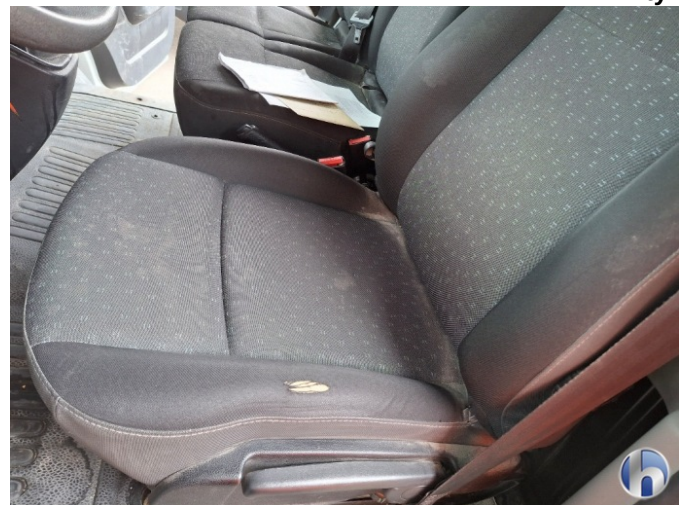
2. Sitzbezug Fahrersitz

| | component | Damage | Rep kind |
|---|---|---|---|
| 2. | Sitzbezug Fahrersitz | Worn | Replace |

**Worn**

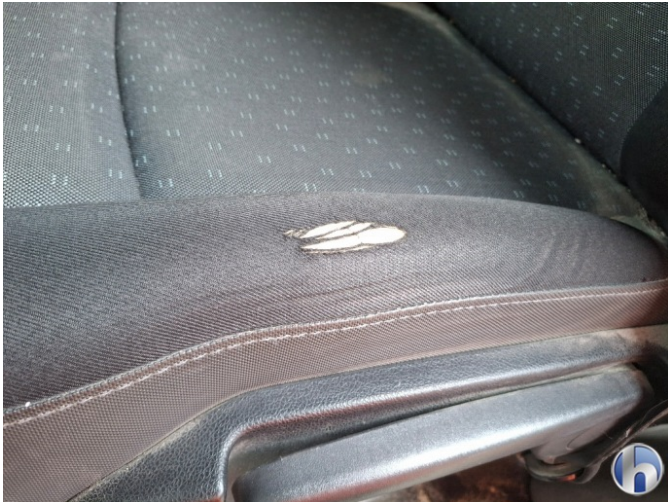
2. Sitzbezug Fahrersitz

Worn

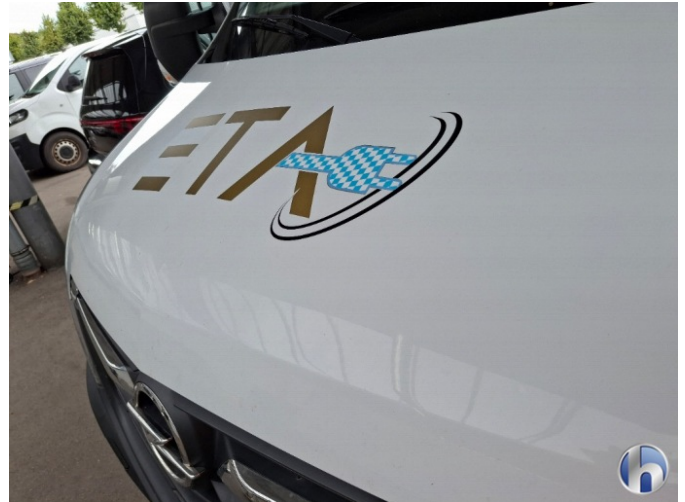
3. hood

Sticker

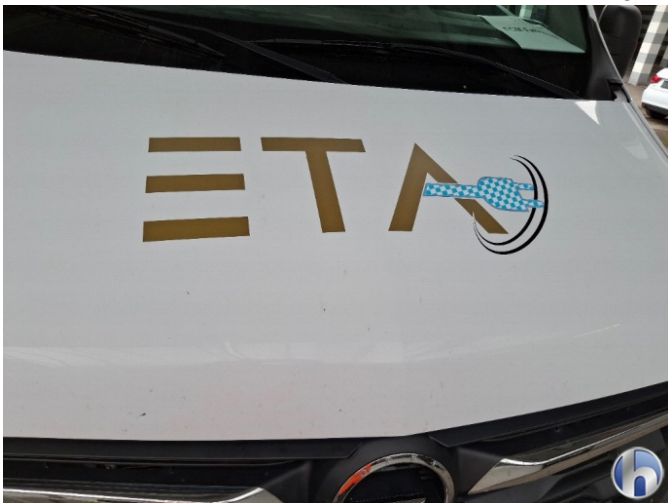
3. hood

Sticker

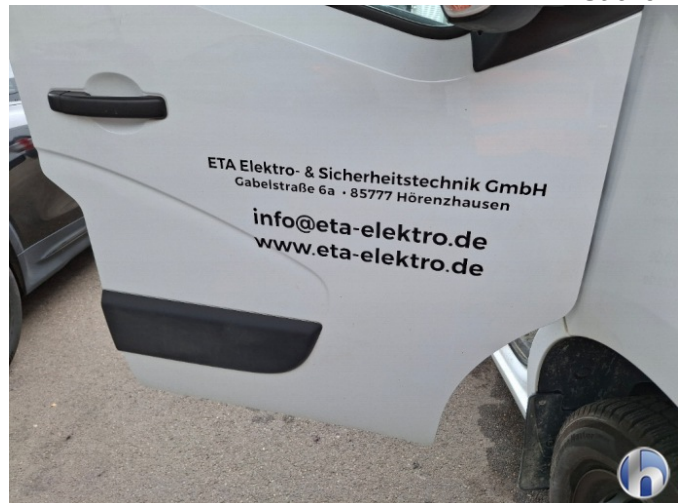
4. Front door - right

Sticker

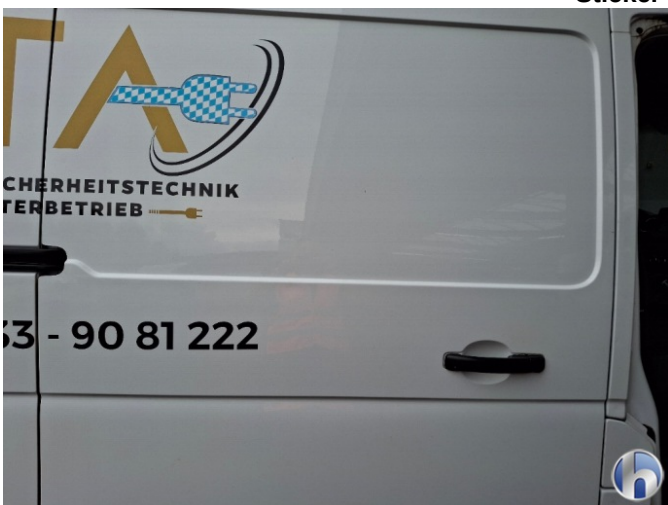
5. Sliding door - right

Sticker

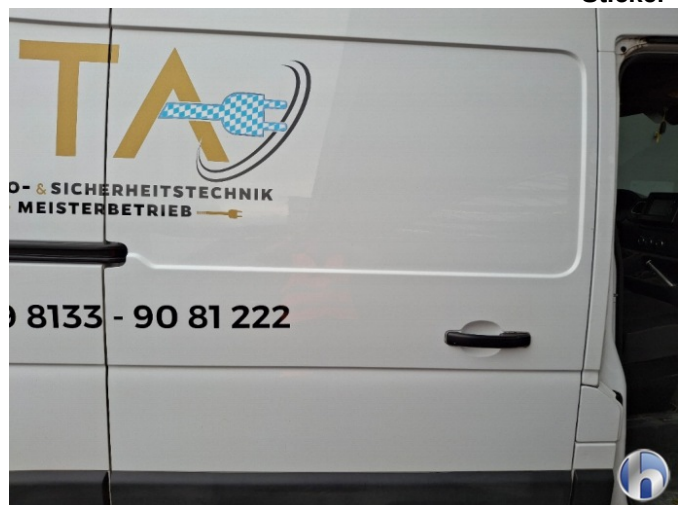
5. Sliding door - right

Sticker

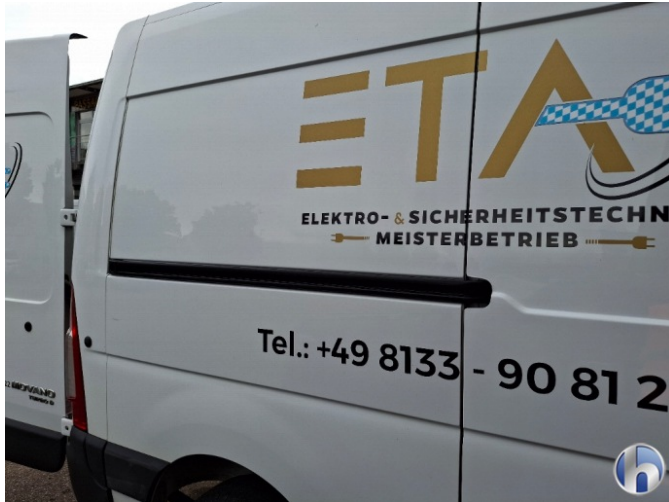
6. Sidewall - Rear - right

**Sticker**

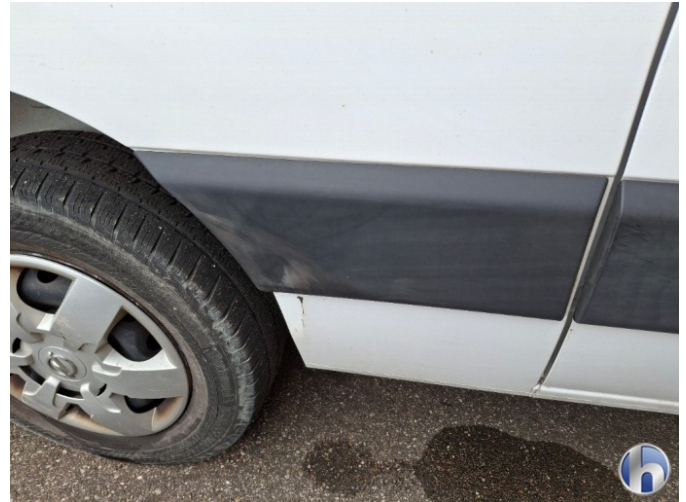
7. Sidewall - Rear - right

| | component | Damage | Rep kind |
|---|---|---|---|
| 7. | Sidewall - Rear - right | Damaged | Refurbish and paint |

**Damaged**

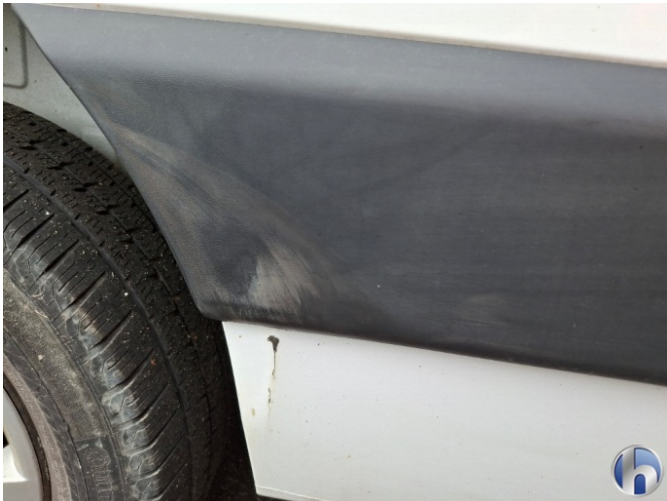
7. Sidewall - Rear - right

**Damaged**

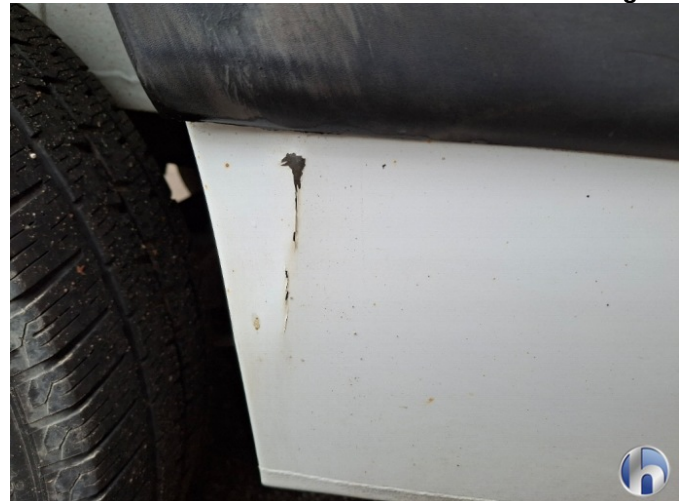
7. Sidewall - Rear - right

**Damaged**

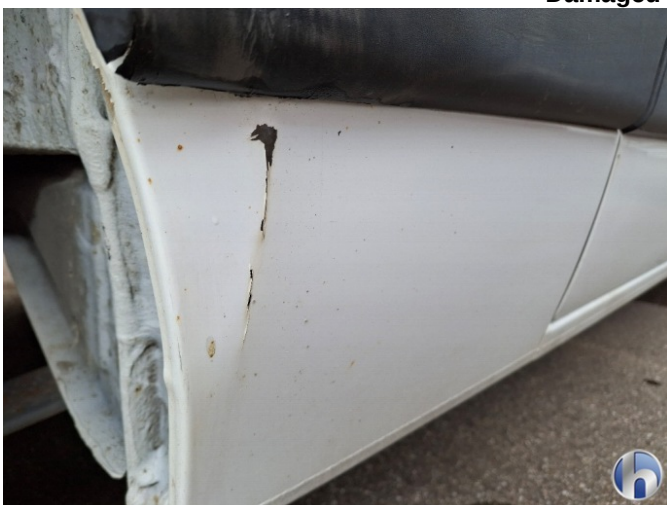
7. Sidewall - Rear - right

**Damaged**

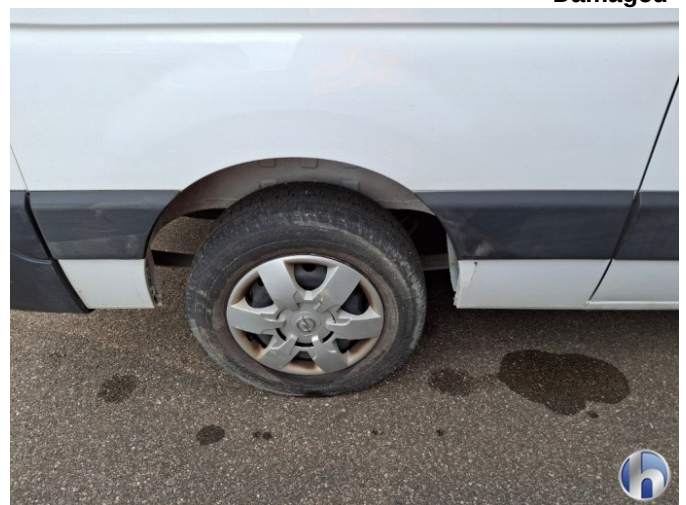
8. Schutzleiste rechts Seitenwand

| | component | Damage | Rep kind |
|---|---|---|---|
| 8. | Schutzleiste rechts Seitenwand | Damaged | Replace |

**Damaged**

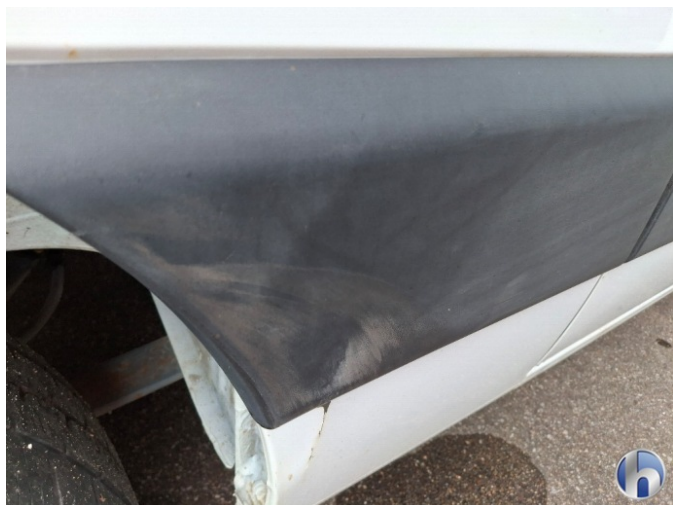
8. Schutzleiste rechts Seitenwand

**Damaged**

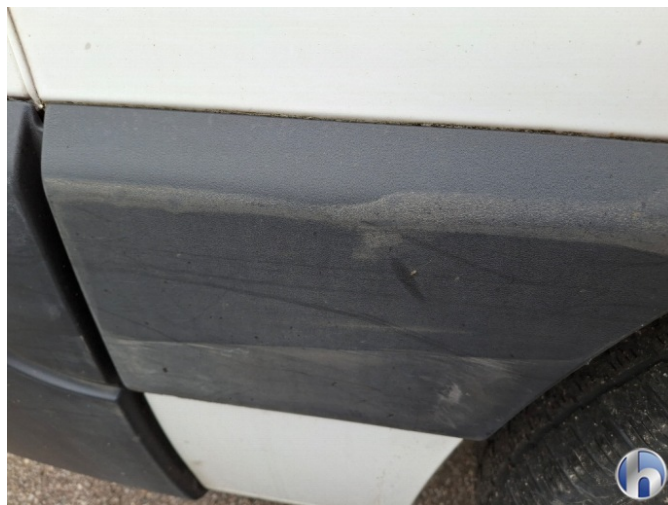
8. Schutzleiste rechts Seitenwand

**Damaged**

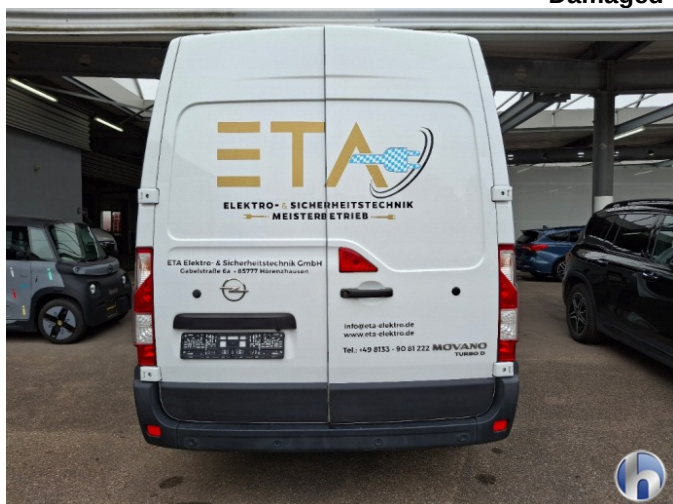
9. tailgate

**Sticker**

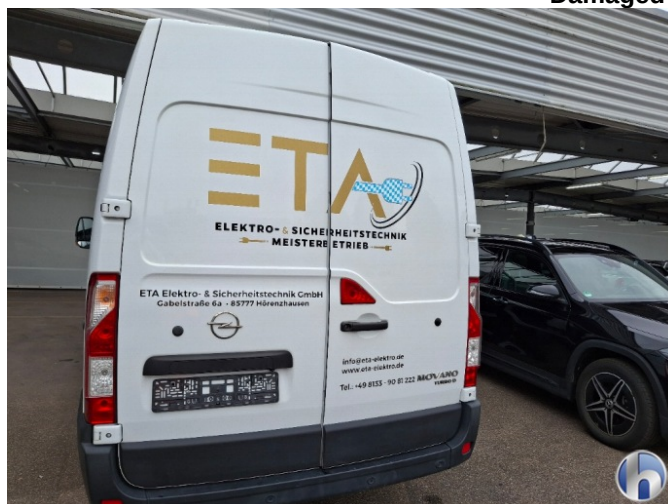
9. tailgate

**Sticker**

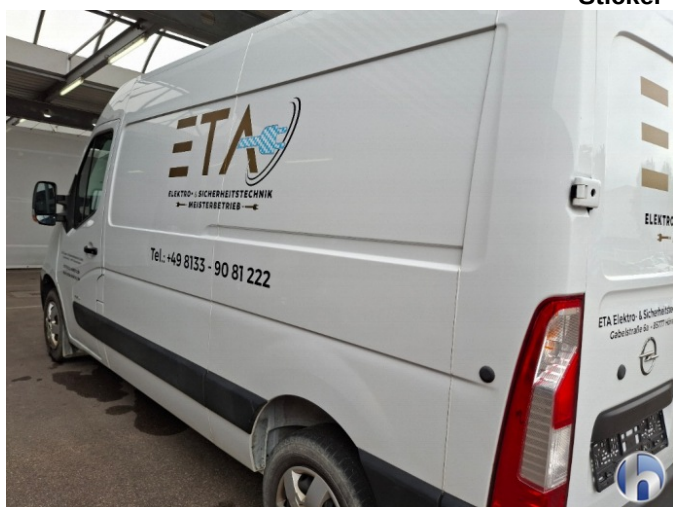
10. Sidewall - Rear - Left

**Sticker**

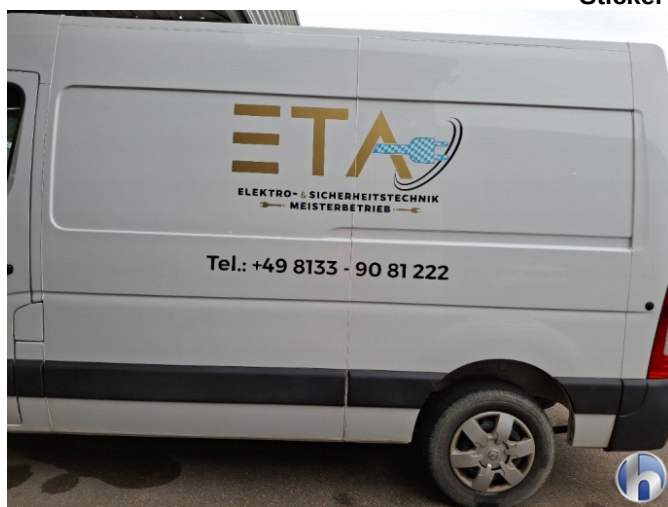
10. Sidewall - Rear - Left

**Sticker**

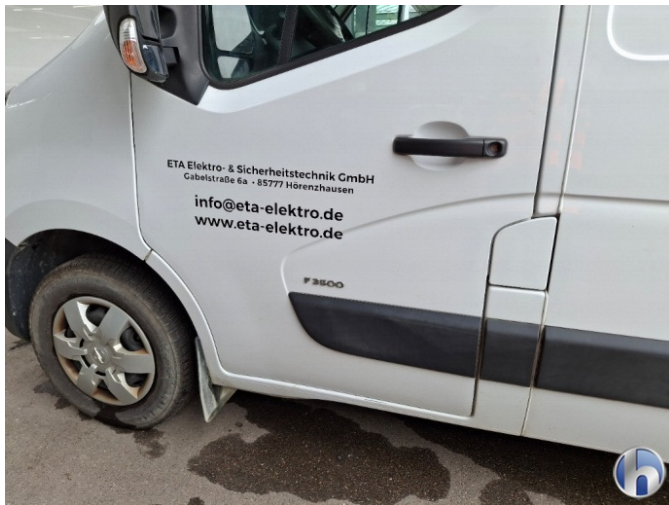
11. Front door - left

**Sticker**

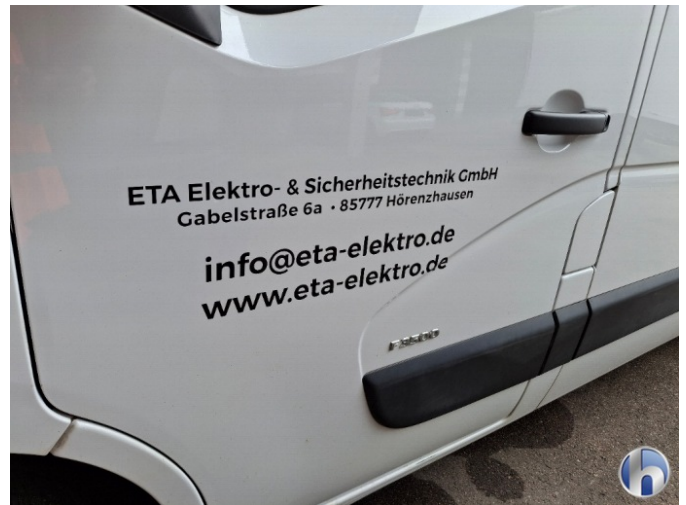
11. Front door - left

**Sticker**

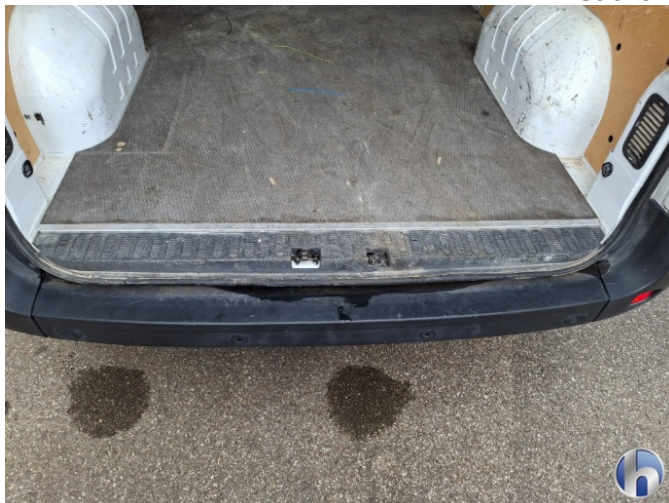
12. Einstiegleiste Laderaum hinten

| | component | Damage | Rep kind |
|---|---|---|---|
| 12. | Einstiegleiste Laderaum hinten | Breakage | Replace |

**Breakage**

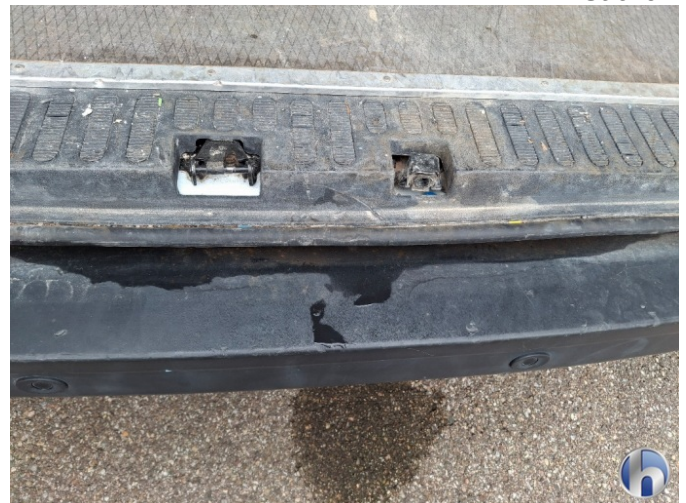
12. Einstiegleiste Laderaum hinten

**Breakage**

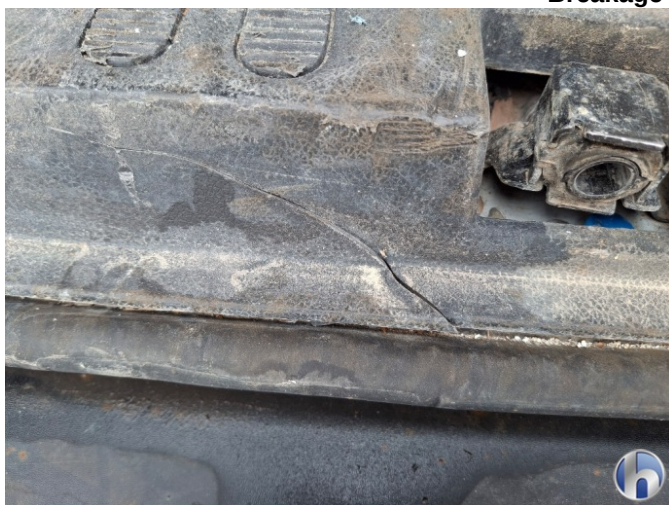
12. Einstiegleiste Laderaum hinten

**Breakage**

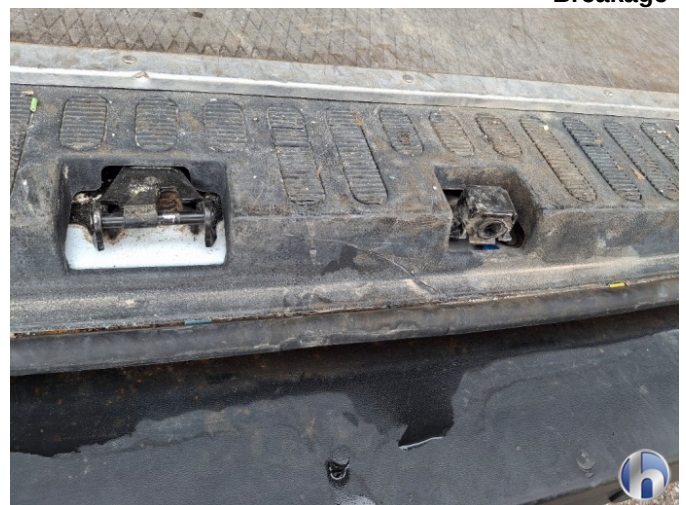
12. Einstiegleiste Laderaum hinten

**Breakage**
