Expertise

Protocol number: 41630885
Order No. / Reference: 25250099
Inspection date: 18 Sept 2025

Manufacturer: Opel	Model: Grandland X Plug-in-Hybrid4 1.6 DI Start/Stop Aut Ultimate
VIN: W0VZ45GB2MS062550

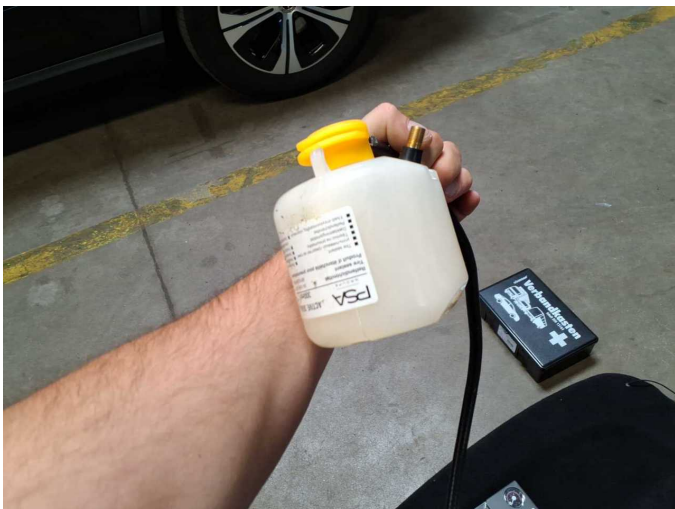
No.	Component group	Description
1	Misc.	Main inspection - No evidence - No deduction
2	Equipment	Tirefit filler - Empty - Replace
3	Mudguard - left side	Wheel well extension - Scratch(es) - Loss in value
4	Door - front left side	Brightware - lower - Scratch(es) - Loss in value
5	Body	Underbody panelling - Broken / torn - Replace
6	Seat - front	Seat cover - left side - Broken / torn - Replace

Damage 2: Equipment: Tirefit filler - Empty - Replace

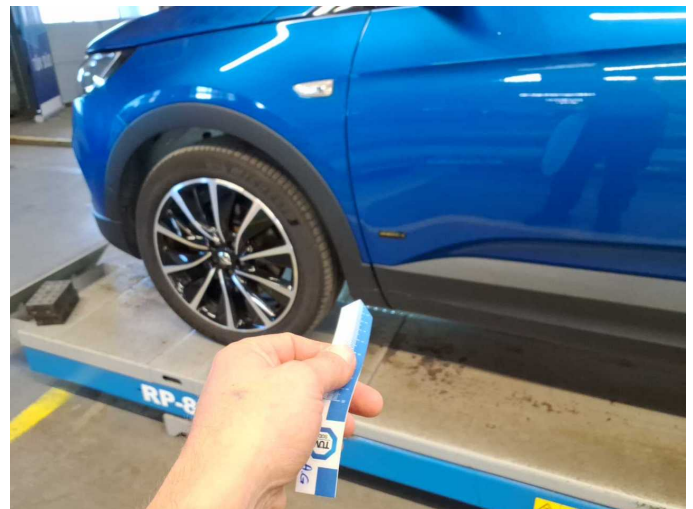
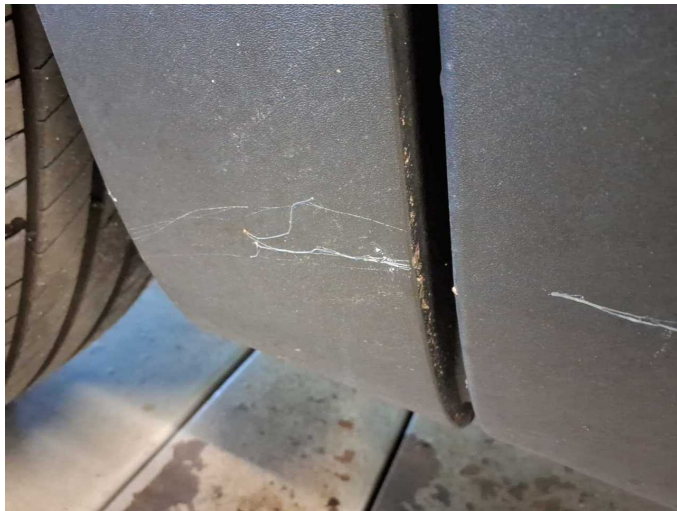
Damage 3: Mudguard - left side: Wheel well extension - Scratch(es) - Loss in value

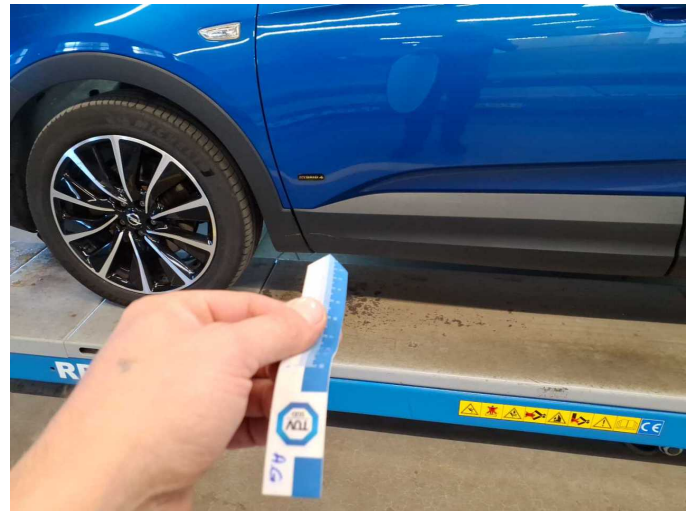
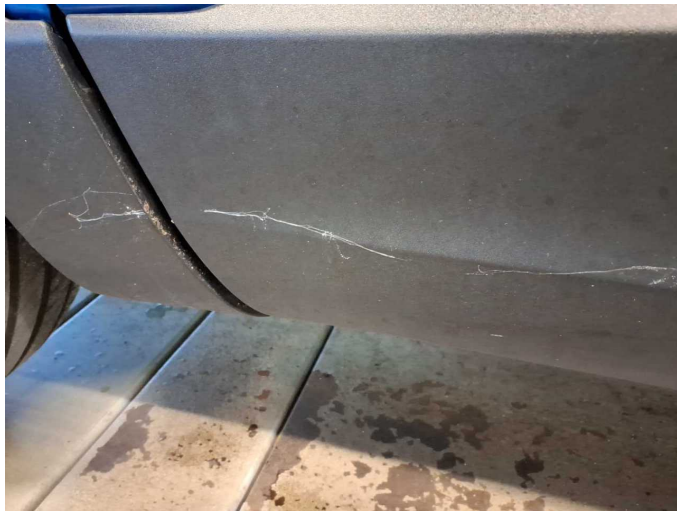
Damage 4: Door - front left side: Brightware - lower - Scratch(es) - Loss in value

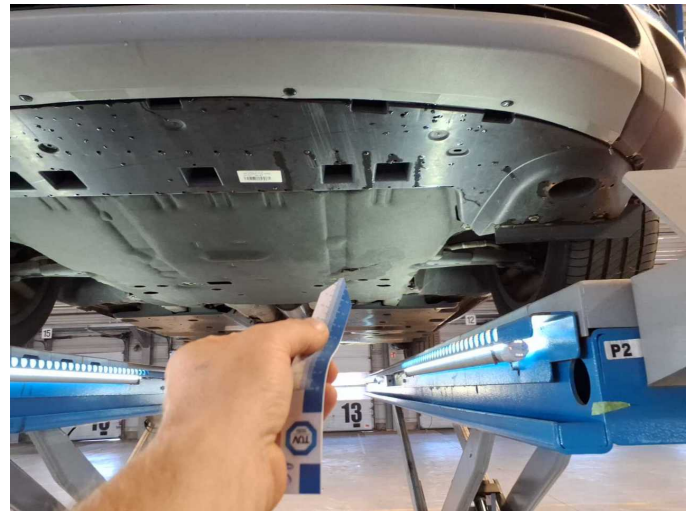
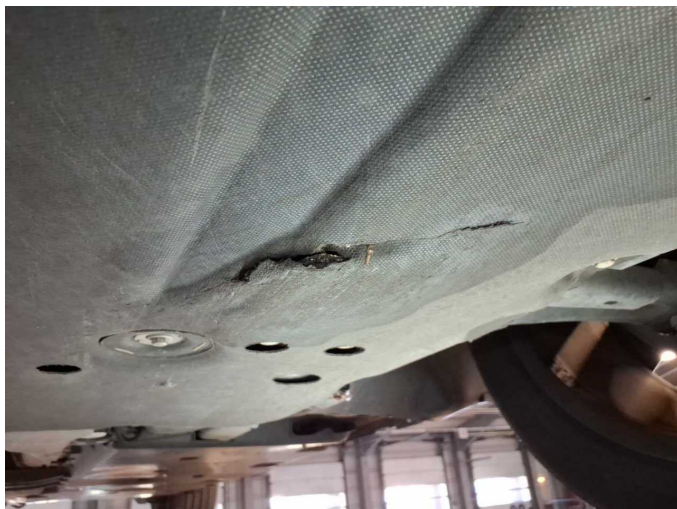
Damage 5: Body: Underbody panelling - Broken / torn - Replace

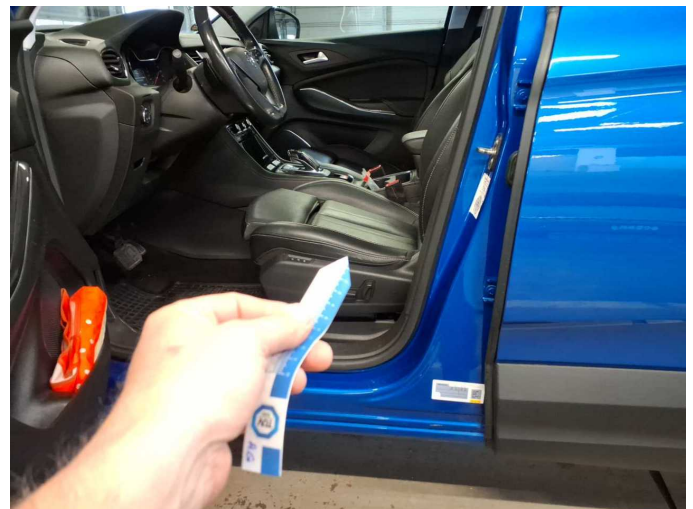
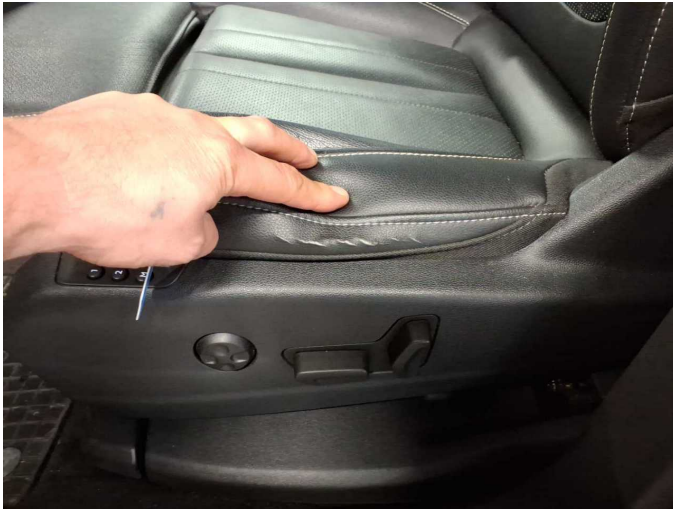
Damage 6: Seat - front: Seat cover - left side - Broken / torn - Replace

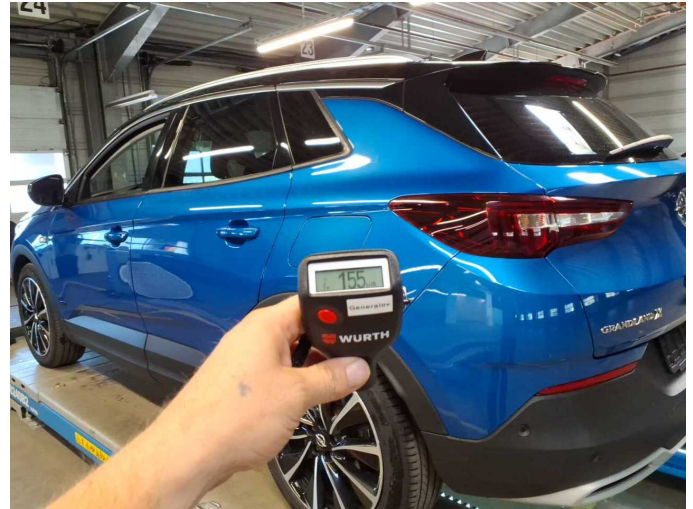
Side panel - rear left side	155 µm	Side panel - rear right side	163 µm
Door - rear left side	216 µm	Door - rear right side	162 µm
Door - front left side	146 µm

Repainting 1: Side panel - rear left side

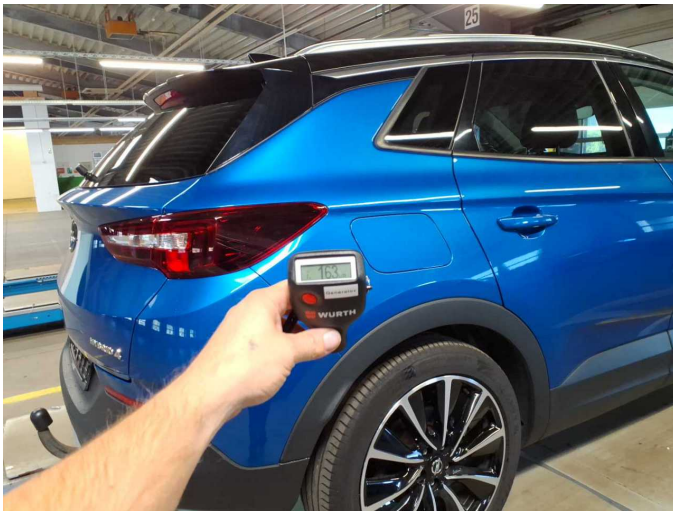
Repainting 2: Side panel - rear right side

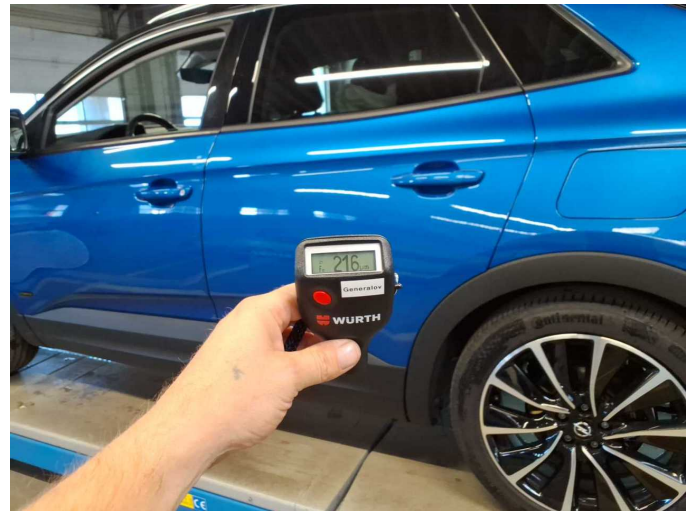
Repainting 3: Door - rear left side

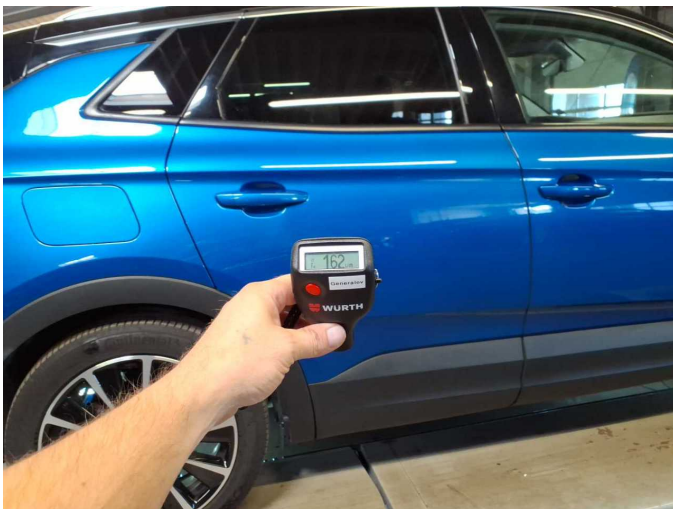
Repainting 4: Door - rear right side

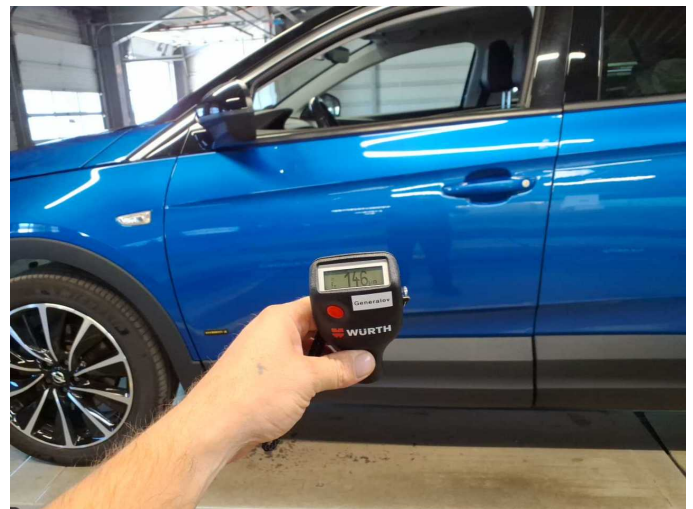
Repainting 5: Door - front left side
