## status report

**customer:** Bank 11, Neuss  
**contract number:** 1135632  
**reference:**

#### Opel Grandland X Ultimate Plug-in-Hybrid

| Vehicle identification number | W0VZ4DGZ2MS055122 | mileage read: | 38573 km |

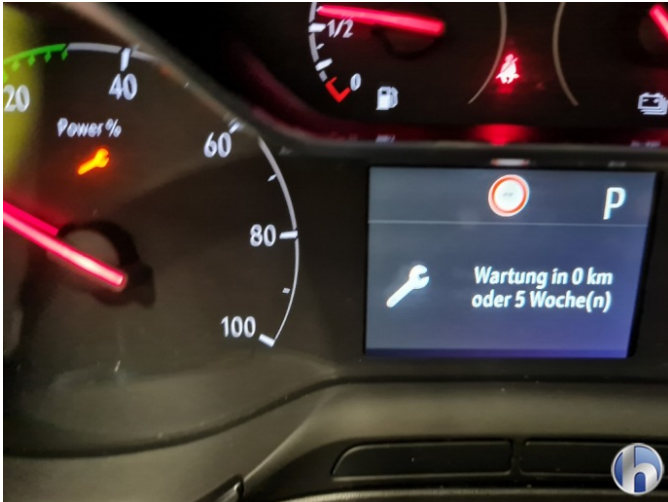
| component | Damage | Rep kind |
|---|---|---|
| 1. Wartung | Error message | Replace |

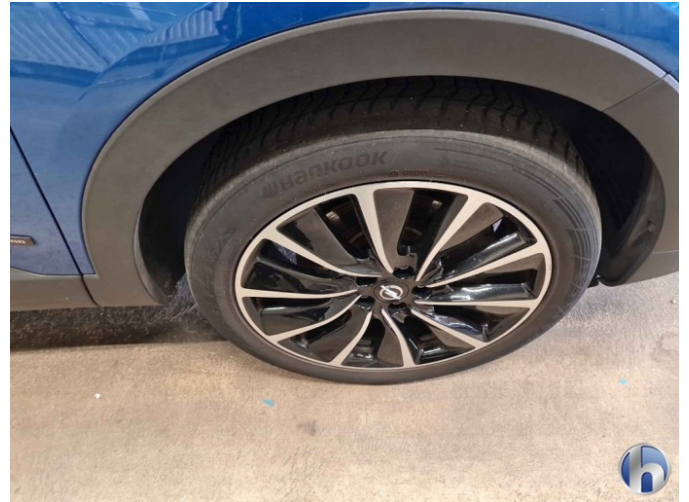
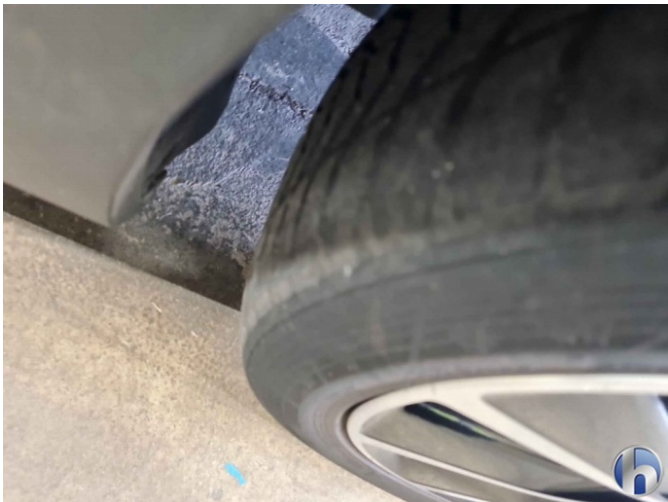
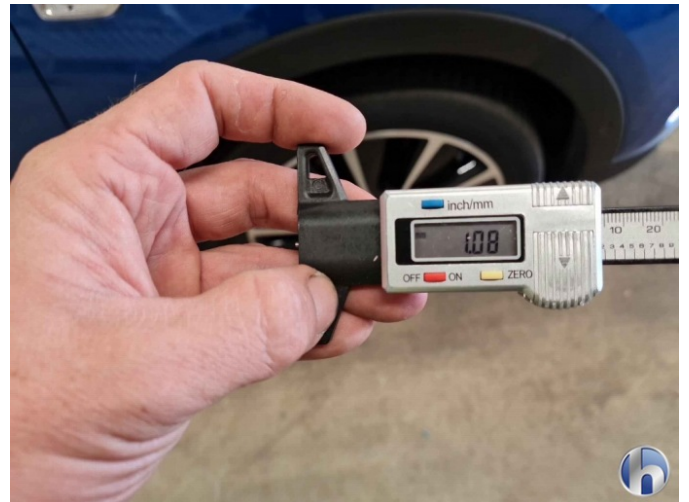
| mounted tires | | |
|---|---|---|
| 1st axis - right / states . | <b>Hankook</b> | <b>205/55/R19/97H 1 mm</b> |

| General examination | |
|---|---|
| <b>Note Road Safe:</b> | Bereifung Vorderachse nicht in Ordnung |

| component | Damage | Rep kind |
|---|---|---|
| 4. tire front - right | Not okay | Replace |

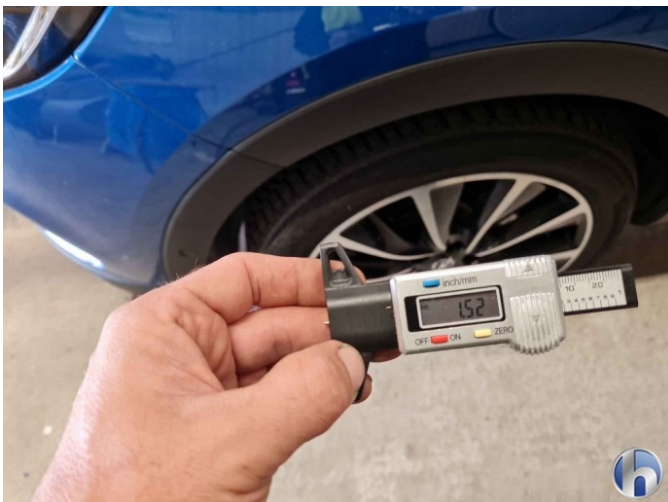
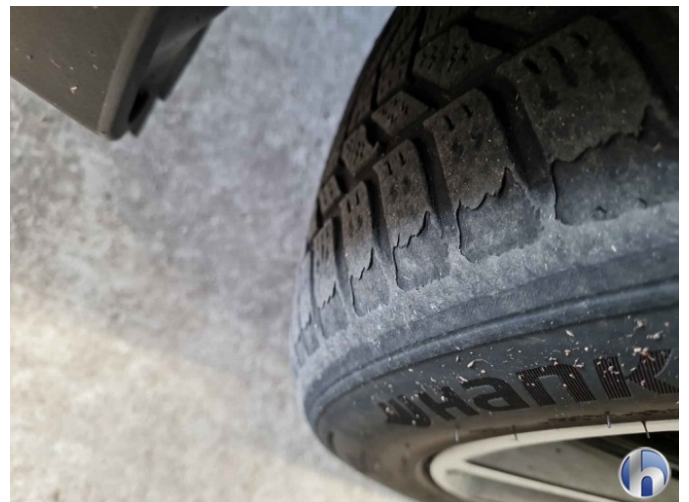
| mounted tires | | |
|---|---|---|
| 1st axis - Left / states . | <b>Hankook</b> | <b>205/55/R19/97H 1.5 mm</b> |

| component | Damage | Rep kind |
|---|---|---|
| 5. tire front - left | Not okay | Replace |

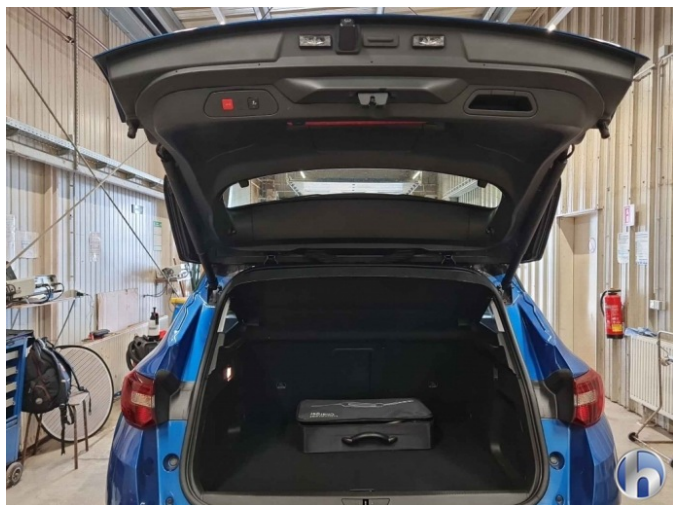
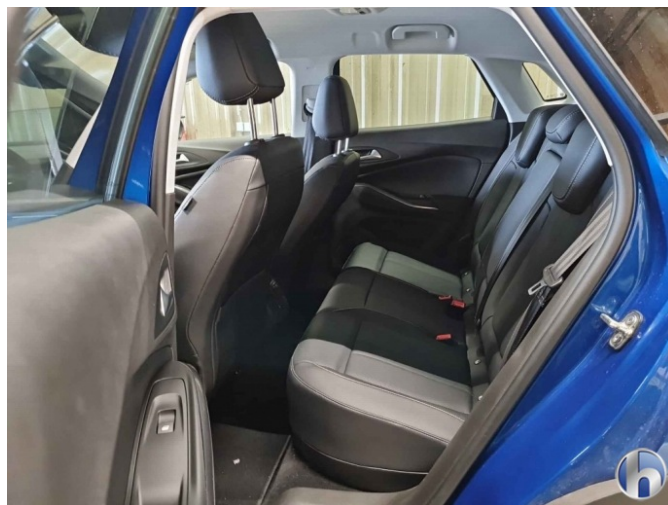
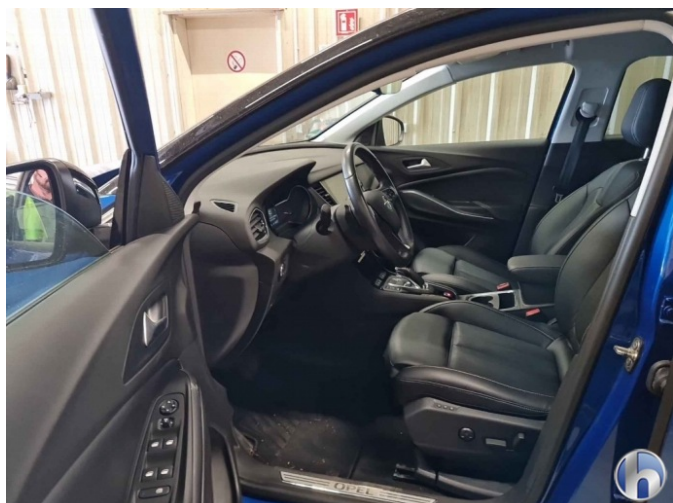
| component | Damage | Rep kind |
|---|---|---|
| 6. Kofferraum und Innenraum | Wear and tear | acceptable |

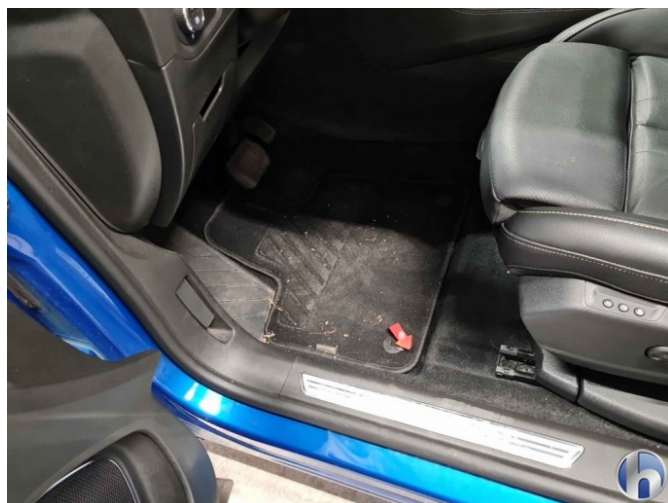
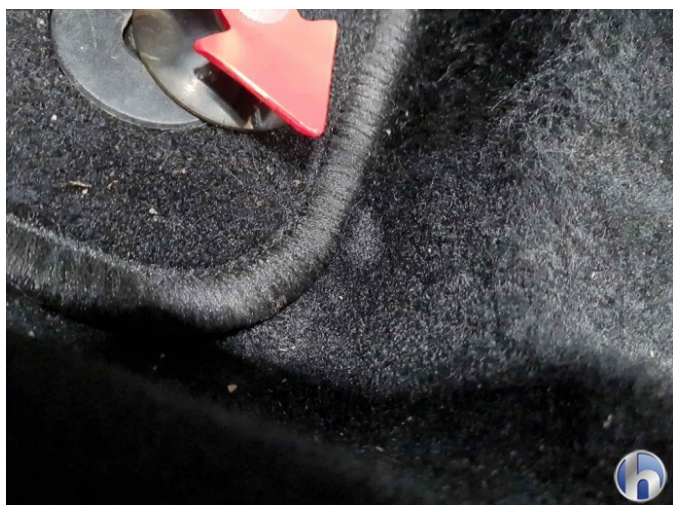
| component | Damage | Rep kind |
|---|---|---|
| 7. flooring | Burn hole | Smart repair |

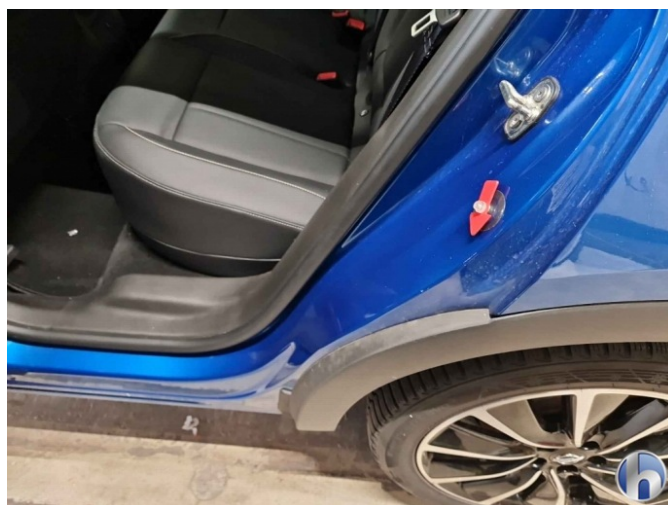
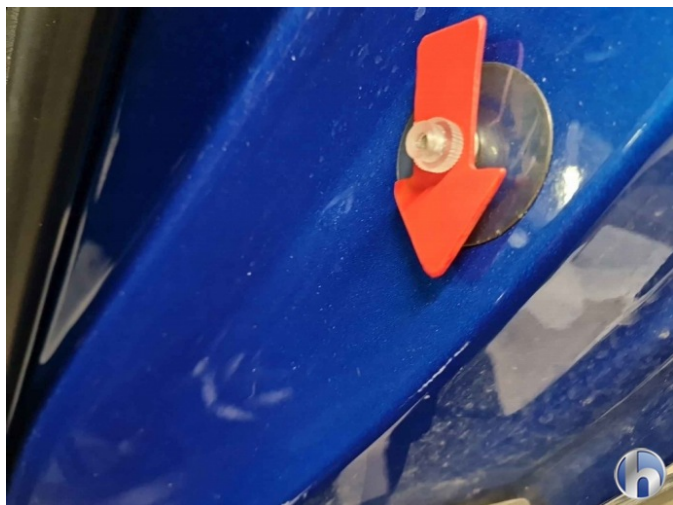
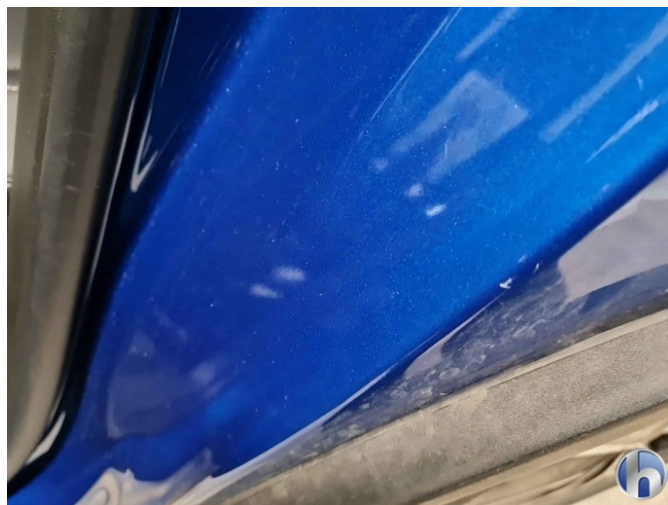
| component | Damage | Rep kind |
|---|---|---|
| 8. Türeinstieg Hinten - Links | Scrape | Smart repair |

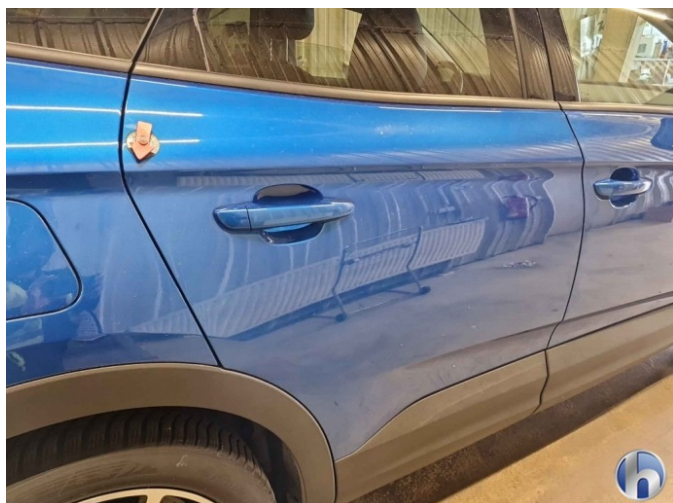
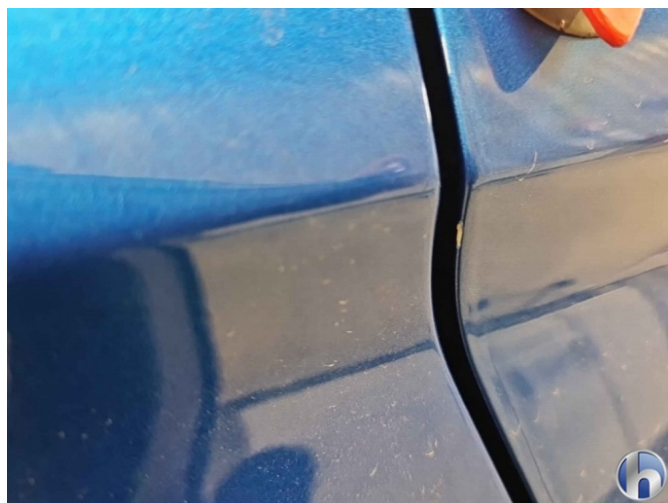
| component | Damage | Rep kind |
|---|---|---|
| 9. Door Rear - right | chipped paint | Smart repair |

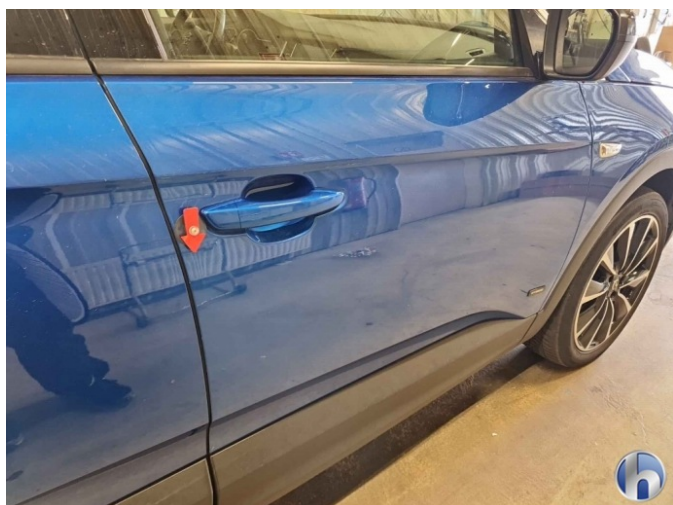
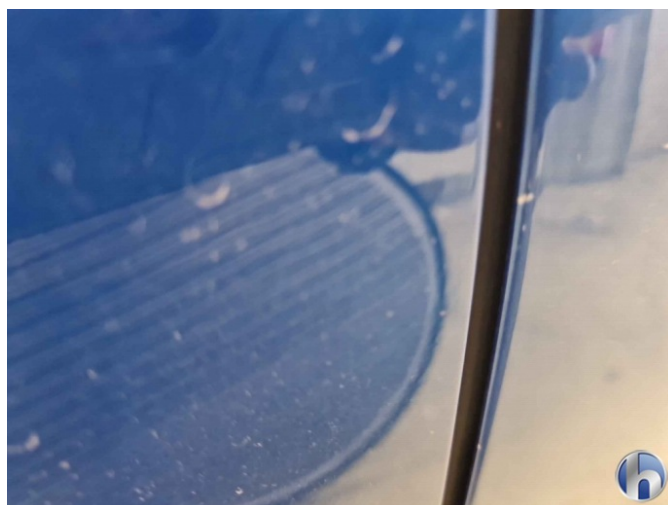
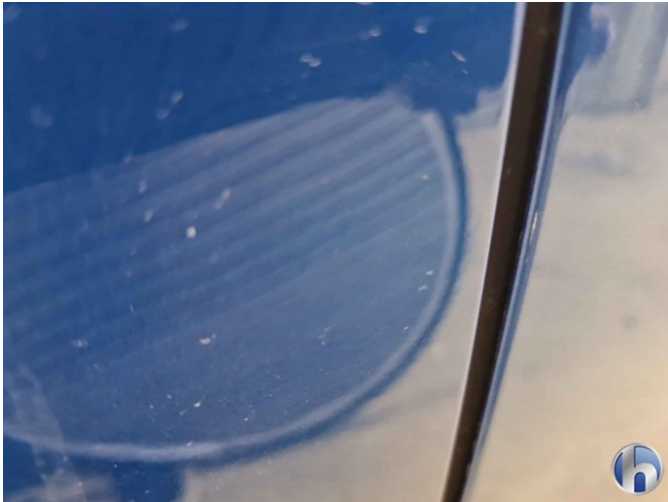
| component | Damage | Rep kind |
|---|---|---|
| 10. Front door - right | chipped paint | Smart repair |

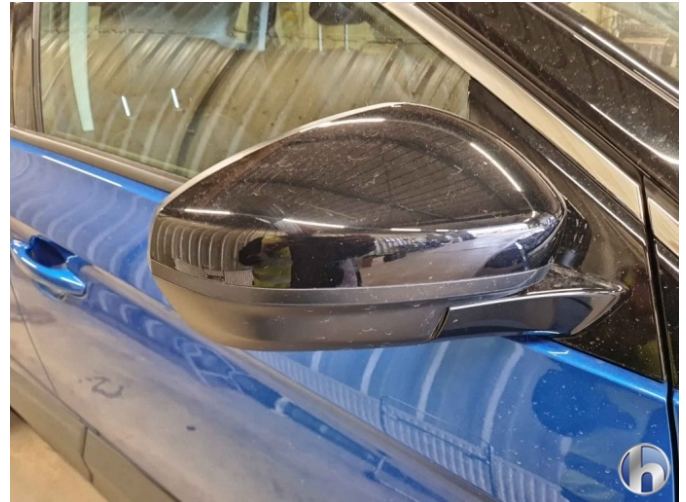
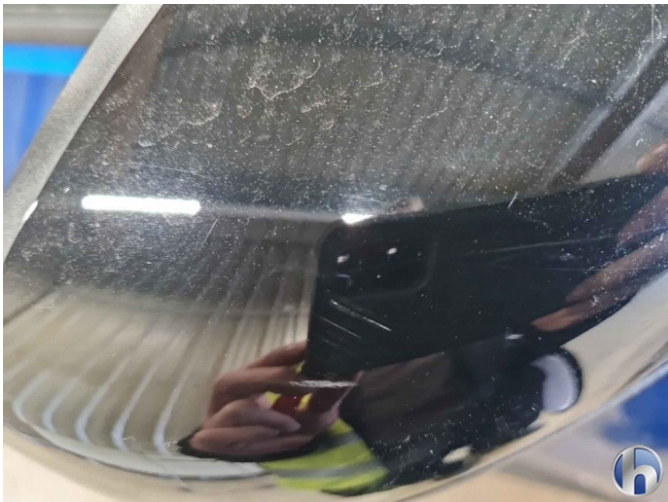
| component | Damage | Rep kind |
|---|---|---|
| 11. Outside mirror - right | Scrape | Paint |

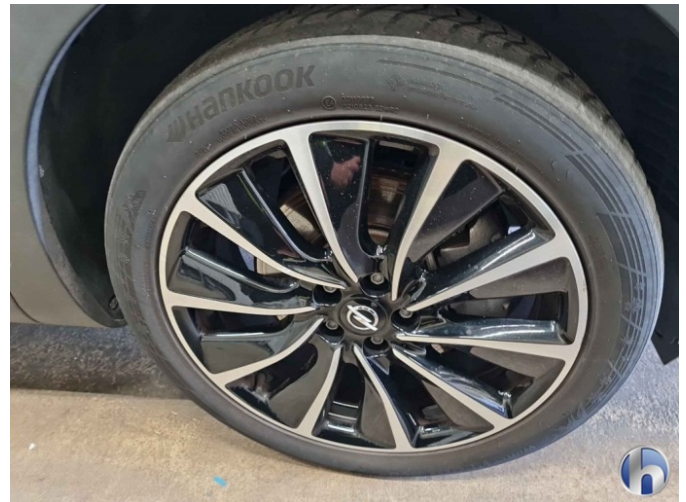
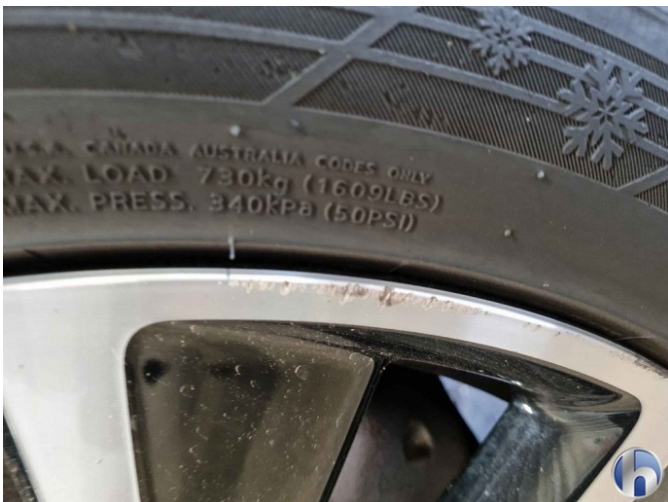
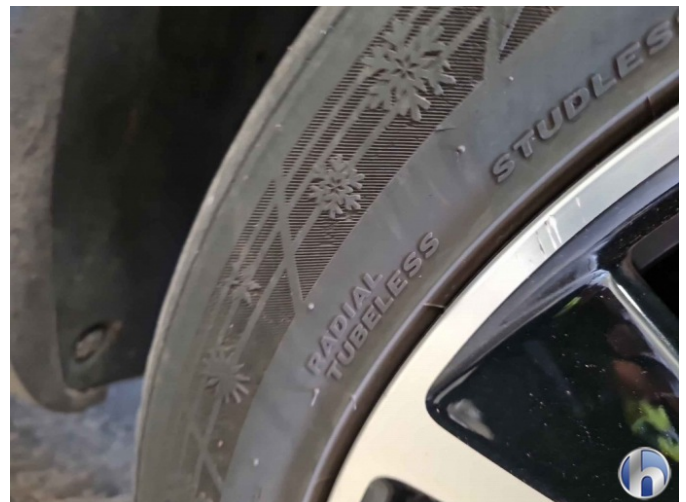
| component | Damage | Rep kind |
|---|---|---|
| 12. | Damaged | Replace |

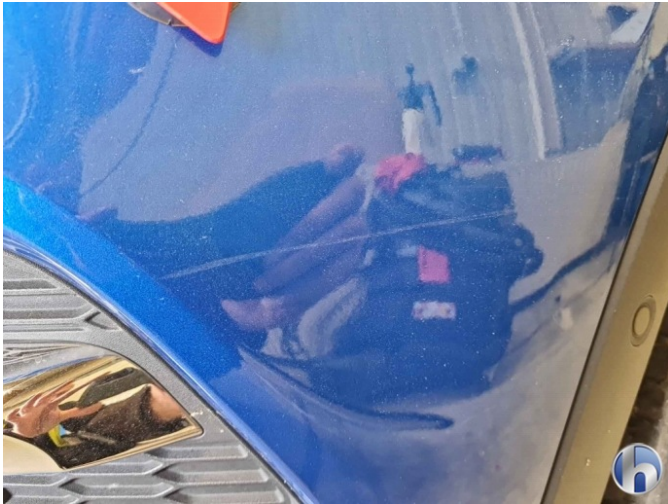
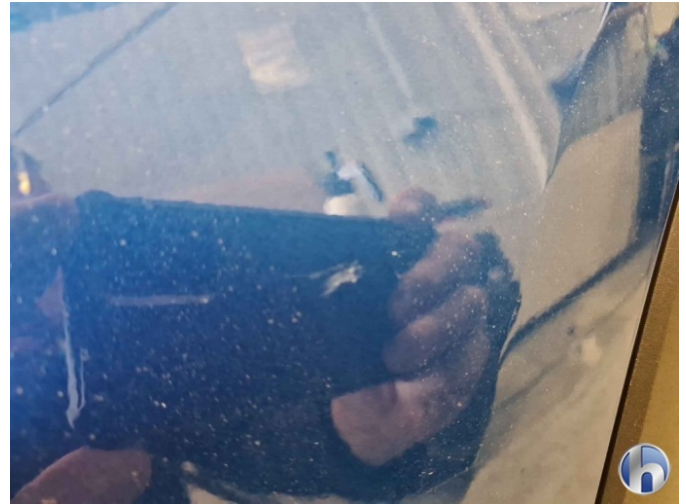
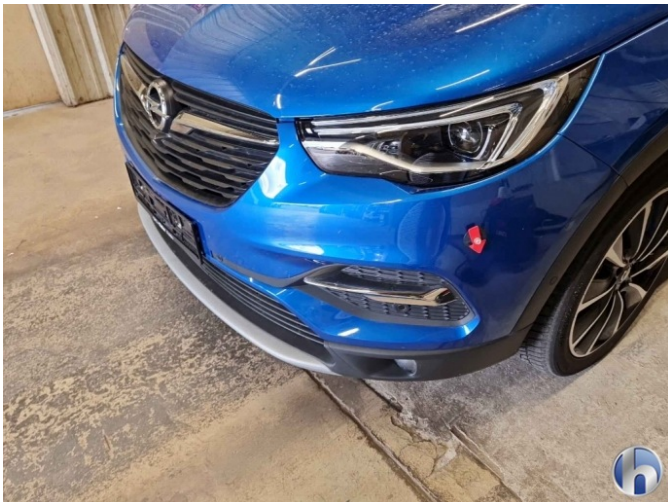
| component | Damage | Rep kind |
|---|---|---|
| 13. Front bumper | Scratch(es) | Paint |

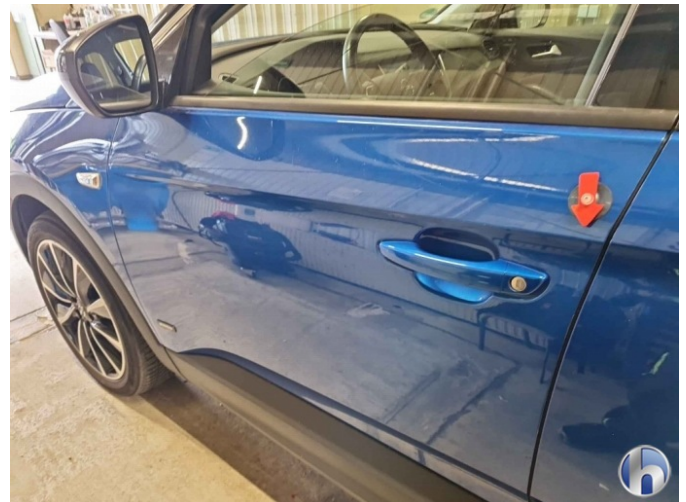
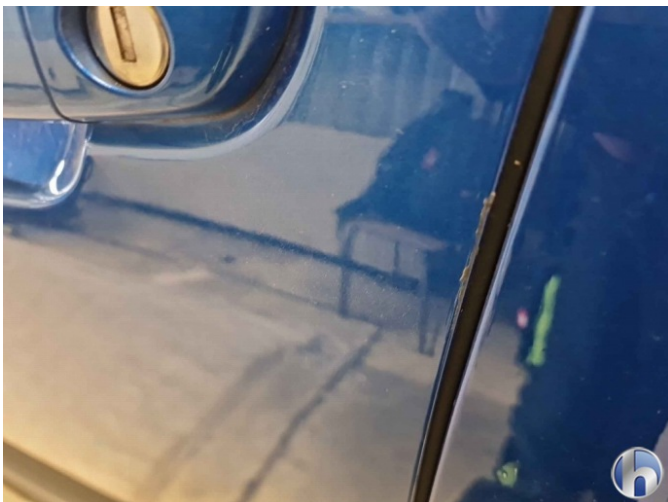
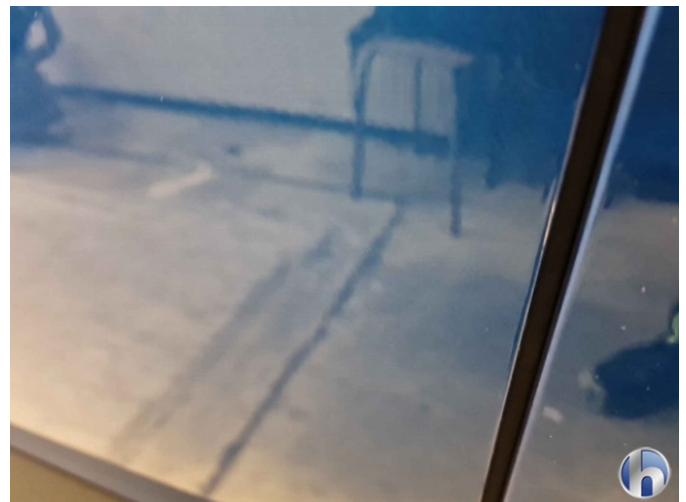
| component | Damage | Rep kind |
|---|---|---|
| 14. Front door - left | chipped paint | Smart repair |

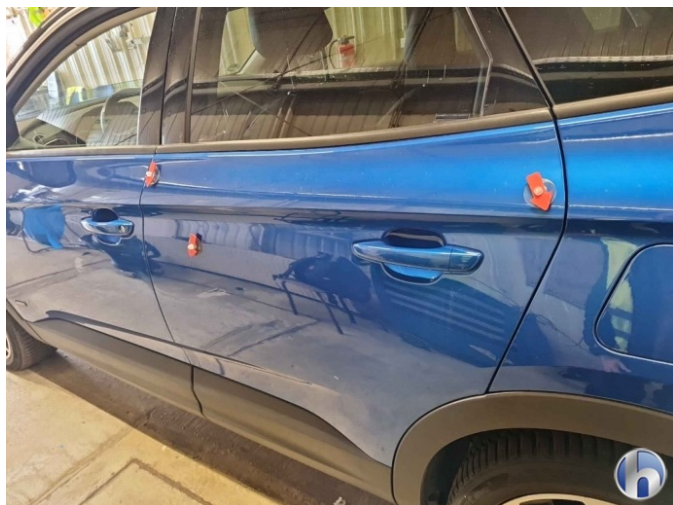
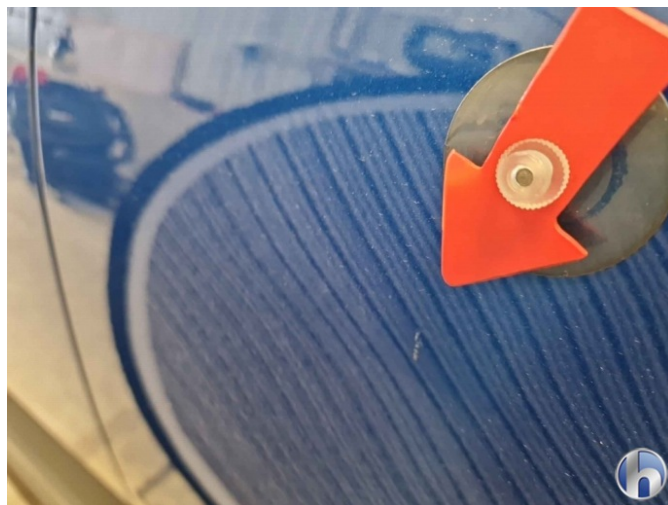
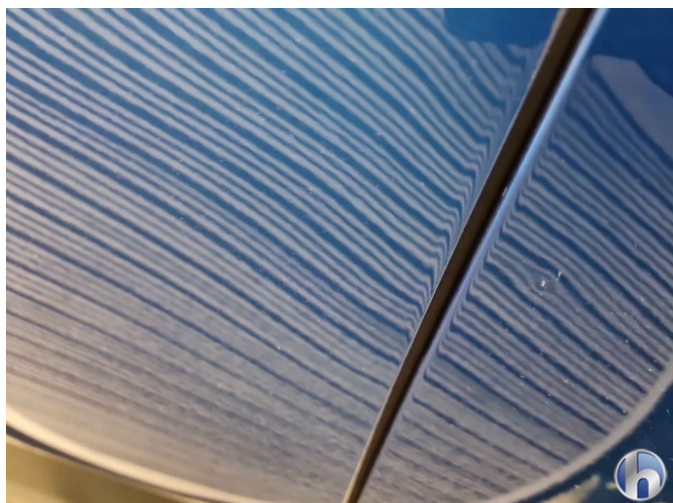
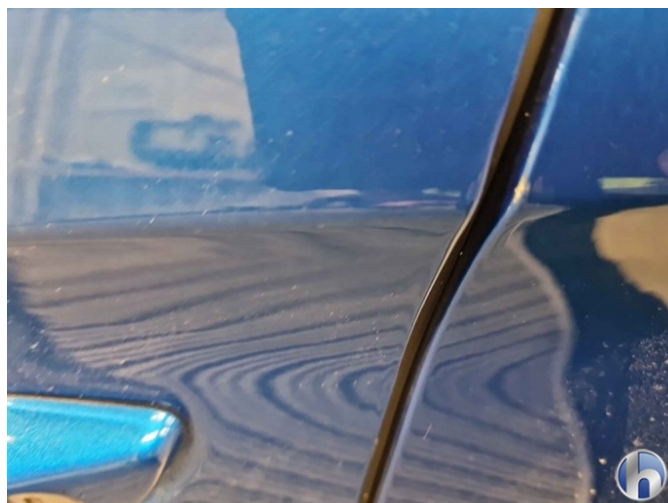
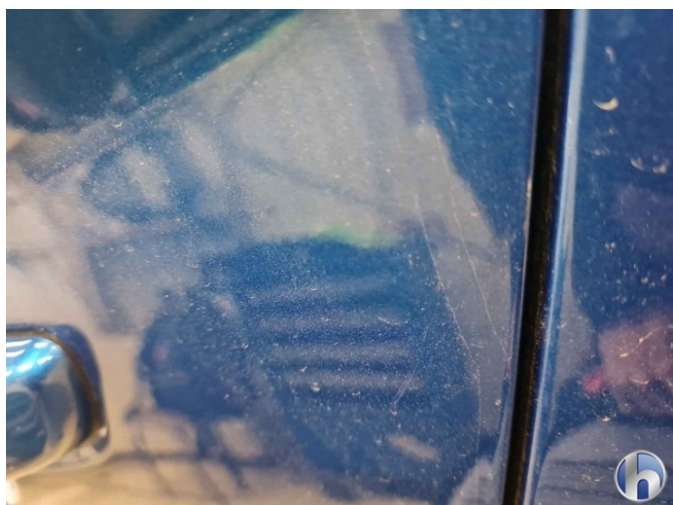
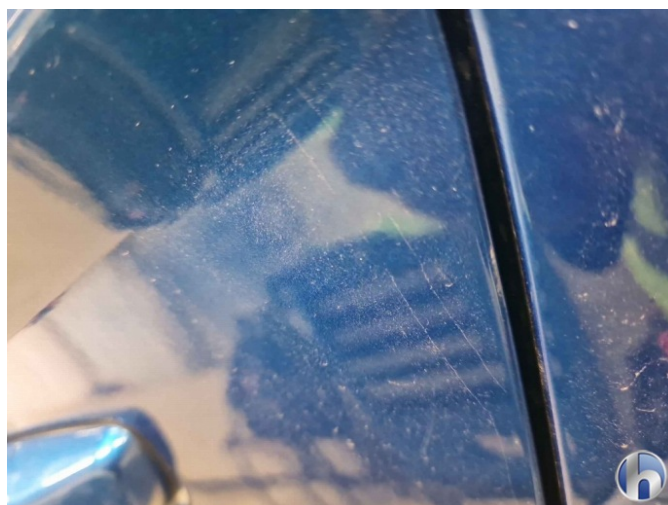
| component | Damage | Rep kind |
|---|---|---|
| 15. Rear door - left | Damaged | Refurbish and paint |

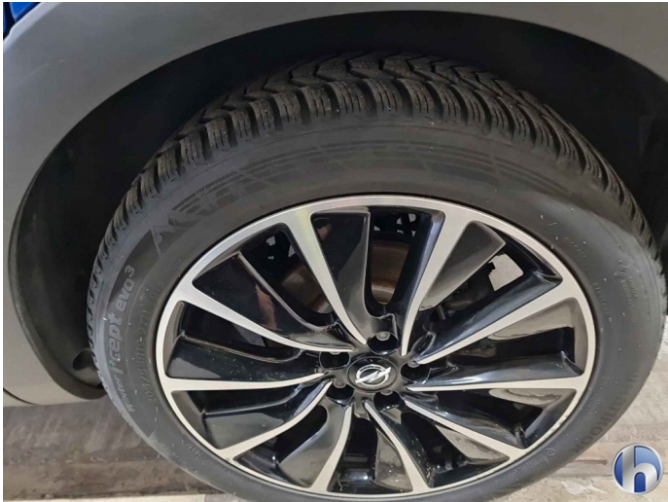
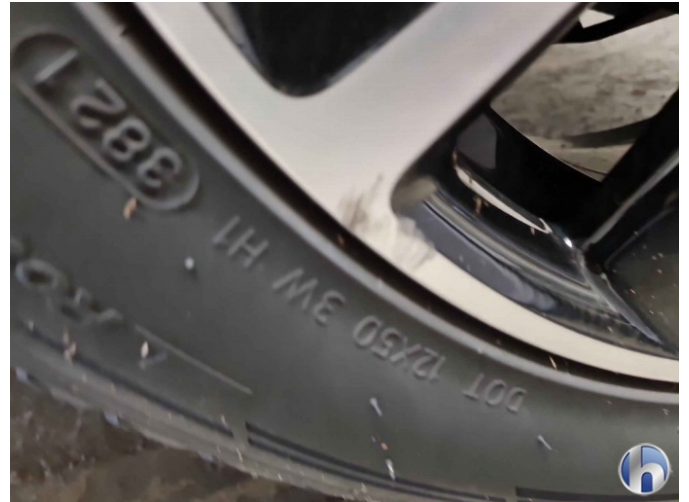
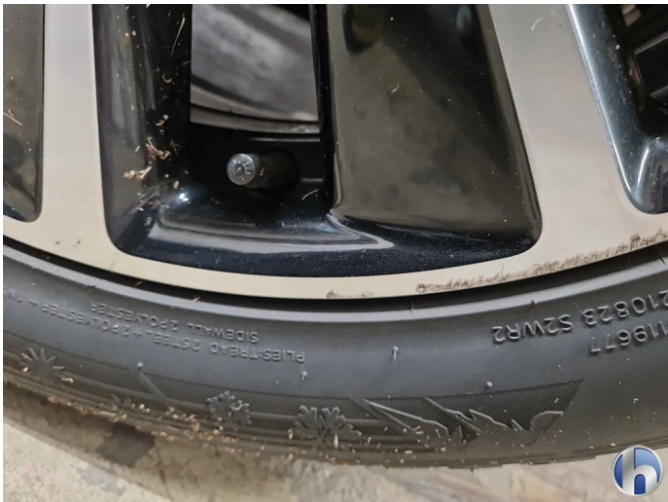
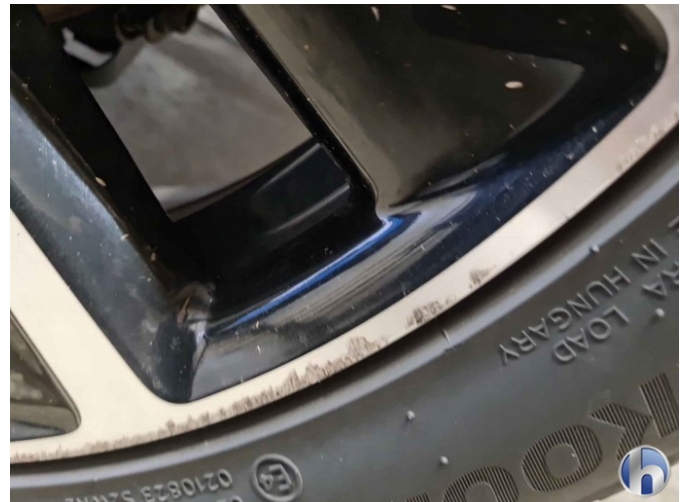
| component | Damage | Rep kind |
|---|---|---|
| 16. Felge (glanzpoliert) Hinten - Links | Damaged | Replace |

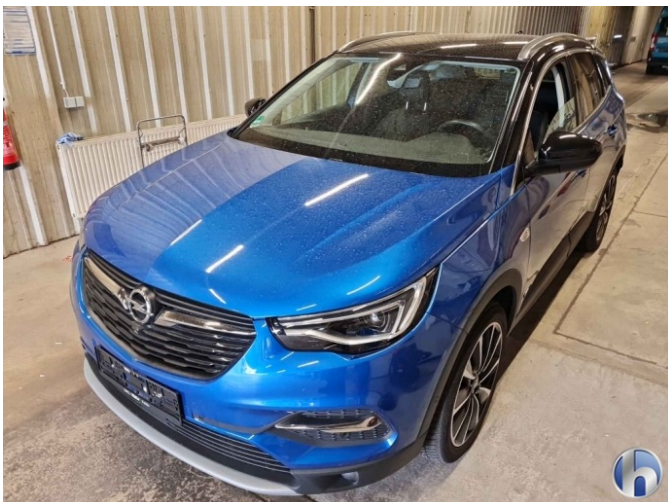
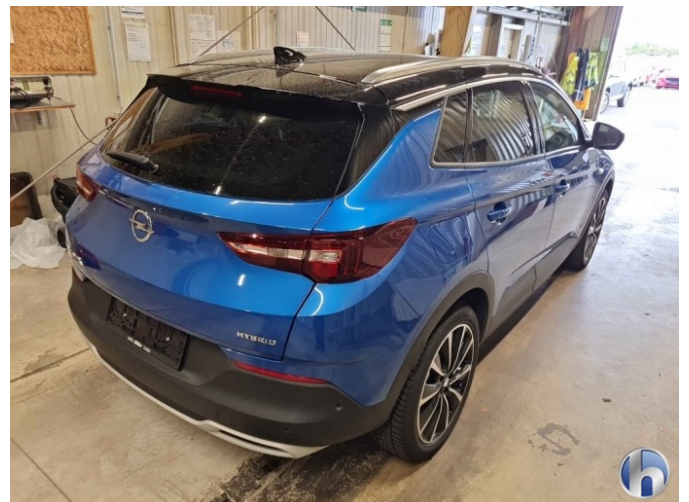
| component | Damage | Rep kind |
|---|---|---|
| 17. Fahrzeug (Kratzer,<br>Harz-/Säureeinwirkung,<br>Verschmutzungen) | Not okay | |

17. Fahrzeug (Kratzer, Harz-/Säureeinwirkung, Verschmutzungen)
