Expertise

Protocol number: 41686026
Order No. / Reference: 25255437
Inspection date: 22 Sept 2025

Manufacturer: Opel

Model: Grandland 1.5 D Automatik Business Edition

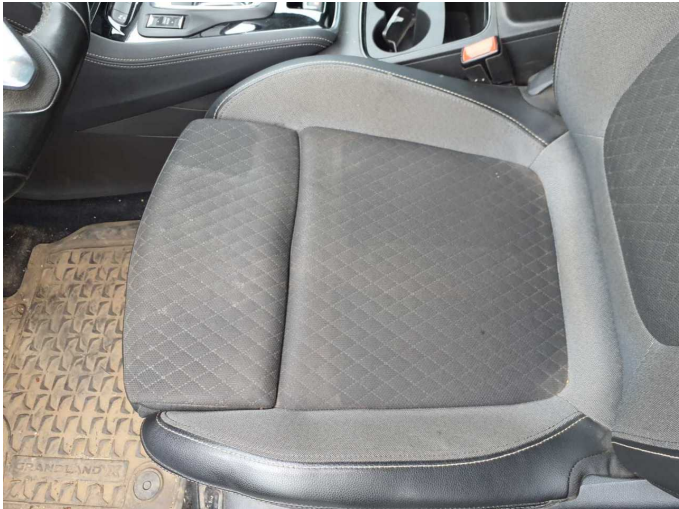
Damage 1: Seat - front: Seat cover - left side - Soiled - Clean

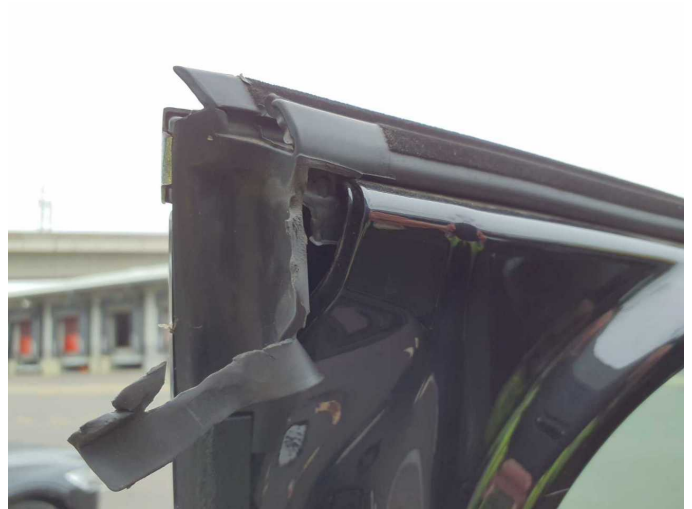
Damage 2: Door - front left side: Door seal - Broken / torn - Replace

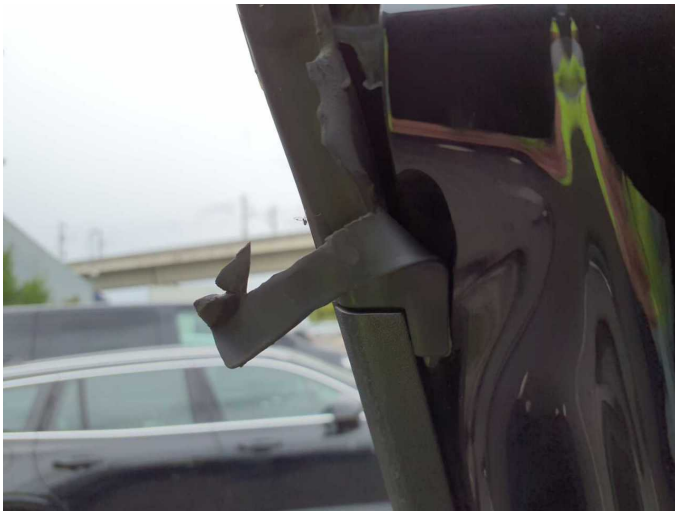
Damage 2: Door - front left side: Door seal - Broken / torn - Replace

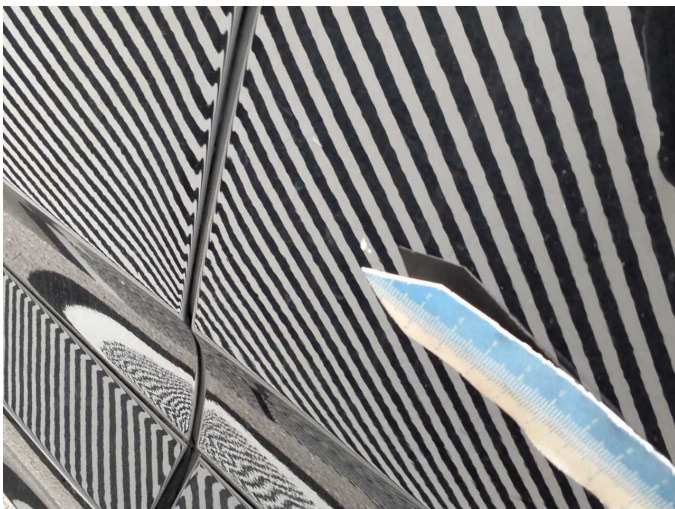
Damage 3: Door - rear left side: Door - Scratched - Smart repair

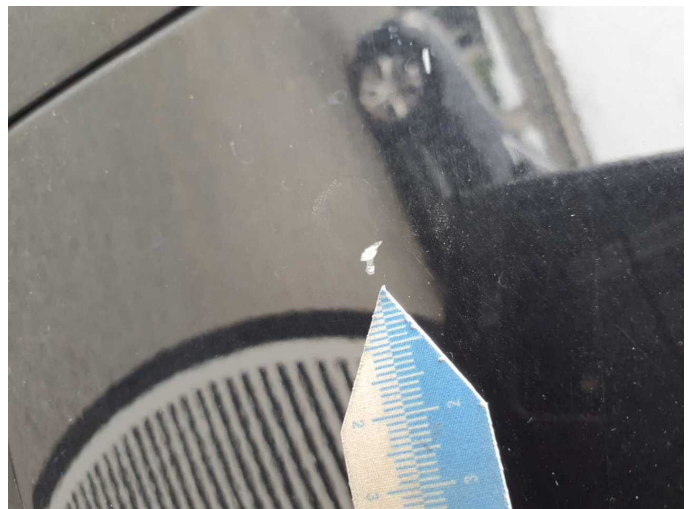
Damage 3: Door - rear left side: Door - Scratched - Smart repair

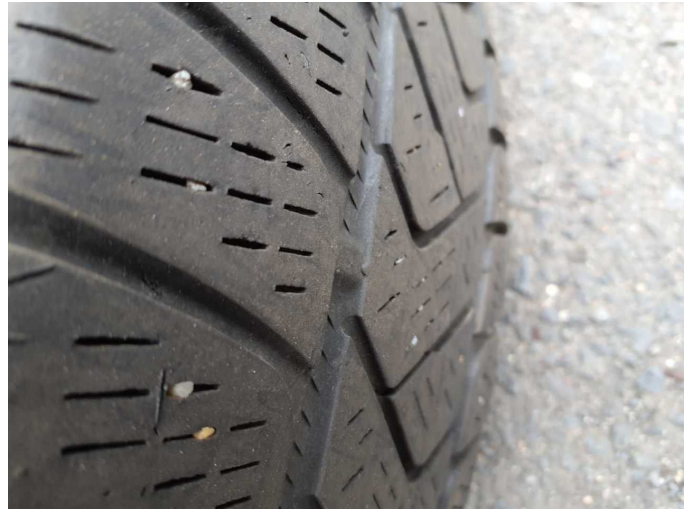
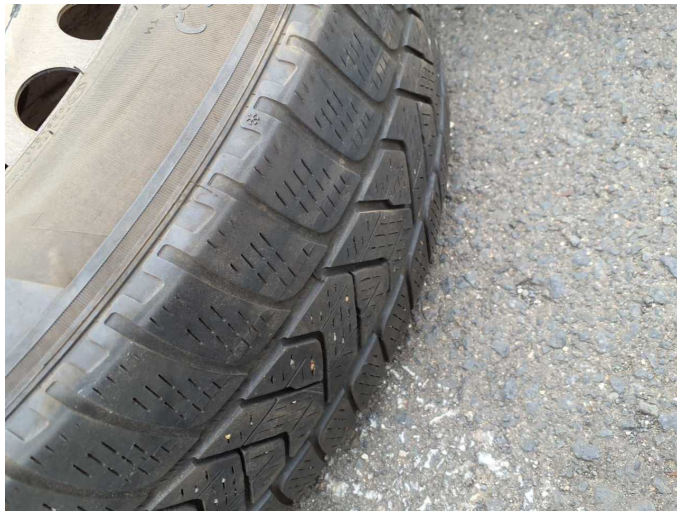
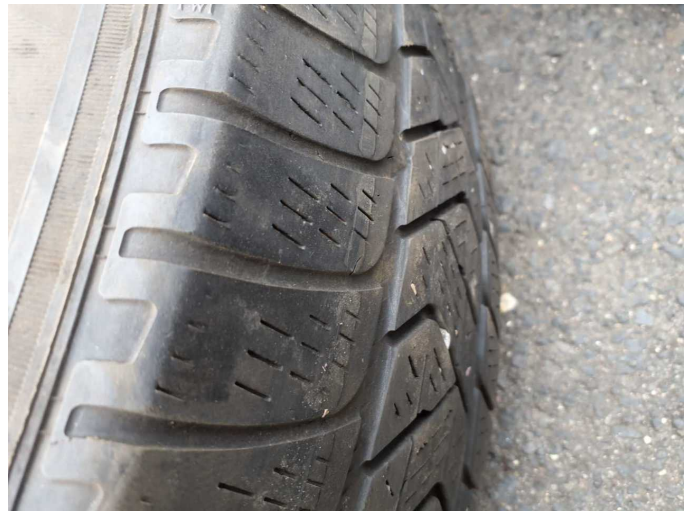
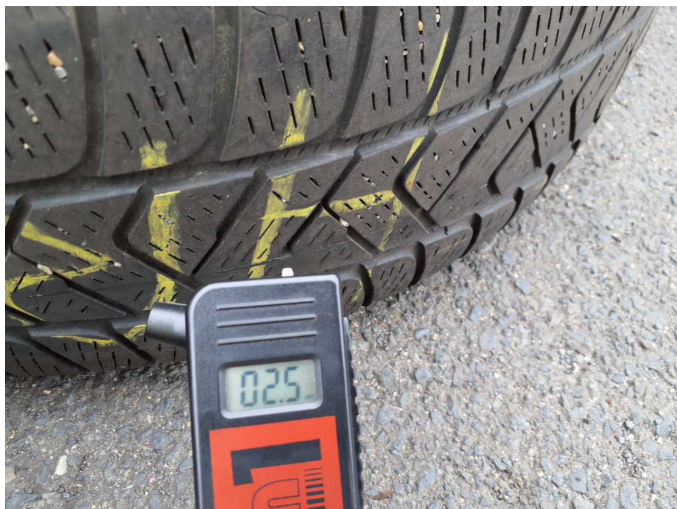
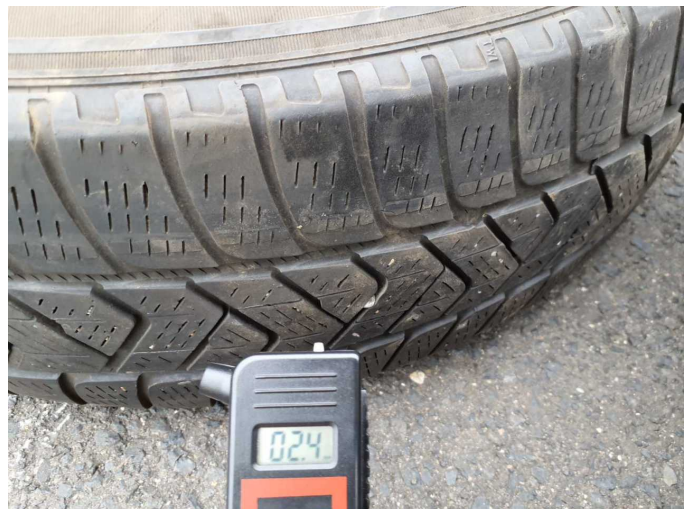
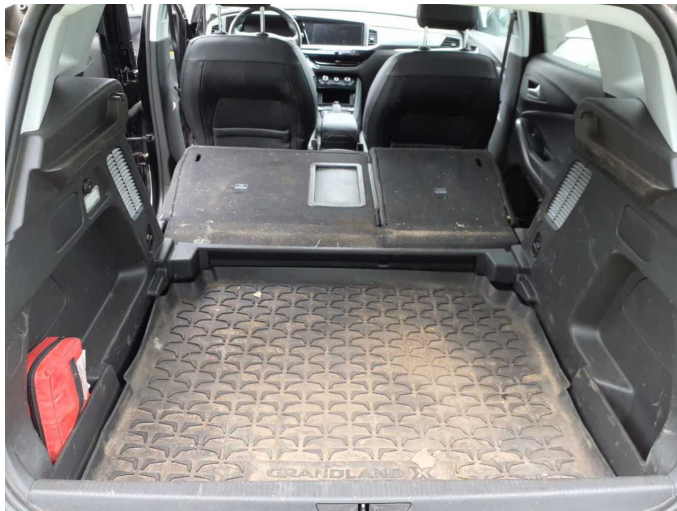
Damage 4: 2nd wheel set: 2 tyres - Does not meet the leasing specifications - Replace

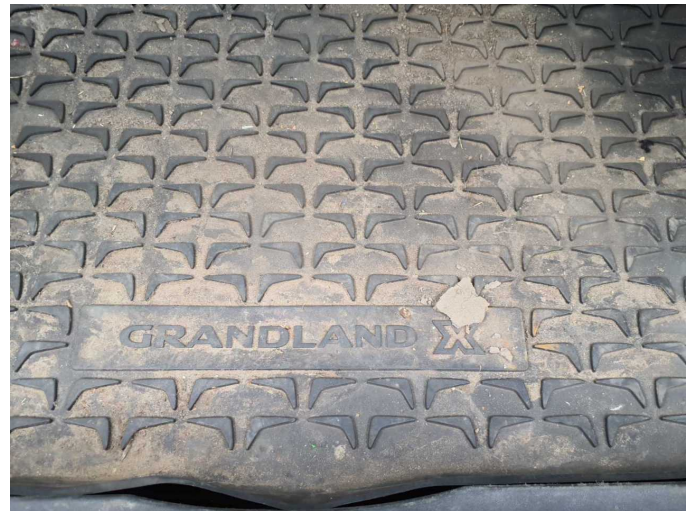
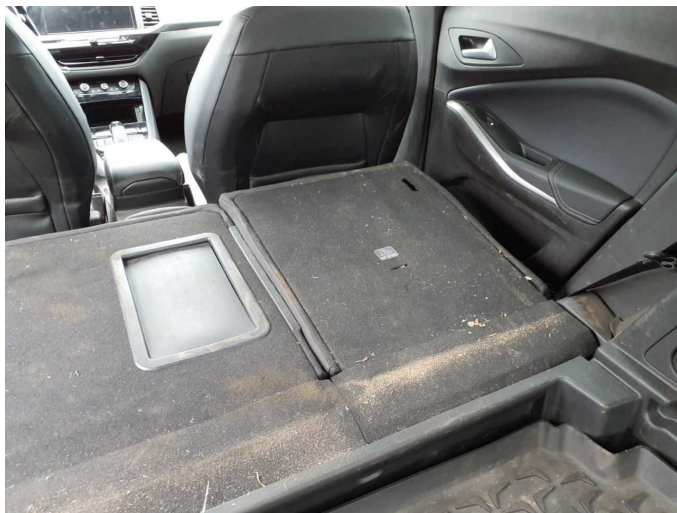
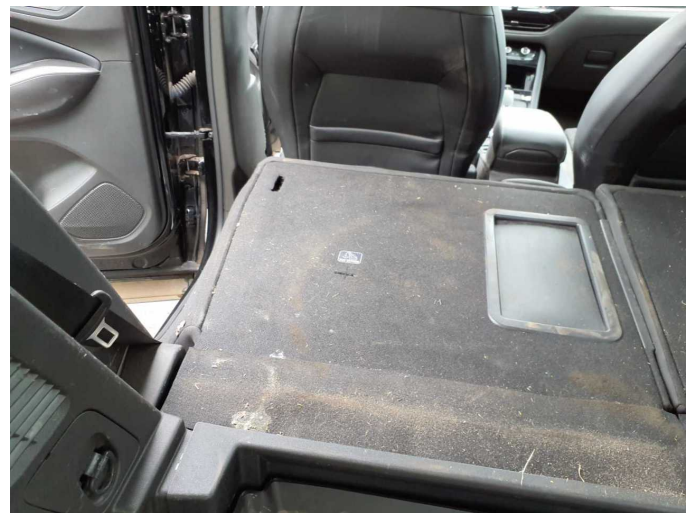
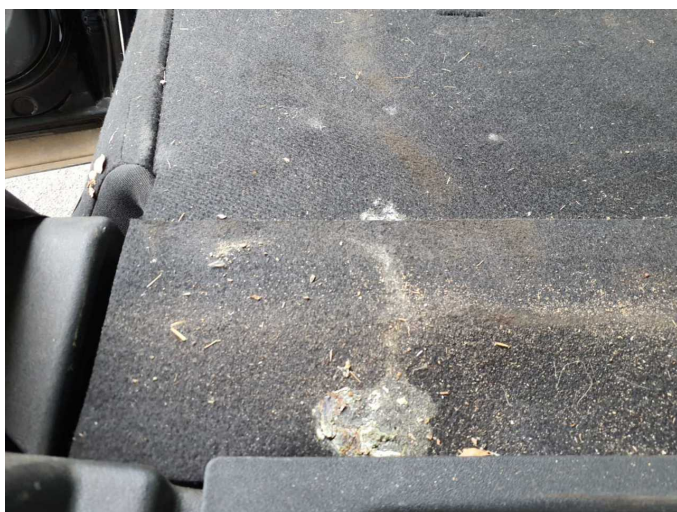
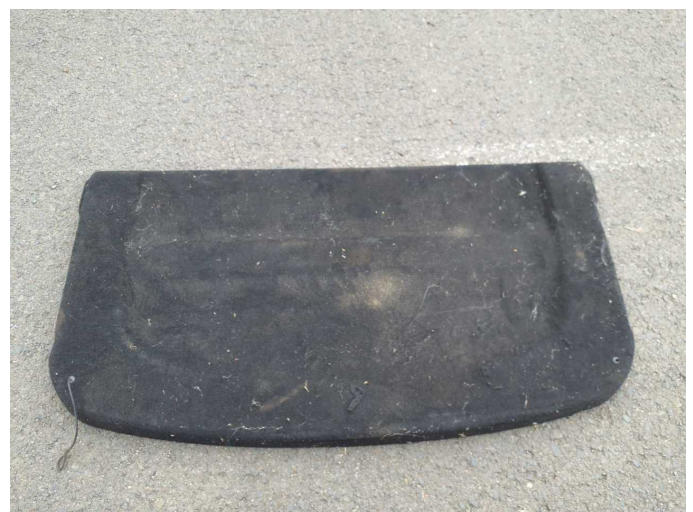
Damage 5: Interior: Interior - Soiled - Clean

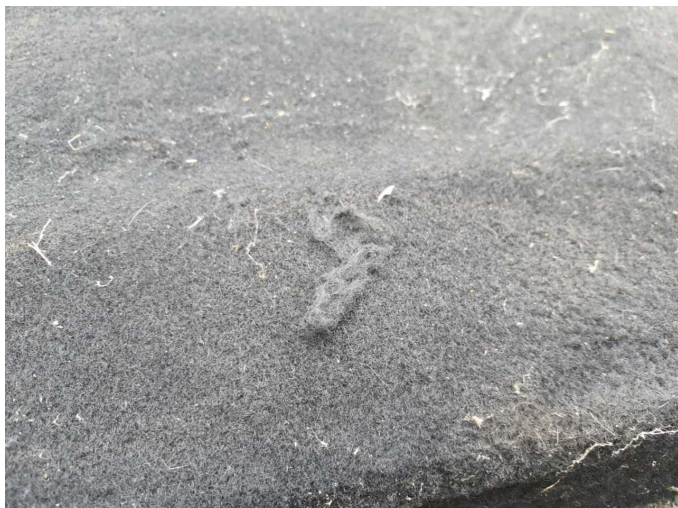
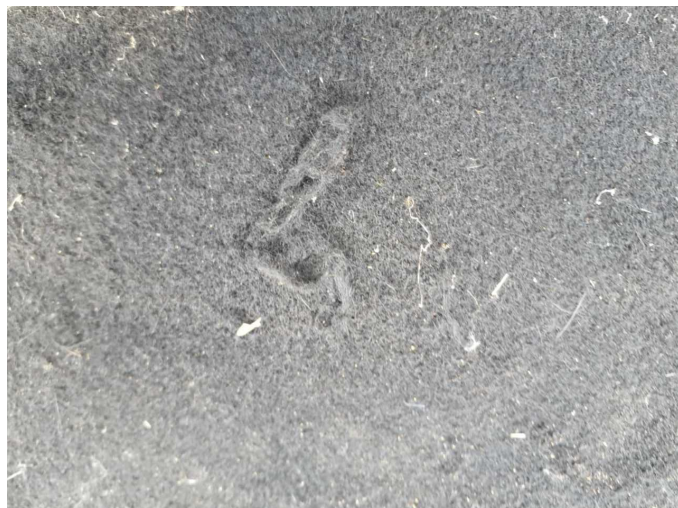
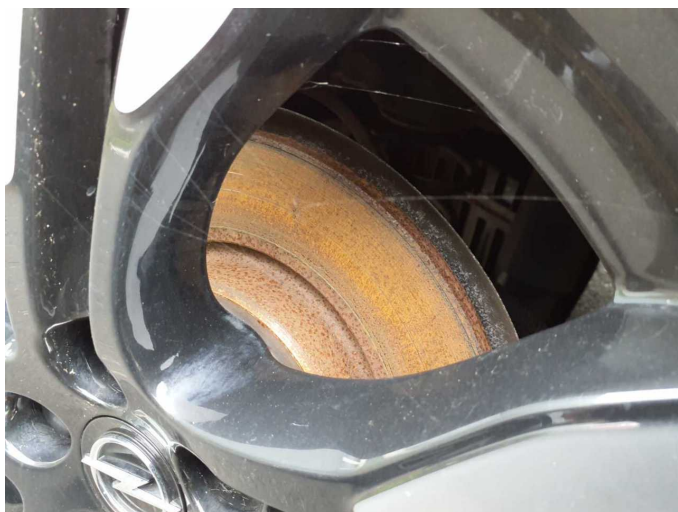
Damage 6: Interior: Rear shelf - Scratched - Replace

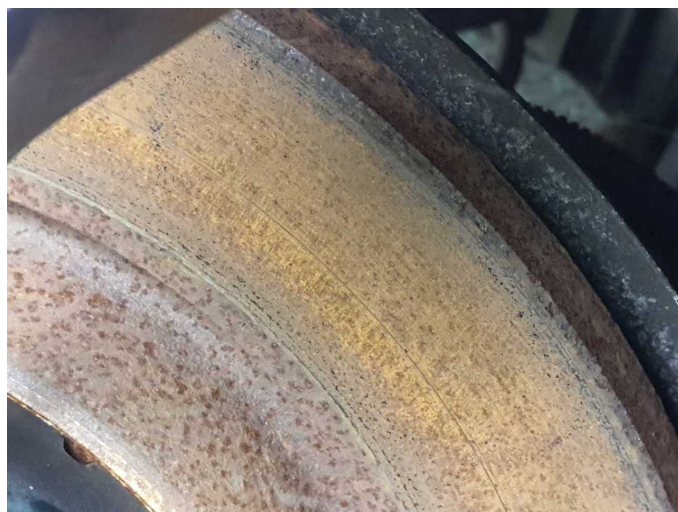
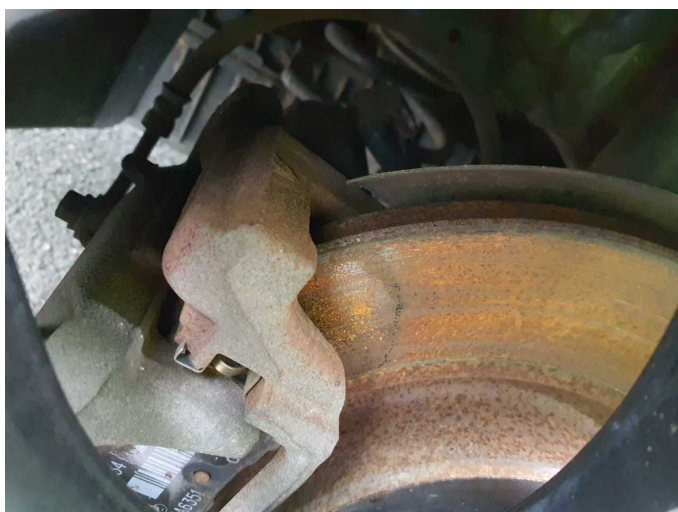
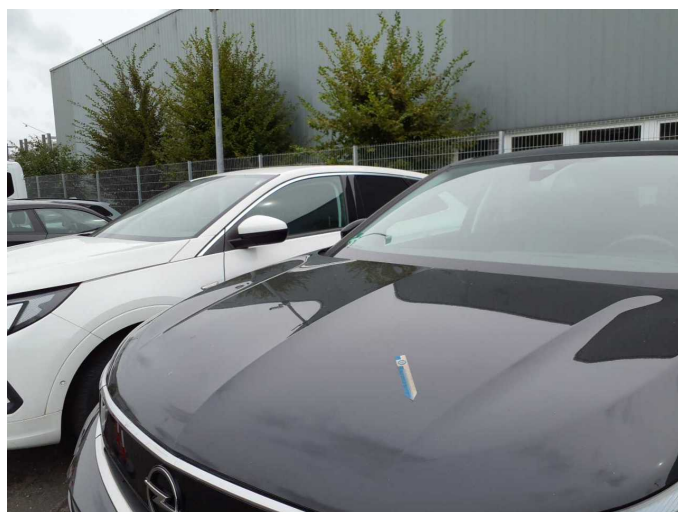
Damage 7: Braking system: Brake discs - rear (Tragbild mangelhaft und Rostrand) - Corrosion - Replace

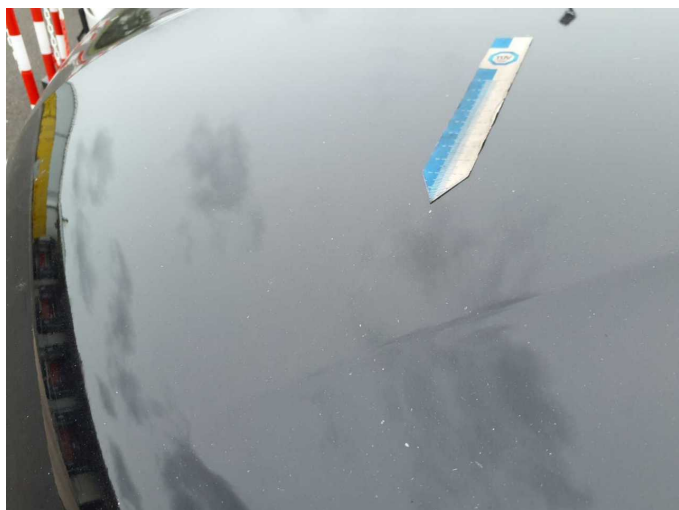
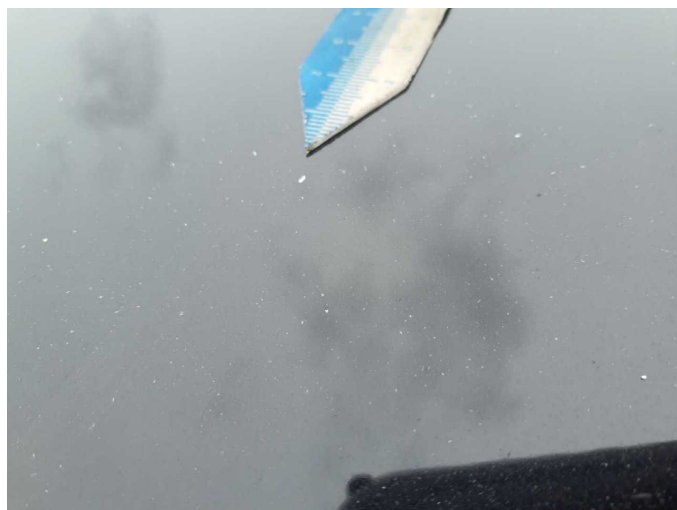
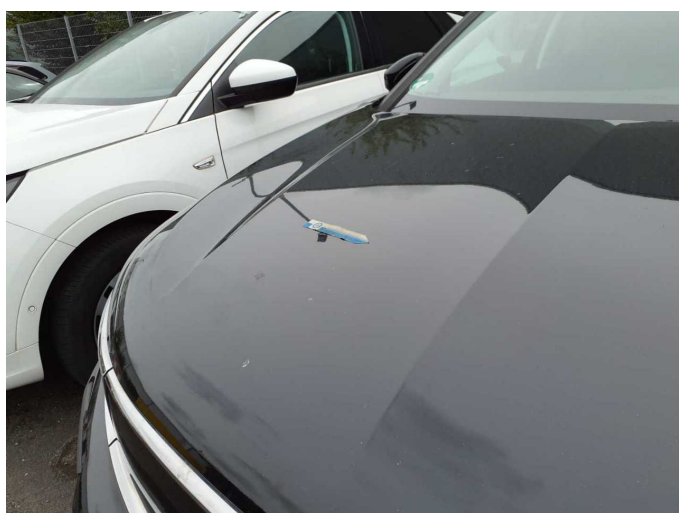
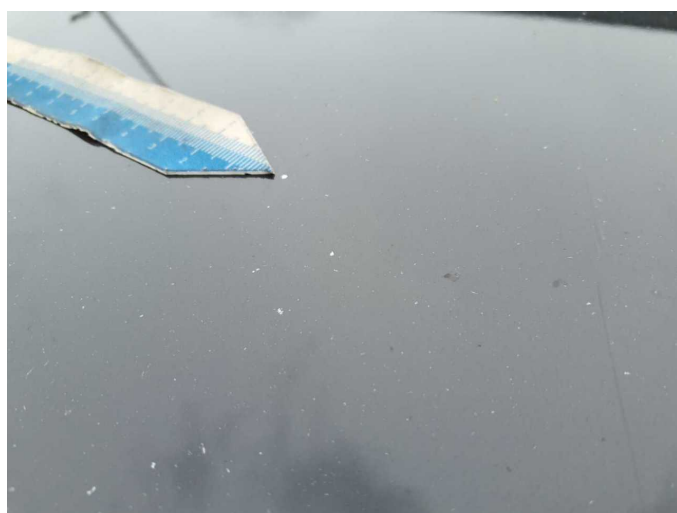
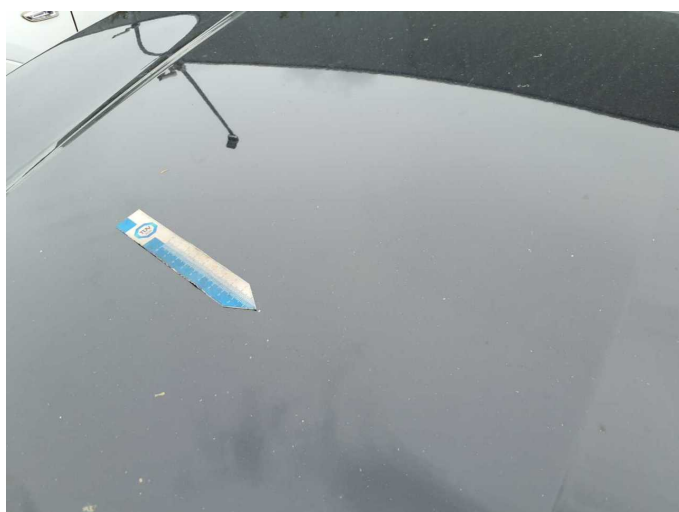
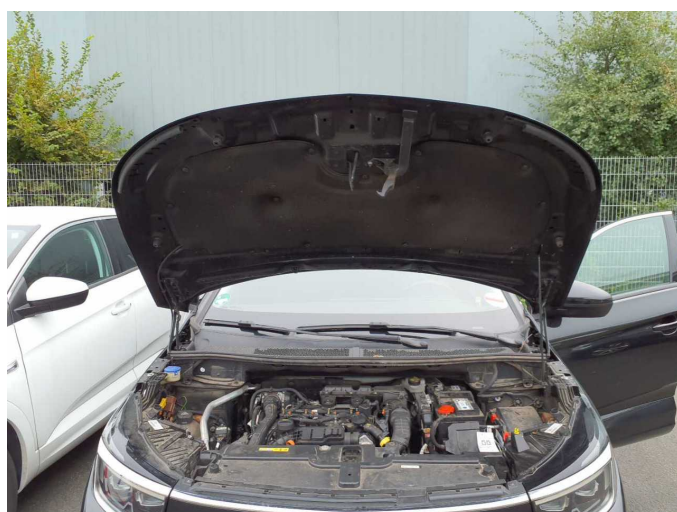
Damage 8: Bonnet: Bonnet (Sandstrahleffekt) - Stone chips - Paint

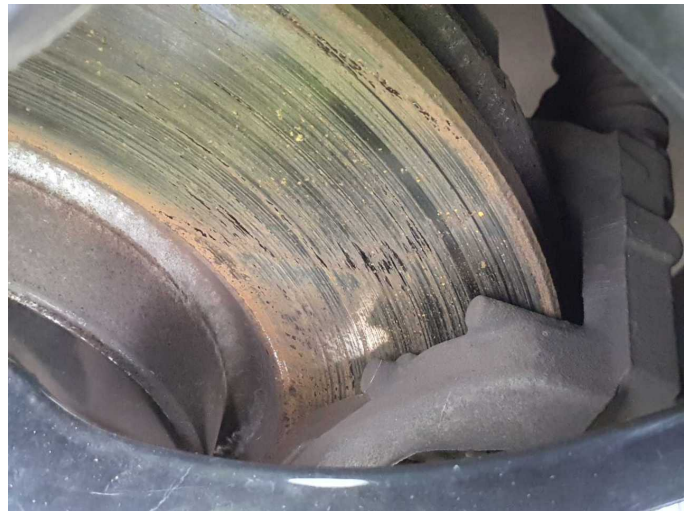
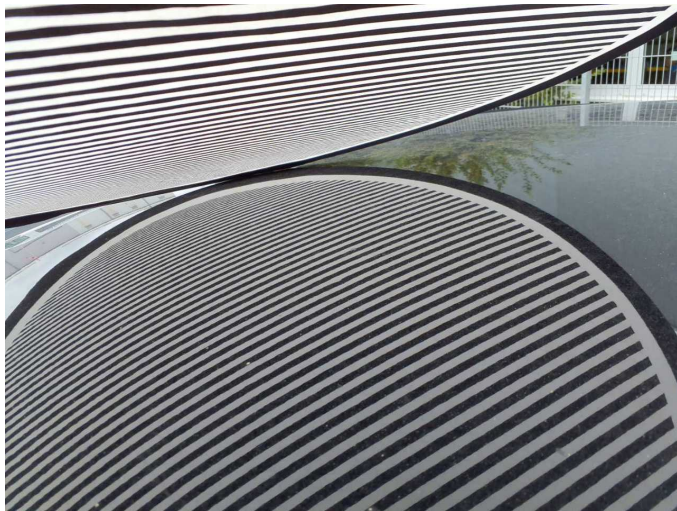
Wear and tear 4: Braking system: Brake discs - front (Freibremsen) - Corrosion - No deduction

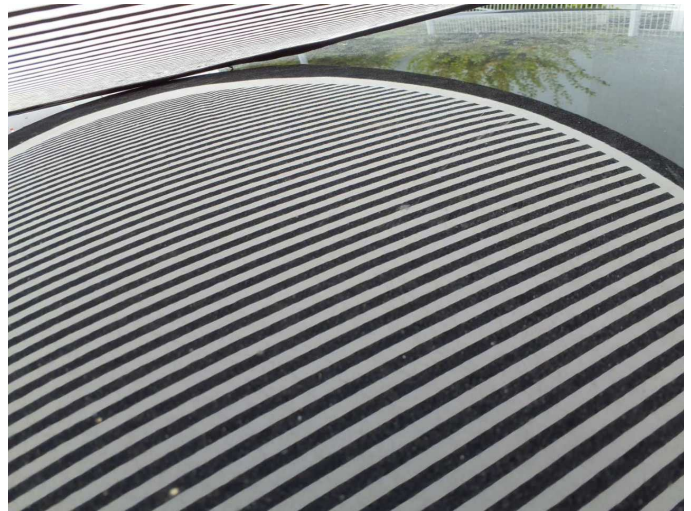
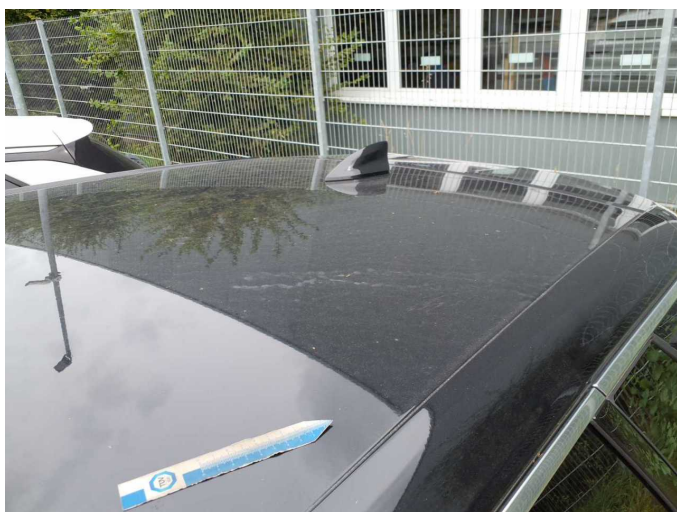
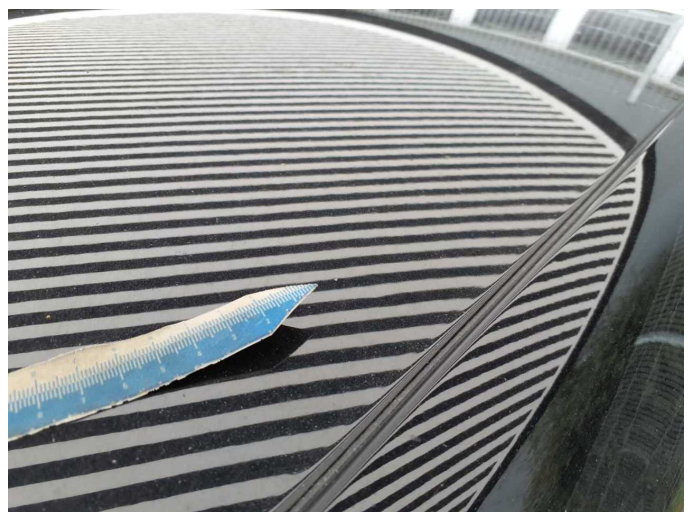
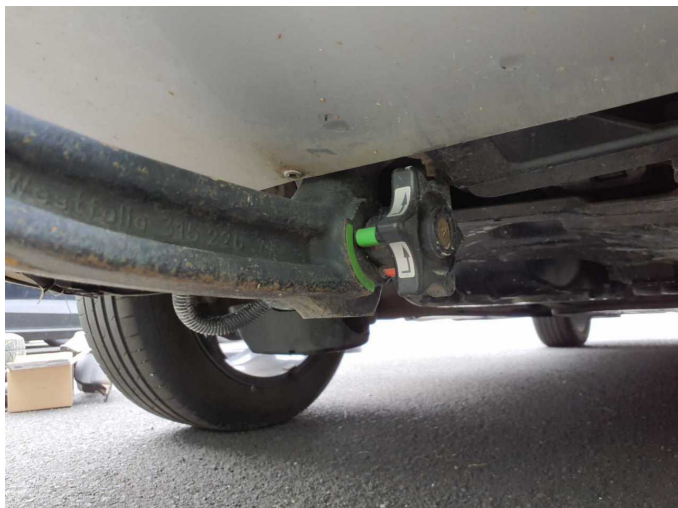
Wear and tear 5: Roof: Roof - dent(s) - Smooth repair work

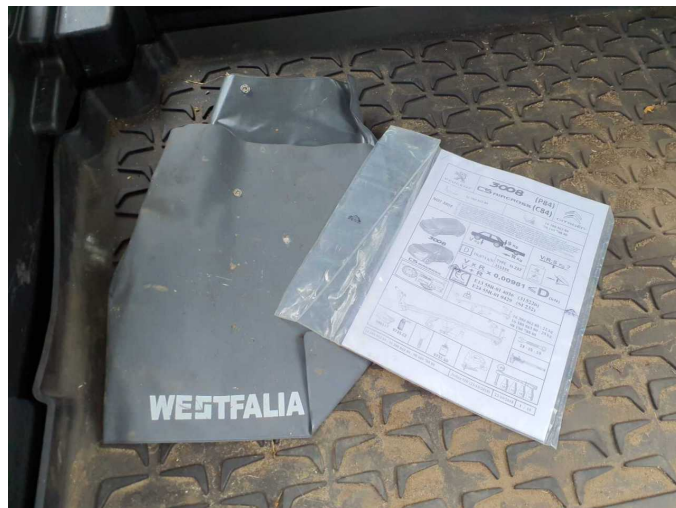
Missing part 1: Rear of vehicle: Key trailer hitch - Missing - Replace
