Expertise

Protocol number: 41382485
Order No. / Reference: 25152200
Inspection date: 29 Aug 2025

Manufacturer: Opel

Model: Grandland 1.5 D Automatik Elegance

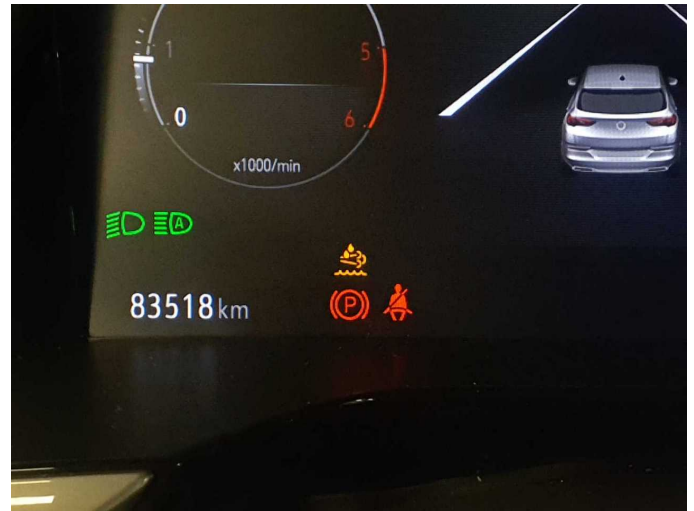
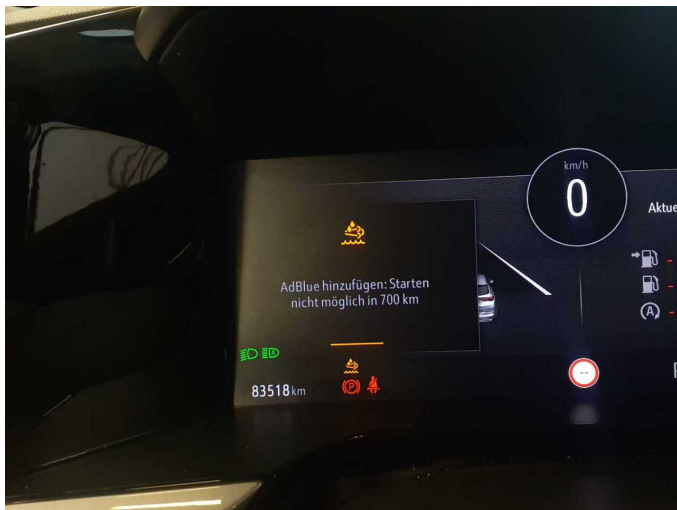
Damage 1: Instrument panel: Indicator light (Adblue befüllen, Motorstart nicht möglich in 700km) - on - No deduction

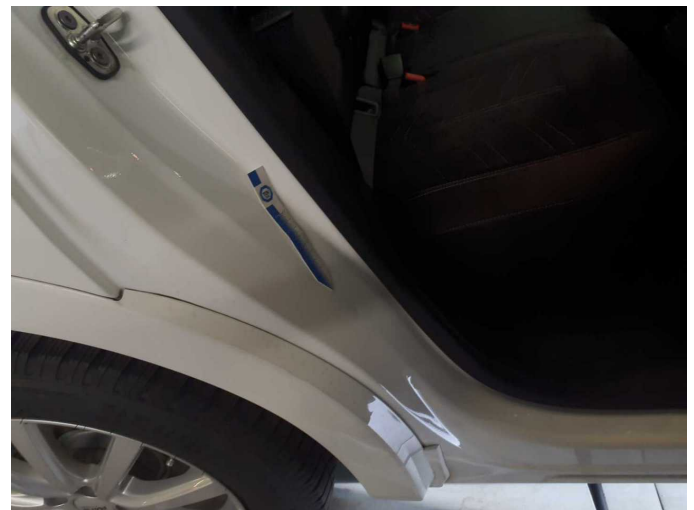
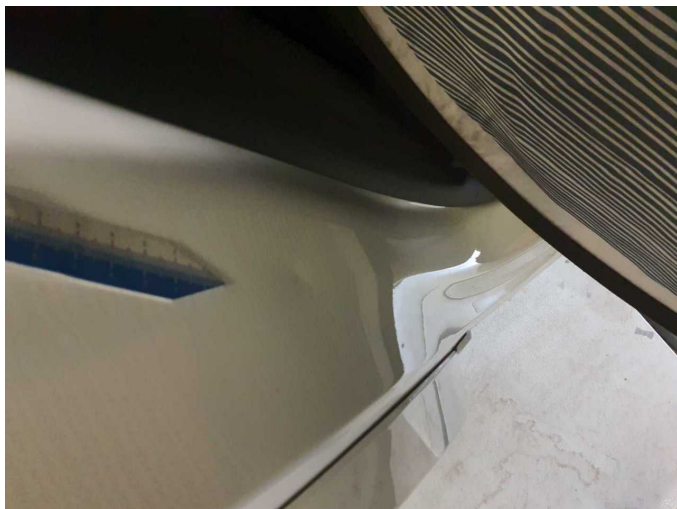
Damage 2: Side panel - rear right side: Sill - dent(s) - Smooth repair work

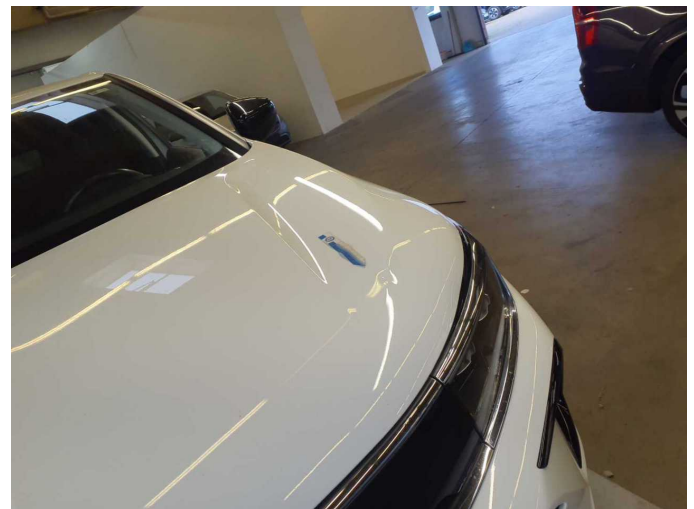
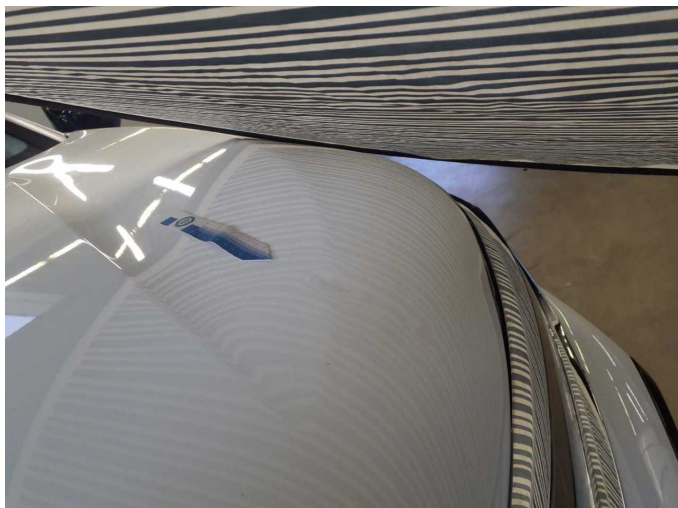
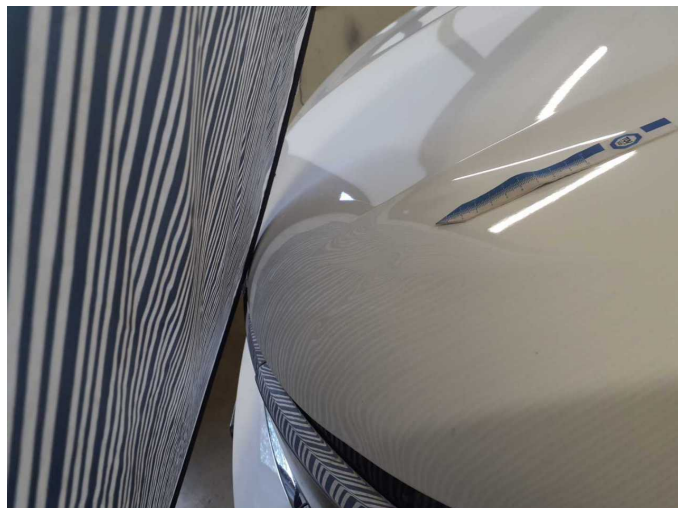
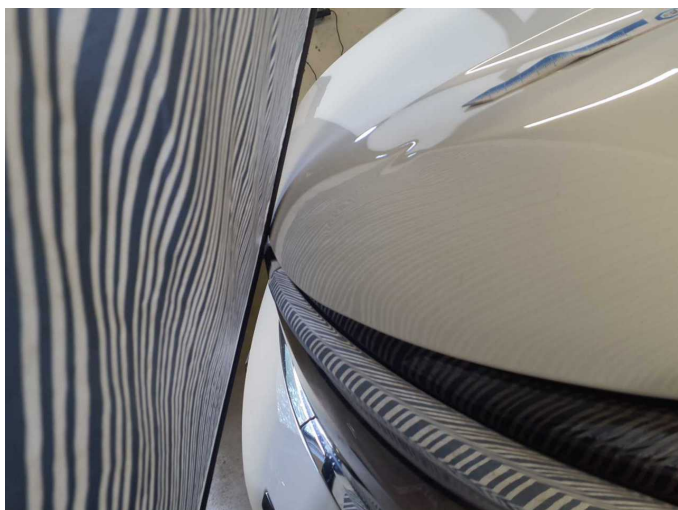
Damage 3: Bonnet: Bonnet - dent(s) - Smooth repair work

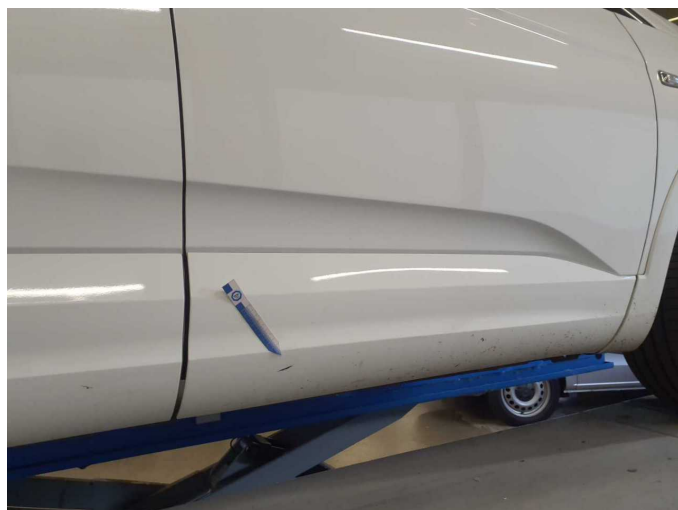
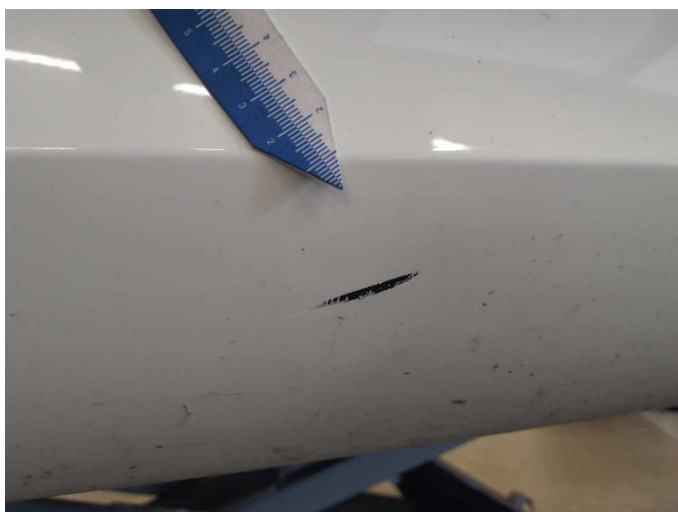
Damage 4: Door - front right side: Brightware - lower - Scratch(es) - Smart repair

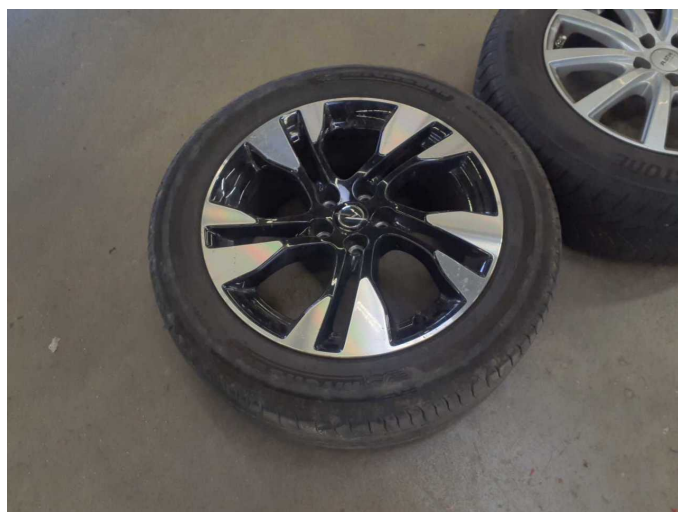
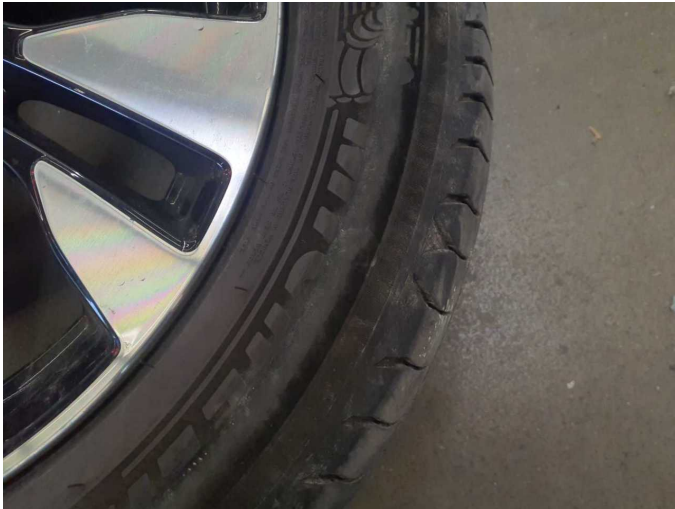
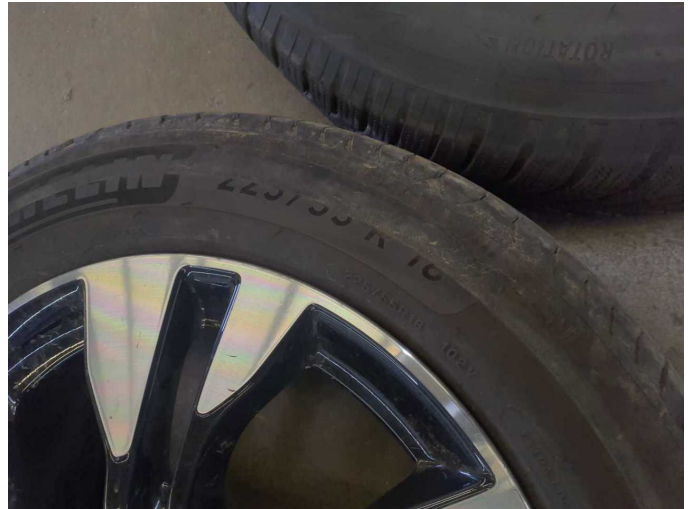
Damage 5: 2nd wheel set: 1 tyre (Reifen Drucklos & Außenflanke verschlissen) - Worn - Replace

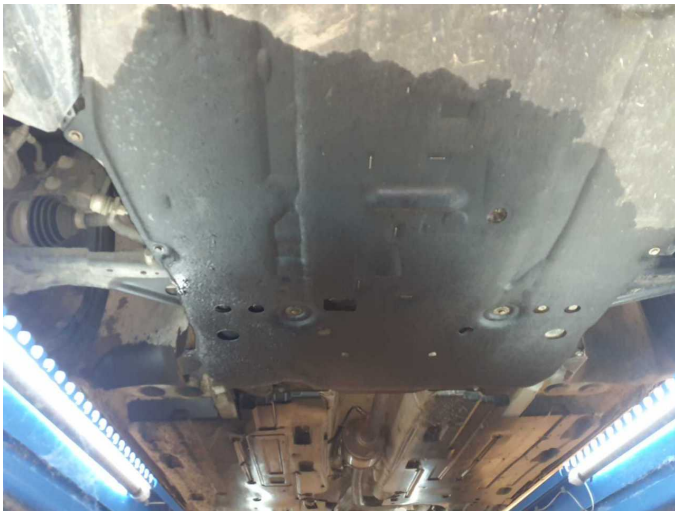
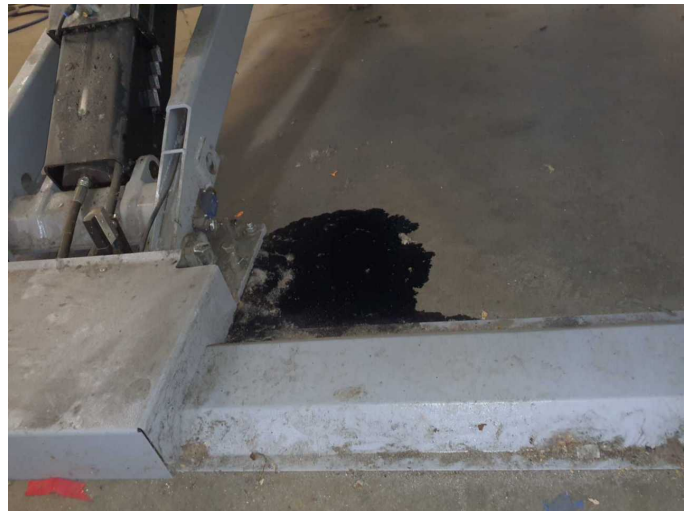
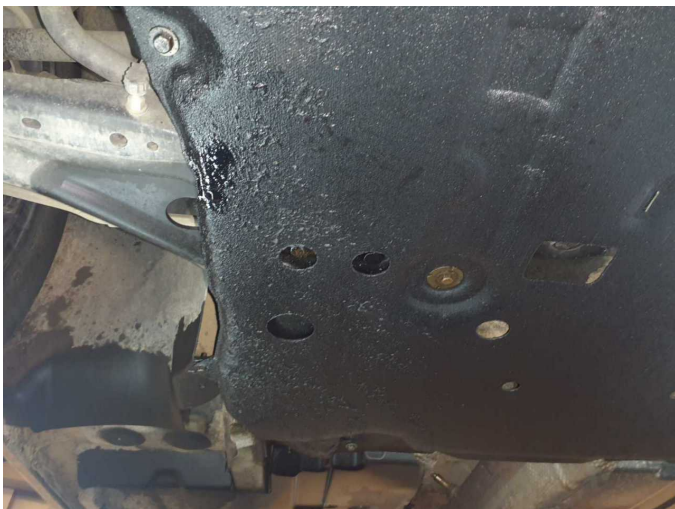
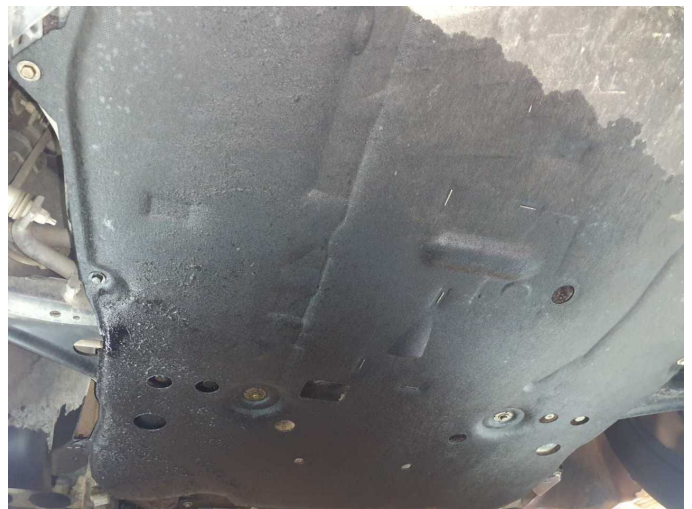
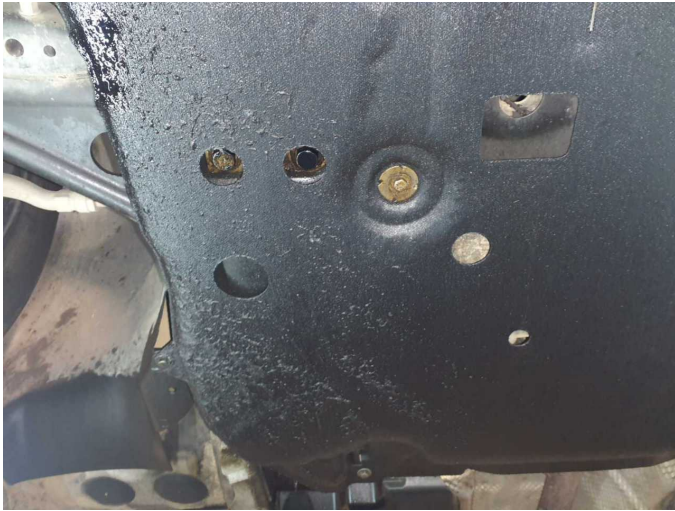
Damage 6: Engine: Engine (Motorraum-Unterboden Ölfeucht) - Leaking - Perform diagnosis

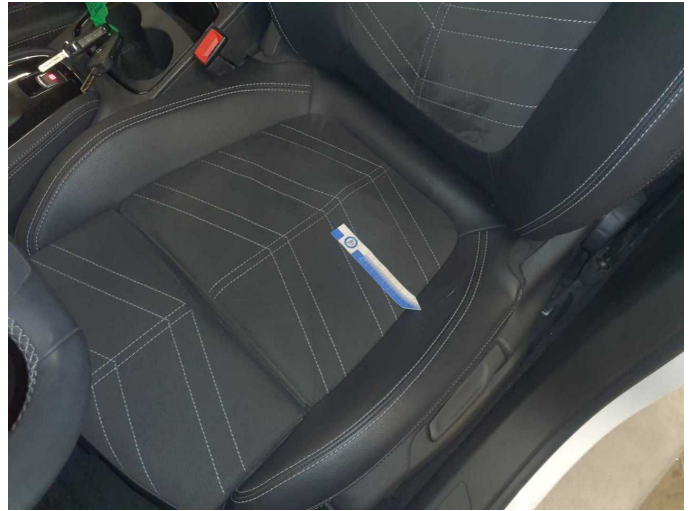
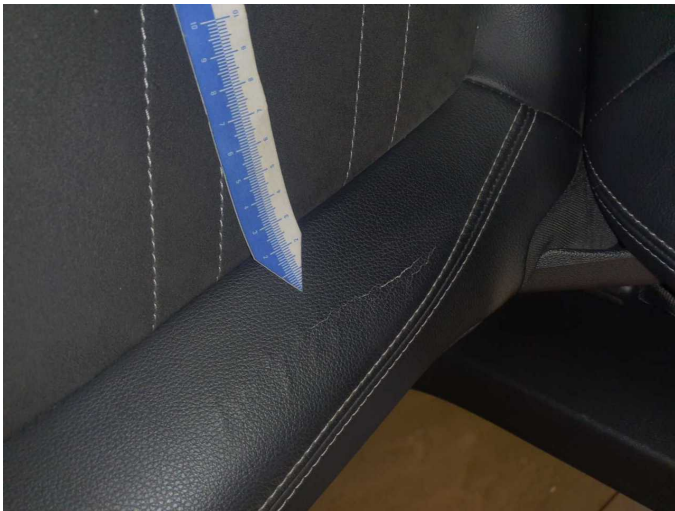
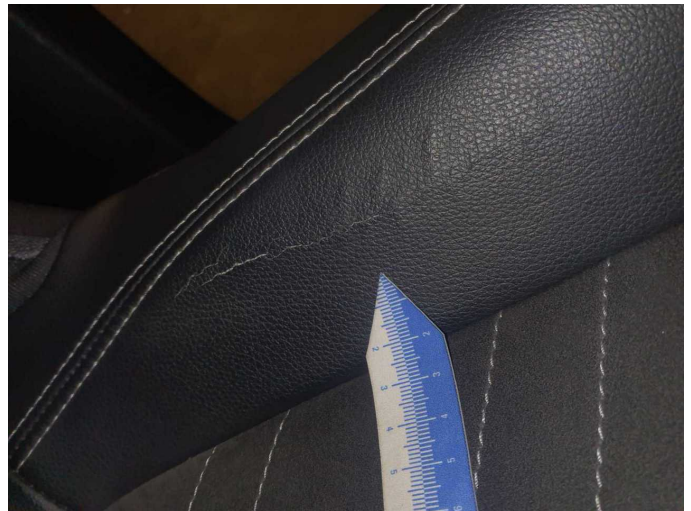
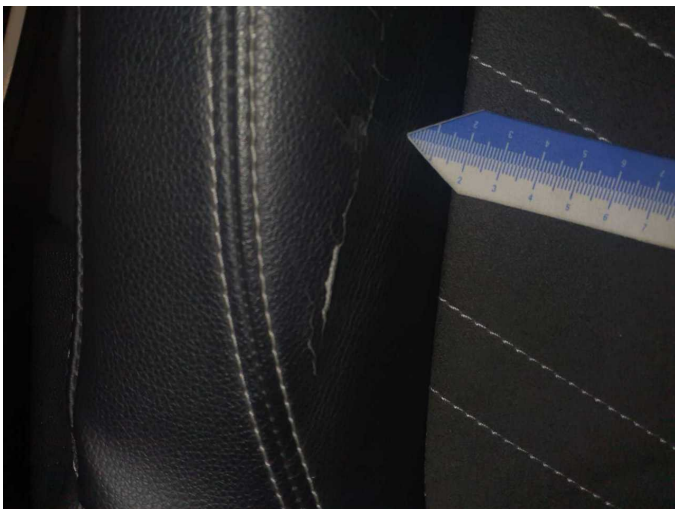
Damage 7: Seat - front: Seat cover - left side - Broken / torn - Replace

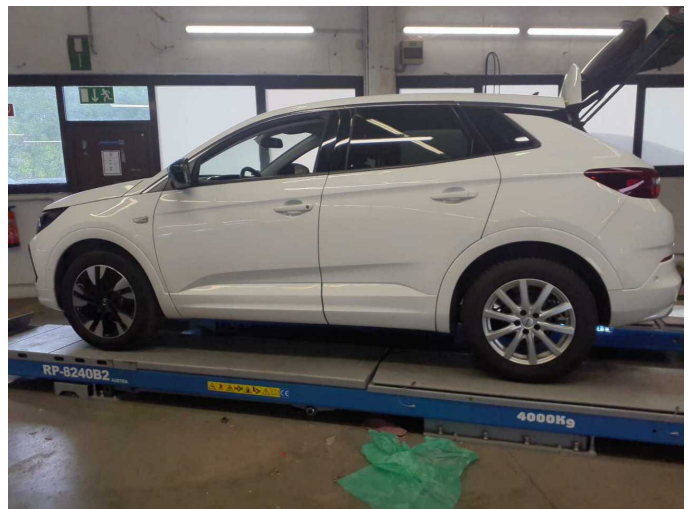
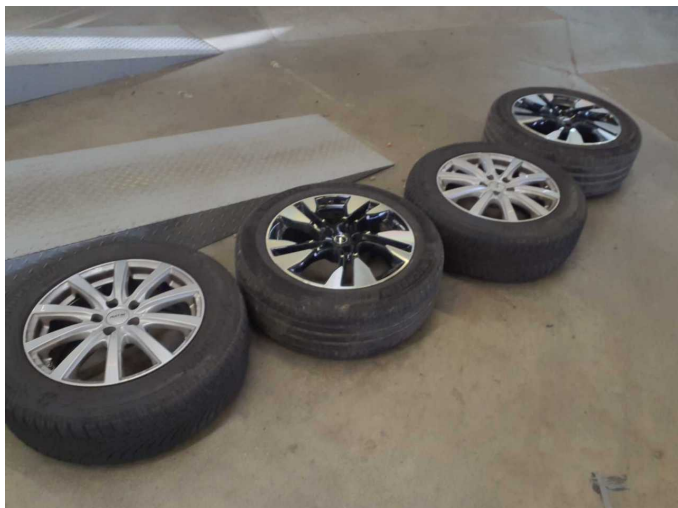
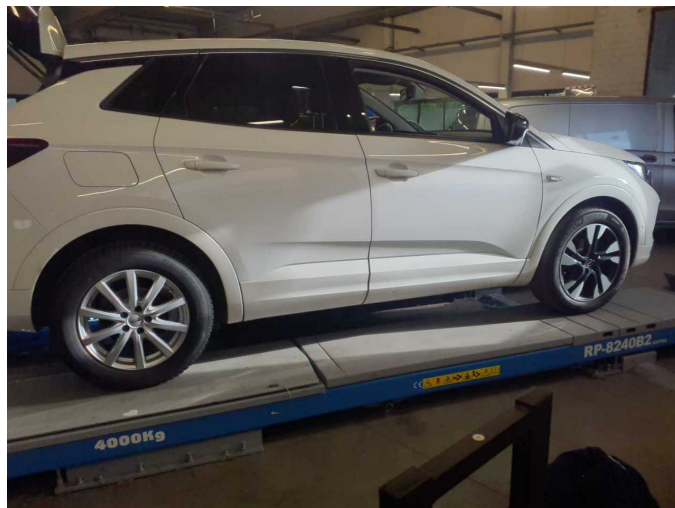
Wear and tear 3: Wheel / tyres: Wheelset - complete (Hinterachse Winterräder, Vorderachse Sommerräder mont.) - Differs from the original configuration - No deduction
