Expertise

Protocol number: 39830122  
Order No. / Reference: 24685180  
Inspection date: 21 May 2025

Manufacturer: Opel	Model: Grandland X 1.5 D Start/Stop Automatik Business Elegance
VIN: W0VZCYHZ8M6814471

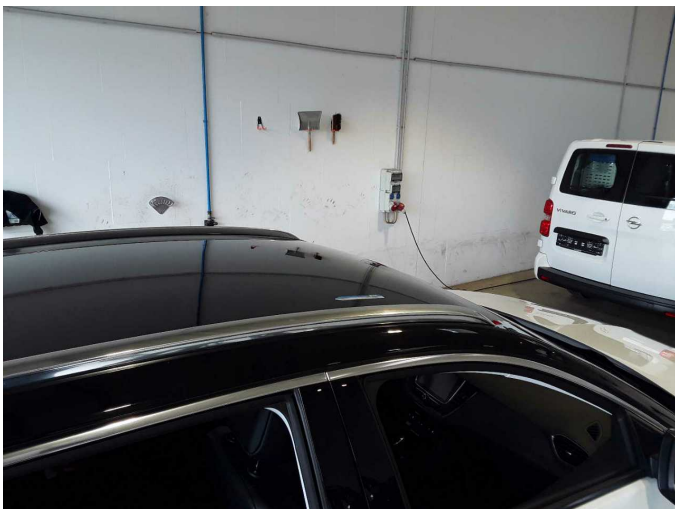
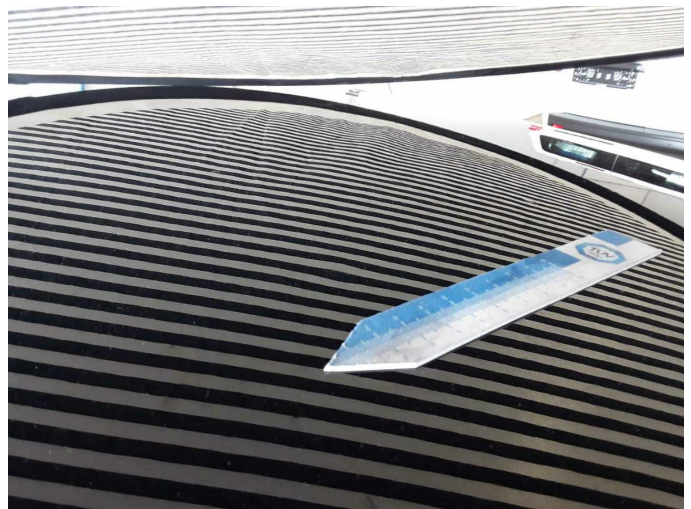
No.	Component group	Description
1	Roof	Roof - dent(s) - Smooth repair work
2	Front bumper	Spoiler - Differs from the original configuration - Un- / install

Damage 1: Roof: Roof - dent(s) - Smooth repair work

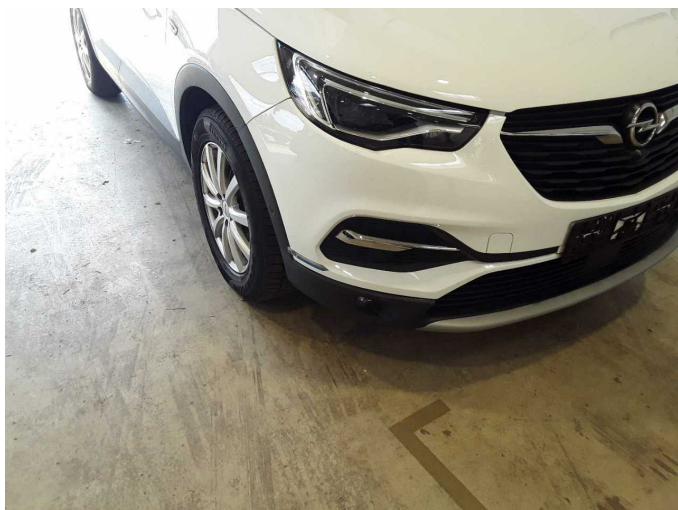
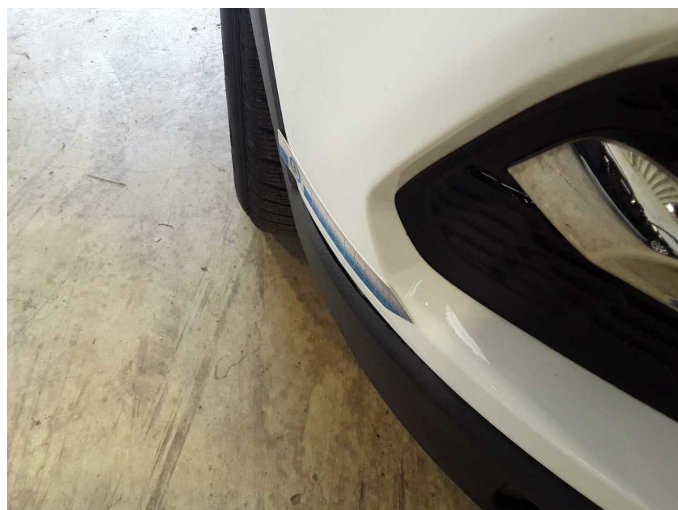
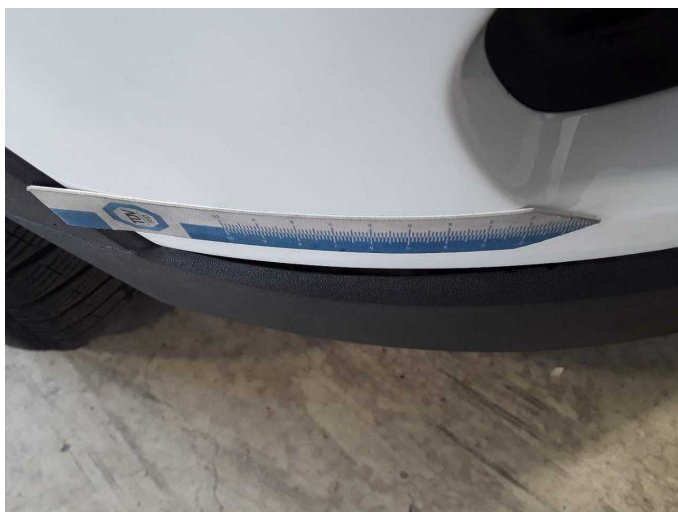
**Damage 2:** Front bumper: Spoiler - Differs from the original configuration  
- Un- / install
