Expertise

Protocol number: 41682492  
Order No. / Reference: 25193136  
Inspection date: 23 Sept 2025

Manufacturer: Opel	Model: Grandland X 1.5 D Start/Stop Automatik INNOVATION
VIN: W0VZCYHZ9LS207887

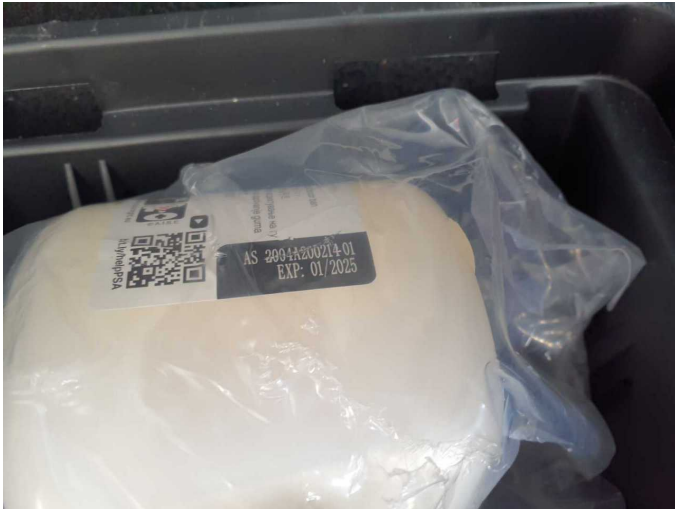
**Damage 1:** Equipment: Tirefit filler - Expired - Replace

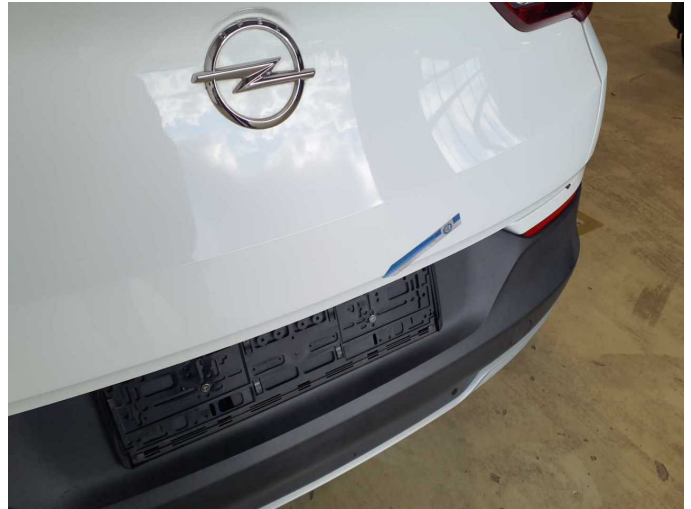
**Damage 2:** Boot lid / rear door: Boot lid (Kante) - Scratched - Smart repair

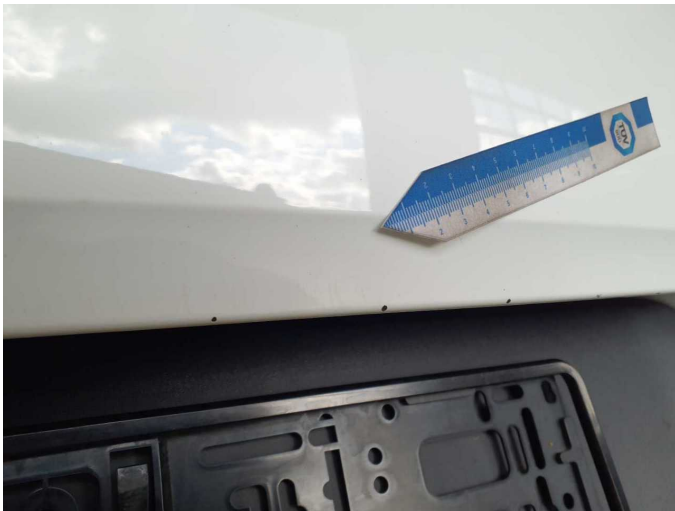
**Damage 2:** Boot lid / rear door: Boot lid (Kante) - Scratched - Smart repair

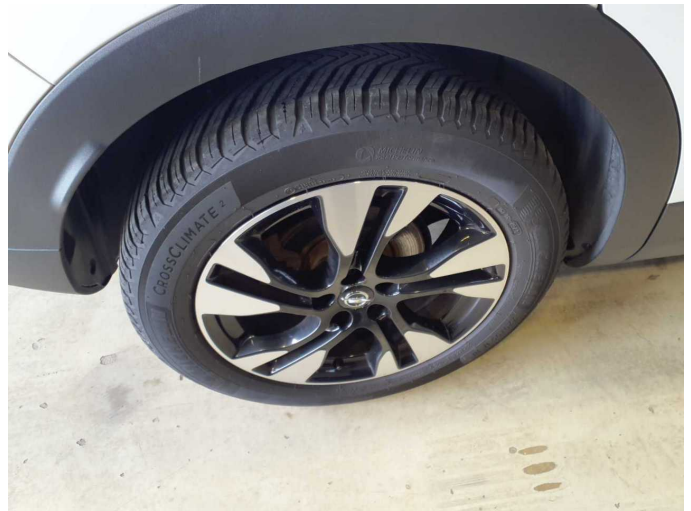
**Damage 3:** Wheel / tyres: Alloy rim - rear right side - Corrosion - Loss in value

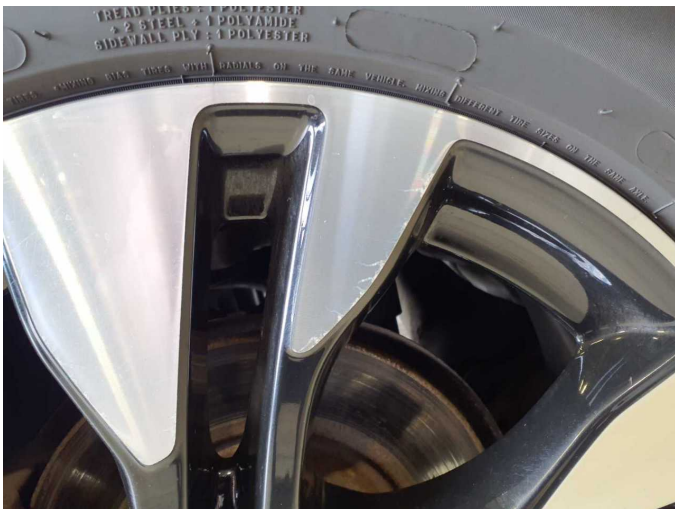
**Damage 3:** Wheel / tyres: Alloy rim - rear right side - Corrosion - Loss in value

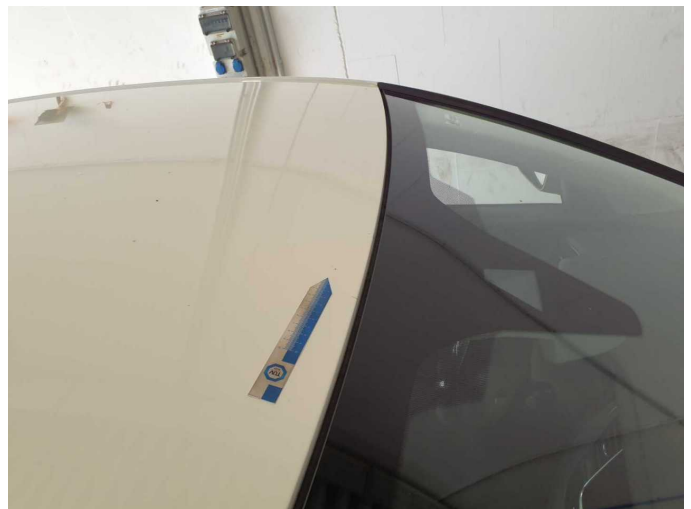
**Damage 4:** Roof: Roof - Stone chips - Smart repair

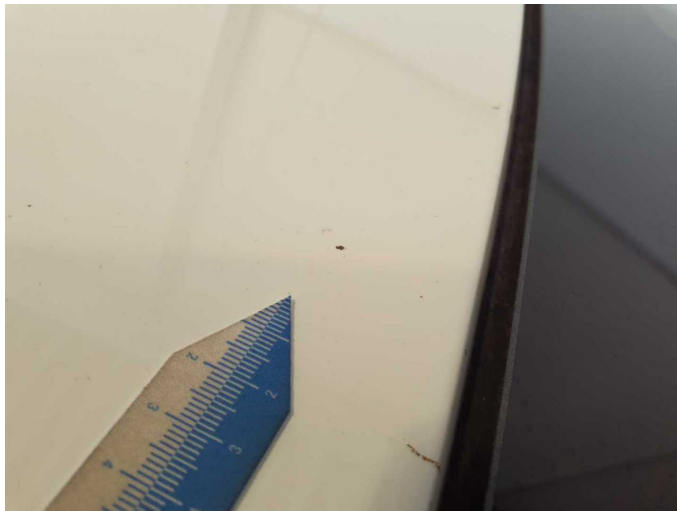
**Damage 4:** Roof: Roof - Stone chips - Smart repair

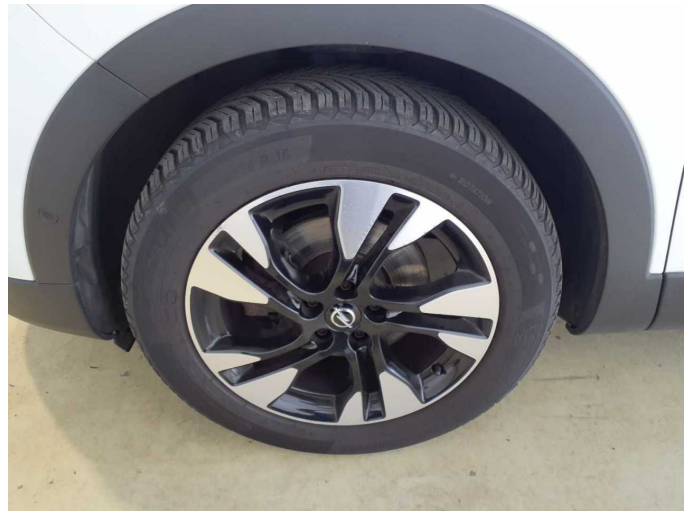
**Damage 5:** Wheel / tyres: Alloy rim - front left side - Corrosion - Loss in value

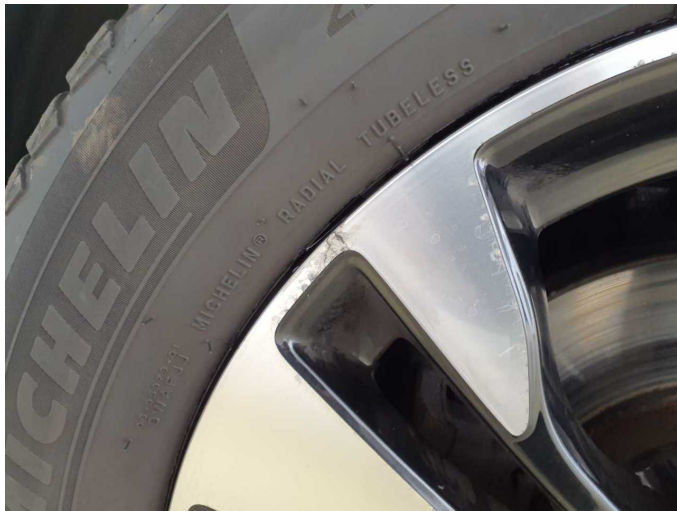
**Damage 5:** Wheel / tyres: Alloy rim - front left side - Corrosion - Loss in value

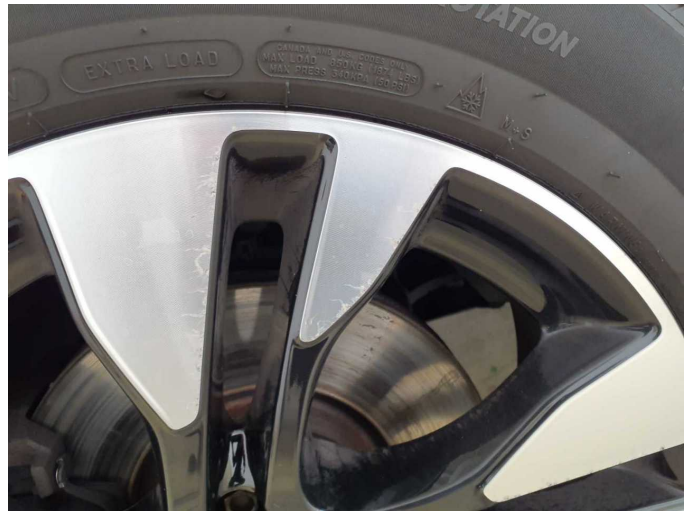
**Damage 5:** Wheel / tyres: Alloy rim - front left side - Corrosion - Loss in value

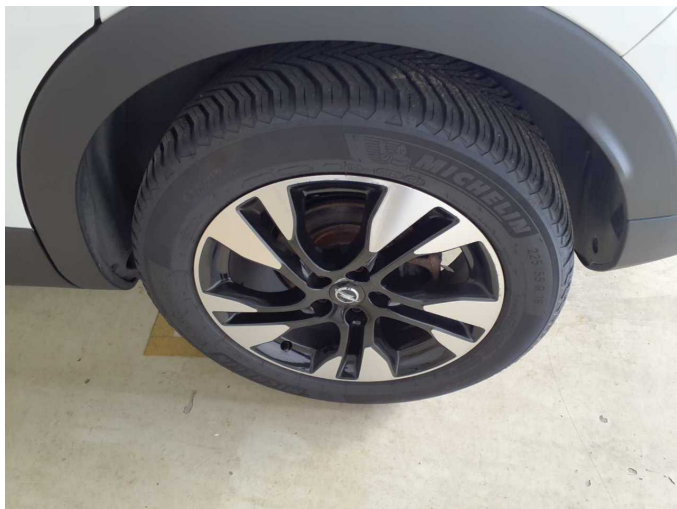
**Damage 6:** Wheel / tyres: Alloy rim - rear left side - Corrosion - Loss in value

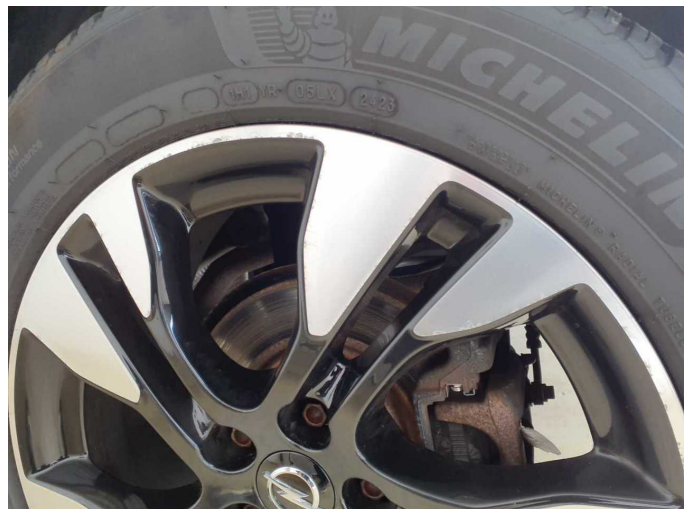
**Damage 6:** Wheel / tyres: Alloy rim - rear left side - Corrosion - Loss in value

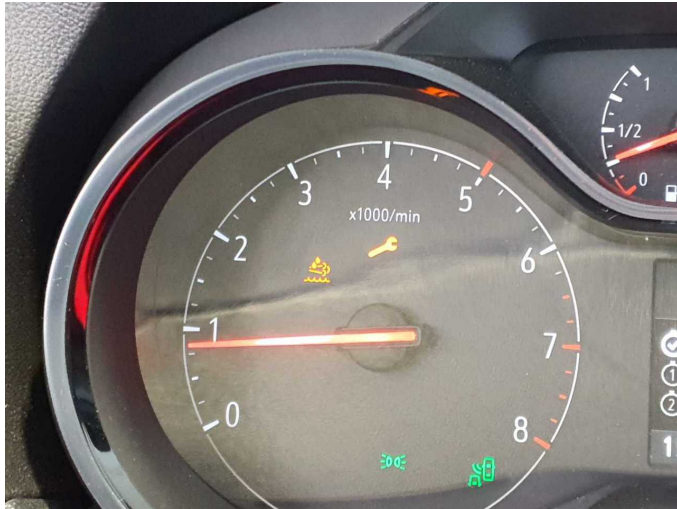
**Damage 7:** Instrument panel: Indicator light (Abgasnachbehandlung) - on  
- Perform diagnosis

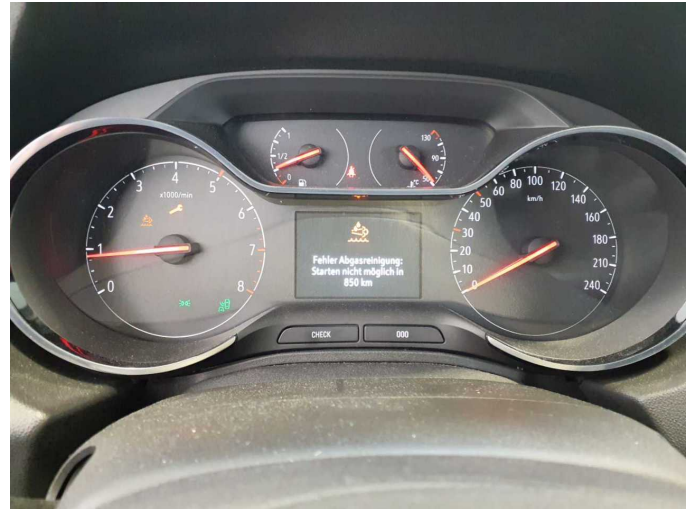
**Damage 7:** Instrument panel: Indicator light (Abgasnachbehandlung) - on  
- Perform diagnosis

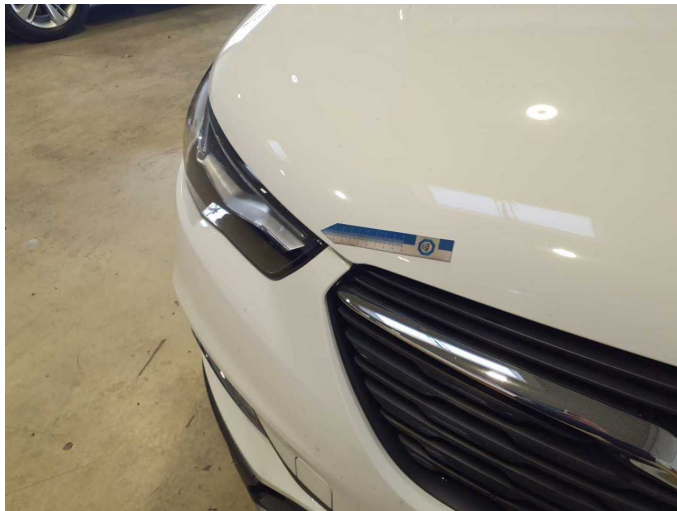
**Damage 8:** Bonnet: Bonnet - Corrosion - Repair and paint

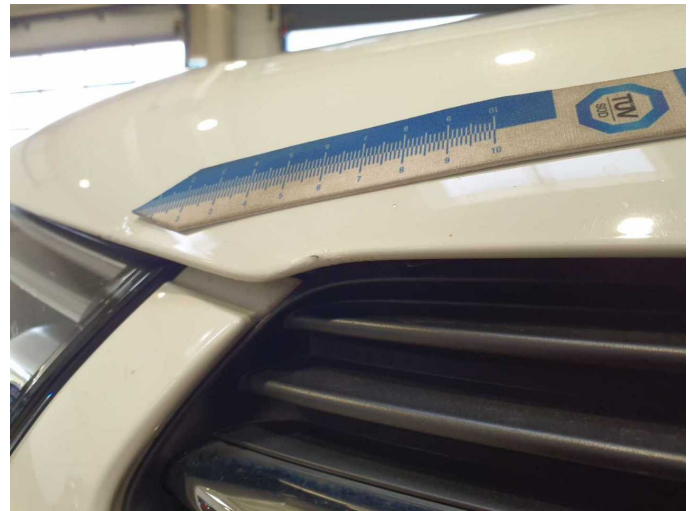
**Damage 8:** Bonnet: Bonnet - Corrosion - Repair and paint

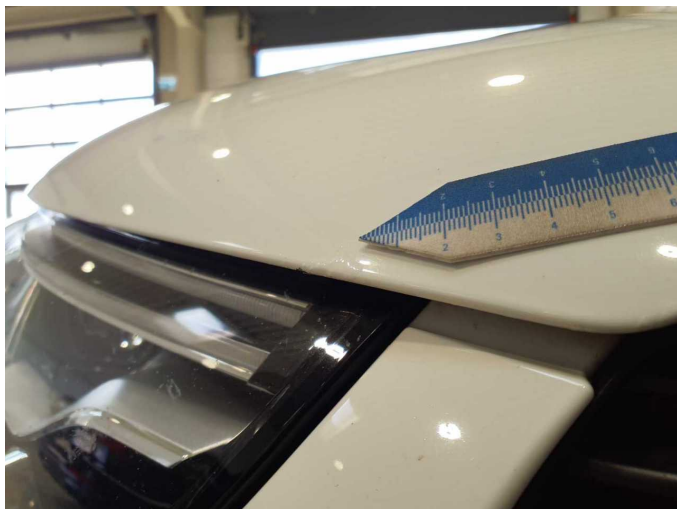
**Damage 8:** Bonnet: Bonnet - Corrosion - Repair and paint

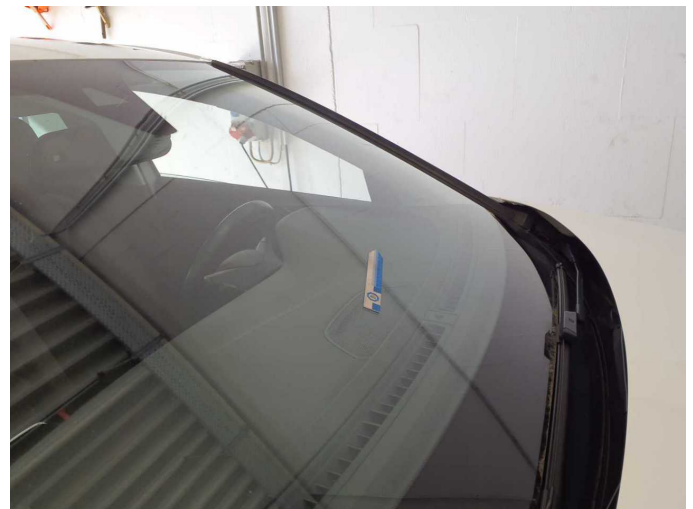
**Wear and tear 1:** Vehicle glazing: Windscreen with lane departure assistant - Stone chips - No deduction

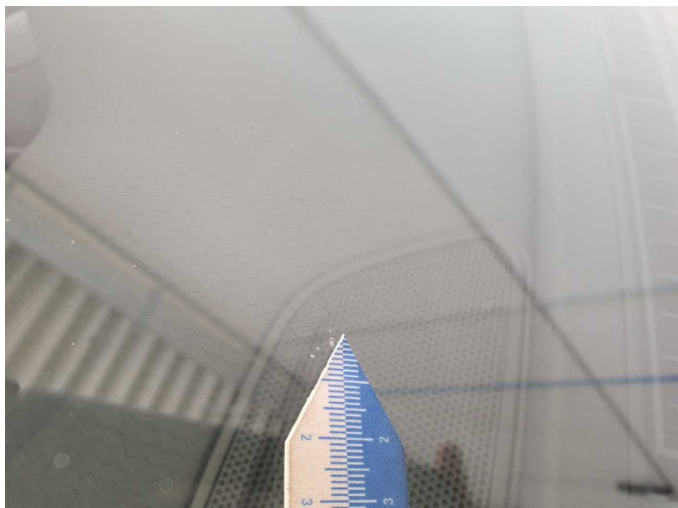
**Wear and tear 1:** Vehicle glazing: Windscreen with lane departure assistant - Stone chips - No deduction
