Expertise

Protocol number: 41726822
Order number / reference: 25213190
Inspection date: 25 Sept 2025

Manufacturer: Opel

Model: Grandland 1.5 D Automatik Elegance

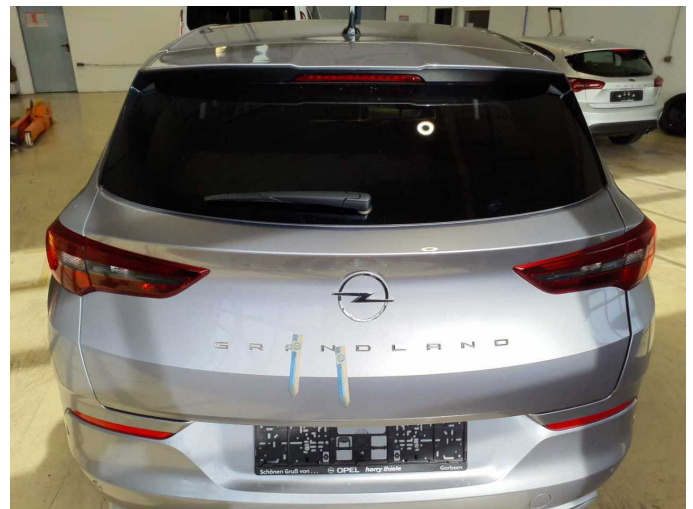
Damage 1: Boot lid / rear door: Boot lid (Teillackierung) - Scratch(es) - Smart repair

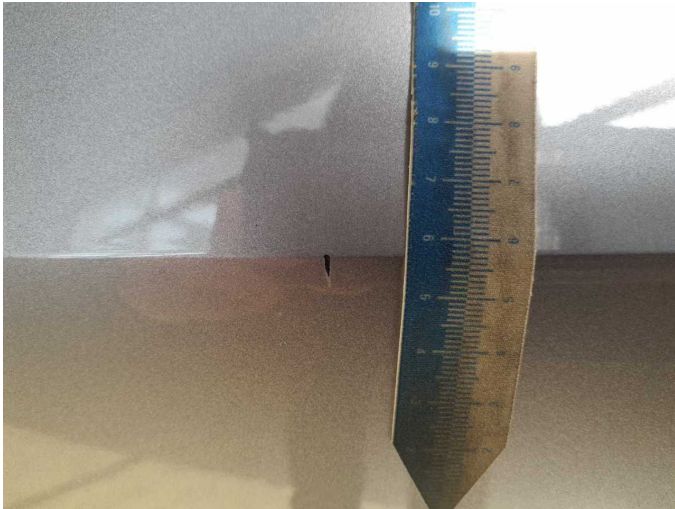
Damage 1: Boot lid / rear door: Boot lid (Teillackierung) - Scratch(es) - Smart repair

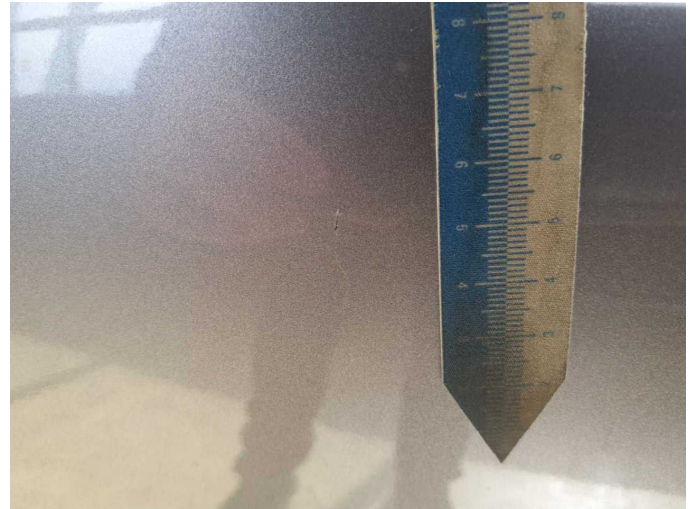
Damage 1: Boot lid / rear door: Boot lid (Teillackierung) - Scratch(es) - Smart repair

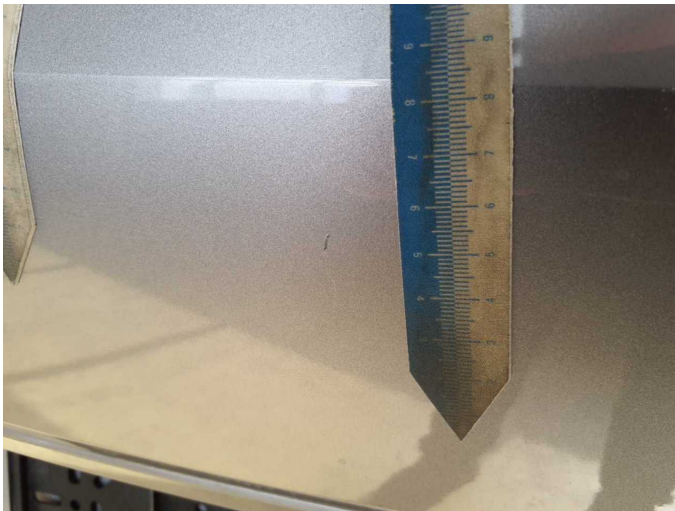
Damage 1: Boot lid / rear door: Boot lid (Teillackierung) - Scratch(es) - Smart repair

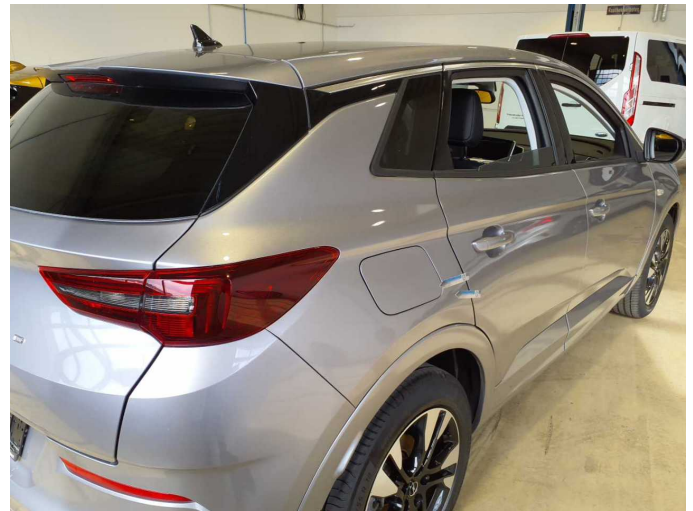
Side panel - rear right side	2,950 µm	Door - rear right side	163 µm
------------------------------	-------------	------------------------	--------

Damage 2: Side panel - rear right side: Side panel (Wellig, stellenweise matt, Spachtel eingefallen) - Unprofessionally repaired - Repair and paint

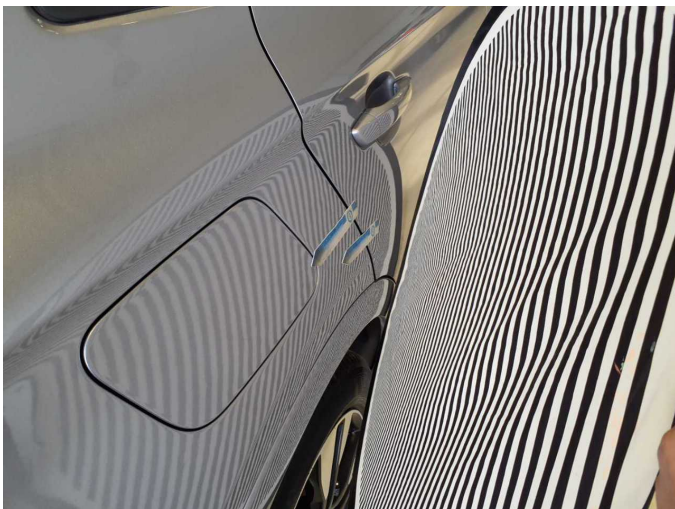
Damage 2: Side panel - rear right side: Side panel (Wellig, stellenweise matt, Spachtel eingefallen) - Unprofessionally repaired - Repair and paint

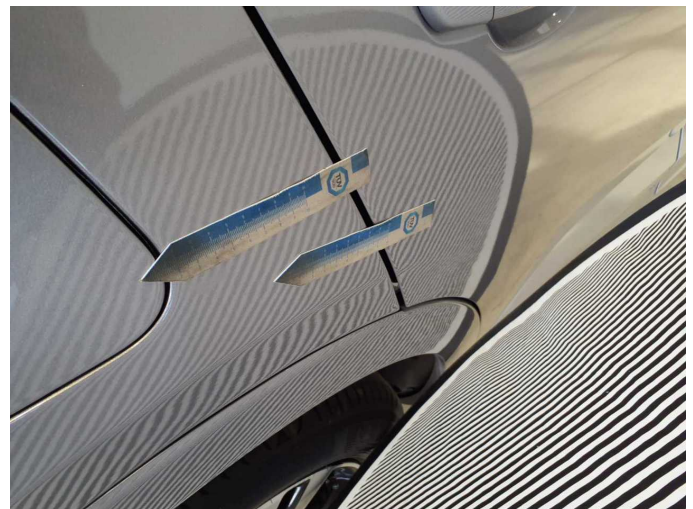
Damage 2: Side panel - rear right side: Side panel (Wellig, stellenweise matt, Spachtel eingefallen) - Unprofessionally repaired - Repair and paint

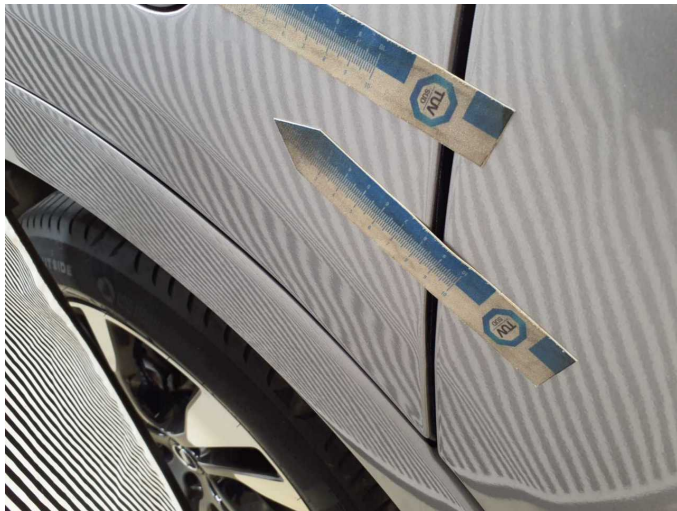
Damage 2: Side panel - rear right side: Side panel (Wellig, stellenweise matt, Spachtel eingefallen) - Unprofessionally repaired - Repair and paint

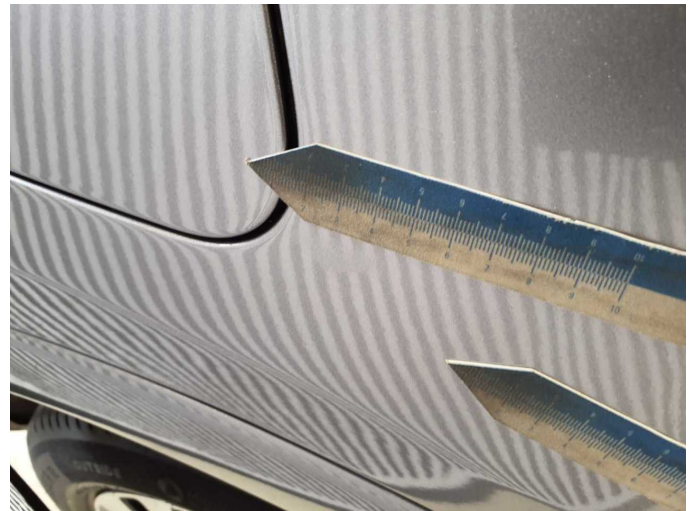
Damage 2: Side panel - rear right side: Side panel (Wellig, stellenweise matt, Spachtel eingefallen) - Unprofessionally repaired - Repair and paint

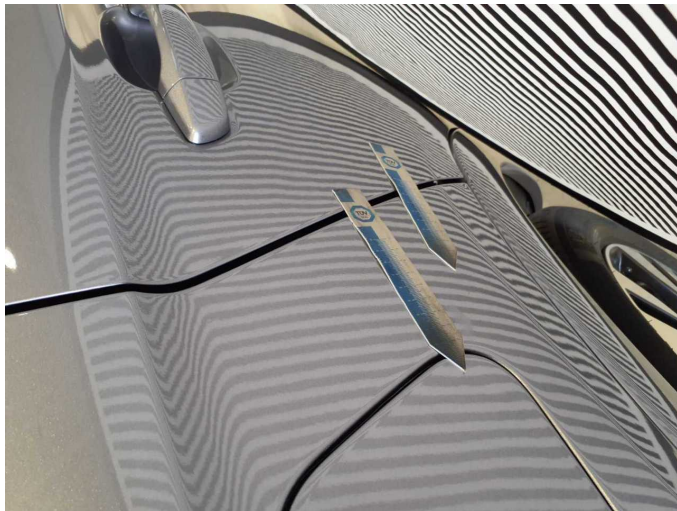
Damage 2: Side panel - rear right side: Side panel (Wellig, stellenweise matt, Spachtel eingefallen) - Unprofessionally repaired - Repair and paint

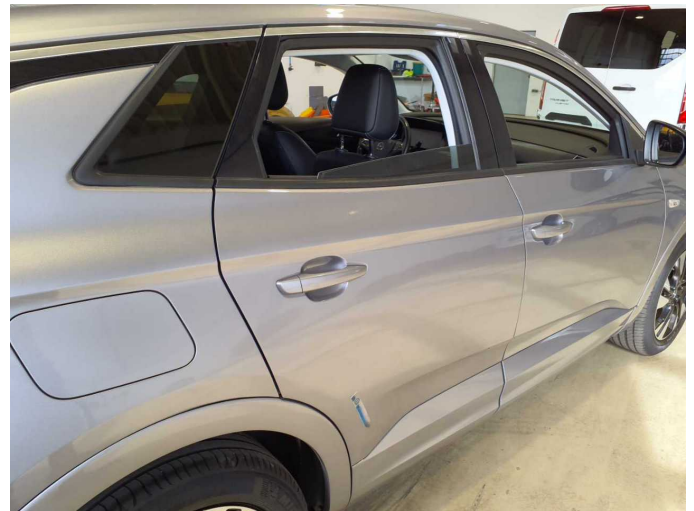
Damage 3: Door - rear right side: Door (Wellig, Spachtel eingefallen) - Unprofessionally repaired - Repair and paint

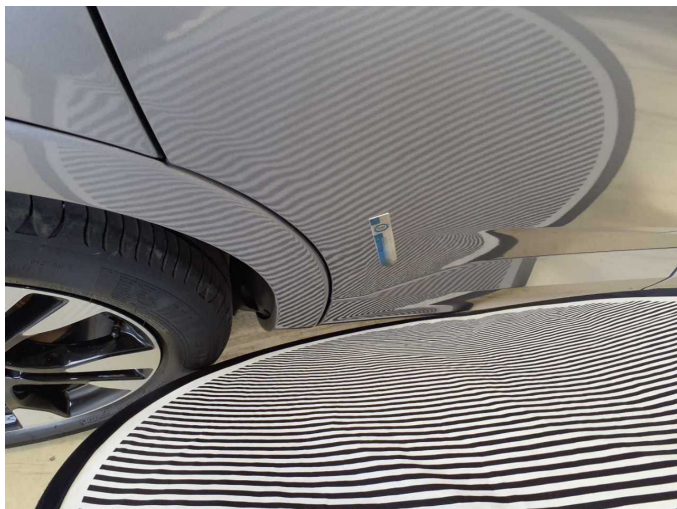
Damage 3: Door - rear right side: Door (Wellig, Spachtel eingefallen) - Unprofessionally repaired - Repair and paint

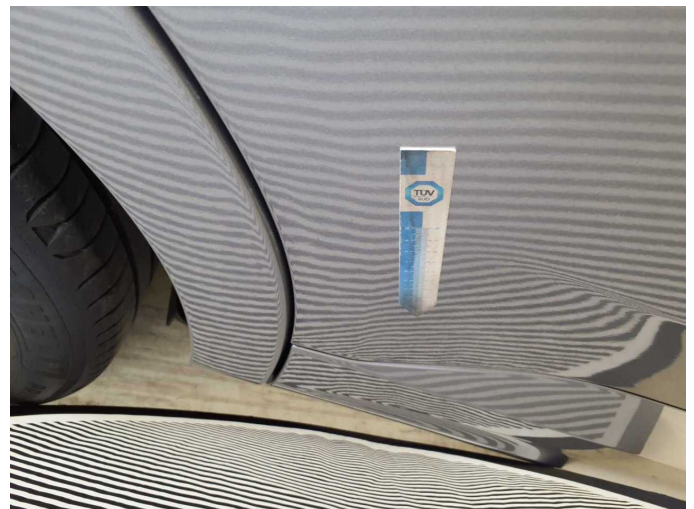
Damage 3: Door - rear right side: Door (Wellig, Spachtel eingefallen) - Unprofessionally repaired - Repair and paint

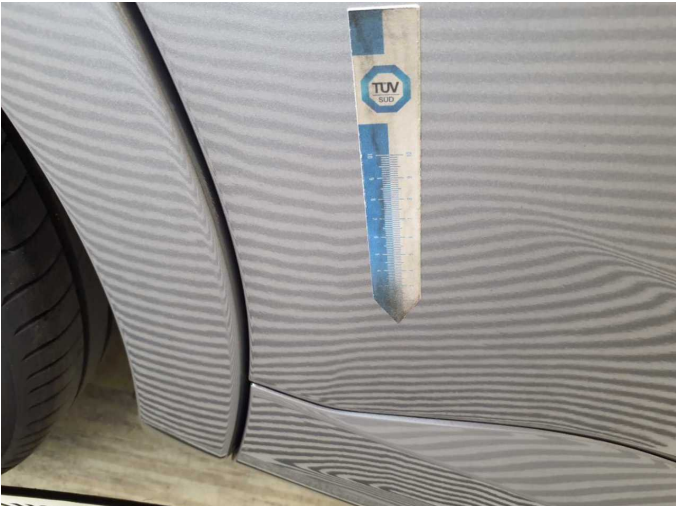
Damage 3: Door - rear right side: Door (Wellig, Spachtel eingefallen) - Unprofessionally repaired - Repair and paint

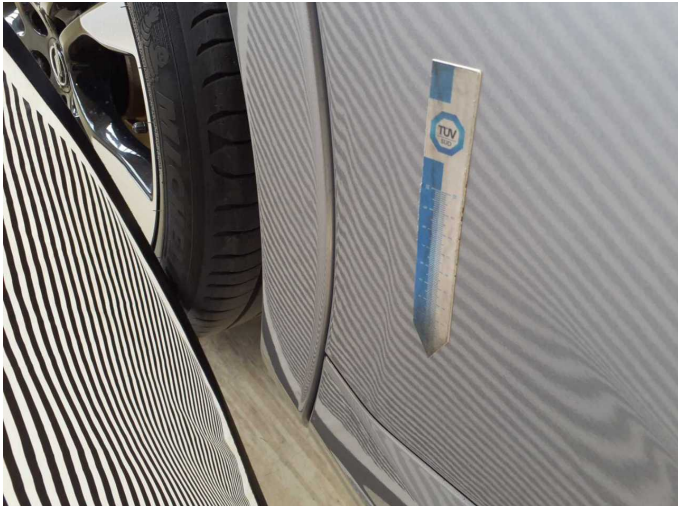
Damage 3: Door - rear right side: Door (Wellig, Spachtel eingefallen) - Unprofessionally repaired - Repair and paint

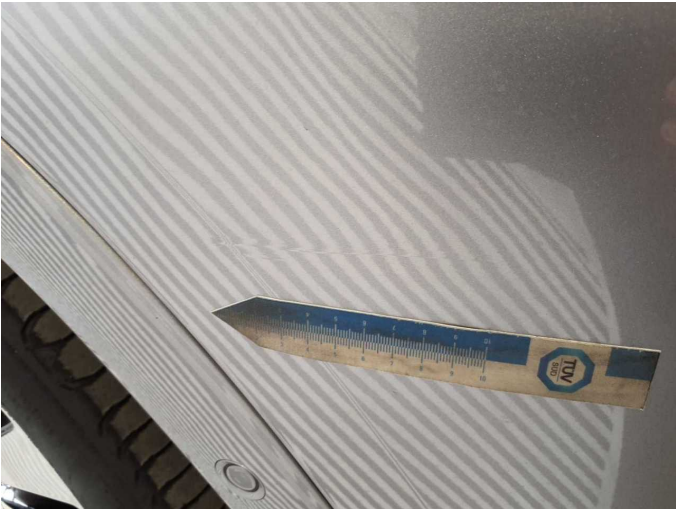
Damage 4: Front bumper: Front bumper - Dent / paintcoat damage - Repair and paint

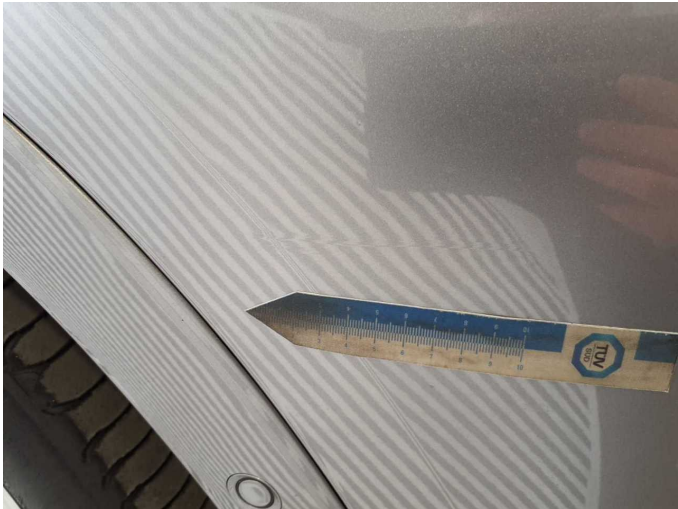
Damage 4: Front bumper: Front bumper - Dent / paintcoat damage - Repair and paint

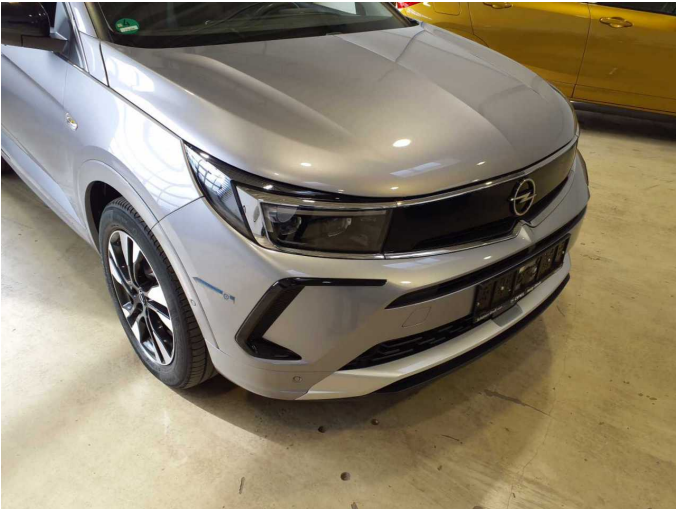
Damage 4: Front bumper: Front bumper - Dent / paintcoat damage - Repair and paint

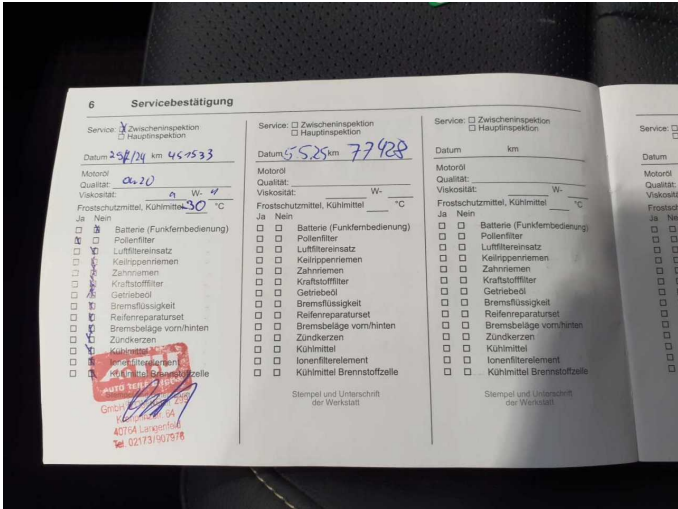
Wear and tear 1: Misc.: Inspection / maintenance (Letzter Servicenachweis unvollständig) - Incomplete - No deduction

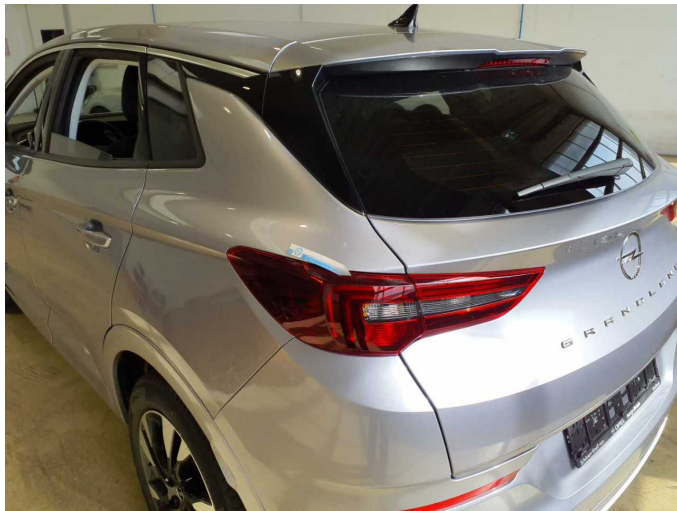
Wear and tear 7: Tail light: Tail lamp - left side - Scratch(es) - No deduction

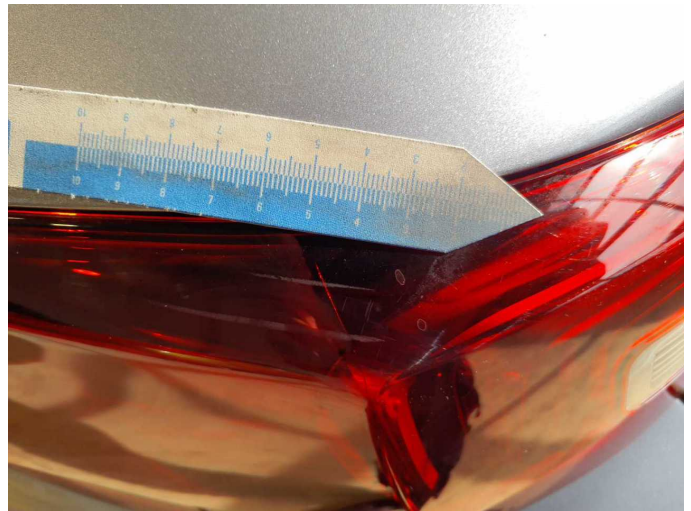
Wear and tear 7: Tail light: Tail lamp - left side - Scratch(es) - No deduction

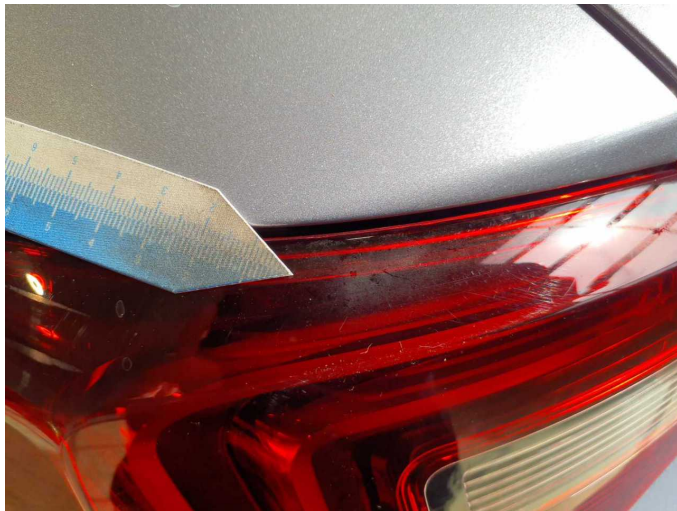
Wear and tear 7: Tail light: Tail lamp - left side - Scratch(es) - No deduction

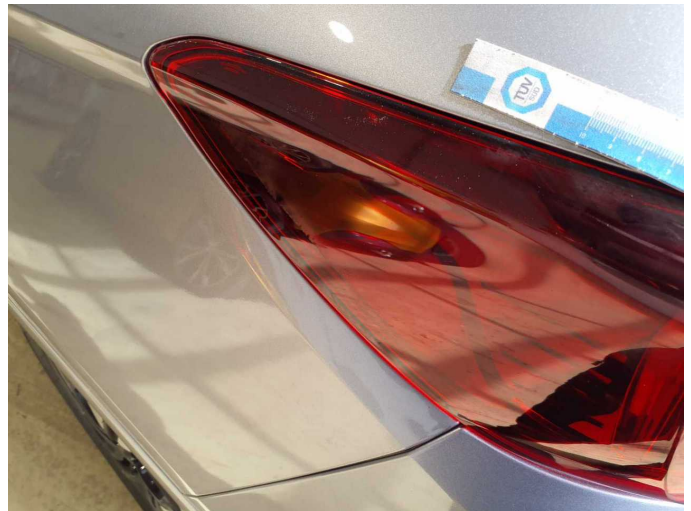
Wear and tear 7: Tail light: Tail lamp - left side - Scratch(es) - No deduction

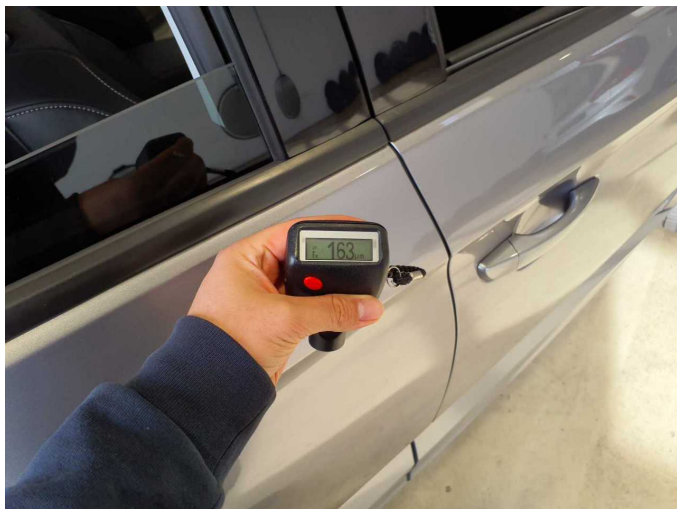
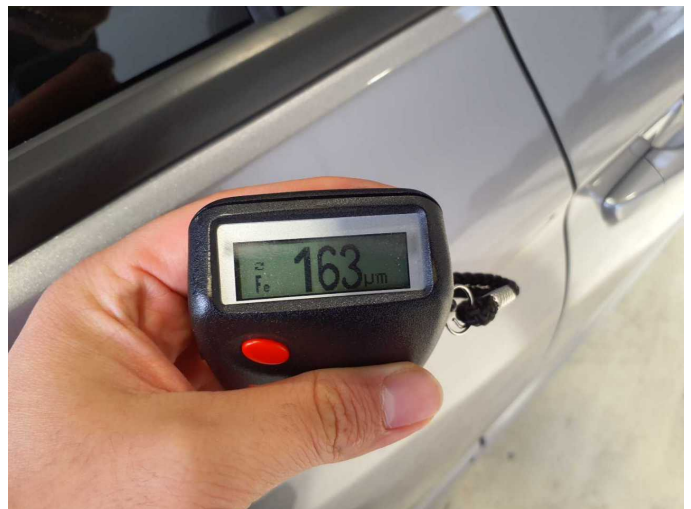
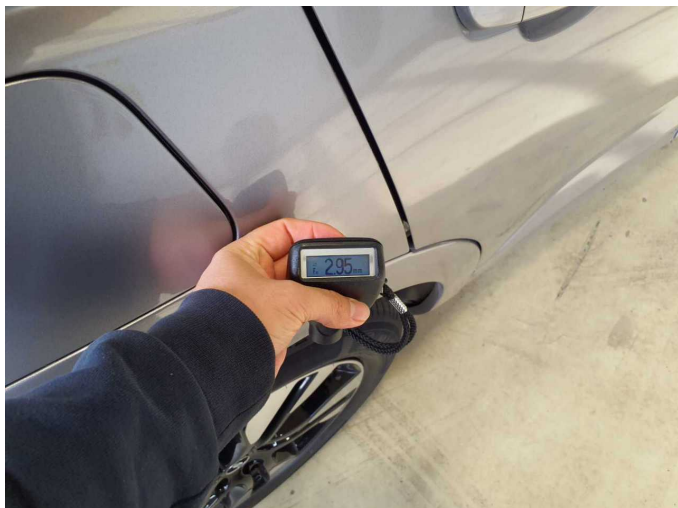
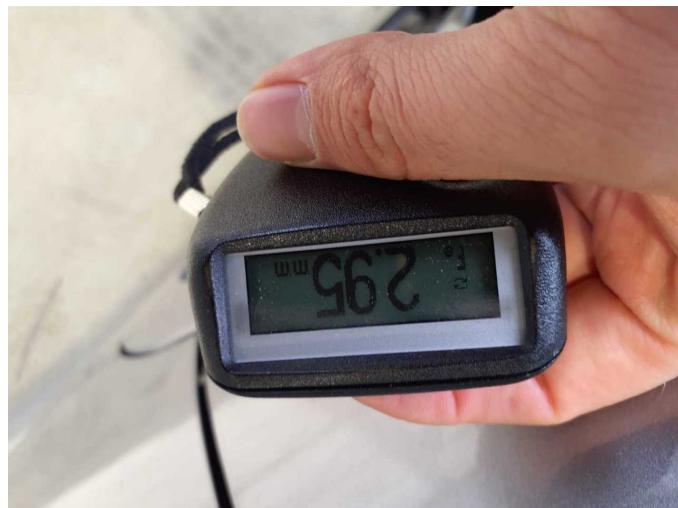
1 Side panel - rear right side, Door - rear right side, Unprofessionally carried out, Invoice of repair done Non-existent

Repainting 1: Side panel - rear right side, Door - rear right side
