## status report

**customer:** BCA Autoauktionen GmbH  
**report Number:** 0000001244679-EN18

#### Opel Grandland (X) GS Line

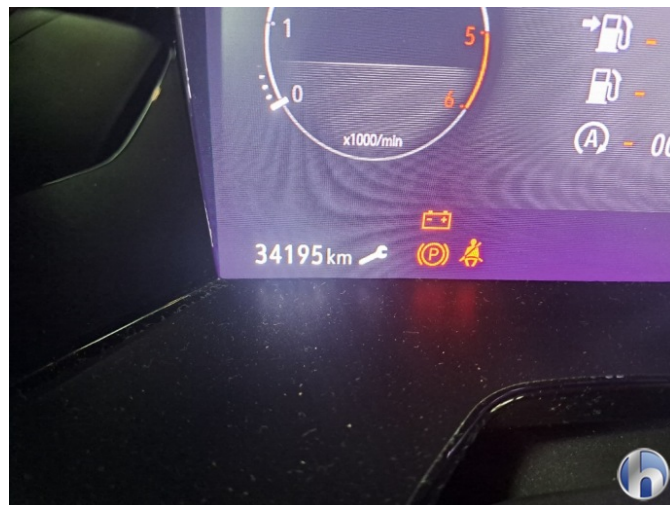
1. maintenance

**Due**

| | component | Damage | Rep kind |
|---|---|---|---|
| 1. | maintenance | Due | Replace |

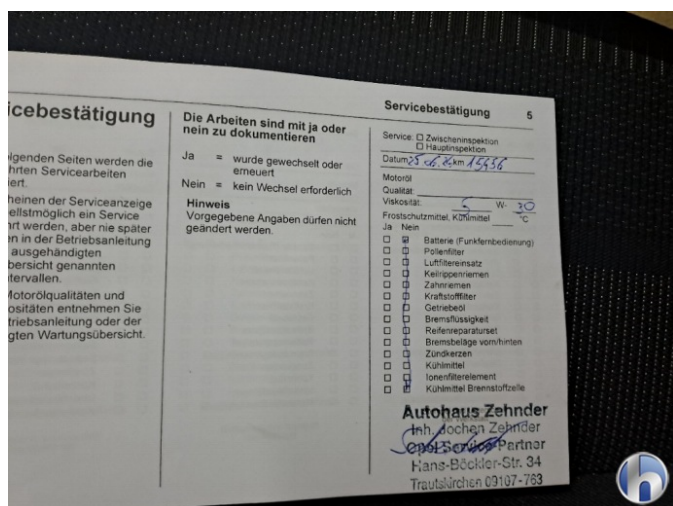
1. maintenance

**Due**

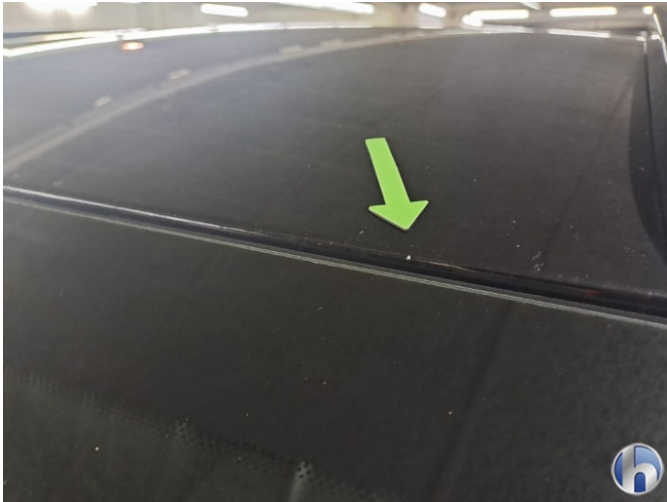
4. roof  
 Scratch(es)

| | component | Damage | Rep kind |
|---|---|---|---|
| 4. | roof | Scratch(es) | Smart repair |

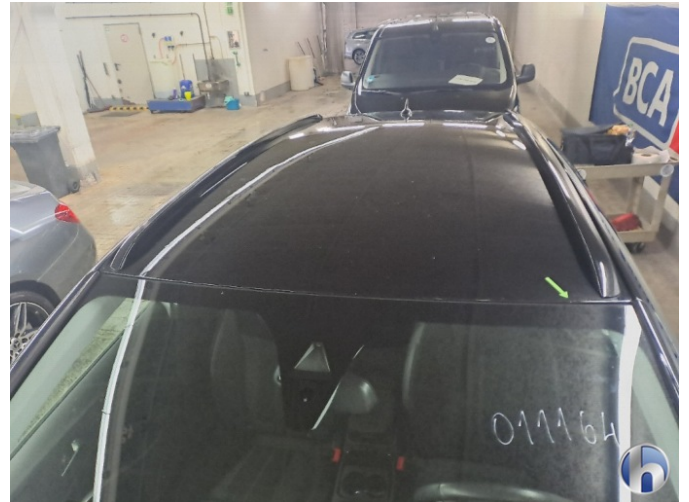
4. roof  
 Scratch(es)

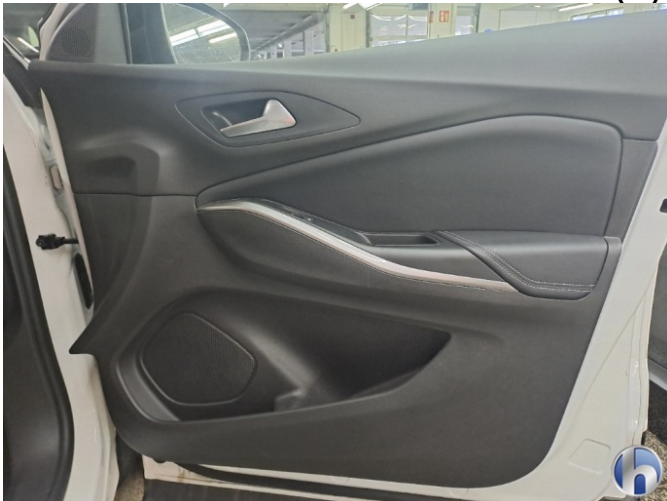
5. Door trim Front - right  
 Scratch(es)

| | component | Damage | Rep kind |
|---|---|---|---|
| 5. | Door trim Front - right | Scratch(es) | Smart repair |

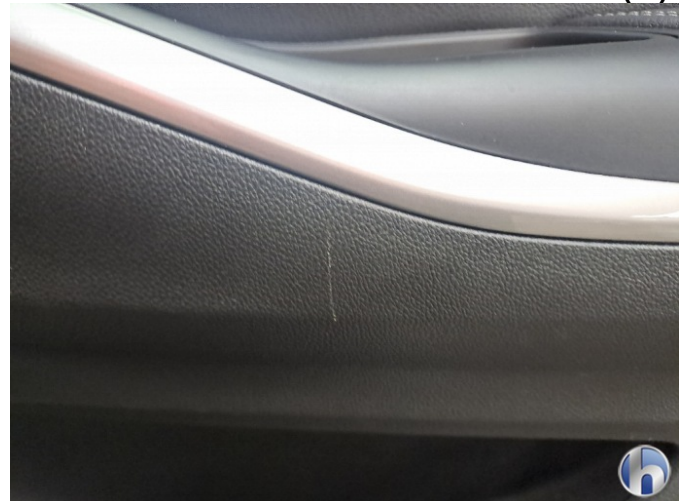
5. Door trim Front - right  
 Scratch(es)

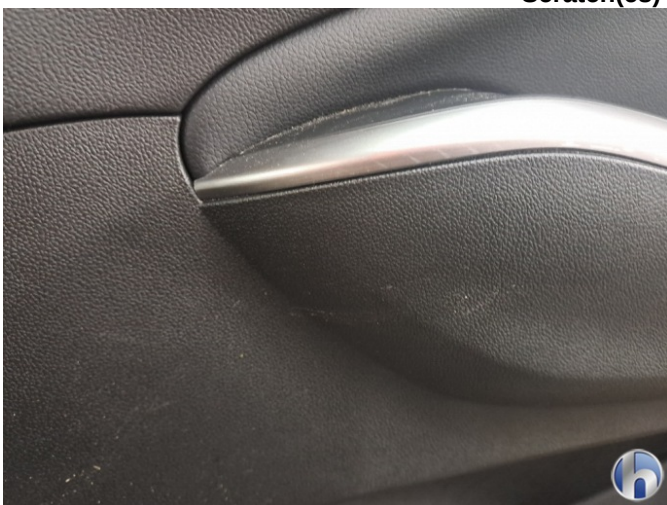
5. Door trim Front - right  
 Scratch(es)

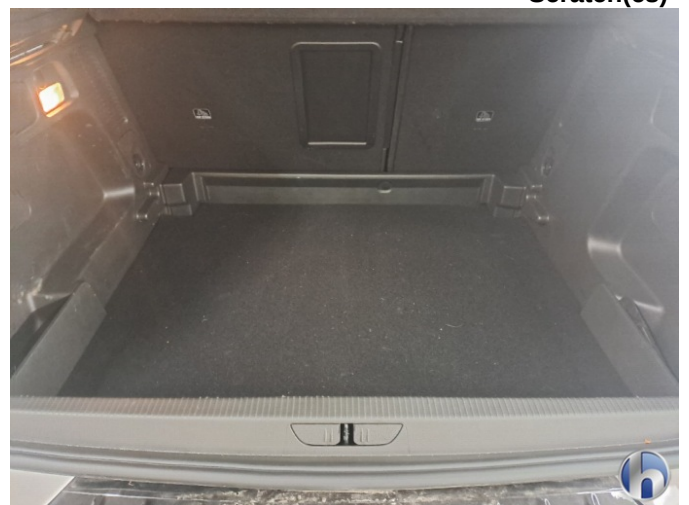
6. Trunk Flooring  
 Missing

| | component | Damage | Rep kind |
|---|---|---|---|
| 6. | Trunk Flooring | Missing | Replace |
