status report

customer: Bank 11, Neuss
contract number: 965626031
reference:

Opel Insignia B Sports Tourer Edition

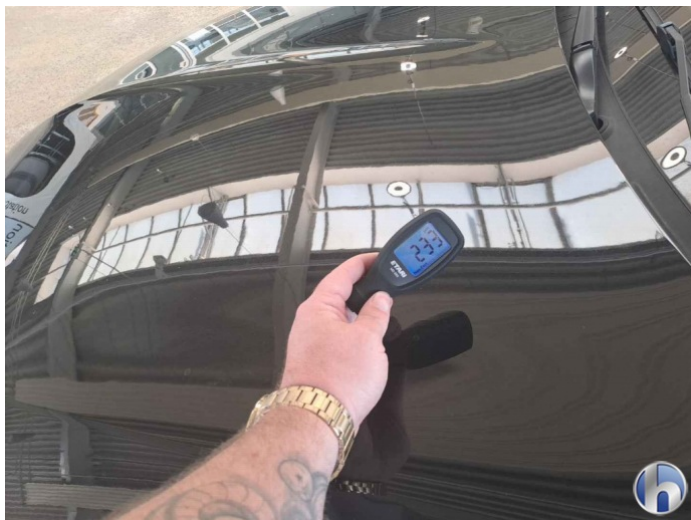
component	Damage	Rep kind
1.	hood	Subsequently painted	acceptable
2.	Hubcap - Rear - Left	Wear and tear	acceptable
3.	roof	Damaged	Refurbish and paint
4.	hood	Damaged	Smart repair
5.	Front bumper	Damaged	Replace
6.	Door Rear - right	Scratch(es)	Paint
7.	Rear bumper	Scratch(es)	Smart repair
