## status report

| <b>customer:</b> | <b>Opel Grosskunden/FSL/Free2Move</b> |

| vehicle data | | | |
|---|---|---|---|
| <b>Opel Grandland GS Line</b> | | | |
| Vehicle identification number | <b>W0VZRHNS8N6802411</b> | mileage read: | <b>54285 km</b> |

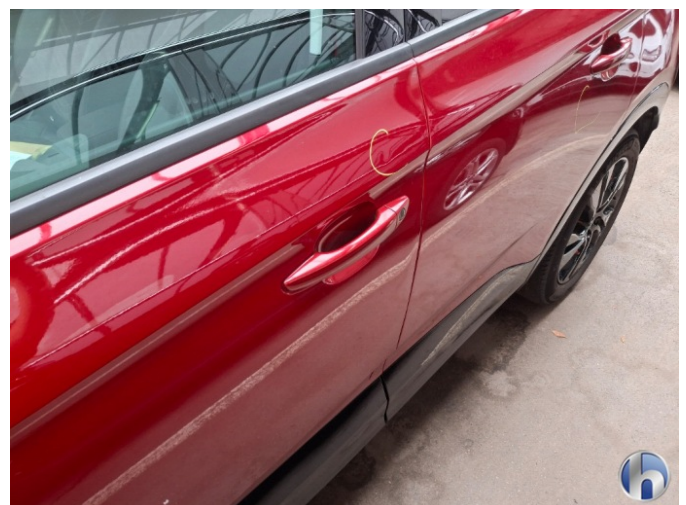
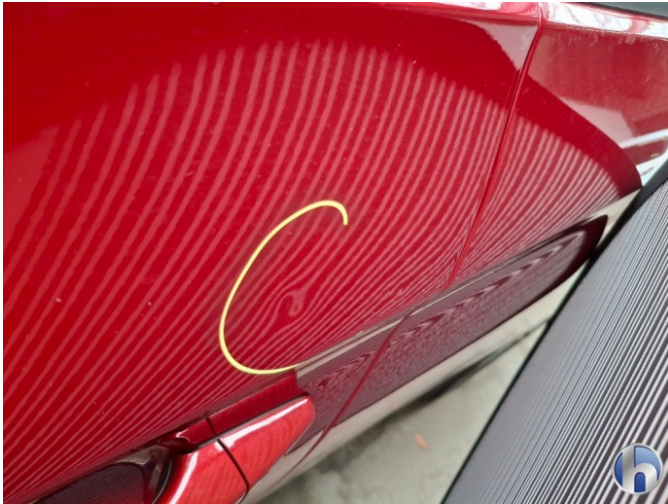
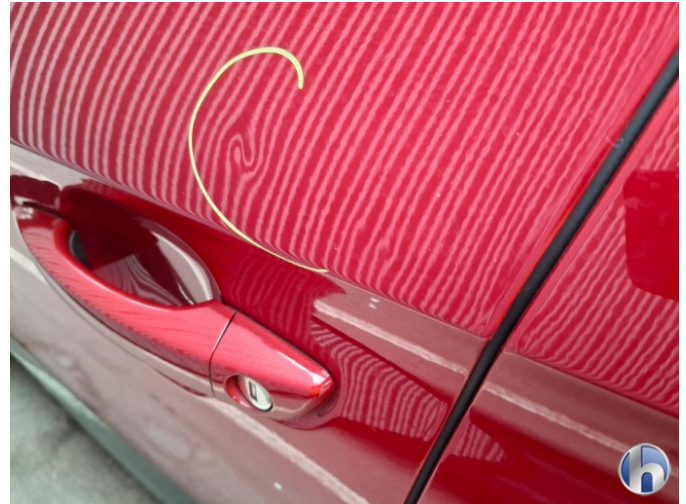
| component | Damage | Rep kind |
|---|---|---|
| 1. Front door - left | | Smart repair |

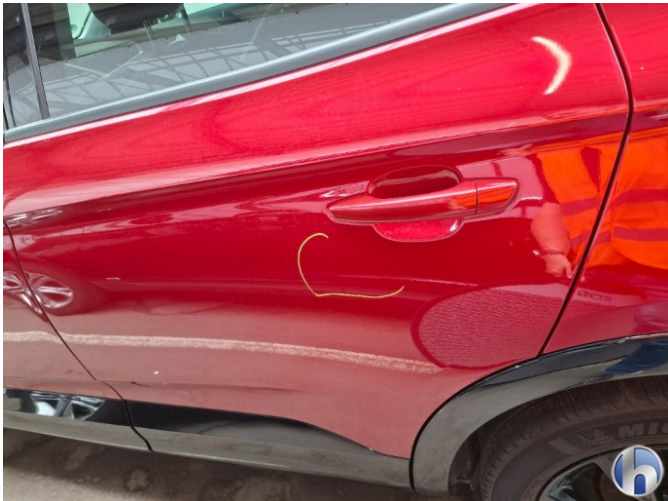
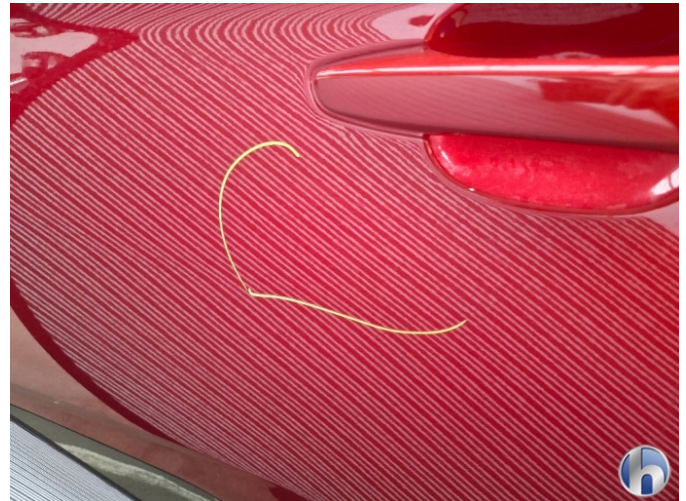
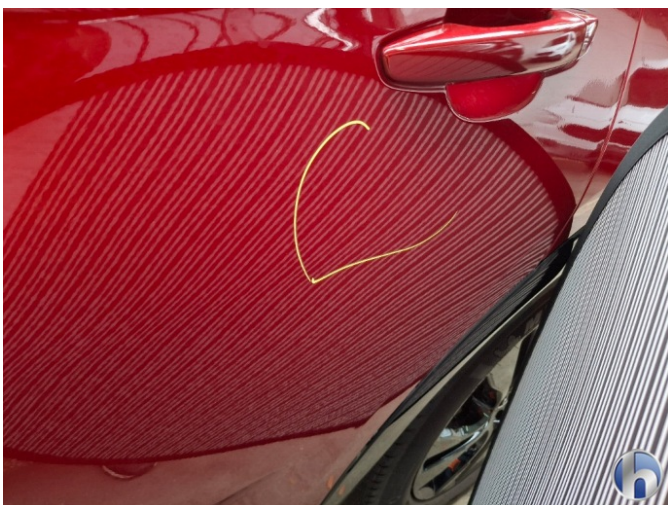
| component | Damage | Rep kind |
|---|---|---|
| 2. Rear door - left | | Smart repair |

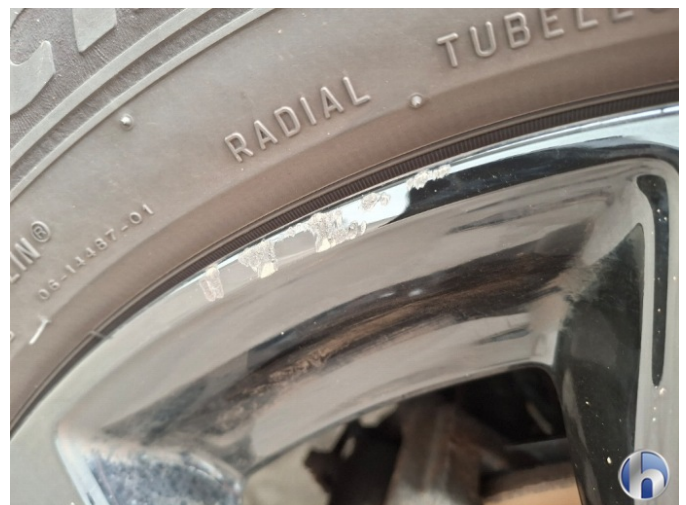
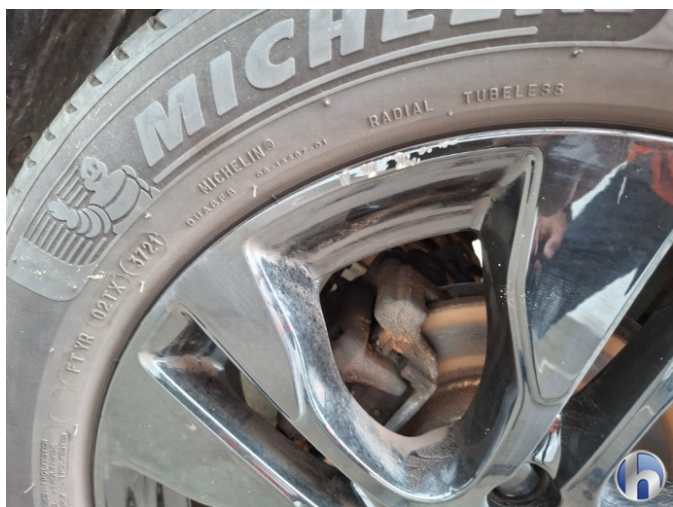
| component | Damage | Rep kind |
|---|---|---|
| 3. Felge (Aluminium) hinten rechts | Scratch(es) | Paint |

**Scratch(es)**
