# **Expertise**

Protocol number: 41259890
Order No. / Reference: 24903082
Inspection date: 25 Aug 2025

Manufacturer: Opel

Model: Insignia Sports Tourer 2.0 Diesel Aut. Ultimate

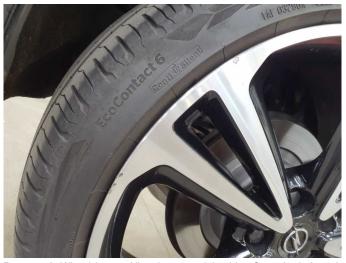
Damage 2: Wheel / tyres: Alloy rim - rear right side - Scratched - Loss in value

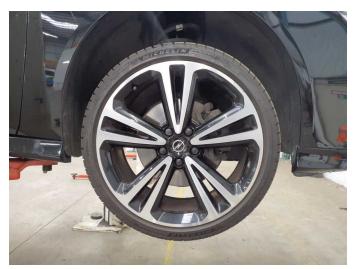
Damage 2: Wheel / tyres: Alloy rim - rear right side - Scratched - Loss in value

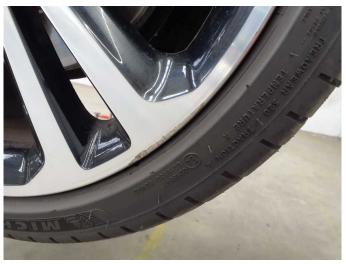
Damage 3: Wheel / tyres: Alloy rim - front right side - Scratched - Loss in value

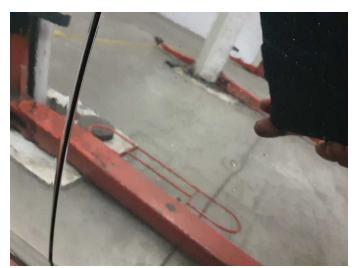
**Damage 4:** Door - rear left side: Door - Dent / paintcoat damage - Repair and paint
