Expertise

Protocol number: 41668859  
Order No. / Reference: 25236850  
Inspection date: 17 Sept 2025

| Manufacturer: Opel | Model: Insignia Grand Sport 2.0 Diesel Automatik Business Elegance |

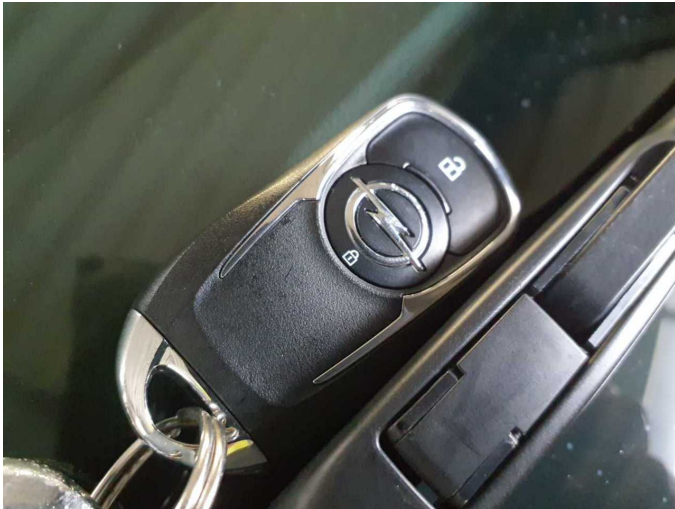
| No. | Component group | Description |
|---|---|---|
| 1 | Equipment | Vehicle key - Non-operational - Perform diagnosis |

**Damage 1:** Equipment: Vehicle key - Non-operational - Perform diagnosis

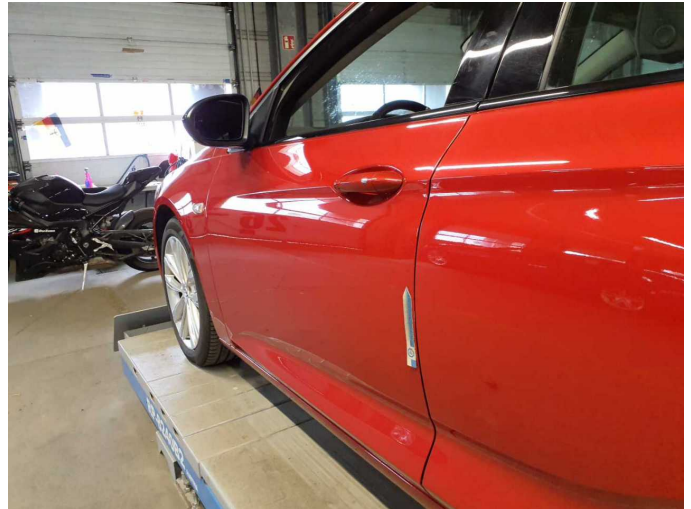
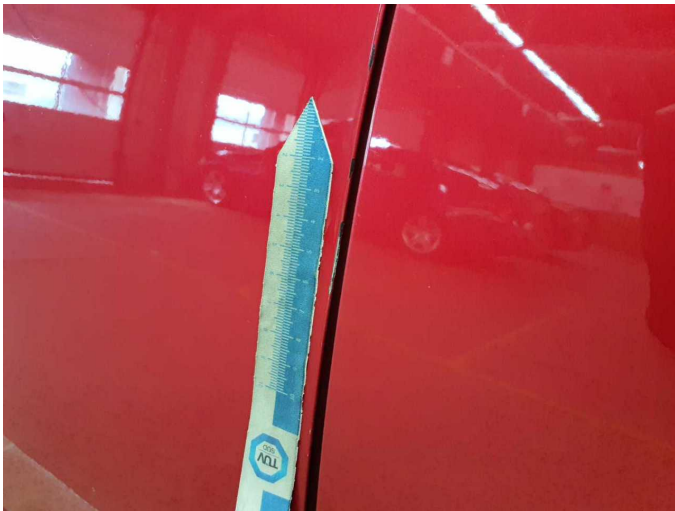
| No. | Component group | Description |
|---|---|---|
| 2 | Door - front left side | Door edge - Scratched - Smart repair |

**Damage 2:** Door - front left side: Door edge - Scratched - Smart repair

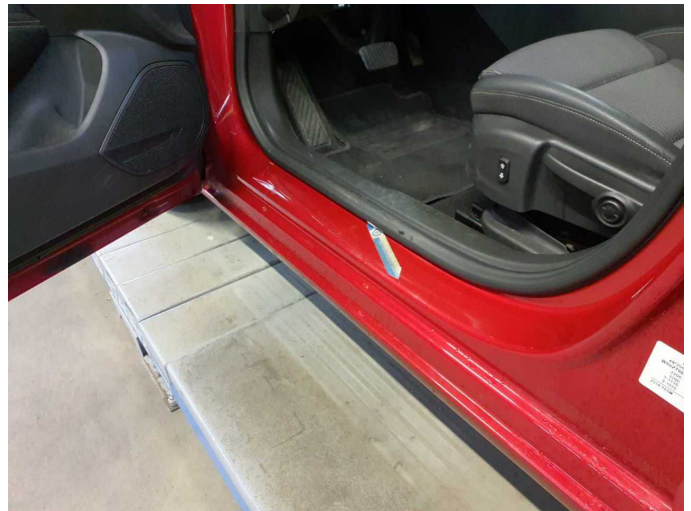
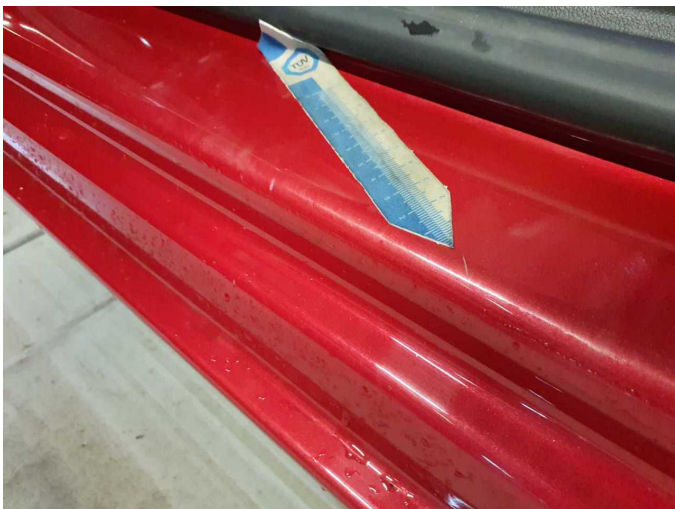
| No. | Component group | Description |
|---|---|---|
| 3 | Sill - left side | Sill - Scratched - Smart repair |

**Damage 3:** Sill - left side: Sill - Scratched - Smart repair

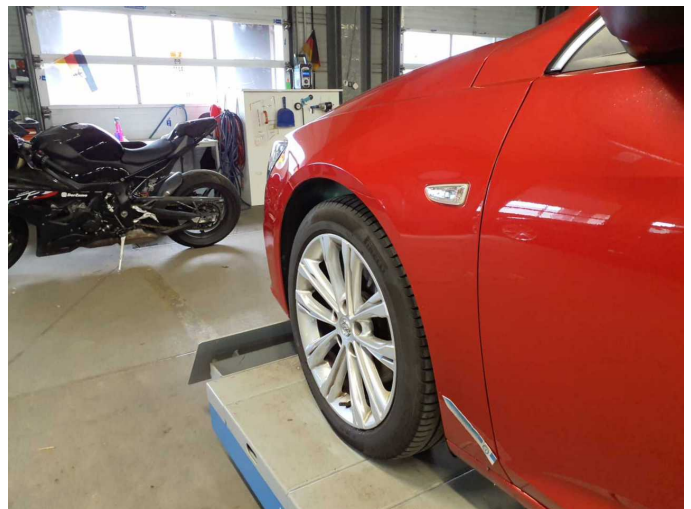
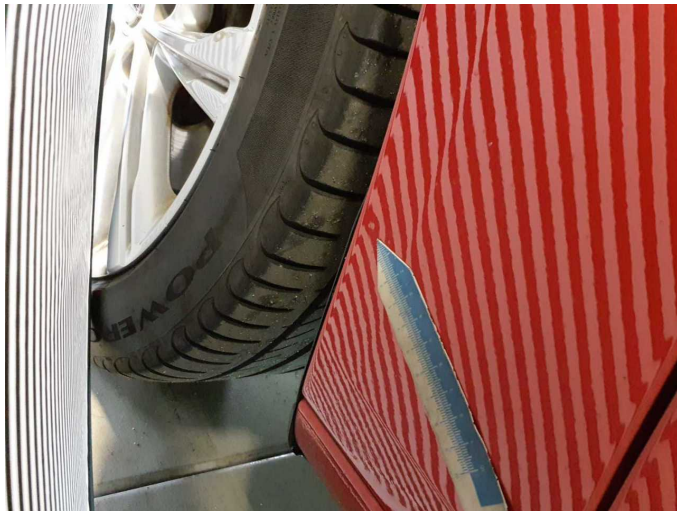
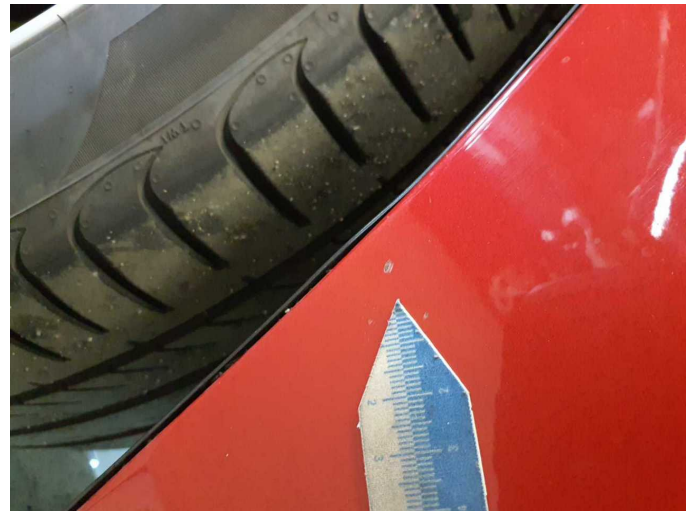
| No. | Component group | Description |
|---|---|---|
| 4 | Mudguard - left side | Mudguard - left side - Dent / paintcoat damage - Smart repair |

**Damage 4:** Mudguard - left side: Mudguard - left side - Dent / paintcoat damage - Smart repair

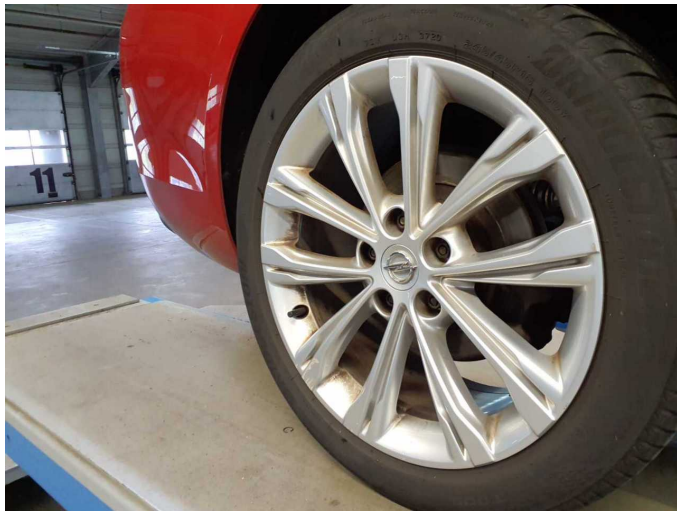
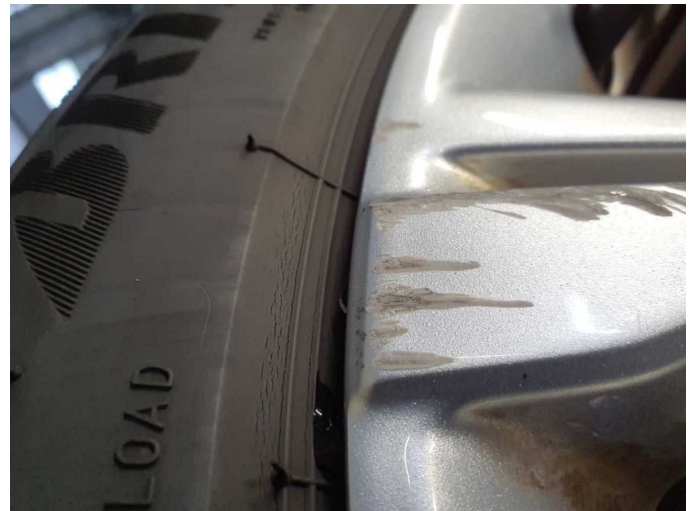
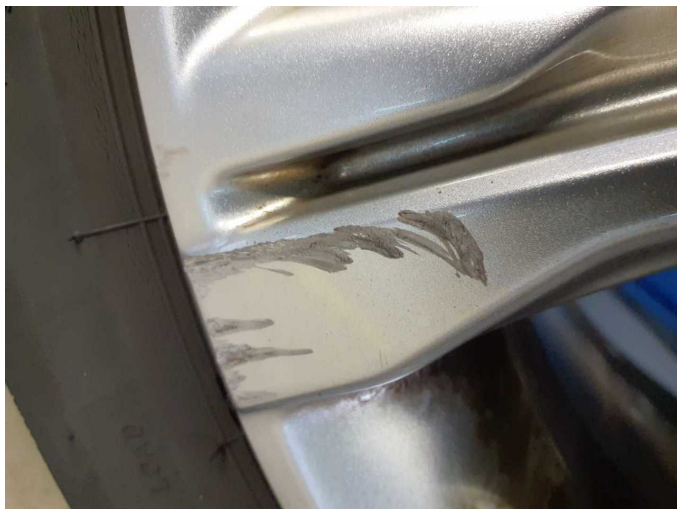
| No. | Component group | Description |
|---|---|---|
| 5 | Wheel / tyres | Alloy rim - rear right side (Materialabtrag) - Damaged - Loss in value |

Die Felgen wurden aufgrund des Alters und der Laufleistung gemindert.

**Damage 5:** Wheel / tyres: Alloy rim - rear right side (Materialabtrag) - Damaged - Loss in value

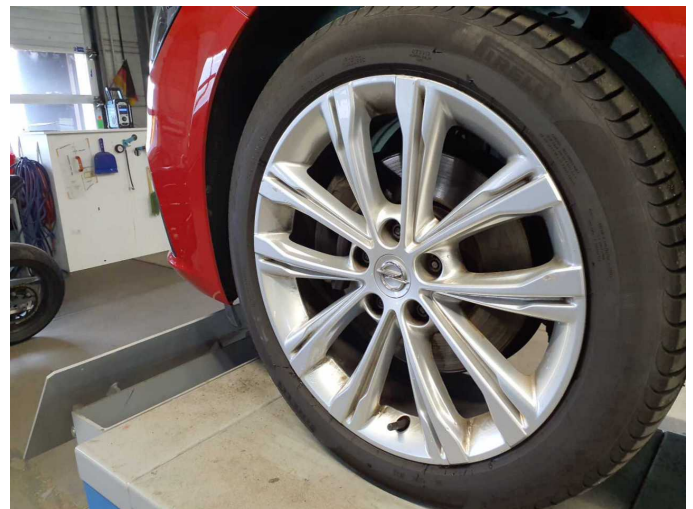
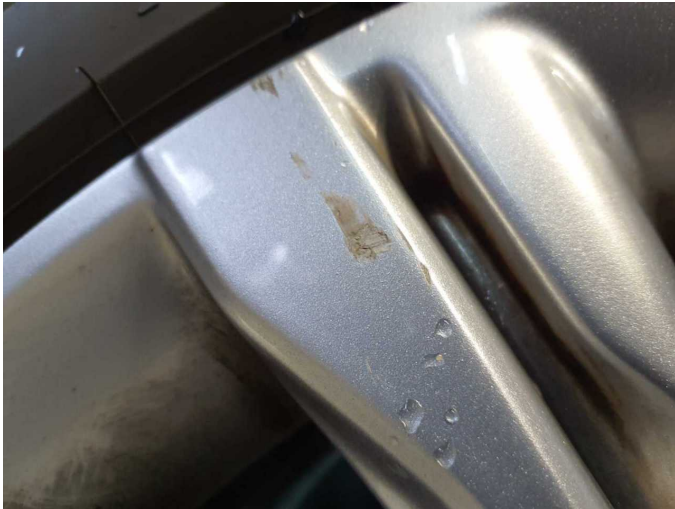
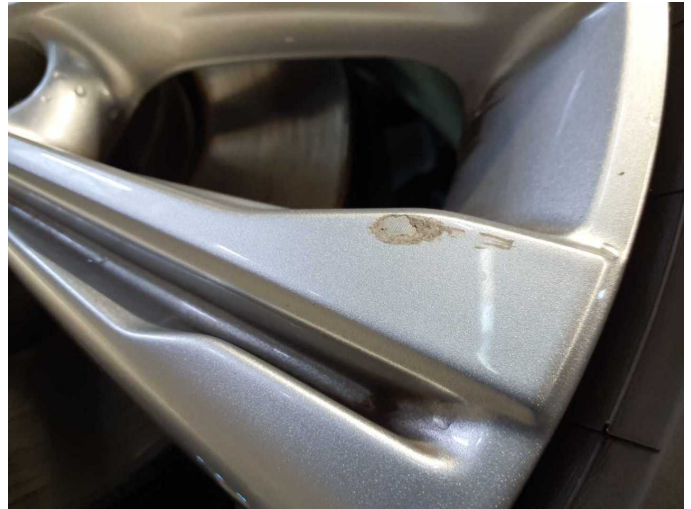
| No. | Component group | Description |
|---|---|---|
| 6 | Wheel / tyres | Alloy rim - front left side (Materialabtrag) - Scratched - Loss in value |

**Damage 6:** Wheel / tyres: Alloy rim - front left side (Materialabtrag) - Scratched - Loss in value

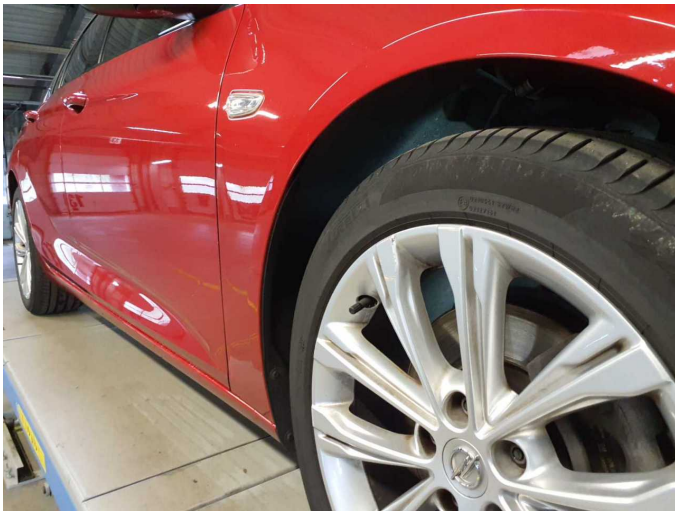
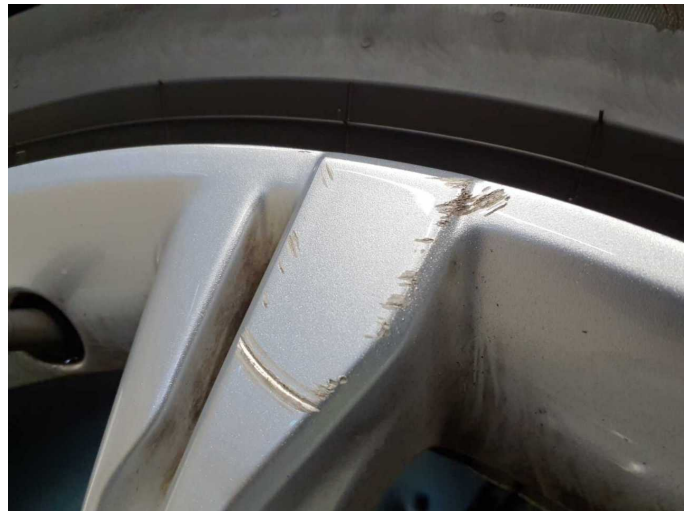
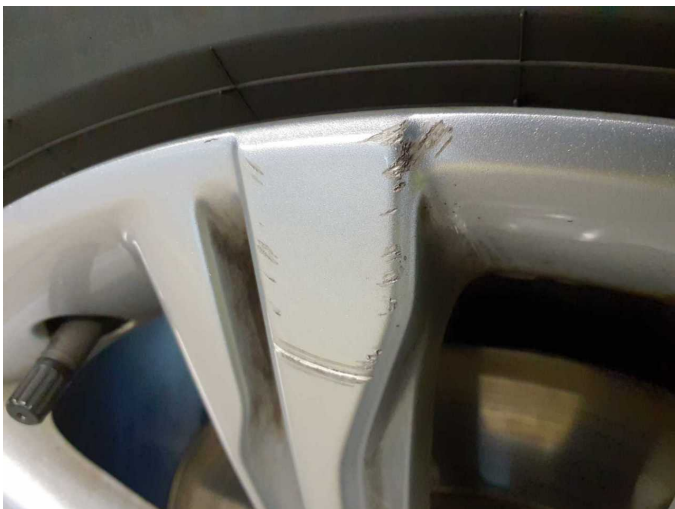
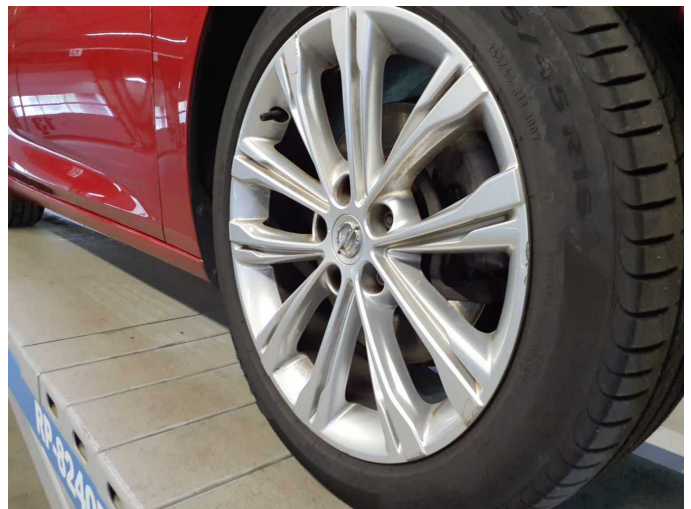
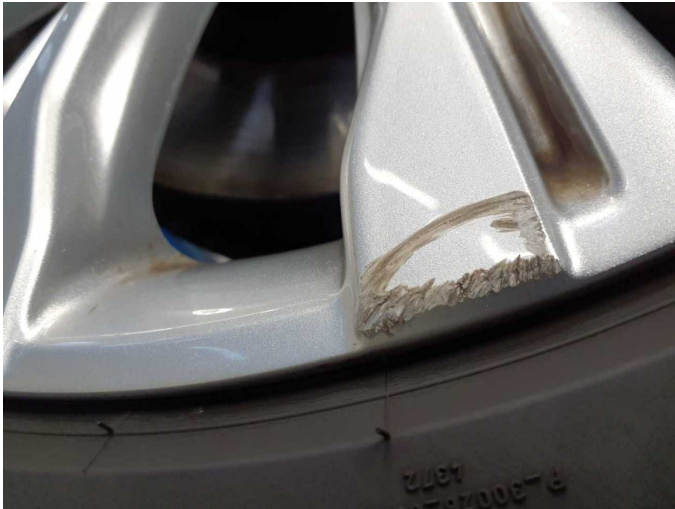
| No. | Component group | Description |
|---|---|---|
| 7 | Wheel / tyres | Alloy rim - front right side (Materialabtrag) - Damaged - Loss in value |

**Damage 7:** Wheel / tyres: Alloy rim - front right side (Materialabtrag) - Damaged - Loss in value

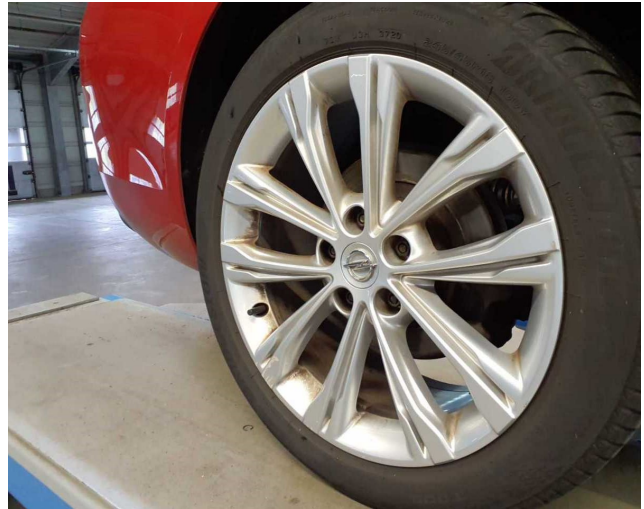
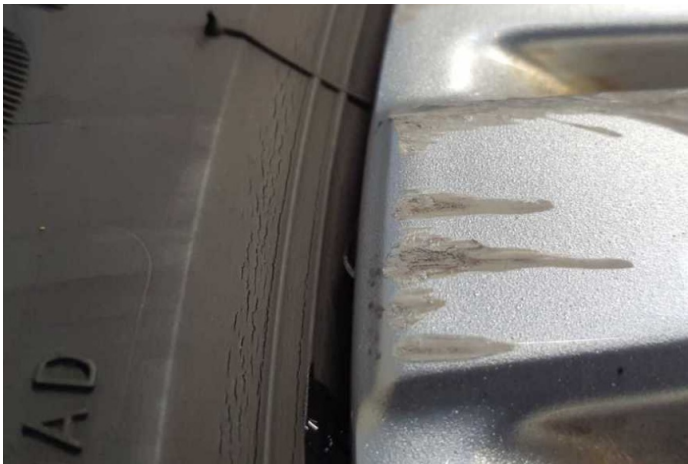
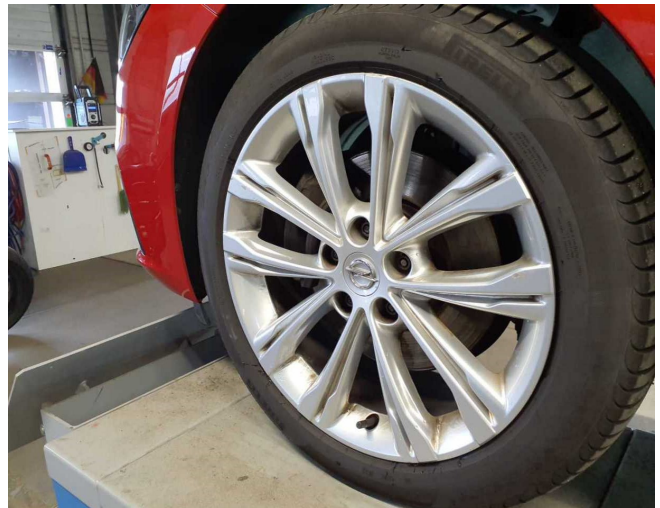
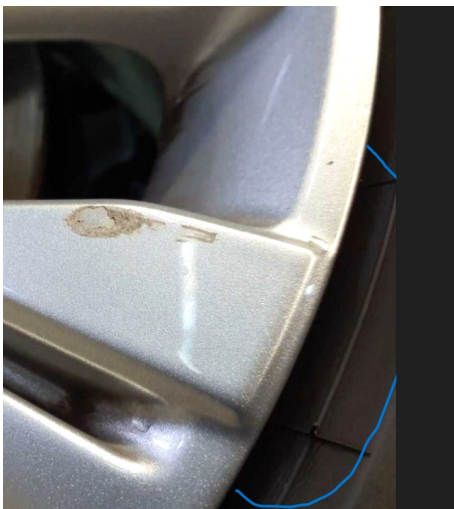
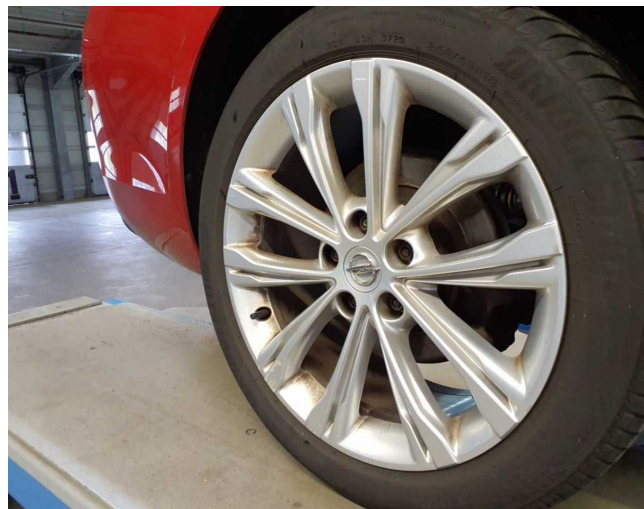
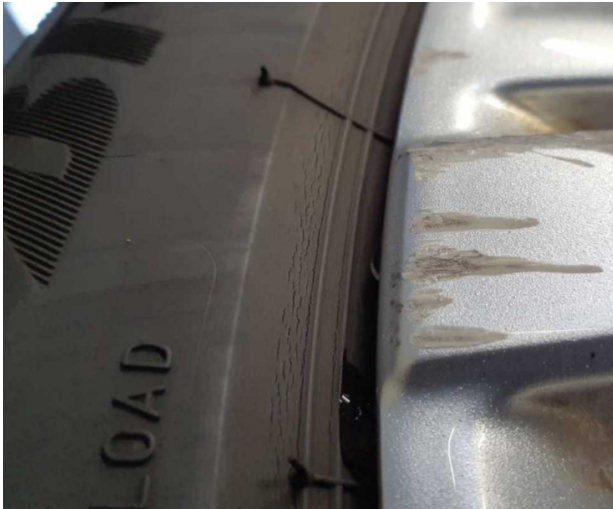
| No. | Component group | Description |
|---|---|---|
| 8 | Wheel / tyres | Tyres - complete set (3 Reifen, nicht fahrbereit) - Porous / cracked - Replace |

**Damage 8:** Wheel / tyres: Tyres - complete set (3 Reifen, nicht fahrbereit) - Porous / cracked - Replace

**Damage 8:** Wheel / tyres: Tyres - complete set (3 Reifen, nicht fahrbereit)  
- Porous / cracked - Replace

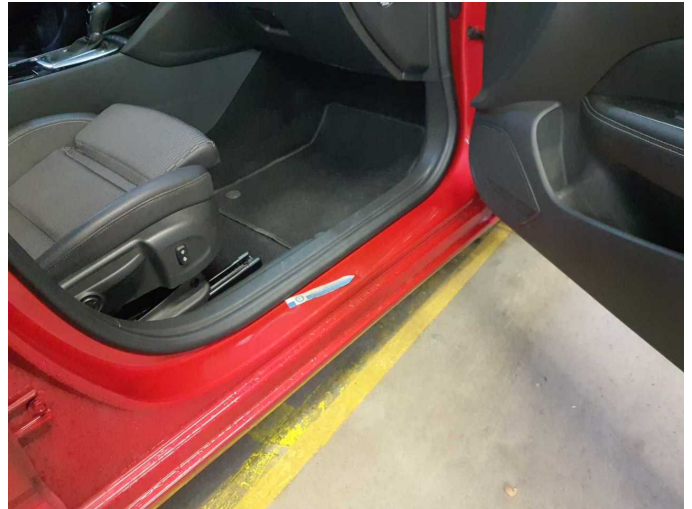
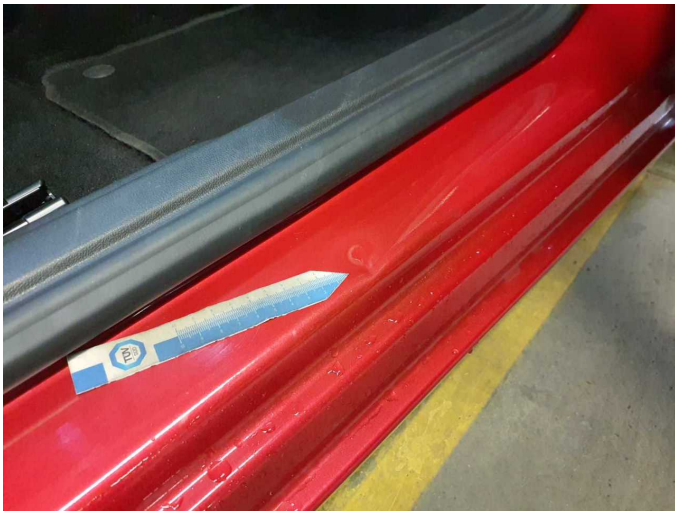
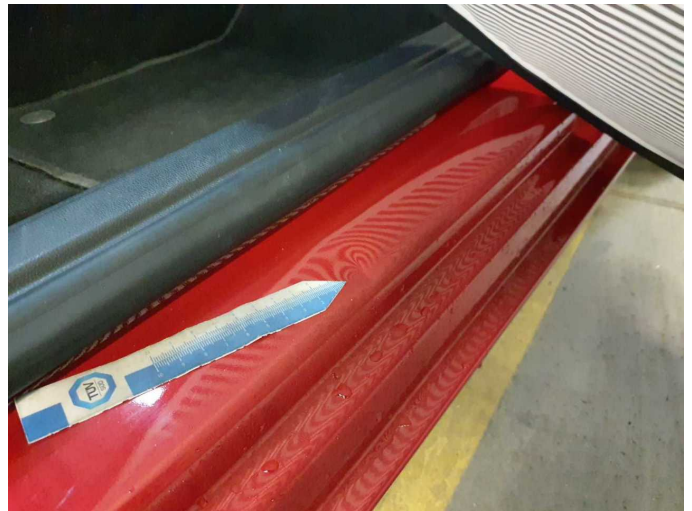
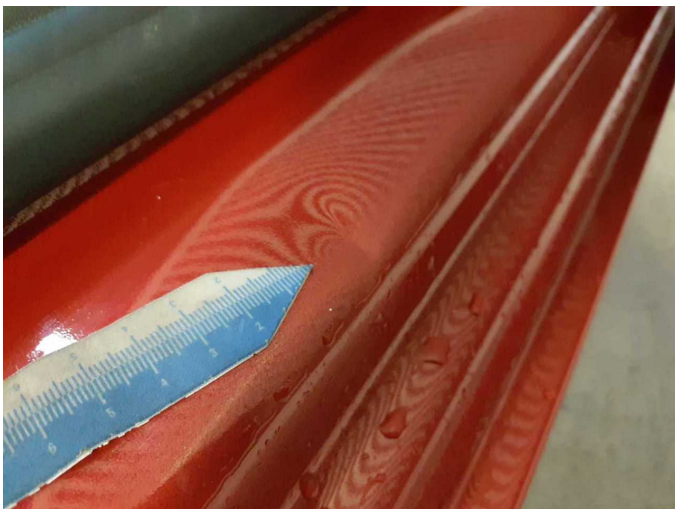
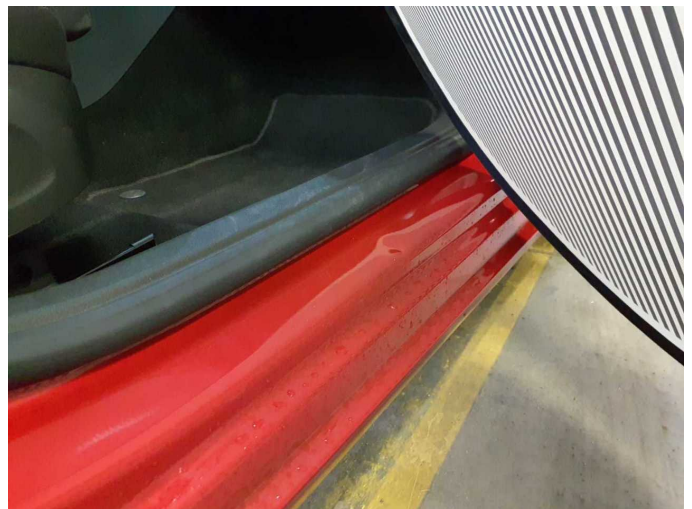
| No. | Component group | Description |
|---|---|---|
| 9 | Sill - right side | Sill - Deformed - Repair and paint |

**Damage 9:** Sill - right side: Sill - Deformed - Repair and paint

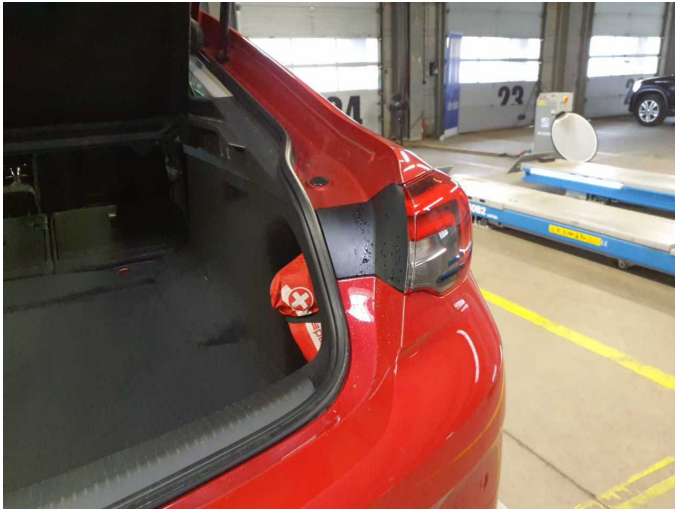
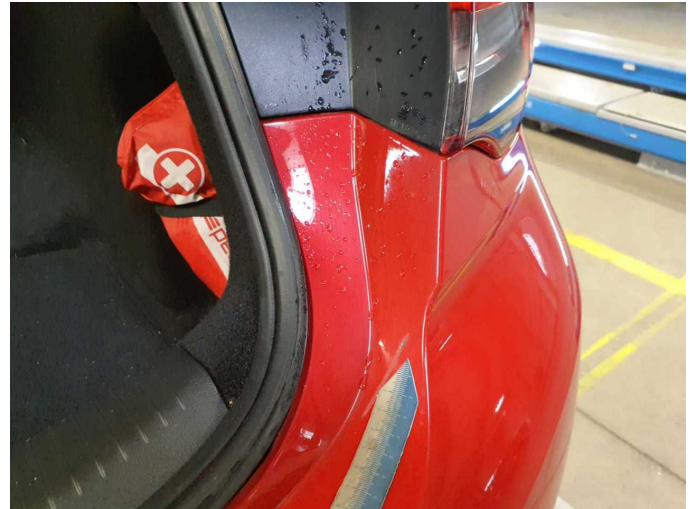
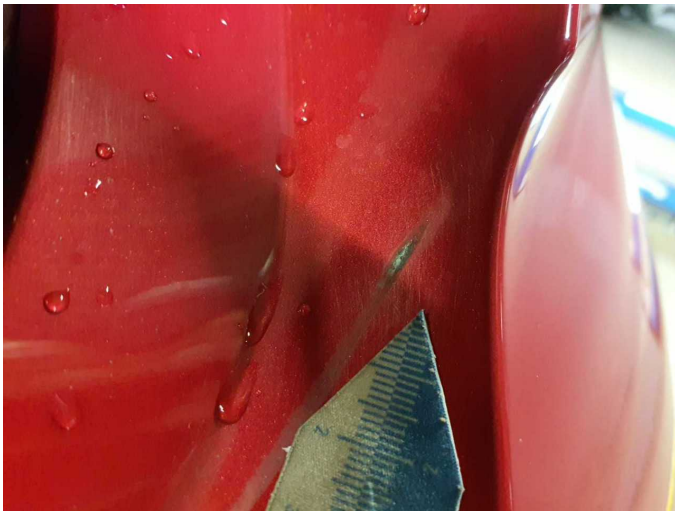
| No. | Component group | Description |
|---|---|---|
| 10 | Rear bumper | Rear bumper - Scratched - Paint |

**Damage 10:** Rear bumper: Rear bumper - Scratched - Paint

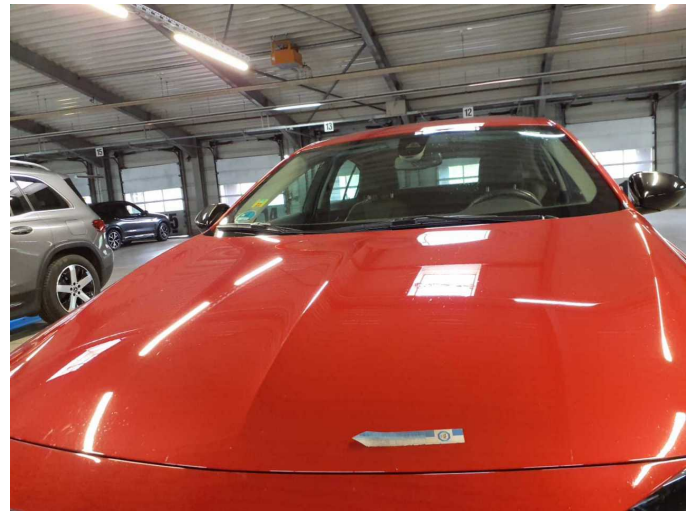
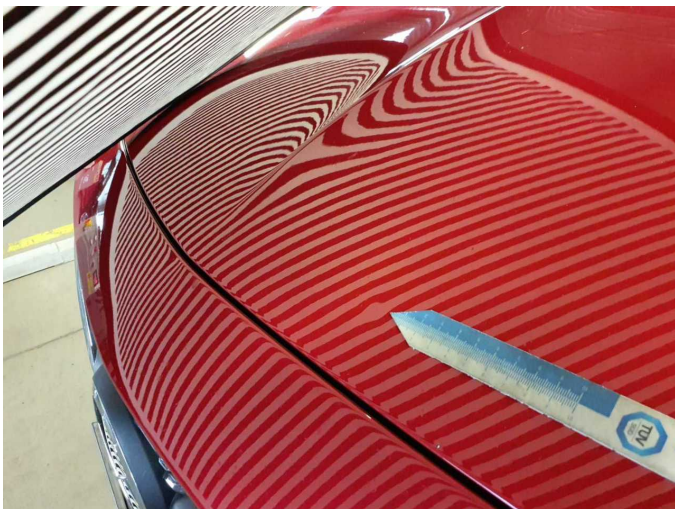
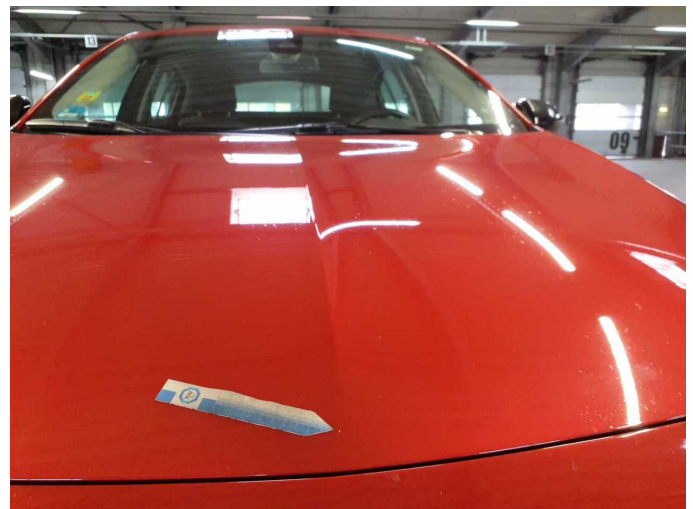
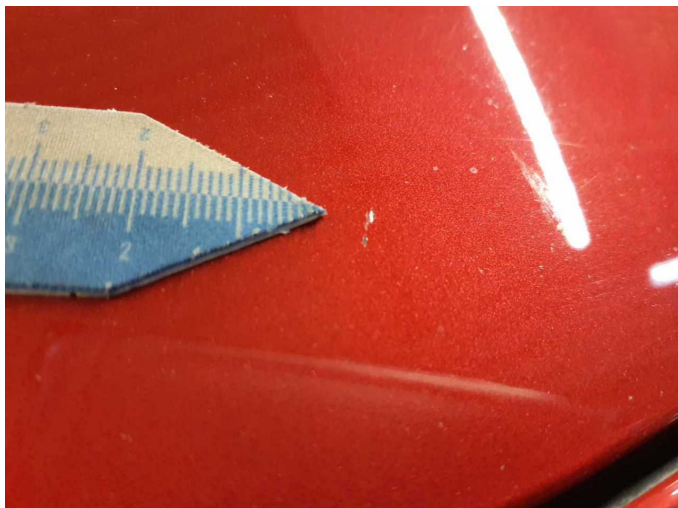
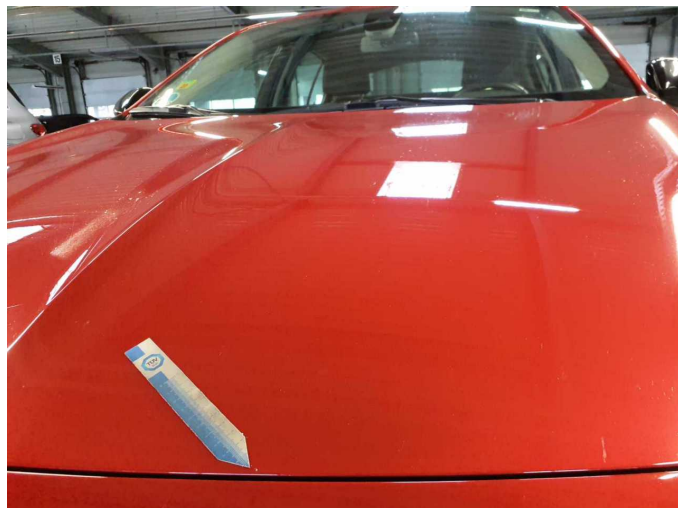
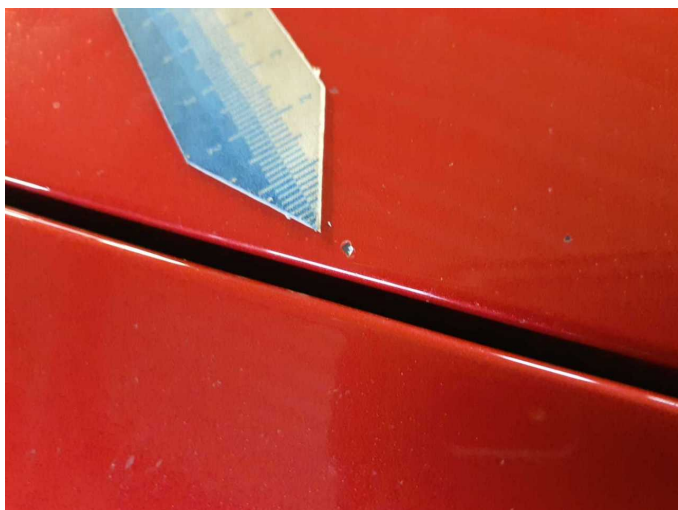
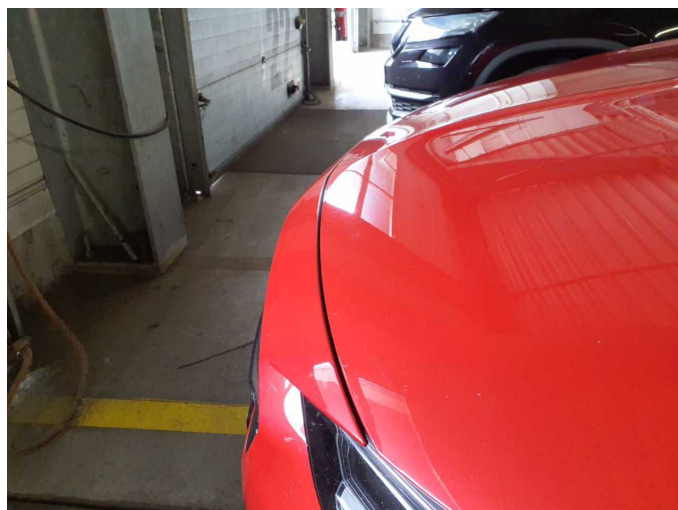
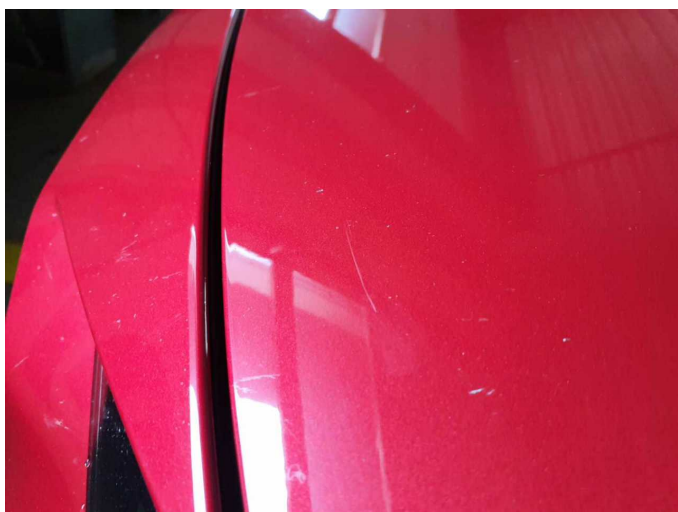
| No. | Component group | Description |
|---|---|---|
| 11 | Bonnet | Bonnet (Kratzer/Steinschlag) - dent(s) - Repair and paint |

**Damage 11:** Bonnet: Bonnet (Kratzer/Steinschlag) - dent(s) - Repair and paint

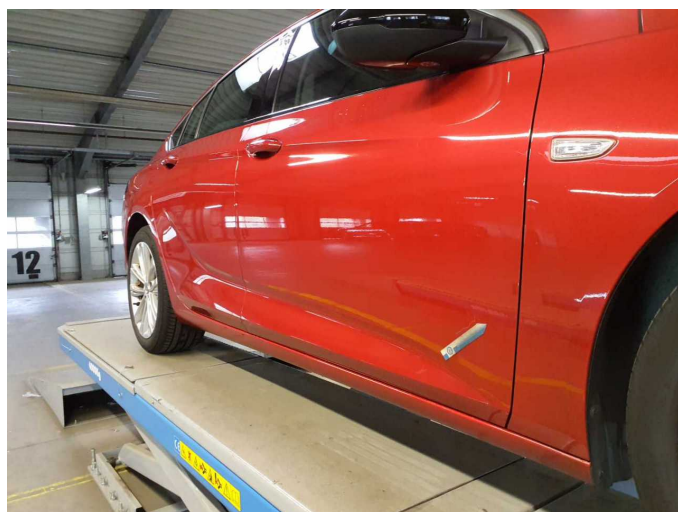
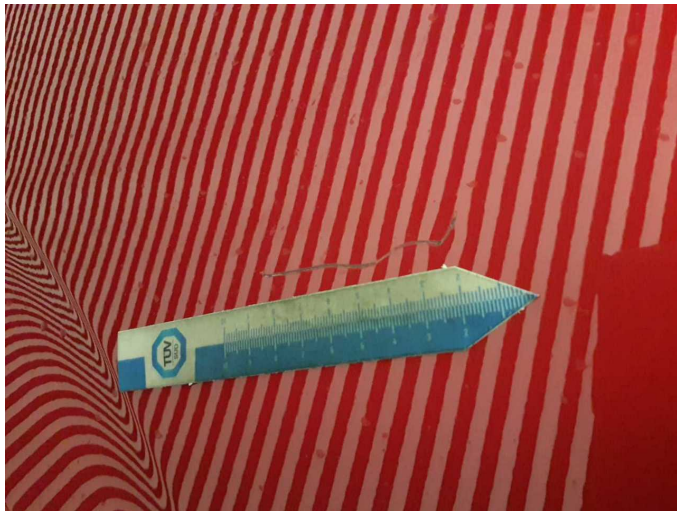
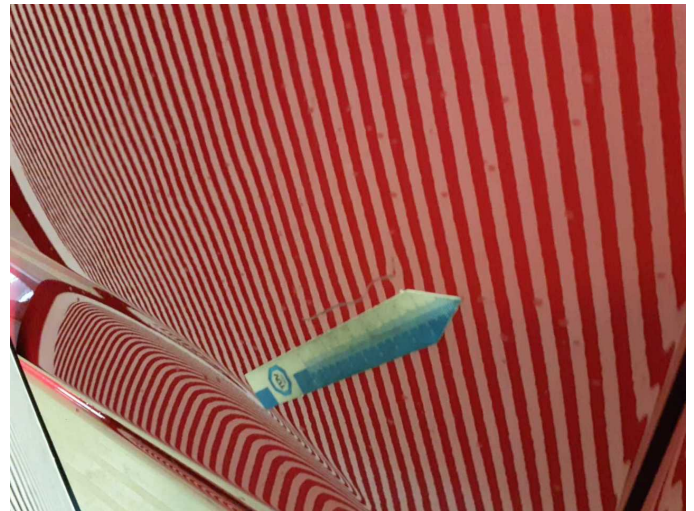
| No. | Component group | Description |
|---|---|---|
| 12 | Door - front right side | Door - Dent / paintcoat damage - Repair and paint |

**Damage 12:** Door - front right side: Door - Dent / paintcoat damage - Repair and paint

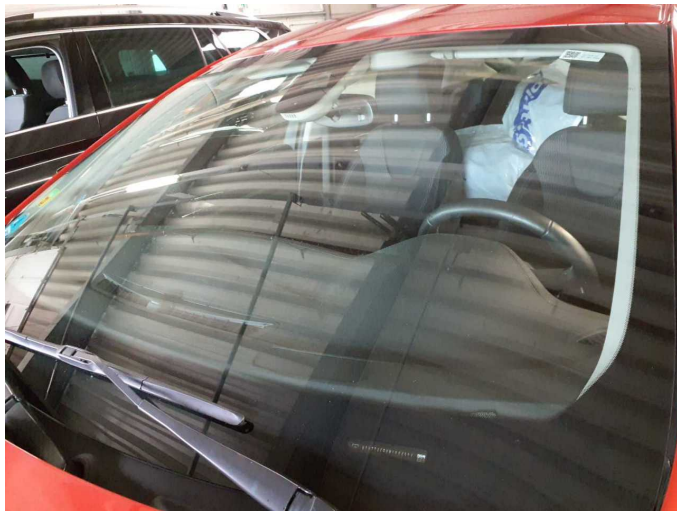
| No. | Component group | Description |
|---|---|---|
| 6 | Vehicle glazing | Windscreen - Stone chips - No deduction |

**Wear and tear 6:** Vehicle glazing: Windscreen - Stone chips - No deduction

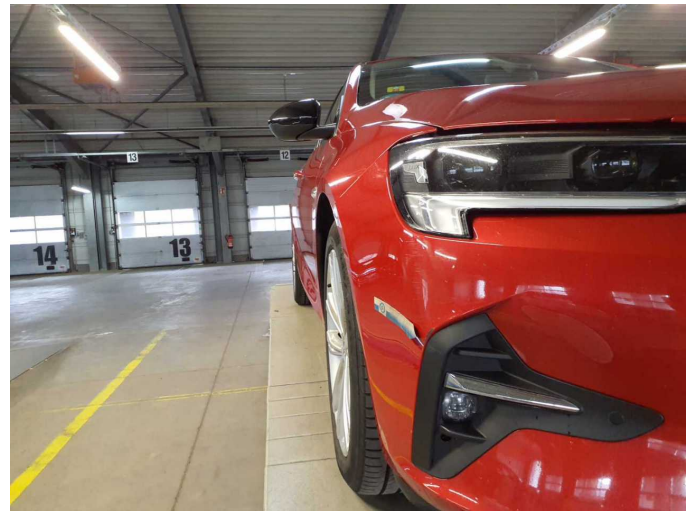
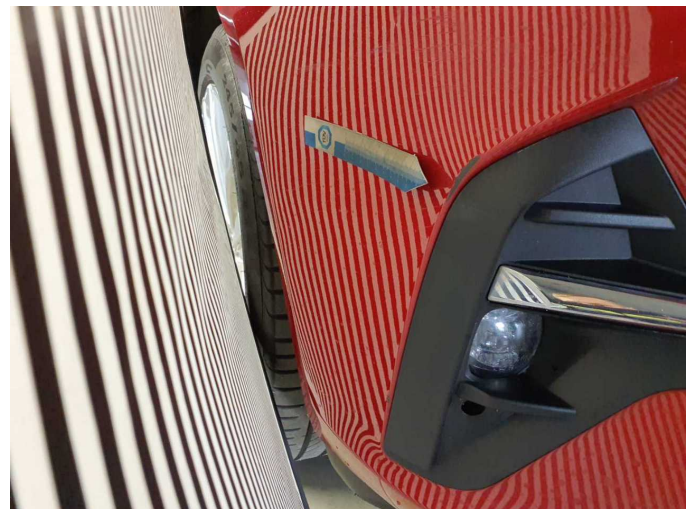
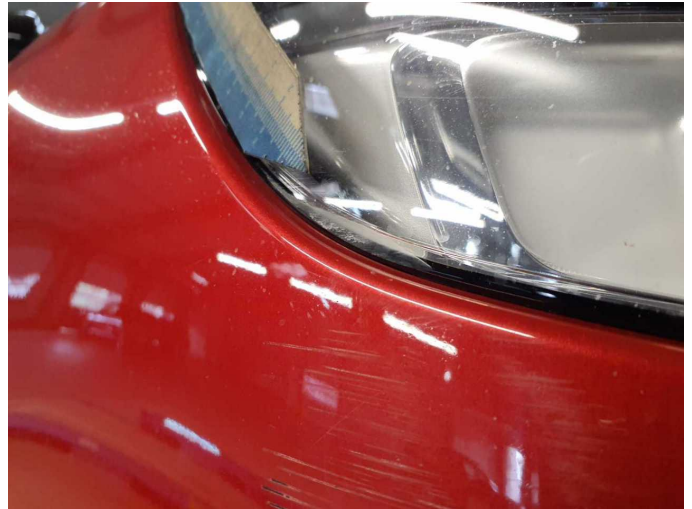
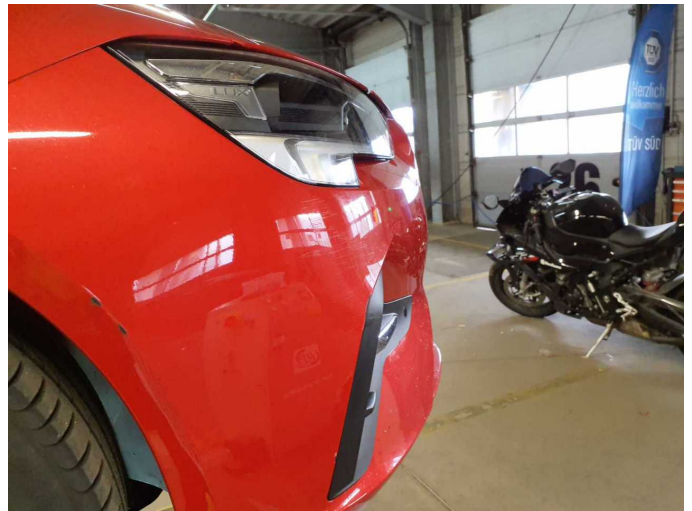
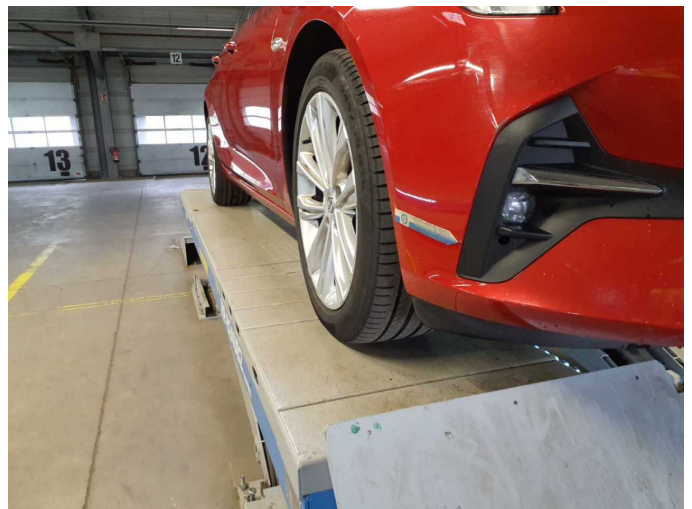
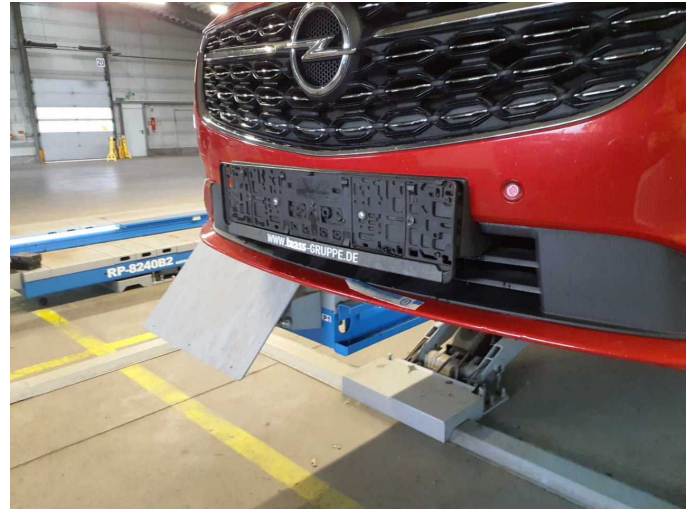
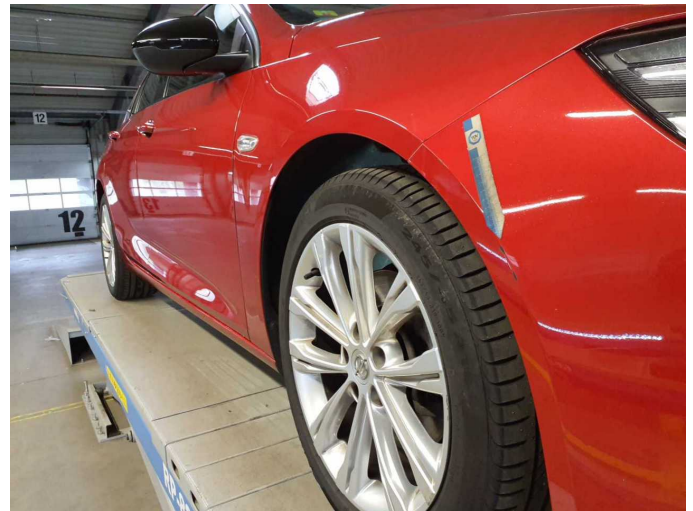
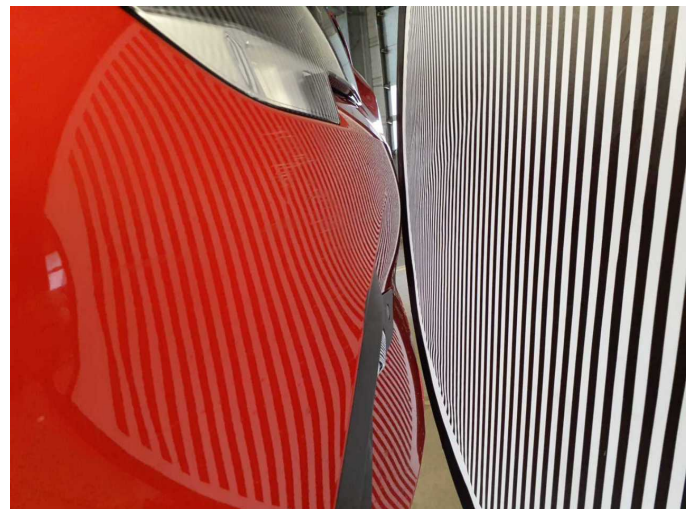
- 1 Front

Non-repaired previous damages were found at the vehicle. The necessary repair costs are listed in the expert report or if necessary, are listed in detail in a separately enclosed repair cost calculation.

Die beigefügte Reparaturkostenkalkulation wurde nach bestem Wissen und Gewissen unter eingeschränkten Besichtigungsbedingung im demontagefreien Zustand erstellt. Es können aufgrund verdeckter Beschädigung erhebliche Mehrkosten und somit Abweichung der für den Unfall ausgewiesenen Reparaturkosten nicht ausgeschlossen werden.

**Accident 1:** Front

**Accident 1: Front**
