Expertise

Protocol number: 41378971  
Order No. / Reference: 25193247  
Inspection date: 4 Sept 2025

| Manufacturer: Opel | Model: Insignia Grand Sport 2.0 Diesel Automatik Business Elegance |

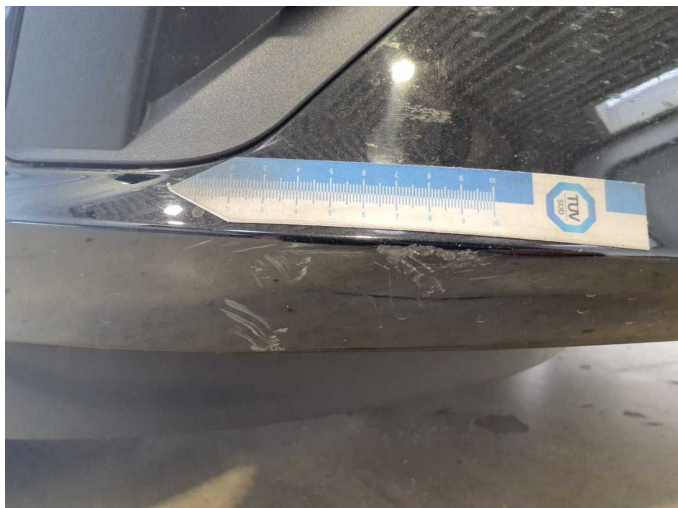
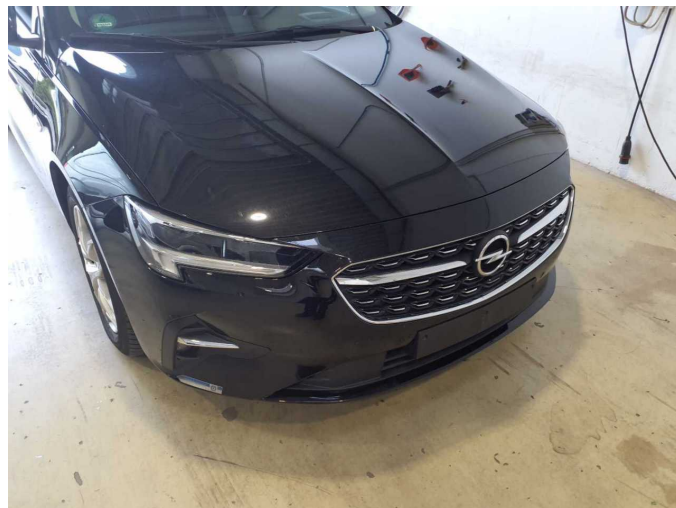
| No. | Component group | Description |
|---|---|---|
| 1 | Front bumper | Front bumper - Scratch(es) - Smart repair |

**Damage 1:** Front bumper: Front bumper - Scratch(es) - Smart repair

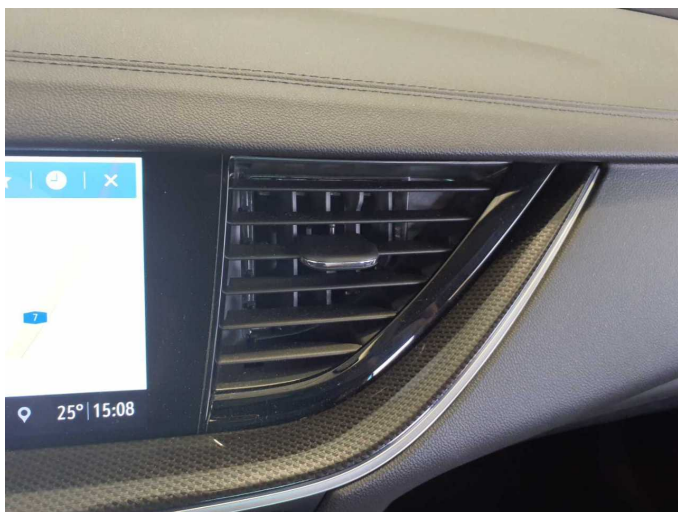
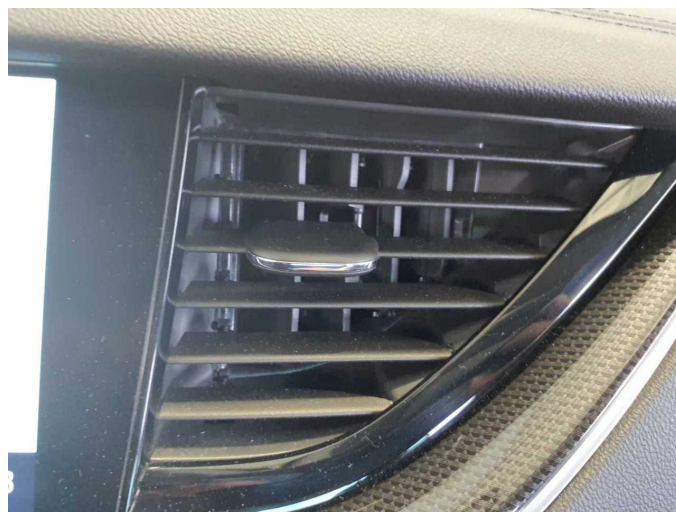
| No. | Component group | Description |
|---|---|---|
| 2 | Instrument panel | Air nozzle - centre - Damaged - Replace |

**Damage 2:** Instrument panel: Air nozzle - centre - Damaged - Replace

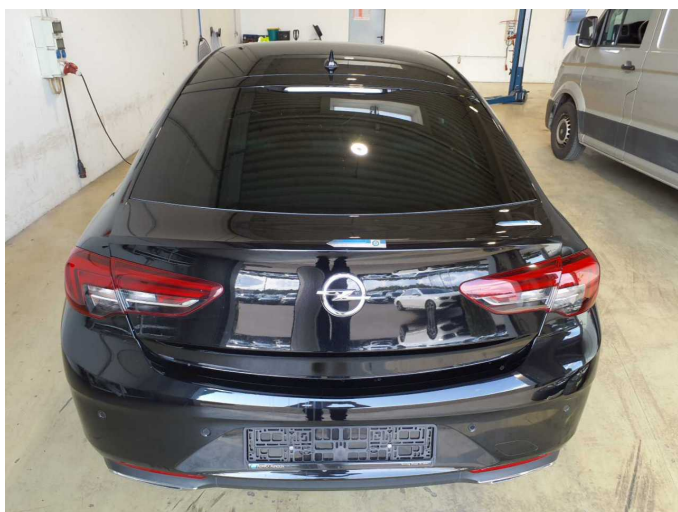
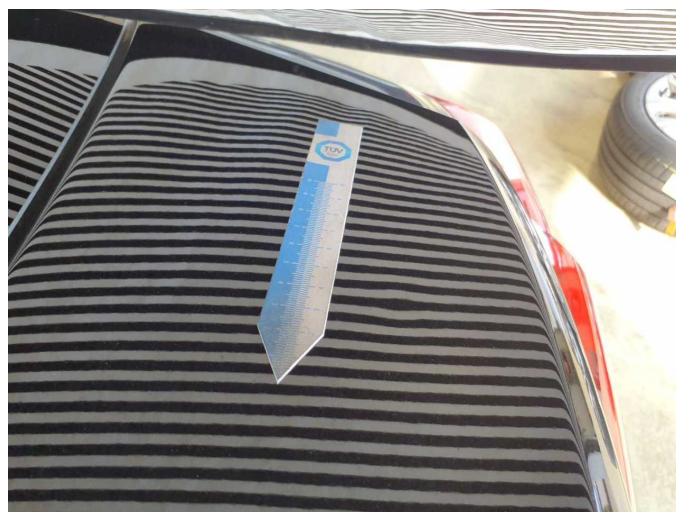
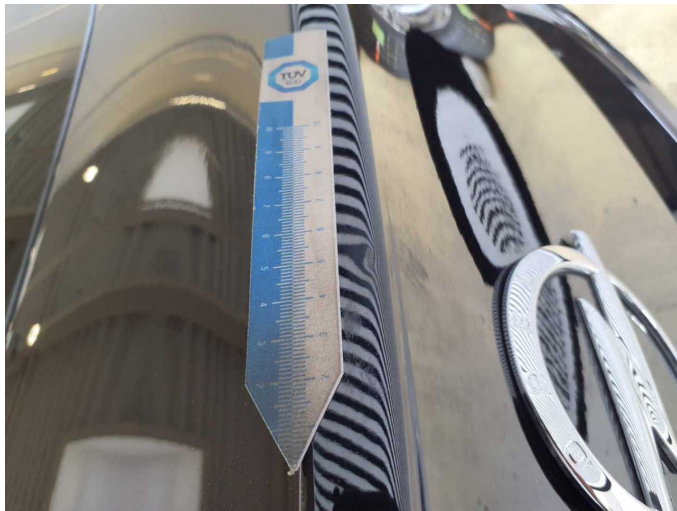
| No. | Component group | Description |
|---|---|---|
| 3 | Boot lid / rear door | Boot lid - dent(s) - Smart repair |

**Damage 3:** Boot lid / rear door: Boot lid - dent(s) - Smart repair

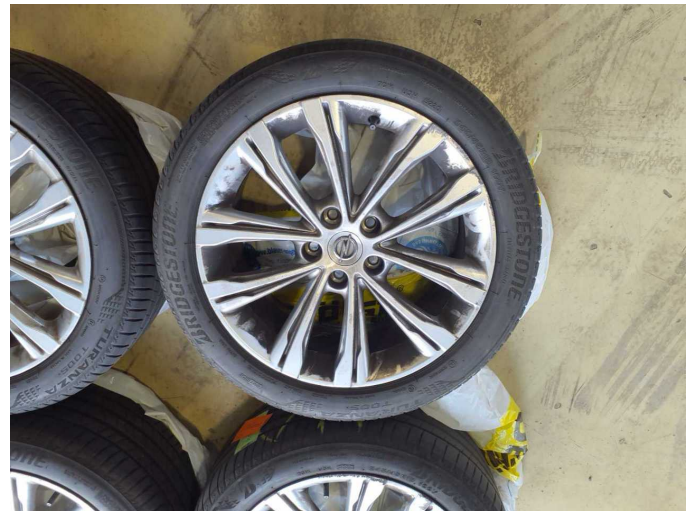
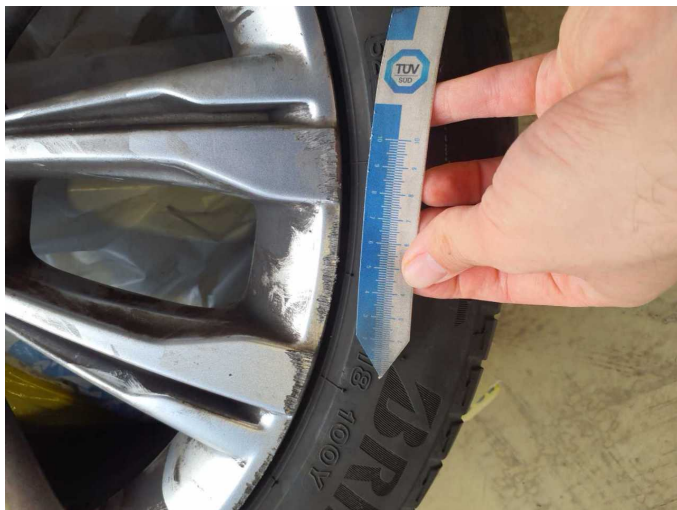
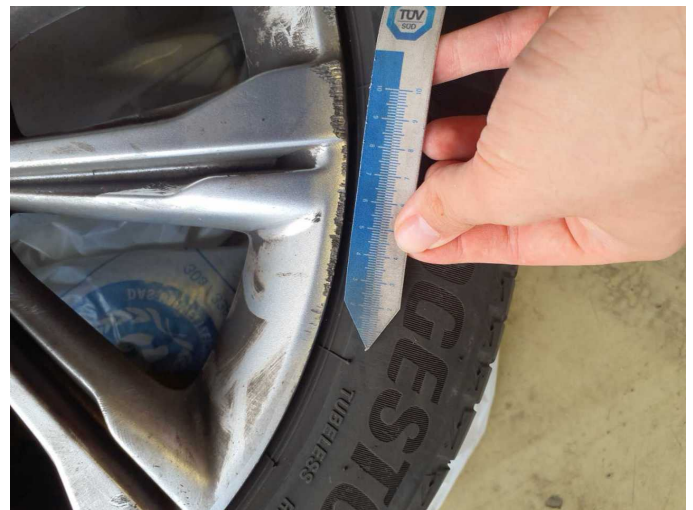
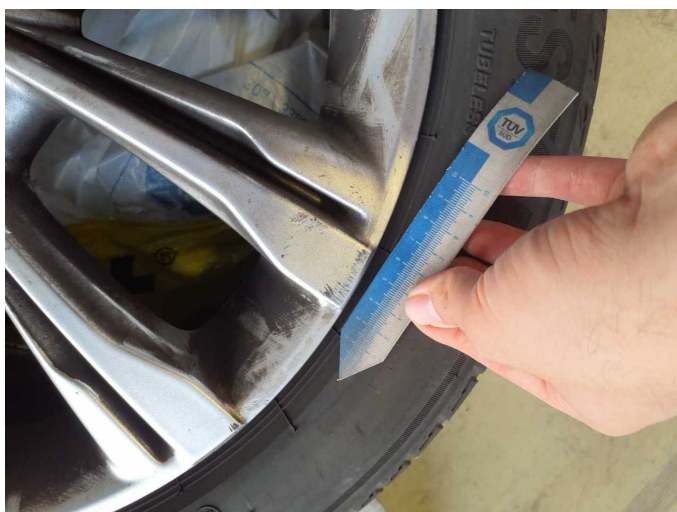
| No. | Component group | Description |
|---|---|---|
| 4 | 2nd wheel set | 1 alloy rim (Materialabtrag) - Scratched - Replace |

**Damage 4:** 2nd wheel set: 1 alloy rim (Materialabtrag) - Scratched - Replace

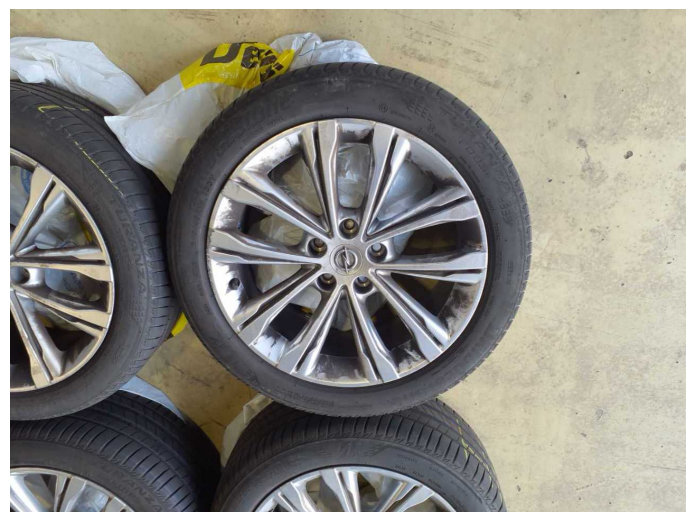
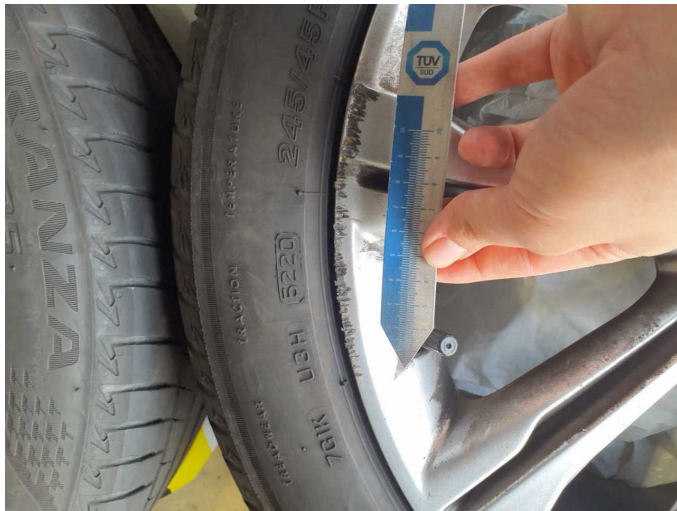
| No. | Component group | Description |
|---|---|---|
| 5 | 2nd wheel set | 1 alloy rim (Materialabtrag) - Scratched - Replace |

**Damage 5:** 2nd wheel set: 1 alloy rim (Materialabtrag) - Scratched - Replace

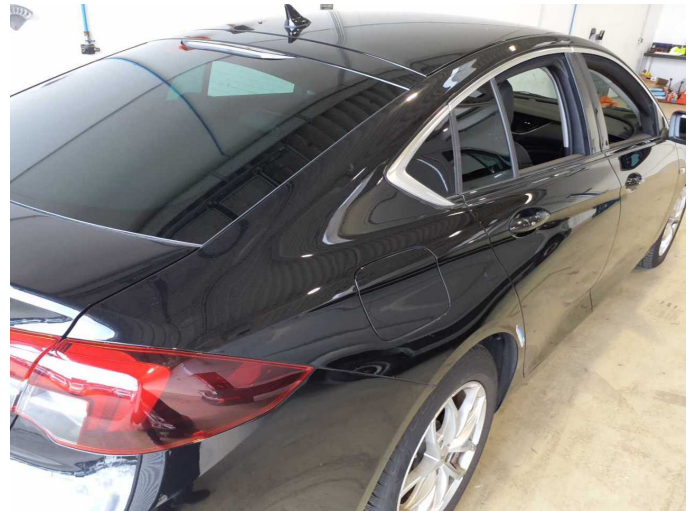
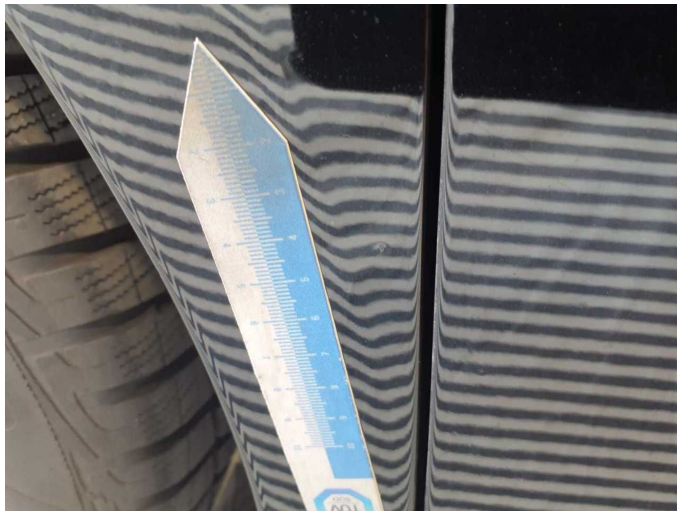
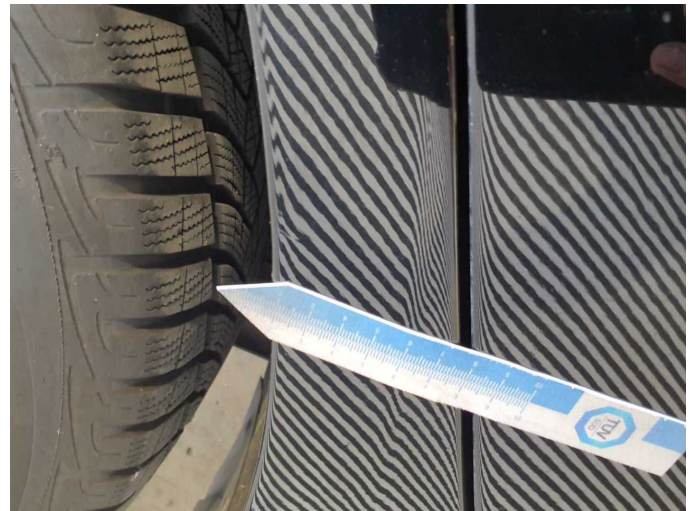
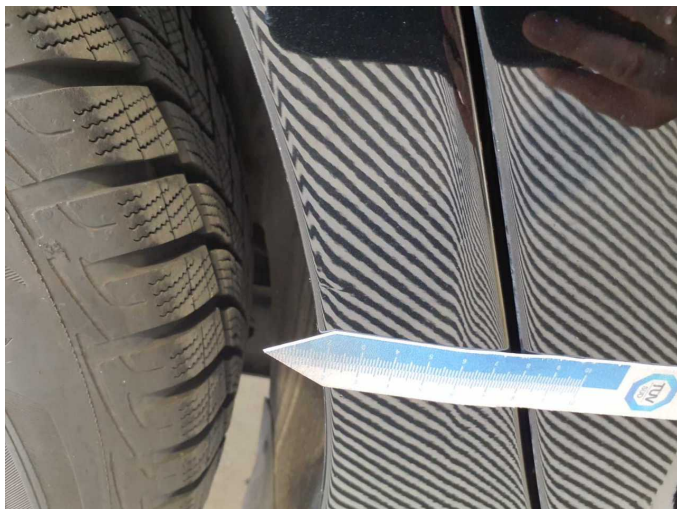
| No. | Component group | Description |
|---|---|---|
| 6 | Side panel - rear right side | Side panel (Staubkorn und wellig) - Unprofessionally repaired - Paint |

| No. | Repainting |
|---|---|
| 2 | Side panel - rear right side, Unprofessionally carried out, Invoice of repair done Non-existent |

| Mudguard - right side | 159 µm | Side panel - rear right side | 1,510 µm |

**Damage 6:** Side panel - rear right side: Side panel (Staubkorn und wellig) - Unprofessionally repaired - Paint

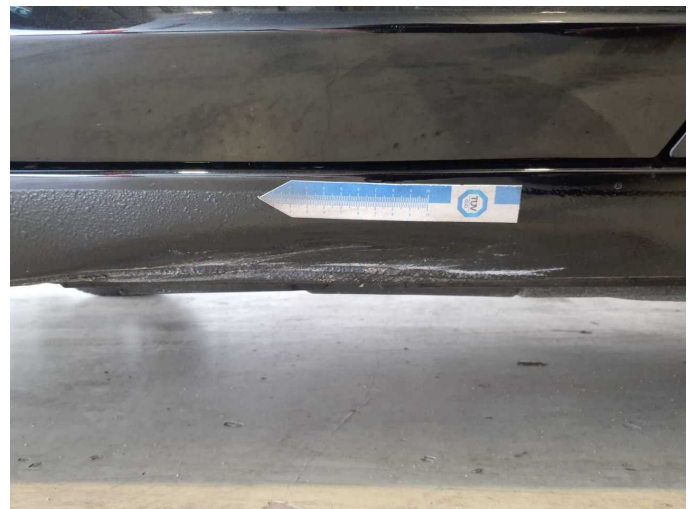
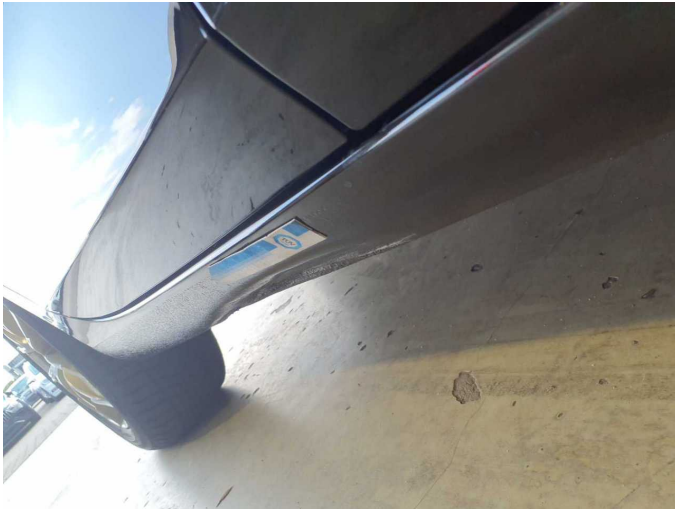
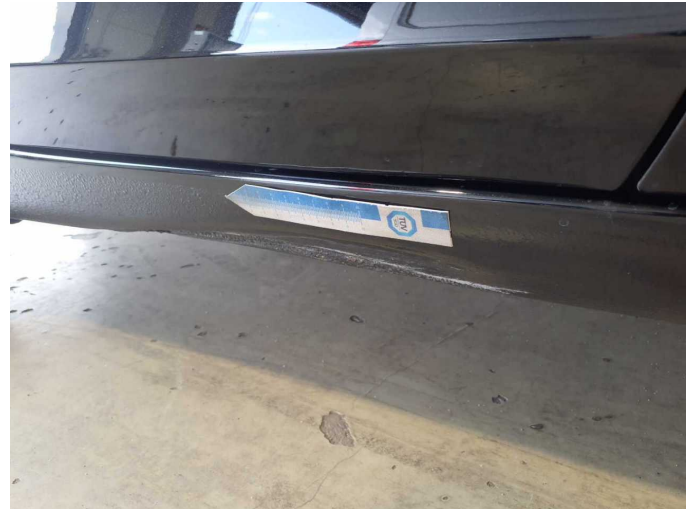
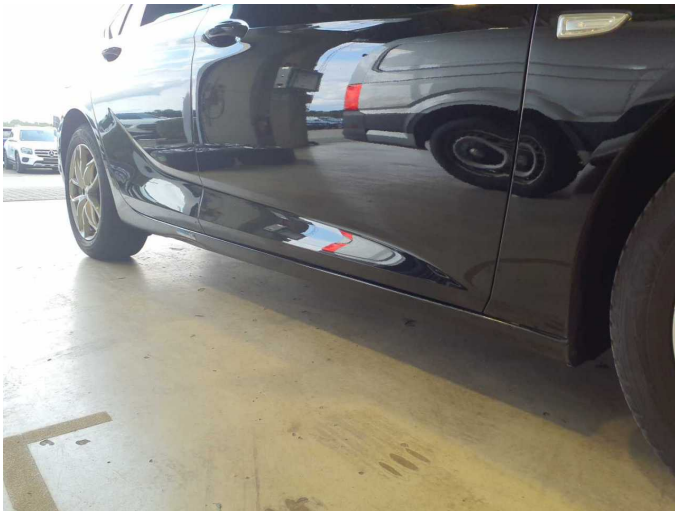
| No. | Component group | Description |
|---|---|---|
| 7 | Sill - right side | Sill - Deformed - Repair and paint |

**Damage 7:** Sill - right side: Sill - Deformed - Repair and paint

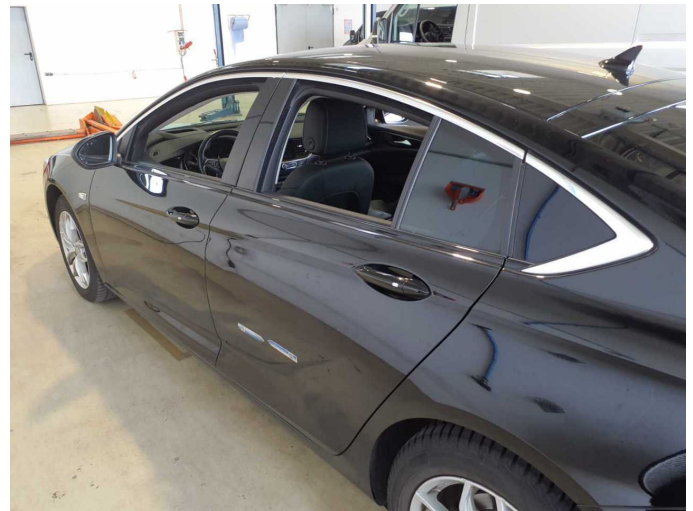
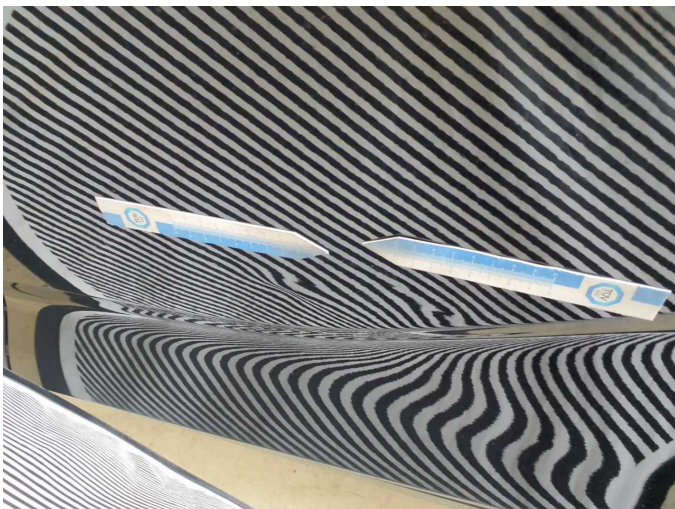
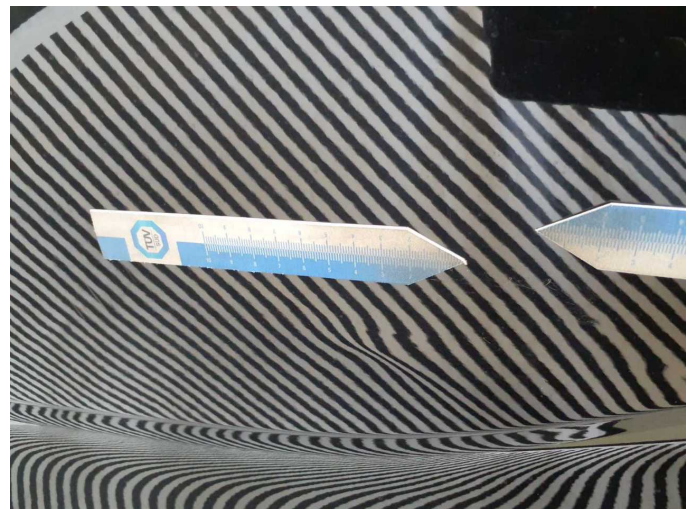
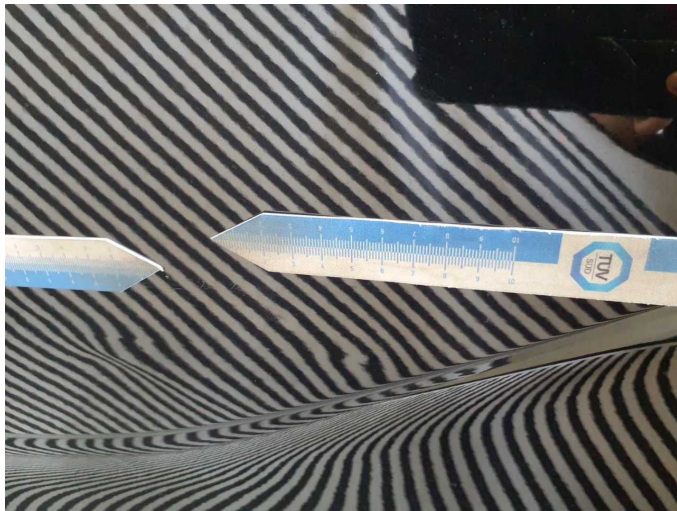
| No. | Component group | Description |
|---|---|---|
| 8 | Door - rear left side | Door - Deformed - Repair and paint |

**Damage 8:** Door - rear left side: Door - Deformed - Repair and paint

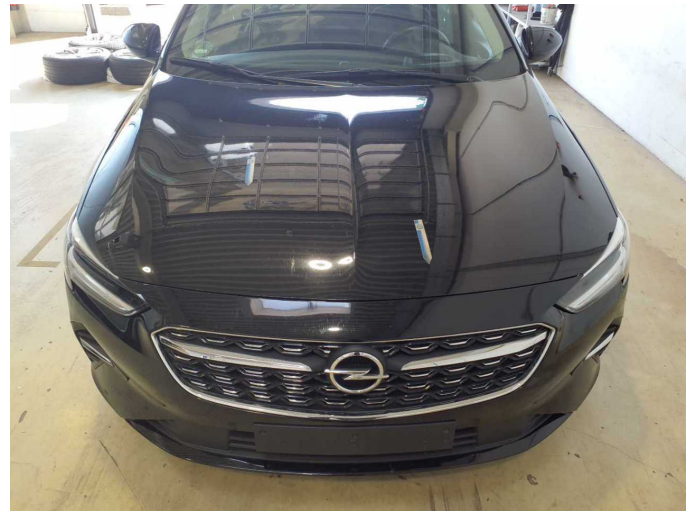
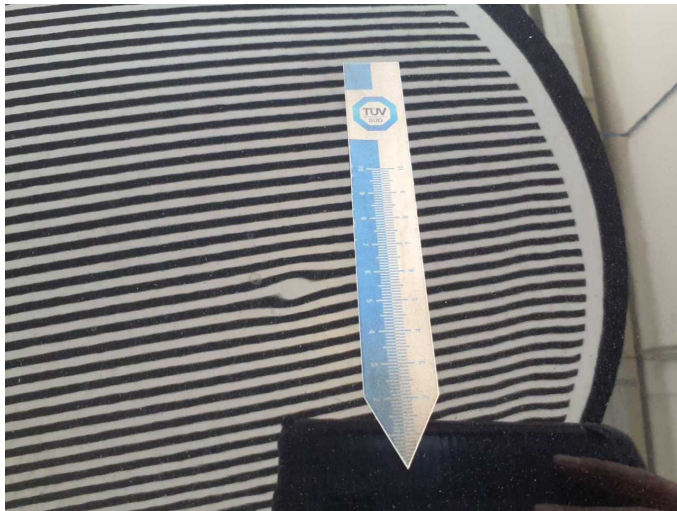
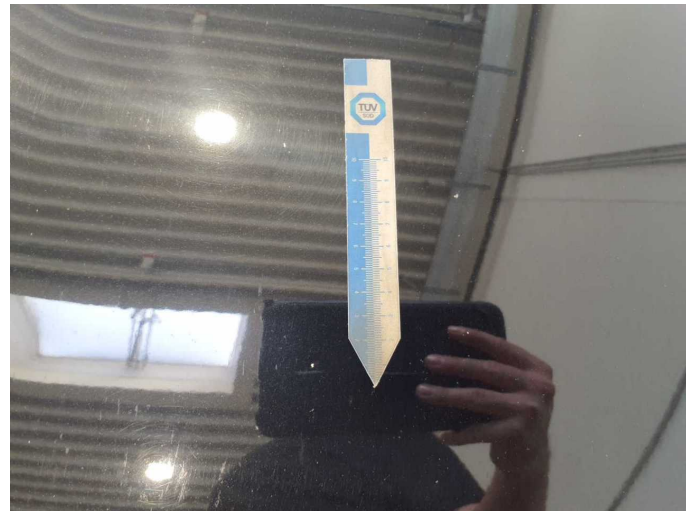
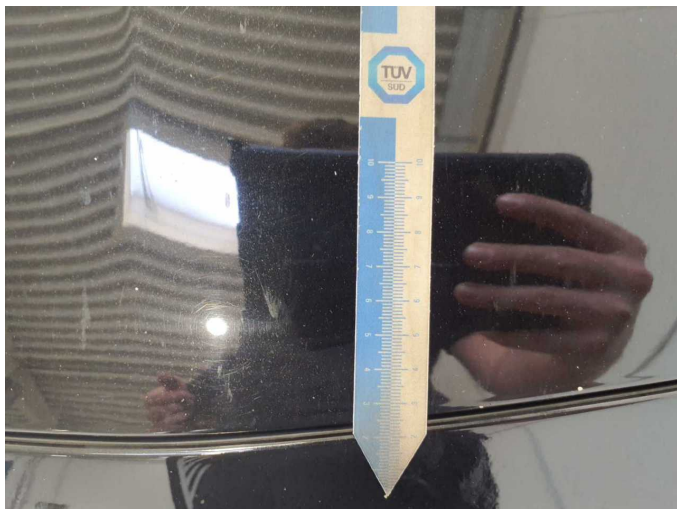
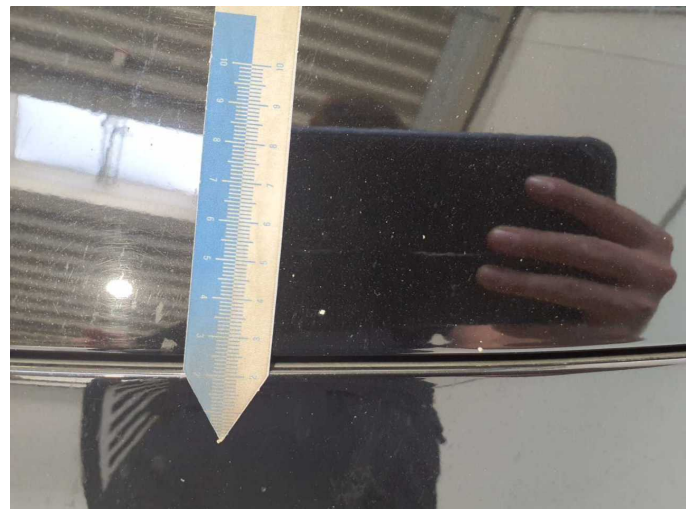
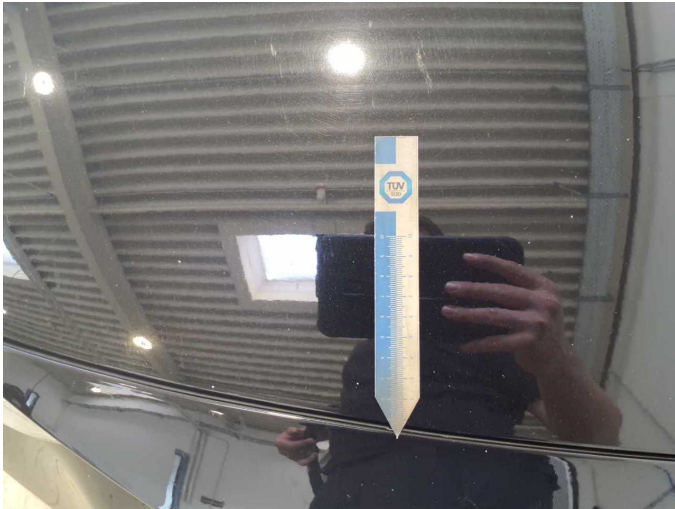
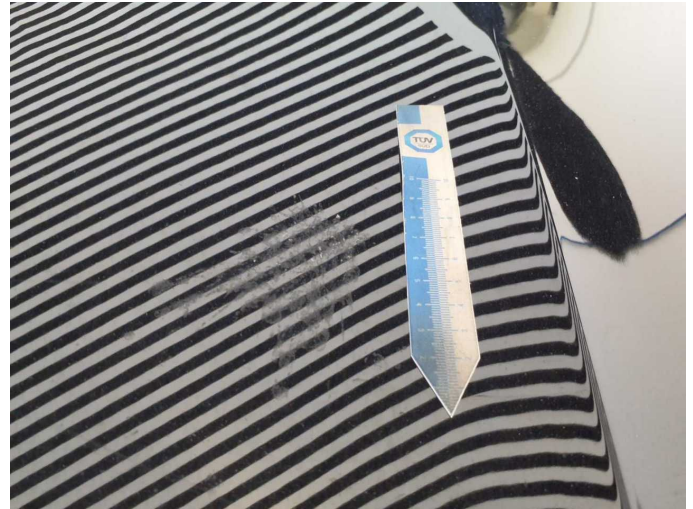
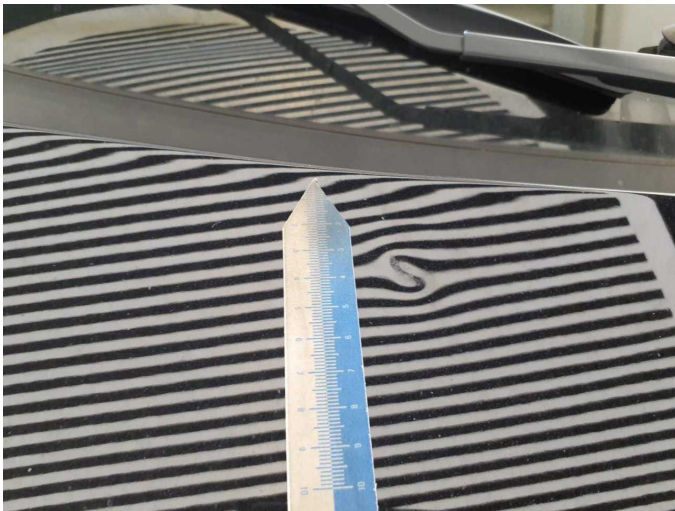
| No. | Component group | Description |
|---|---|---|
| 9 | Bonnet | Bonnet (Anätzung+Dellen/Steinschläge) - Paint defect - Repair and paint |

**Damage 9:** Bonnet: Bonnet (Anätzung+Dellen/Steinschläge) - Paint defect - Repair and paint

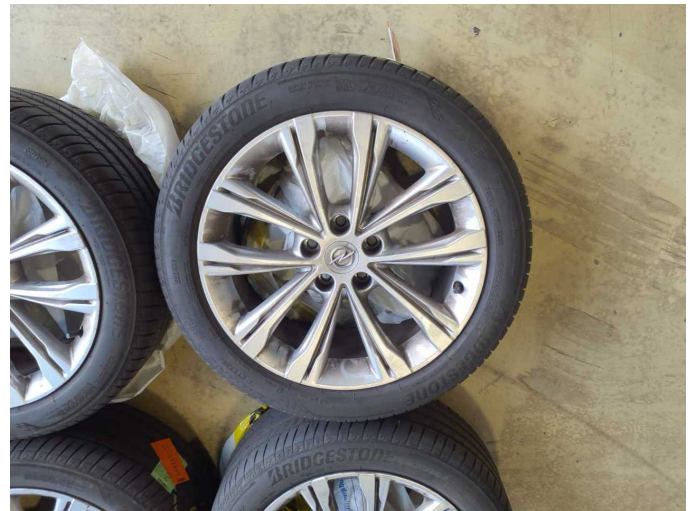
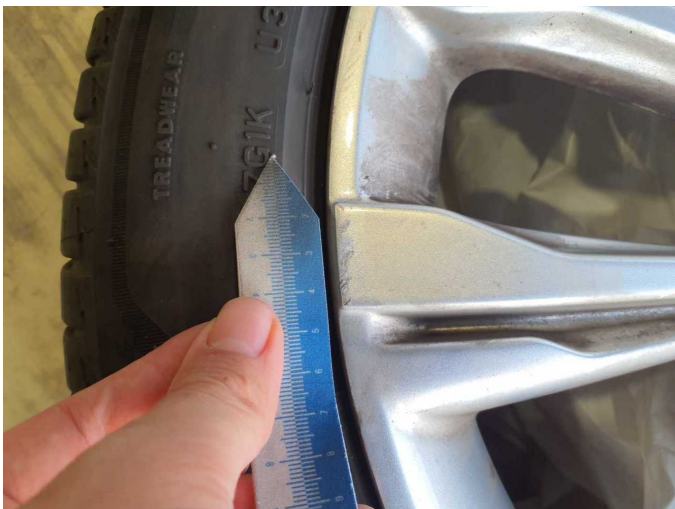
| No. | Component group | Description |
|---|---|---|
| 5 | 2nd wheel set | 1 alloy rim - Scratch(es) - No deduction |

**Wear and tear 5:** 2nd wheel set: 1 alloy rim - Scratch(es) - No deduction

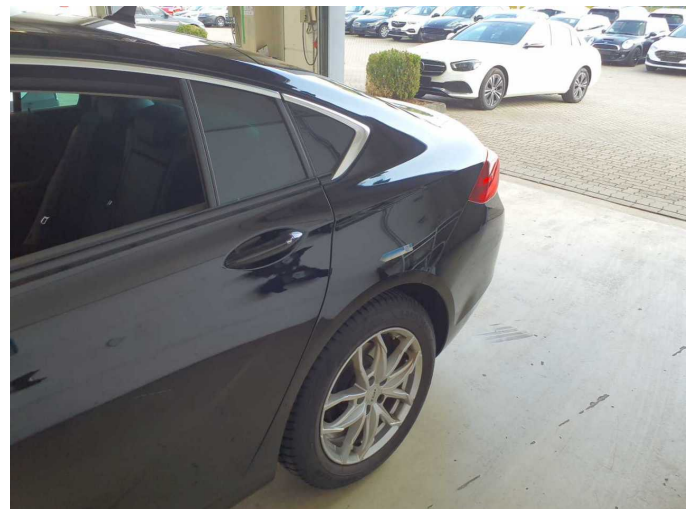
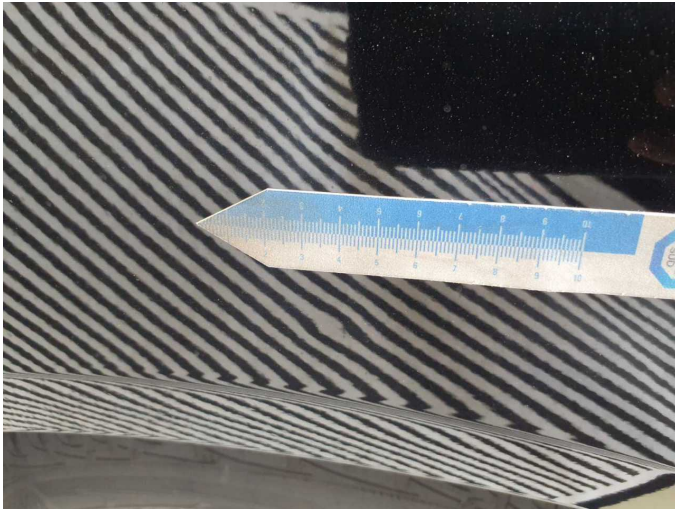
| No. | Component group | Description |
|---|---|---|
| 6 | Side panel - rear left side | Side panel - dent(s) - No deduction |

**Wear and tear 6:** Side panel - rear left side: Side panel - dent(s) - No deduction

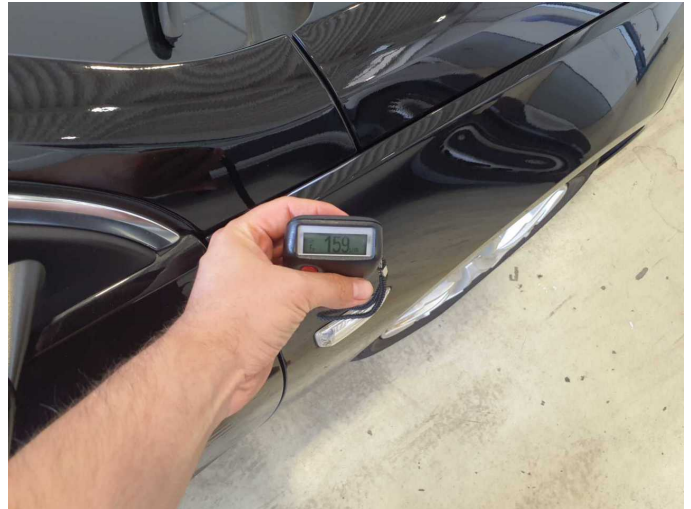
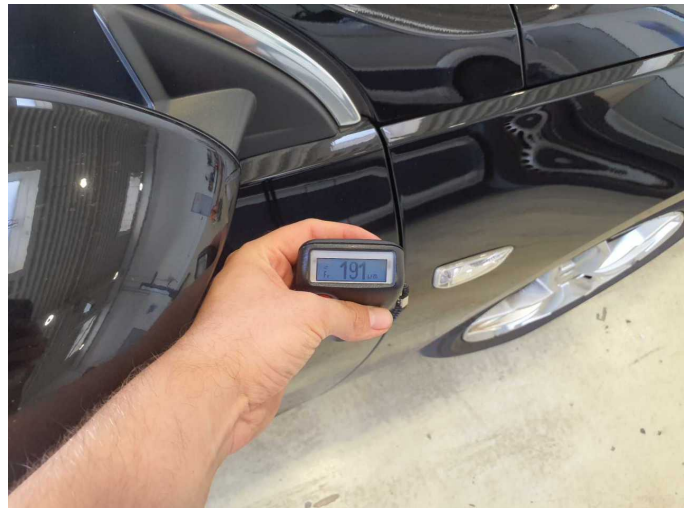
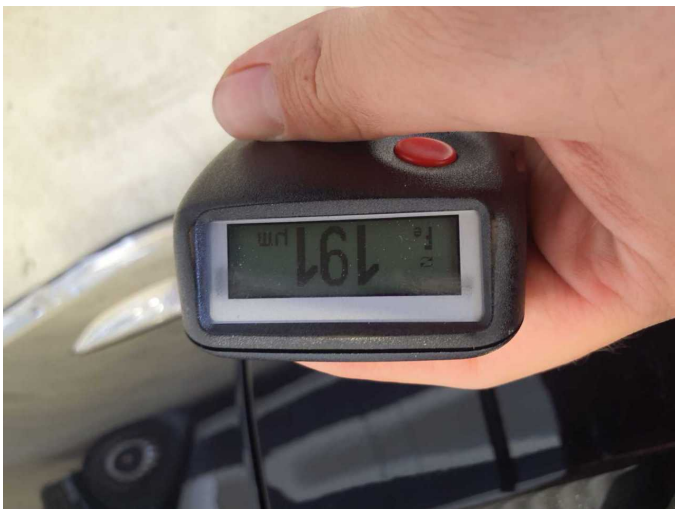
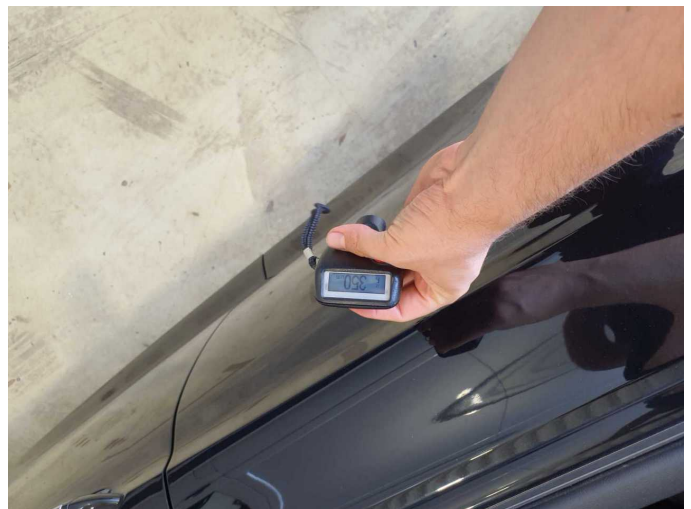
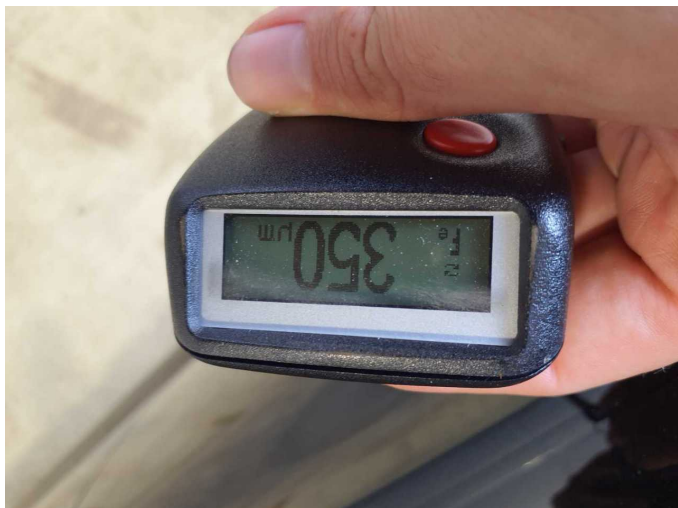
| No. | Repainting |
|---|---|
| 1 | Mudguard - right side, Door - rear right side, Door - front right side, Professionally carried out, Invoice of repair done Non-existent |

**Repainting 1:** Mudguard - right side, Door - rear right side, Door - front right side

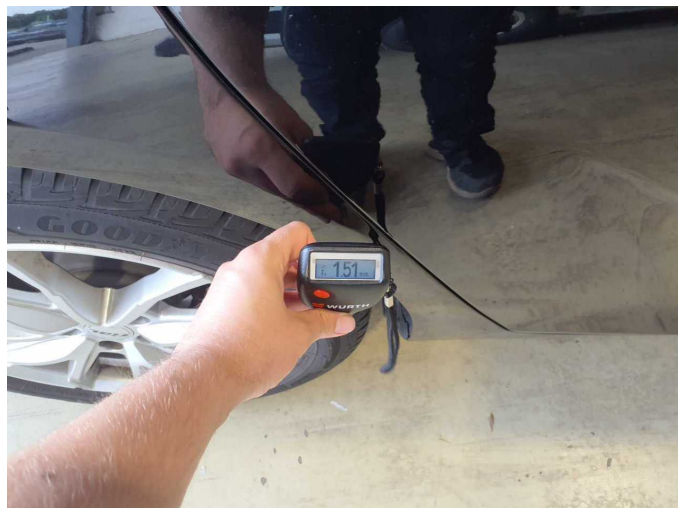
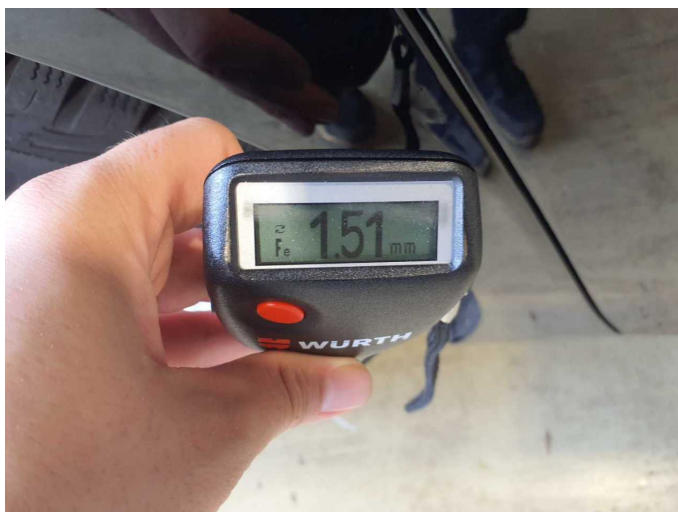
**Repainting 2:** Side panel - rear right side
