## status report

#### Opel Insignia B Sports Tourer Ultimate

| Vehicle identification number | <b>W0VZT8EF5L1026639</b> | mileage read: | <b>44017 km</b> |
| First Registration / construction year: | <b>30.06.2020 / 2019</b> | Visit Date / place of birth: | <b>17.02.2025 Heidenheim</b> |

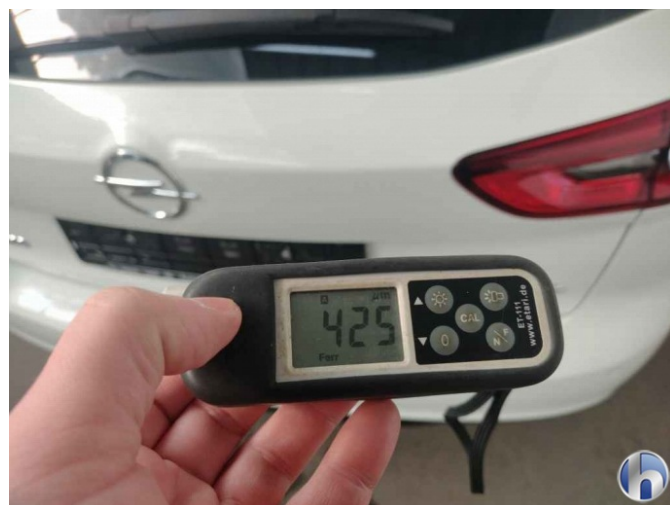
| component | Damage | Rep kind |
|---|---|---|
| 1. tailgate | Subsequently painted | acceptable |

Subsequently painted

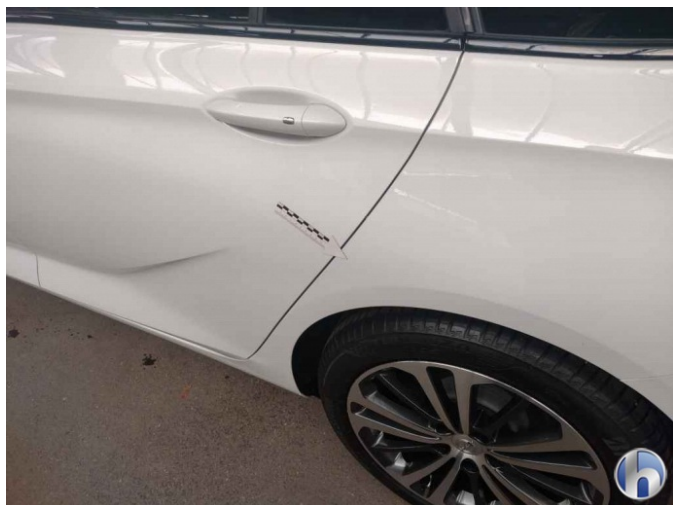
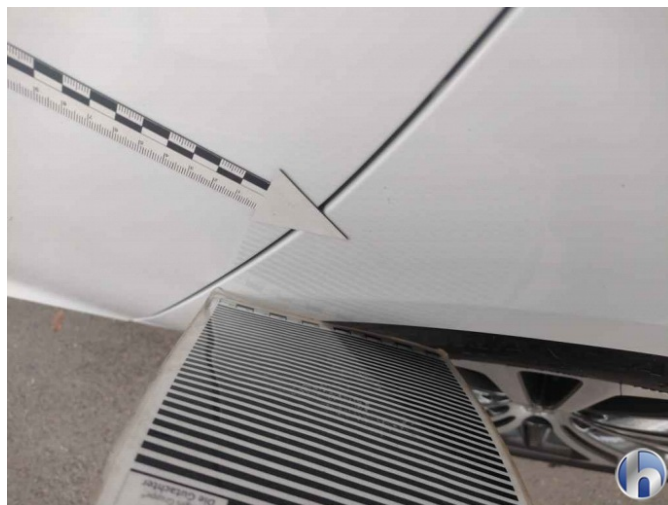
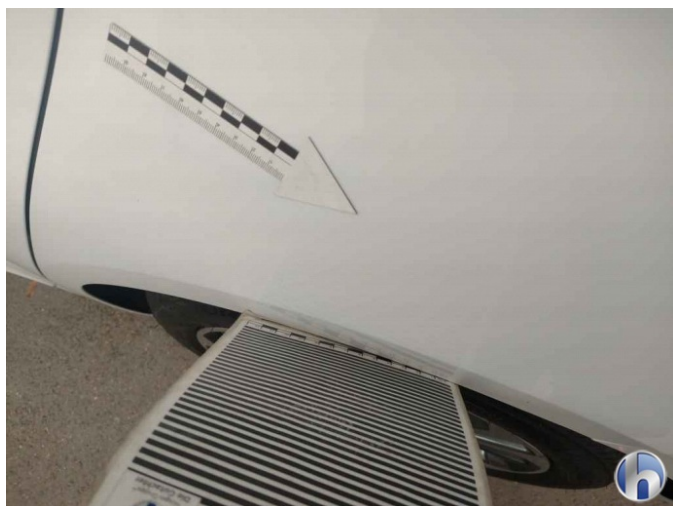
| component | Damage | Rep kind |
|---|---|---|
| 2. Sidewall - Rear - Left | | Smart repair |

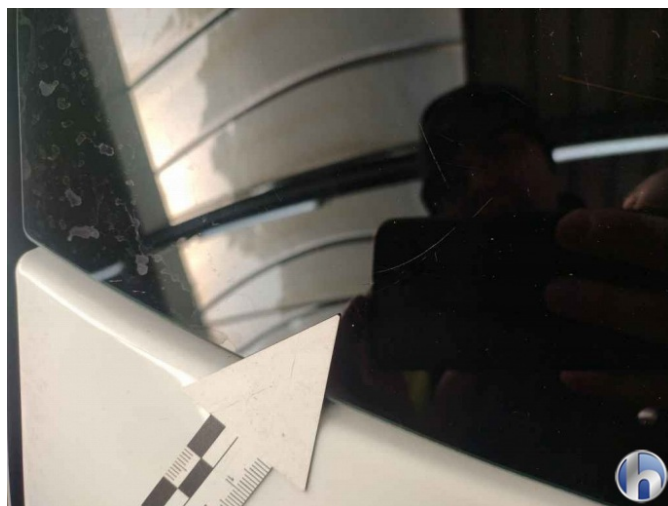
| component | Damage | Rep kind |
|---|---|---|
| 3. rear window | Scratch(es) | Replace |

**Scratch(es)**
