## status report

#### Opel Insignia B Sports Tourer Business Elegance

| Vehicle identification number | <b>W0VZT8EN5M1009834</b> | mileage read: | <b>91350 km</b> |

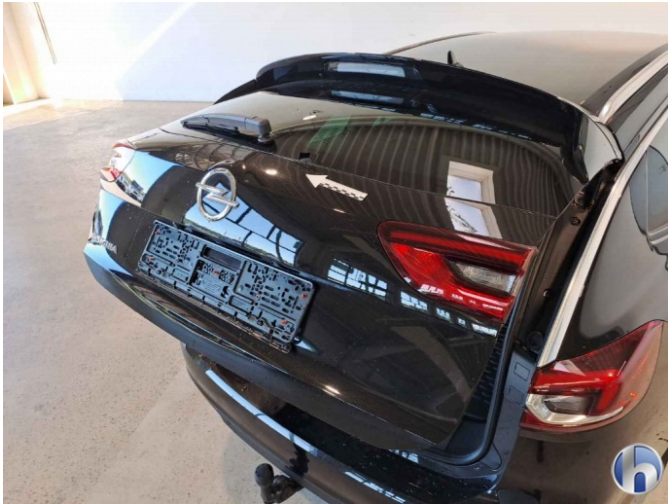
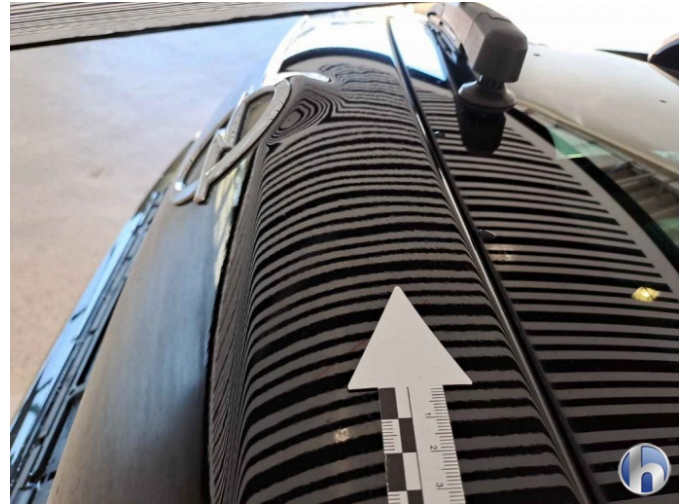
| component | Damage | Rep kind |
|---|---|---|
| 1. tailgate | Deformed (slightly) | Refurbish and paint |

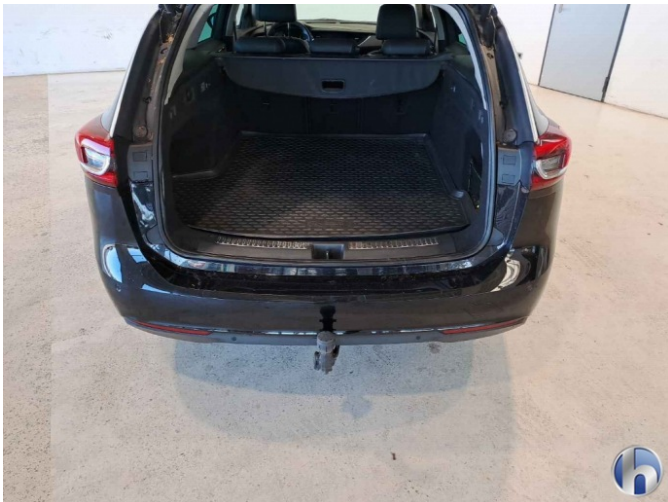
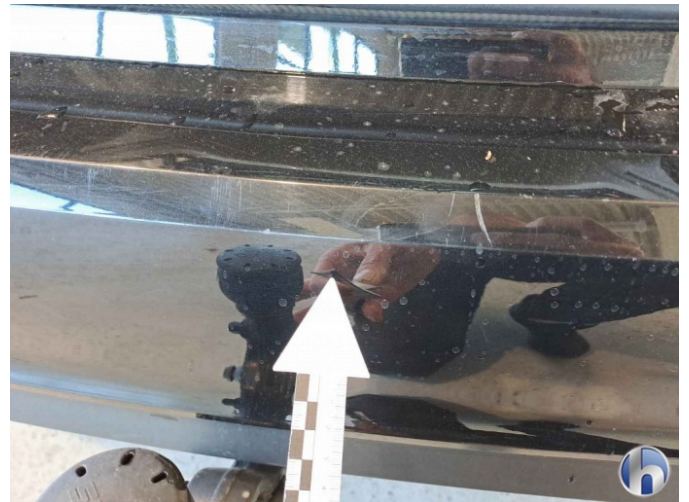
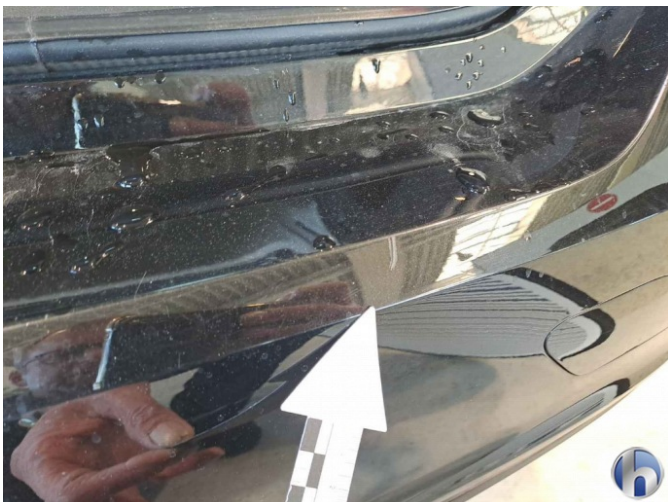
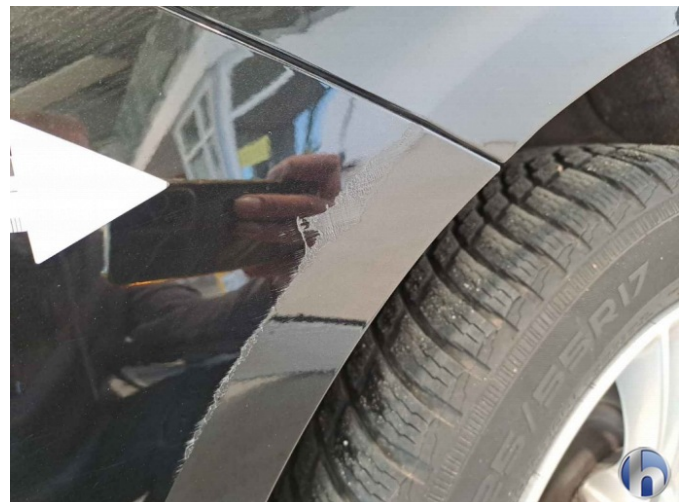
| component | Damage | Rep kind |
|---|---|---|
| 2. Rear bumper | Scrape | Paint |

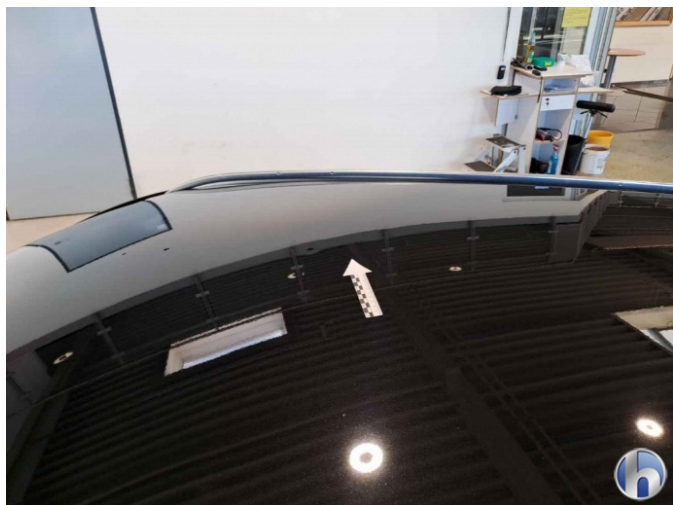
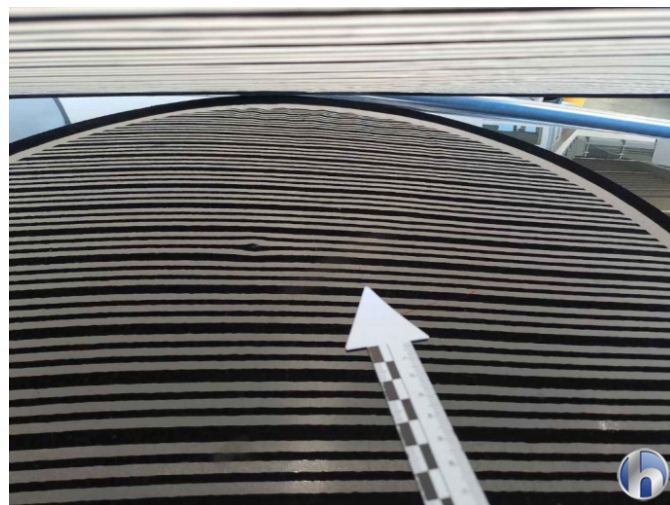
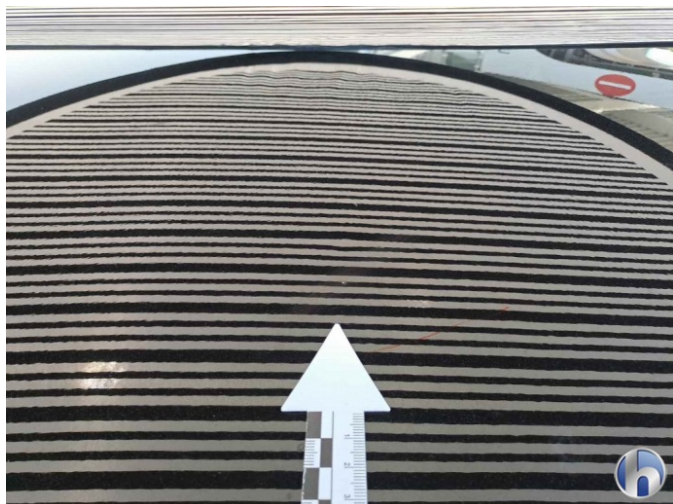
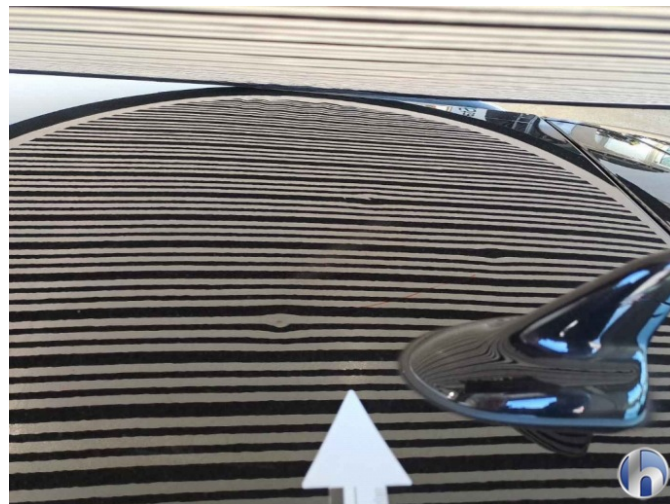
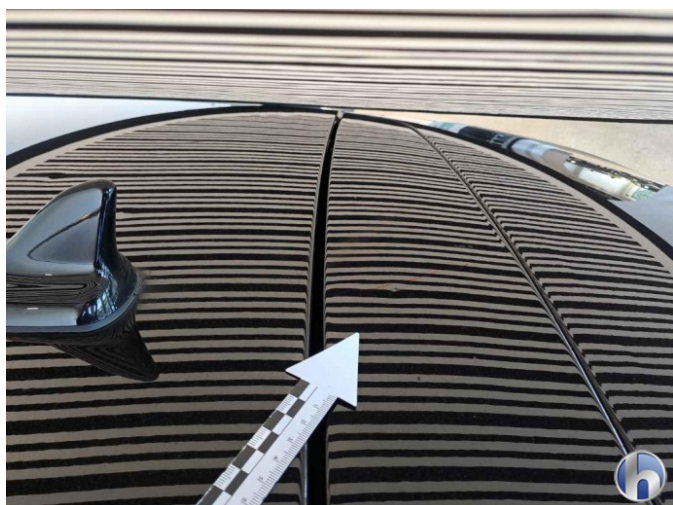
| component | Damage | Rep kind |
|---|---|---|
| 3. roof | Dented | Smart repair |

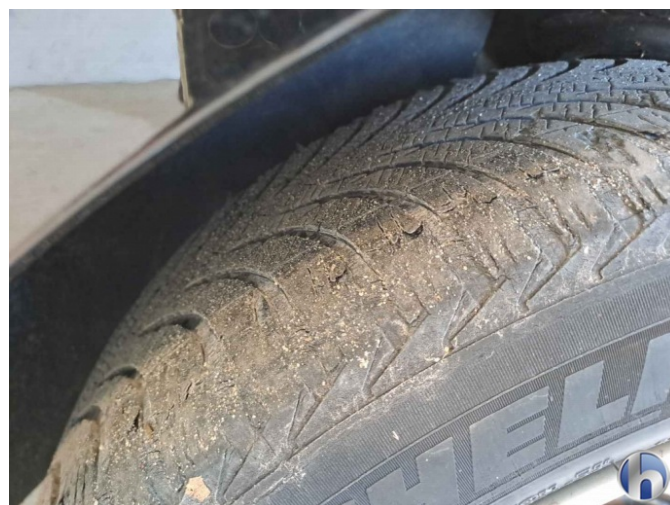
| General examination | |
|---|---|
| <b>Note Road Safe:</b> | Reifen VA verschlissen |

| component | Damage | Rep kind |
|---|---|---|
| 4. | Worn | Replace |

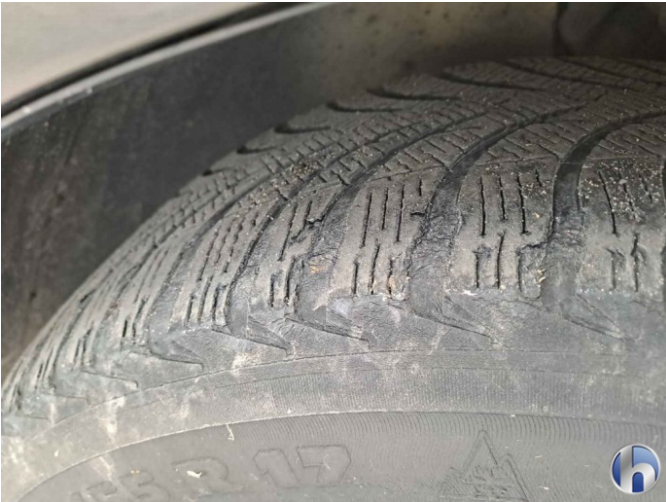
| component | Damage | Rep kind |
|---|---|---|
| 5. | Worn | Replace |

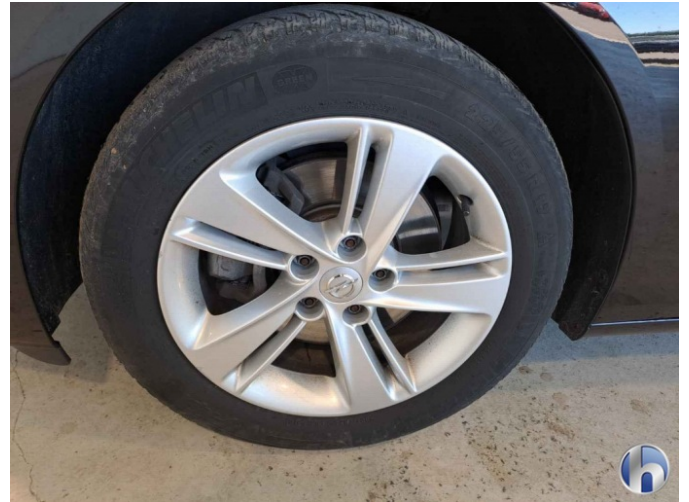
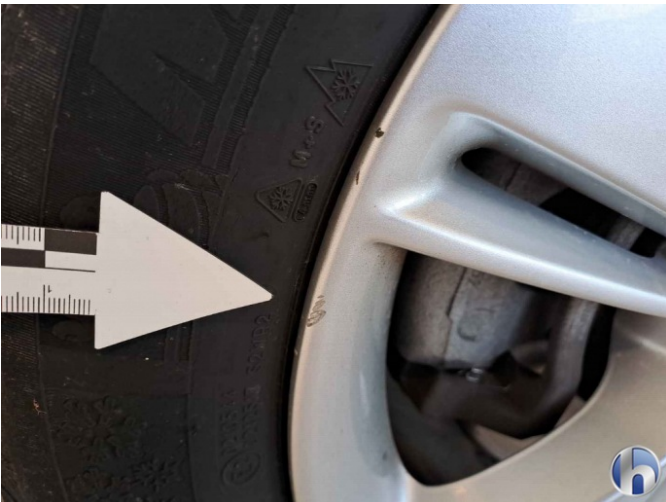
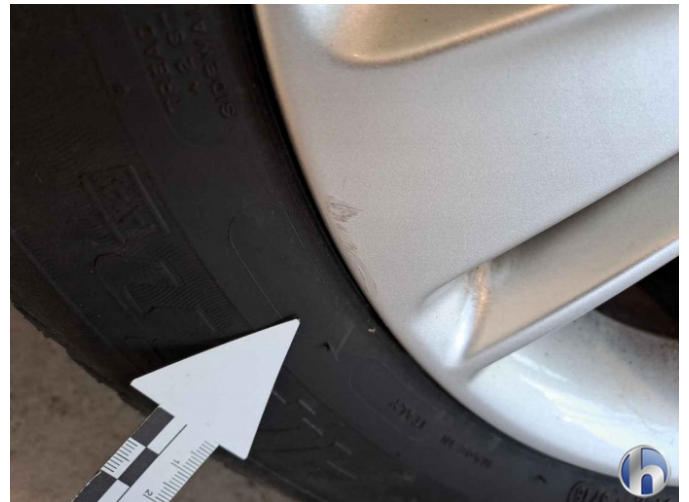
| component | Damage | Rep kind |
|---|---|---|
| 6. Rim front - right | Scratch(es) | Paint |

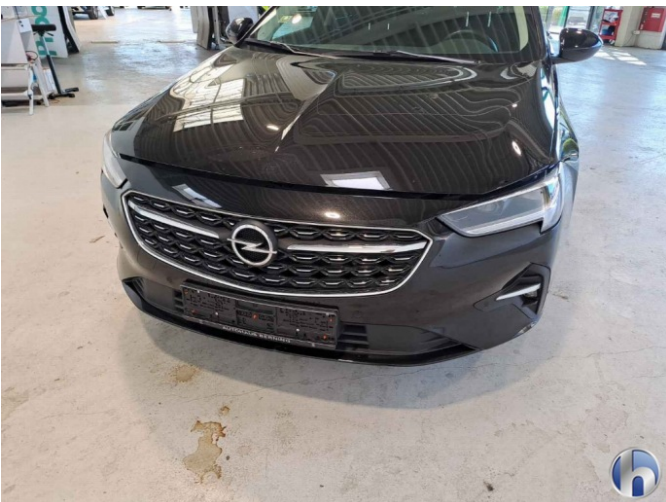
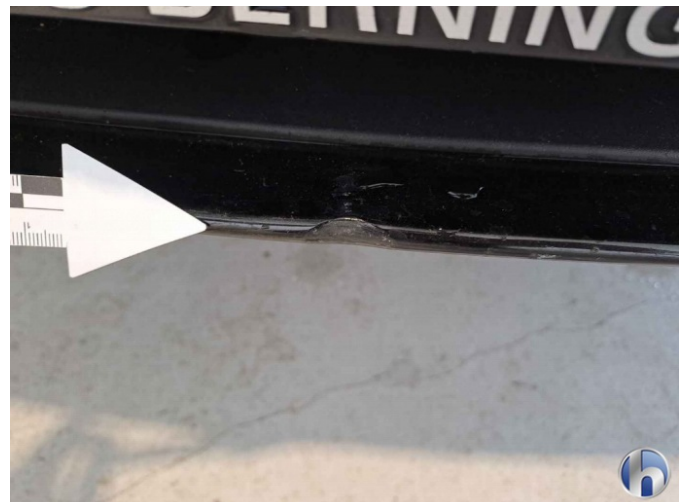
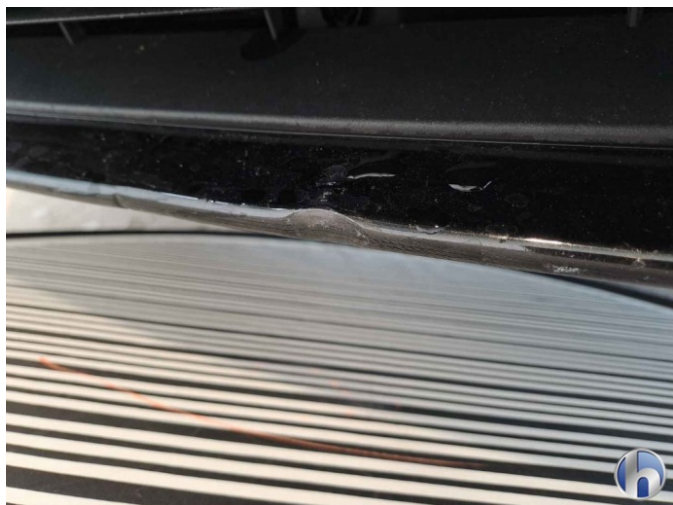
| component | Damage | Rep kind |
|---|---|---|
| 7. Front bumper | Damaged | Replace |

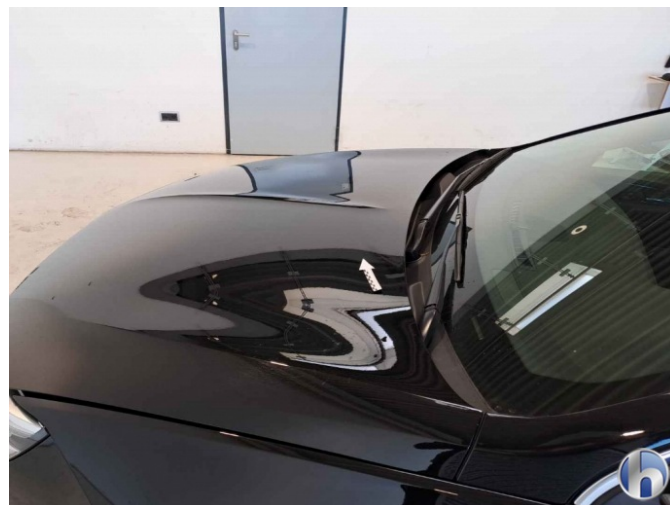
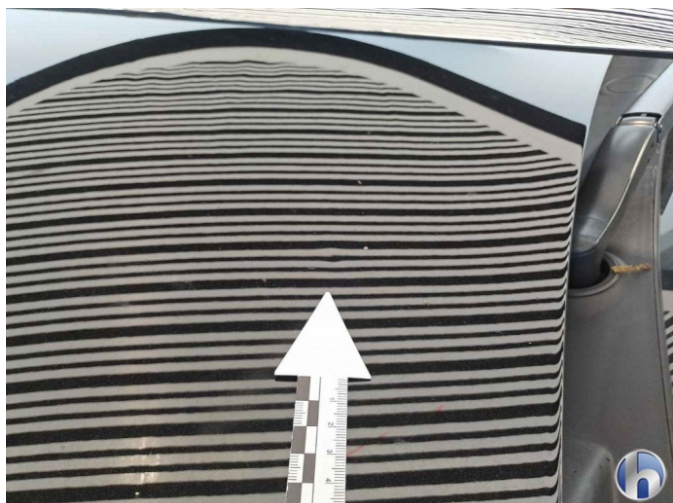
| component | Damage | Rep kind |
|---|---|---|
| 8. hood | Delle | Smart repair |

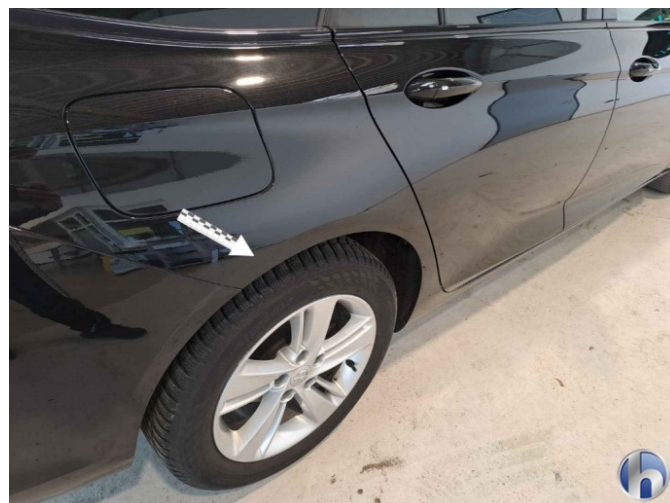
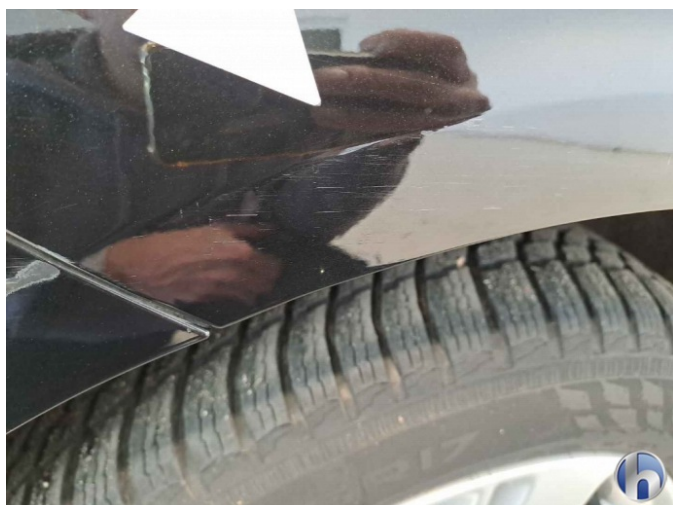
| component | Damage | Rep kind |
|---|---|---|
| 9. Sidewall - Rear - right | Scrape | Smart repair |

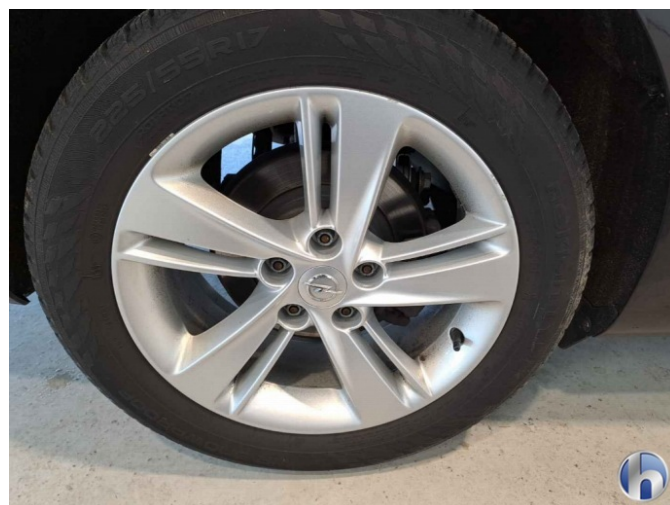
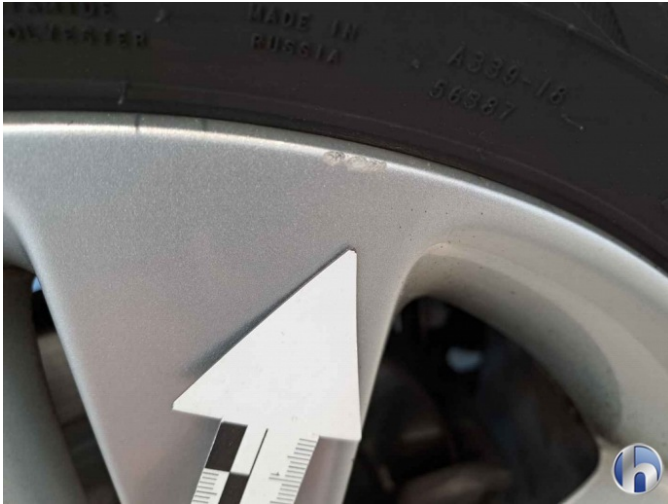
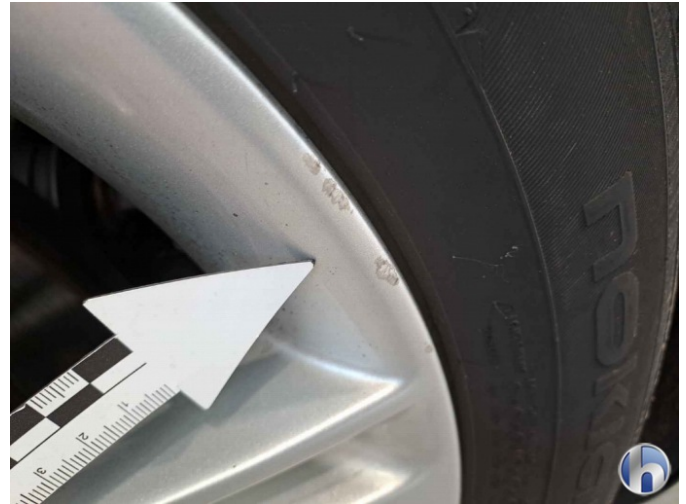
| component | Damage | Rep kind |
|---|---|---|
| 10. Rim rear - right | Scratch(es) | Paint |

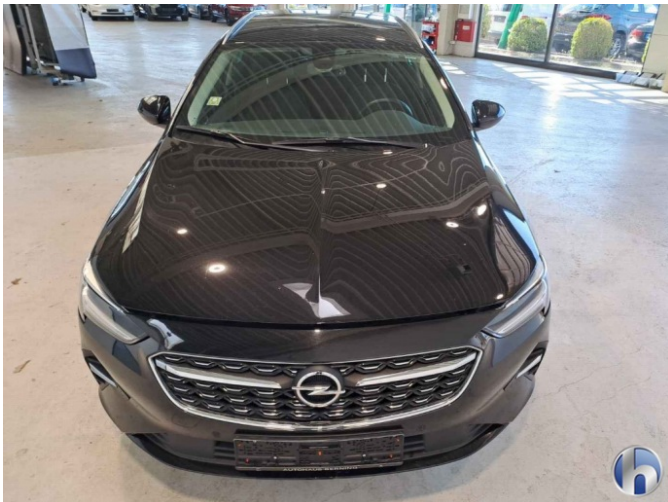
| component | Damage | Rep kind |
|---|---|---|
| 11. exterior body | Surface scratch(es) | |

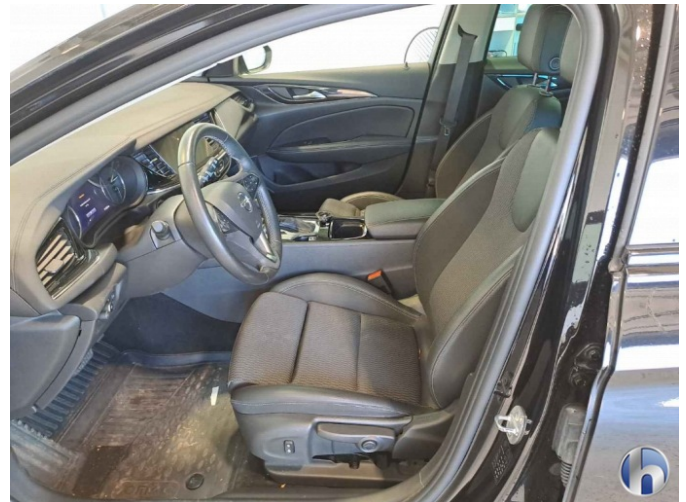
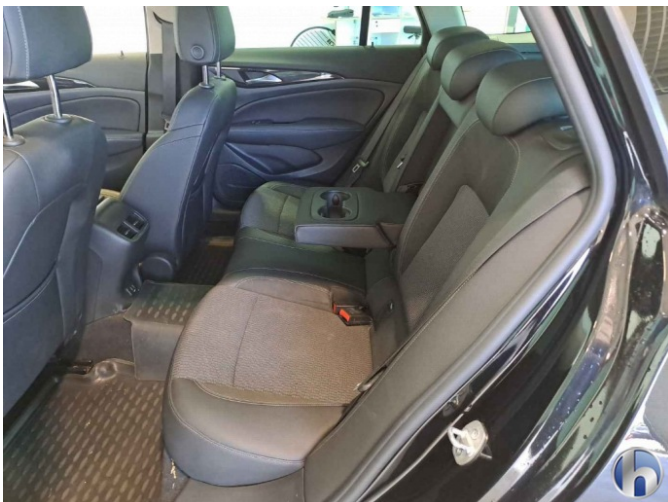
| component | Damage | Rep kind |
|---|---|---|
| 12. | Wear and tear | acceptable |

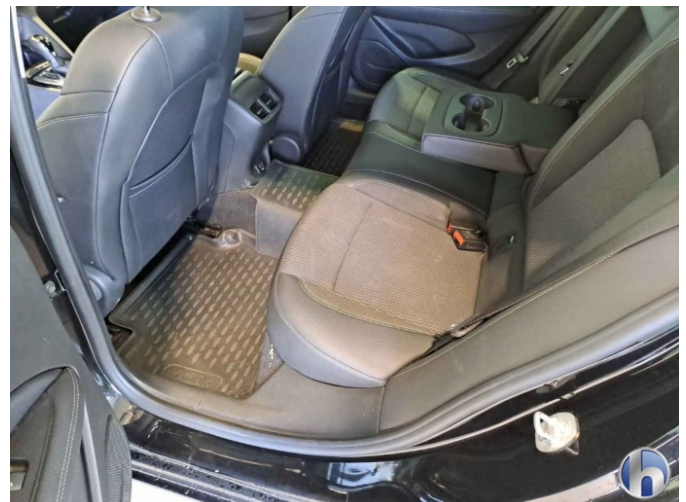
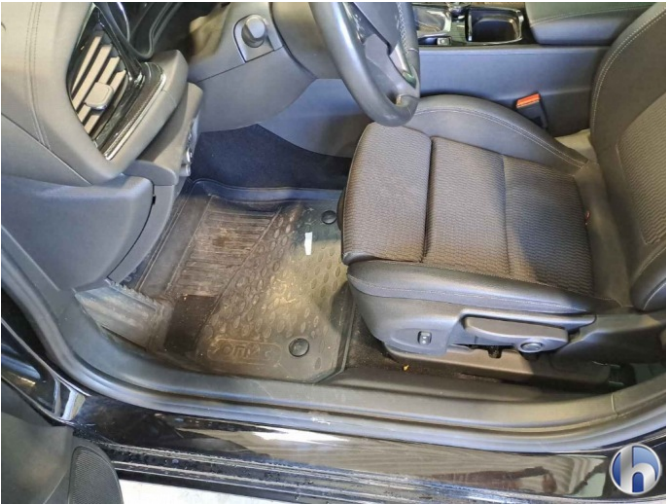
| component | Damage | Rep kind |
|---|---|---|
| 13. | Dirty | |

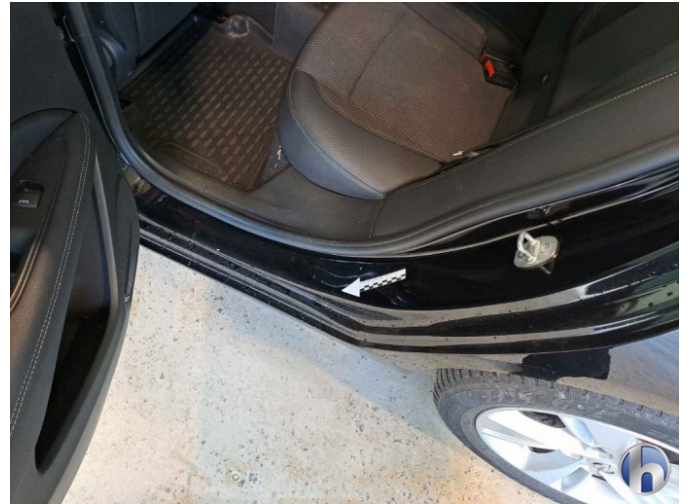
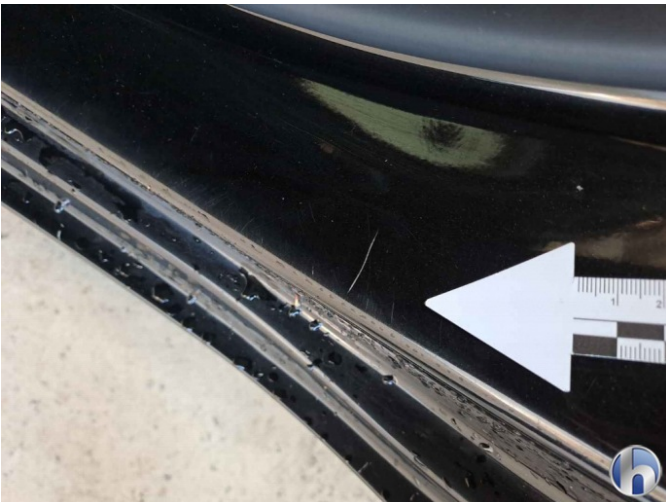
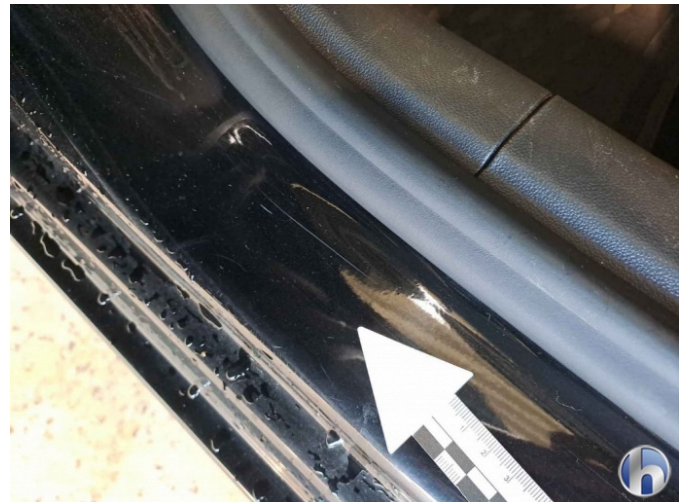
| component | Damage | Rep kind |
|---|---|---|
| 14. Türeinstieg Hinten - Links | Scratch(es) | Smart repair |

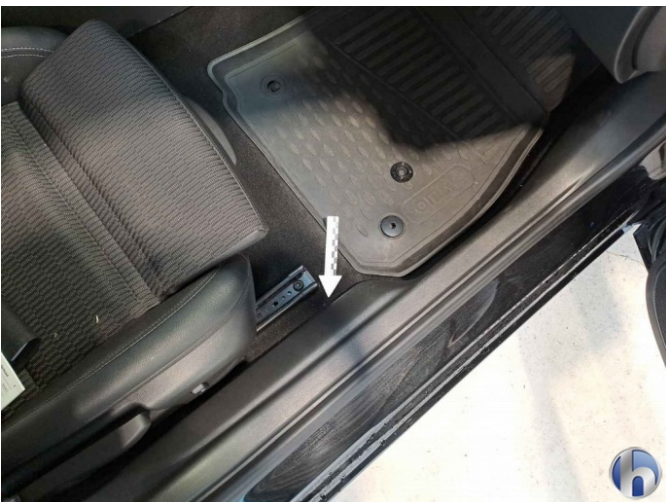
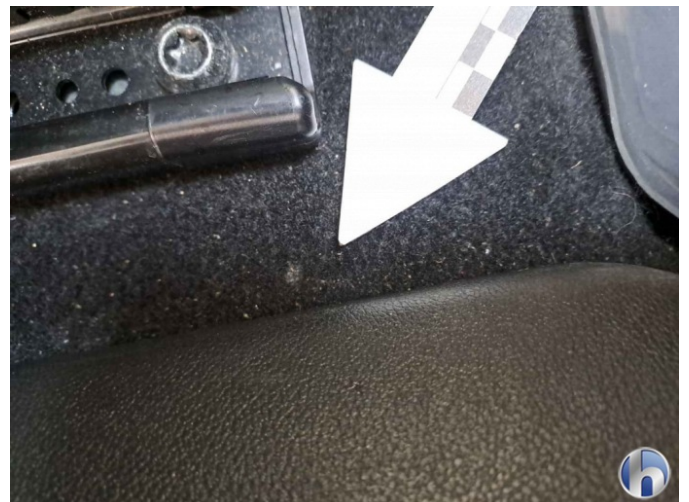
| component | Damage | Rep kind |
|---|---|---|
| 15. flooring | Burn hole | Smart repair |

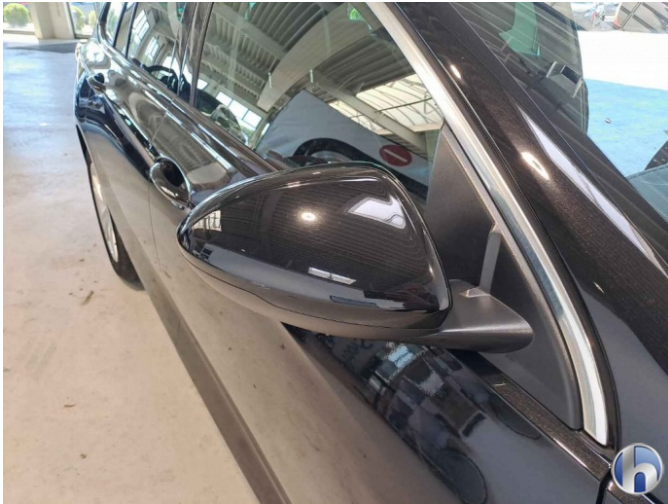
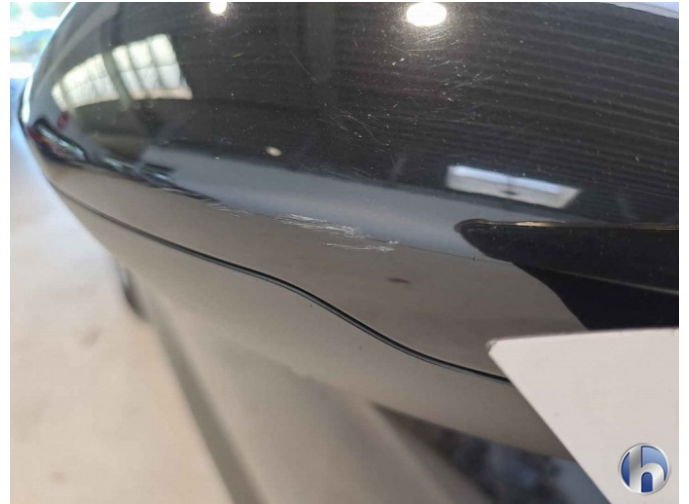
| component | Damage | Rep kind |
|---|---|---|
| 17. | Scrape | Smart repair |
