Expertise

Protocol number: 41090791
Order No. / Reference: 25084030
Inspection date: 18 Aug 2025

Manufacturer: Opel

Model: Insignia Sports Tourer 2.0 Diesel Aut. Elegance

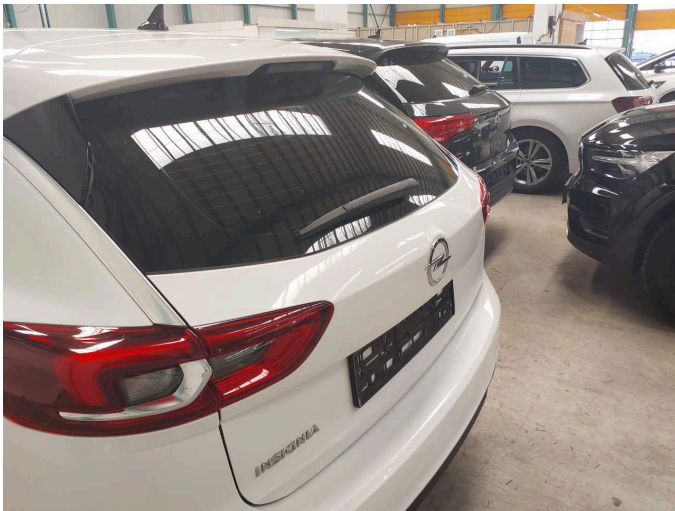
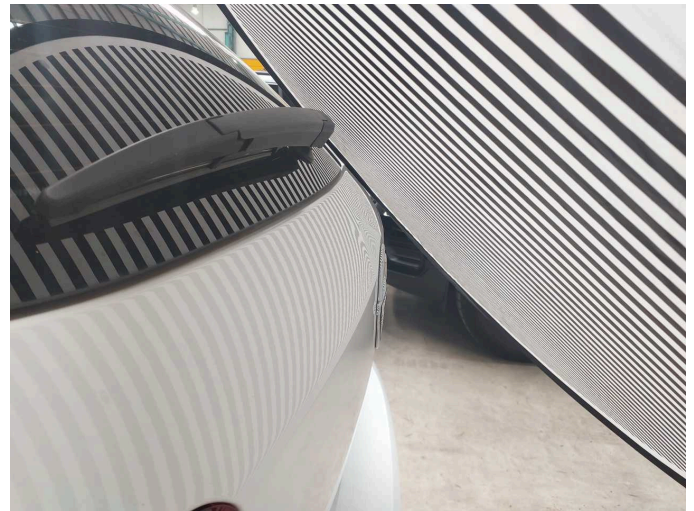
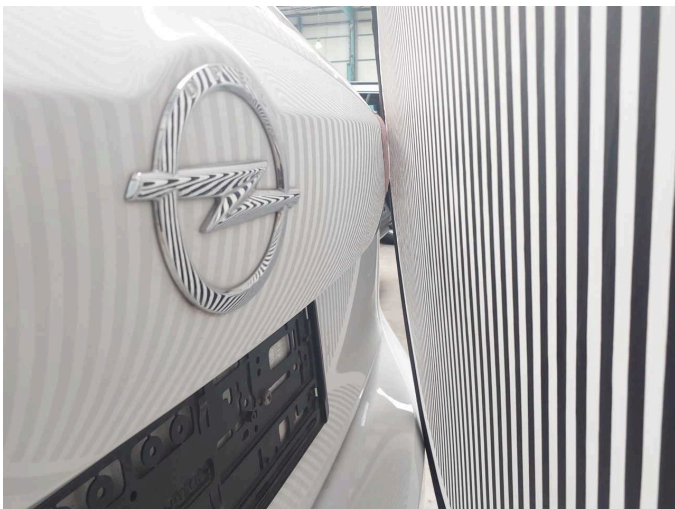
| No. | Component group | Description |
|---|---|---|
| 1 | Boot lid / rear door | Boot lid - dent(s) - Smart repair |

Damage 1: Boot lid / rear door: Boot lid - dent(s) - Smart repair

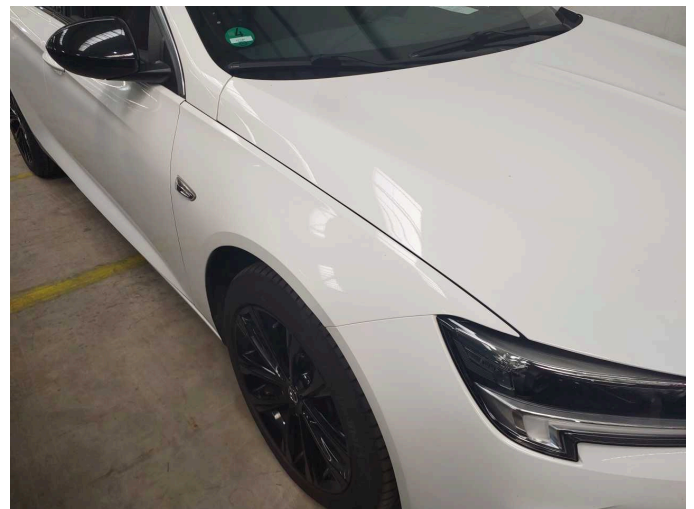
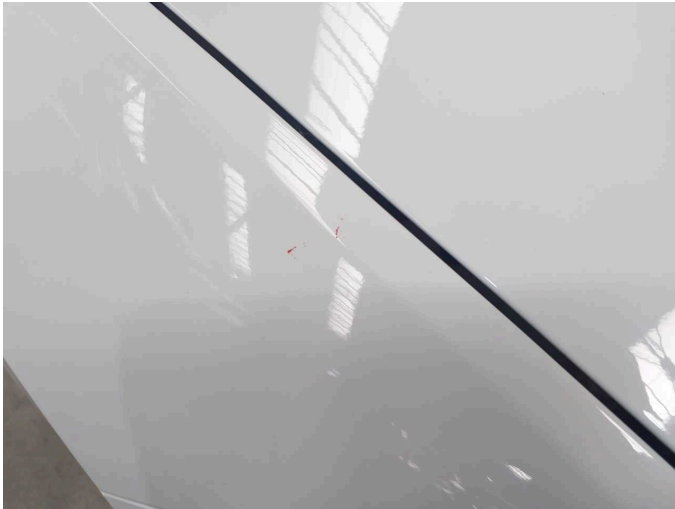
| No. | Component group | Description |
|---|---|---|
| 2 | Mudguard - right side | Mudguard - right side - Scratch(es) - Smart repair |

Damage 2: Mudguard - right side: Mudguard - right side - Scratch(es) - Smart repair

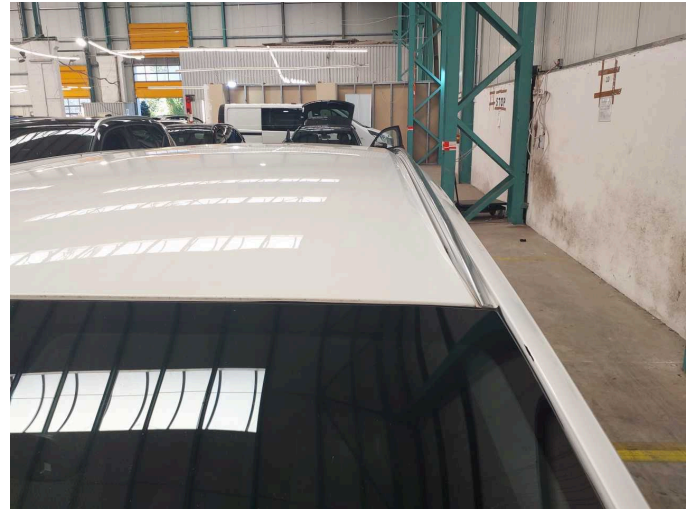
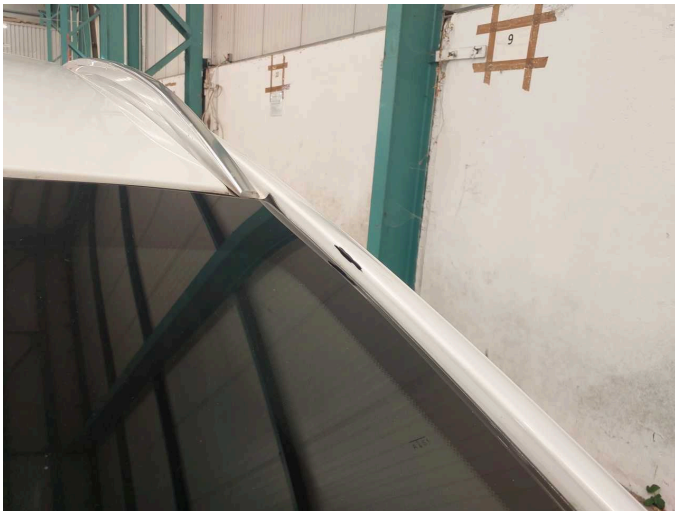
| No. | Component group | Description |
|---|---|---|
| 3 | Roof | Roof rail - left side - Scratched - Smart repair |

Damage 3: Roof: Roof rail - left side - Scratched - Smart repair

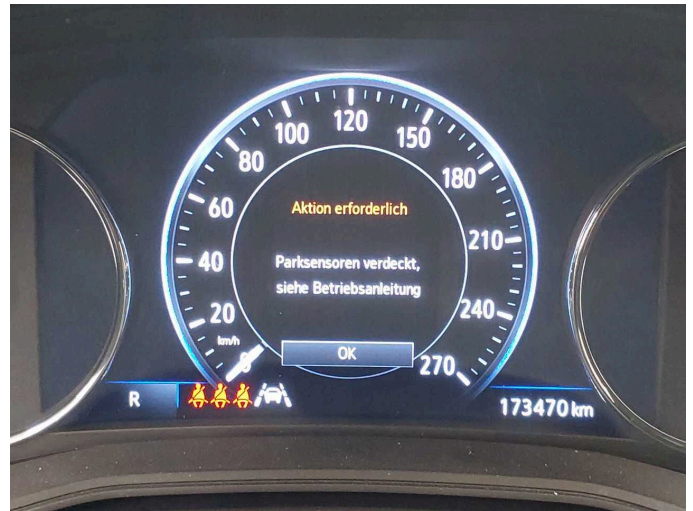
| No. | Component group | Description |
|---|---|---|
| 4 | Instrument panel | Indicator light (Parksensoren) - Specify findings - Diagnosed and repair if necessary |

Damage 4: Instrument panel: Indicator light (Parkensoren) - Specify findings - Diagnosed and repair if necessary

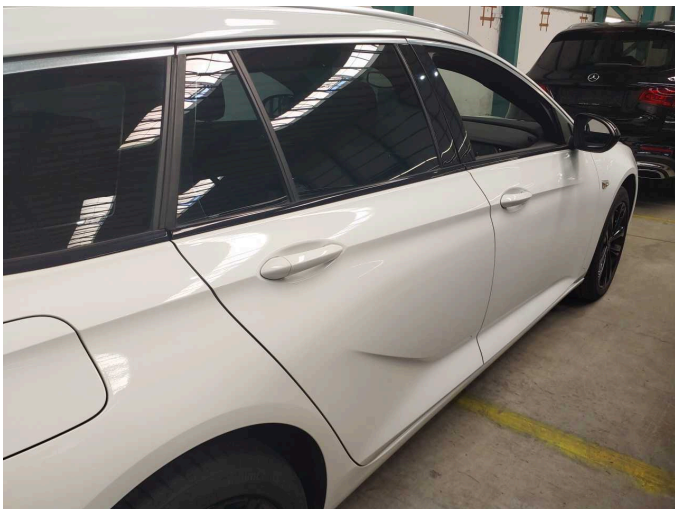
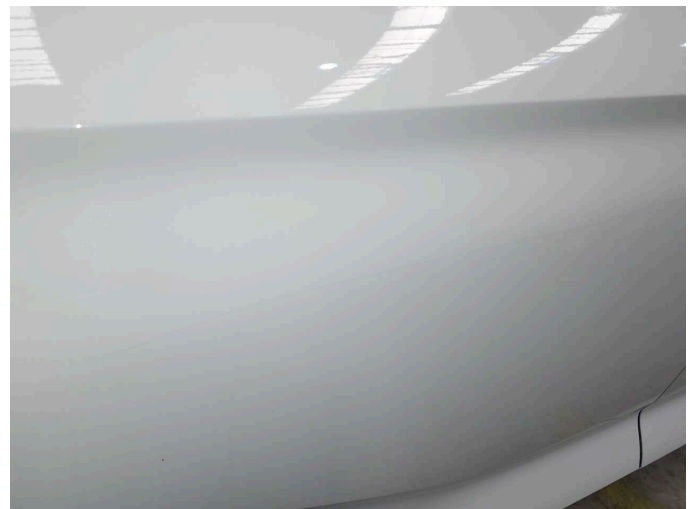
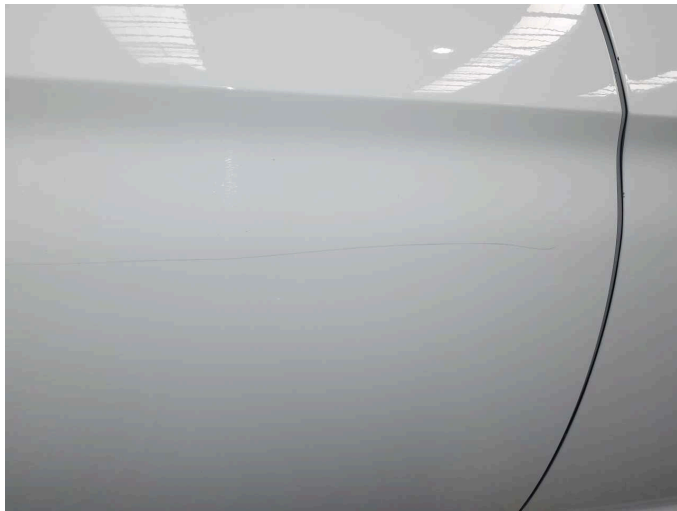
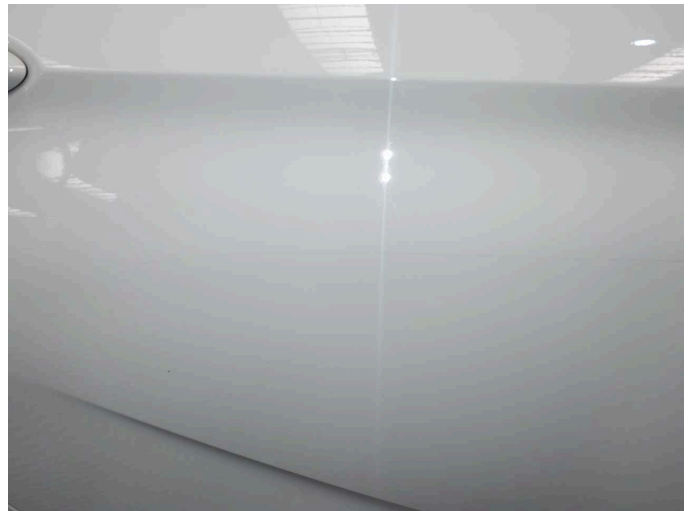
| No. | Component group | Description |
|---|---|---|
| 5 | Door - rear right side | Door - Scratch(es) - Paint |

Damage 5: Door - rear right side: Door - Scratch(es) - Paint

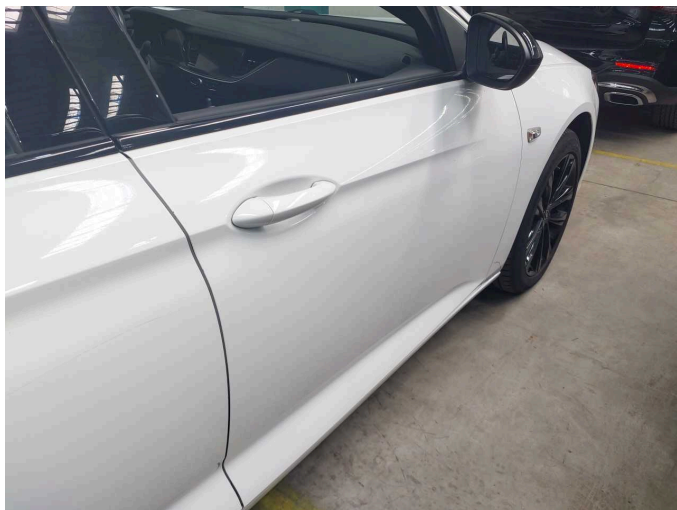
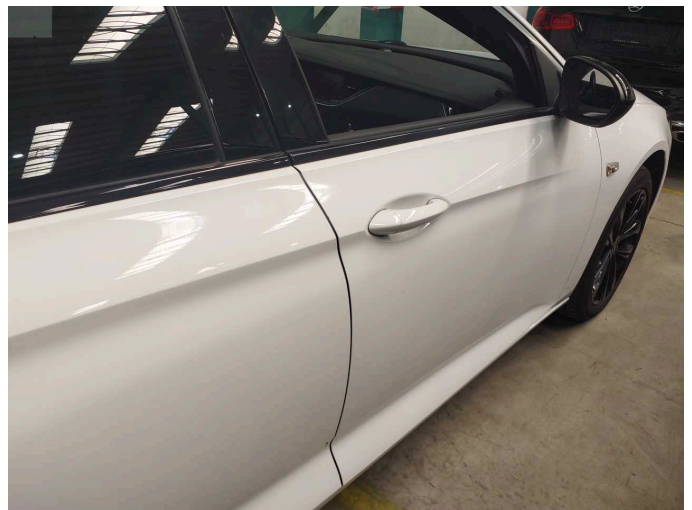
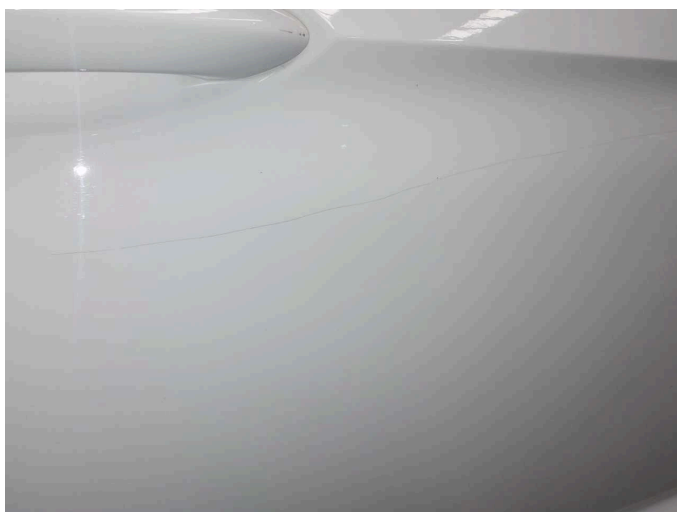
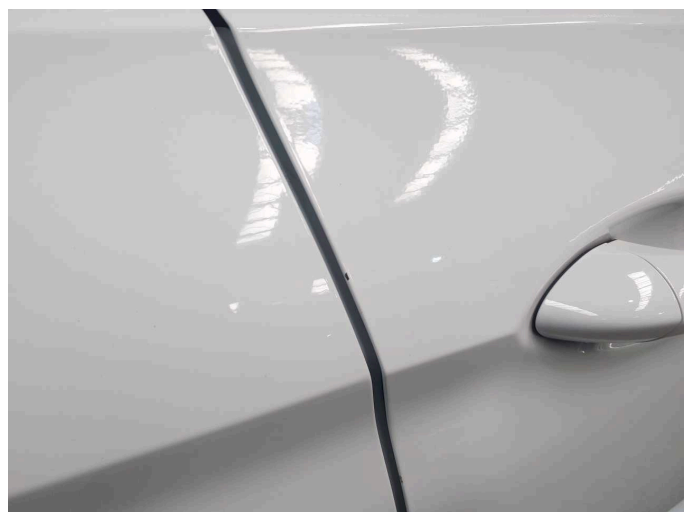
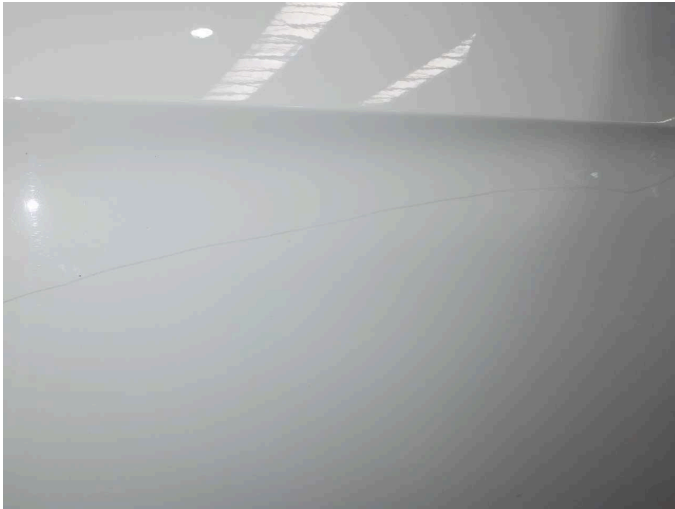
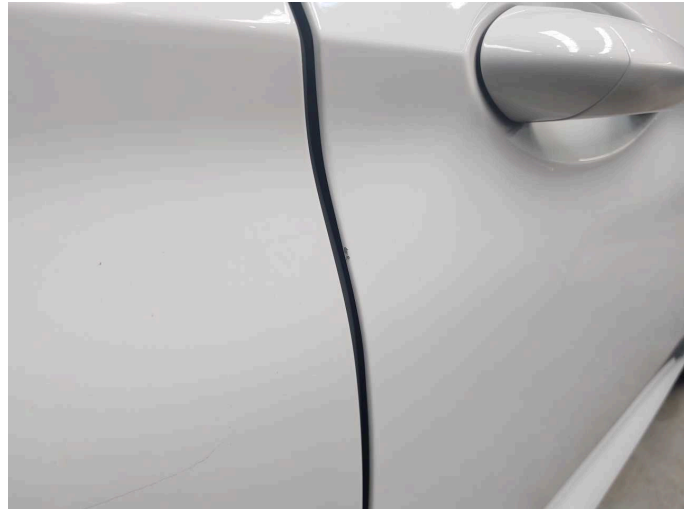
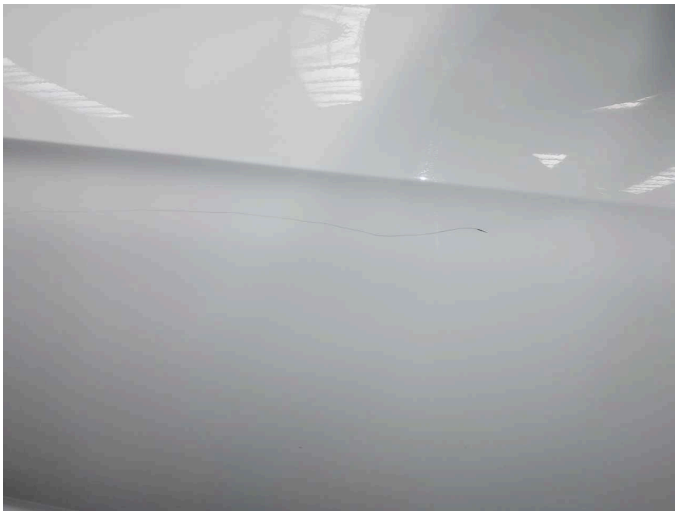
| No. | Component group | Description |
|---|---|---|
| 6 | Door - front right side | Door - Scratch(es) - Paint |

Damage 6: Door - front right side: Door - Scratch(es) - Paint

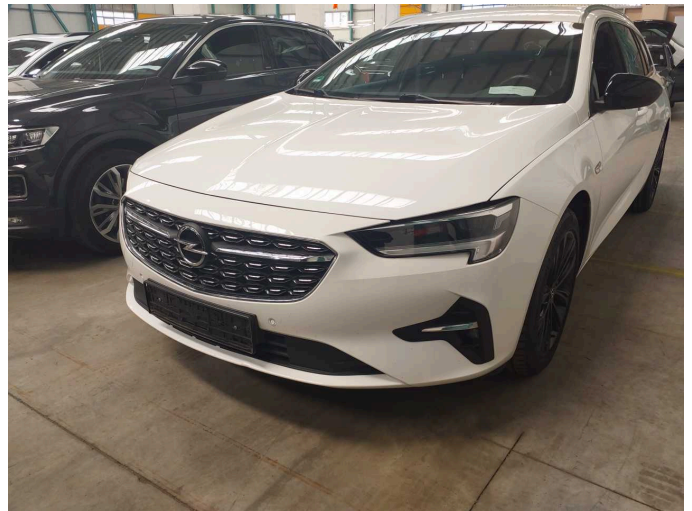
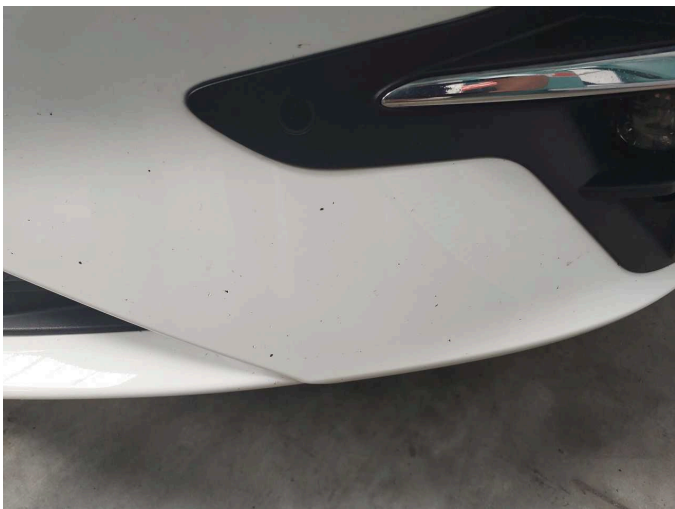
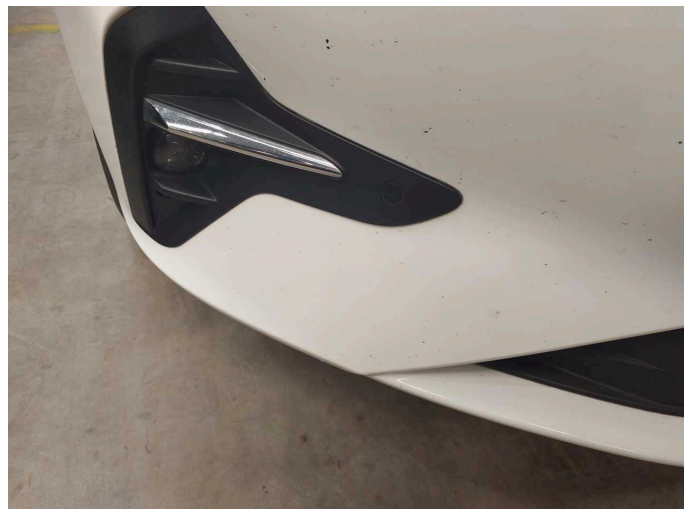
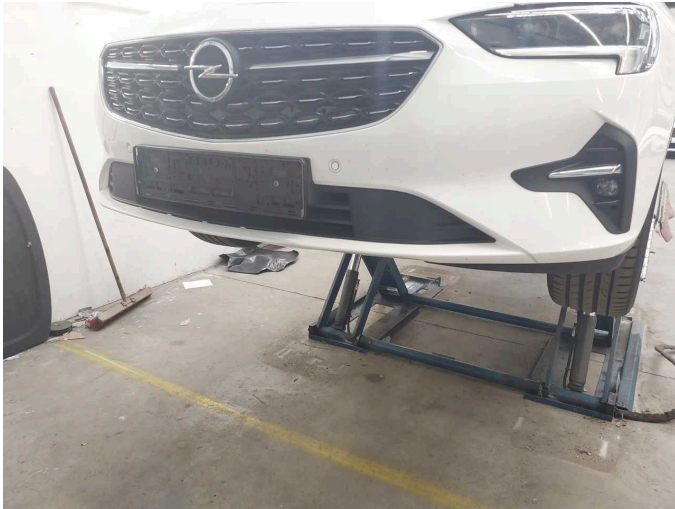
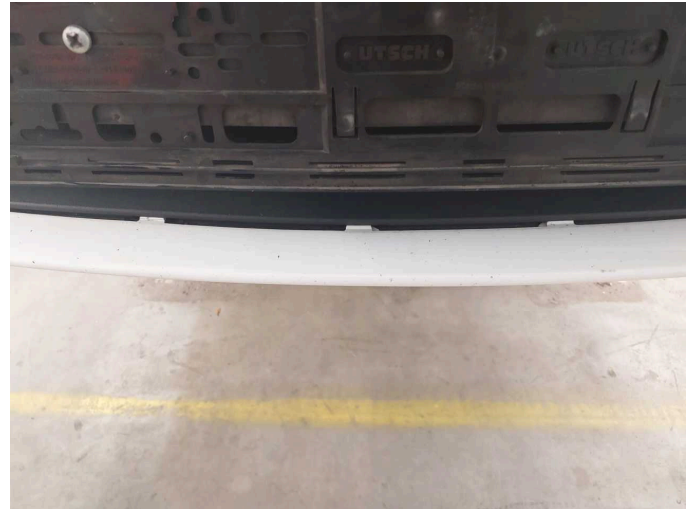
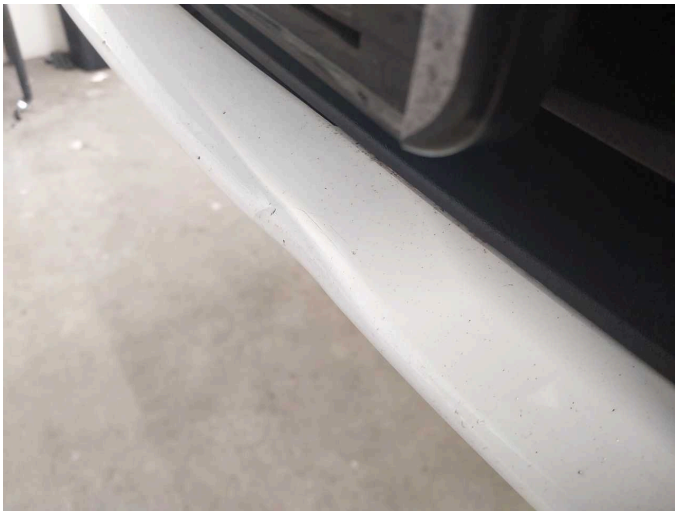
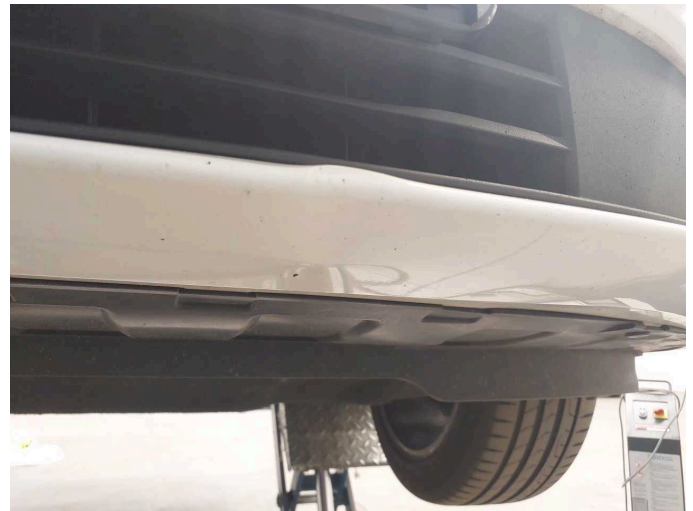
| No. | Component group | Description |
|---|---|---|
| 7 | Front bumper | Front bumper - Dent / paintcoat damage - Repair and paint |

Damage 7: Front bumper: Front bumper - Dent / paintcoat damage - Repair and paint

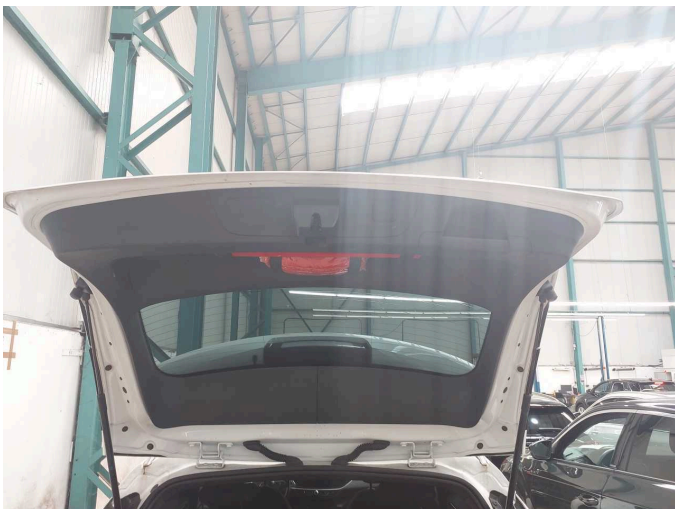
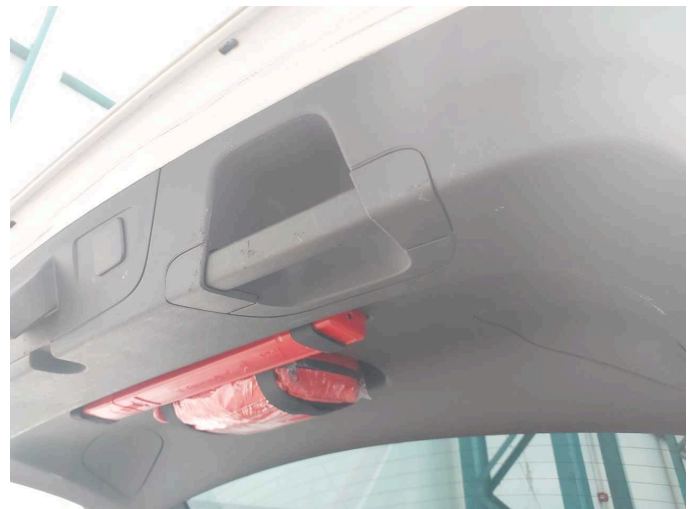
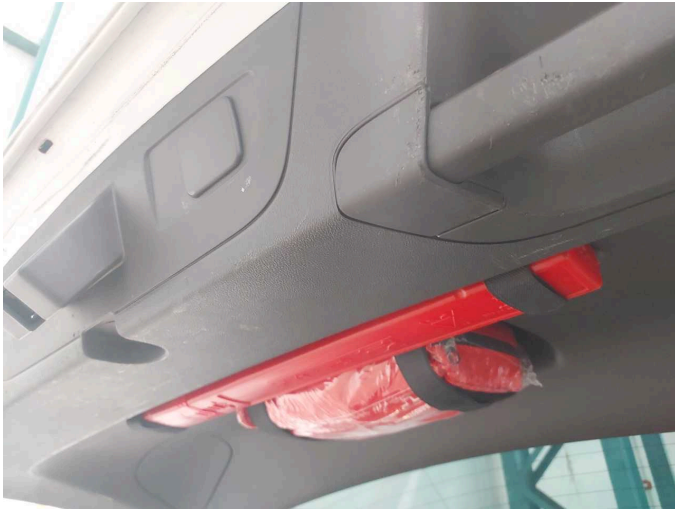
| No. | Component group | Description |
|---|---|---|
| 1 | Trim / covers | Boot lid - interior trim - Scratch(es) - No deduction |

Wear and tear 1: Trim / covers: Boot lid - interior trim - Scratch(es) - No deduction

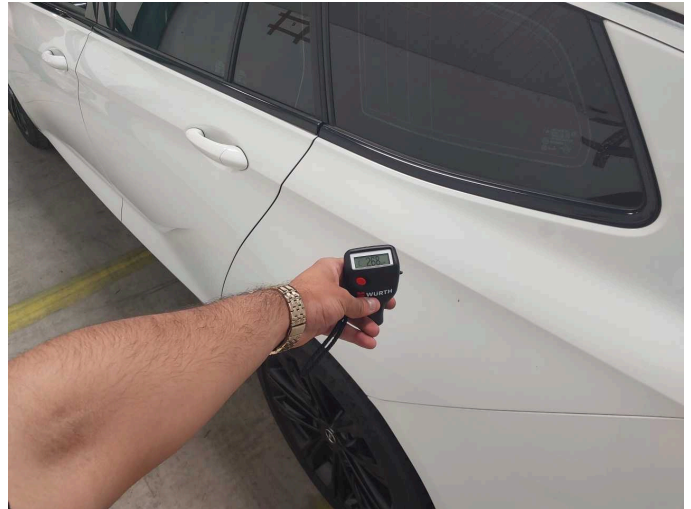
| No. | Repainting |
|---|--|
| 1 | Side panel - rear left side, Professionally carried out, Invoice of repair done Non-existent |

Repainting 1: Side panel - rear left side

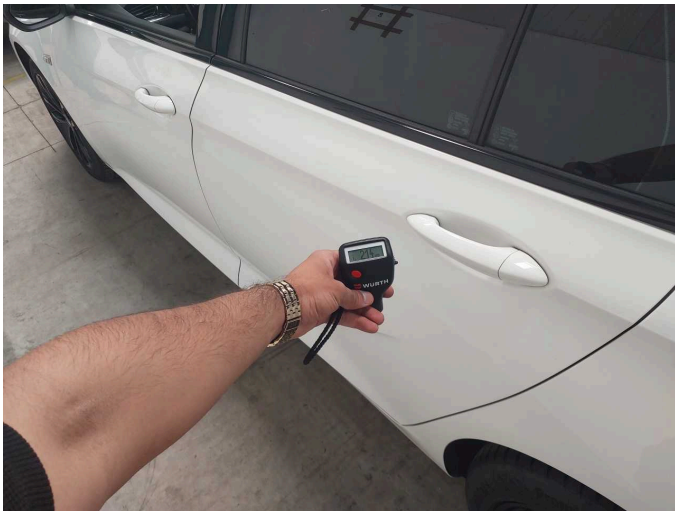
| No. | Repainting |
|---|--|
| 2 | Door - rear left side, Professionally carried out, Invoice of repair done Non-existent |

Repainting 2: Door - rear left side

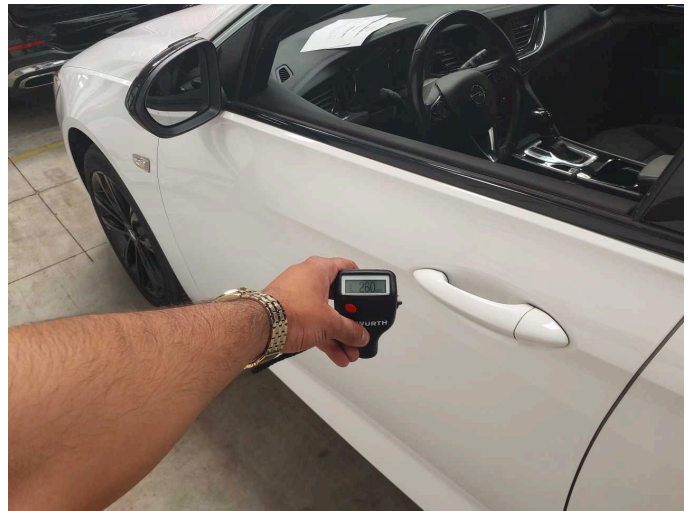
| No. | Repainting |
|---|--|
| 3 | Door - front left side, Professionally carried out, Invoice of repair done Non-existent |

Repainting 3: Door - front left side

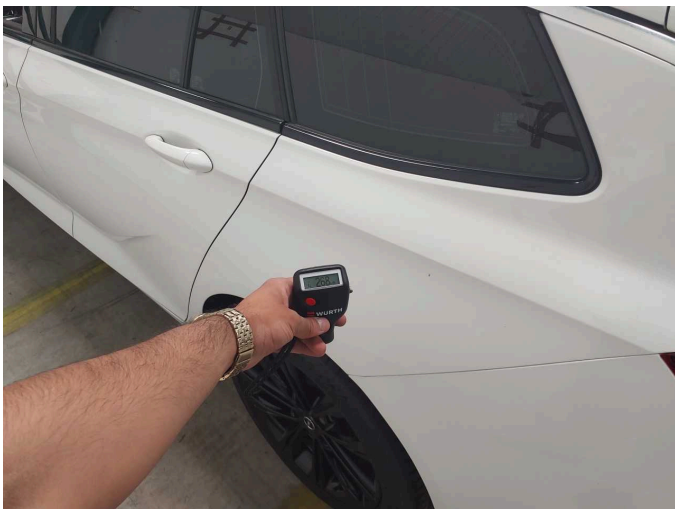
Side panel - rear left side: 268 µm

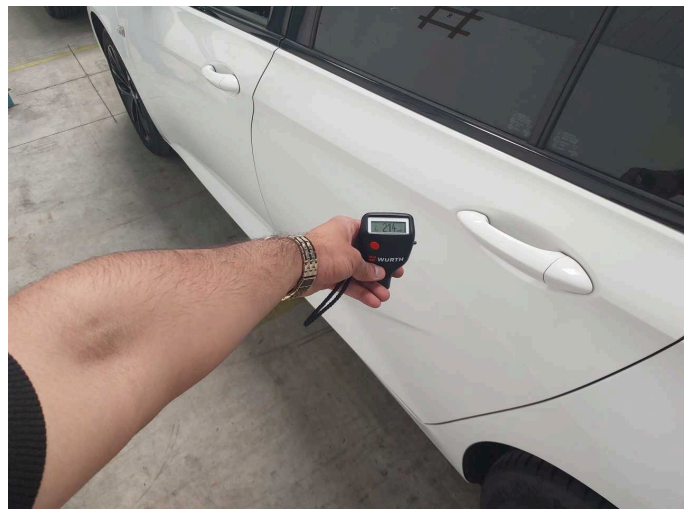
Door - rear left side: 214 µm

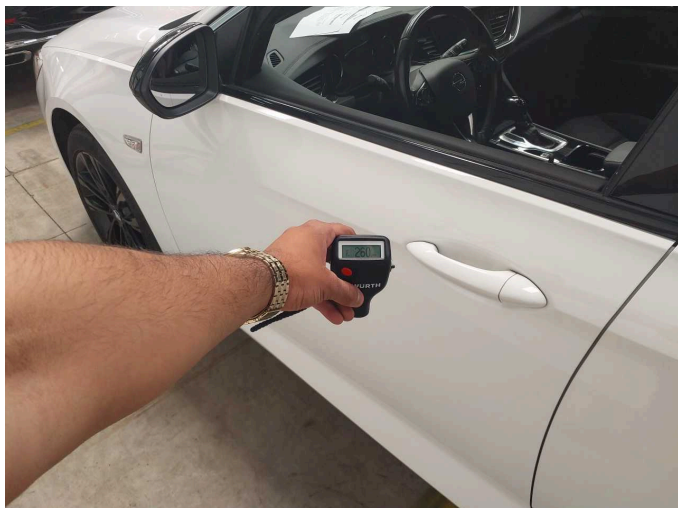
Door - front left side: 260 μm
