Expertise

Protocol number: 41512496  
Order No. / Reference: 25183375  
Inspection date: 12 Sept 2025

Manufacturer: Opel

Model: Insignia Sports Tourer 2.0 Diesel Business Elegance

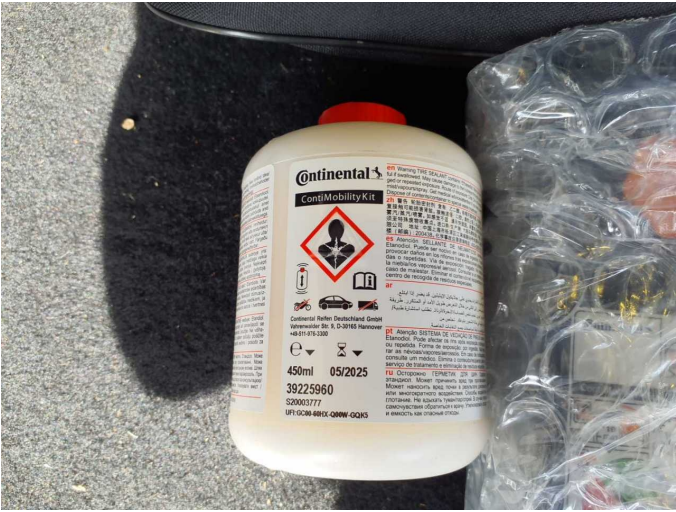
| No. | Component group | Description |
|---|---|---|
| 1 | Equipment | Tirefit filler - Expired - Replace |

Damage 1: Equipment: Tirefit filler - Expired - Replace

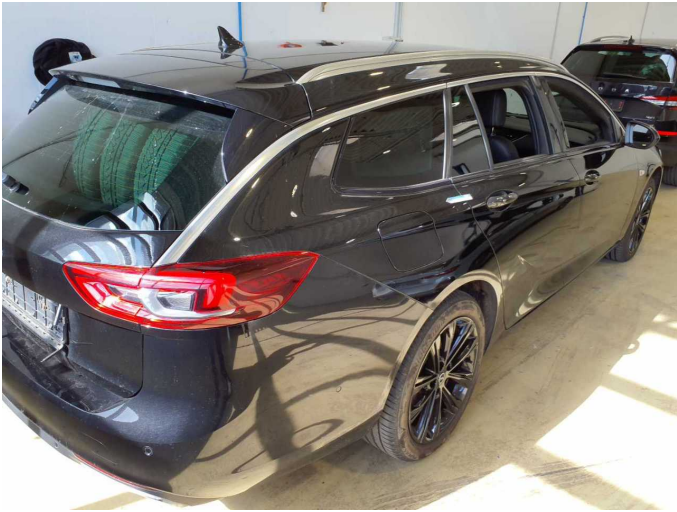
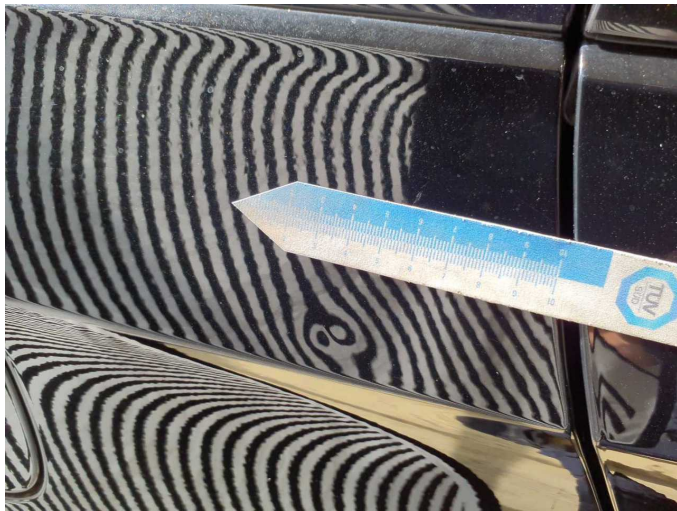
| No. | Component group | Description |
|---|---|---|
| 2 | Side panel - rear right side | Side panel - dent(s) - Smooth repair work |

Damage 2: Side panel - rear right side: Side panel - dent(s) - Smooth repair work

**Damage 2:** Side panel - rear right side: Side panel - dent(s) - Smooth repair work

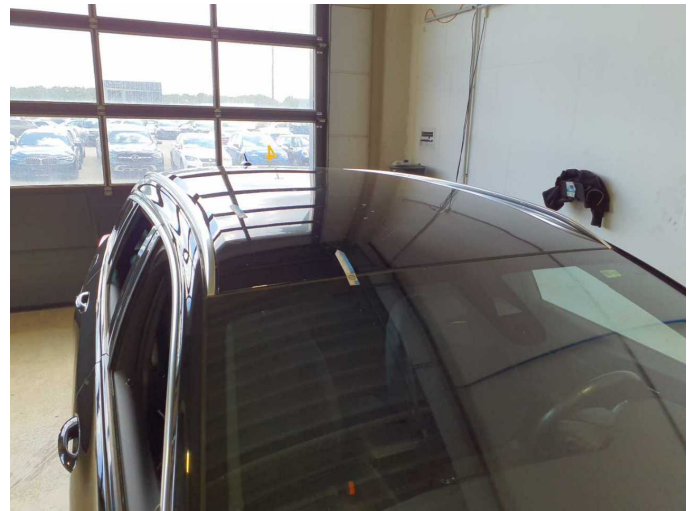
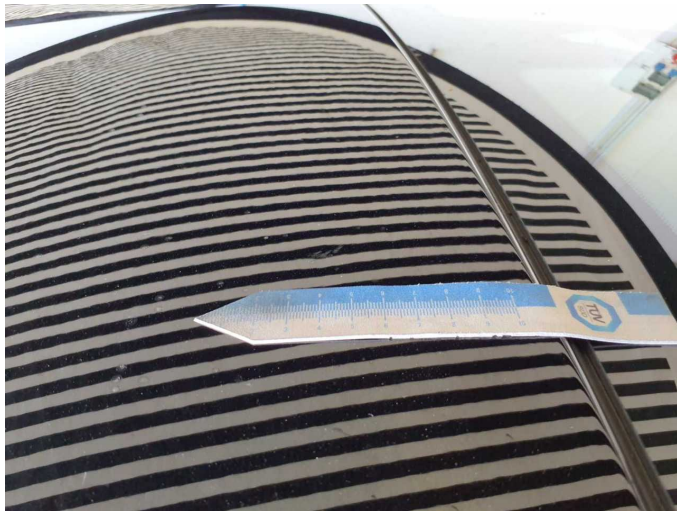
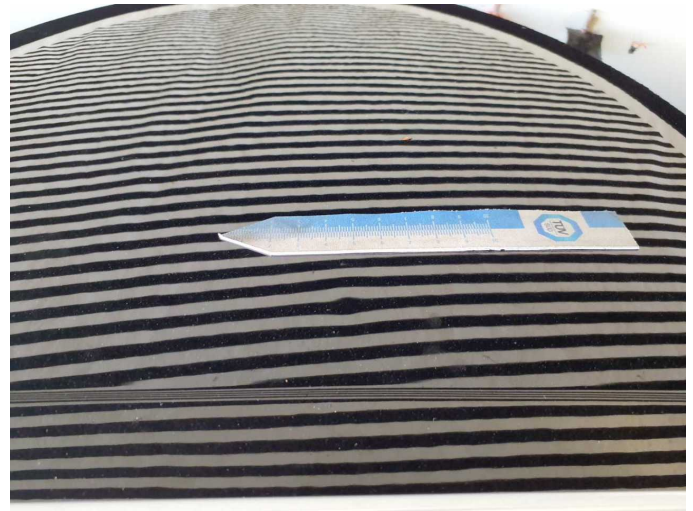
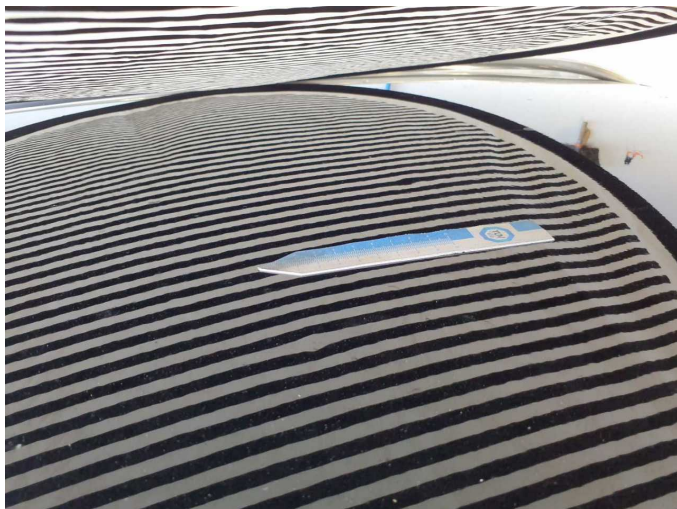
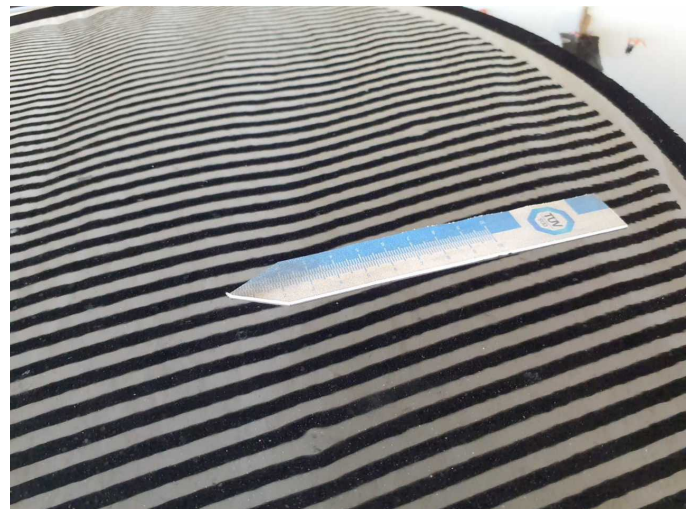
| No. | Component group | Description |
|---|---|---|
| 3 | Roof | Roof - dent(s) - Smooth repair work |

**Damage 3:** Roof: Roof - dent(s) - Smooth repair work

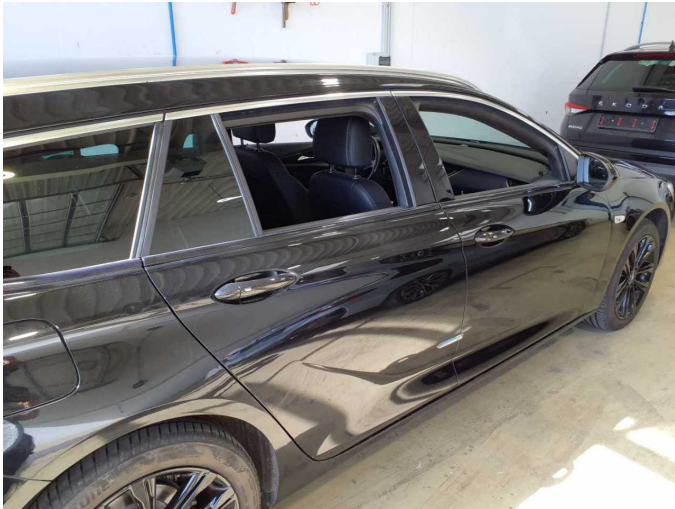
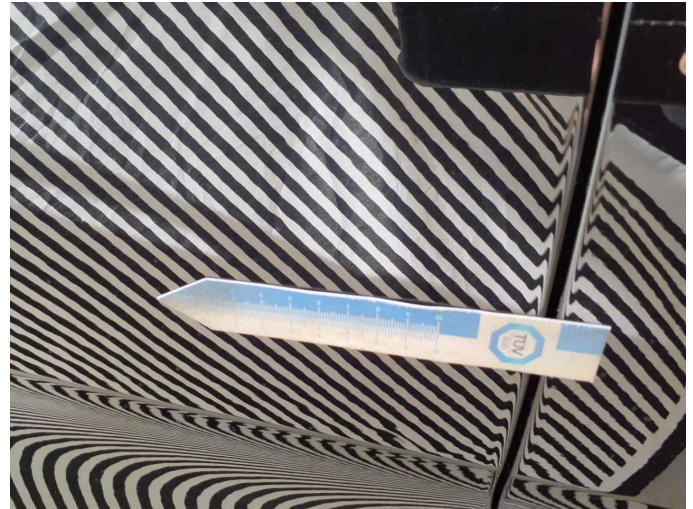
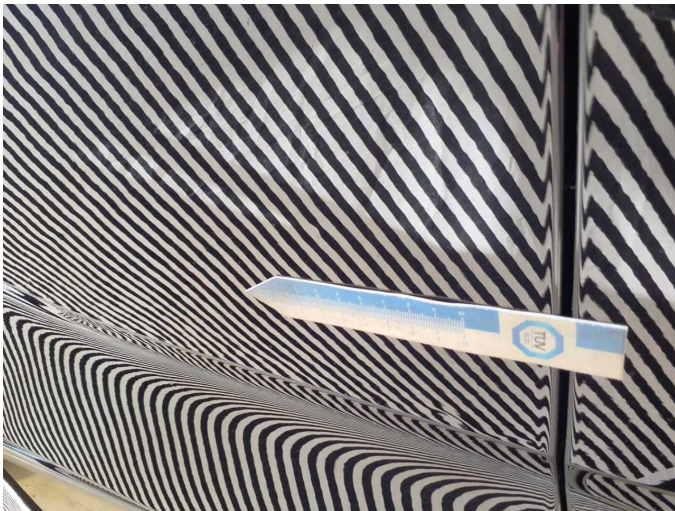
| No. | Component group | Description |
|---|---|---|
| 4 | Door - rear right side | Door - dent(s) - Smart repair |

**Damage 4:** Door - rear right side: Door - dent(s) - Smart repair

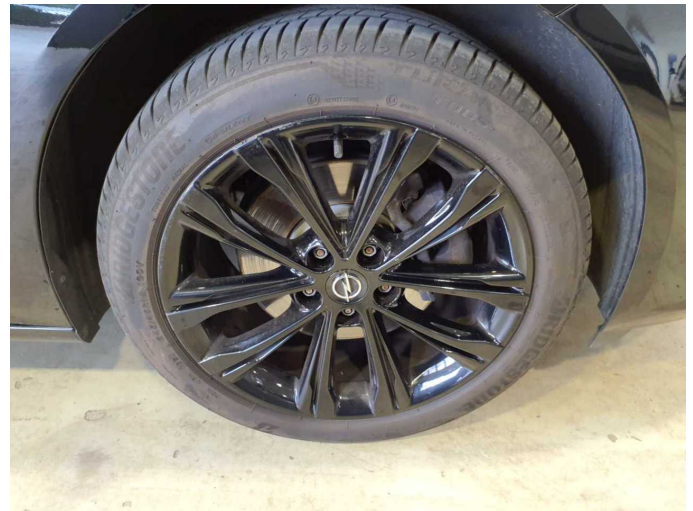
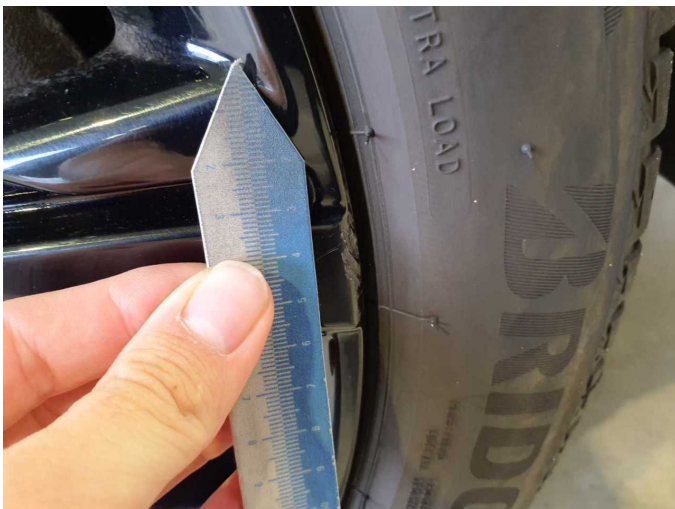
| No. | Component group | Description |
|---|---|---|
| 5 | Wheel / tyres | Alloy rim - front right side - Scratch(es) - Loss in value |

**Damage 5:** Wheel / tyres: Alloy rim - front right side - Scratch(es) - Loss in value

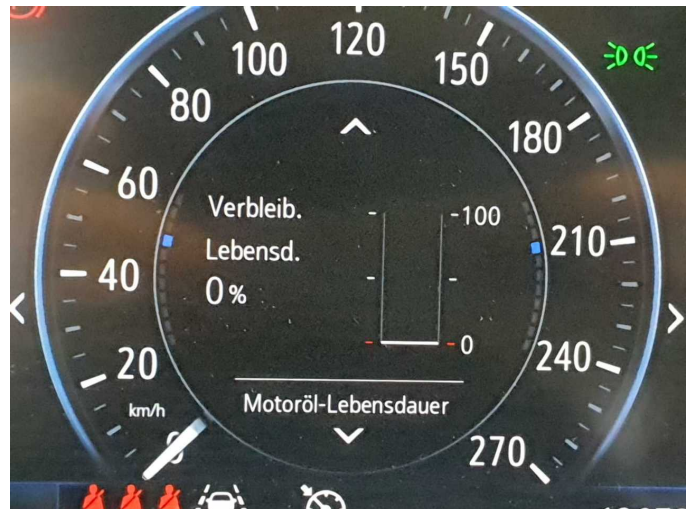
| No. | Component group | Description |
|---|---|---|
| 6 | Misc. | Inspection / maintenance - Due - Perform |

**Damage 6:** Misc.: Inspection / maintenance - Due - Perform

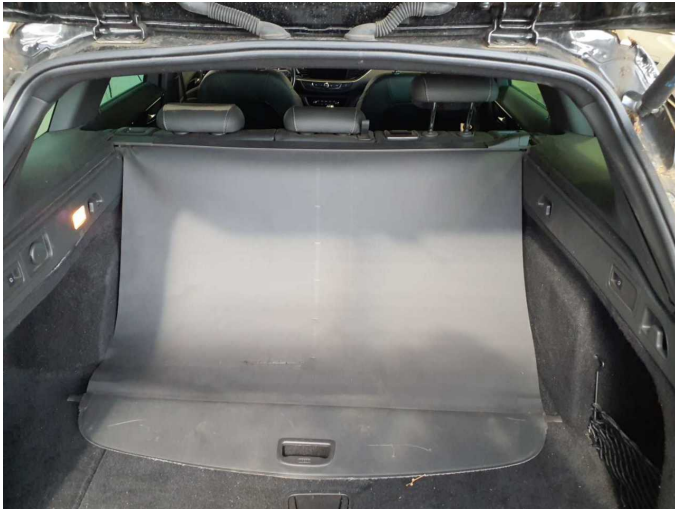
| No. | Component group | Description |
|---|---|---|
| 7 | Interior | Boot cover / roller cover - Damaged - Replace |

**Damage 7:** Interior: Boot cover / roller cover - Damaged - Replace

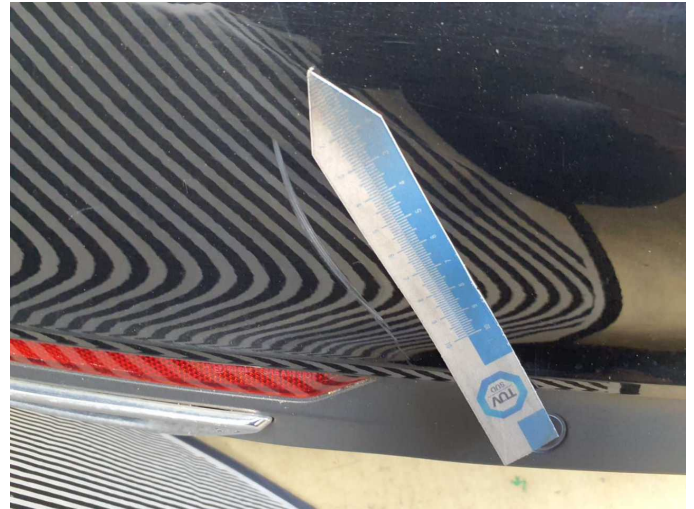
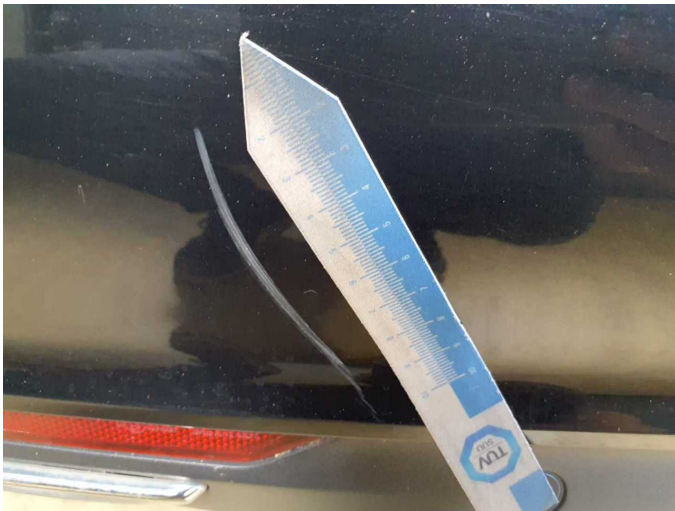
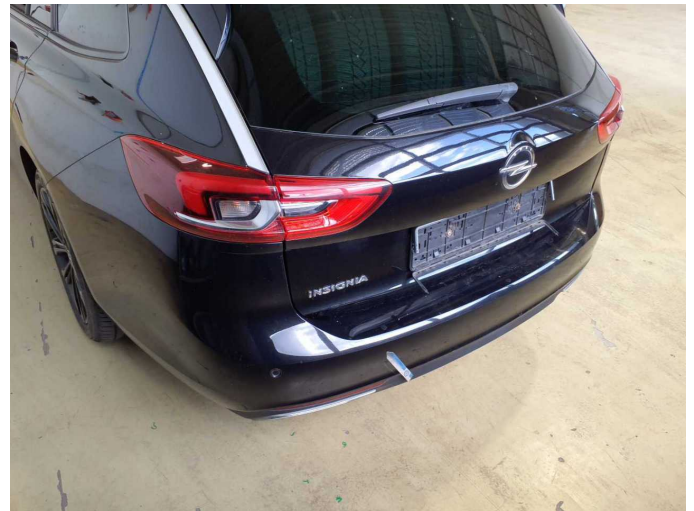
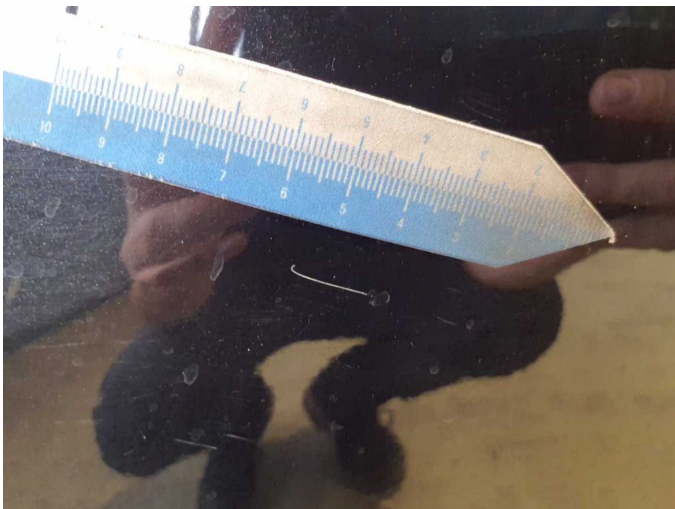
| No. | Component group | Description |
|---|---|---|
| 8 | Rear bumper | Rear bumper - Scratch(es) - Paint |

**Damage 8:** Rear bumper: Rear bumper - Scratch(es) - Paint

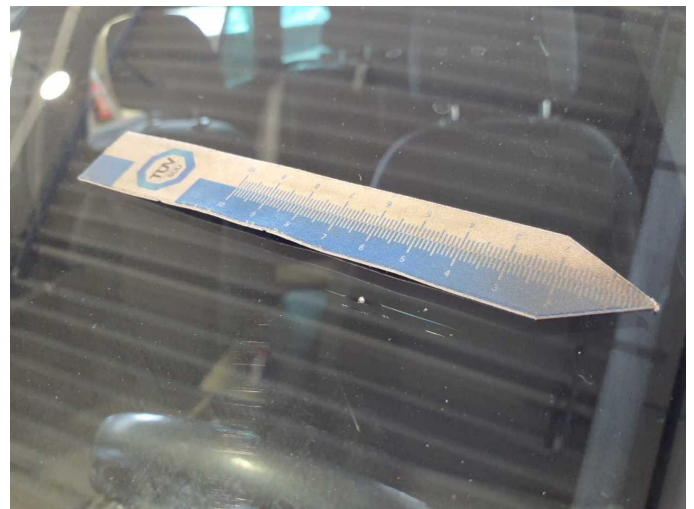
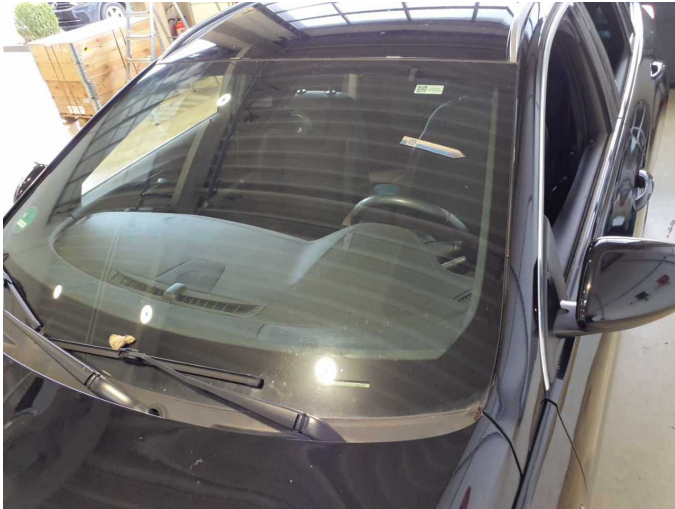
| No. | Component group | Description |
|---|---|---|
| 9 | Vehicle glazing | Windscreen - Damaged - Replace |

**Damage 9:** Vehicle glazing: Windscreen - Damaged - Replace

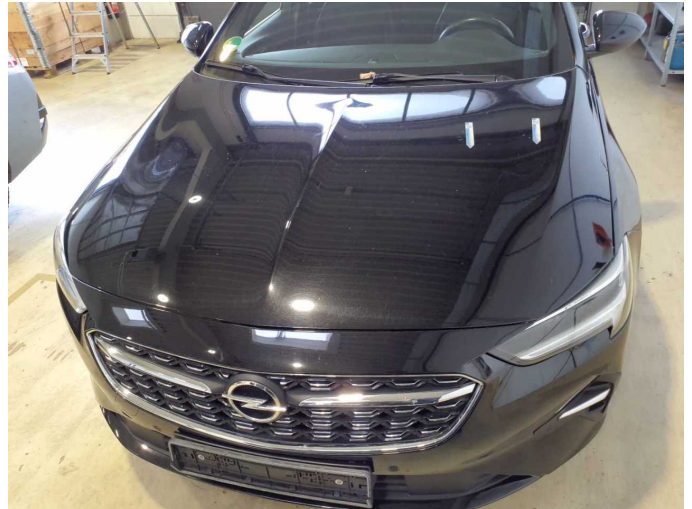
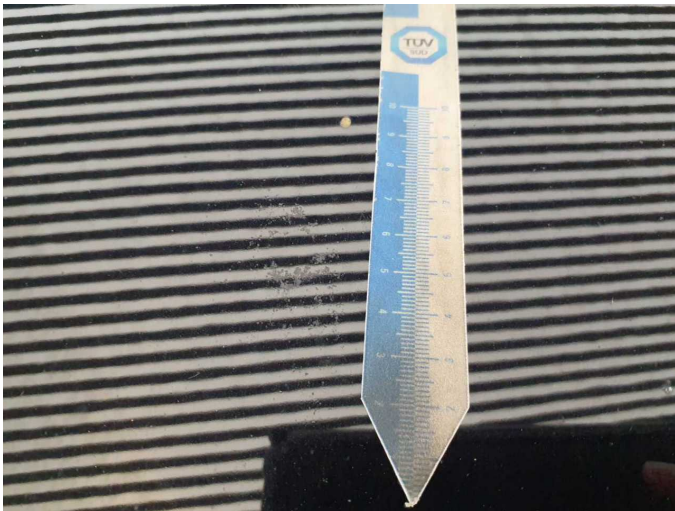
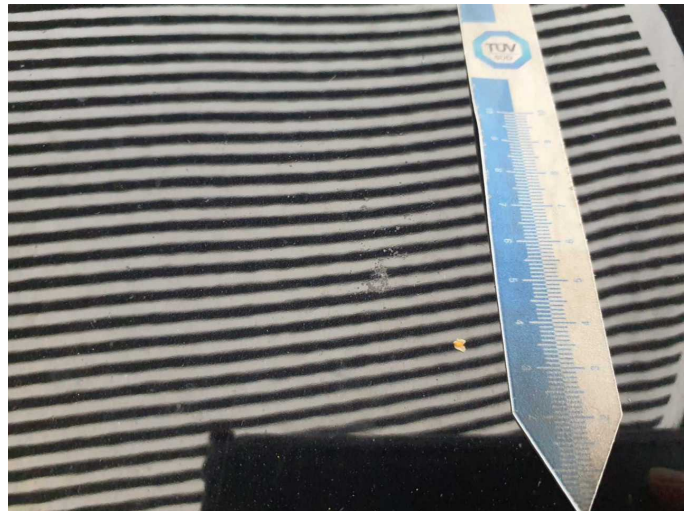
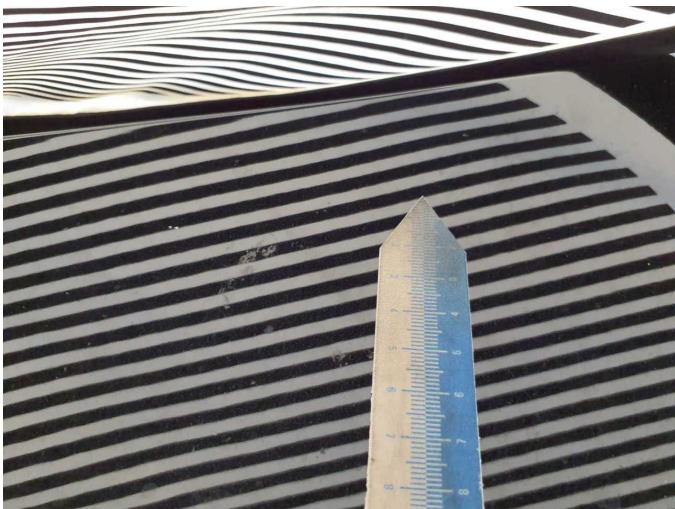
| No. | Component group | Description |
|---|---|---|
| 10 | Bonnet | Bonnet (Anätzung) - Paint defect - Paint |

**Damage 10:** Bonnet: Bonnet (Anätzung) - Paint defect - Paint

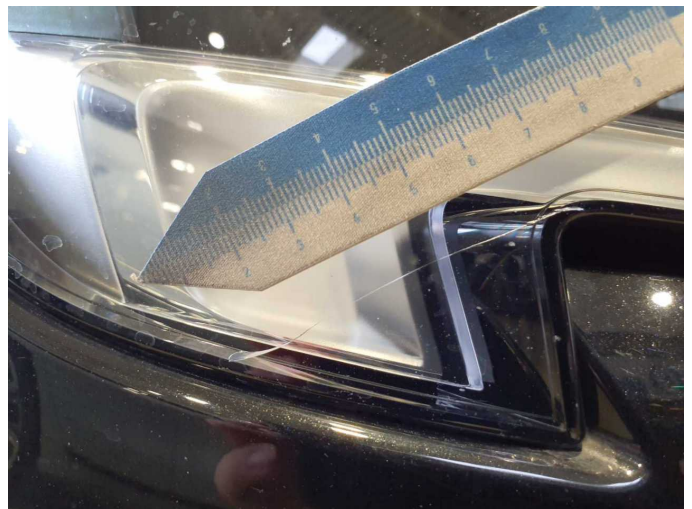
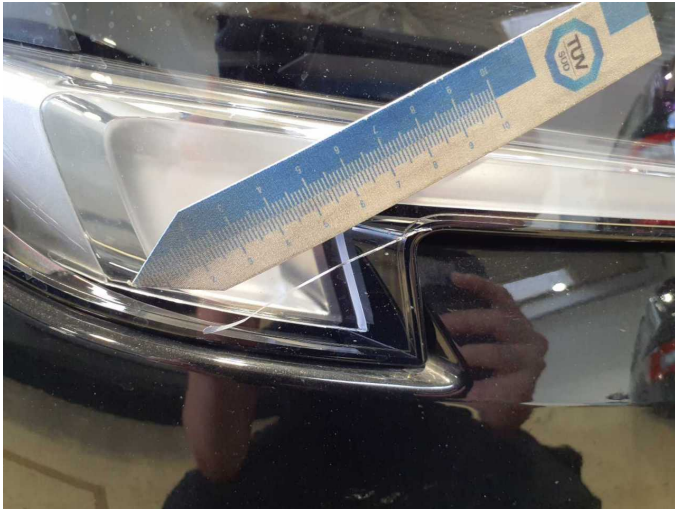
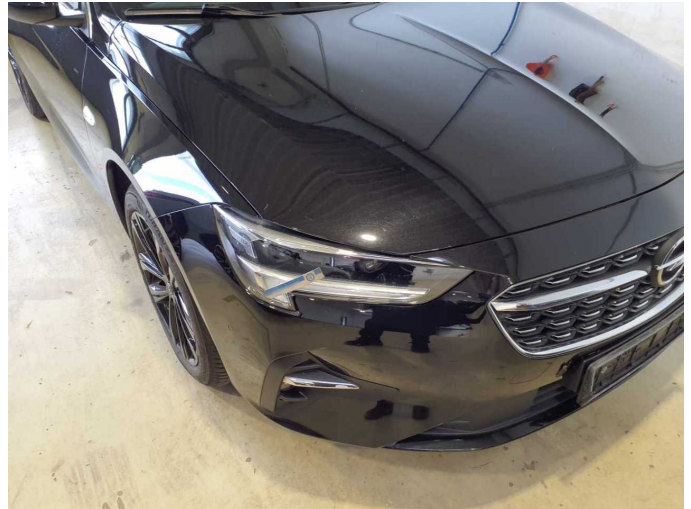
| No. | Component group | Description |
|---|---|---|
| 11 | Headlight | Headlight - right side - Damaged - Replace |

**Damage 11:** Headlight: Headlight - right side - Damaged - Replace

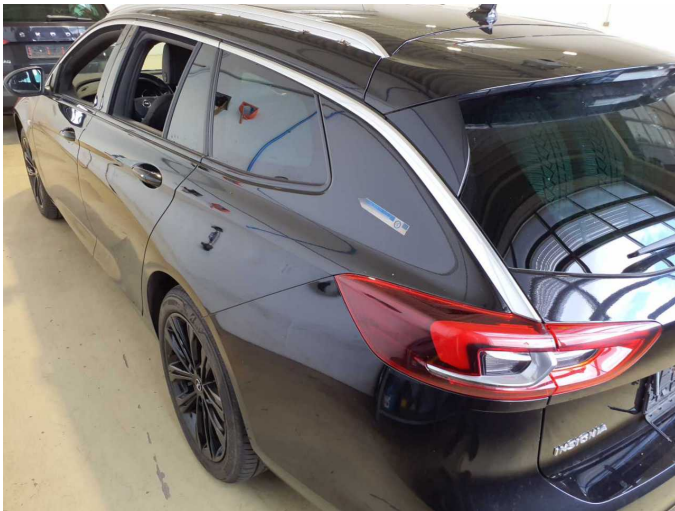
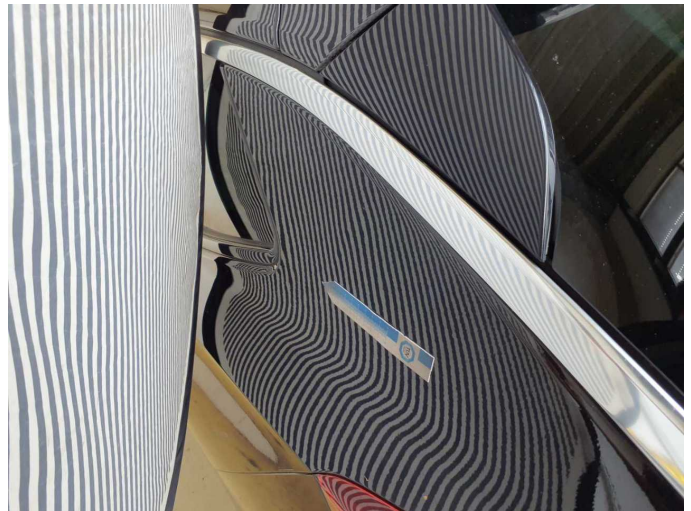
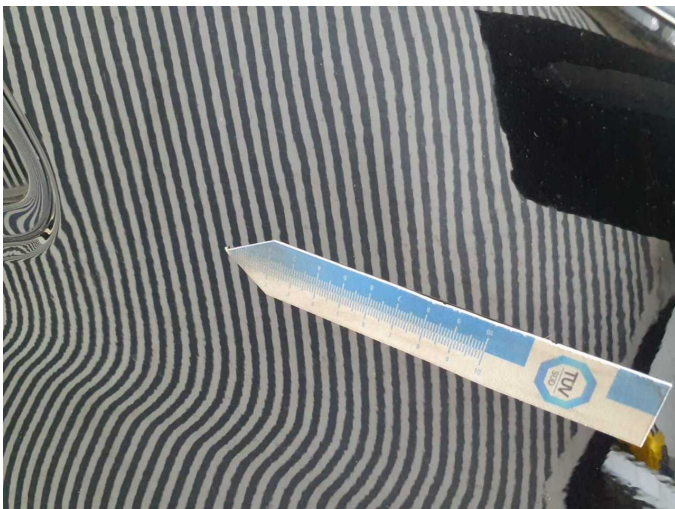
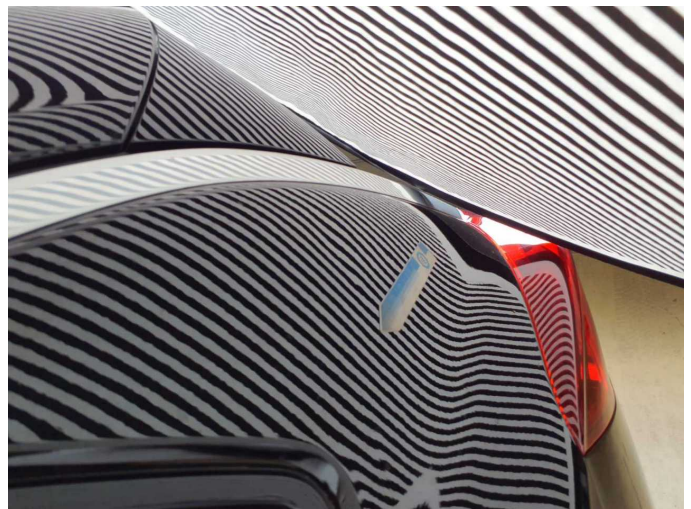
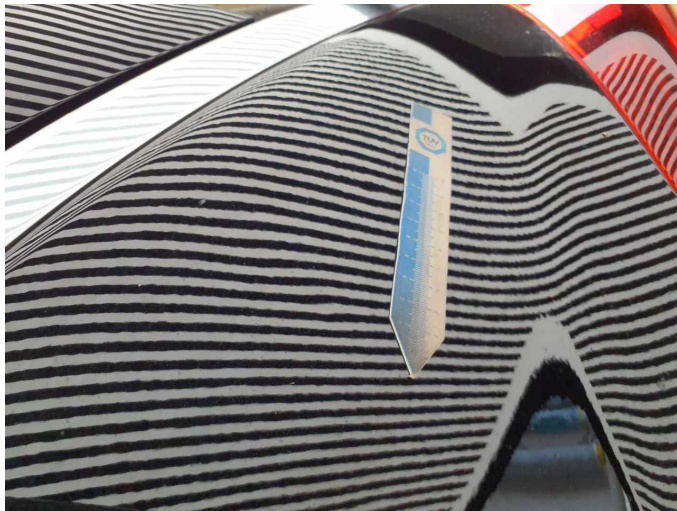
| No. | Component group | Description |
|---|---|---|
| 5 | Side panel - rear left side | Side panel - dent(s) - No deduction |

**Wear and tear 5:** Side panel - rear left side: Side panel - dent(s) - No deduction

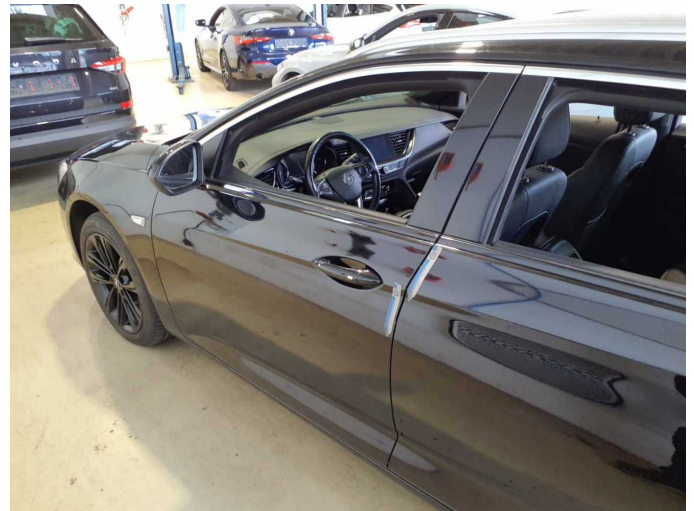
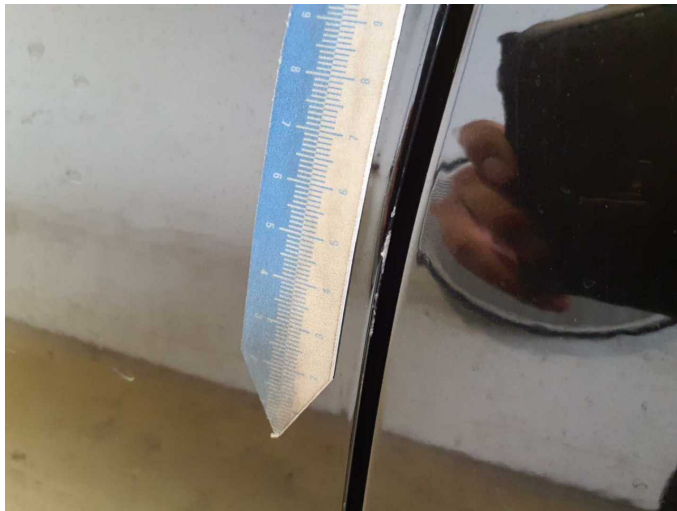
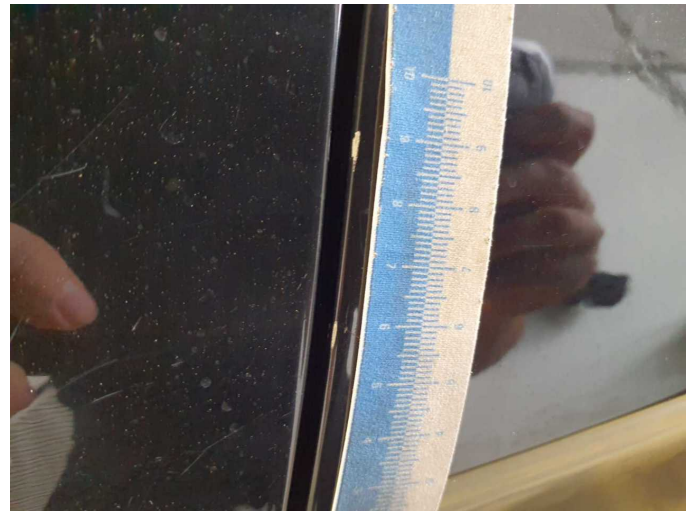
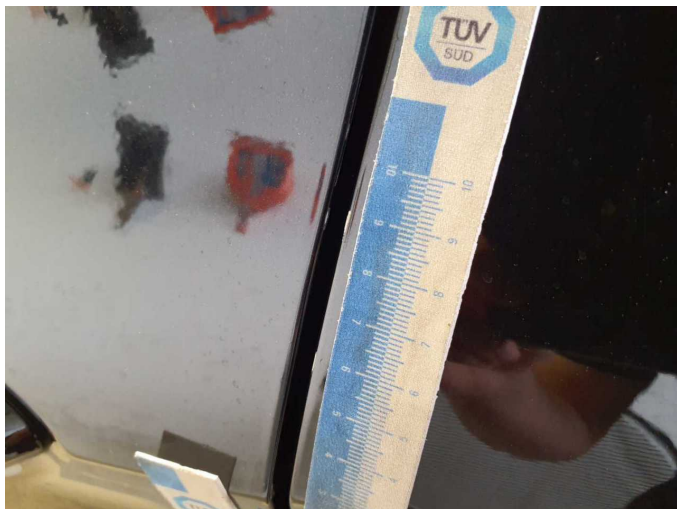
| No. | Component group | Description |
|---|---|---|
| 6 | Door - front left side | Door edge - Scratch(es) - No deduction |

**Wear and tear 6:** Door - front left side: Door edge - Scratch(es) - No deduction

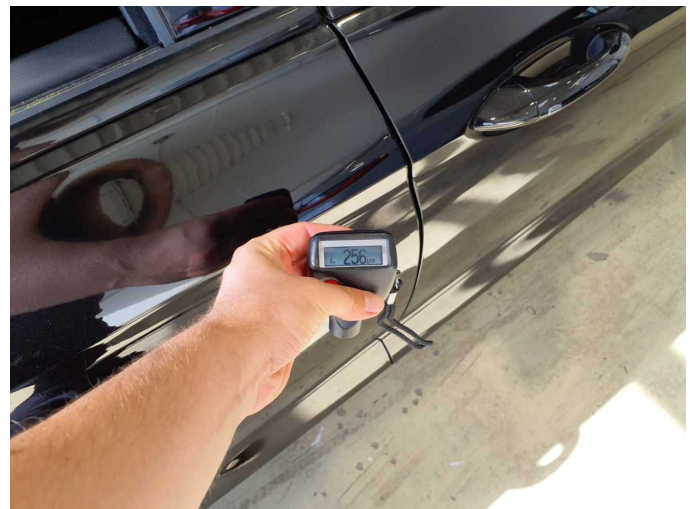
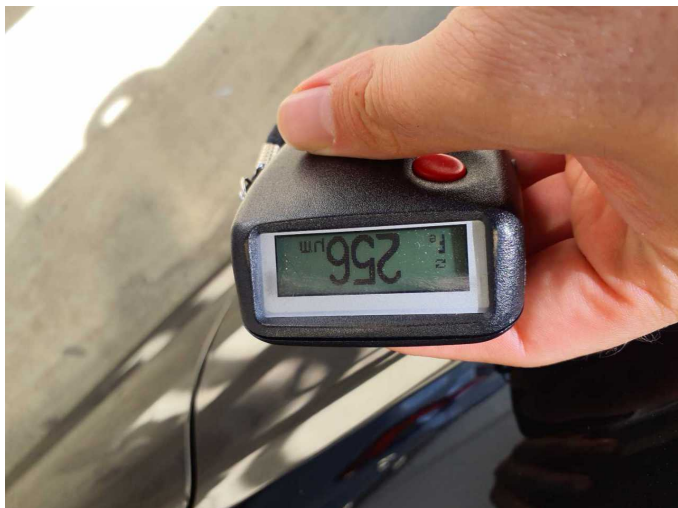
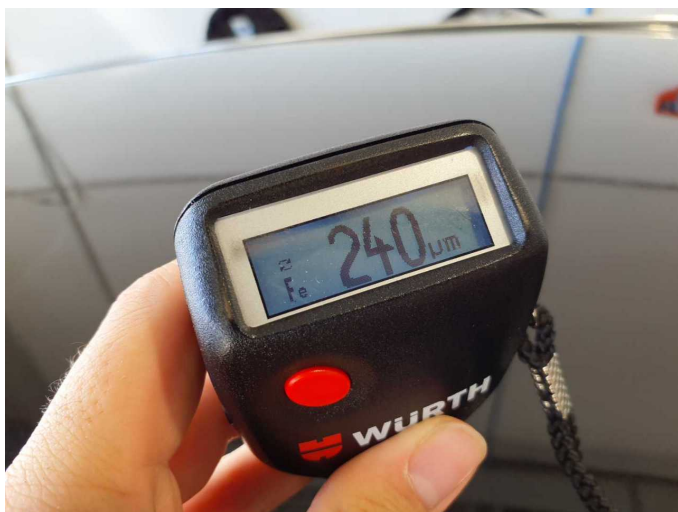
1 Roof, Door - rear right side, Professionally carried out, Invoice of repair done Non-existent

| Roof | 240 µm | Door - rear right side | 256 µm |

**Repainting 1:** Roof, Door - rear right side
