Expertise

Protocol number: 41323102  
Order No. / Reference: 25098484  
Inspection date: 29 Aug 2025

Manufacturer: Opel

Model: Insignia Sports Tourer 2.0 Diesel Business

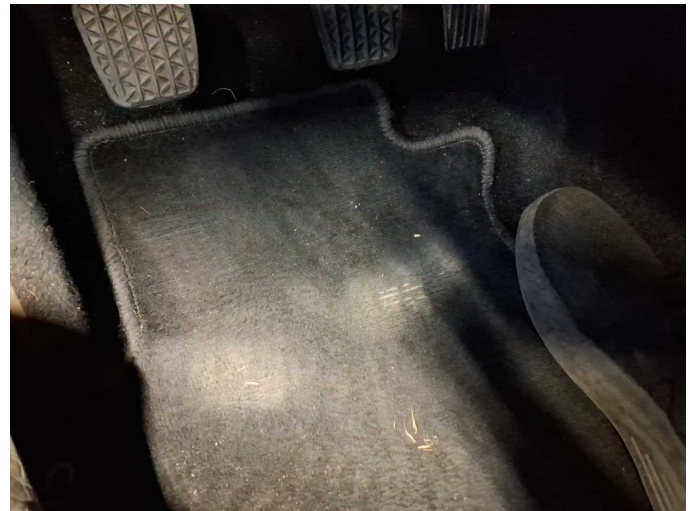
**Damage 2:** Trim / covers: Floor mats - Broken / torn - Replace

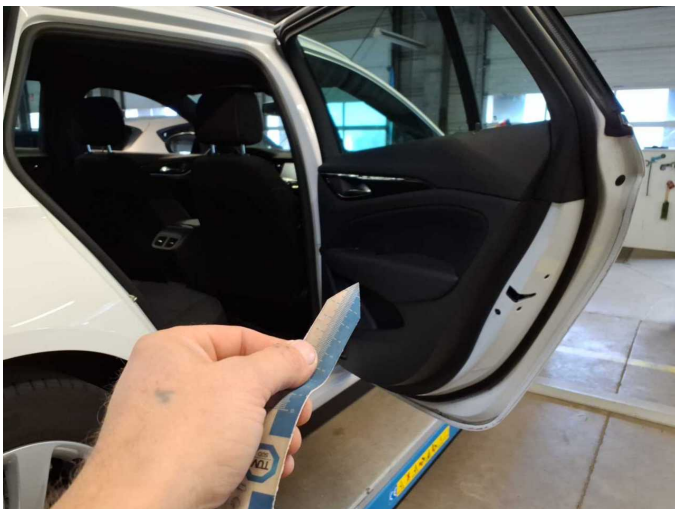
**Damage 3:** Trim / covers: Door trim - rear right side - Deformed - Smart repair

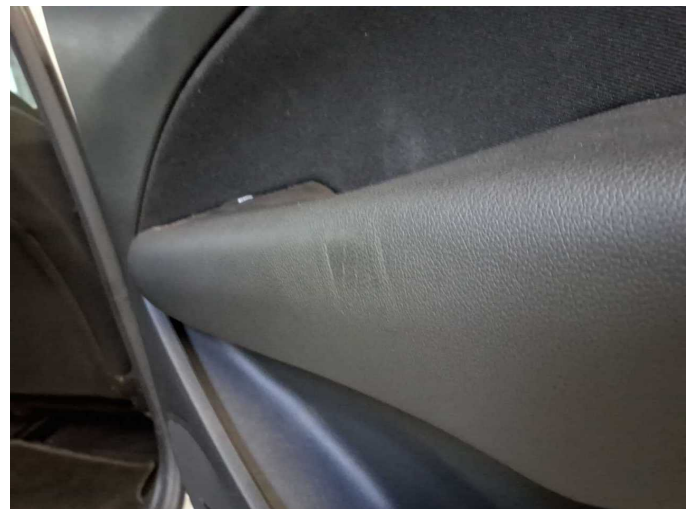
**Damage 3:** Trim / covers: Door trim - rear right side - Deformed - Smart repair

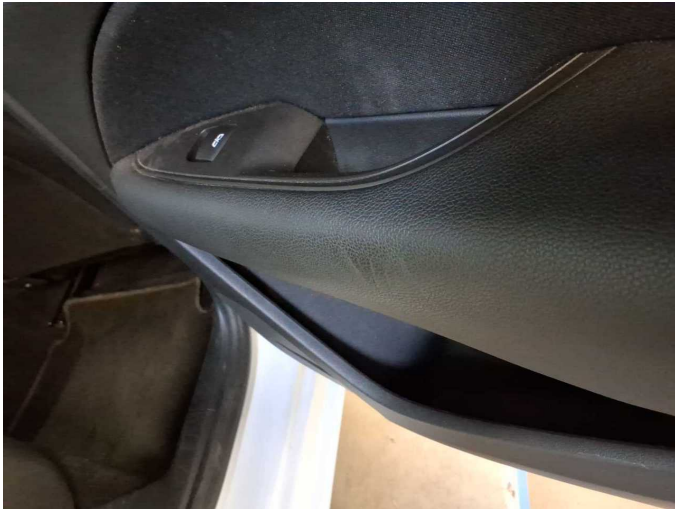
**Damage 3:** Trim / covers: Door trim - rear right side - Deformed - Smart repair

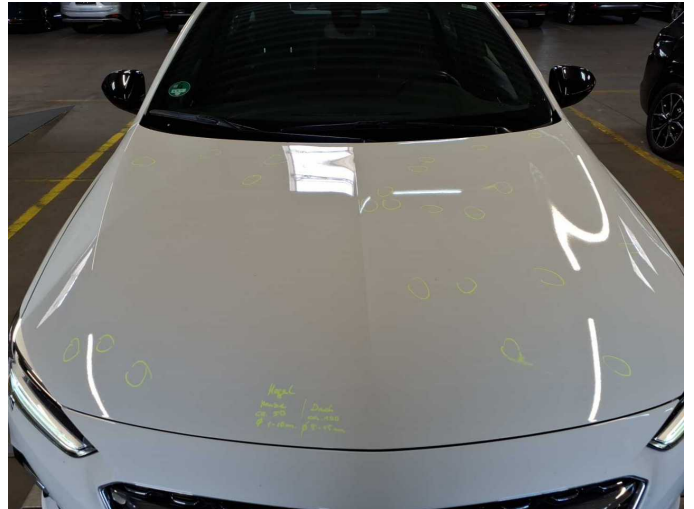
**Damage 4:** Body: Body - Damage by hail - repair according to calculation

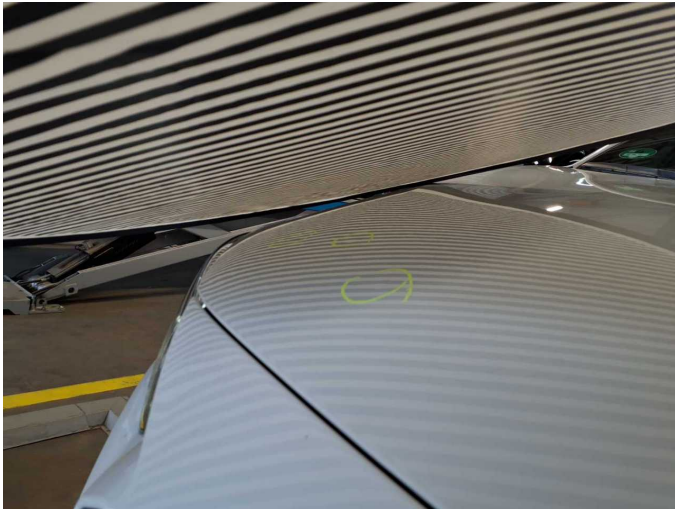
**Damage 4:** Body: Body - Damage by hail - repair according to calculation

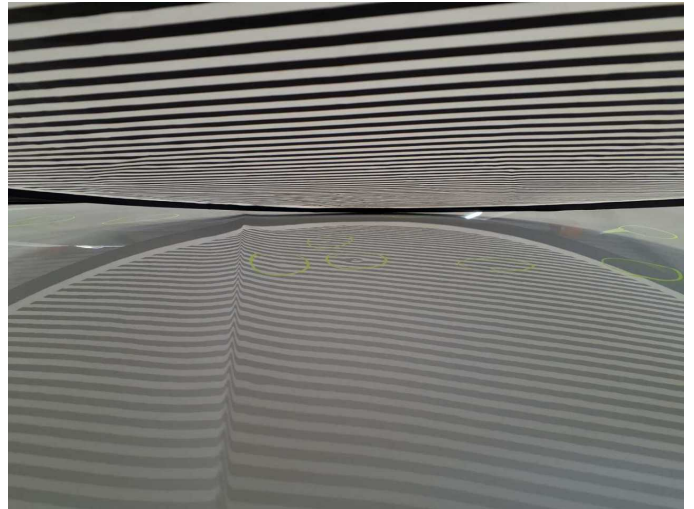
**Damage 4:** Body: Body - Damage by hail - repair according to calculation

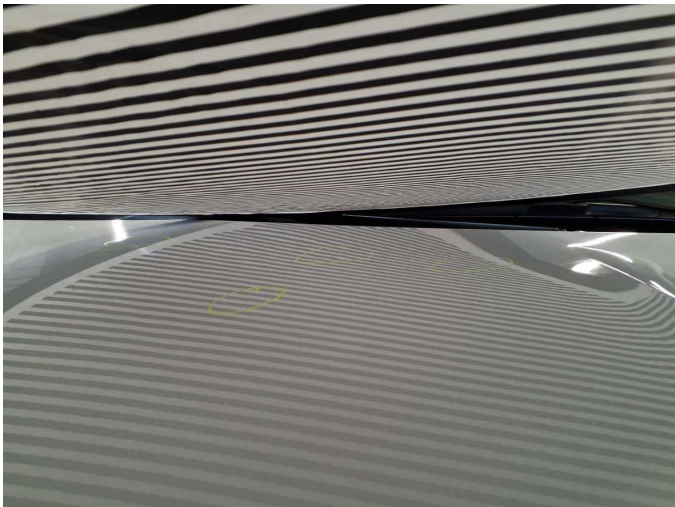
**Damage 4:** Body: Body - Damage by hail - repair according to calculation

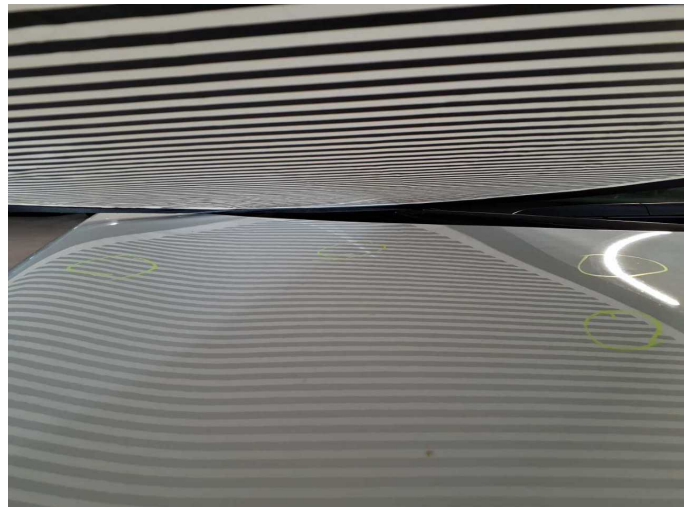
**Damage 4:** Body: Body - Damage by hail - repair according to calculation

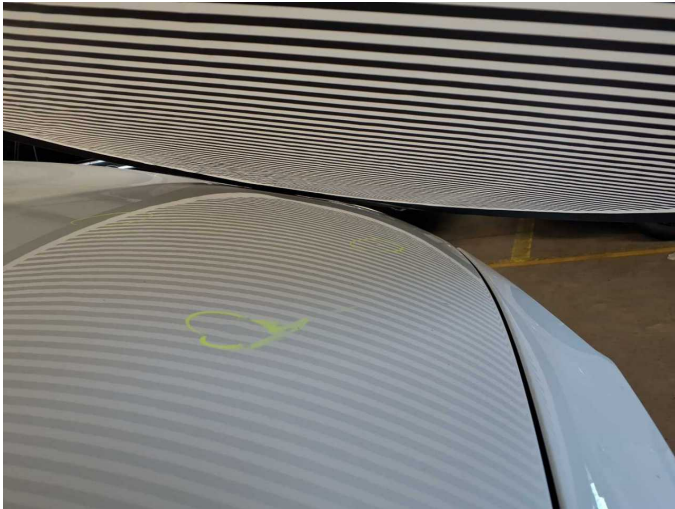
**Damage 4:** Body: Body - Damage by hail - repair according to calculation

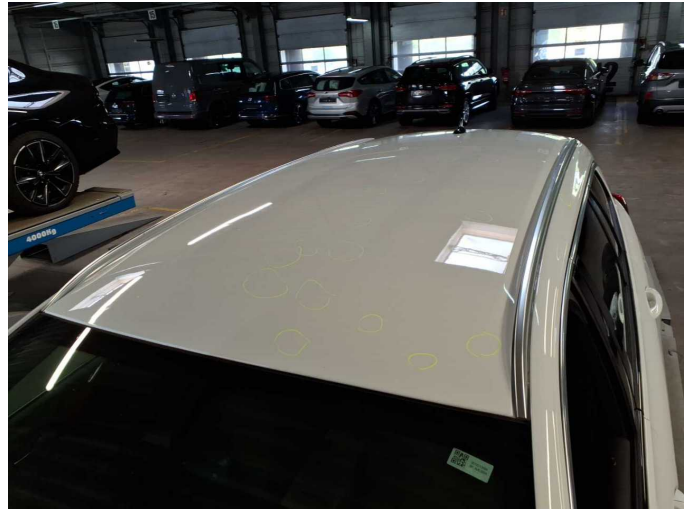
**Damage 4:** Body: Body - Damage by hail - repair according to calculation

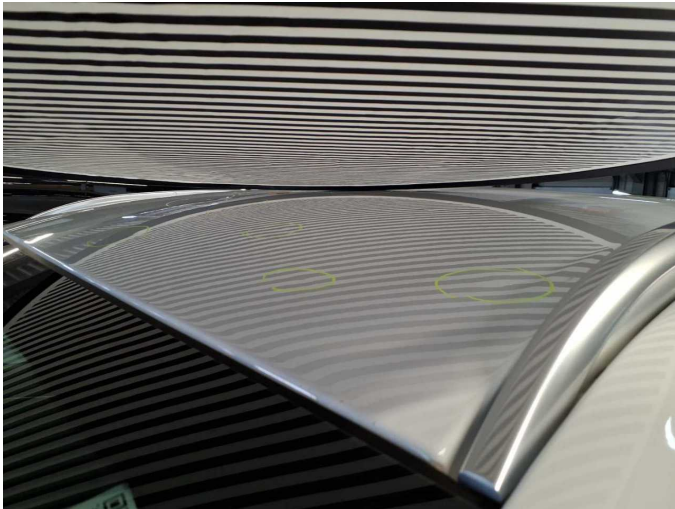
**Damage 4:** Body: Body - Damage by hail - repair according to calculation

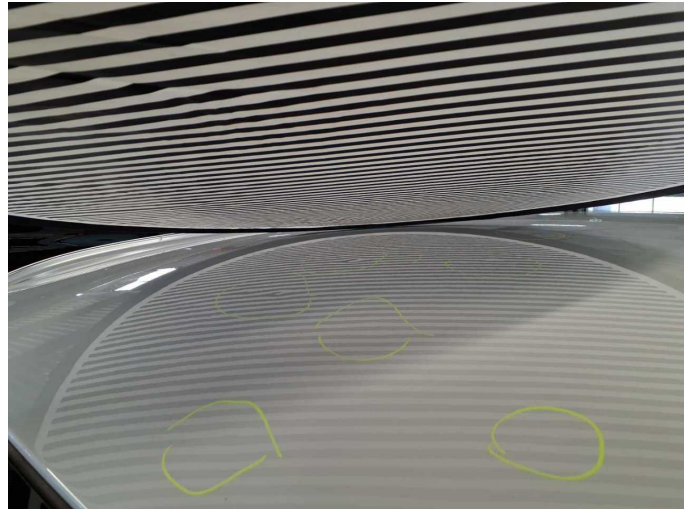
**Damage 4:** Body: Body - Damage by hail - repair according to calculation

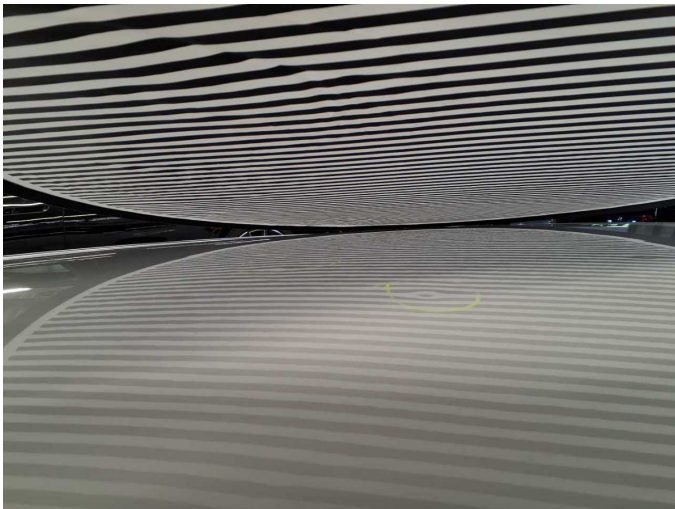
**Damage 4:** Body: Body - Damage by hail - repair according to calculation

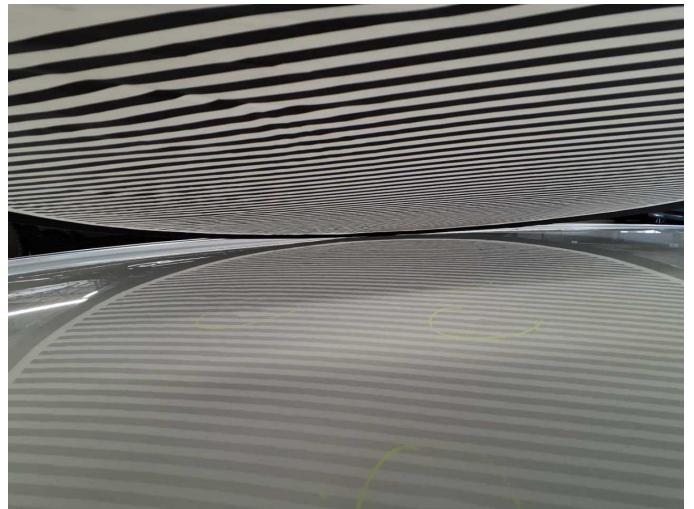
**Damage 4:** Body: Body - Damage by hail - repair according to calculation
