Expertise

Protocol number: 41207452  
Order No. / Reference: 25084960  
Inspection date: 21 Aug 2025

Manufacturer: Opel

Model: Insignia Sports Tourer 2.0 Diesel Aut. Business

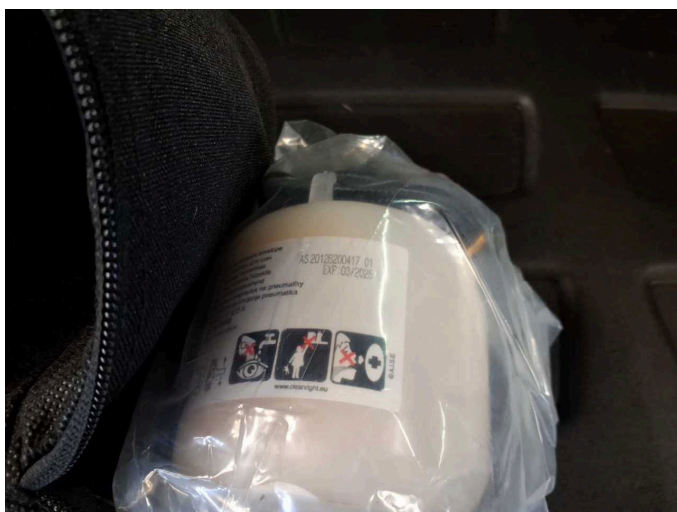
Damage 1: Equipment: Tirefit filler - Expired - Replace

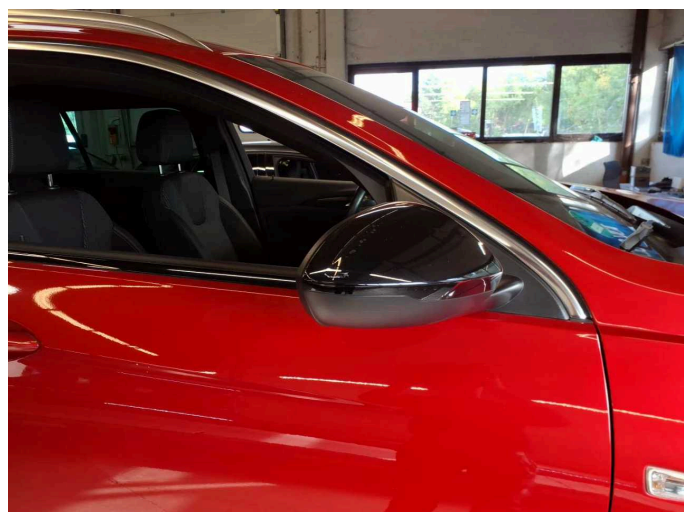
Damage 2: Wing mirror - right side: Cap - Scratch(es) - Smart repair

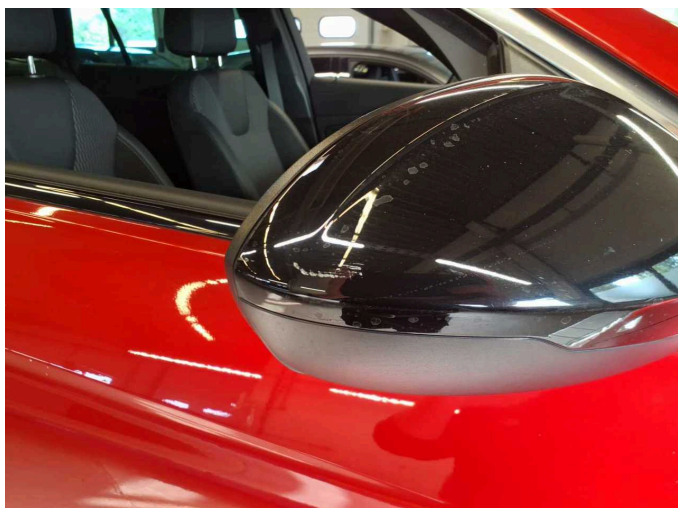
**Damage 2:** Wing mirror - right side: Cap - Scratch(es) - Smart repair

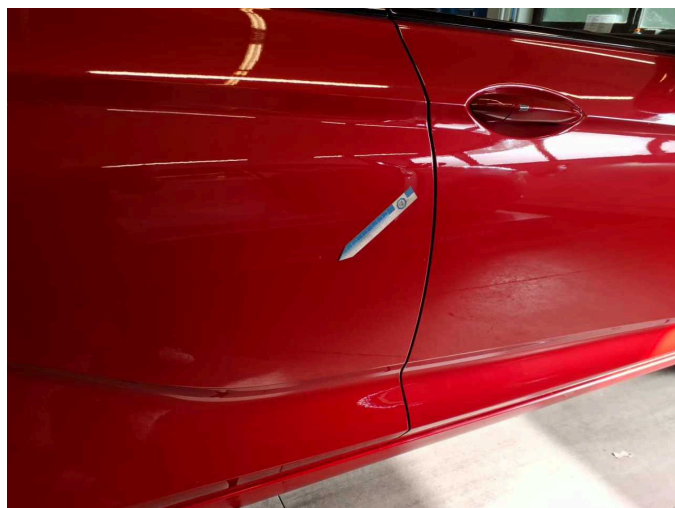
**Damage 3:** Door - rear right side: Door - Scratch(es) - Smart repair

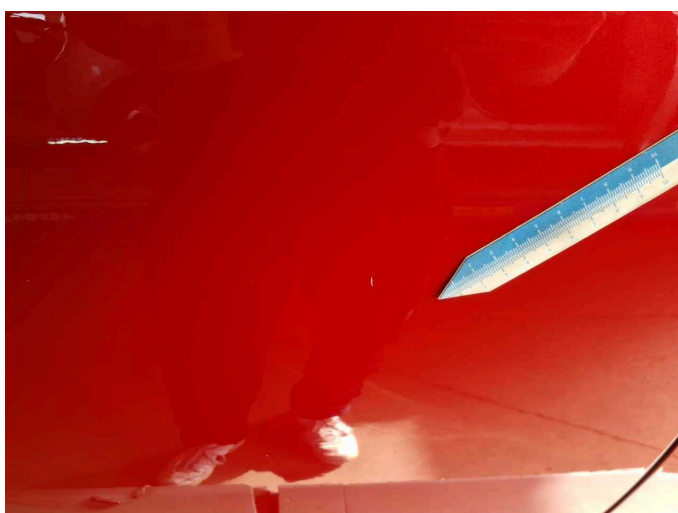
**Damage 3:** Door - rear right side: Door - Scratch(es) - Smart repair

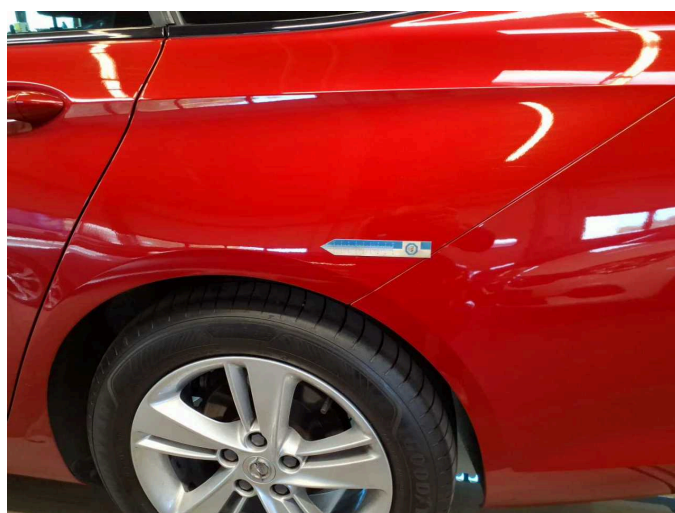
**Damage 4:** Side panel - rear left side: Side panel - Scratch(es) - Smart repair

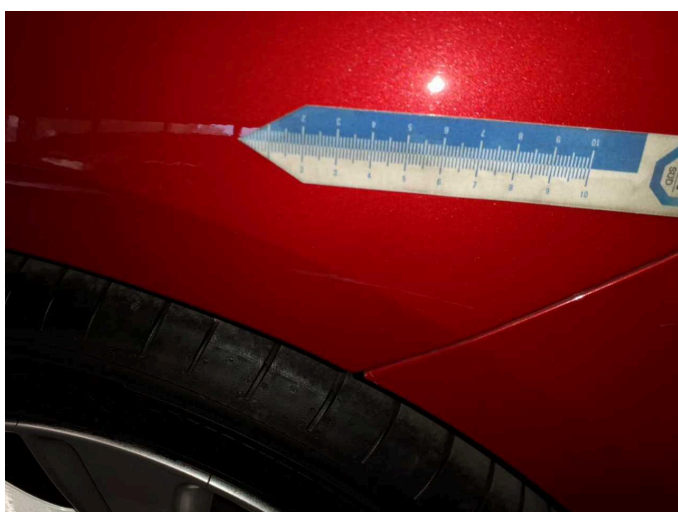
**Damage 4:** Side panel - rear left side: Side panel - Scratch(es) - Smart repair

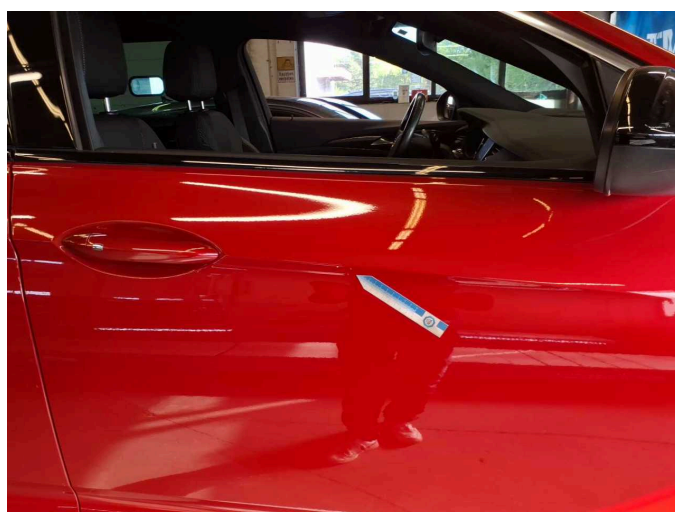
**Damage 5:** Door - front right side: Door - Stone chips - Smart repair

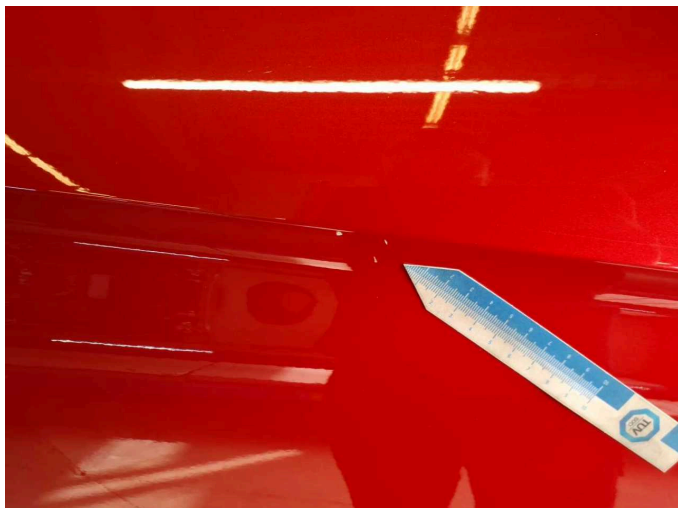
**Damage 5:** Door - front right side: Door - Stone chips - Smart repair

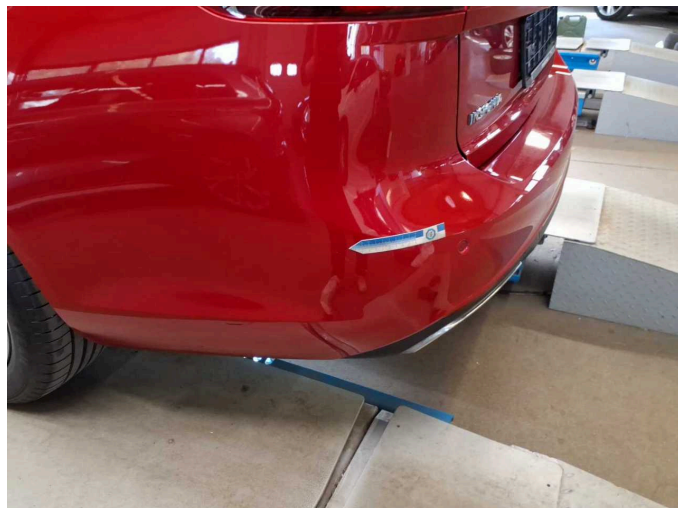
**Damage 6:** Rear bumper: Rear bumper - Scratch(es) - Smart repair

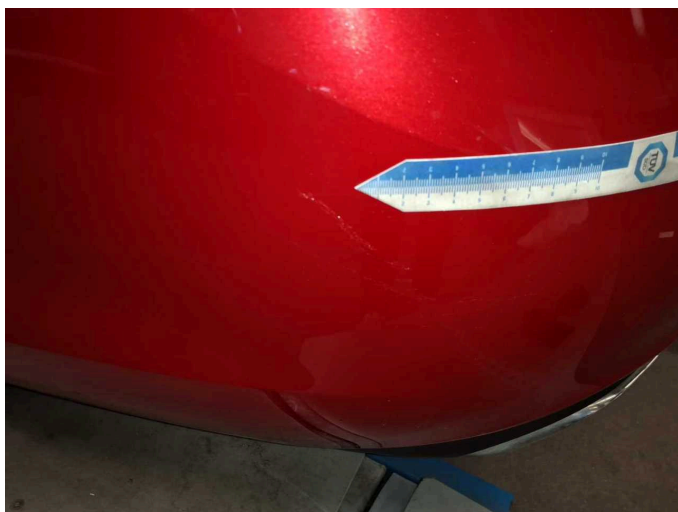
**Damage 6:** Rear bumper: Rear bumper - Scratch(es) - Smart repair

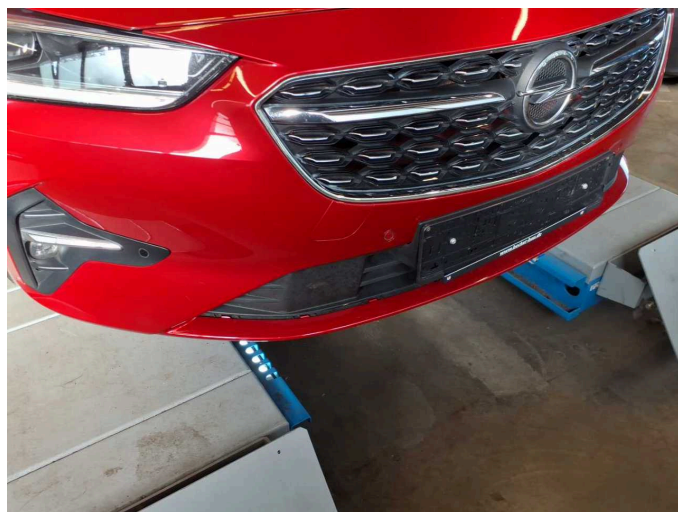
**Damage 7:** Front bumper: Grille - Malposition - Repair

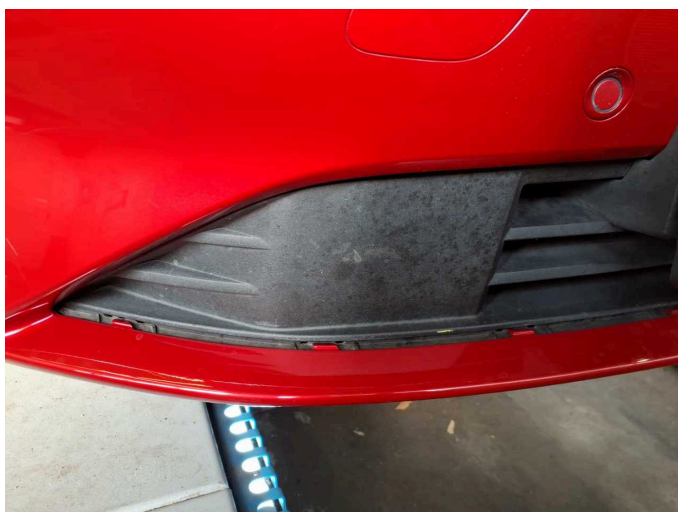
**Damage 7:** Front bumper: Grille - Malposition - Repair

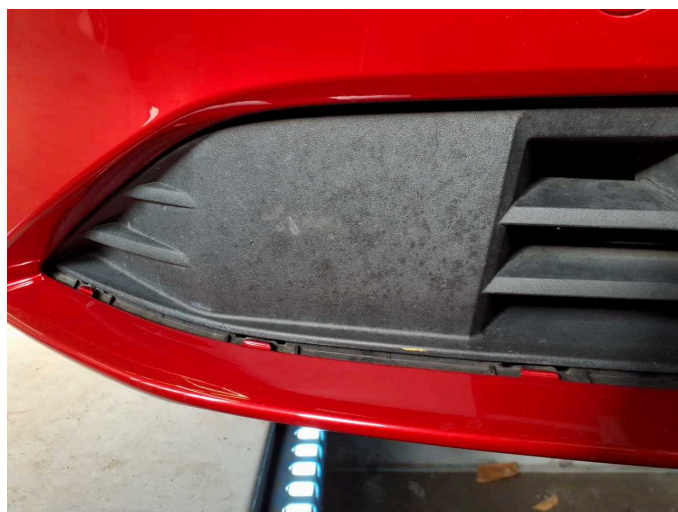
**Damage 7:** Front bumper: Grille - Malposition - Repair

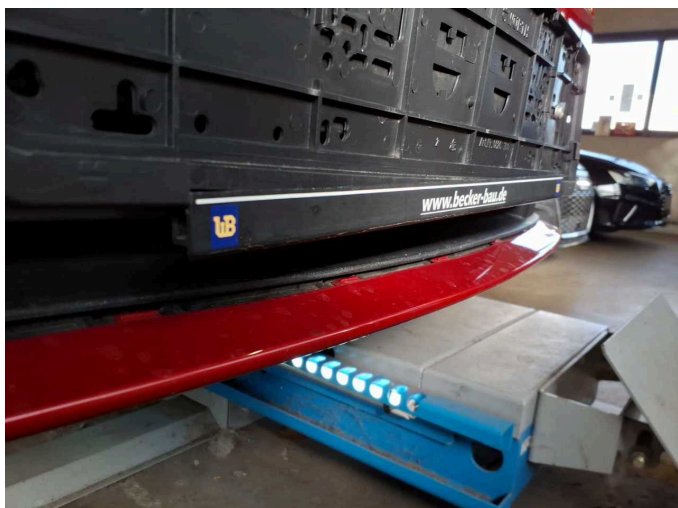
**Damage 7:** Front bumper: Grille - Malposition - Repair

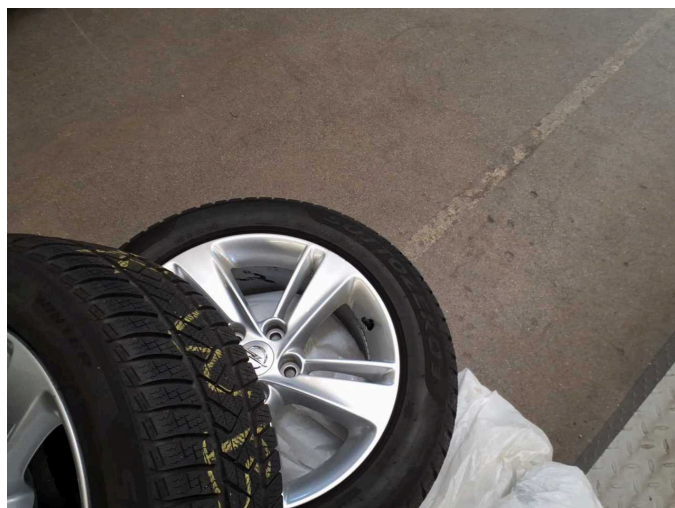
**Damage 8:** 2nd wheel set: 1 alloy rim - Scratch(es) - Loss in value

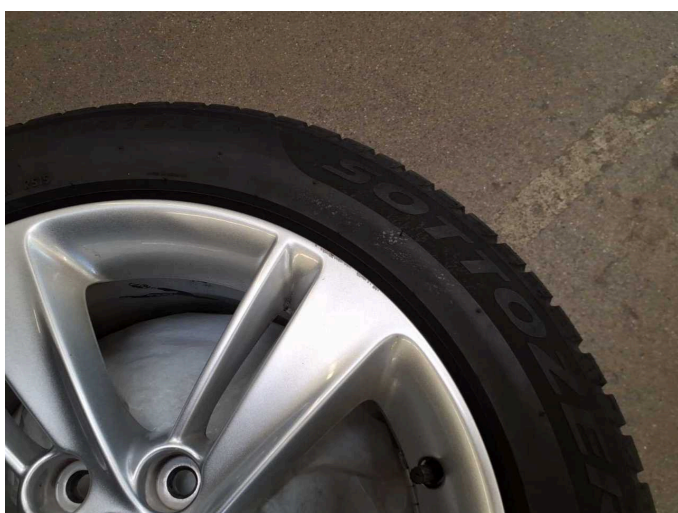
**Damage 8:** 2nd wheel set: 1 alloy rim - Scratch(es) - Loss in value

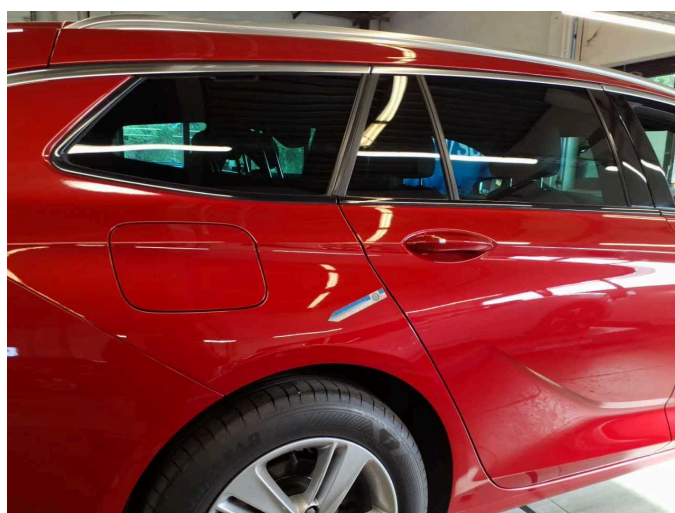
**Damage 9:** Side panel - rear right side: Side panel (Vogelkotverätzung + Kratzer) - Paint defect - Paint

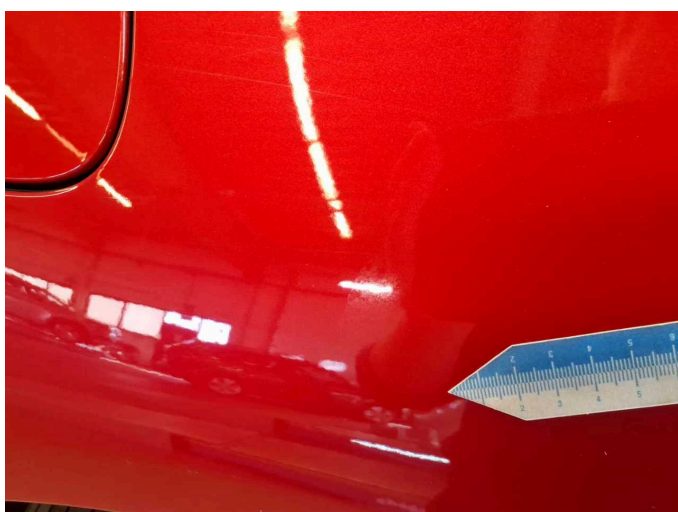
**Damage 9:** Side panel - rear right side: Side panel (Vogelkotverätzung + Kratzer) - Paint defect - Paint

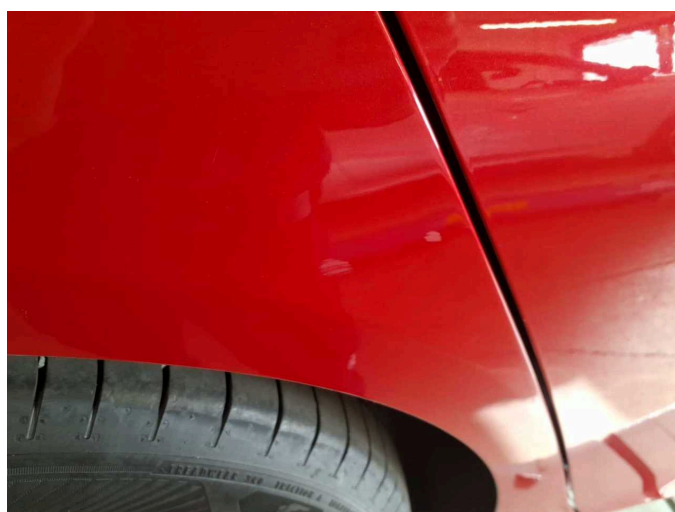
**Damage 9:** Side panel - rear right side: Side panel (Vogelkotverätzung + Kratzer) - Paint defect - Paint

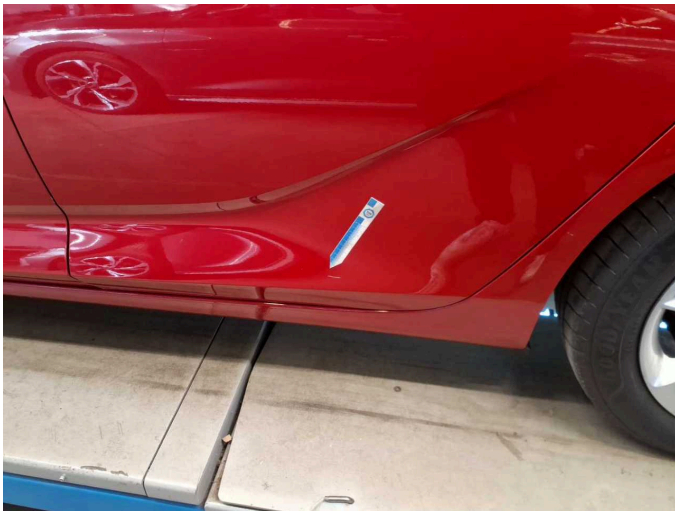
**Damage 10:** Door - rear left side: Door - Scratch(es) - Paint

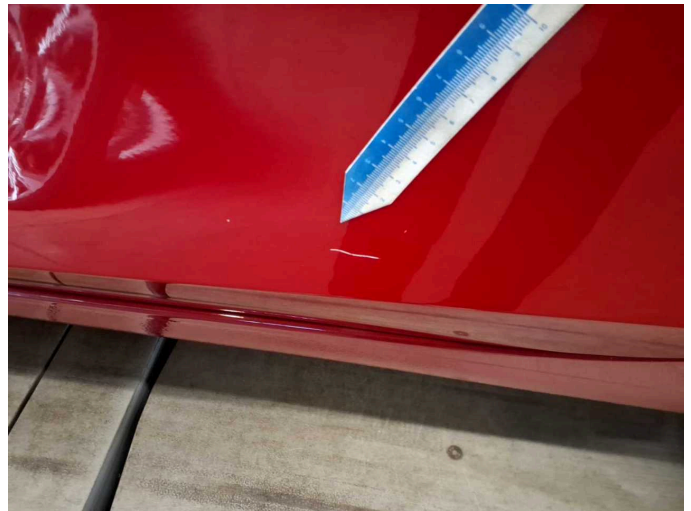
**Damage 10:** Door - rear left side: Door - Scratch(es) - Paint

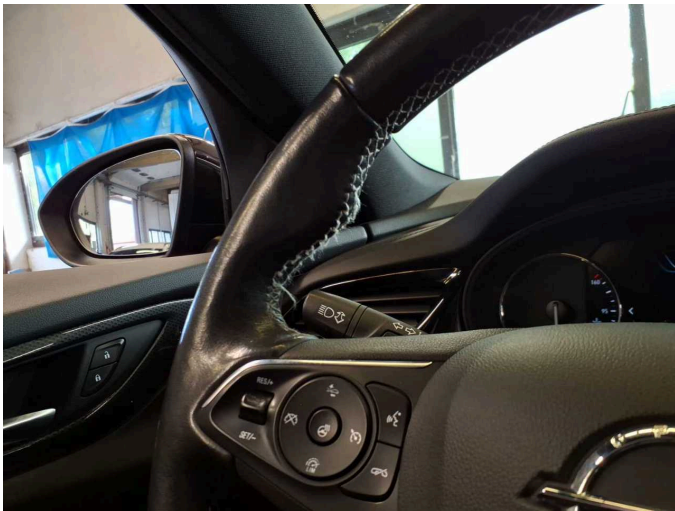
**Wear and tear 2:** Steering system: Steering wheel sheath (Nähte) - Worn - No deduction

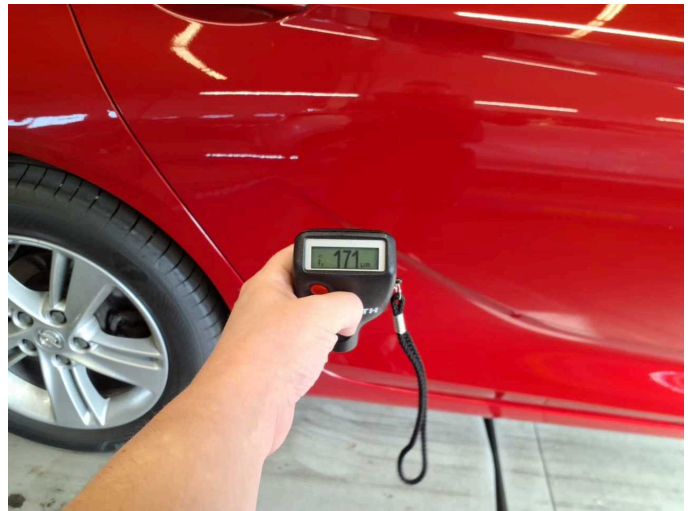
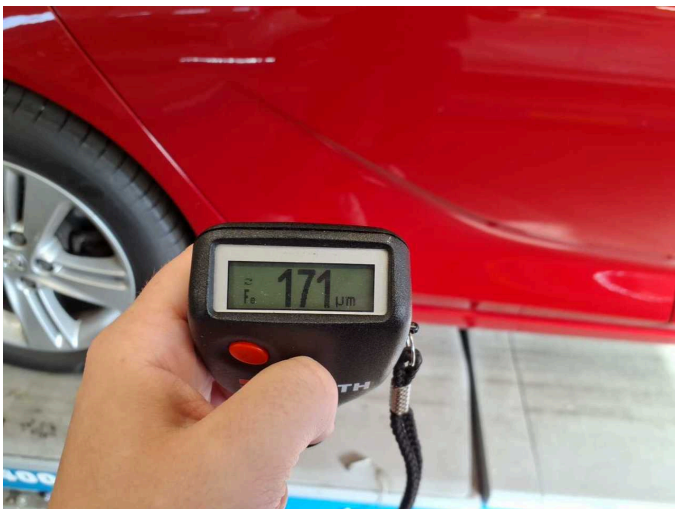
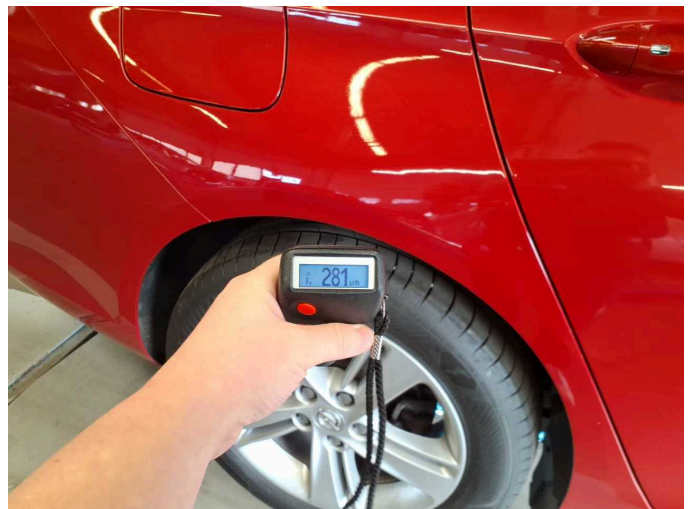
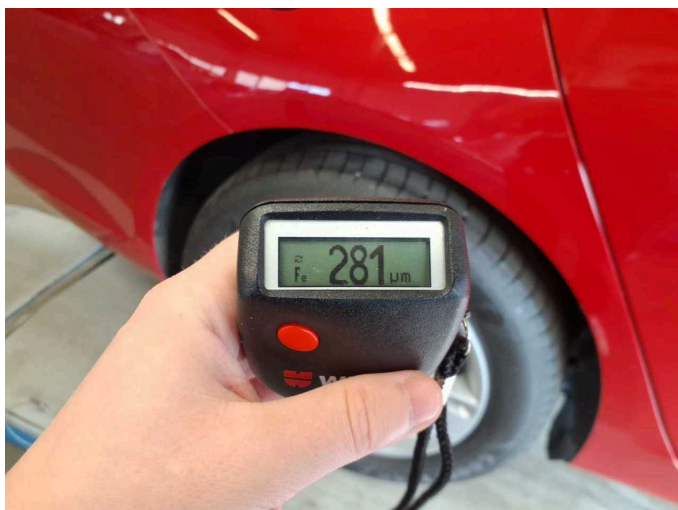
No.	Repainting
1	Side panel - rear right side, Door - rear right side, Professionally carried out, Invoice of repair done Non-existent

Side panel - rear right side	281 µm	Door - rear right side	171 µm
------------------------------	--------	------------------------	--------

**Repainting 1:** Side panel - rear right side, Door - rear right side
