Expertise

Protocol number: 41177463
Order No. / Reference: 24894279
Inspection date: 15 Aug 2025

Manufacturer: Opel

Model: Insignia Sports Tourer 2.0 Direct InjectionTurbo GSI

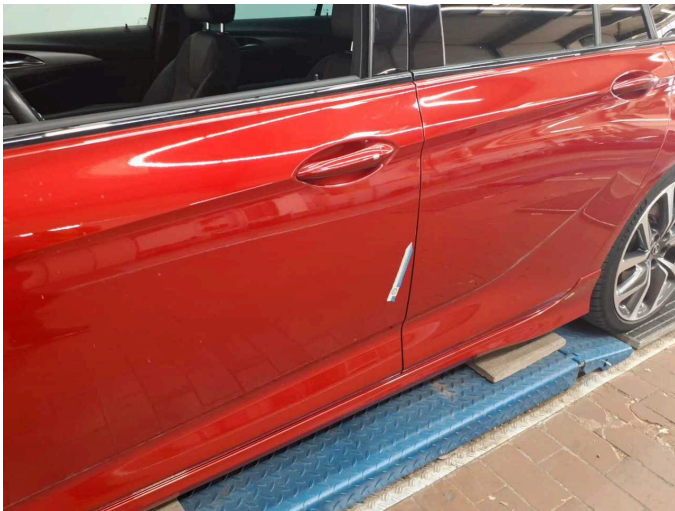
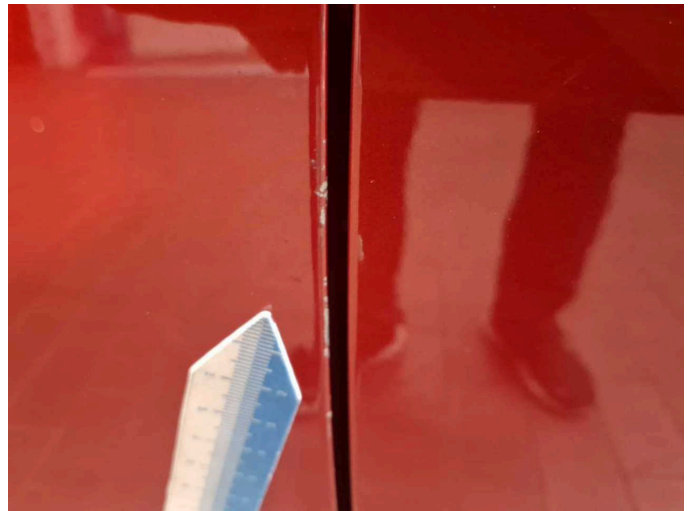
Damage 1: Door - front left side: Door - Scratch(es) - Smart repair

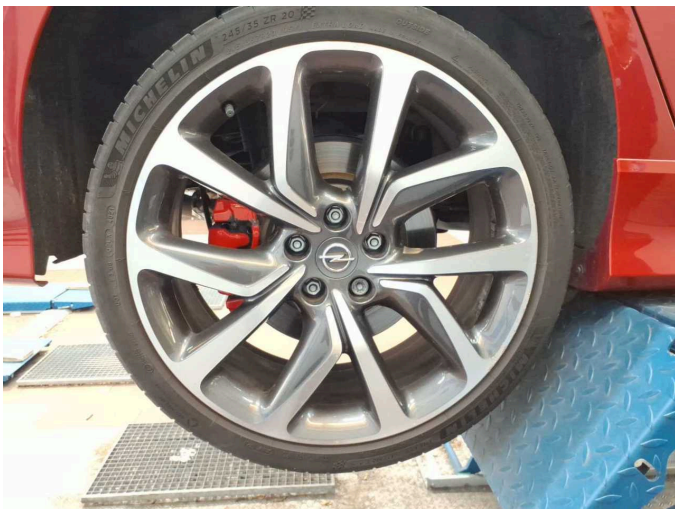
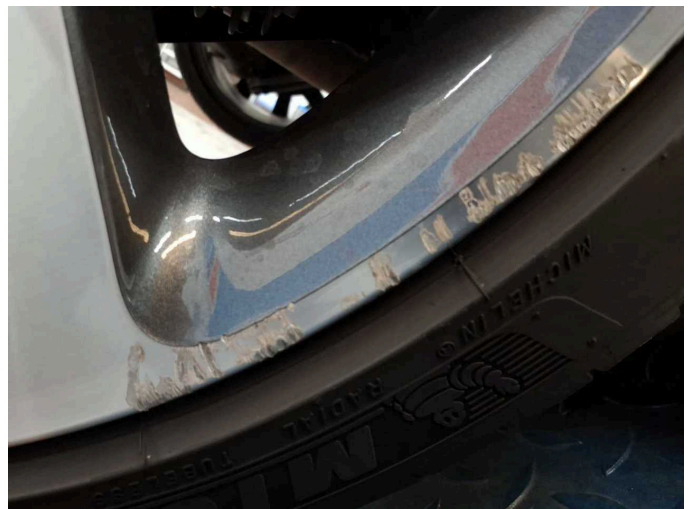
Damage 2: Wheel / tyres: Alloy rim - rear right side - Scratch(es) - Loss in value

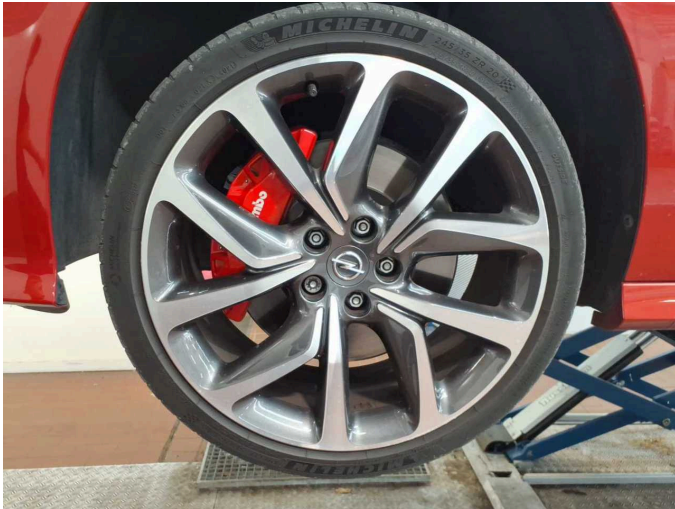
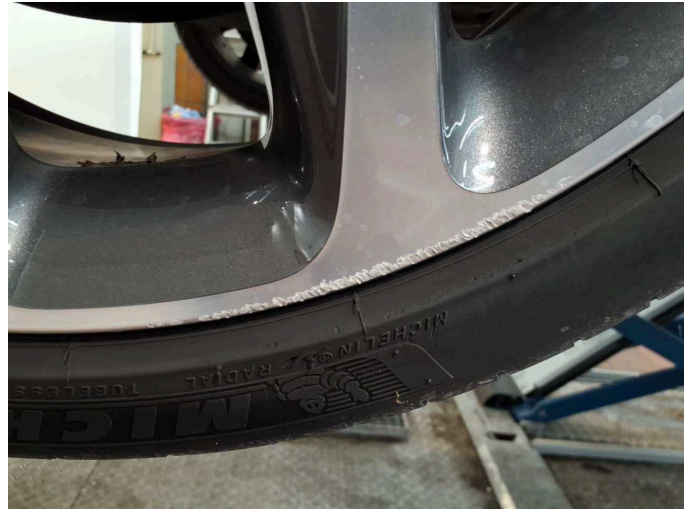
Damage 3: Wheel / tyres: Alloy rim - front left side - Scratch(es) - Loss in value

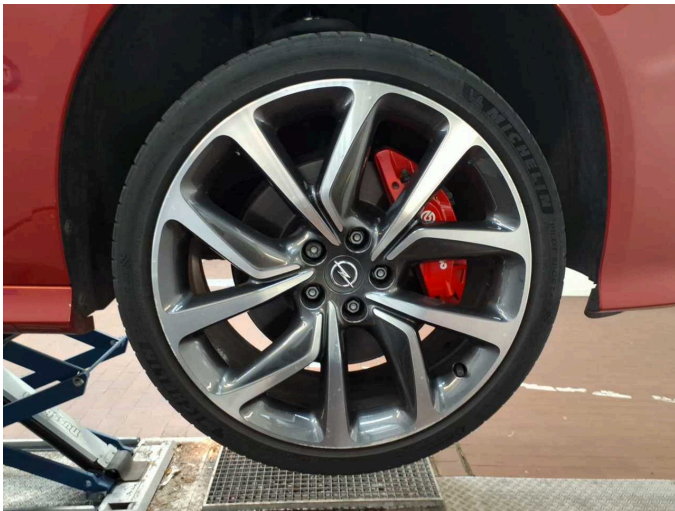
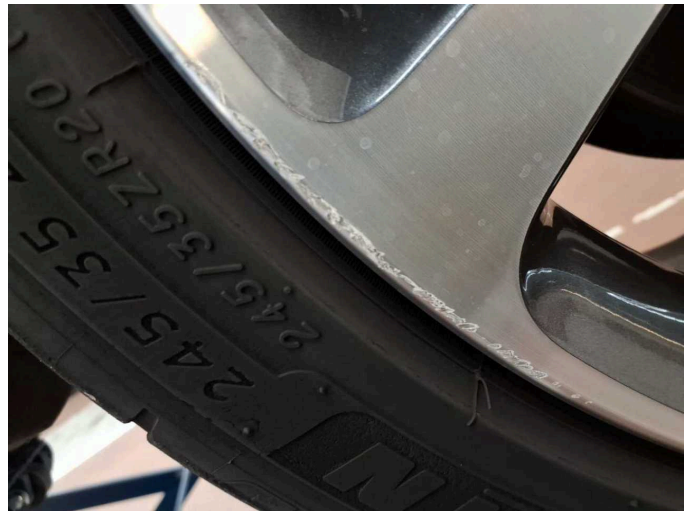
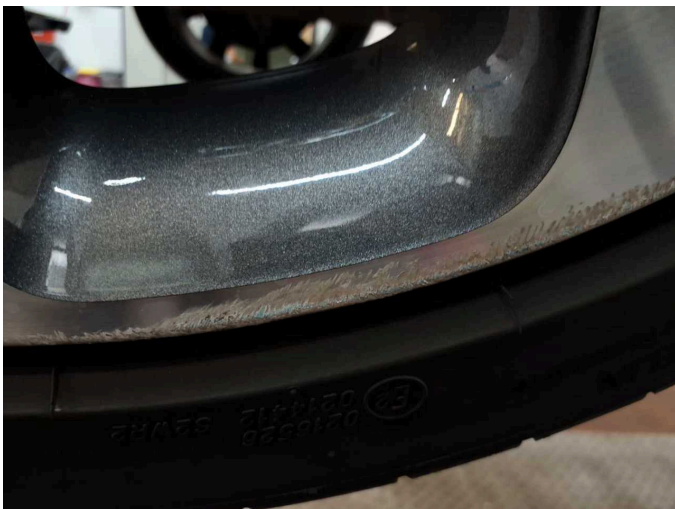
Damage 4: Wheel / tyres: Alloy rim - front right side - Scratch(es) - Loss in value

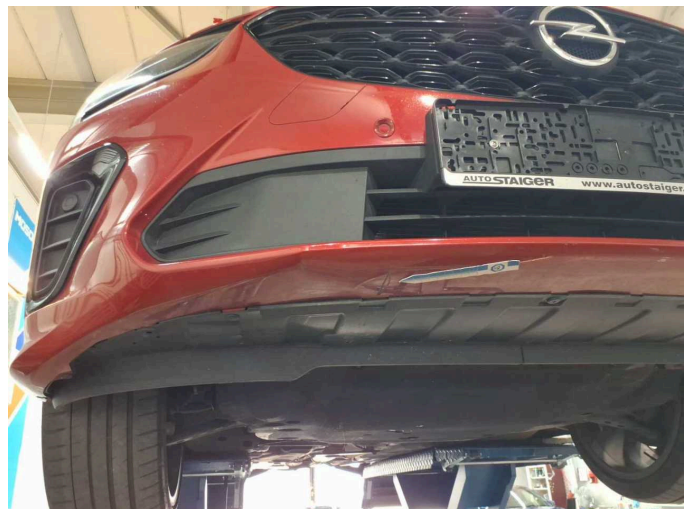
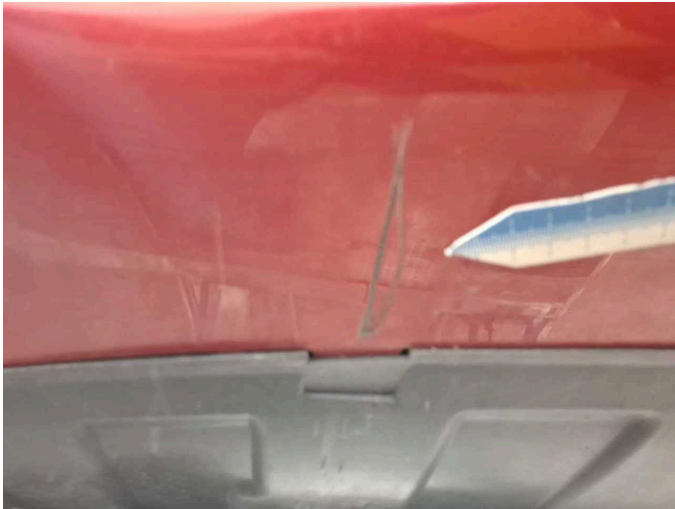
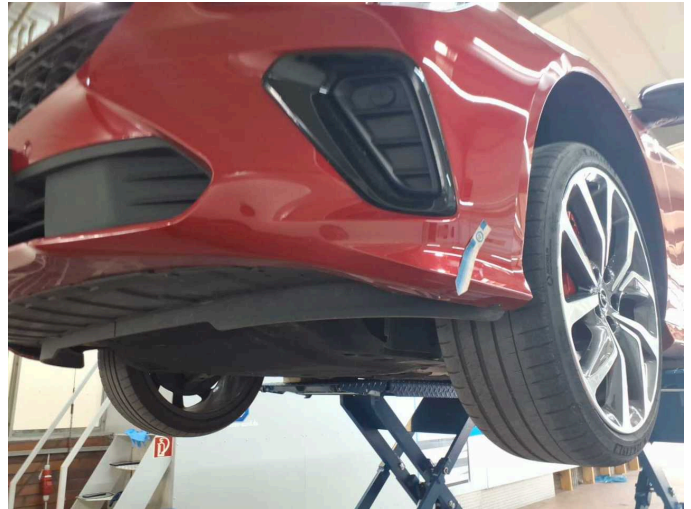
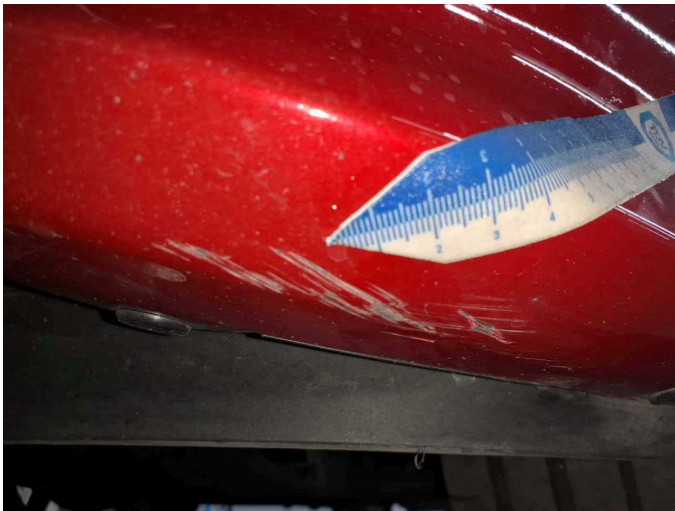
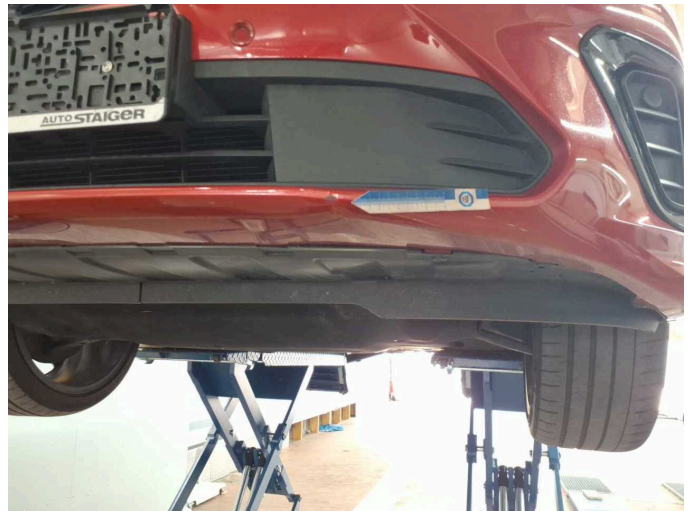
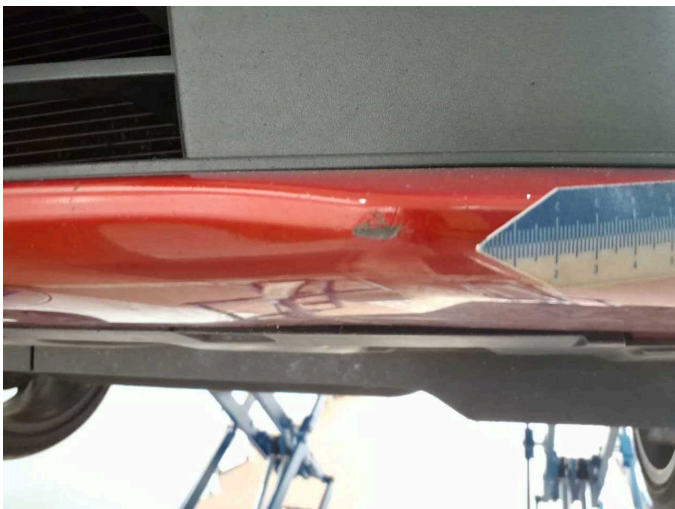
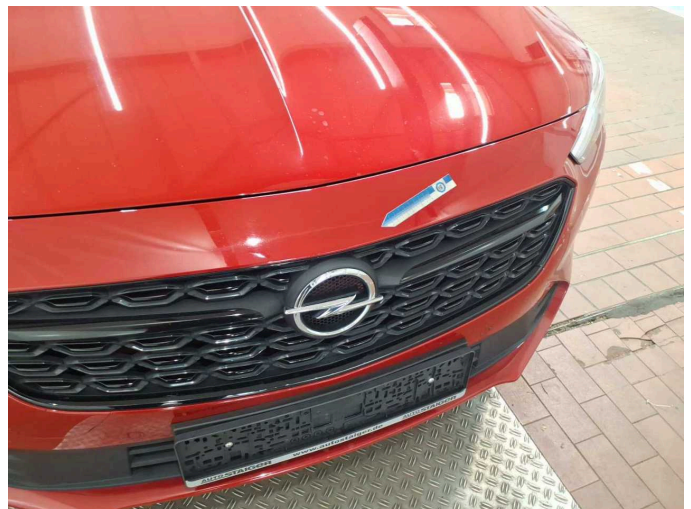
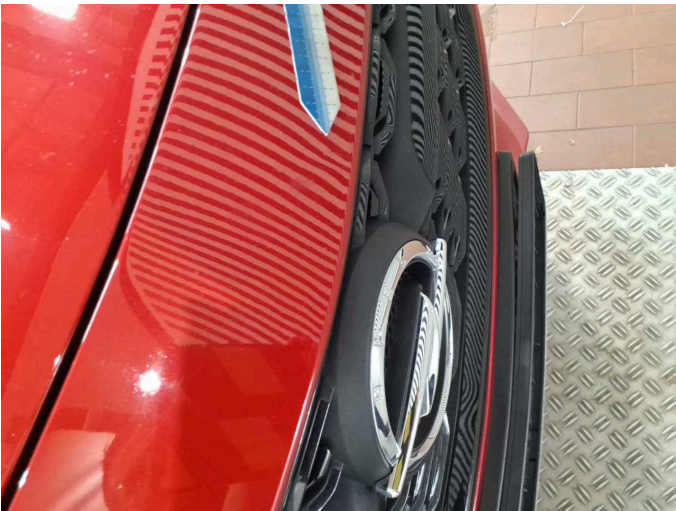
Damage 5: Front bumper: Front bumper - Dent / paintcoat damage - Repair and paint

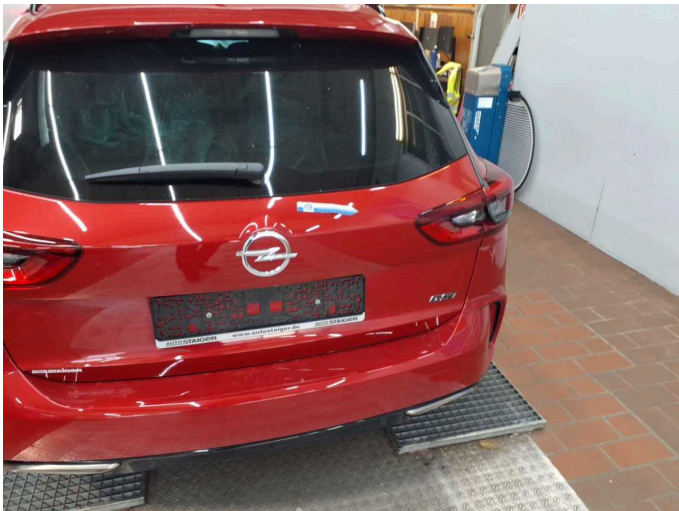
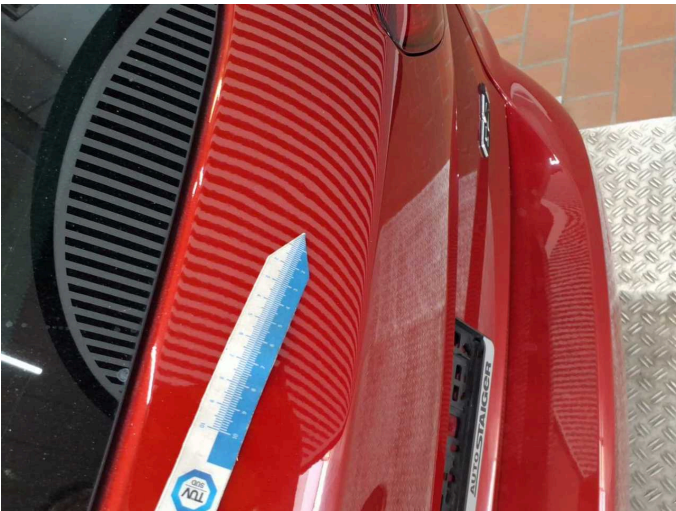
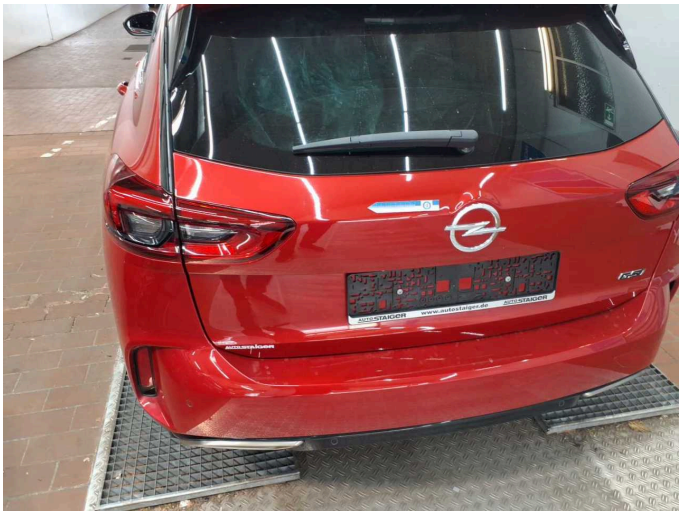
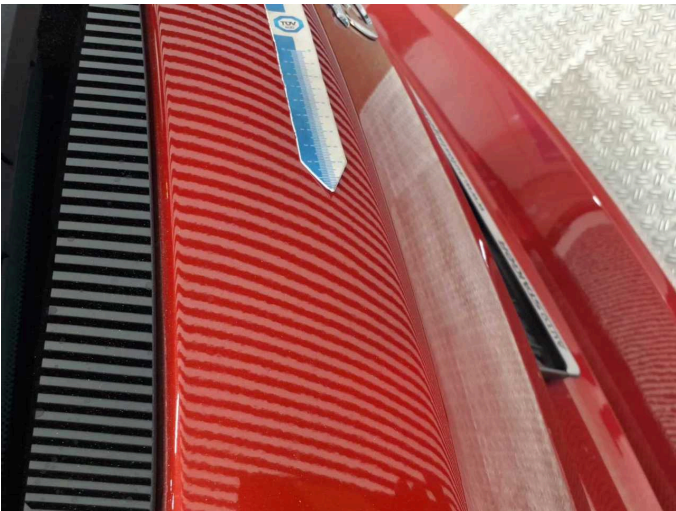
Wear and tear 3: Boot lid / rear door: Boot lid - dent(s) - No deduction
