Expertise

Protocol number: 41431239  
Order No. / Reference: 25120433-1  
Inspection date: 3 Sept 2025

Manufacturer: SMART	Model: fortwo coupe EQ
VIN: W1A4533911K474306

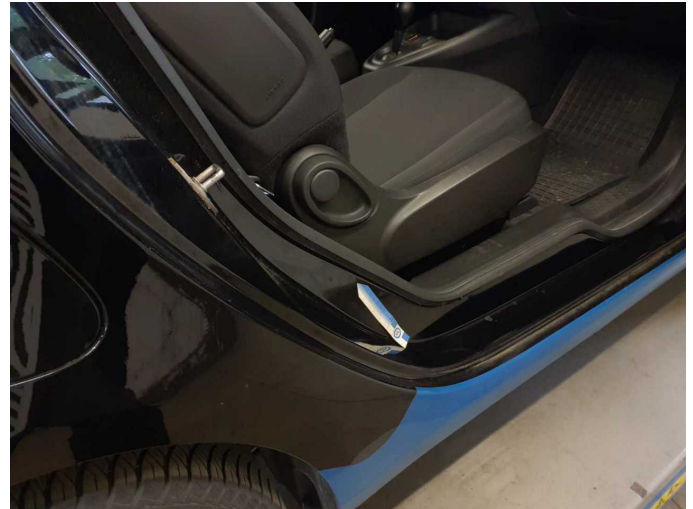
**Damage 1:** Side panel - rear right side: Sill (1) - dent(s) - Smart repair

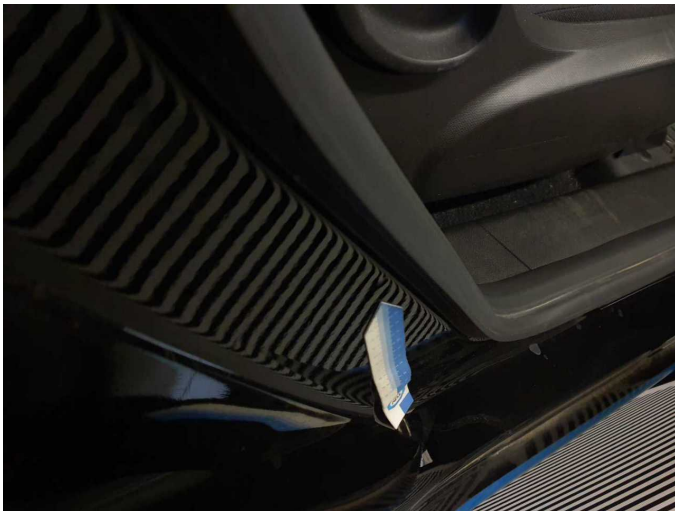
**Damage 1:** Side panel - rear right side: Sill (1) - dent(s) - Smart repair

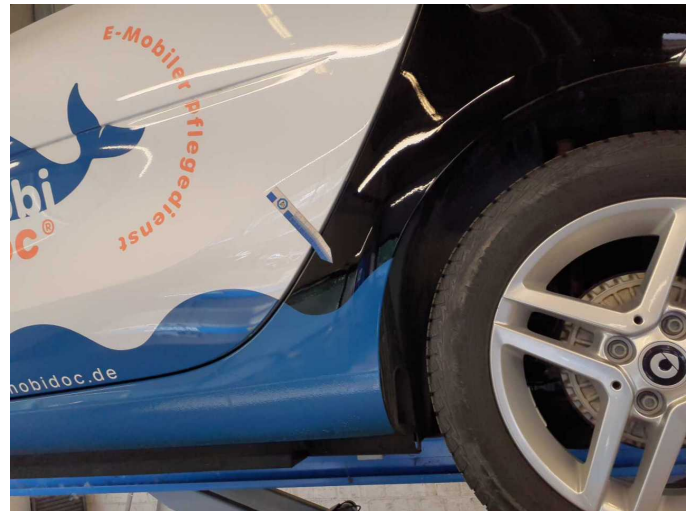
**Damage 2:** Side panel - rear left side: Elbow (1) - dent(s) - Smart repair

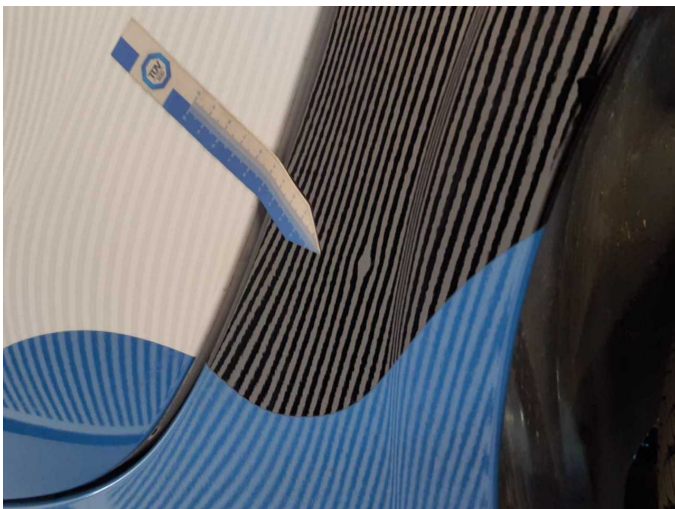
**Damage 2:** Side panel - rear left side: Elbow (1) - dent(s) - Smart repair

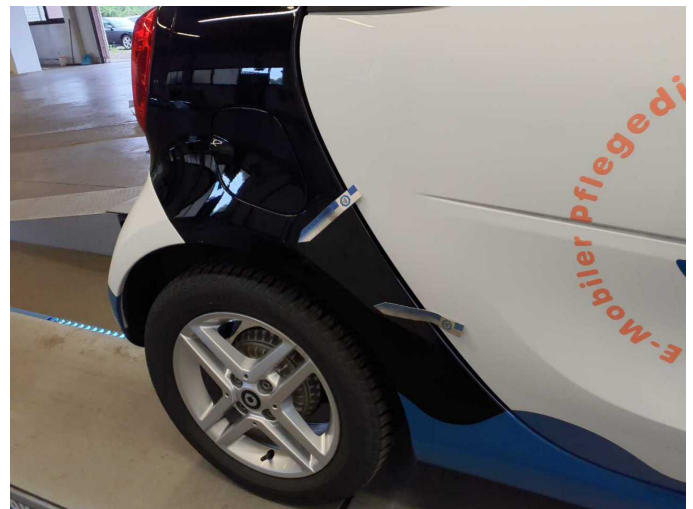
**Damage 3:** Side panel - rear right side: Wheel arch (+gebrauchsspuren) - dent(s) - Smart repair

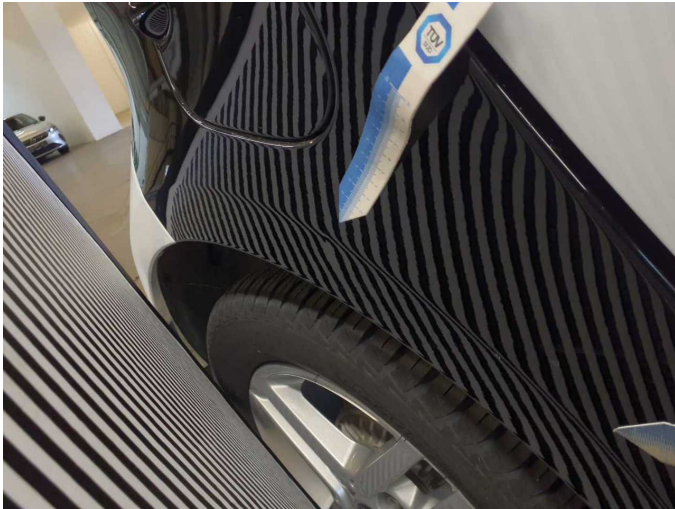
**Damage 3:** Side panel - rear right side: Wheel arch (+gebrauchsspuren) - dent(s) - Smart repair

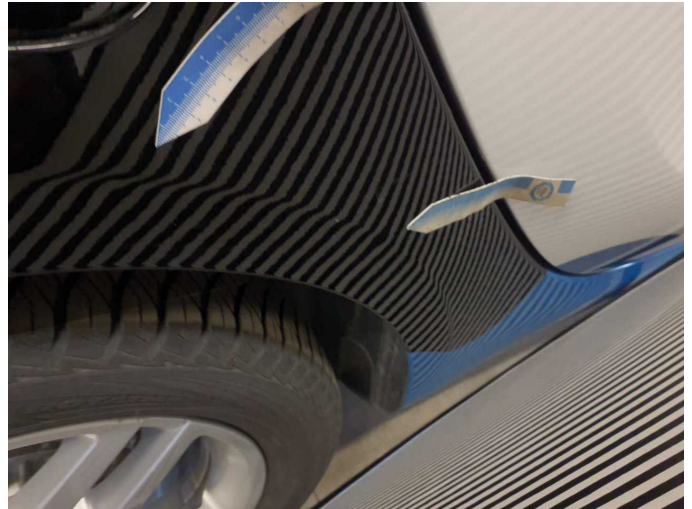
**Damage 3:** Side panel - rear right side: Wheel arch (+gebrauchsspuren) - dent(s) - Smart repair

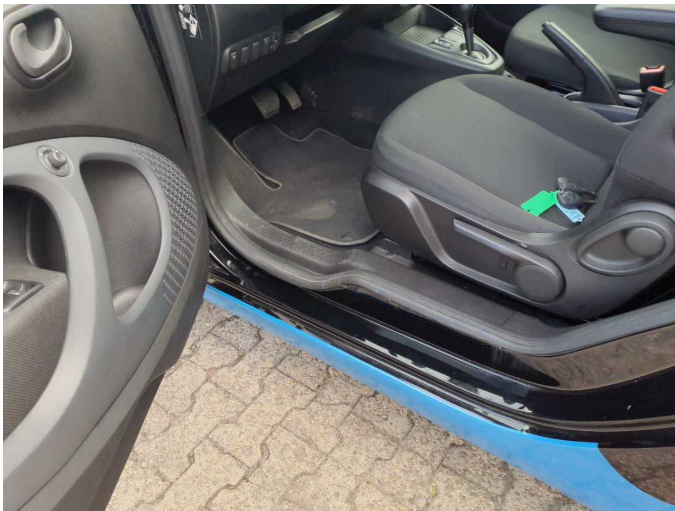
**Damage 4:** Body: Door seal - front left side - Broken / torn - Replace

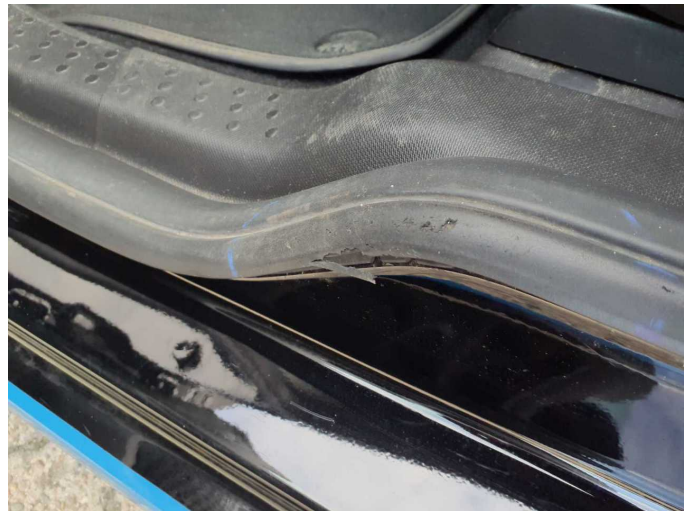
**Damage 4:** Body: Door seal - front left side - Broken / torn - Replace

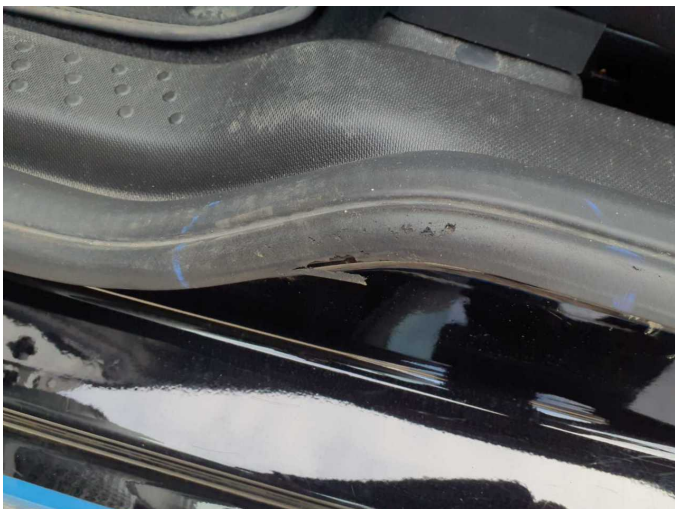
**Damage 4:** Body: Door seal - front left side - Broken / torn - Replace

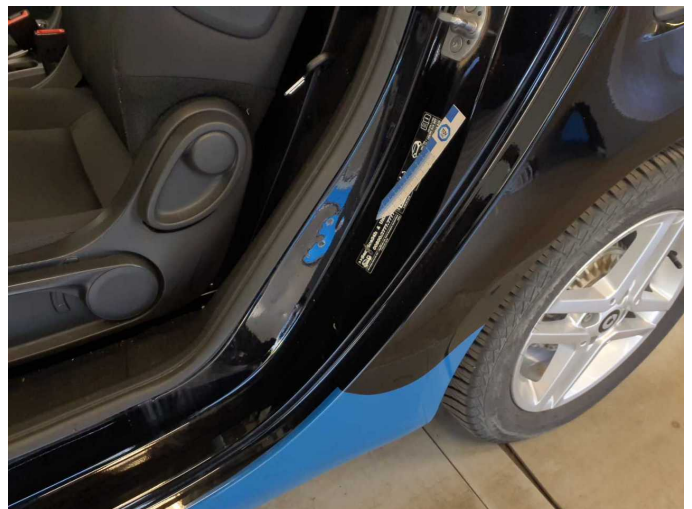
**Damage 5:** Sill - left side: Sill - Dent / paintcoat damage - Smart repair

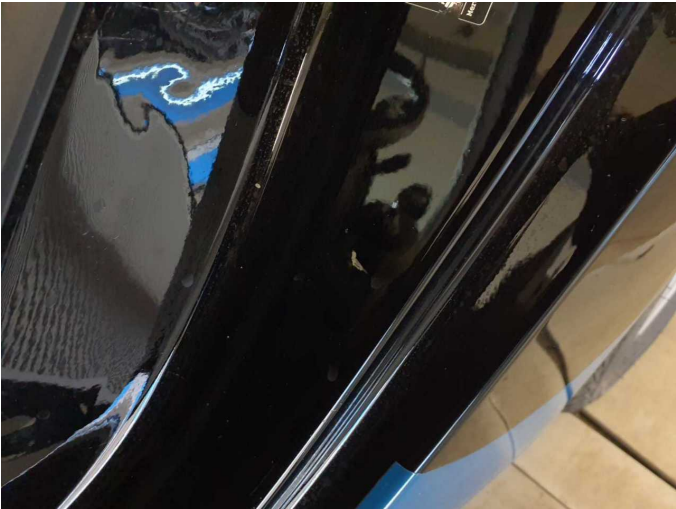
Damage 5: Sill - left side: Sill - Dent / paintcoat damage - Smart repair

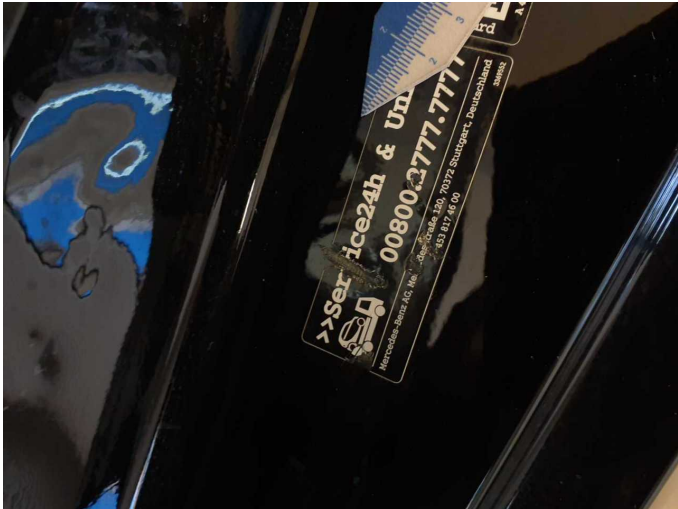
Damage 5: Sill - left side: Sill - Dent / paintcoat damage - Smart repair

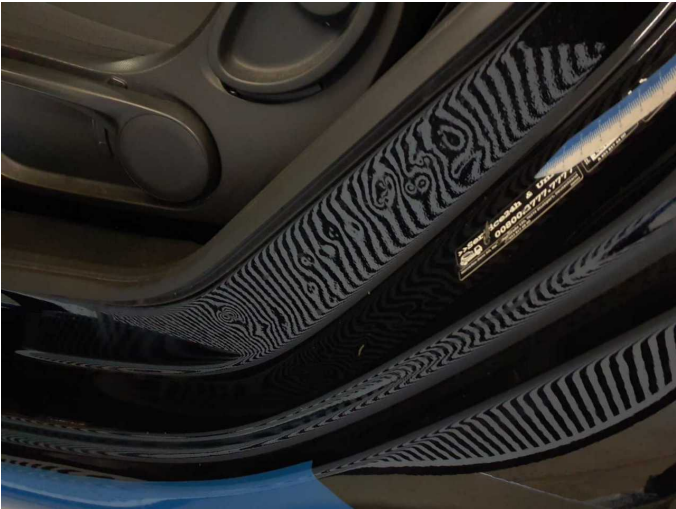
Damage 5: Sill - left side: Sill - Dent / paintcoat damage - Smart repair

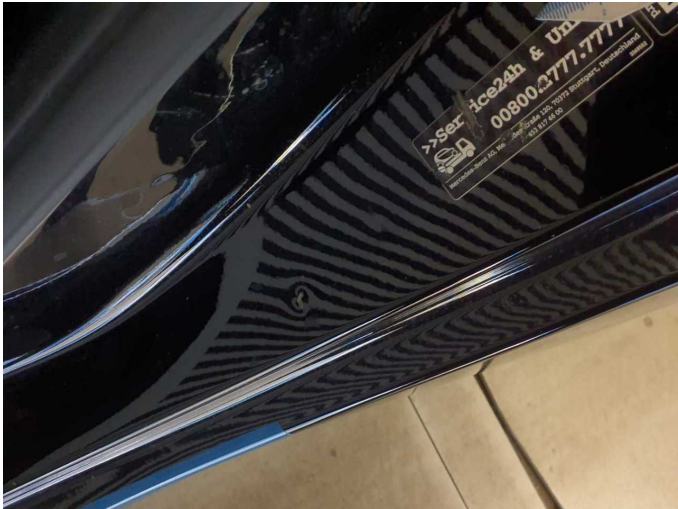
Damage 5: Sill - left side: Sill - Dent / paintcoat damage - Smart repair

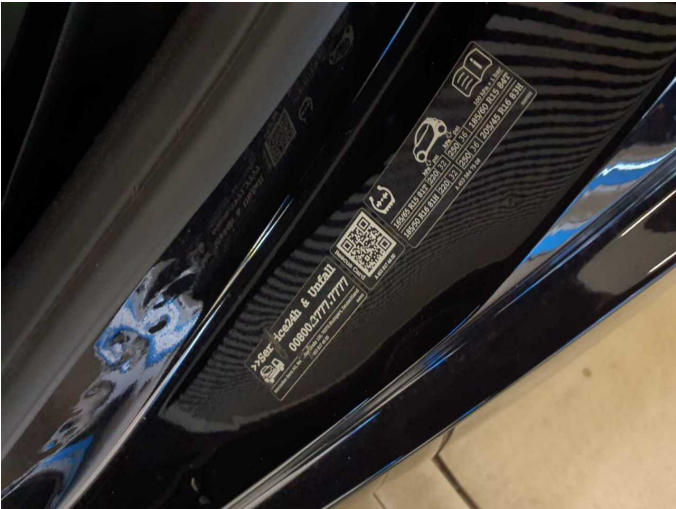
Damage 5: Sill - left side: Sill - Dent / paintcoat damage - Smart repair

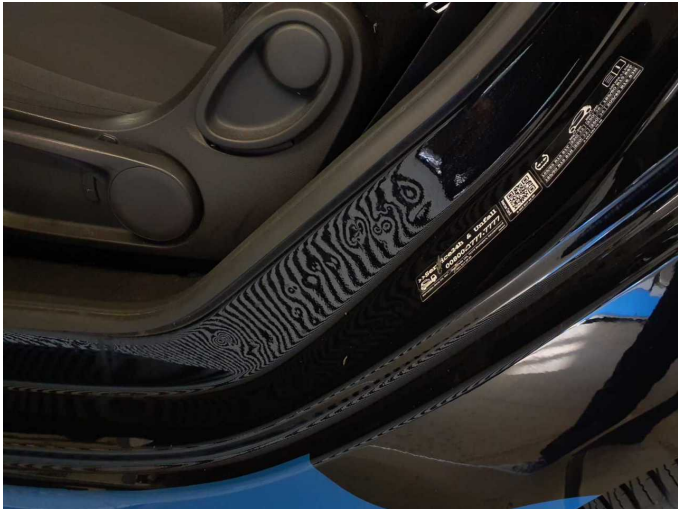
Damage 5: Sill - left side: Sill - Dent / paintcoat damage - Smart repair

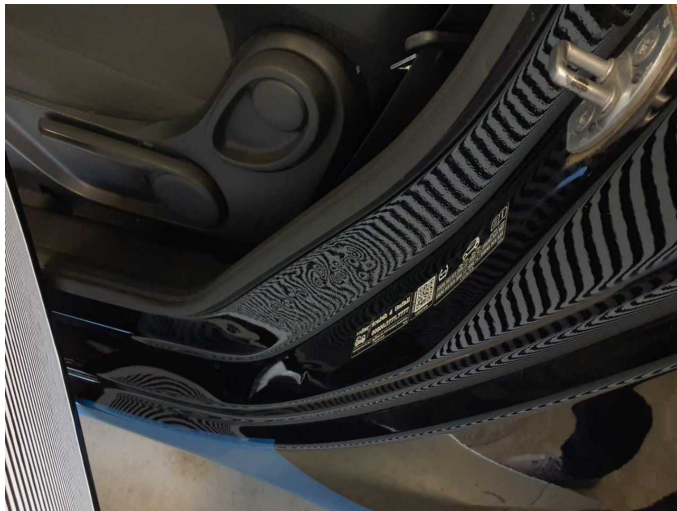
**Damage 5:** Sill - left side: Sill - Dent / paintcoat damage - Smart repair

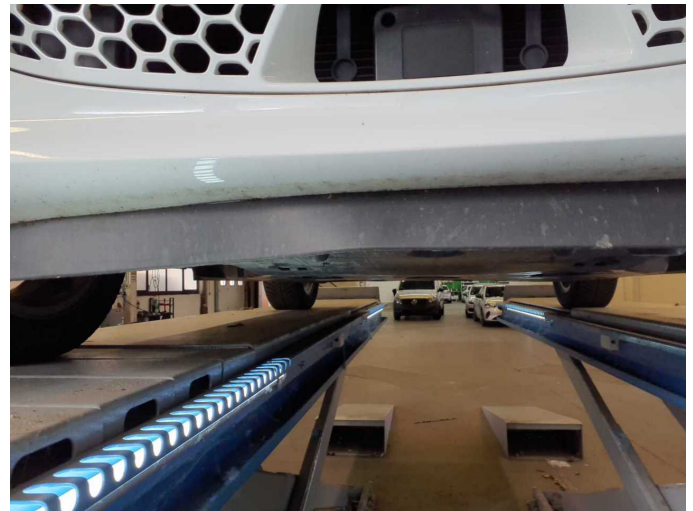
**Damage 6:** Front bumper: Spoiler - Deformed - Replace

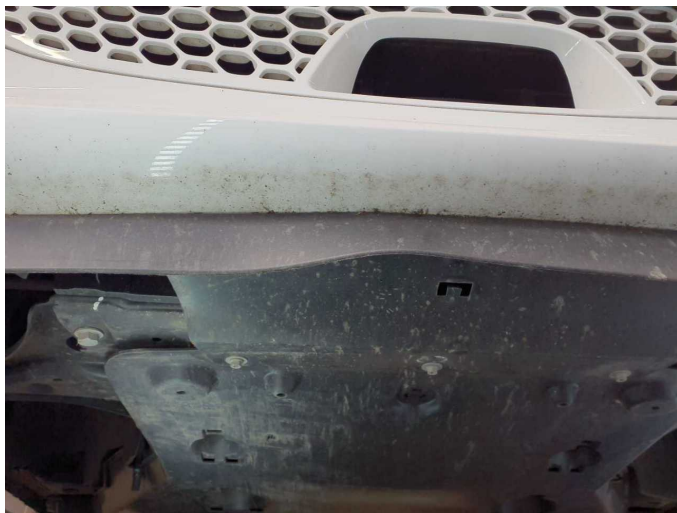
**Damage 6:** Front bumper: Spoiler - Deformed - Replace

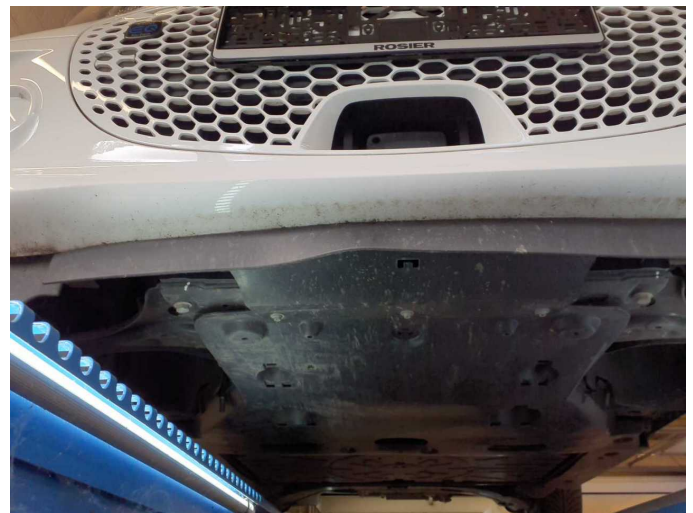
**Damage 6:** Front bumper: Spoiler - Deformed - Replace

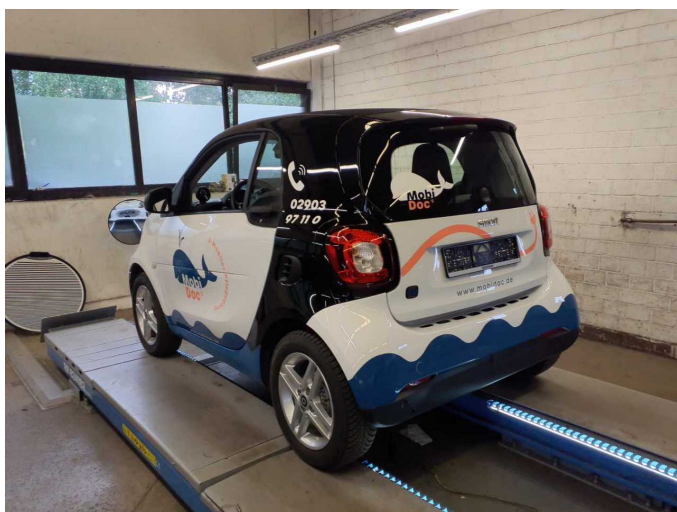
**Damage 7:** Body: Body - Glued / labelled - De-glue / neutralise

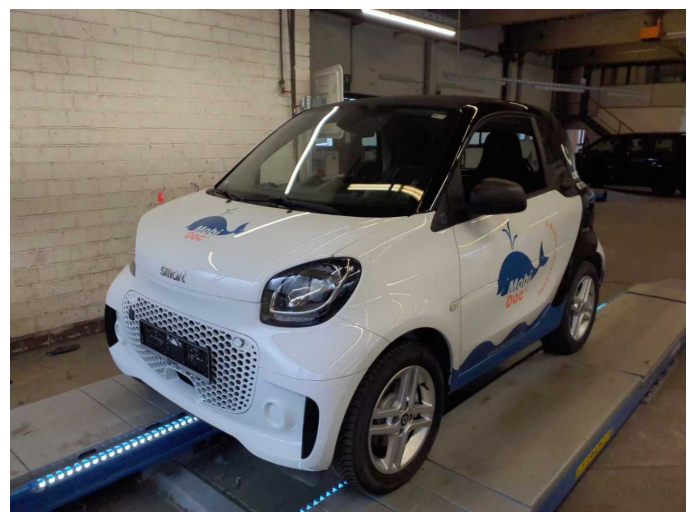
**Damage 7:** Body: Body - Glued / labelled - De-glue / neutralise

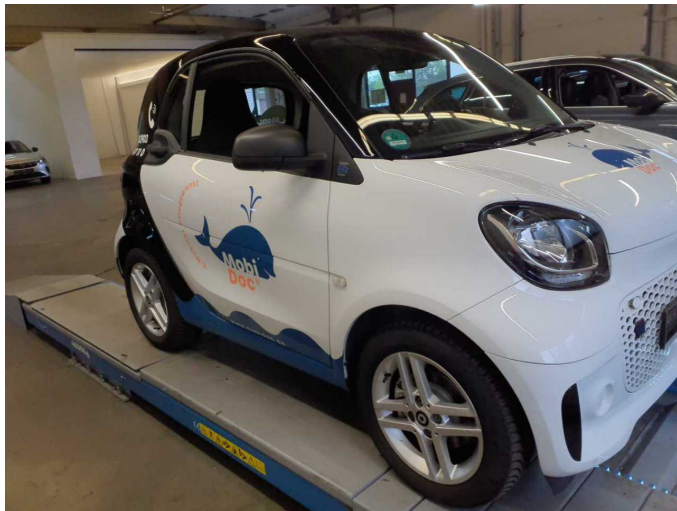
**Damage 7:** Body: Body - Glued / labelled - De-glue / neutralise

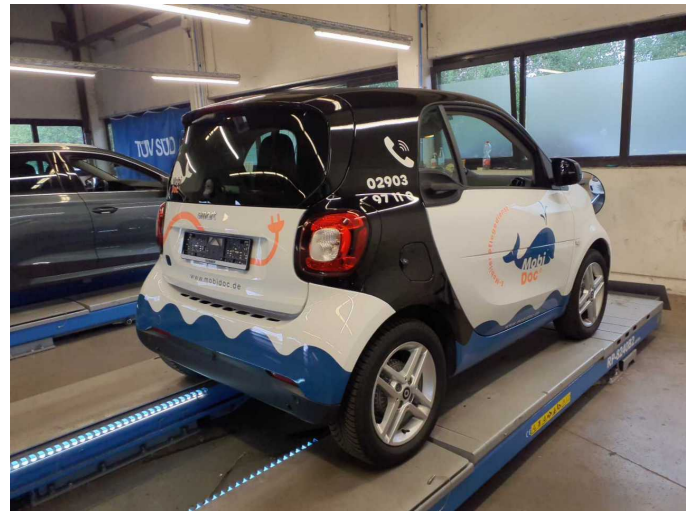
**Damage 7:** Body: Body - Glued / labelled - De-glue / neutralise

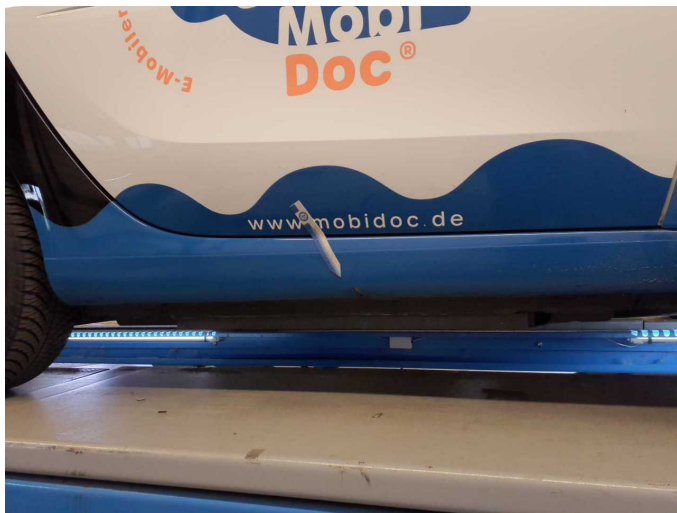
**Damage 8:** Sill - right side: Sill - Damaged - Repair and paint

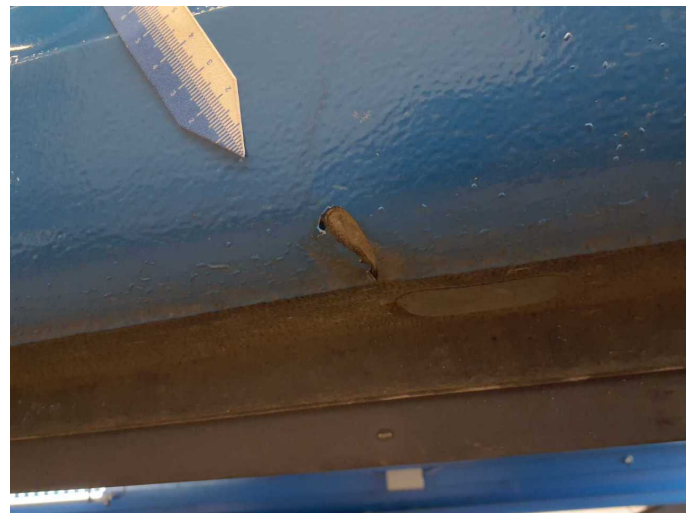
**Damage 8:** Sill - right side: Sill - Damaged - Repair and paint

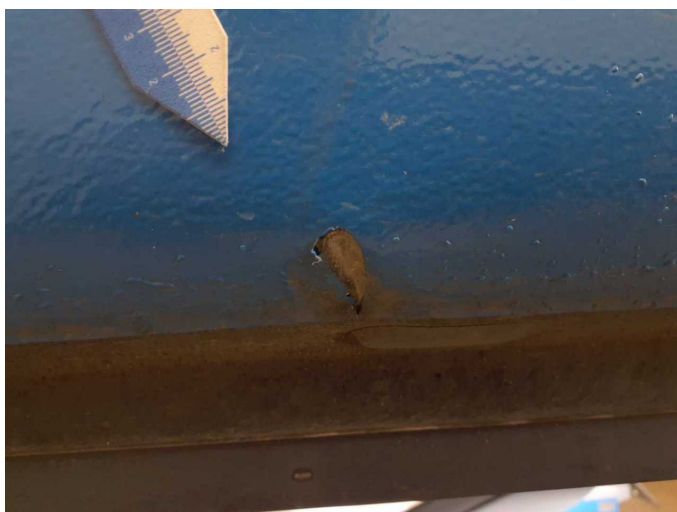
**Damage 8:** Sill - right side: Sill - Damaged - Repair and paint

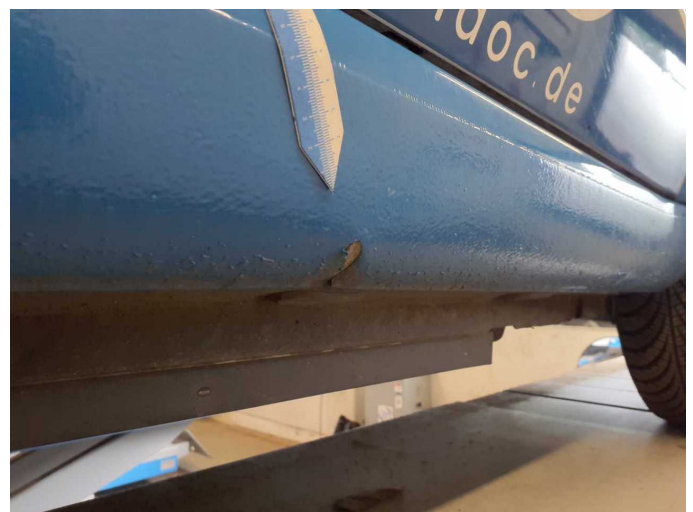
**Damage 8:** Sill - right side: Sill - Damaged - Repair and paint

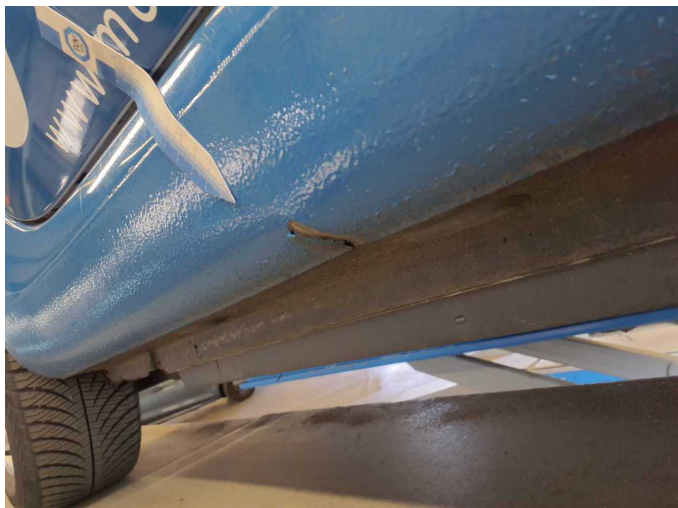
**Damage 8:** Sill - right side: Sill - Damaged - Repair and paint

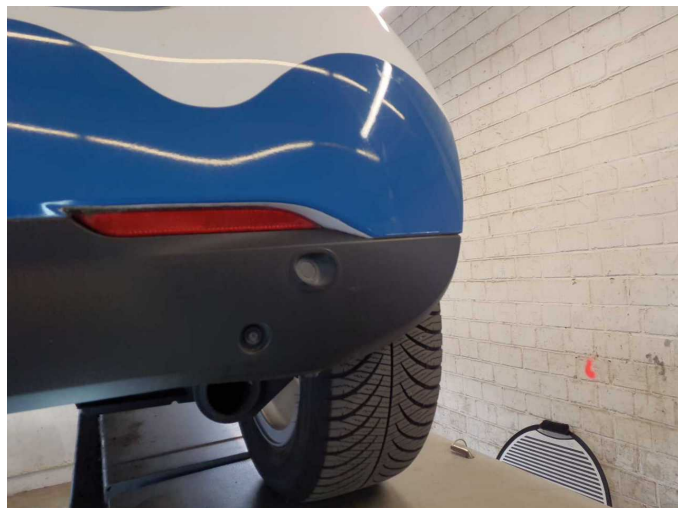
**Wear and tear 1:** Rear bumper: Rear bumper - Scratch(es) - No deduction

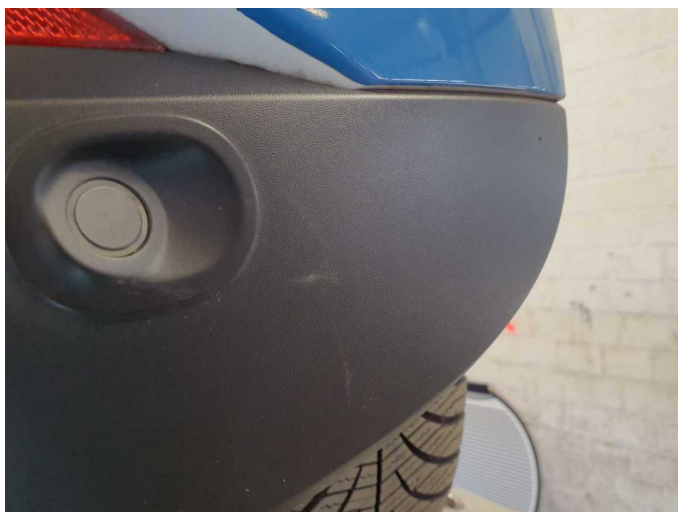
**Wear and tear 1:** Rear bumper: Rear bumper - Scratch(es) - No deduction

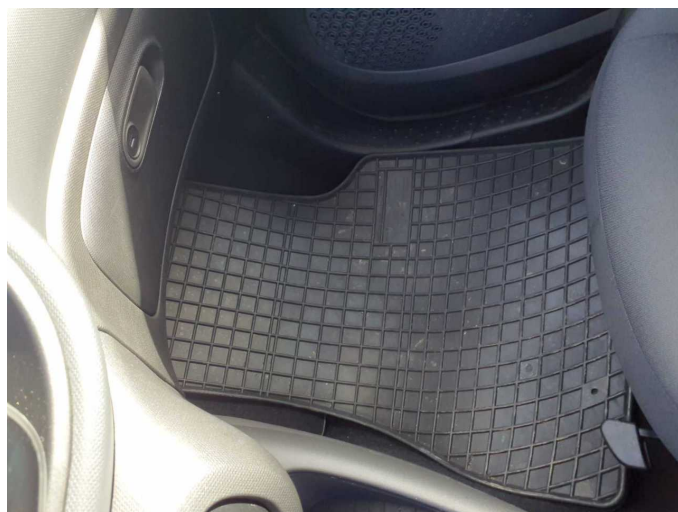
**Missing part 1:** Trim / covers: Floor mats (Rechts) - Missing - Replace
